THE ALASKA EARTHQUAKE, MARCH 27, 1964—  
EFFECTS ON COMMUNITIES

# Effects of the Earthquake Of March 27, 1964 At Anchorage, Alaska

*A description and analysis of the damage resulting from seismic vibration, ground cracks, and especially landslides in Alaska's largest city*

GEOLOGICAL SURVEY PROFESSIONAL PAPER 542-A

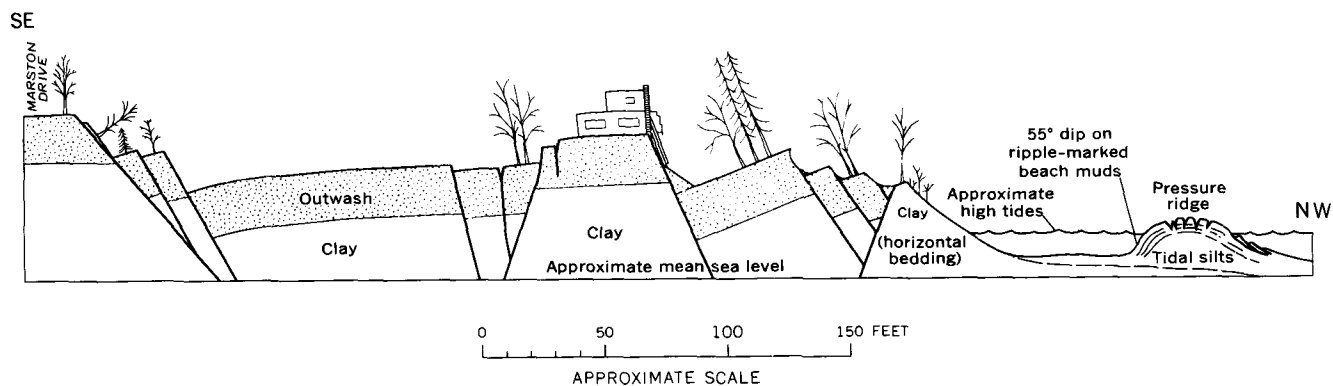
44.—Sketch section through eastern part of Turnagain Heights slide. Note pressure ridge, upright blocks at center and to left of pressure ridge, and tilted collapsed blocks between.
