THE ALASKA EARTHQUAKE, MARCH 27, 1964:
EFFECTS ON COMMUNITIES

Effects of the Earthquake
Of March 27, 1964
On the Communities of
Kodiak and Nearby Islands

By REUBEN KACHADOORIAN and GEORGE PLAFKER

GEOLOGICAL SURVEY PROFESSIONAL PAPER 542-F

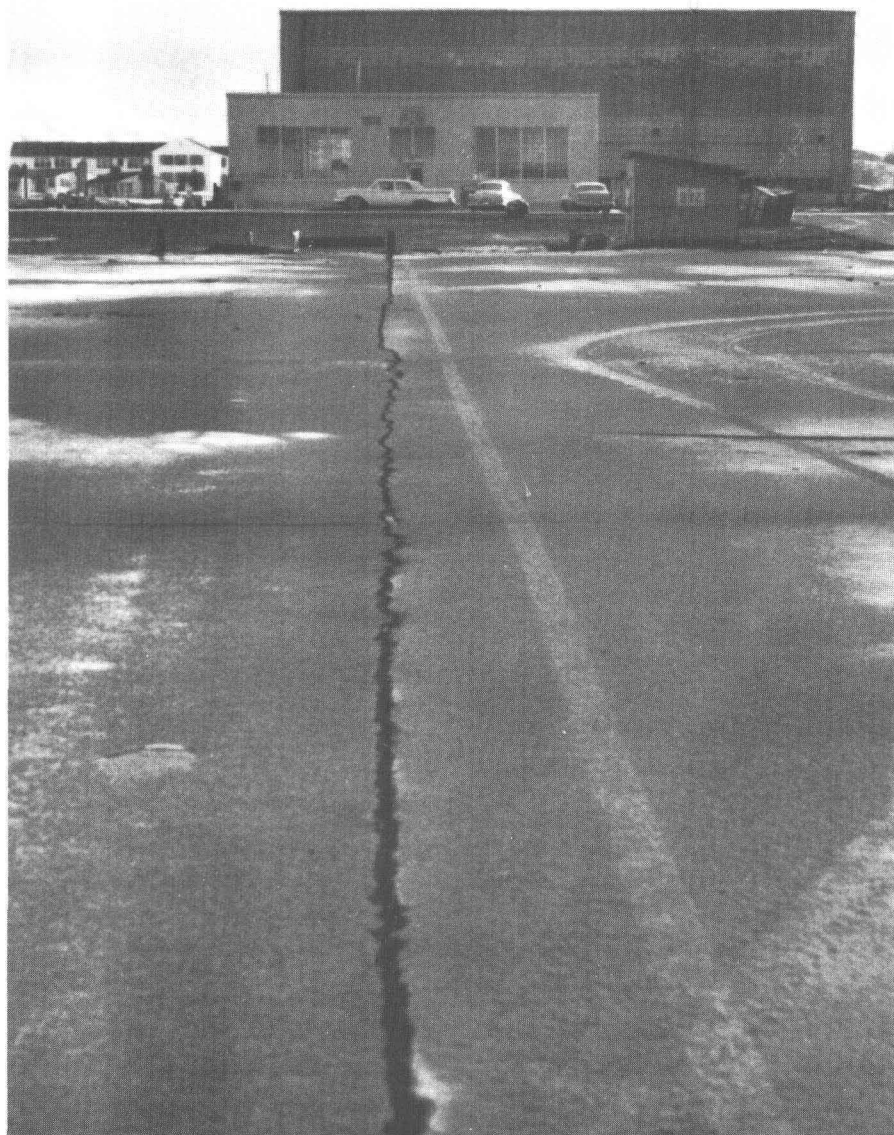
3.—East-west-trending fissure in aircraft parking ramp at Kodiak Naval Station. View is west. Photograph by U.S. Navy, March 29, 1964.

One of the effects of the earthquake was the development of fissures in the low-lying areas underlain by unconsolidated sediments and artificial fill. Fissuring occurred in the asphalt of the aircraft parking ramps at the head of Womens Bay (fig. 3) and along the highways throughout the station. Figure 3 shows a long east-west-trending fissure. The surface ex-

pression of the fissure may in part be controlled by the type of construction that was employed when the asphalt was placed and may actually represent a construction joint. The fissures developed only in areas where more than 5 feet of unconsolidated deposits or fill overlay the bedrock. In at least one locality, at the aircraft parking ramps, fissures developed primarily as a result of seismic shaking that caused some lateral extension or displacement of the unconsolidated deposits and artificial fill toward a free face. The sediments underlying the parking

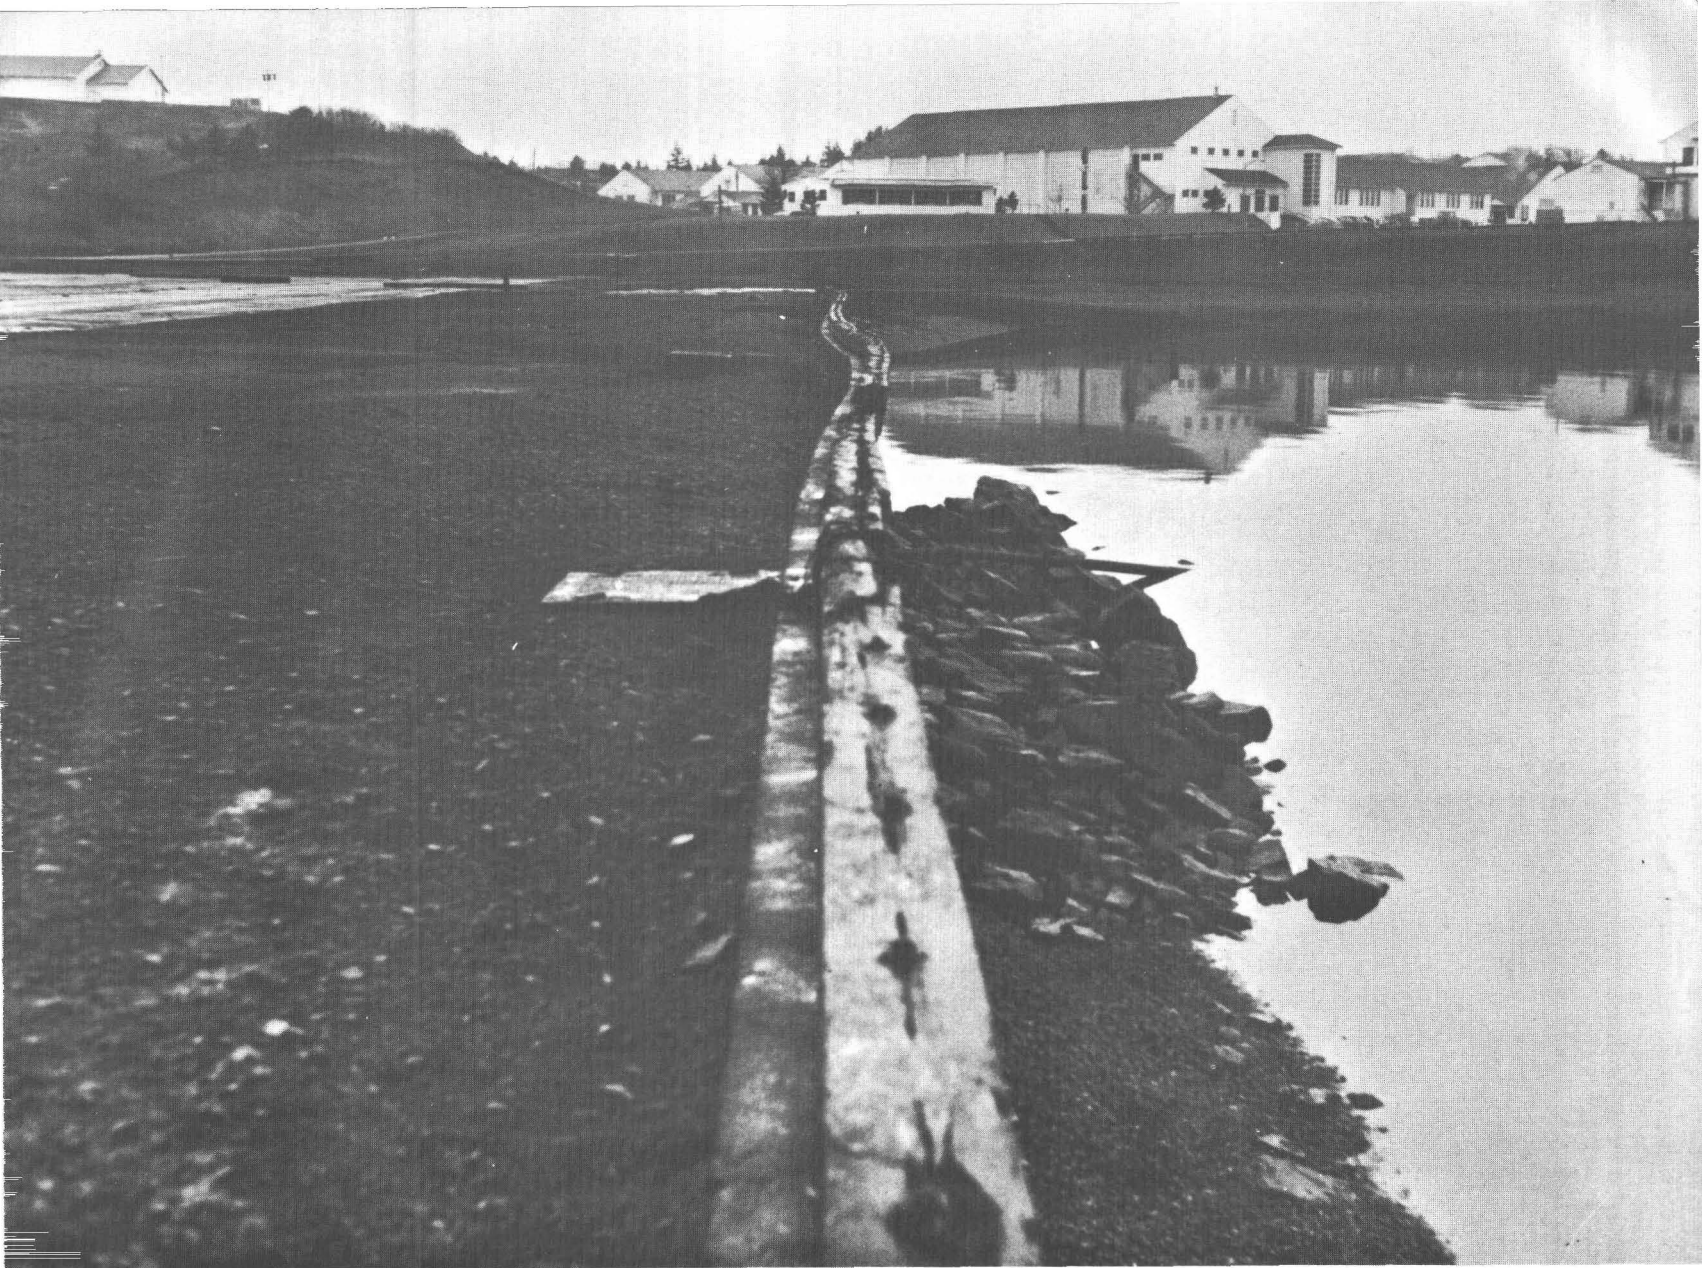
4.—Displacement of seawall toward Womens Bay, Kodiak Naval Station. View is east. Photograph by U.S. Navy, April 1, 1964.

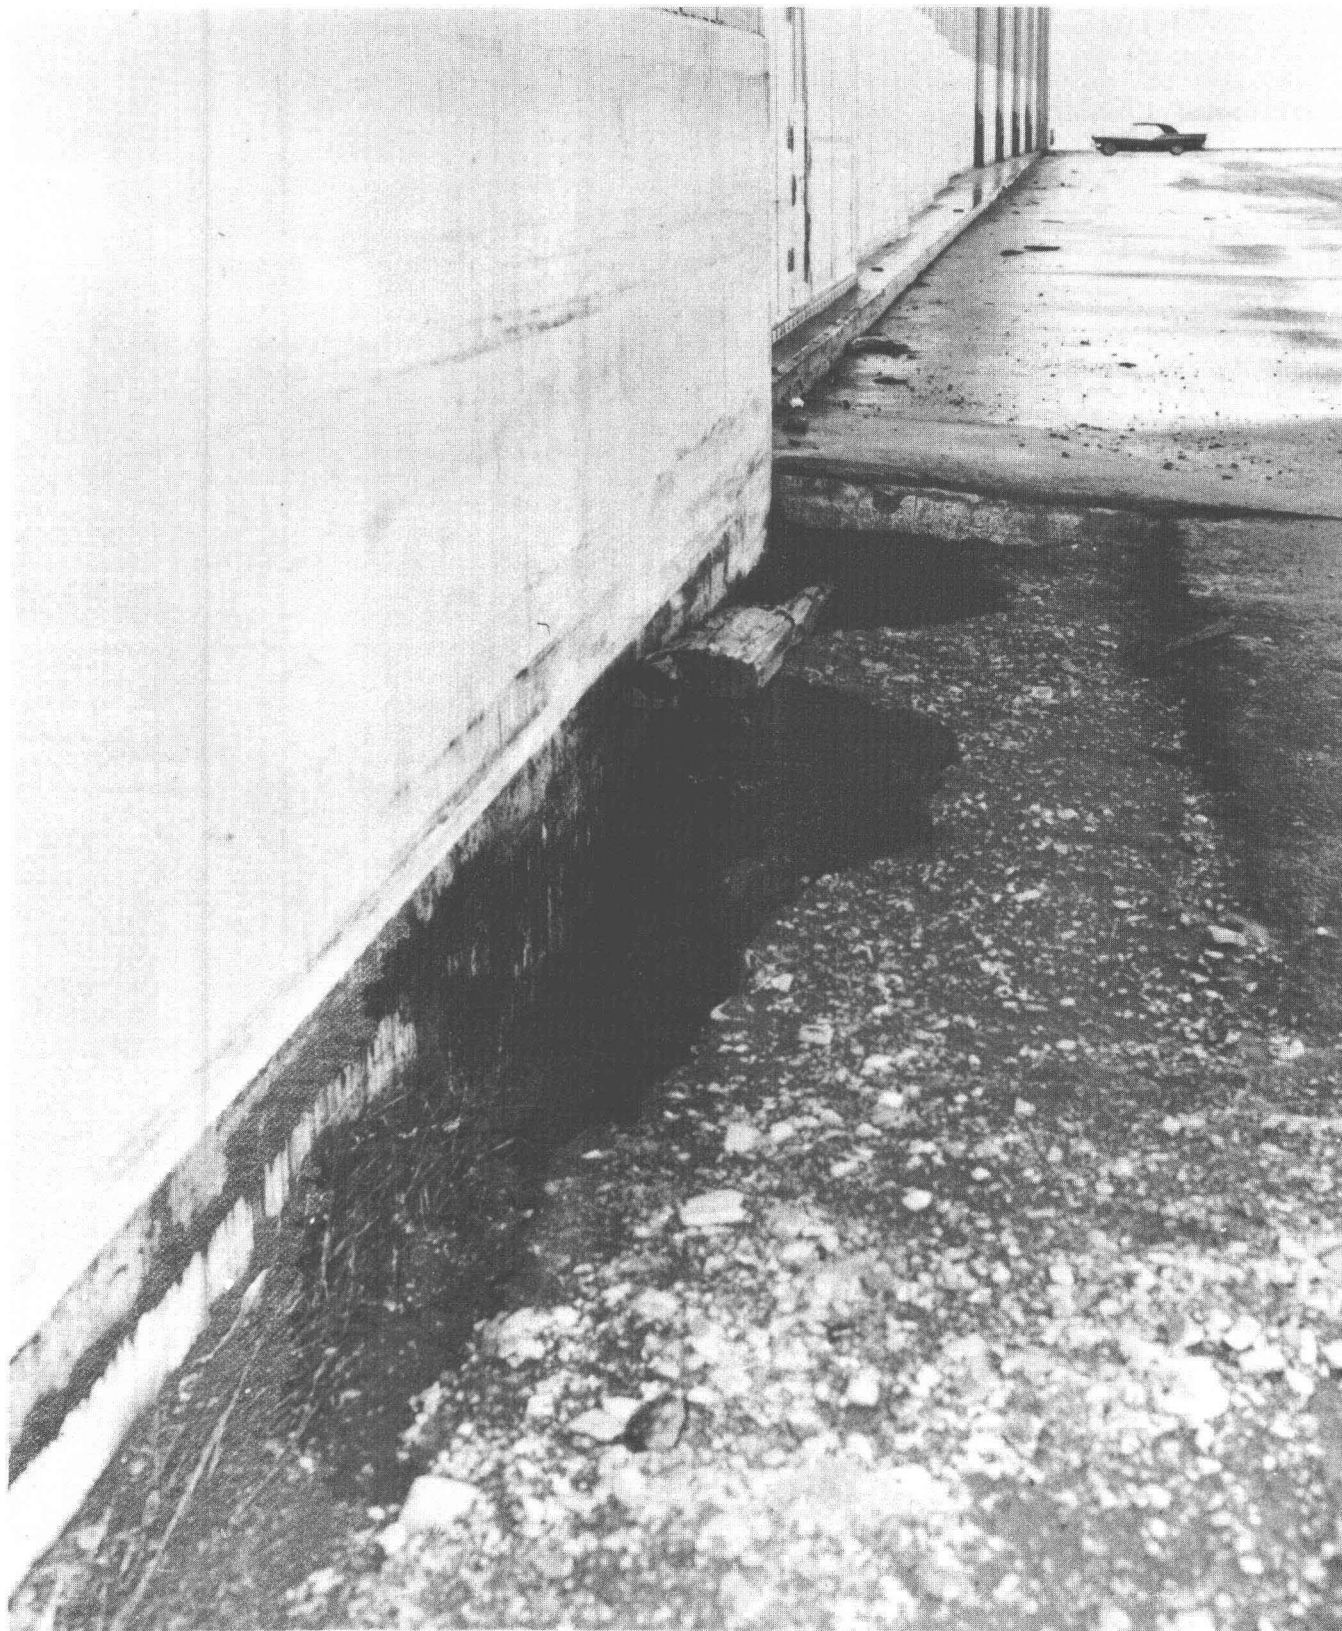
Differential settlement, or compaction, took place in the unconsolidated sediments underlying some of the structures at the Kodiak Naval Station. The compaction was due to seismic action and amounted to as much as 1 foot beneath hanger 1. Compaction of fill also occurred under the asphalt aircraft ramp outside a hangar (fig. 5, next page). The compac-

5.—Result of compaction of fill debris underlying asphalt aircraft ramp outside hangar at Kodiak Naval Station. Note the settlement of back-fill material adjacent to foundation of structure in the foreground. Photograph by U.S. Navy, March 29, 1964.

tion here was so great that a step several inches high developed between the footing of the hangar and the ramp. The hangar footing itself had some slight differential settling. Locally, the backfill material against the foundation of the hangar has compacted substantially. One might expect that scouring would have occurred during the retreat of the inundating seismic sea waves, but if it had occurred, it would have been widespread throughout the naval station, and none was observed. Furthermore, we noted the same

phenomenon of differential compaction at the Eklutna Hydroelectric Project near Anchorage, Alaska, where seismic sea waves had not inundated the area. The hangars were constructed on 15–20 feet of engineered fill consisting of glacial debris (Tudor, 1964). The columns of the hangars rested on piles, whereas the deck of the hangars rested on fill. There apparently was not settlement of the columns of the hangars, but differential settlement of the fill beneath the hangar footings caused slight deformation of the bracing

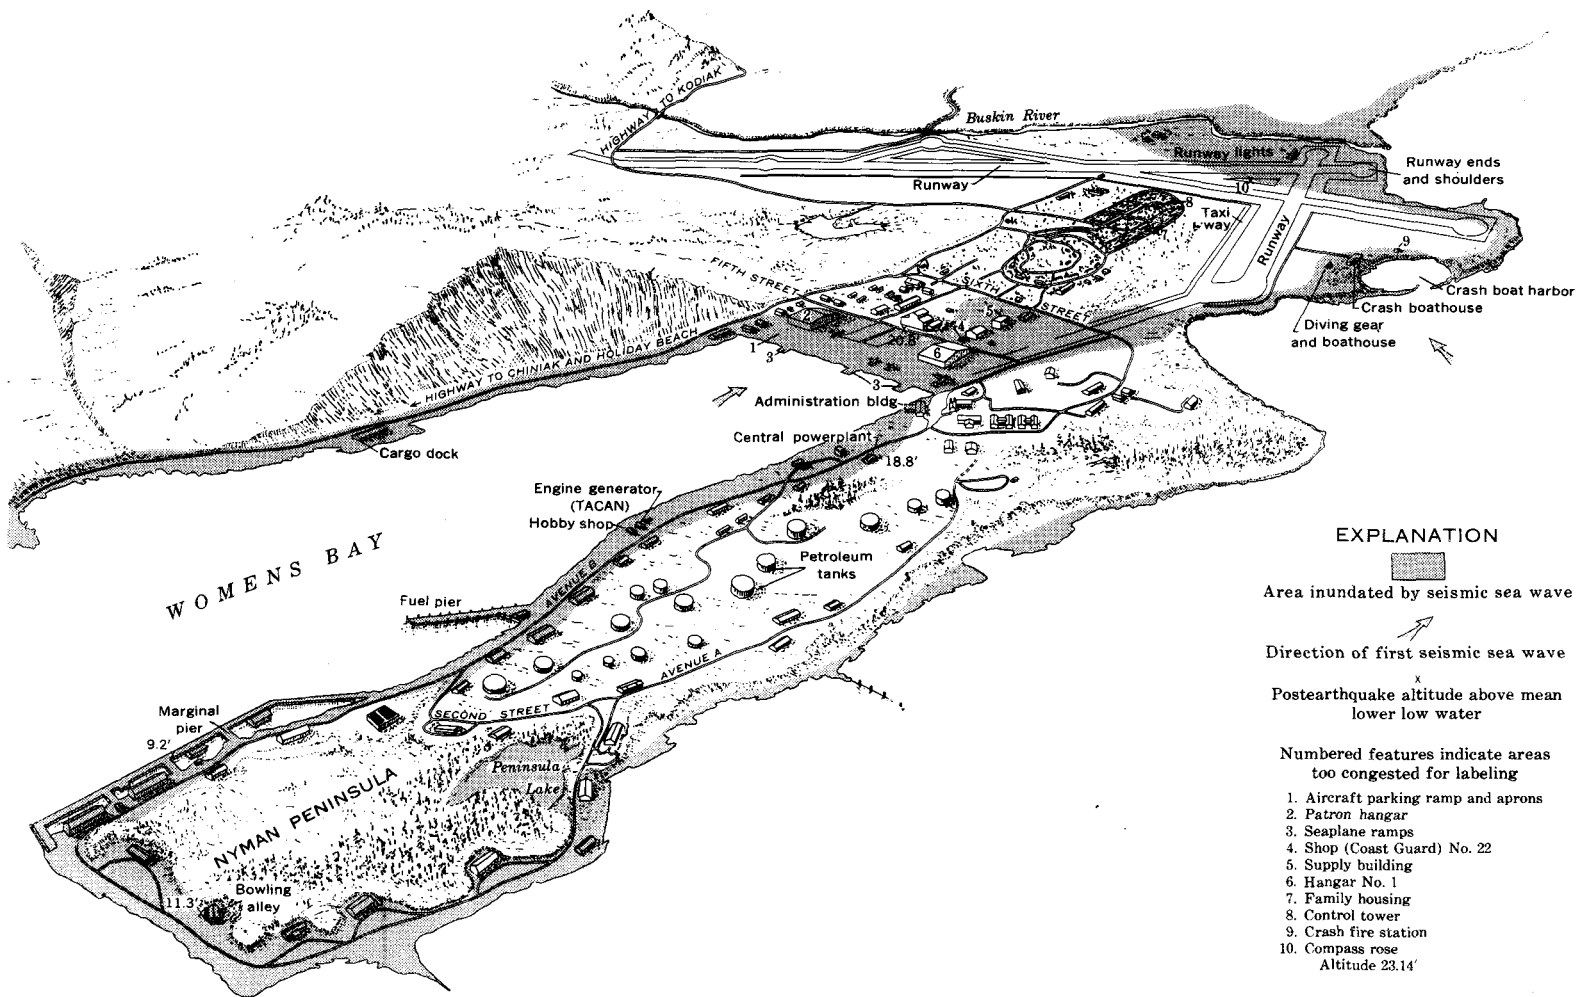
6.—Area of maximum inundation by seismic sea waves and structures damaged at Kodiak Naval Station.

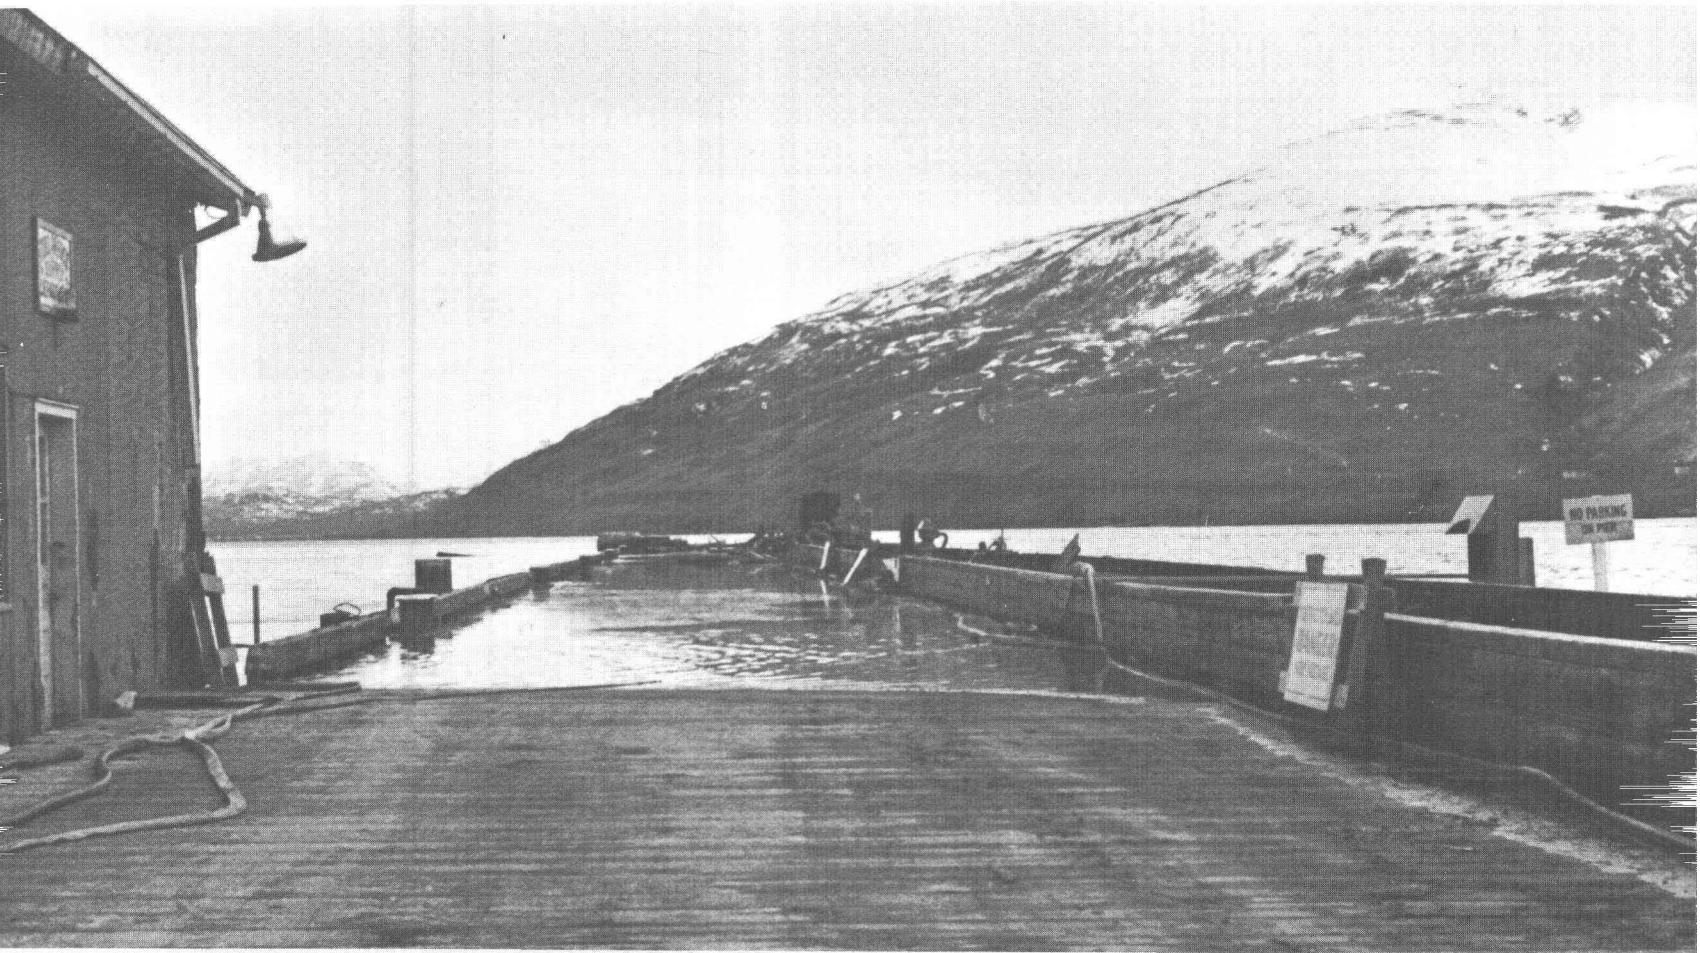
7.—Inundation of fuel pier during high tide at Kodiak Naval Station. Photograph by U.S. Navy, 12:59 p.m., April 12, 1964.

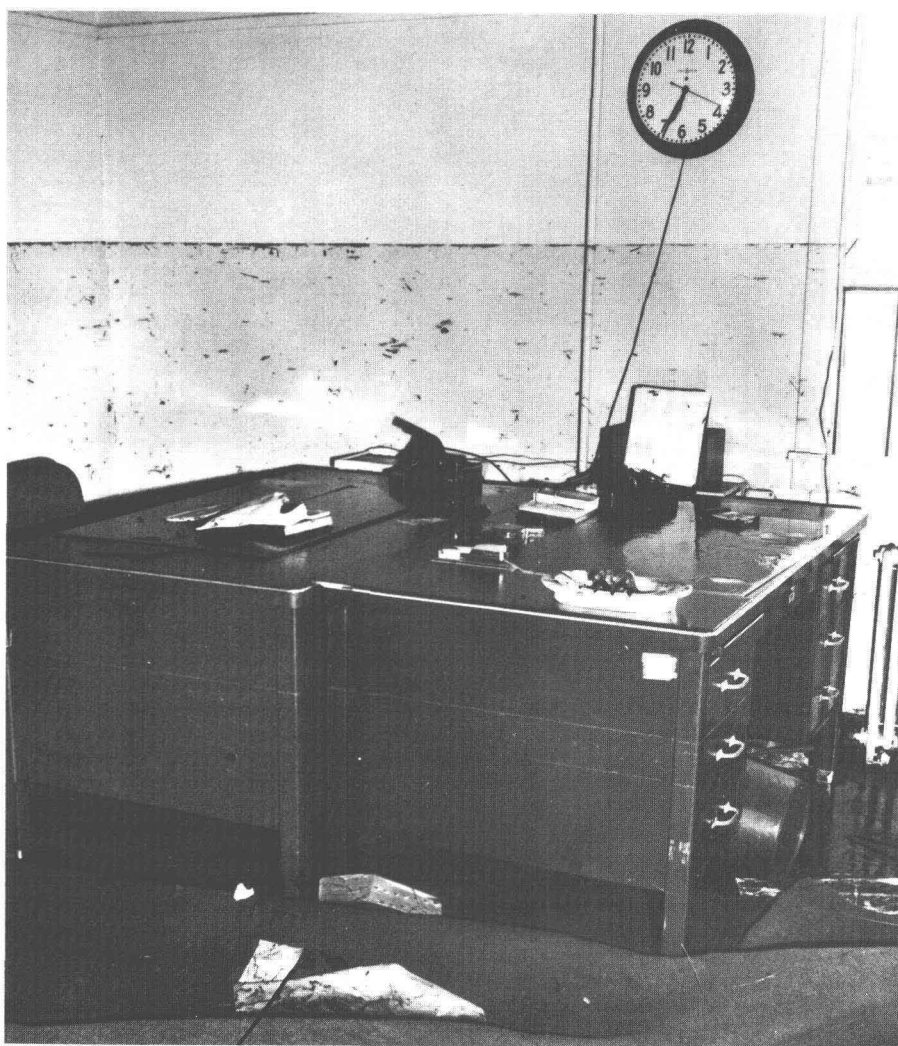
9.—Clock in the intelligence office, Kodiak Naval Station, showing time power failed at the station. Black watermark on the wall indicates maximum height of inundation. Photograph by U.S. Navy, March 29, 1964.

station buildings and living quarters were lost. The same wave broke water mains and disrupted water service to the structures. Figure 9, a photograph of the naval station intelligence office, indicates that power was cut off at about 6:39 p.m. Figure 10 shows the first seismic sea wave striking the hangar area at the northeast head of Womens Bay. The two PV2 Neptune aircraft of Patrol

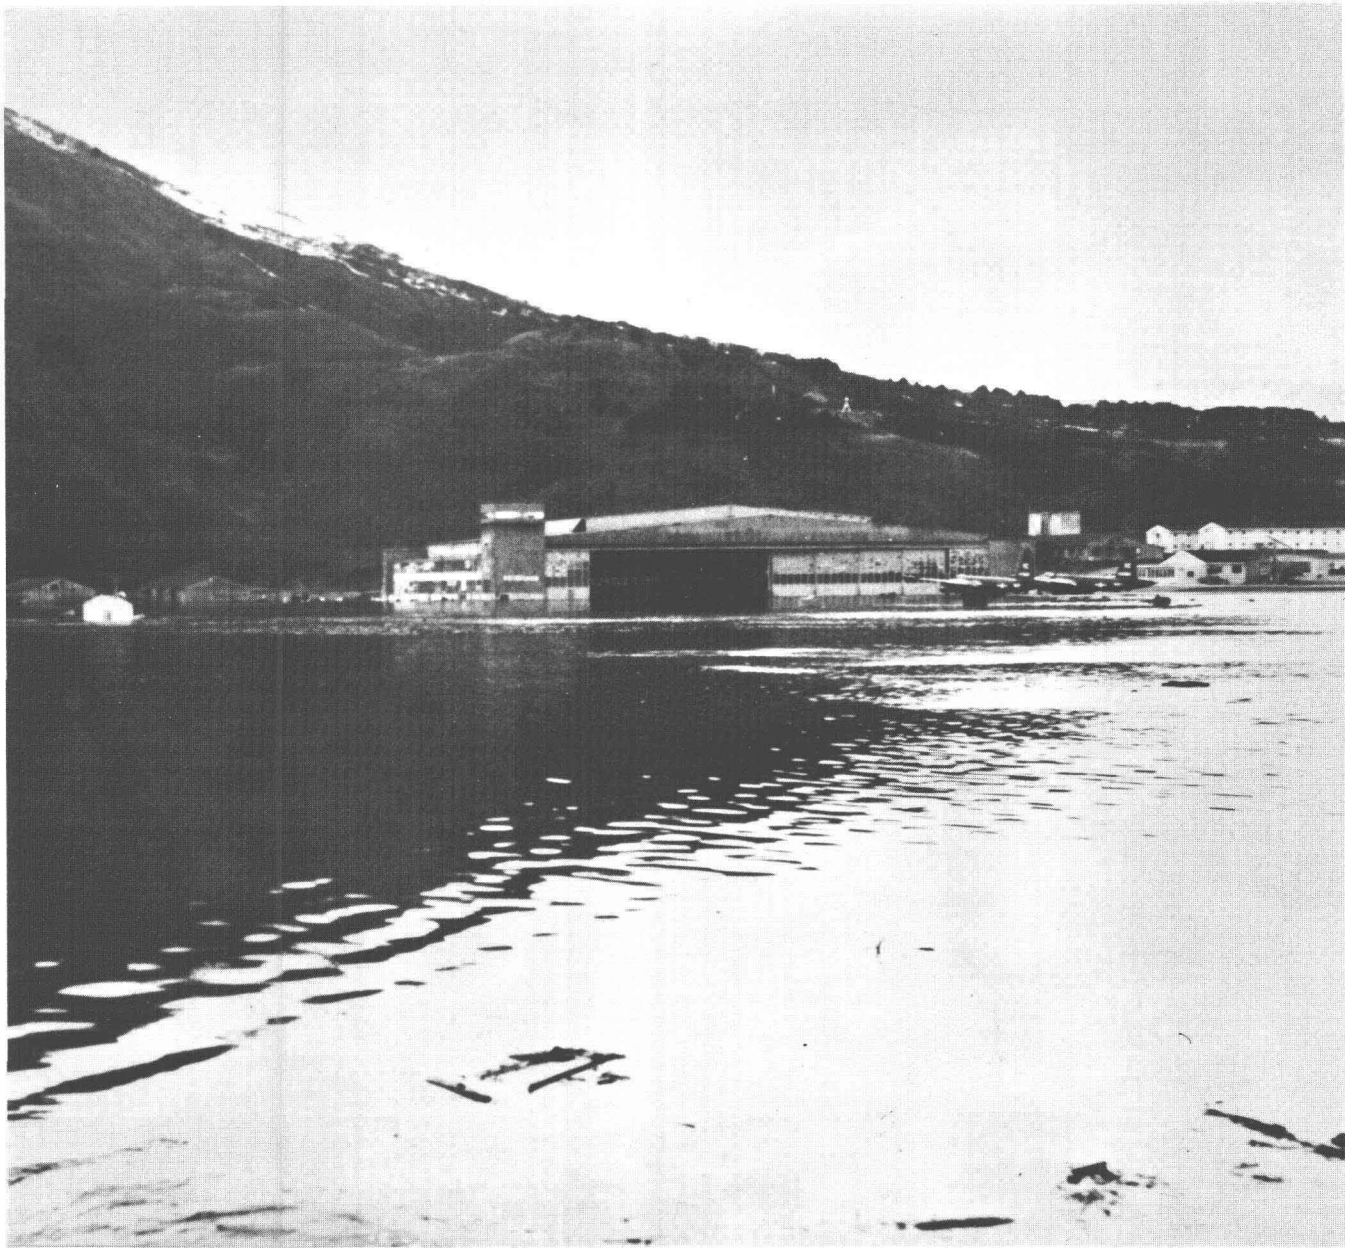
10.—First seismic sea wave flooding parts of the Kodiak Naval Station. View is west. Photograph by U.S. Navy, March 27, 1964.

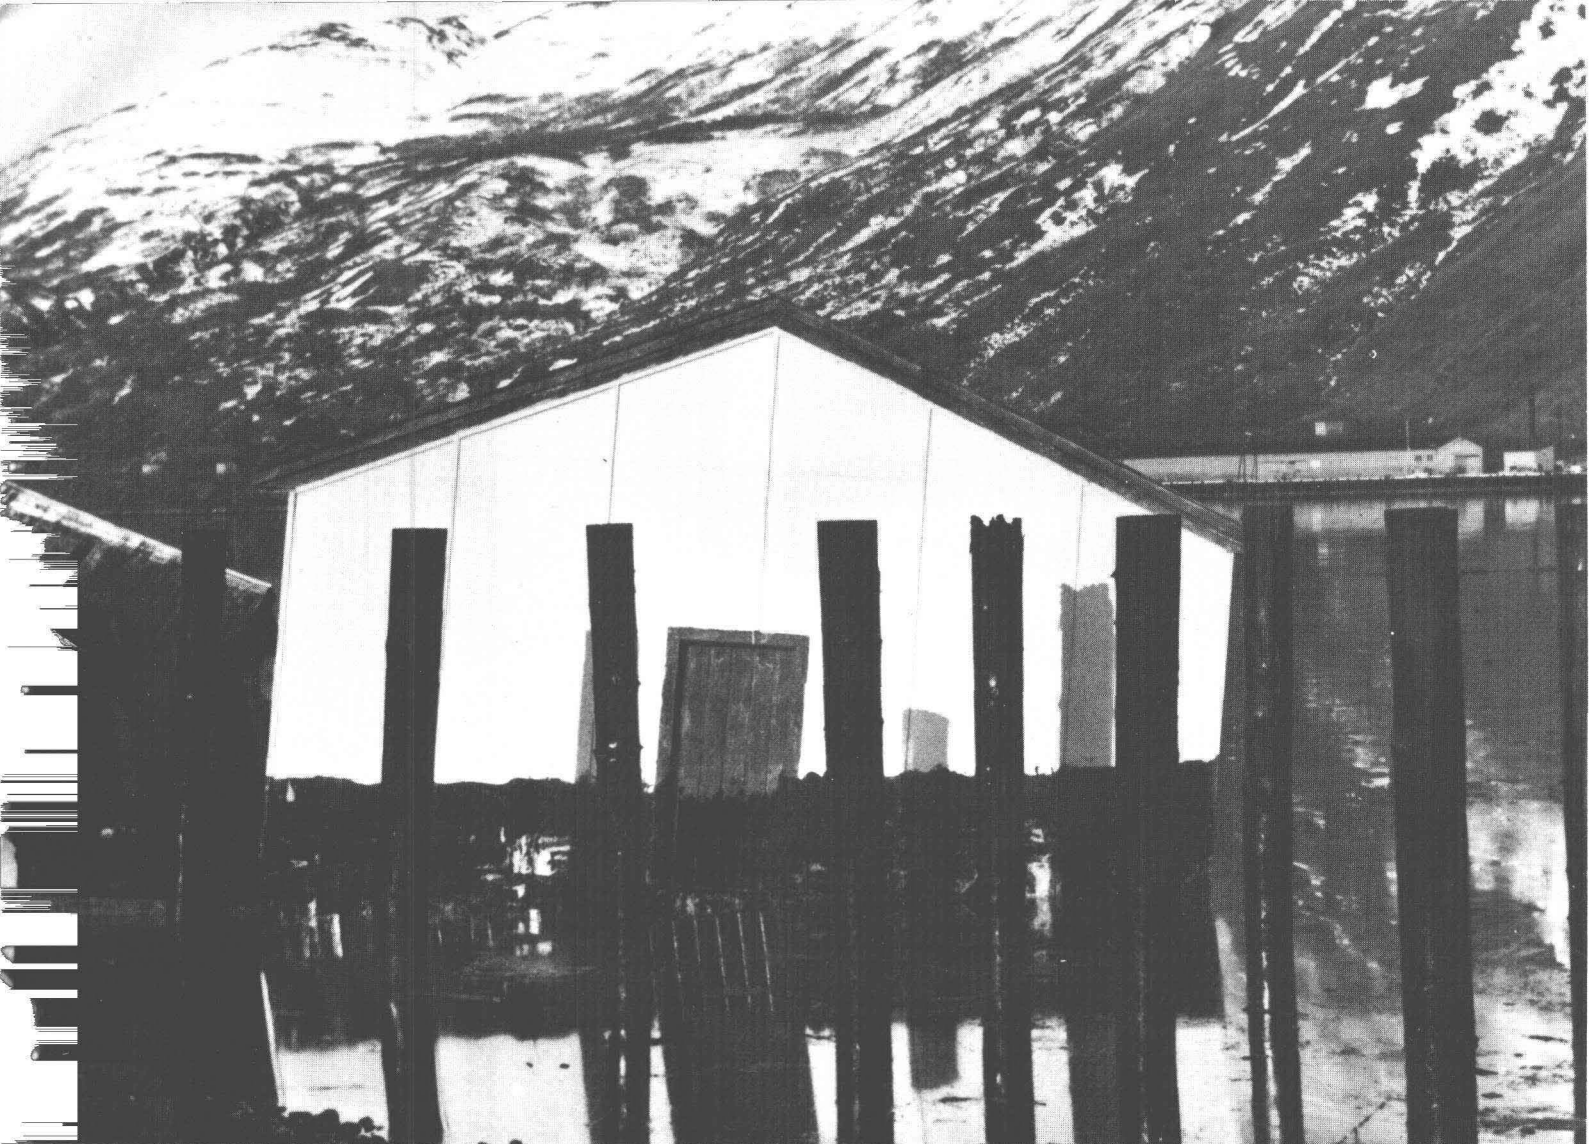
11.—Hobby shop swept off its piling foundation by seismic sea waves, Kodiak Naval Station. Black poles are piles upon which structure rested prior to the earthquake. Photograph by U.S. Navy, March 28, 1964.

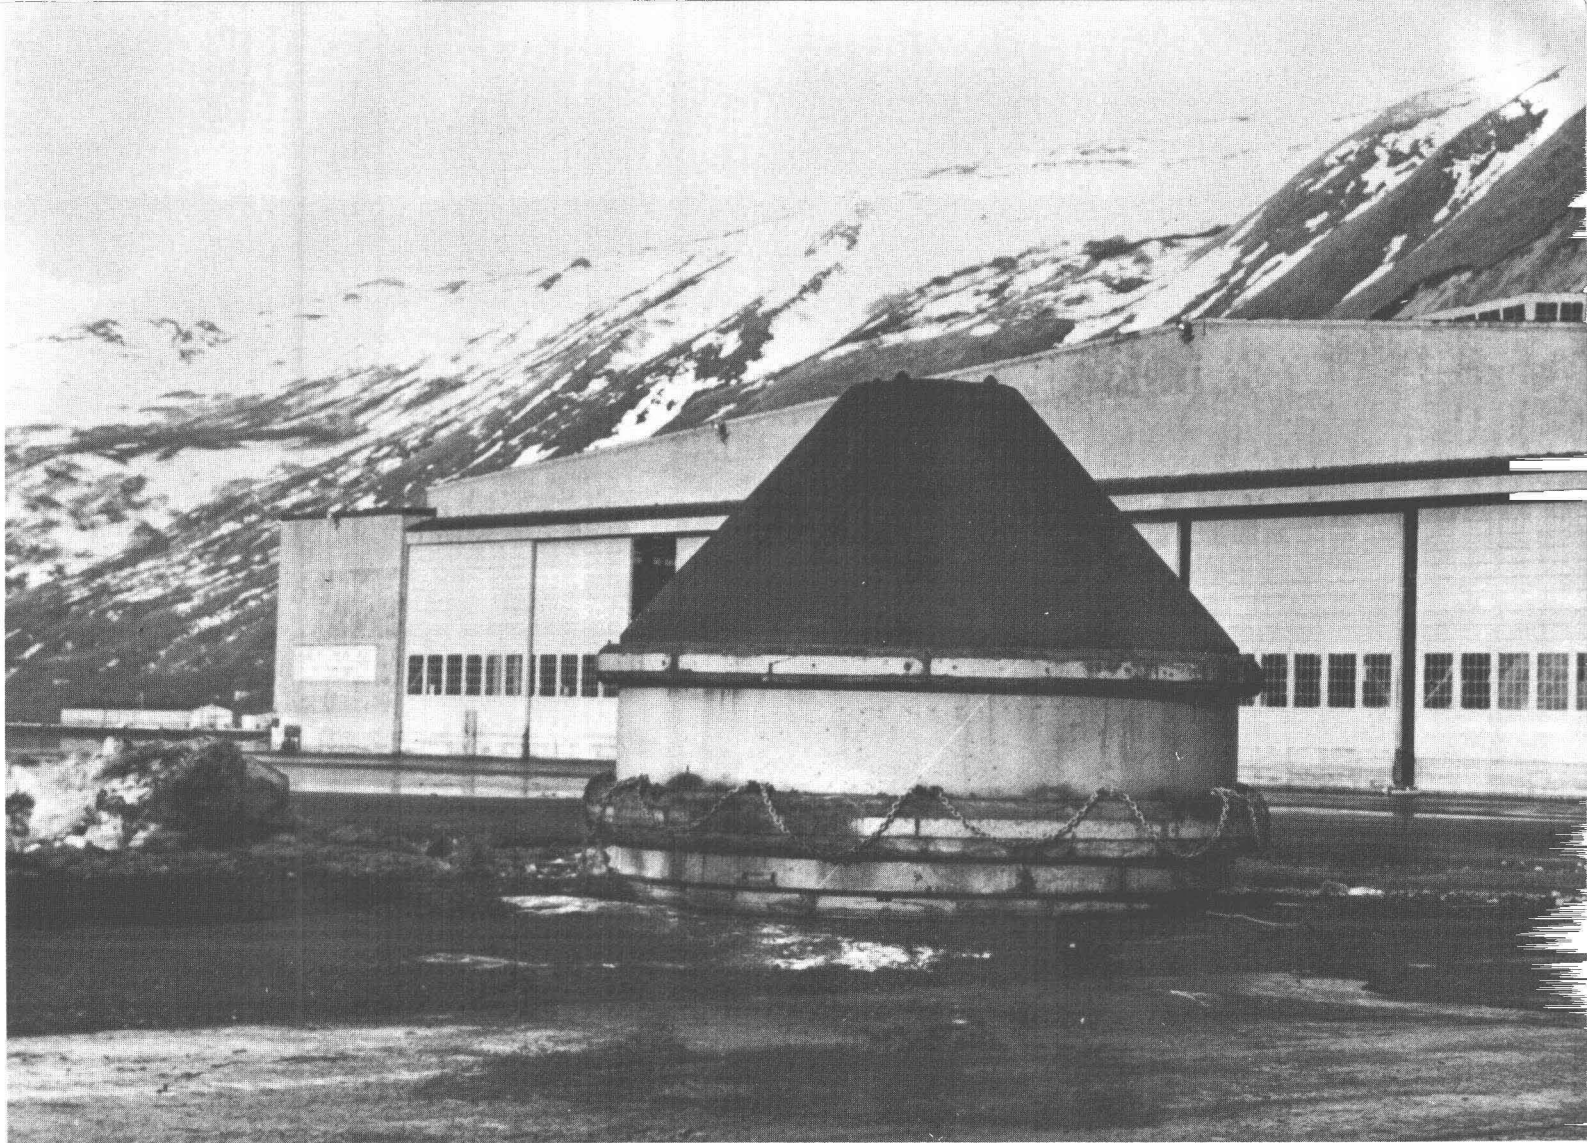
12.—Mooring buoy washed ashore by seismic sea waves, Kodiak Naval Station. Photograph by U.S. Navy, March 28, 1964.

The water also tore loose a 10-ton mooring buoy from its anchorage and deposited it on the taxiway near the supply building (fig. 12). The buoy was carried about a quarter of a mile inland by the water and came to rest at a post-earthquake altitude of about 16 feet. It was carried to this position by the fifth seismic sea wave, which crested, between 11:16 and 11:34 p.m. on March 27, 18.8 feet above postearthquake MLLW.

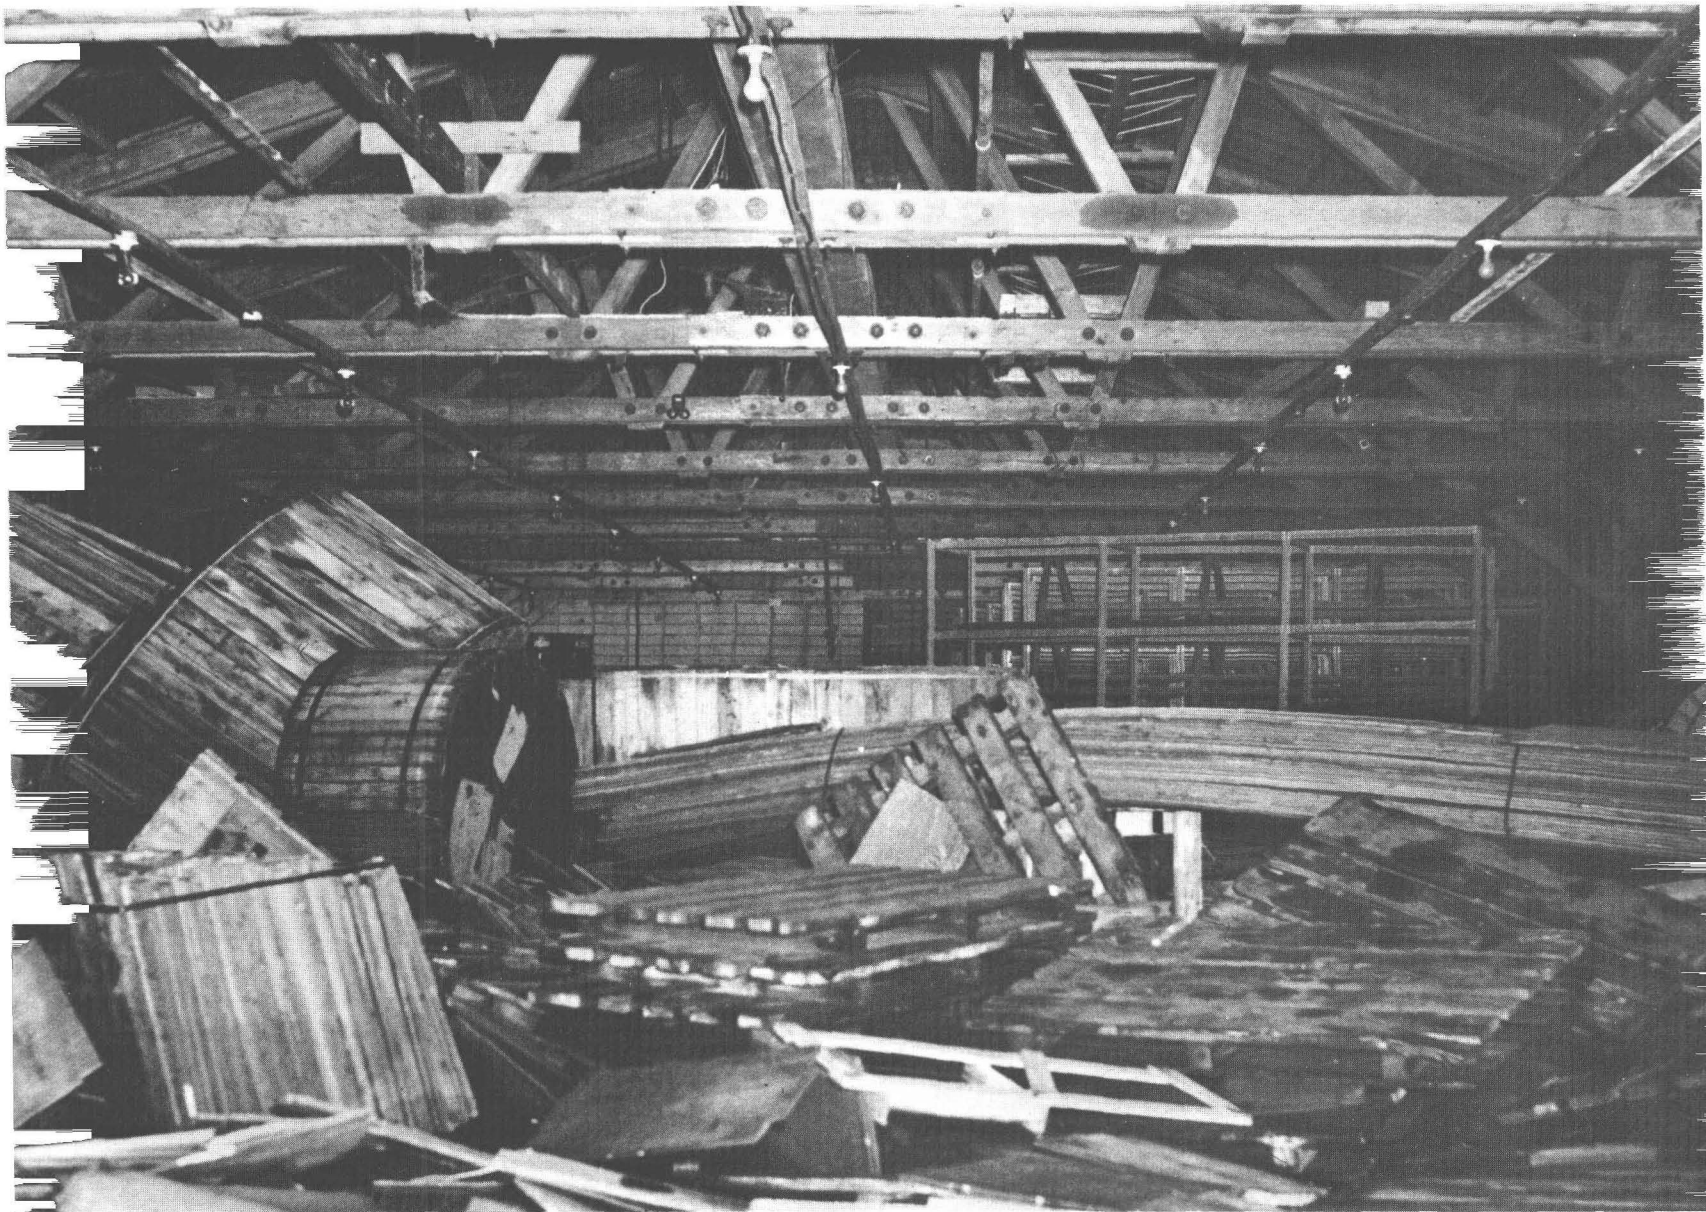
13.—Photograph of interior of supply building, Kodiak Naval Station, showing condition of supplies stored in building after the retreat of the seismic sea waves. Photograph by U.S. Navy, March 29, 1964.

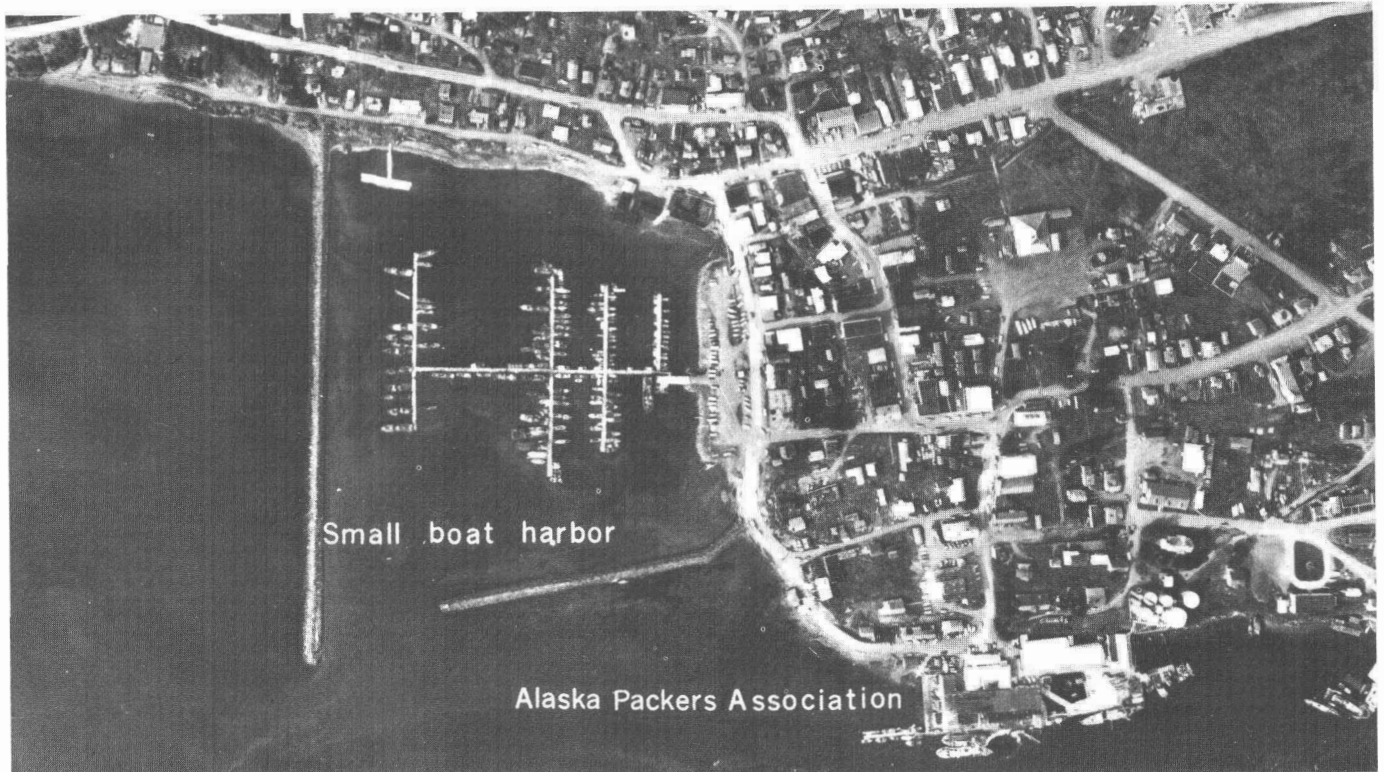
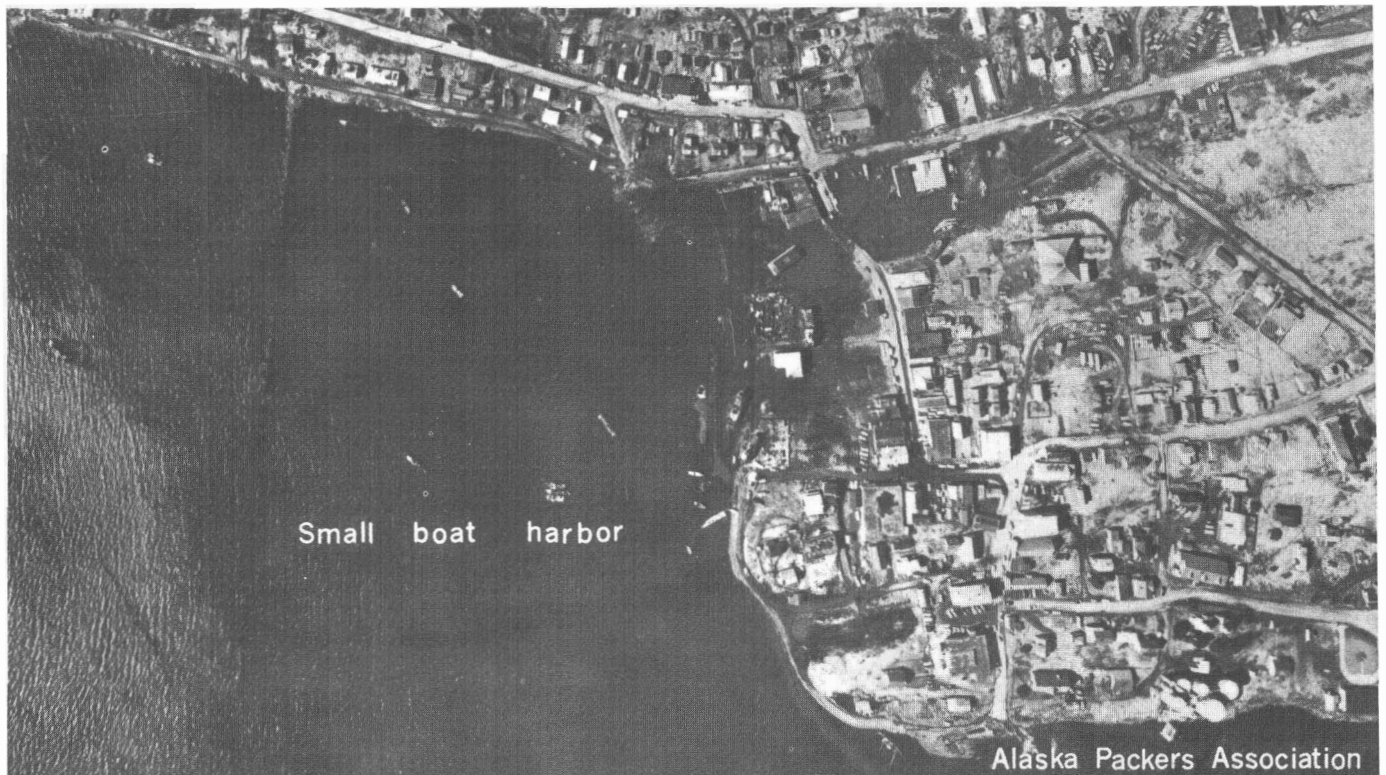
15.—Vertical aerial views of downtown Kodiak, scale 1:6,000. Top, preearthquake photograph by Bureau of Land Management, September 10, 1962. Bottom, postearthquake photograph by Air Photo Tech, Anchorage, April 14, 1964.

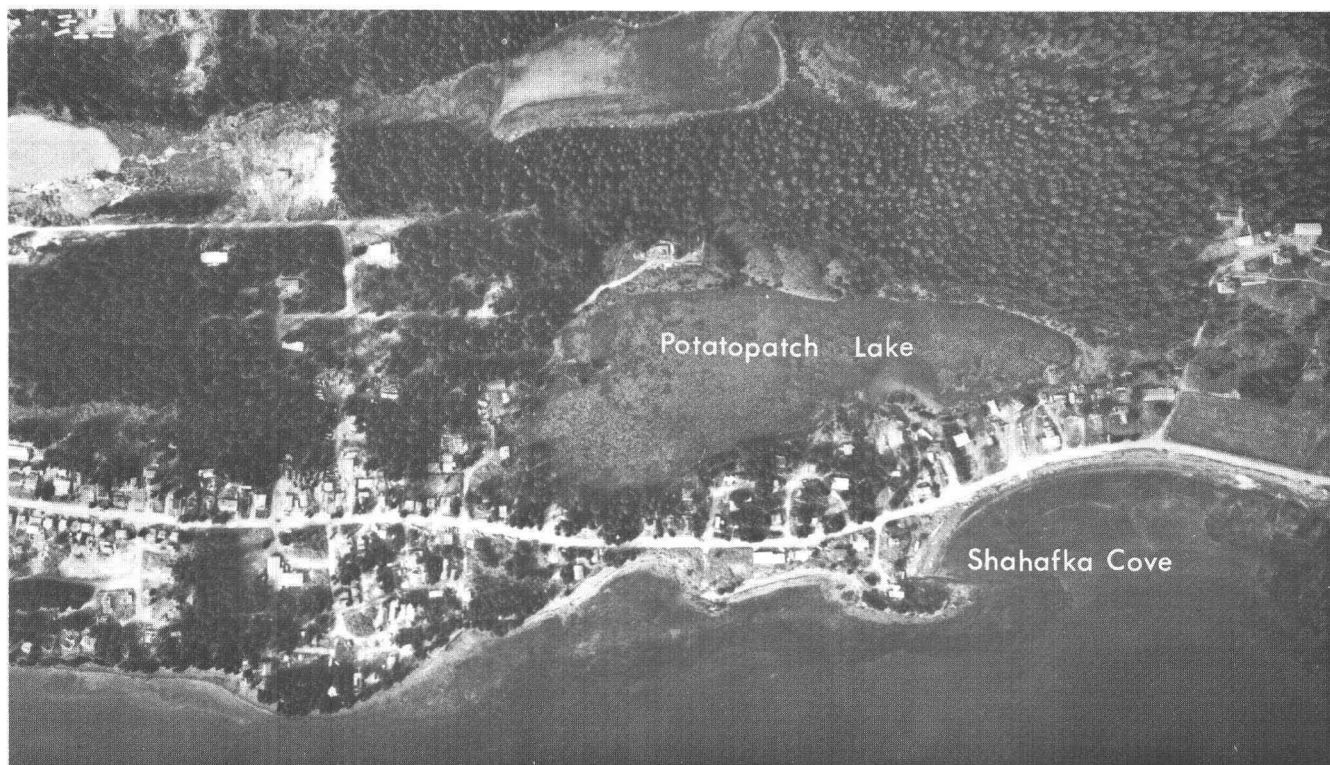
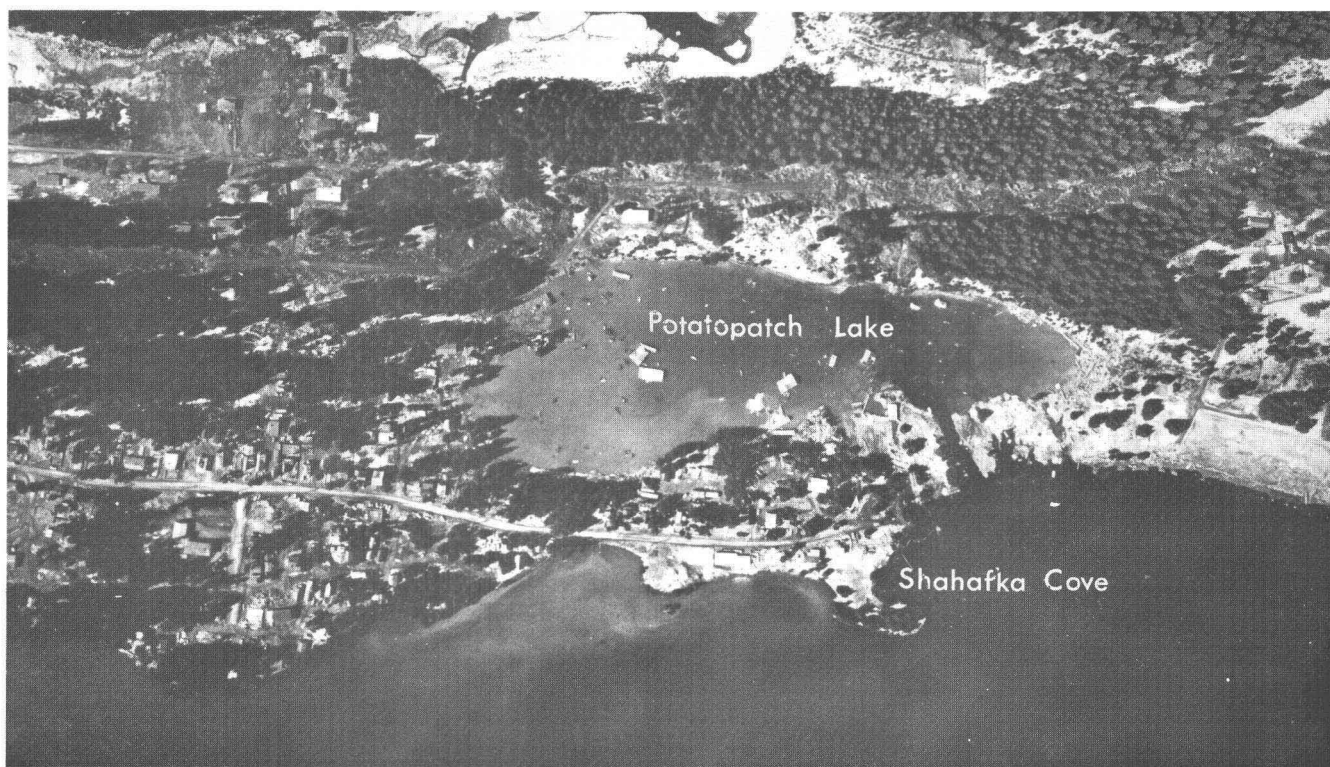
16.—Vertical aerial views of Potatopatch Lake area, northeast of downtown Kodiak, scale 1:6,000. Top, preearthquake photograph by Bureau of Land Management, September 10, 1962. Bottom, postearthquake photograph by Air Photo Tech, Anchorage, April 14, 1964.
