THE ALASKA EARTHQUAKE, MARCH 27, 1964:
EFFECTS ON COMMUNITIES

Effects of the Earthquake
Of March 27, 1964
On the Communities of
Kodiak and Nearby Islands

By REUBEN KACHADOORIAN and GEORGE PLAFKER

GEOLOGICAL SURVEY PROFESSIONAL PAPER 542-F

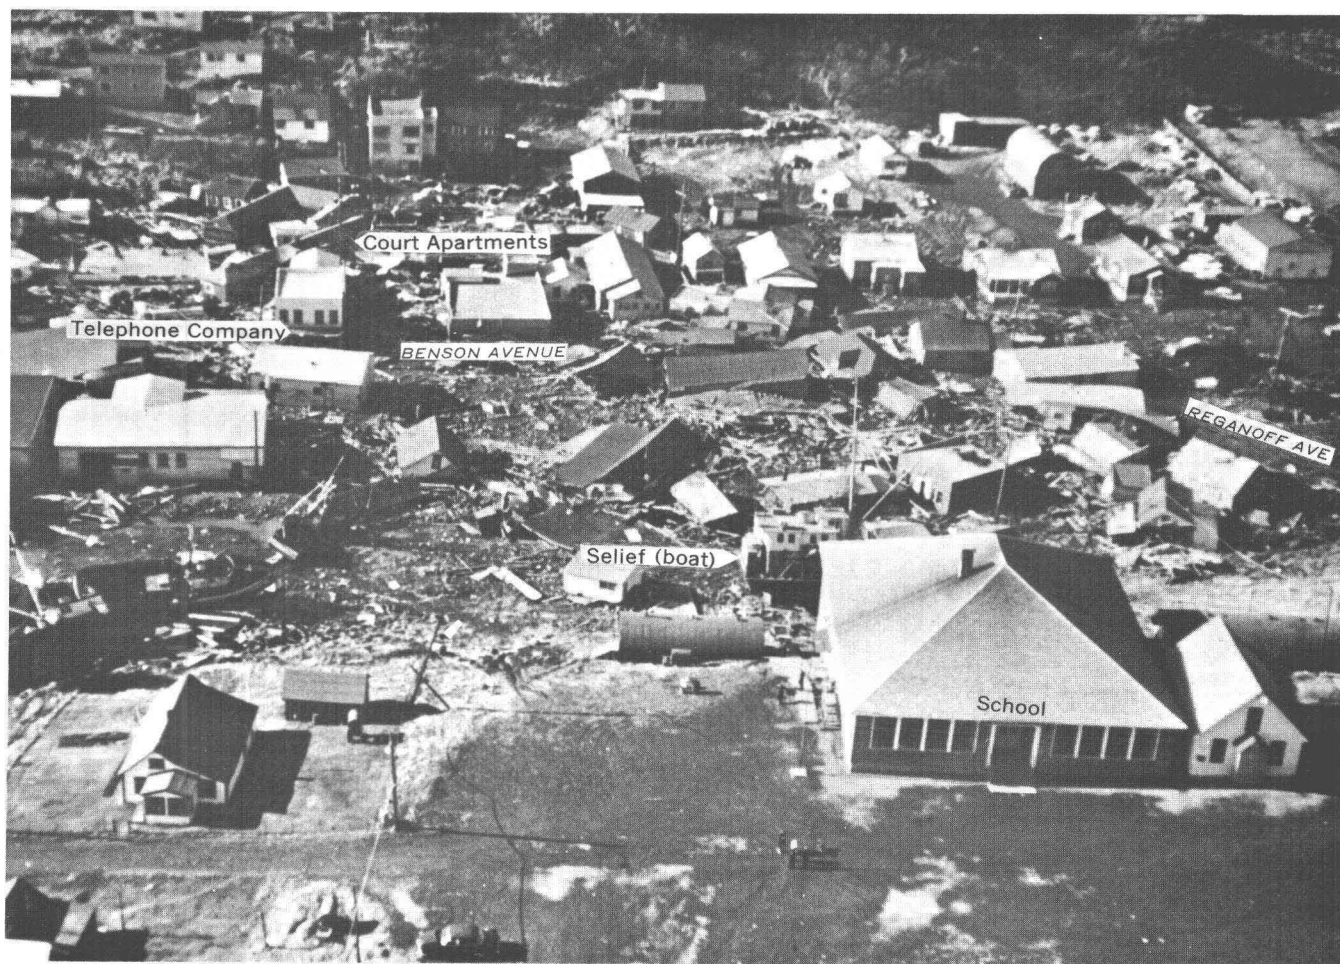
17.—Structures displaced by seismic sea waves, downtown Kodiak. View is west toward intersection of Benson and Reganoff Avenues. Photograph by Mr. Alf Madsen, Kodiak, March 1964.

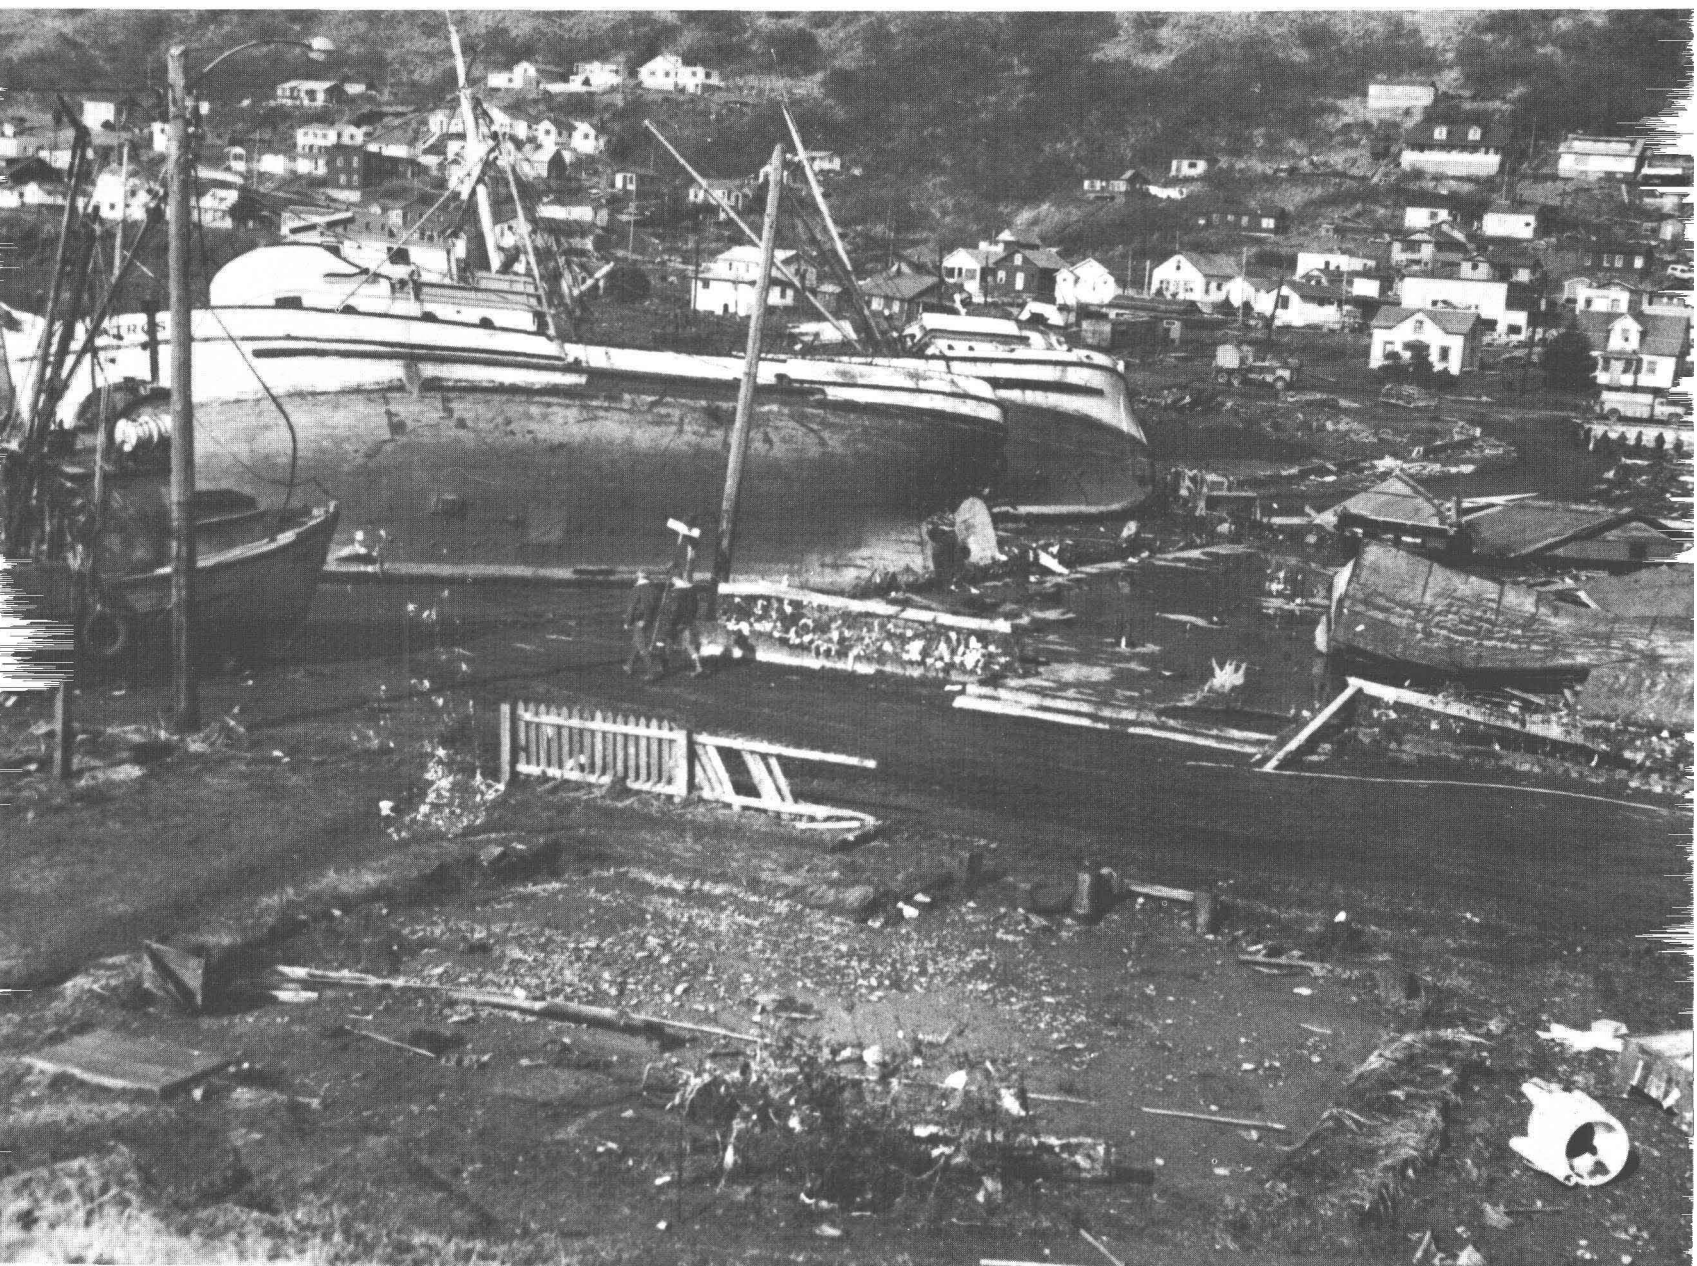
18.—Foundations of structures swept away by seismic sea waves, downtown Kodiak. View is west from intersection of Marine Way and Mill Bay Road. Foundation across Mill Bay Road was the Elks Bowling Alley; the boats are the *Cindy*, *Albatross*, and *Hekla*. Photograph by U.S. Navy, March 28, 1964.

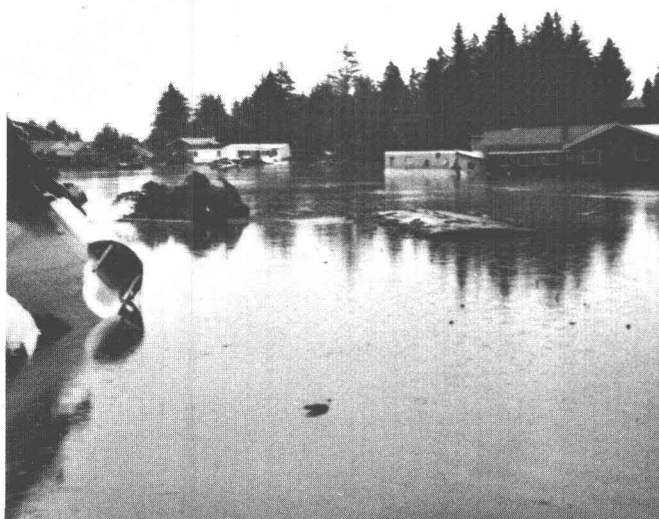
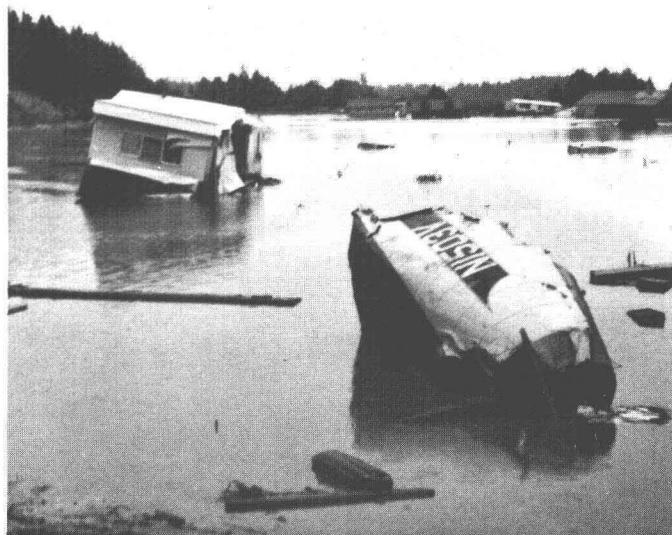
19.—Debris and houses washed into Potatopatch Lake by seismic sea waves. Photographs by Alaska Department of Highway, Kodiak.

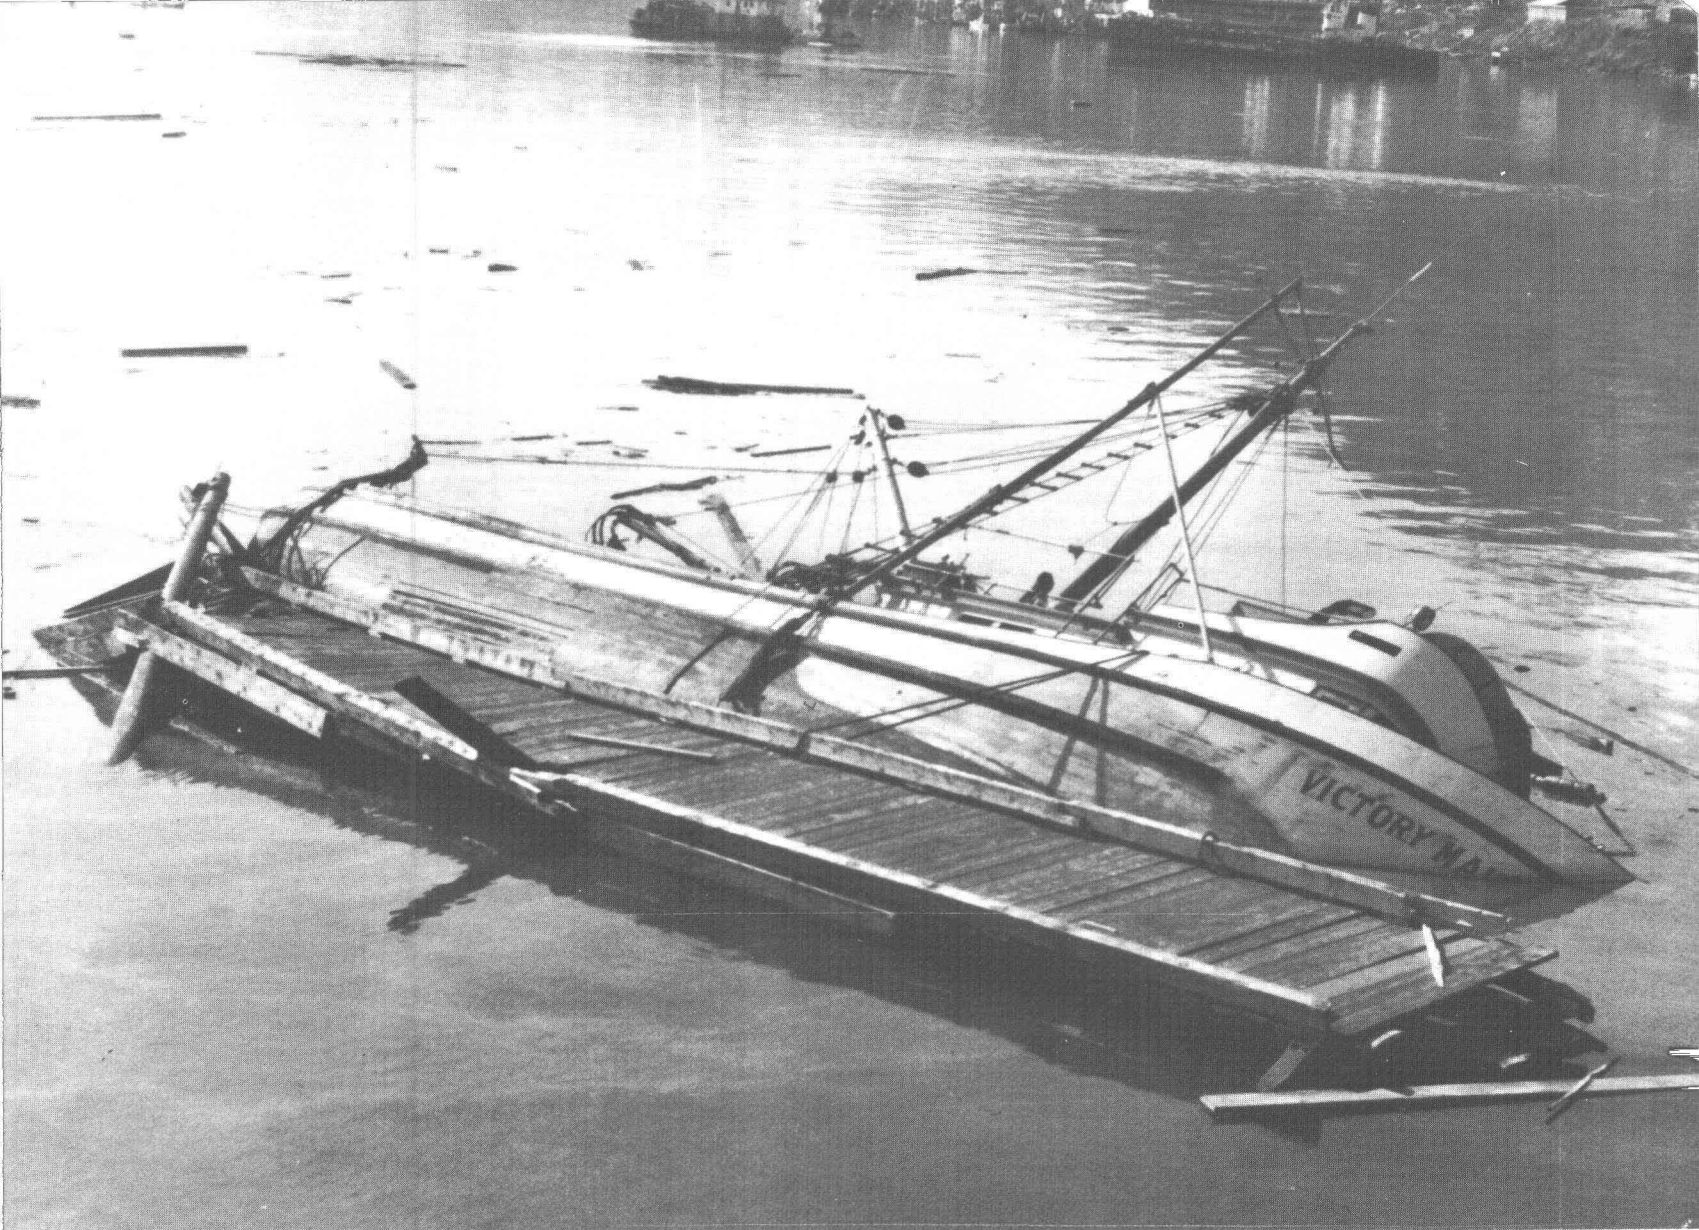
20.—The *Victory Maid* still tied to its dock but aground in Inner Anchorage. City dock is background. Photograph by U.S. Navy, March 28, 1964.

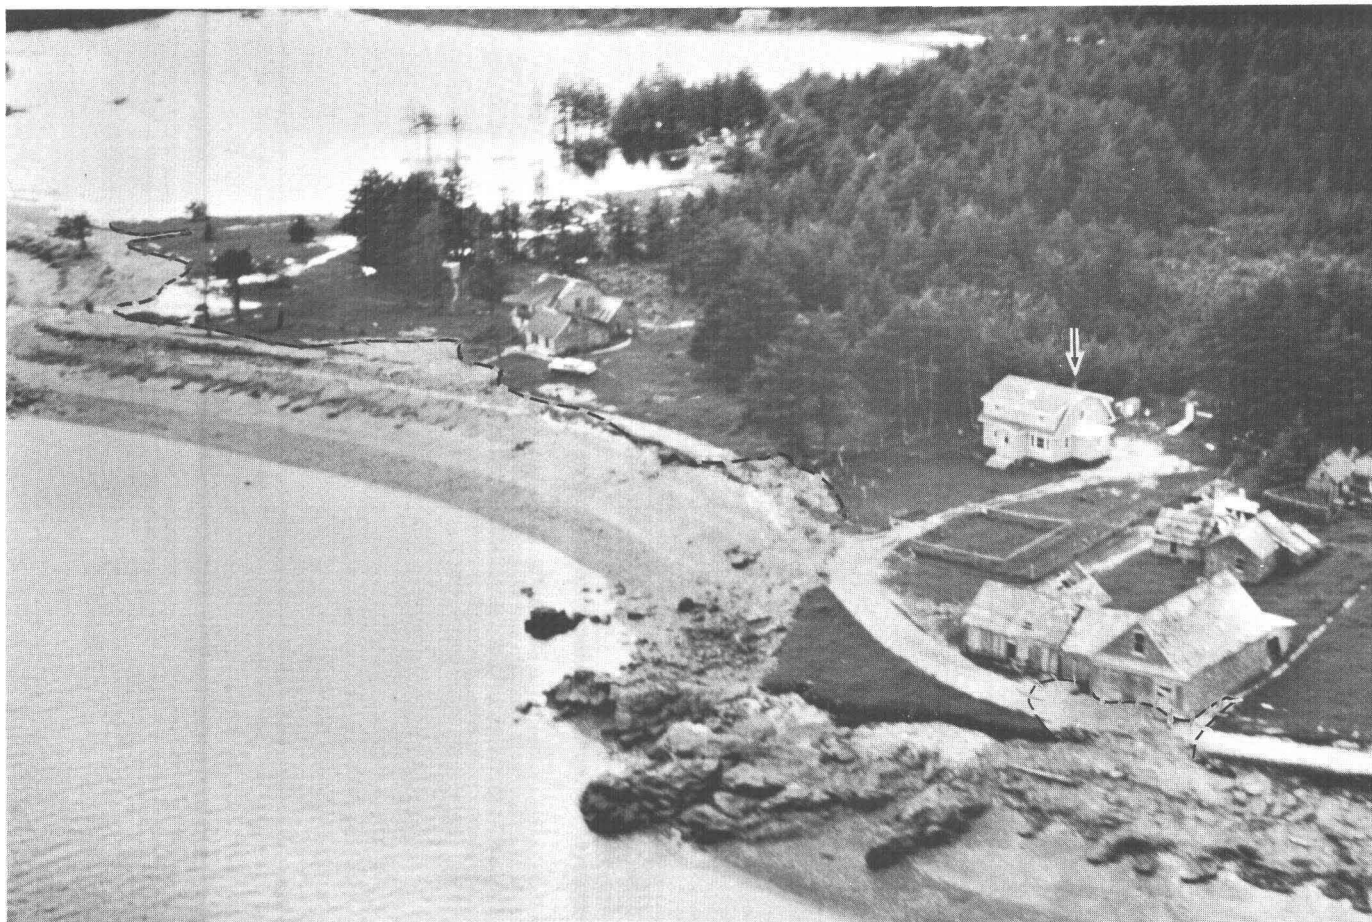
22.—Part of Afognak; note eroded road along coast, new beach berms (outlined by dashed line), and part of large lagoon ponded behind beach berm. The arrow points to undamaged brick chimney. Location of this view is shown on figure 21.

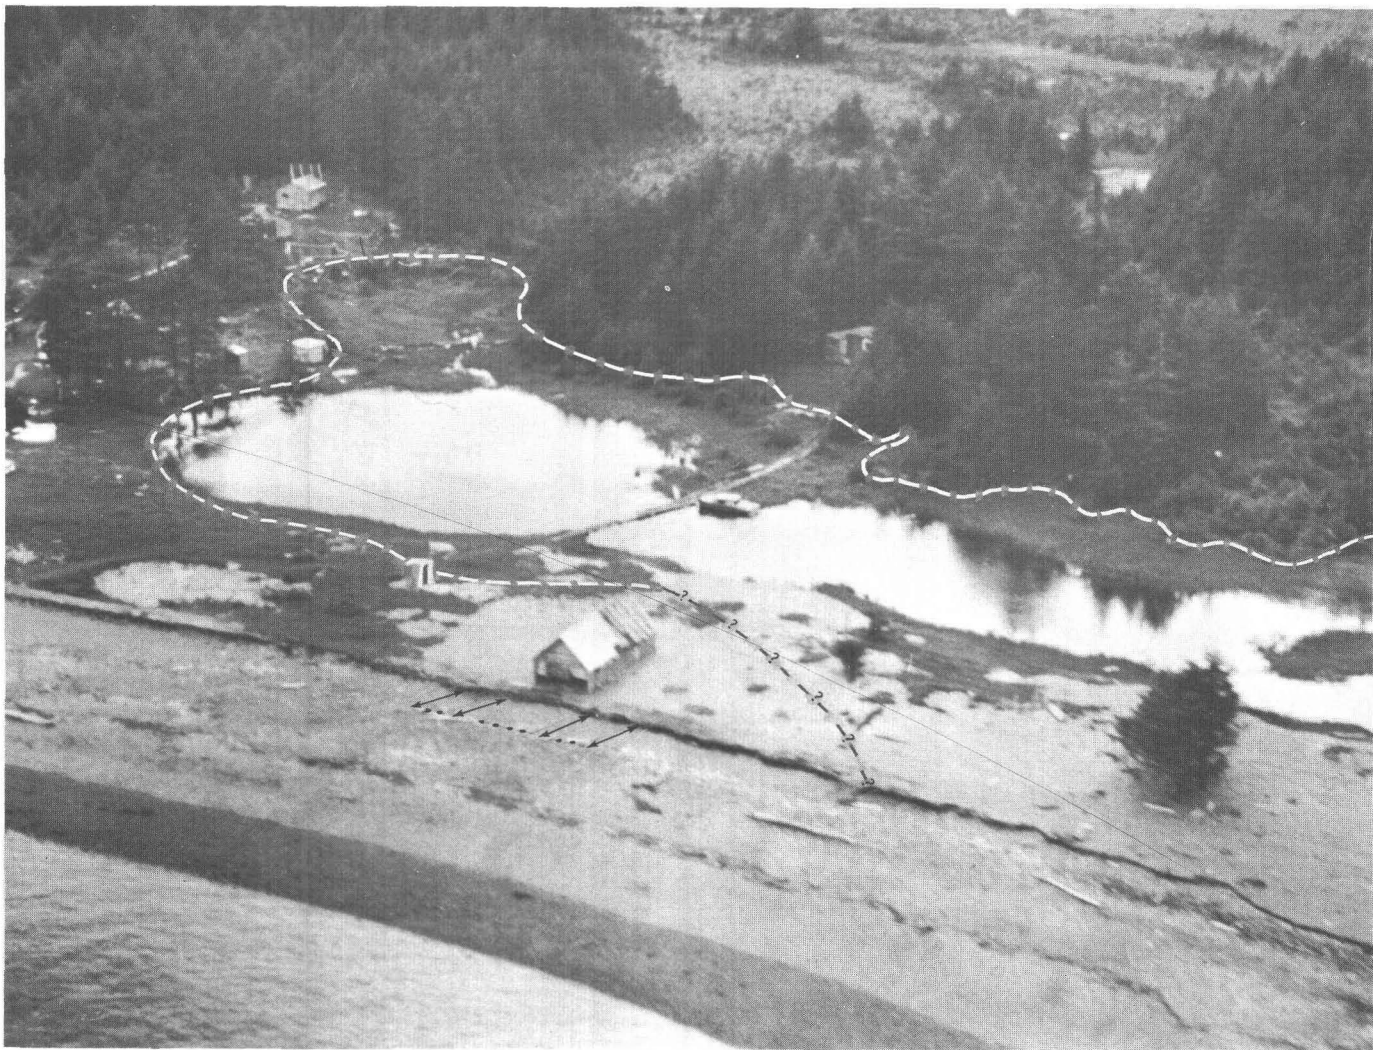
23.—Part of coast at Afognak. Arrows show approximate amount of landward retreat; newly formed beach berm is gray, and approximate extent of seismic sea wave inundation is indicated by dotted line. Note partly submerged automobile in pond.

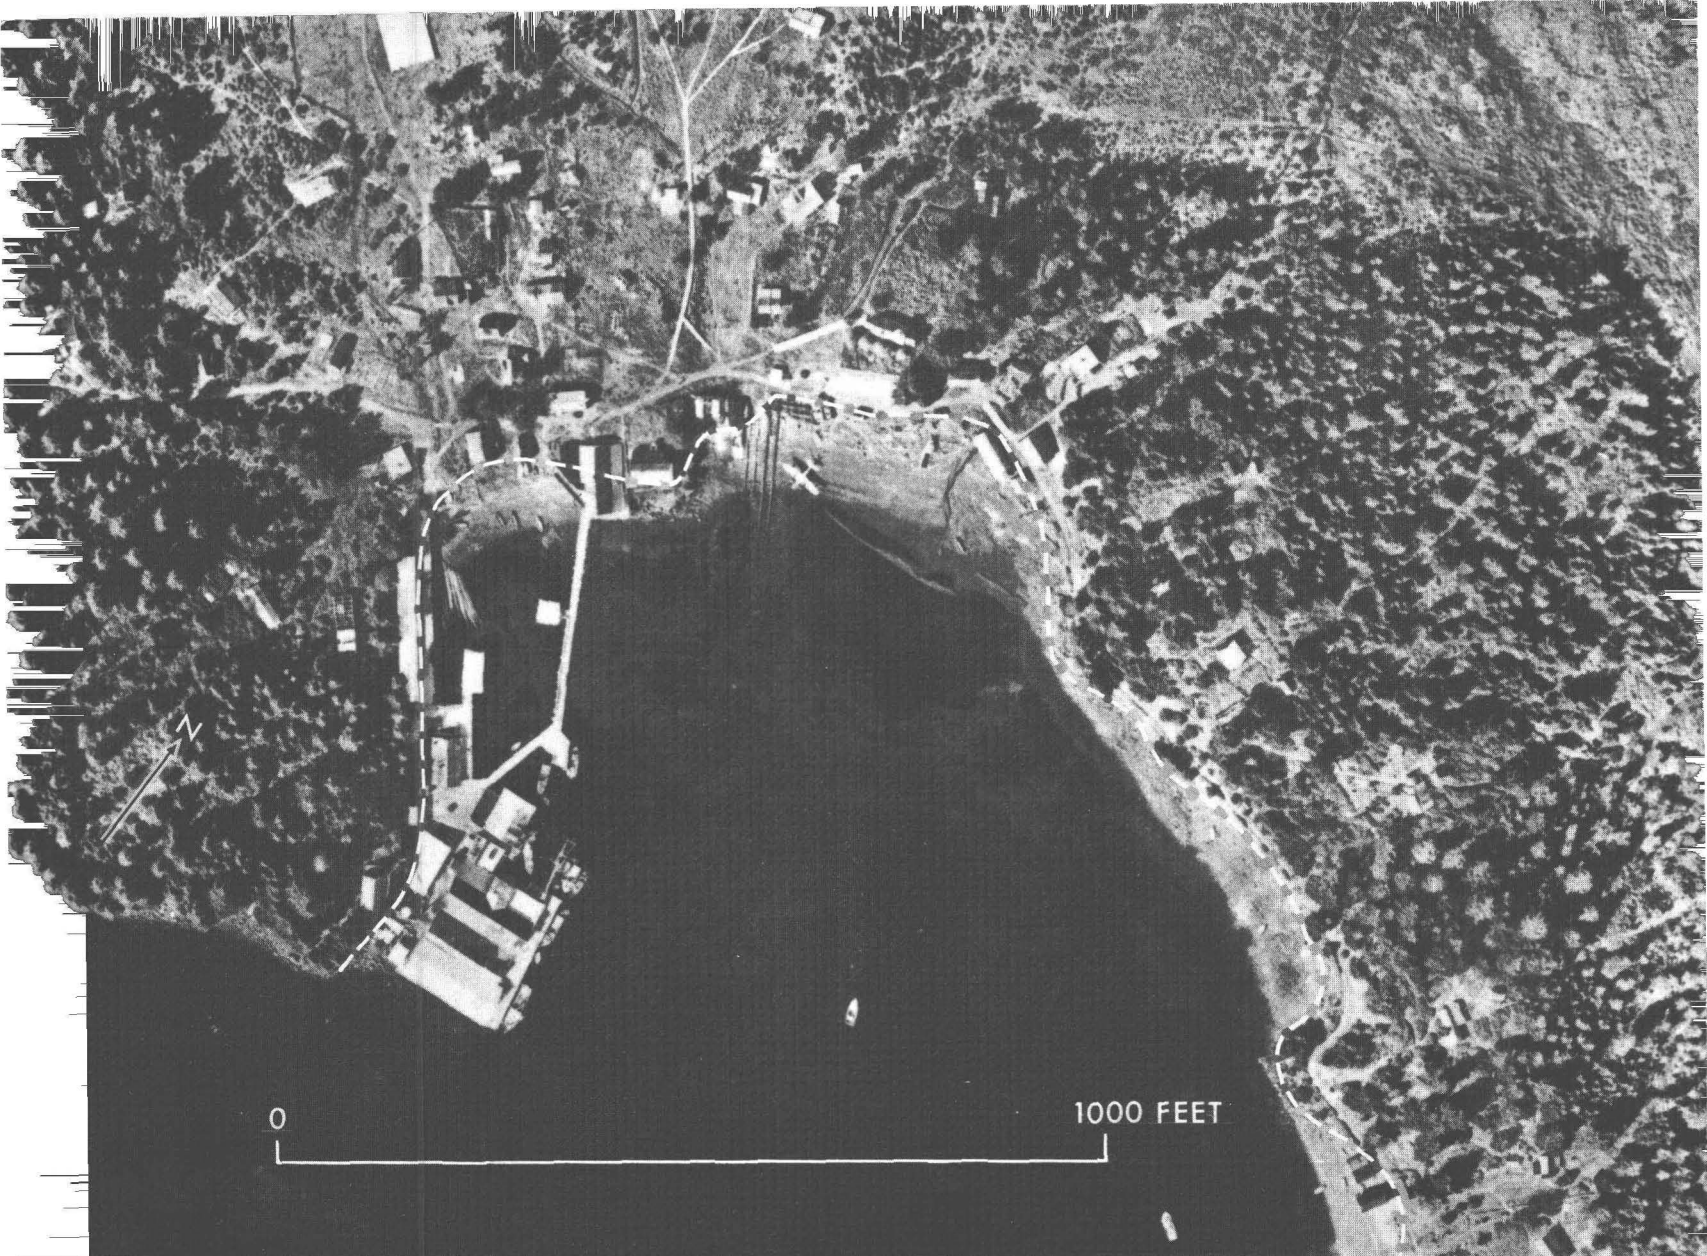
24.—Aerial mosaic of Uzinki in 1962 showing large cannery complex along the waterfront belonging to the Ouzinkie Packing Co. and approximate inland limit of seismic sea wave inundation (dashed line).

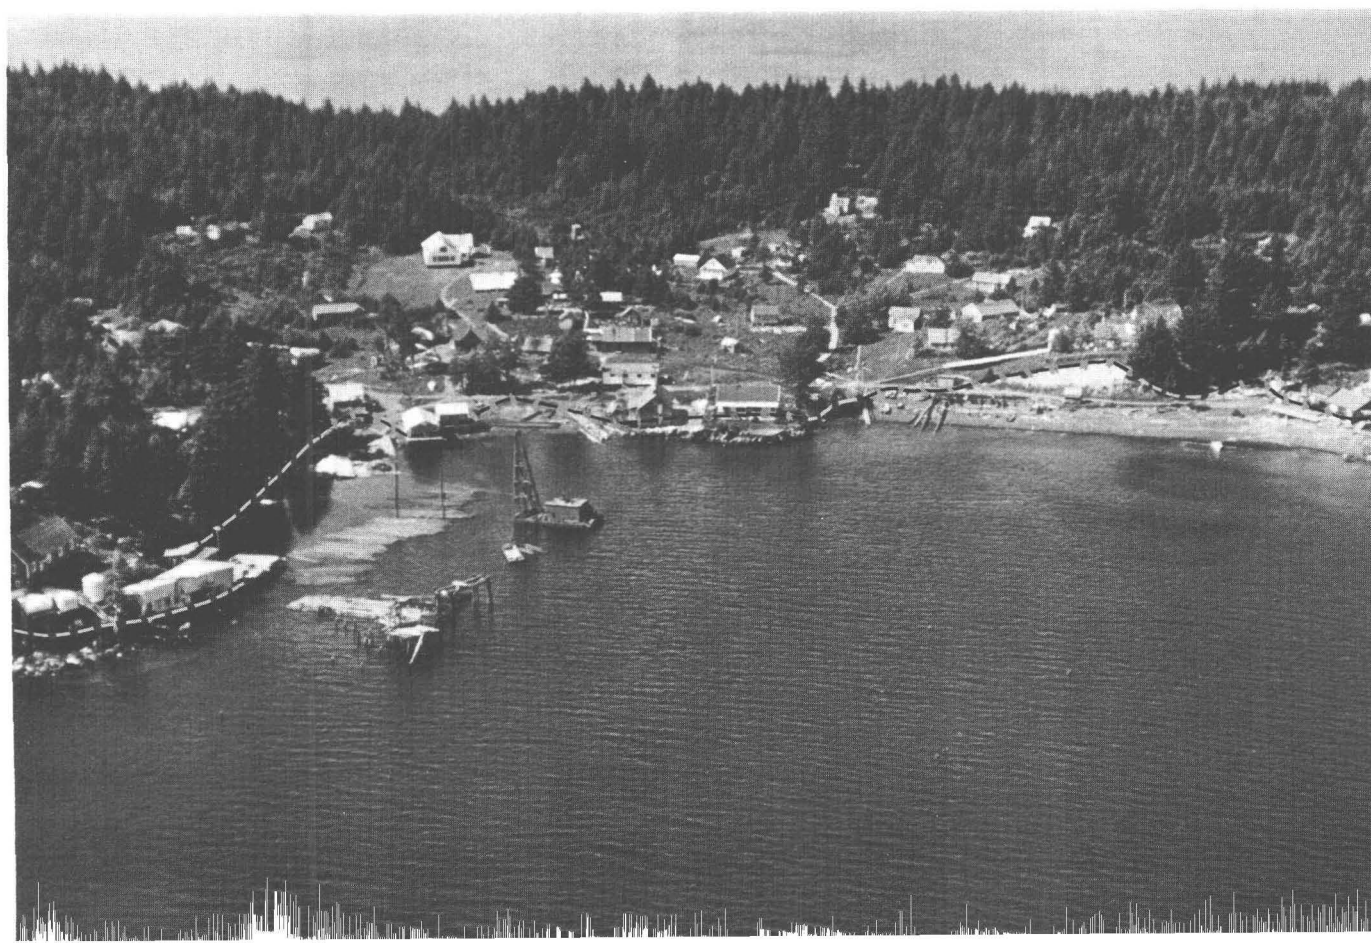
25.—Oblique aerial view of Uzinki in July 1965 showing approximate inland limit of seismic sea wave inundation (dashed line) and remains of the Ouzinkie Packing Co.'s salmon cannery (left center).

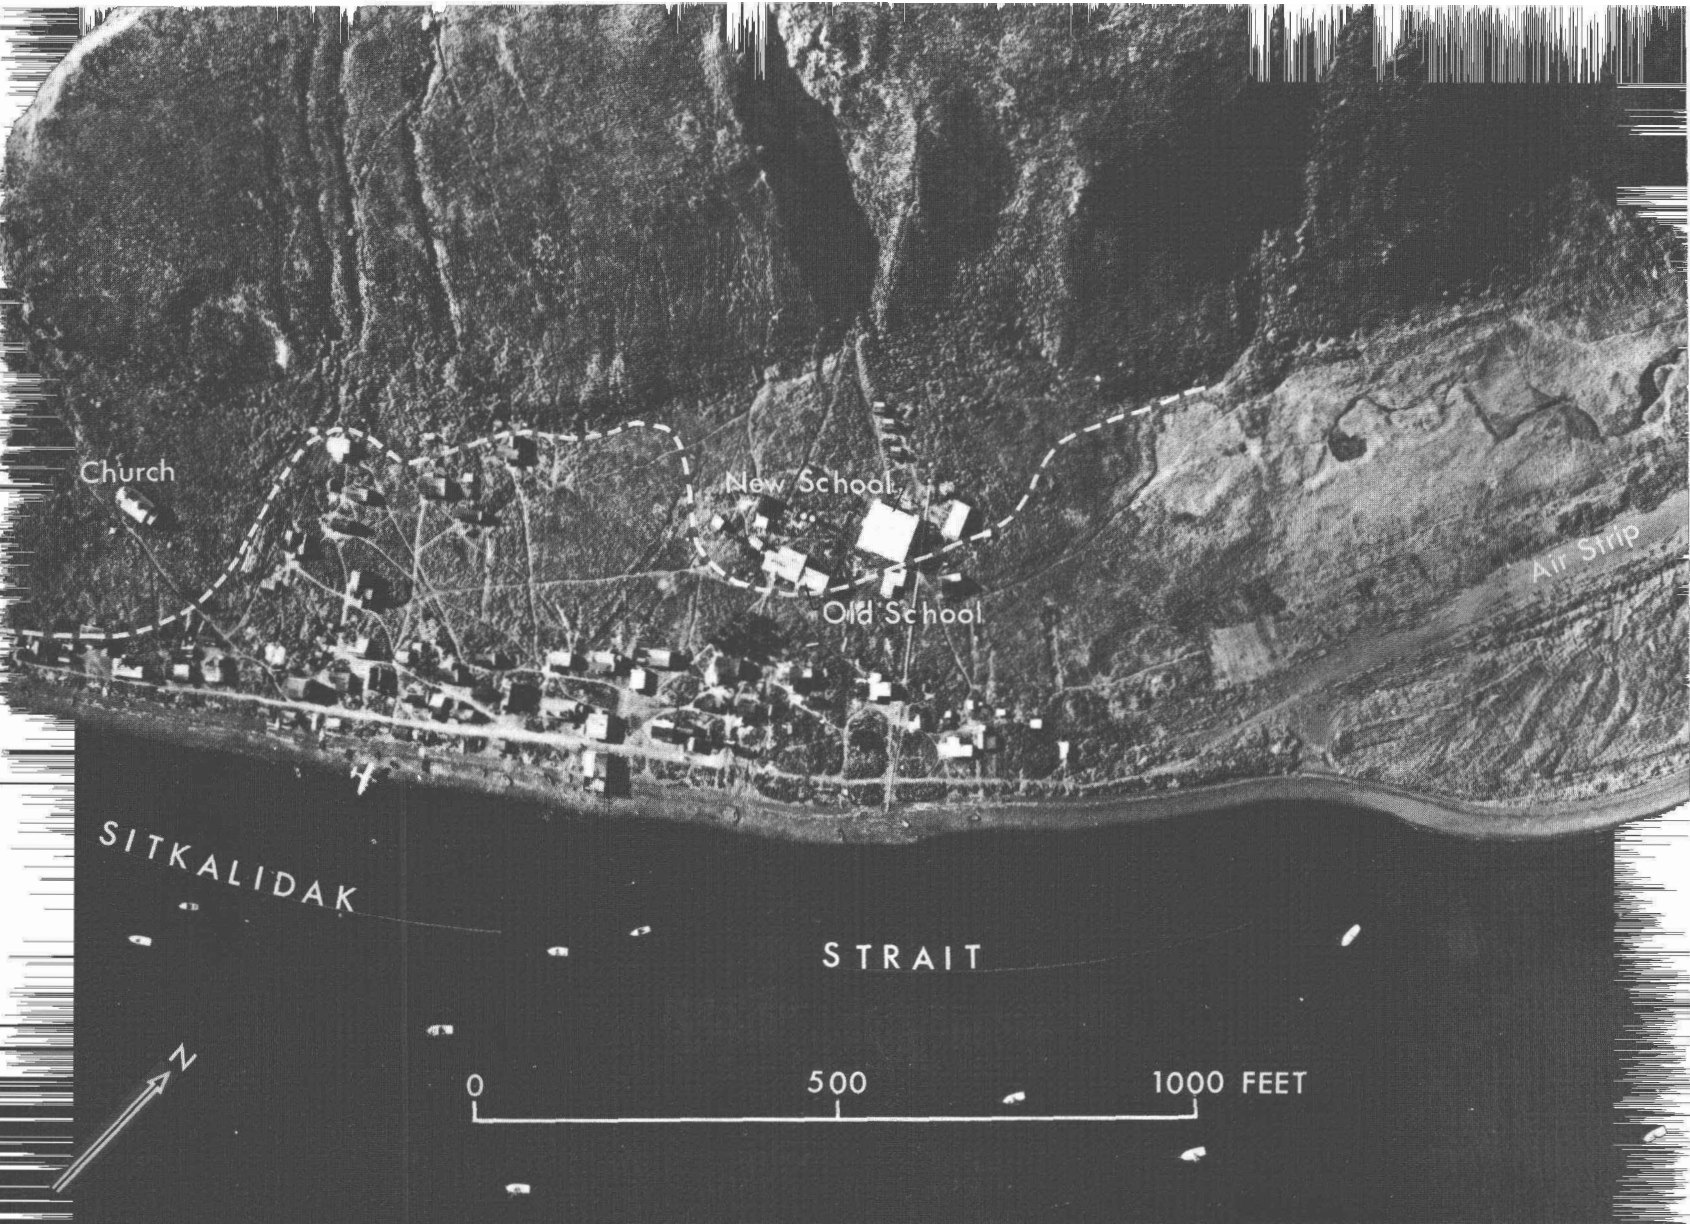
26.—Aerial mosaic of Old Harbor showing approximate inland limit of inundation by seismic sea waves (dashed line). Mosaic by U.S. Bureau of Land Management, 1962.

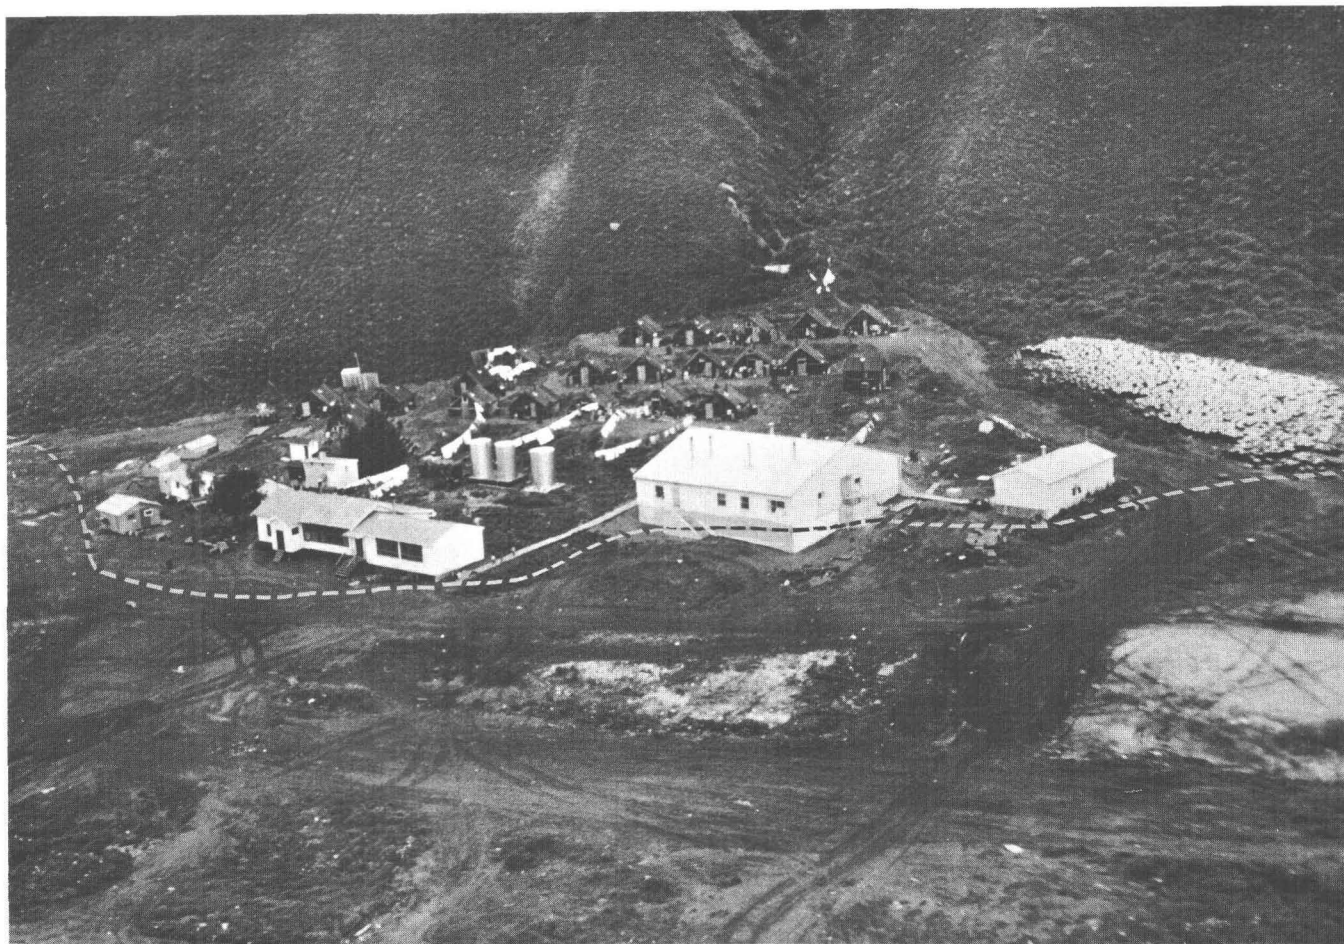
27.—Oblique aerial view of school area, Old Harbor, showing approximate inland limit of seismic sea wave inundation (dashed line). The area below the high-water line had been cleared of debris by the time this photo was taken (July 15, 1964). The structures near the apex of the alluvial fan are temporary shelters.

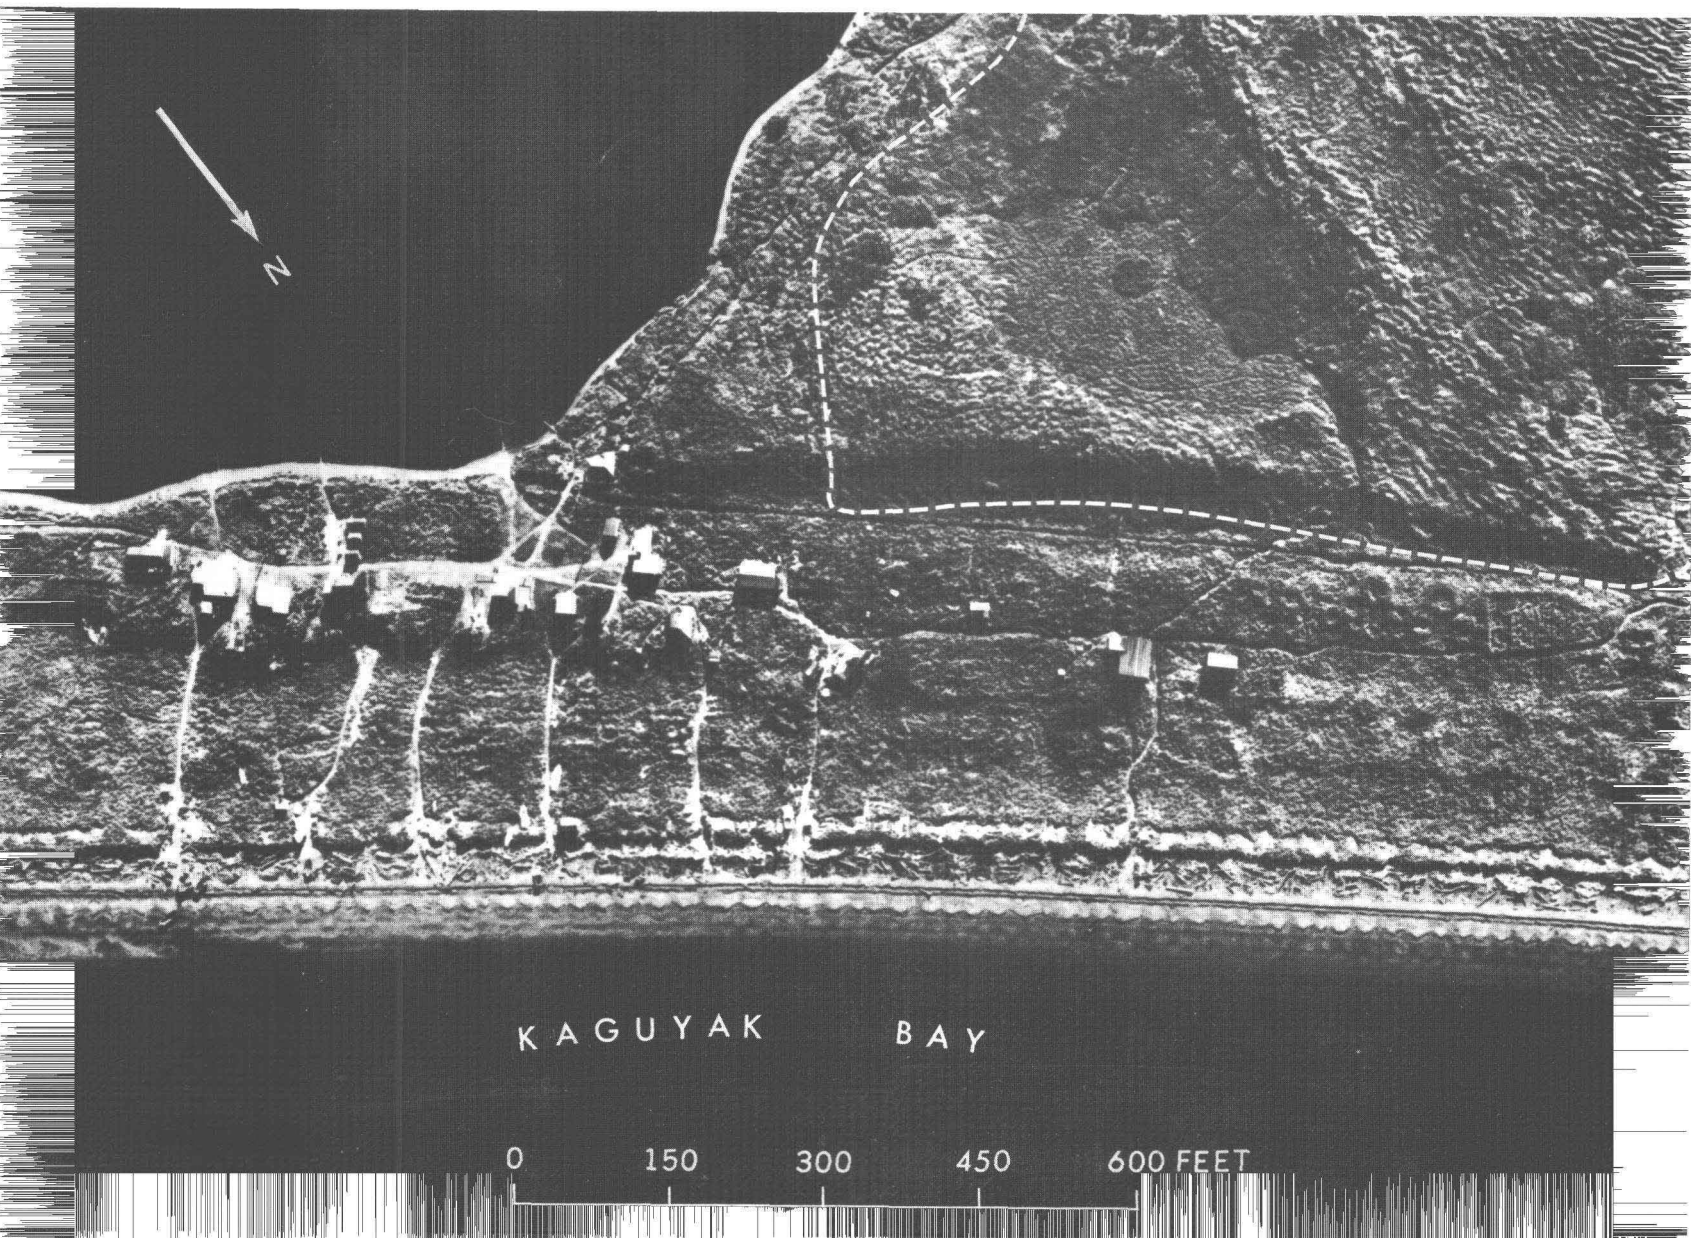
28.—Aerial mosaic of Kaguyak in 1962. Dashed line shows approximate inland limit of seismic sea wave inundation. Mosaic by U.S. Bureau of Land Management.

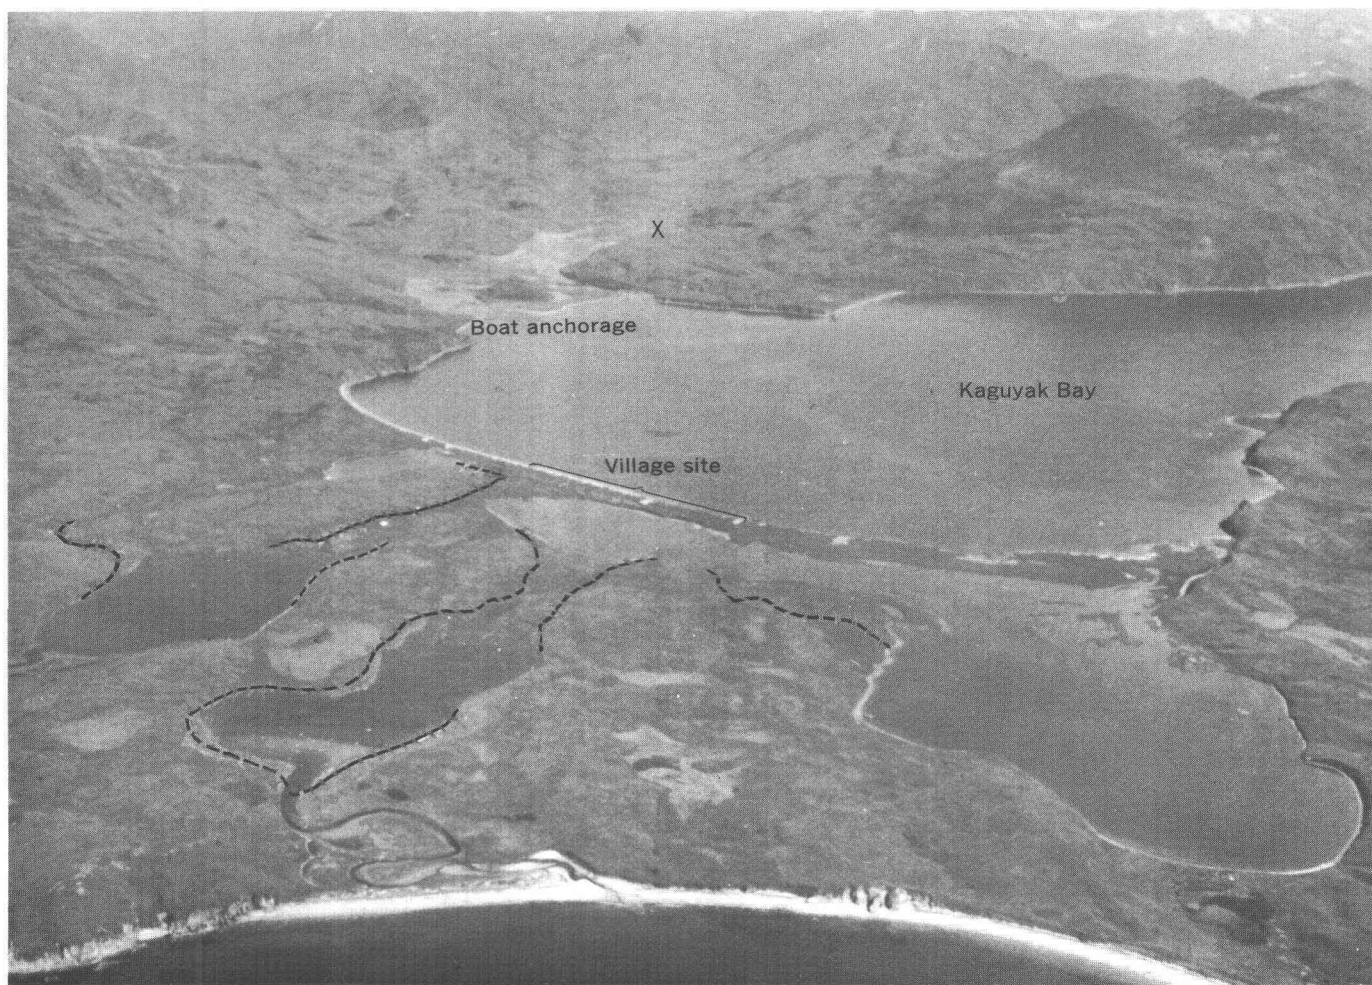
29.—Oblique aerial view of the head of Kaguyak Bay showing site of Kaguyak (fig. 28), approximate inland limits of debris deposited by seismic sea waves (dashed line), and location of small-boat anchorage. X marks position at which one 30-foot salmon trawler was stranded by the waves.

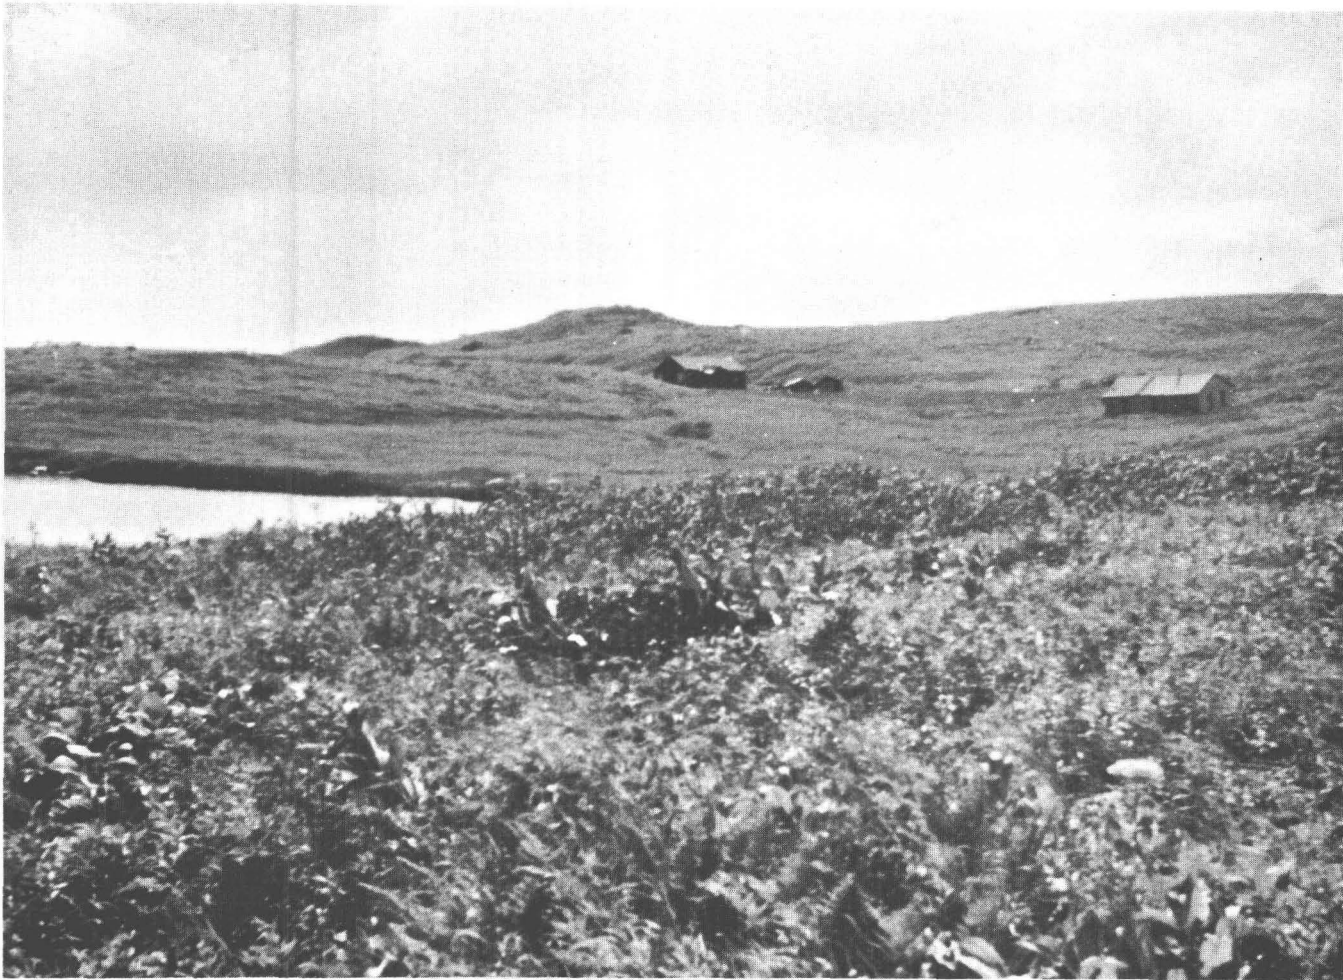
All the significant earthquake-related damage and loss of life at Kaguyak resulted from inundation by seismic sea waves. The nine residences and their appurtenant structures and the church (fig. 28) were floated from their foundations and were either washed out to sea or were stranded virtually intact as much as half a mile inland (fig. 30). One of several 30-foot salmon trawlers that were in the small-boat anchorage at the mouth of the river (fig. 29) was floated 1.8 miles upstream and stranded. Flooding of the village site also caused brine pollution of

30.—Wood-frame houses that were floated inland from Kaguyak by seismic sea waves and deposited almost undamaged.
