*A description and analysis of the geologic  
controls of earthquake damage to The Alaska  
Railroad, with emphasis on damage caused  
by the mobilization of unconsolidated  
sediments*

In the 1964 Alaska earthquake, the federally owned Alaska Railroad sustained damage of more than \$35 million: 54 percent of the cost for port facilities; 25 percent, roadbed and track; 9 percent, buildings and utilities; 7 percent, bridges and culverts; and 5 percent, landslide removal. Principal causes of damage were: (1) landslides, landslide-generated waves, and seismic sea waves that destroyed costly port facilities built on deltas; (2) regional tectonic subsidence that necessitated raising and armoring 22 miles of roadbed made susceptible to marine erosion; and (3), of greatest importance in terms of potential damage in seismically active areas, a general loss of strength experienced by wet water-laid unconsolidated granular sediments (silt to coarse gravel) that allowed embankments to settle and enabled sediments to undergo flowlike displacement toward topographic depressions, even in flat-lying areas. The term "landspreading" is proposed for the lateral displacement and distension of mobili

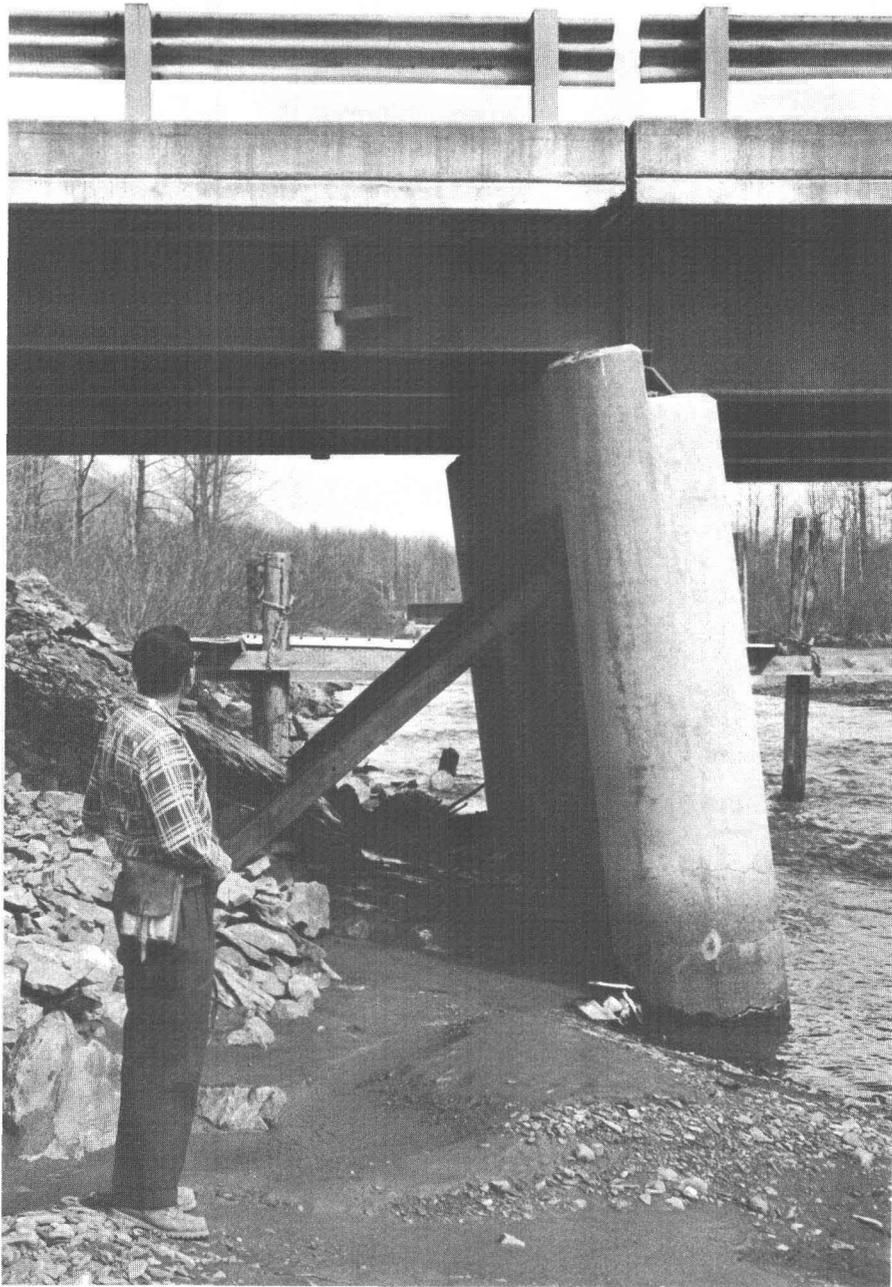
6.—The pier of a highway bridge at Resurrection River that was rotated as its base was carried toward the channel while its top was restrained by the deep central steel deck beam. A crack that formed in the pier is visible just above the water.

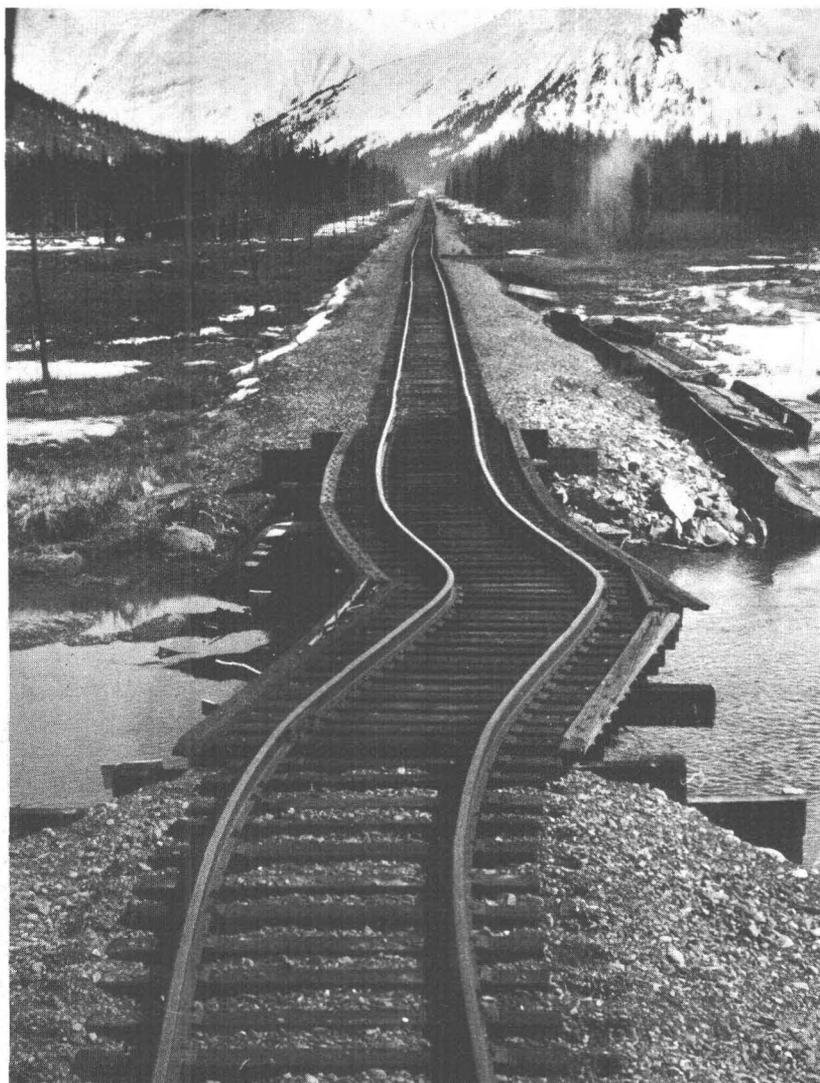
12.—Laterally buckled and broken stringers of bridge 37.3, resulting from  $7\frac{1}{4}$  inches of streambank closure.

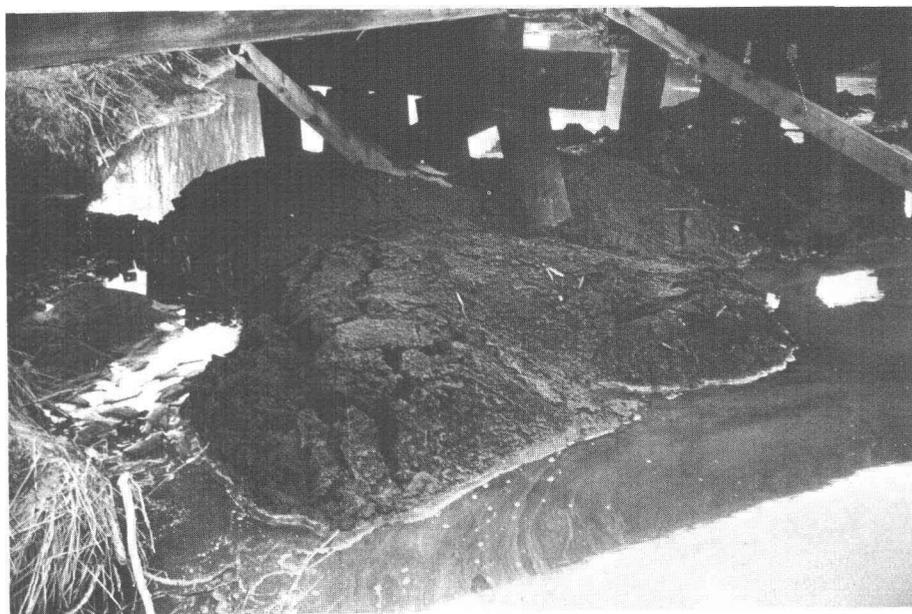
17.—Mounds of sand ejected with ground water from cracks in the floor of the stream at bridge 34.7 on Hunter Flats.

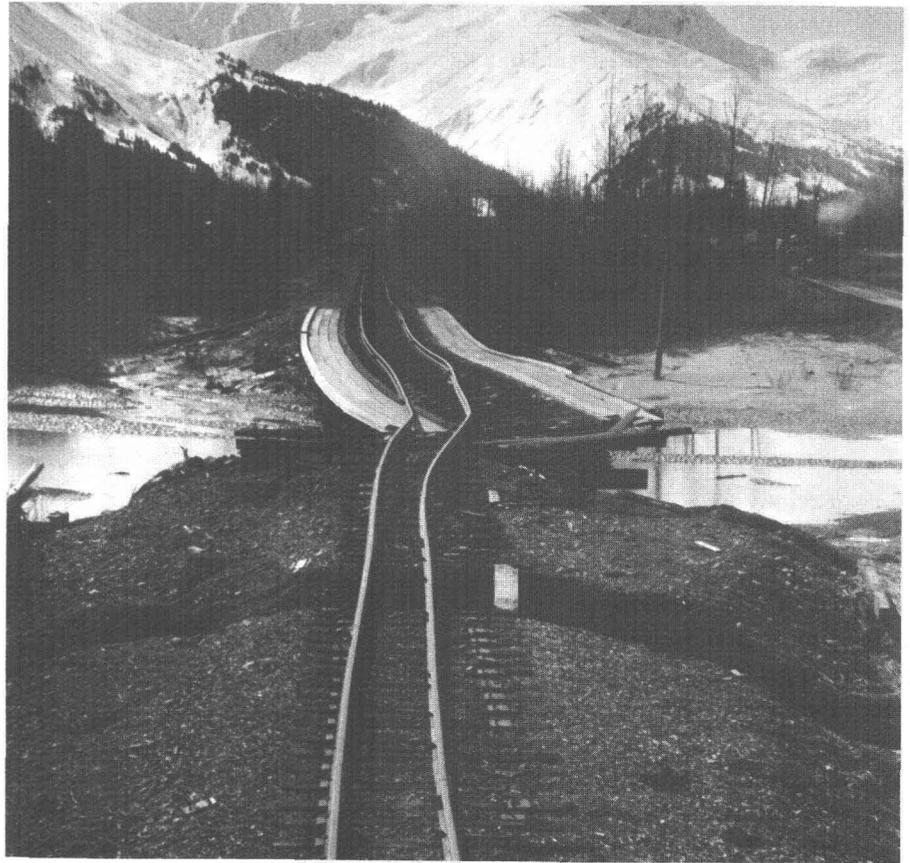
18.—View to the south of bridge 63.0. Compression, which deflected the deck 8 feet to the east in a sharp kink, broke the stringers. A wide tension fracture in the foreground broke the embankment; it shifted to the right at the fracture and skewed the bridge.

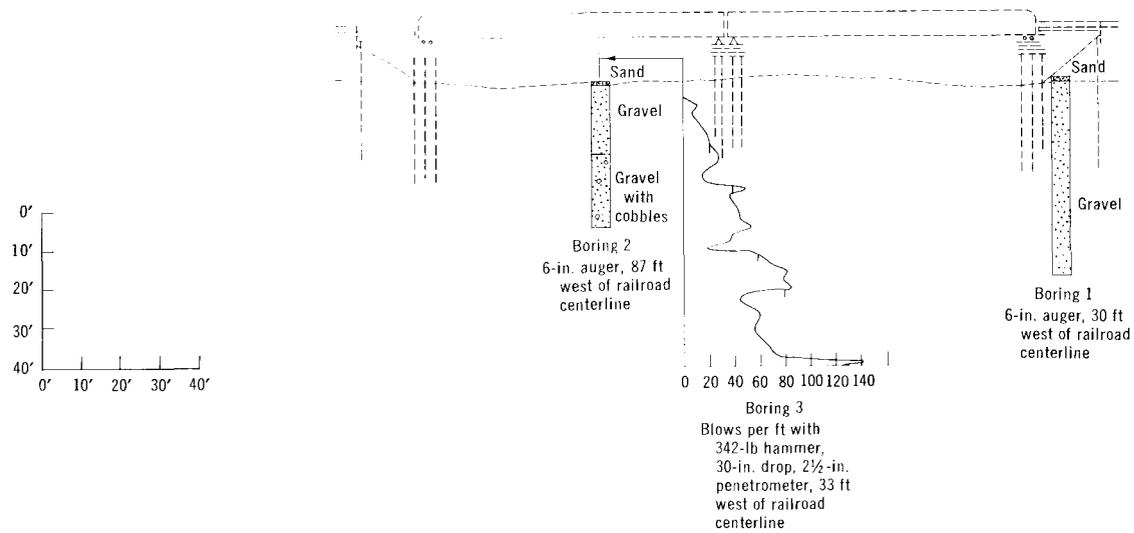
29.—Bridge 3.0; construction, damage, and subsurface information. Subsurface data projected to rail line at proper altitude.

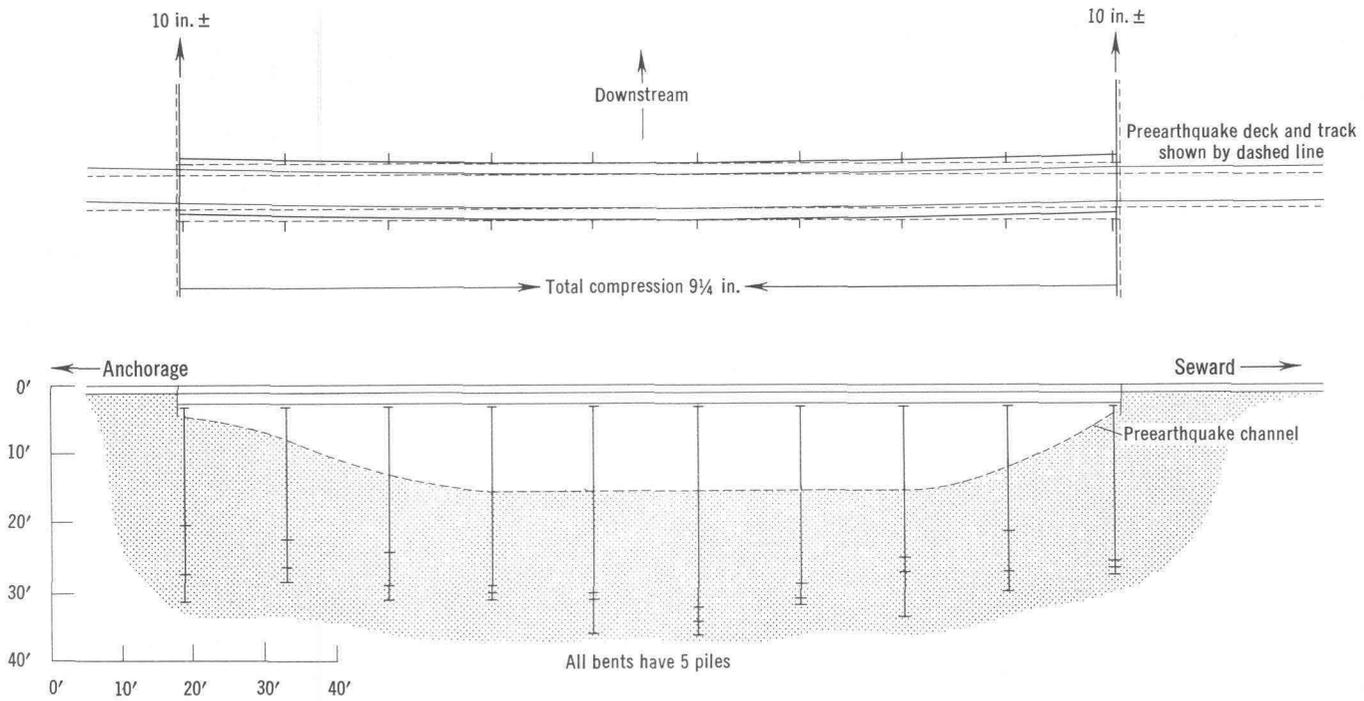
31.—Bridge 3.2; construction, damage, and subsurface information. Subsurface data projected to rail line at proper altitude.

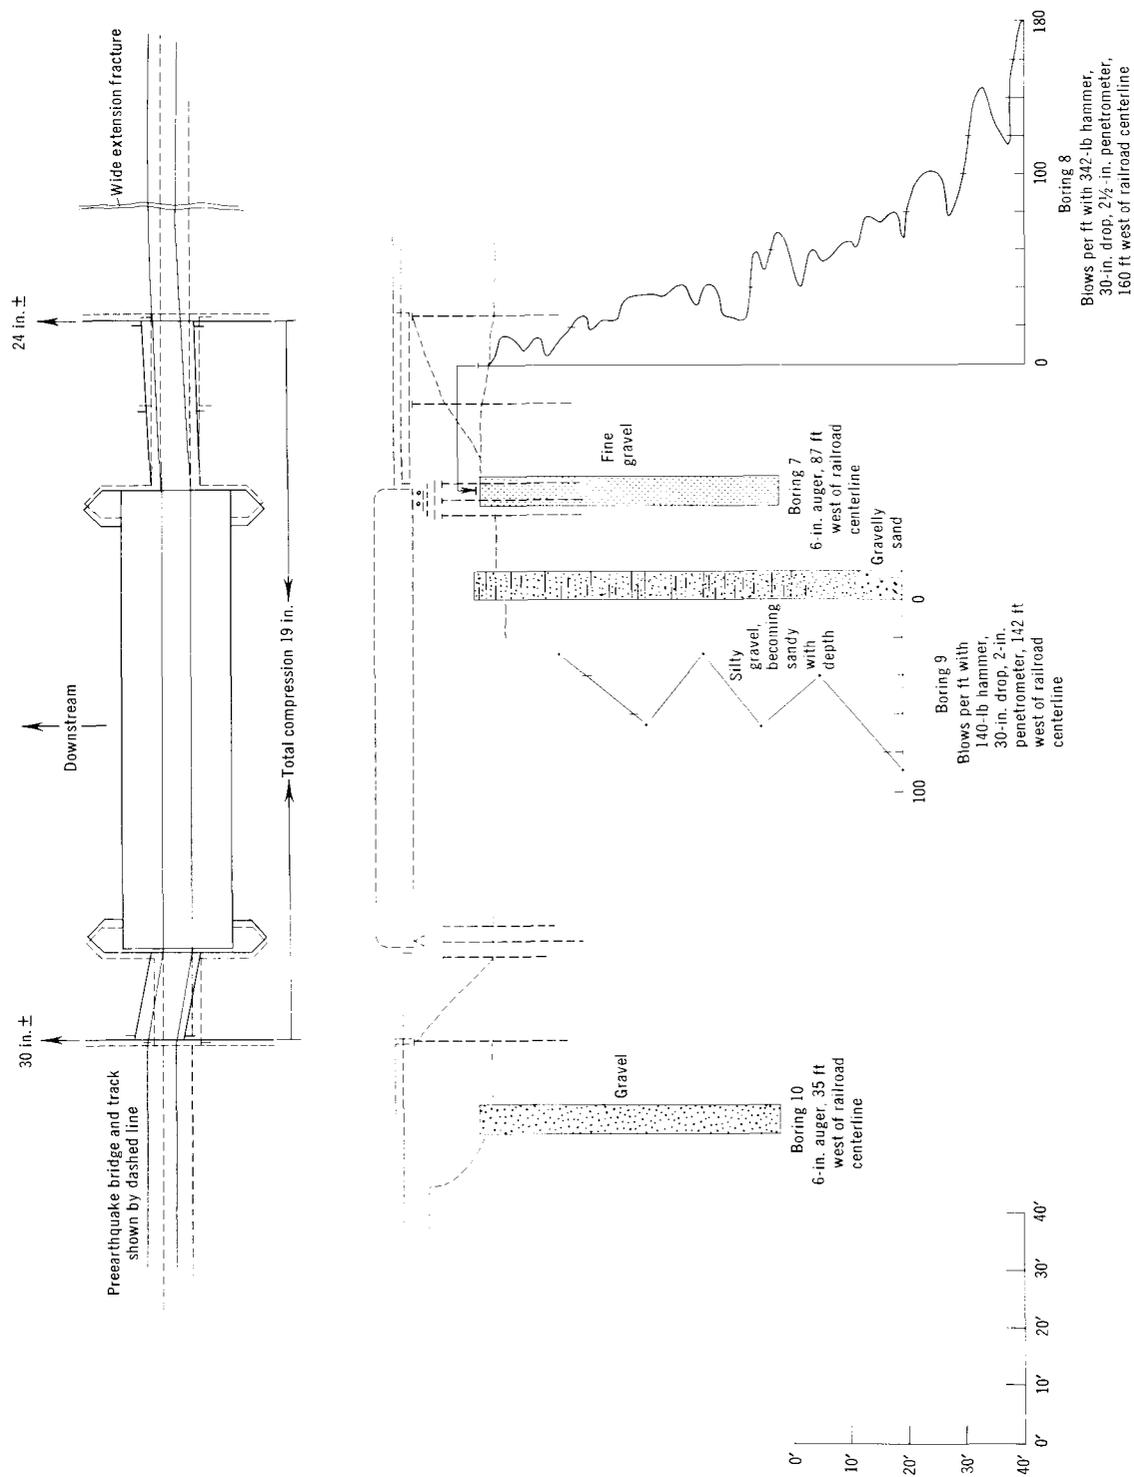
32.—Bridge 3.3; construction, damage, and subsurface information. Subsurface data projected to rail line at proper altitude.

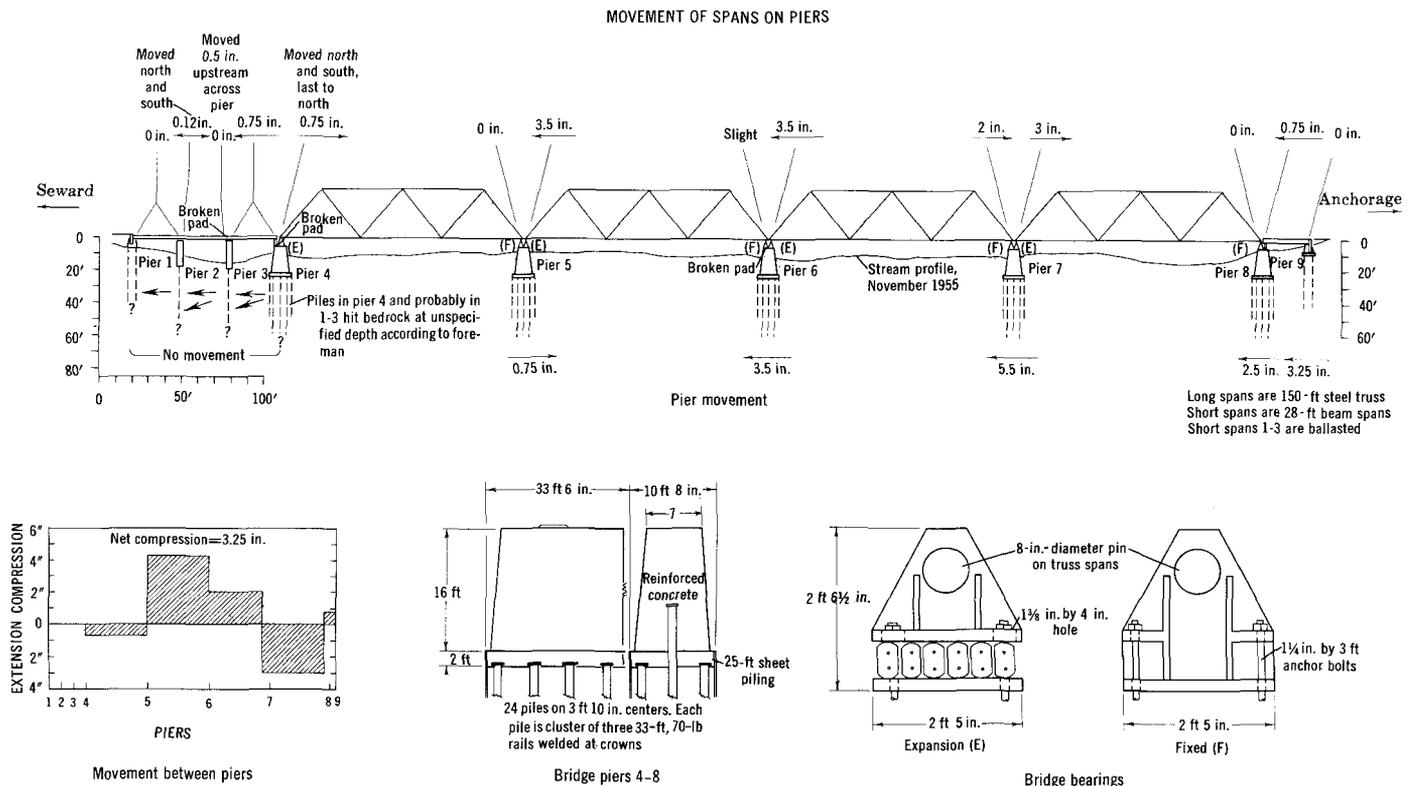
33.—Construction and damage to Snow River bridge (14.5).

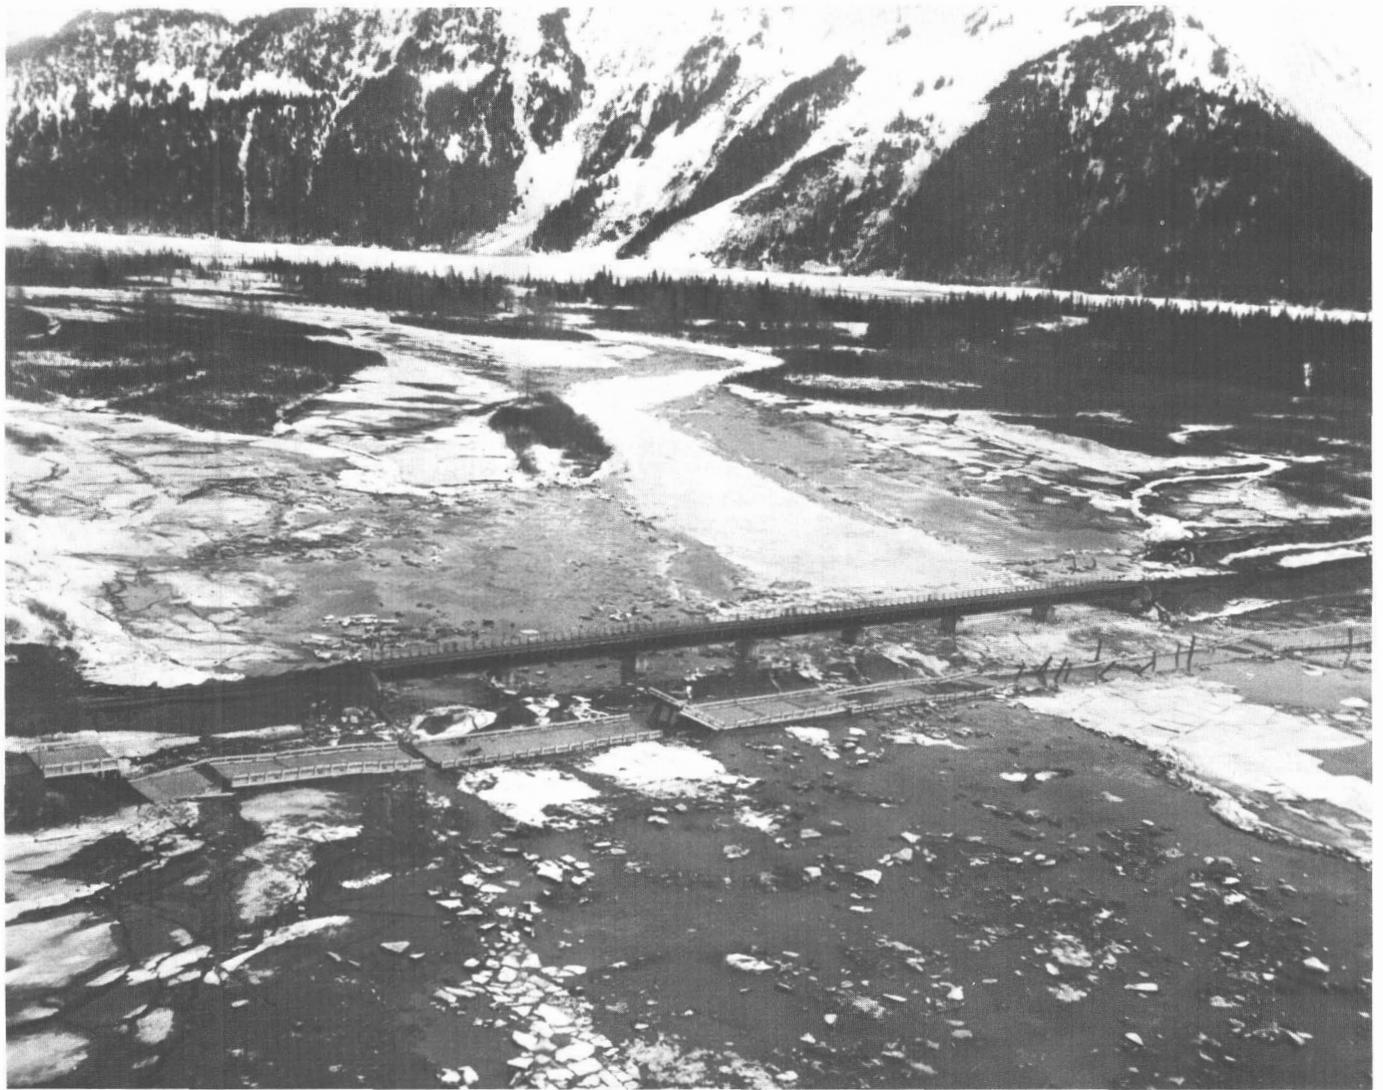
35.—Railroad bridge (64.7) and highway bridge at Twentymile River, Portage. All concrete deck sections of the highway bridge except one were knocked from their piles, and some piles were driven through the concrete. The railroad bridge was compressed and some of its piers shifted (see fig. 36). Note the severe cracking in the embankments, flood-plain, and tidal sediments (see pl. 3). Photograph by Arthur Kennedy, U.S. Forest Service, Anchorage.

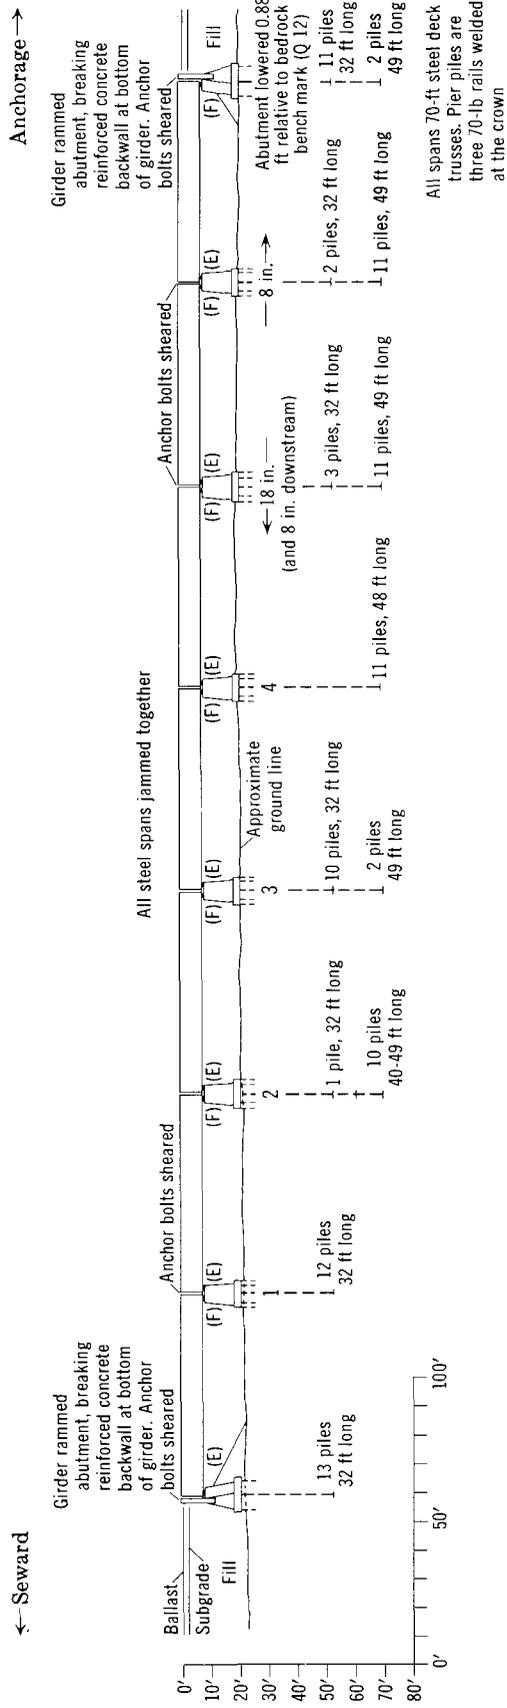
36.—Construction of and damage to Twentymile River bridge (64.7).

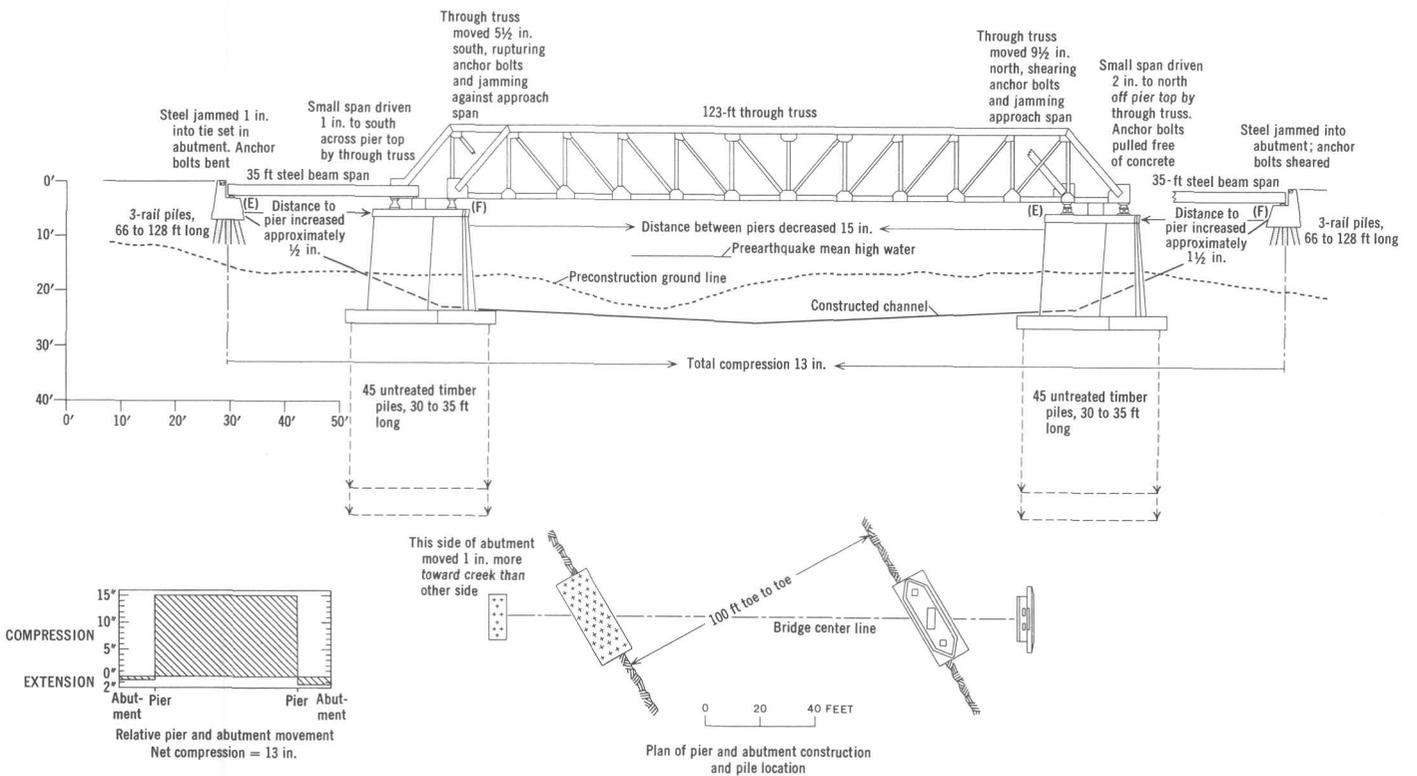
38.—Construction of and damage to Ship Creek bridge (114.3).

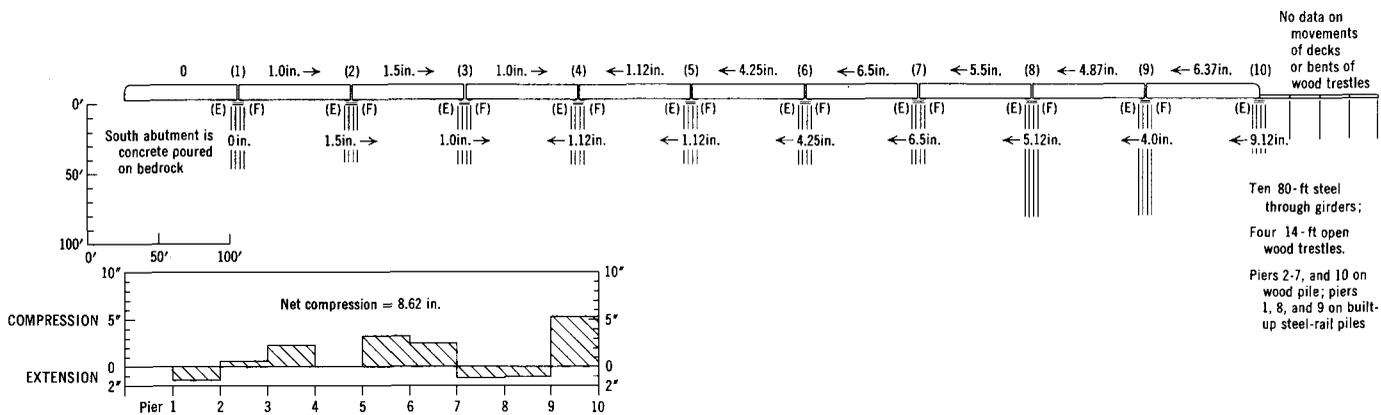
39.—Construction of and damage to Knik River bridge (146.4).

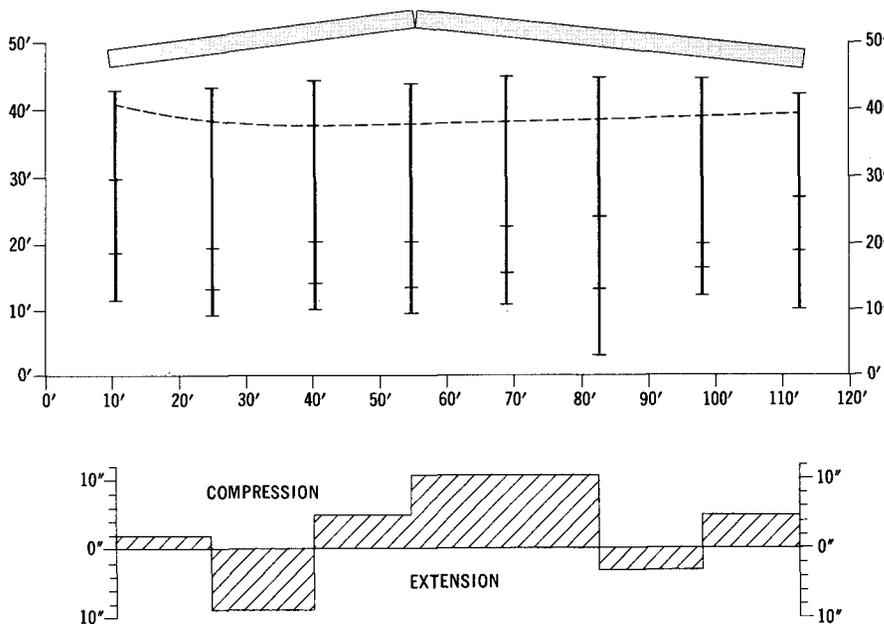
42.—Postearthquake positions on bents and deck of bridge 34.5. Relative interbent movements shown in graph.

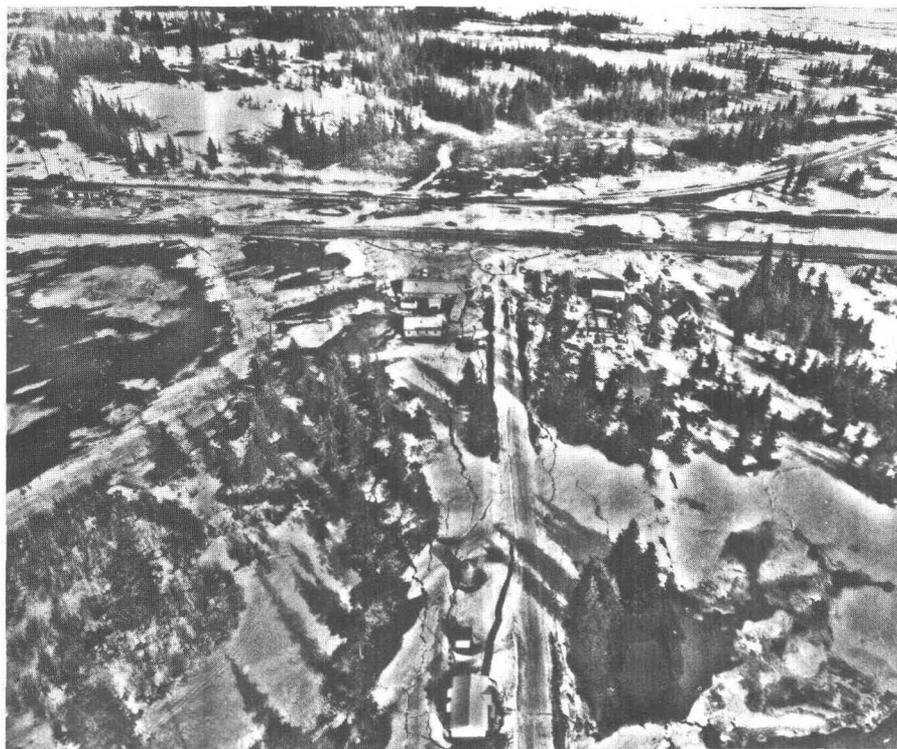
49.—Ground cracks generated by an embankment in Portage. Note dark areas flooded by ground water. Photograph by U.S. Army.

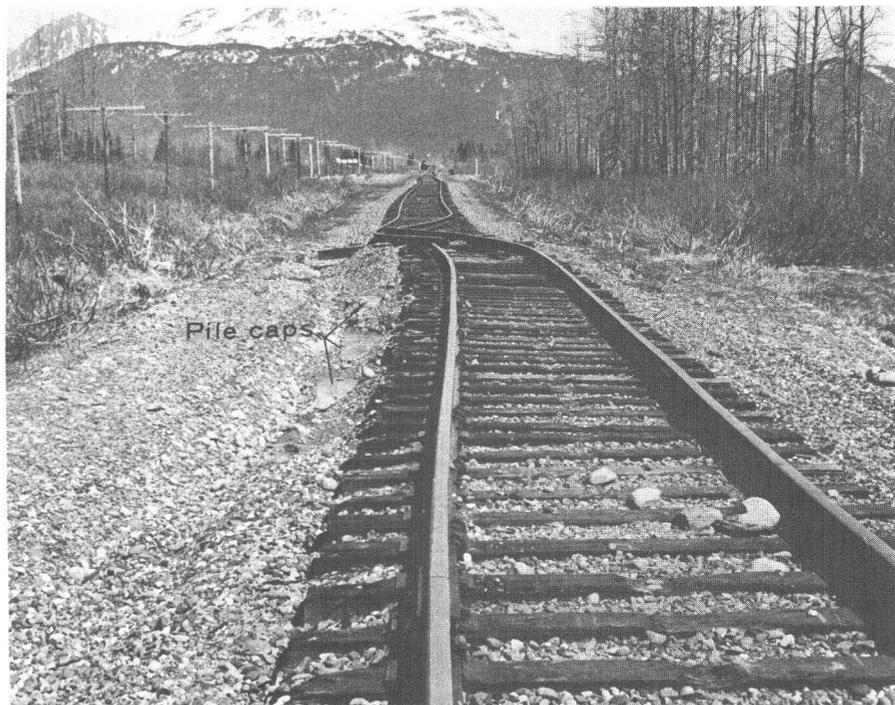
60.—Lateral offsetting and compression at the end of filled-over bridge (looking north toward bridge 62.3). Note the ends of pile caps exposed to left of the ties.

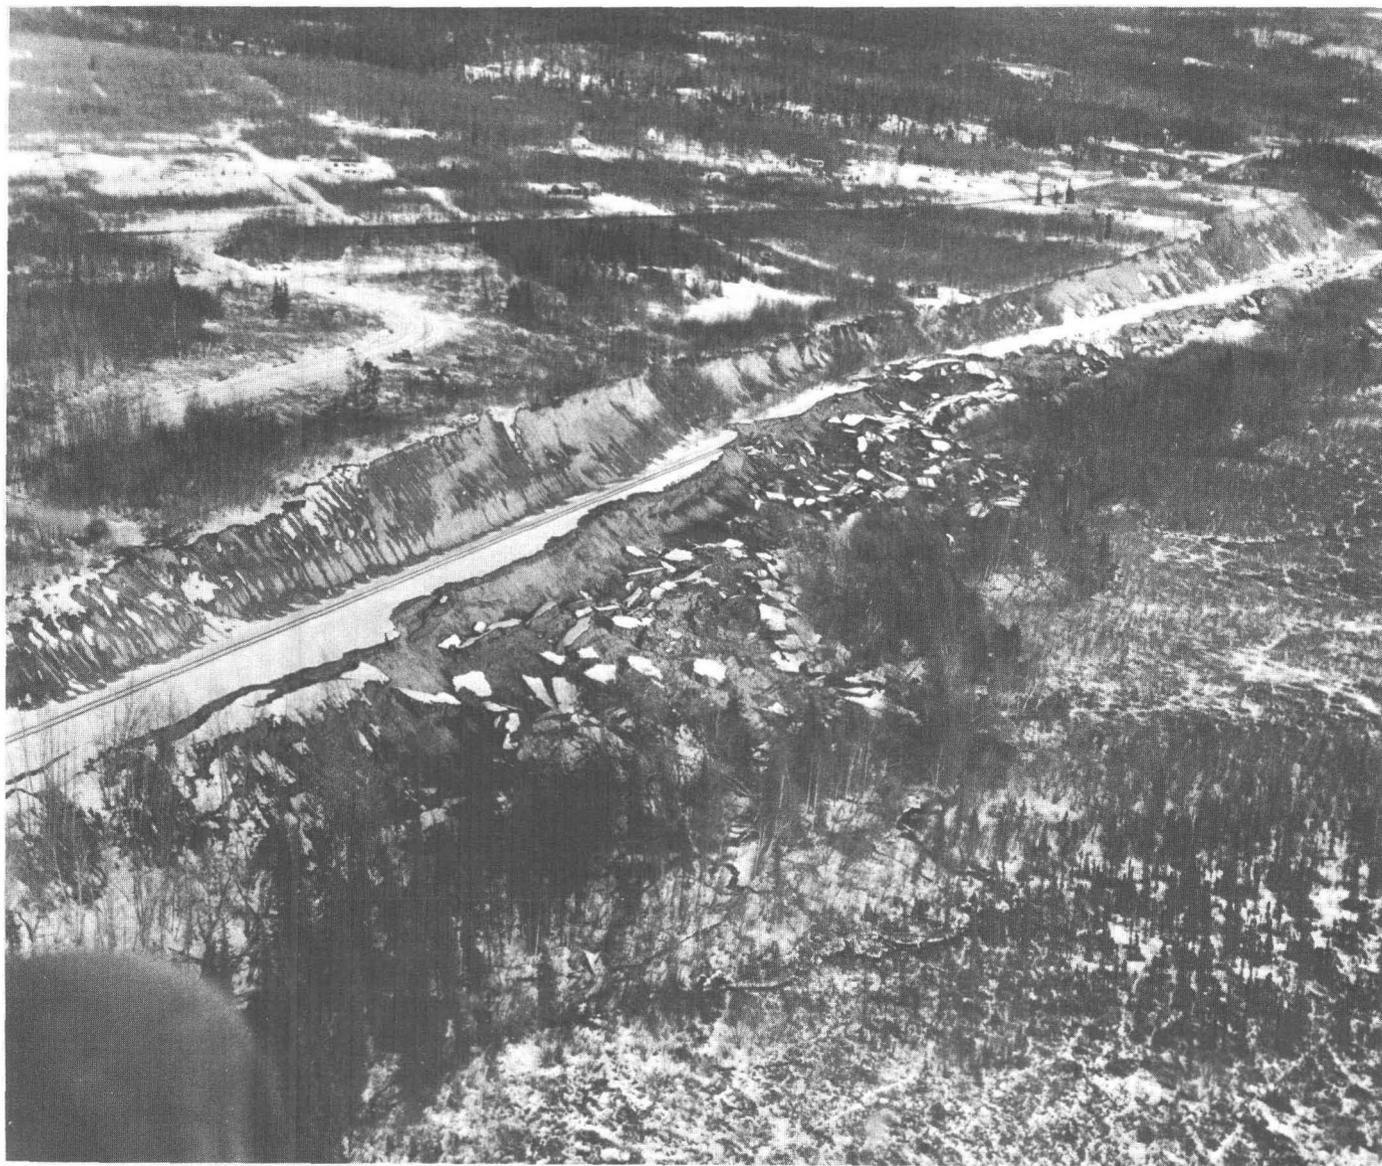
65.—View of Potter Hill slides. Note the overthrusts in the low-lying tidal flat in the foreground, and dark strata of water-saturated sediments in the slide scarps. Photograph by The Alaska Railroad.

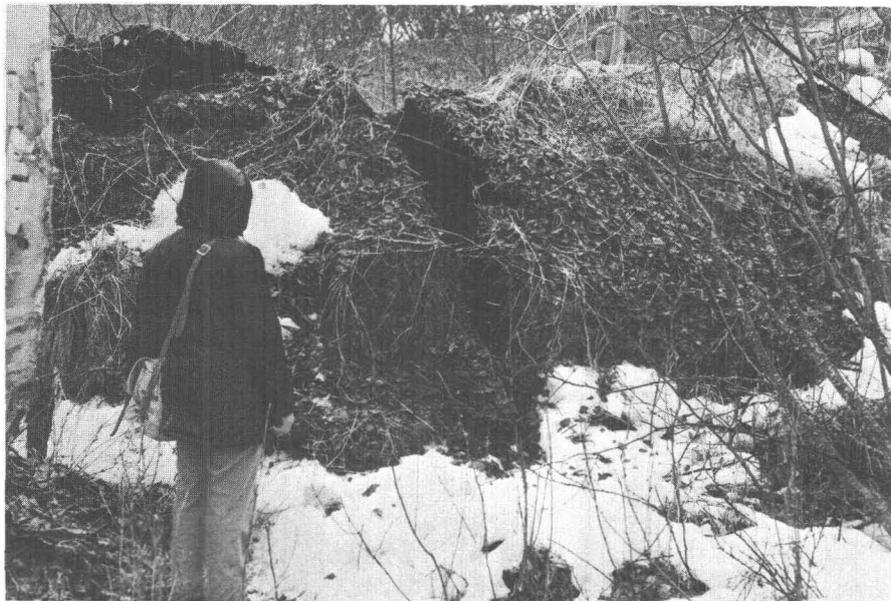
71.—Frozen turf arched upward in a hollow pressure ridge at the toe of the slide at mile 138.4. The hollow center can be seen where the ridge is broken by an extension fracture. The slide lies behind the viewer.

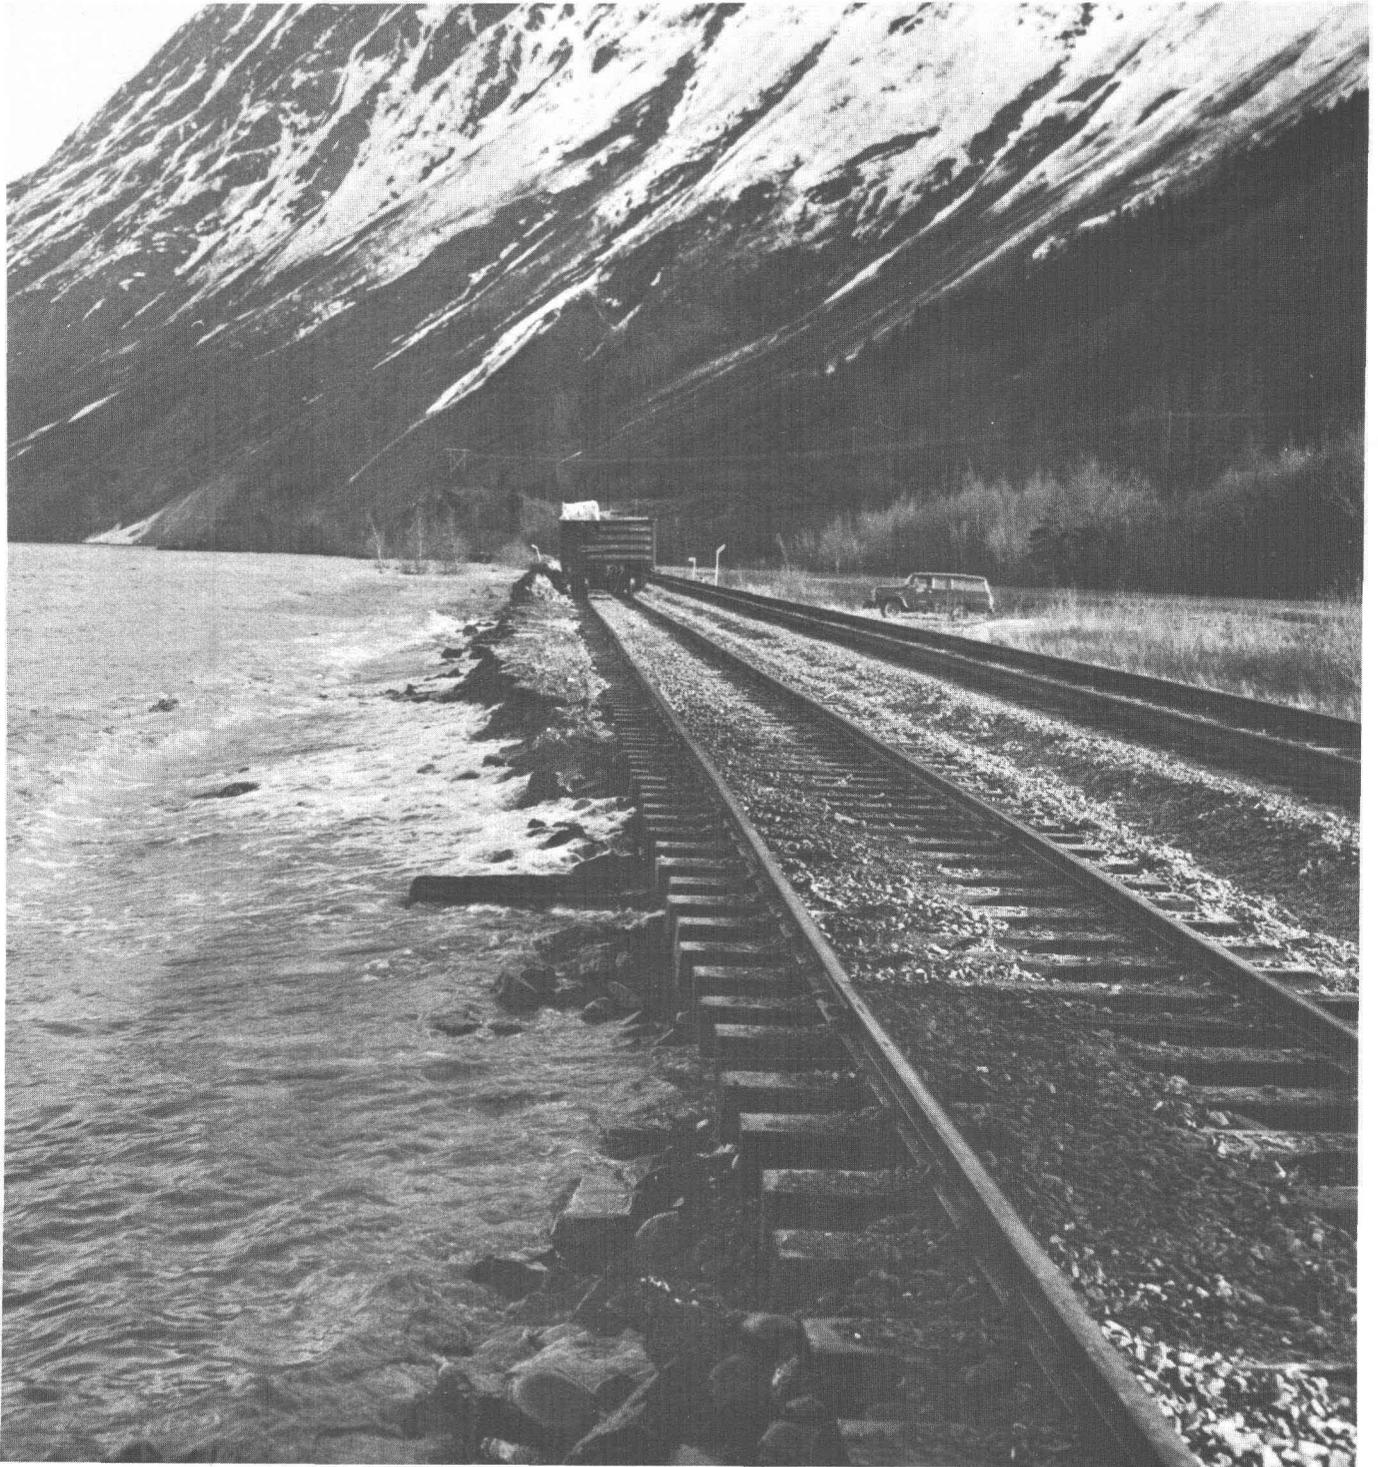
76.—Waves eroding the railroad embankment lowered by tectonic subsidence along Turnagain Arm. Photograph by The Alaska Railroad.

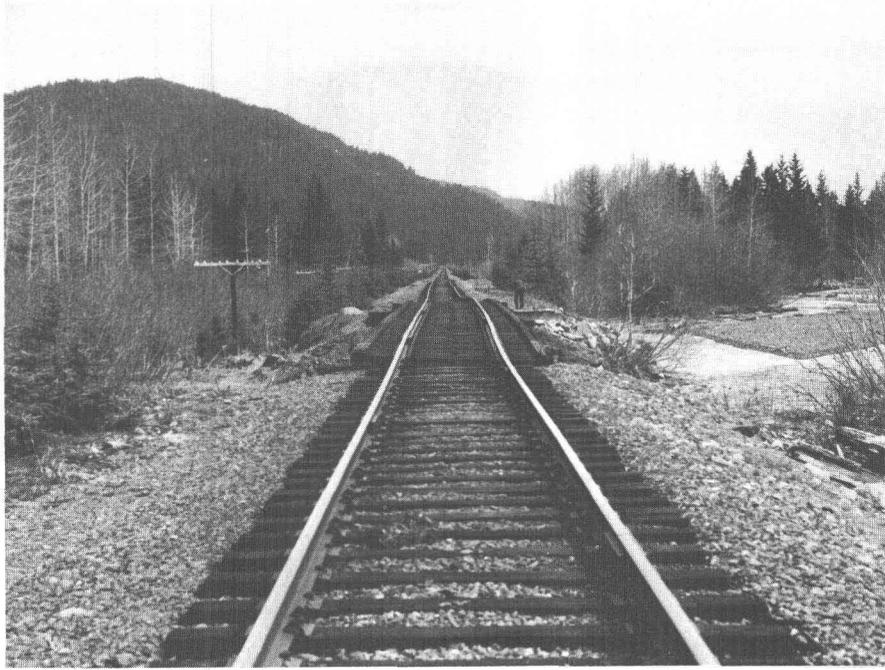
79.—View north over arched and compressed bridge 4.8. Sags of about 2 feet and horizontal displacement of about 1 foot can be seen in the roadbed to the north.

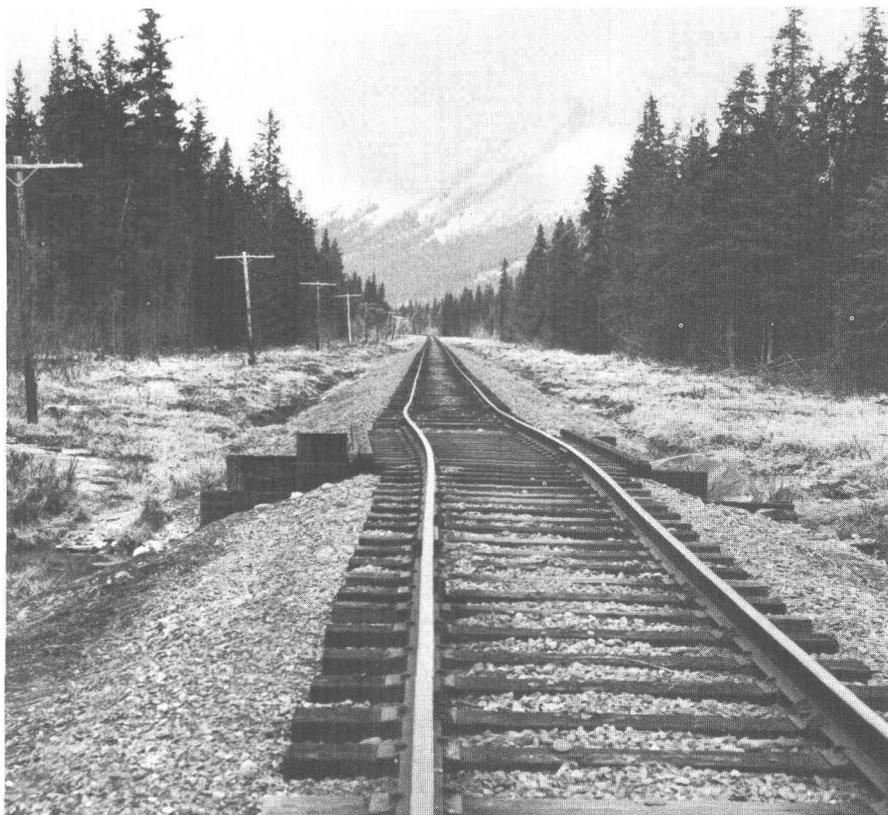
82.—View north over bridge 15.2 on the inactive floodplain terrace of Snow River. Approximately 950 feet of the embankment north of the bridge shifted about  $1\frac{1}{2}$  feet to the west toward an abandoned stream channel 220 to 230 feet to the west, in the tree-covered area.

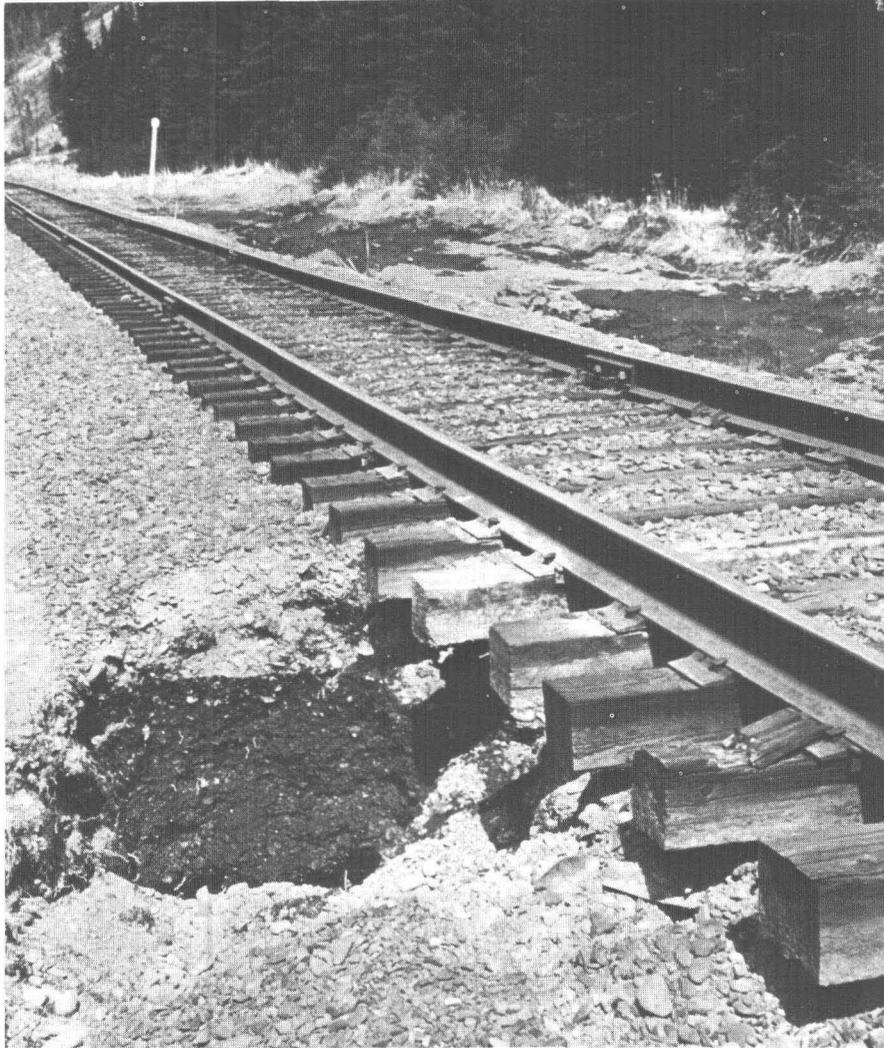
86.—A 4-foot-wide and 2-foot-deep cavity excavated beneath the ties by the forceful expulsion of ground water at mile 17.2.

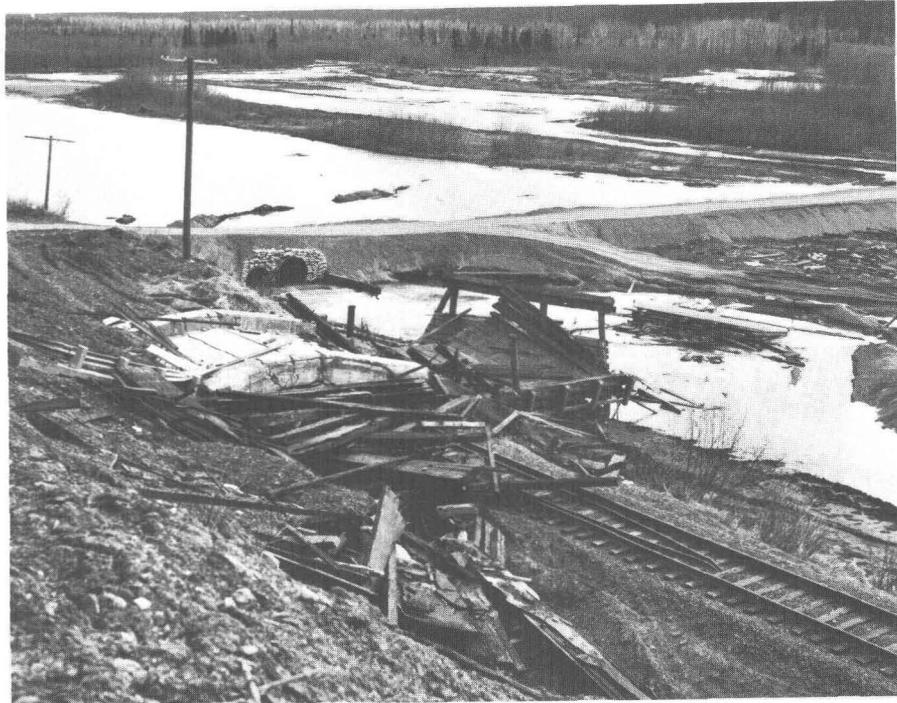
87.—The concrete deck of a highway overpass at Snow River delta that collapsed onto the railroad.

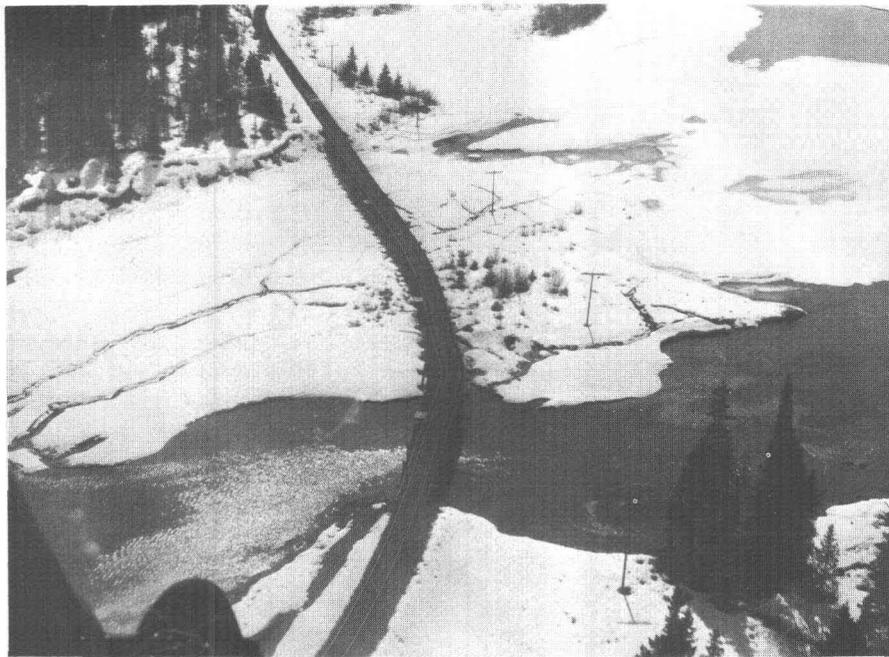
93.—View south over bridge 33.0 at the north end of Upper Trail Lake. Compression buckled the bridge deck laterally. Note the large ground cracks in the flood-plain sediments. Photograph by The Alaska Railroad.
