*A description and analysis of the geologic  
controls of earthquake damage to The Alaska  
Railroad, with emphasis on damage caused  
by the mobilization of unconsolidated  
sediments*

In the 1964 Alaska earthquake, the federally owned Alaska Railroad sustained damage of more than \$35 million: 54 percent of the cost for port facilities; 25 percent, roadbed and track; 9 percent, buildings and utilities; 7 percent, bridges and culverts; and 5 percent, landslide removal. Principal causes of damage were: (1) landslides, landslide-generated waves, and seismic sea waves that destroyed costly port facilities built on deltas; (2) regional tectonic subsidence that necessitated raising and armoring 22 miles of roadbed made susceptible to marine erosion; and (3), of greatest importance in terms of potential damage in seismically active areas, a general loss of strength experienced by wet water-laid unconsolidated granular sediments (silt to coarse gravel) that allowed embankments to settle and enabled sediments to undergo flowlike displacement toward topographic depressions, even in flat-lying areas. The term "landspreading" is proposed for the lateral displacement and distension of mobili

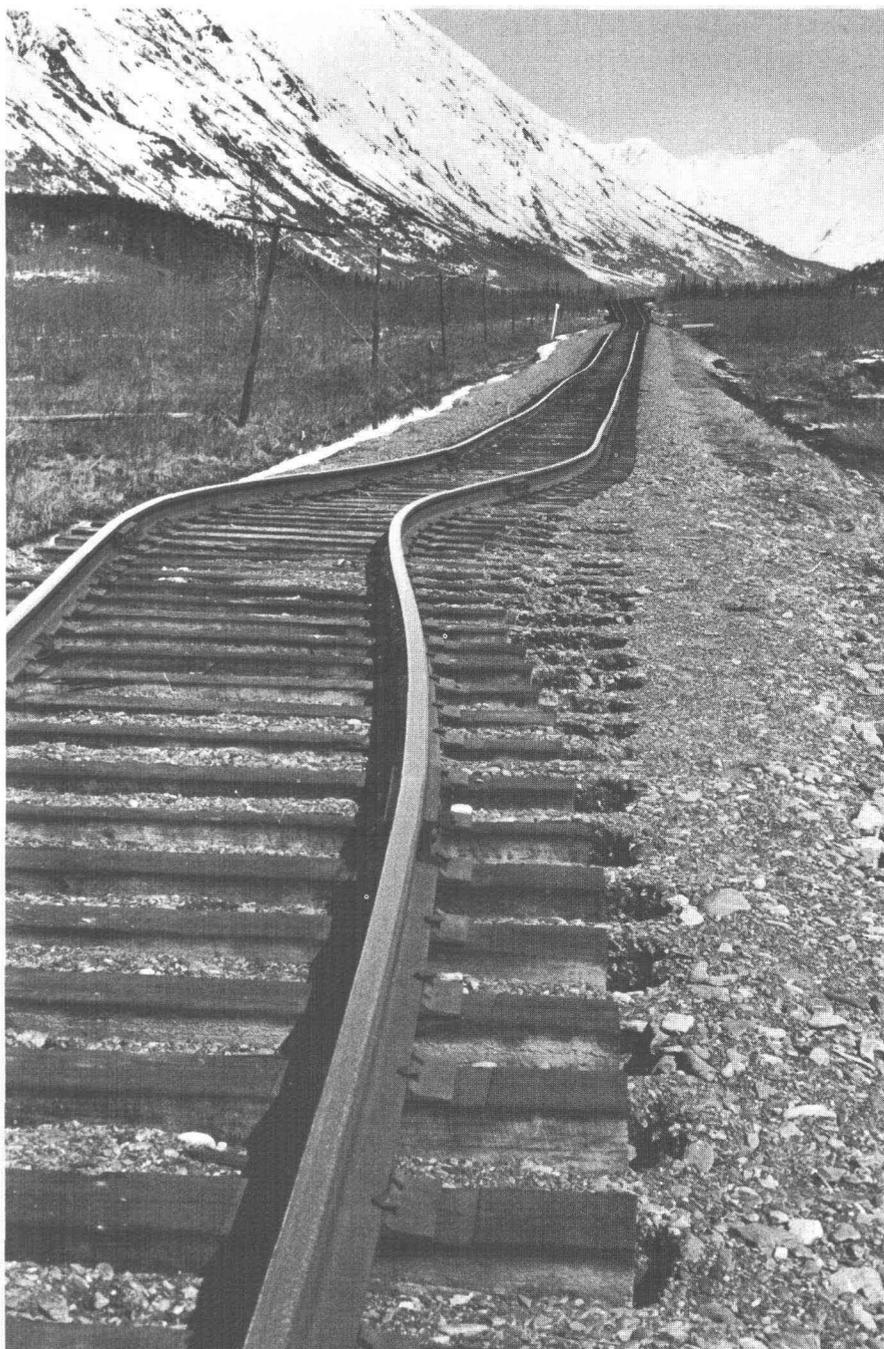
94.—A lateral buckle in the track at mile 34.3, possibly a result of longitudinal compression of the roadbed fill. Bridge 34.5 is visible in the background.

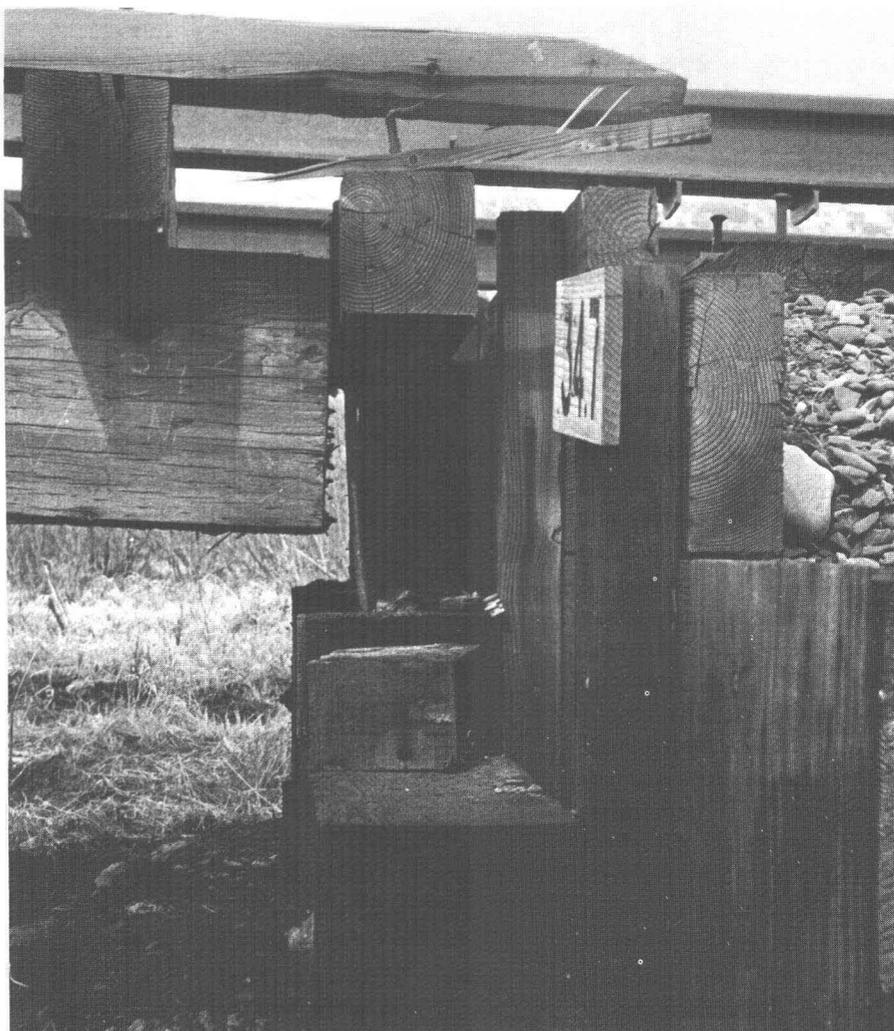
97.—Stringers of extended bridge 34.7 that were pulled  $4\frac{1}{2}$  inches away from the north bulkhead and cantilevered  $5\frac{1}{2}$  inches up off the bulkhead bent.

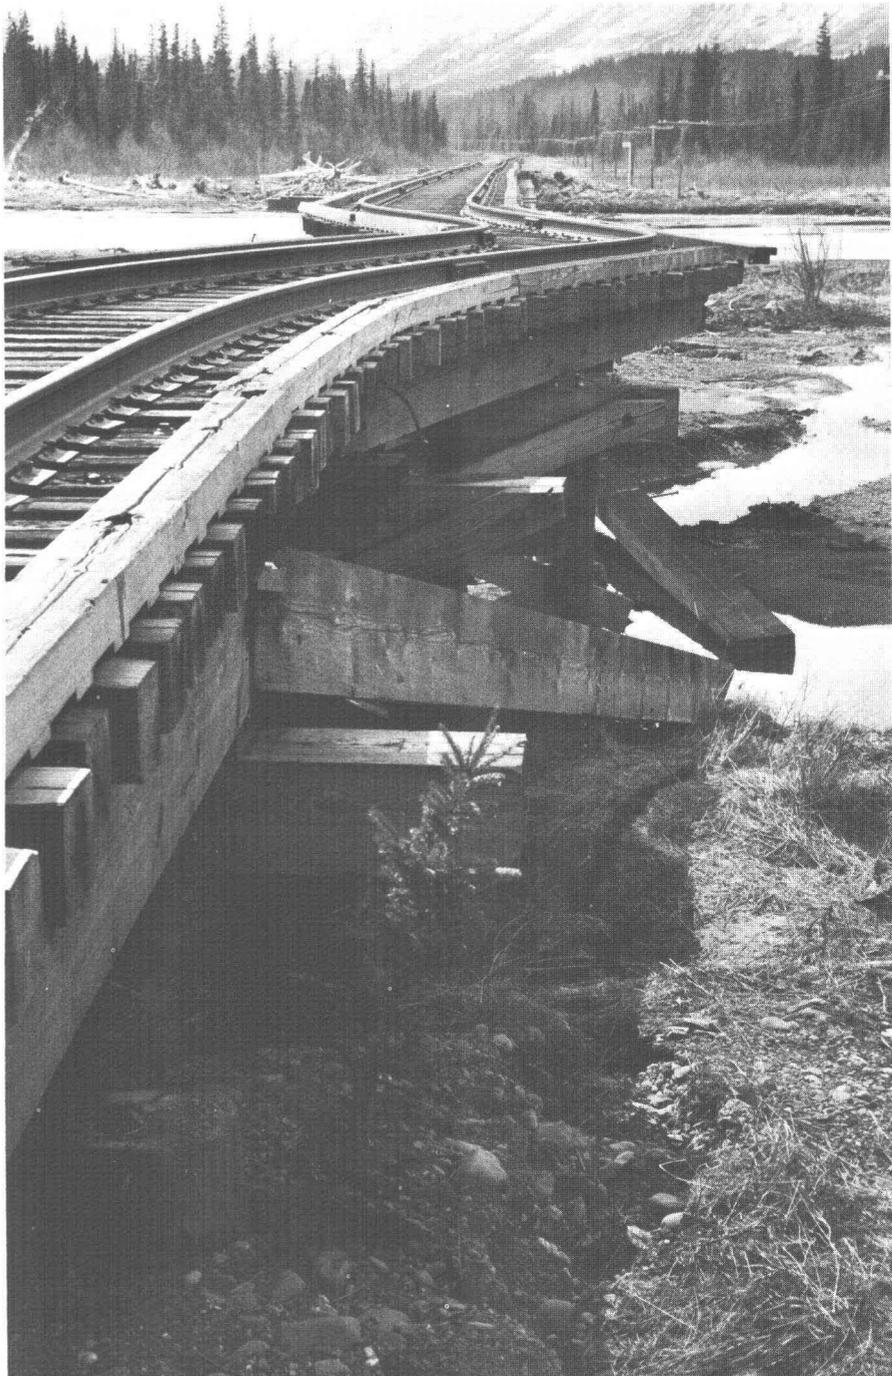
99.—Laterally buckled deck of bridge 37.0, on Hunter Flats. The buckling stringers broke free of some bents and pulled others (at apex of bend) laterally through the sediments.

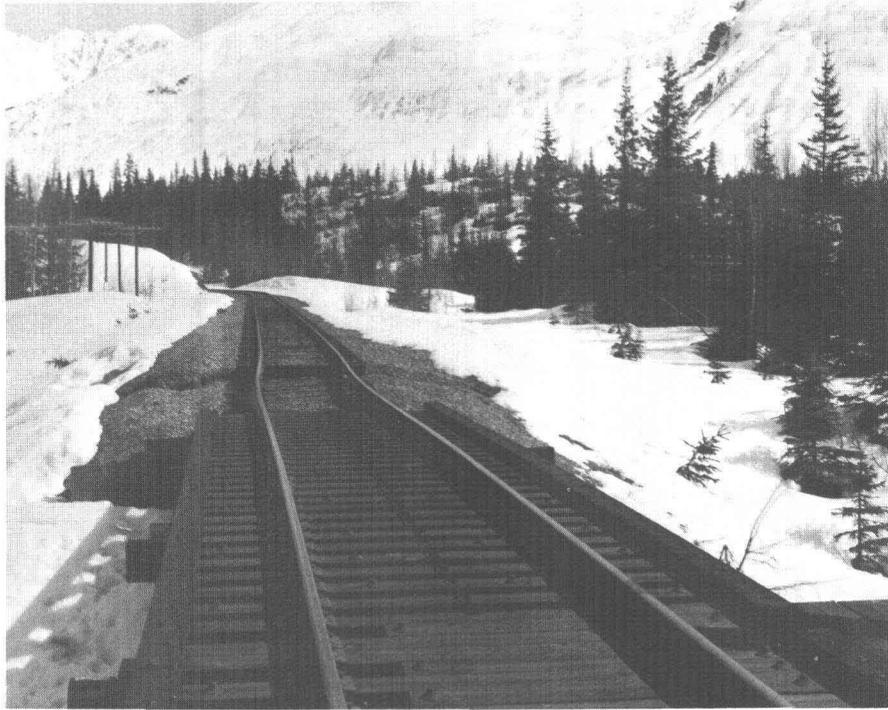
102.—View north over bridge 41.6, where 18 feet of the approach fill was lowered about 1.5 feet. Photograph by The Alaska Railroad.

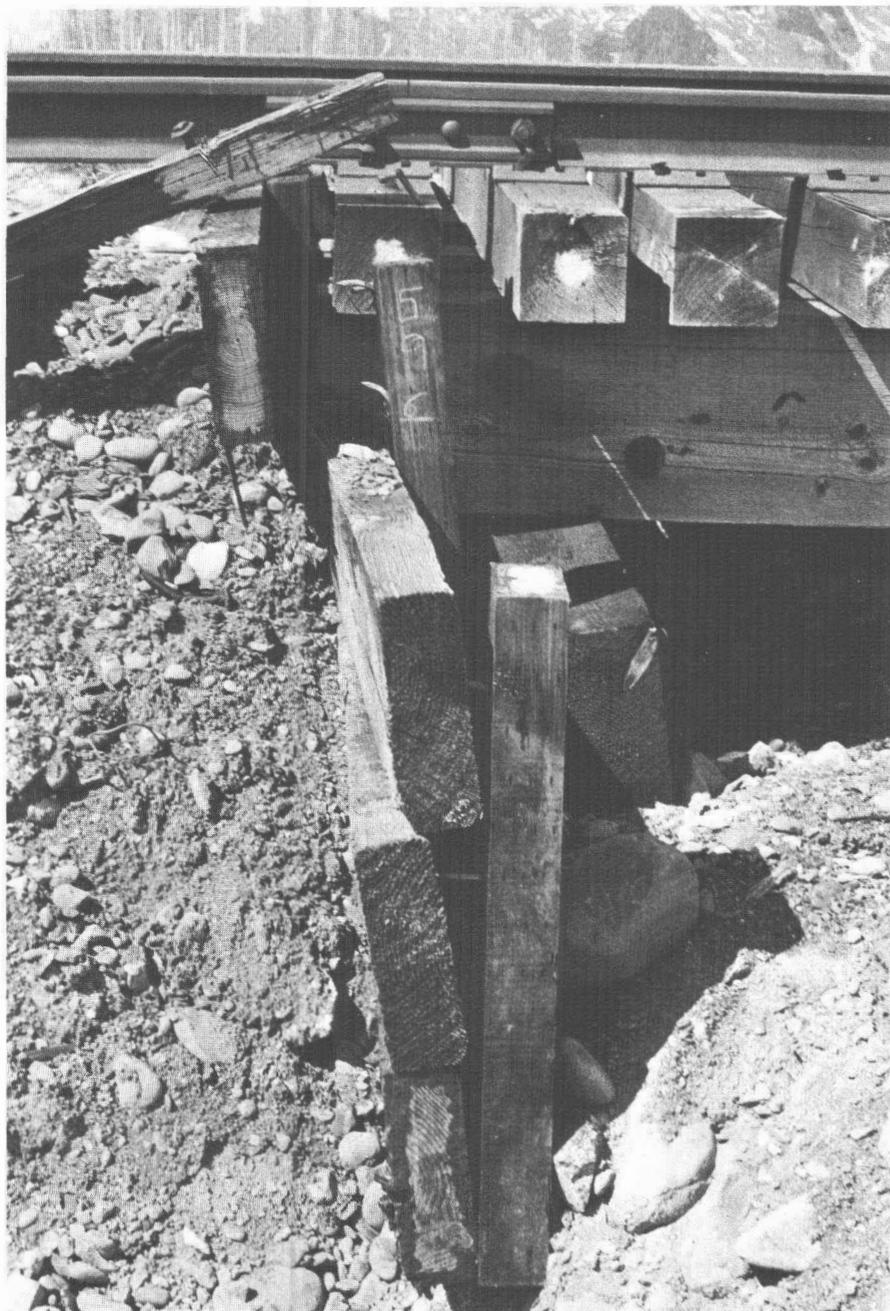
105.—The stringers of bridge 59.6 driven into and through the bulkhead planks.

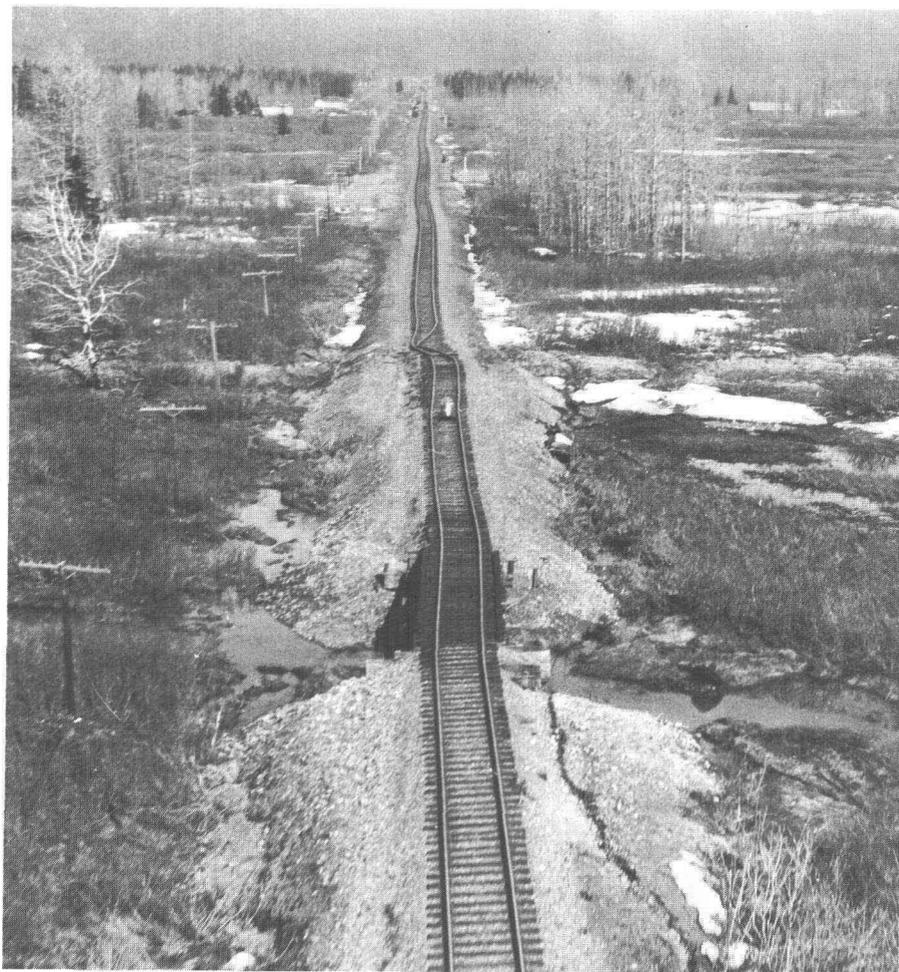
116.—Broken and laterally displaced embankment north of bridge 62.3. Photograph by The Alaska Railroad.

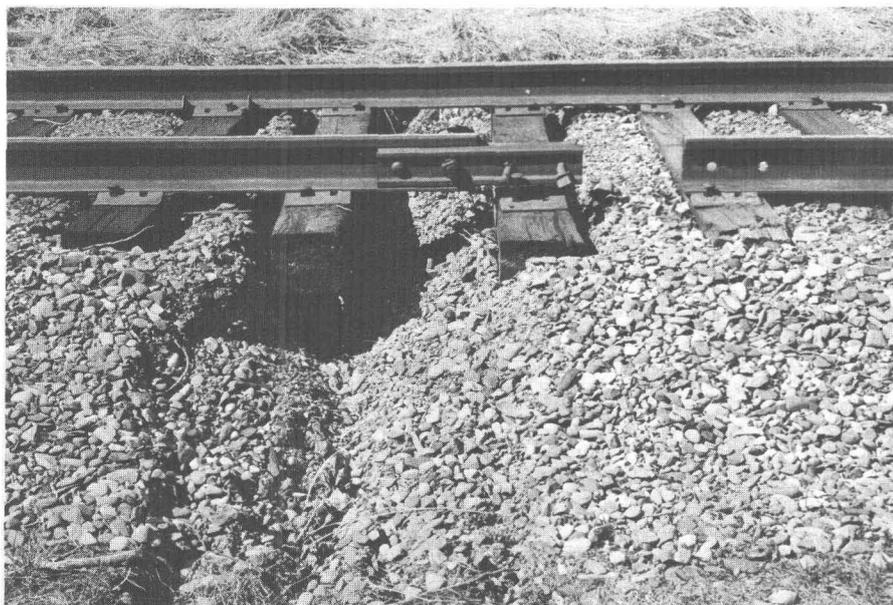
118.—Tension fracture in the roadbed and a 2-foot pull-apart in the rail at about mile 61.9 caused by spreading of the underlying flood-plain sediments (see pl. 3).

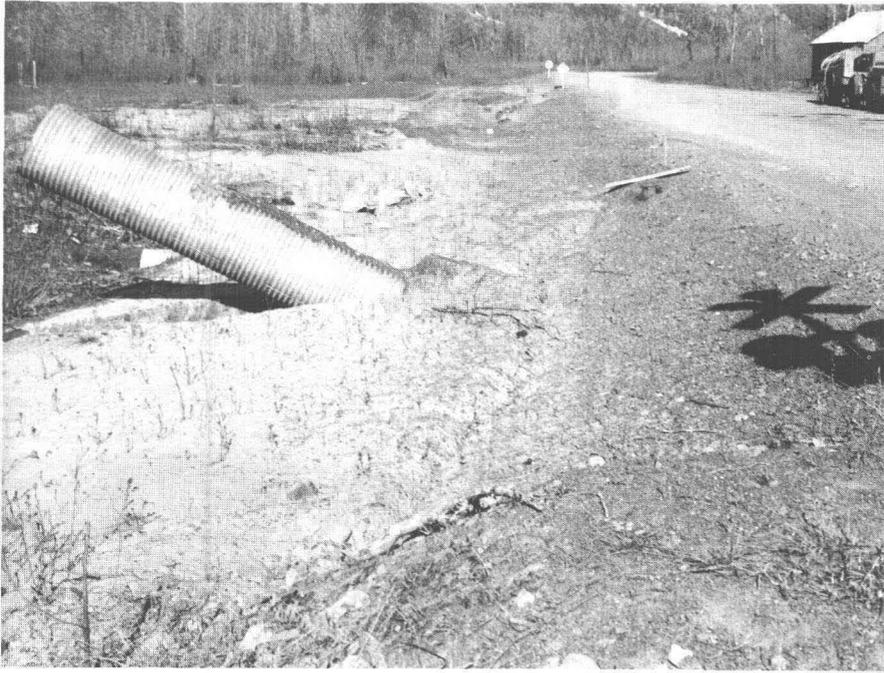
119.—Three-foot-diameter culvert cantilevered upward by sinking of the highway fill just north of the grade crossing at mile 62.9.

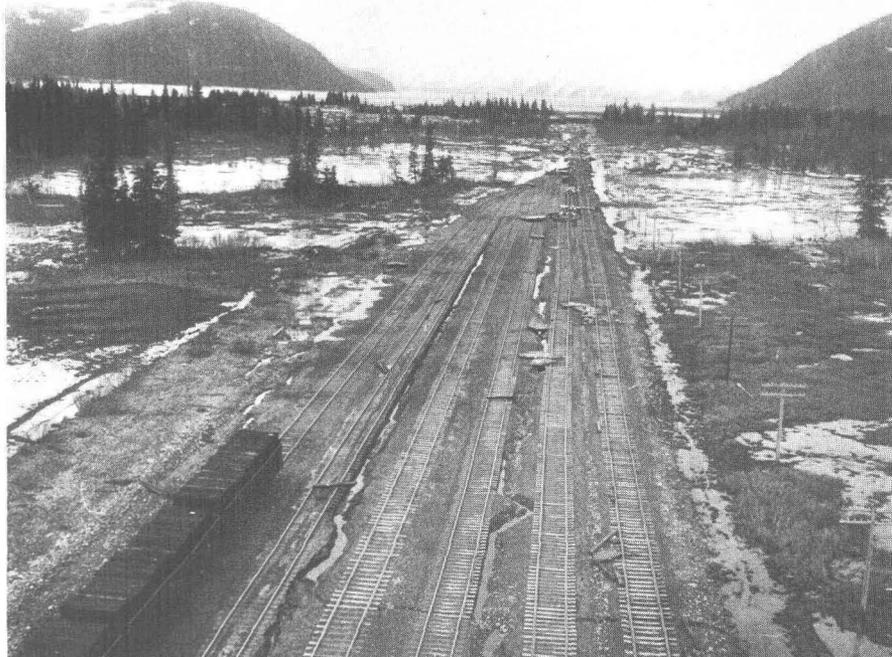
124.—Tension fractures between tracks on the Whittier branch marshaling yards. The subgrade fill failed by lateral spreading and the ballast failed in tension.

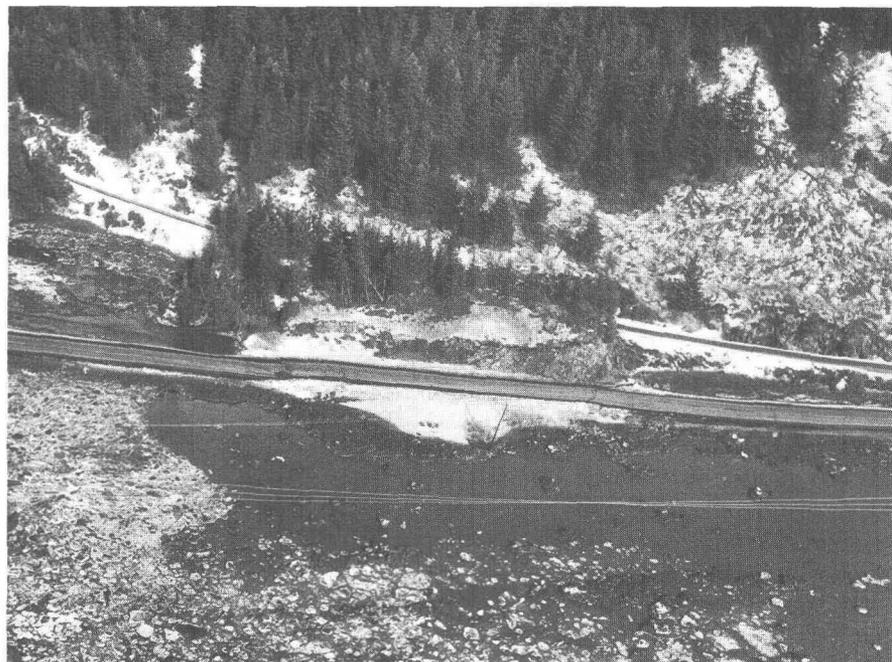
125.—Highway embankment along the north shore of Turnagain Arm that settled abruptly on tidal sediments adjacent to a bedrock promontory. Similar settlement occurred on the railroad embankment. Embankments on tidal sediments also were shifted toward the arm and offset horizontally.

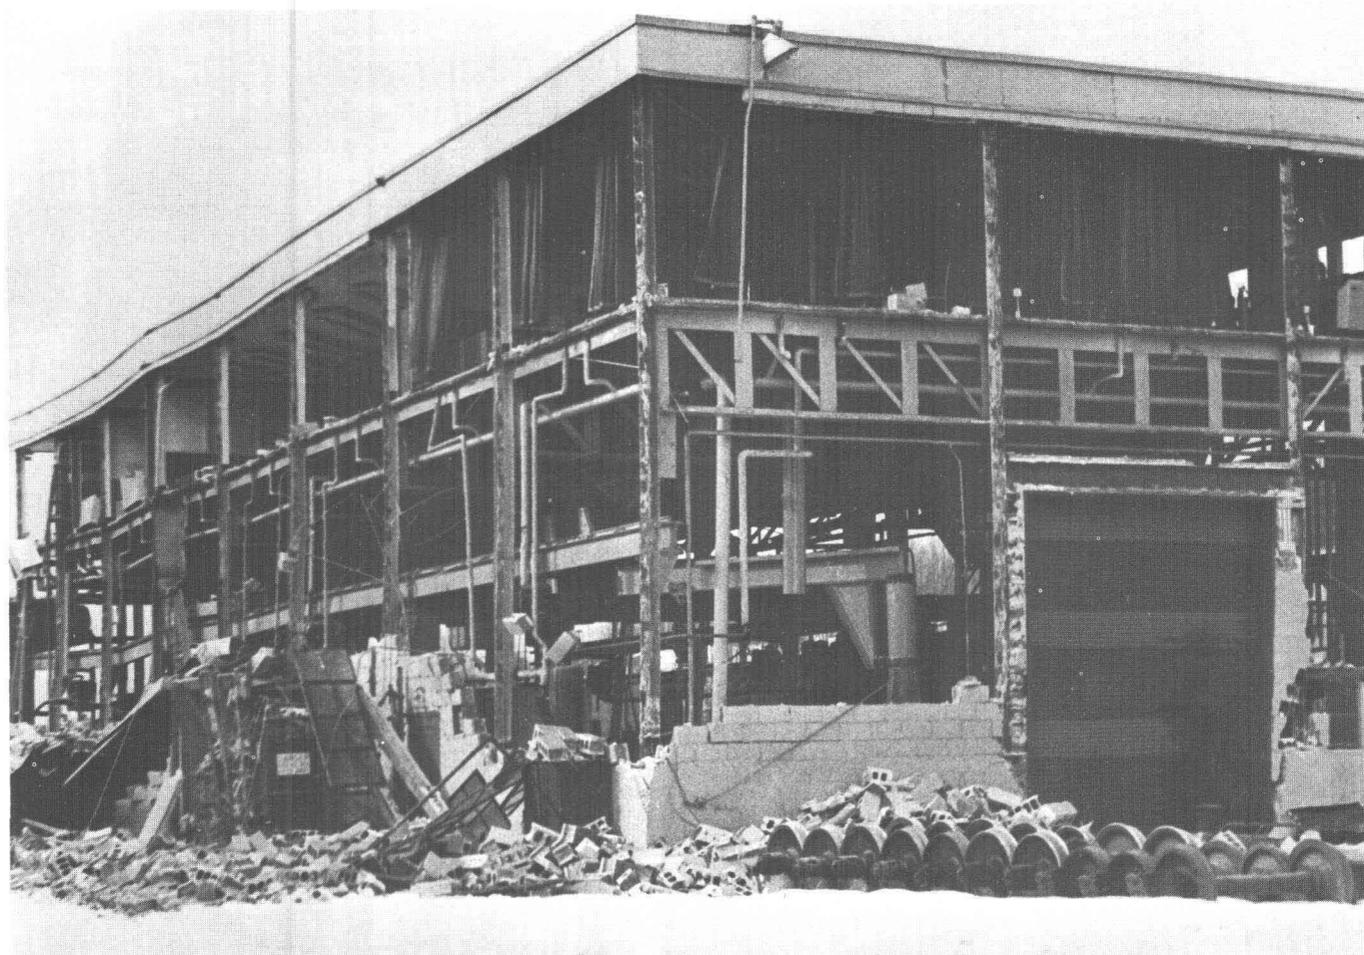
127.—Postearthquake view of the Wheel Shop-Mechanical Offices, showing the steel frame exposed by the collapse of the concrete block walls. Photograph by The Alaska Railroad.

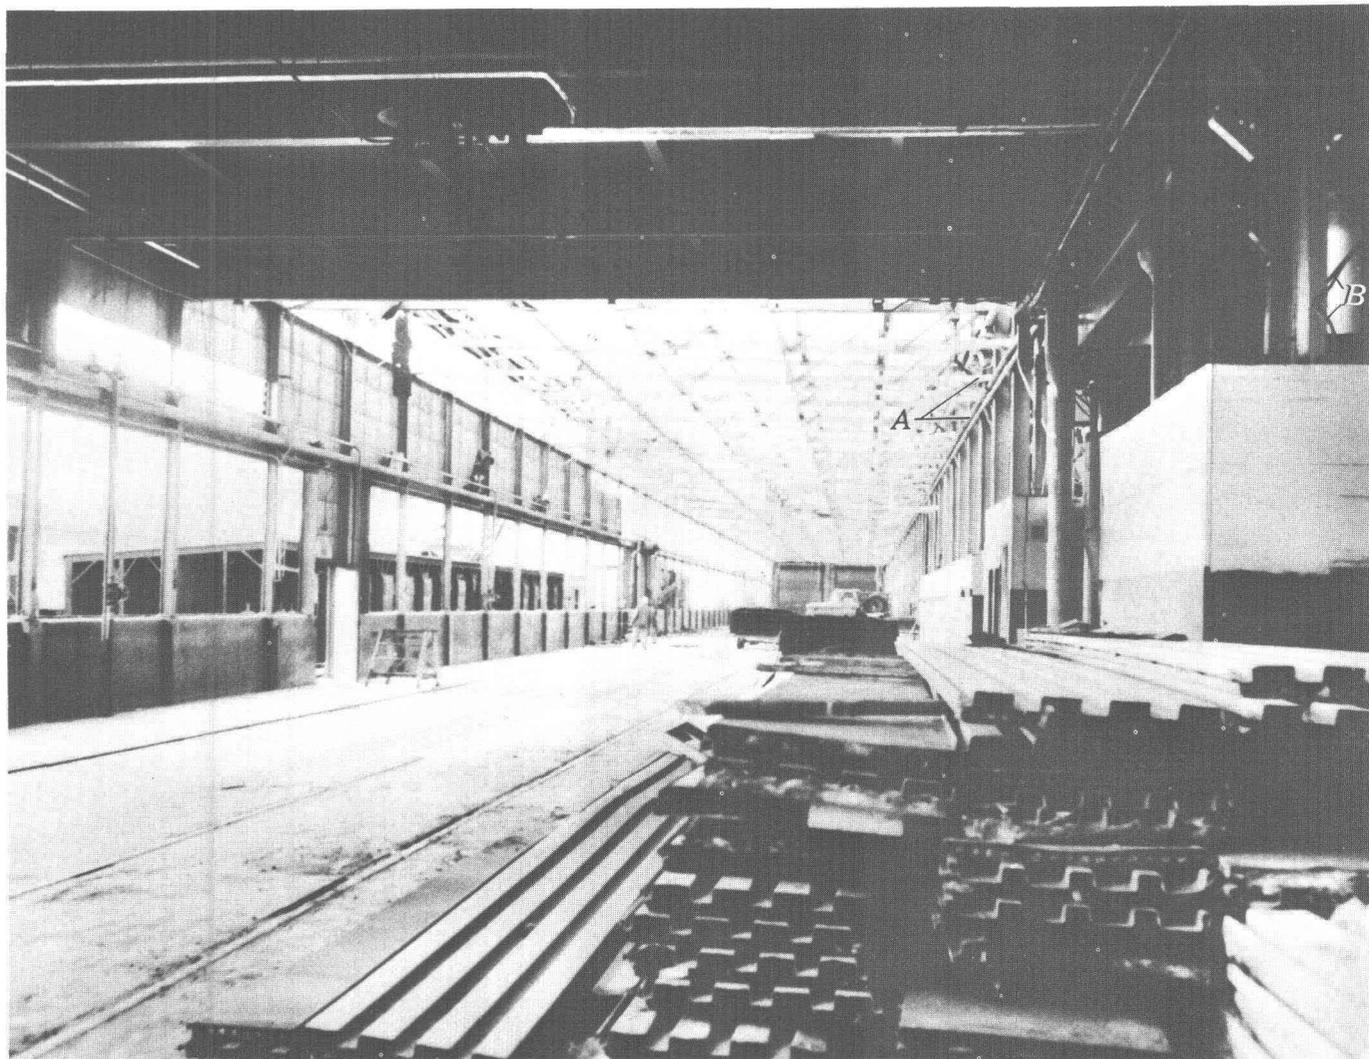
130.—Interior view of the south bay of the Car and Coach Shop showing *A*, the roof trusses resting on a horizontal steampipe and *B*, buckled rods between H-beam columns. Insulated sheathing panels removed during repairs. Photograph by The Alaska Railroad.

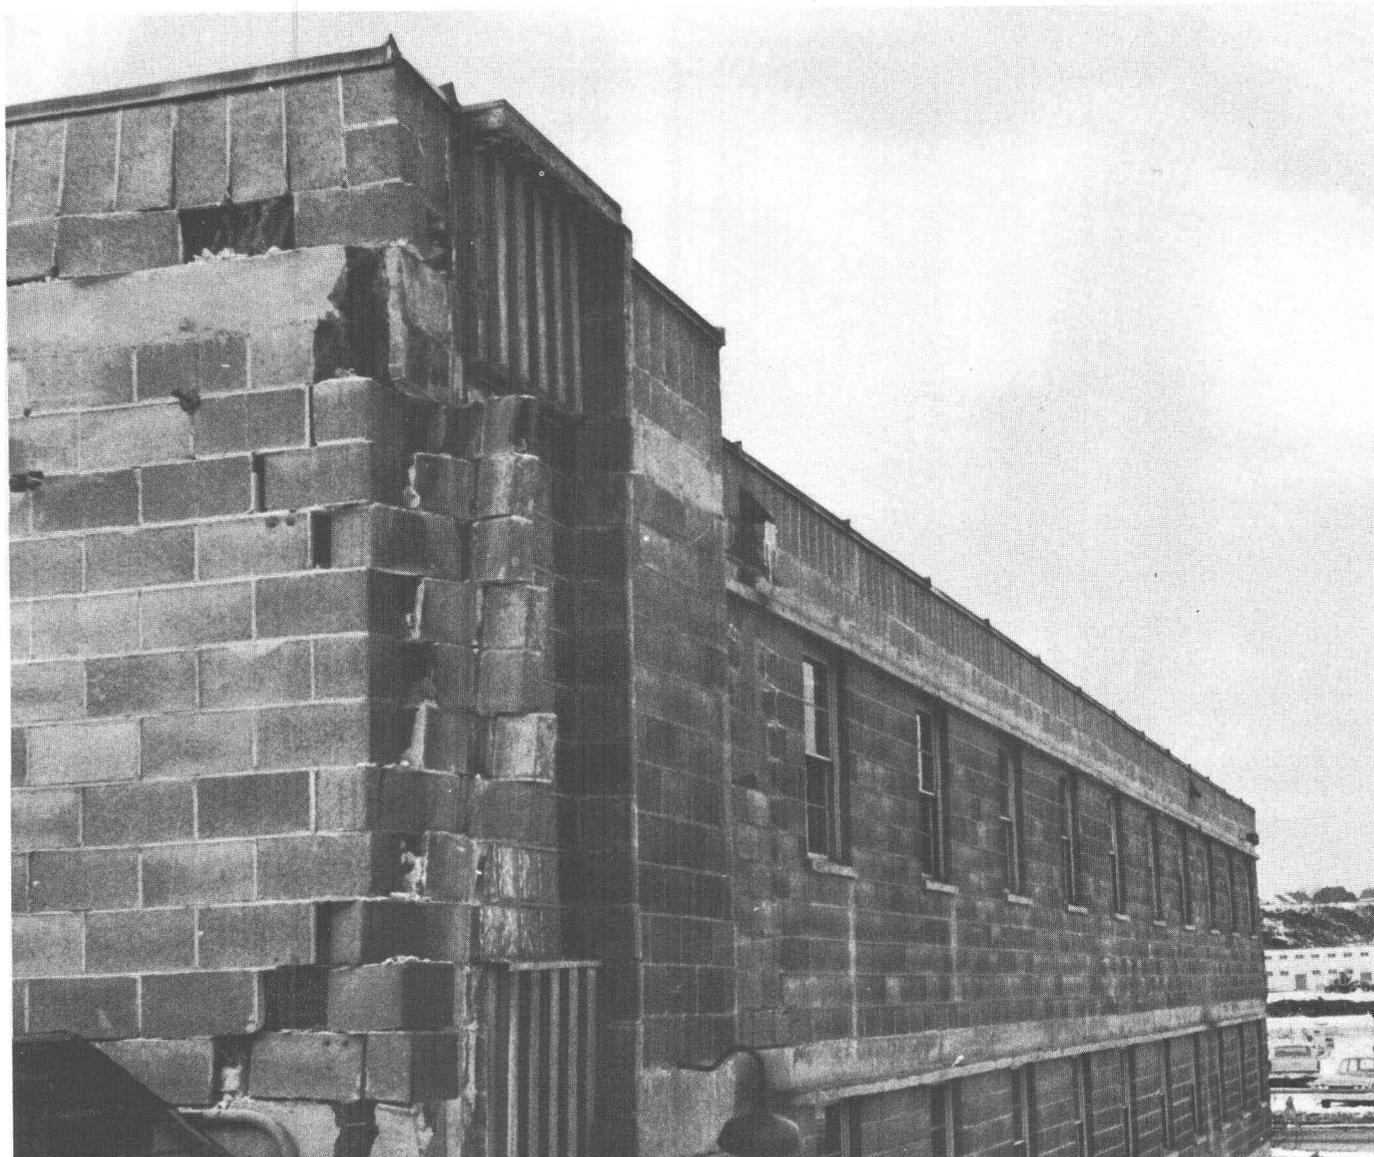
133.—View of the southeast corner of the Office Annex building, showing the rupturing of the block and mortar. Photograph by The Alaska Railroad.

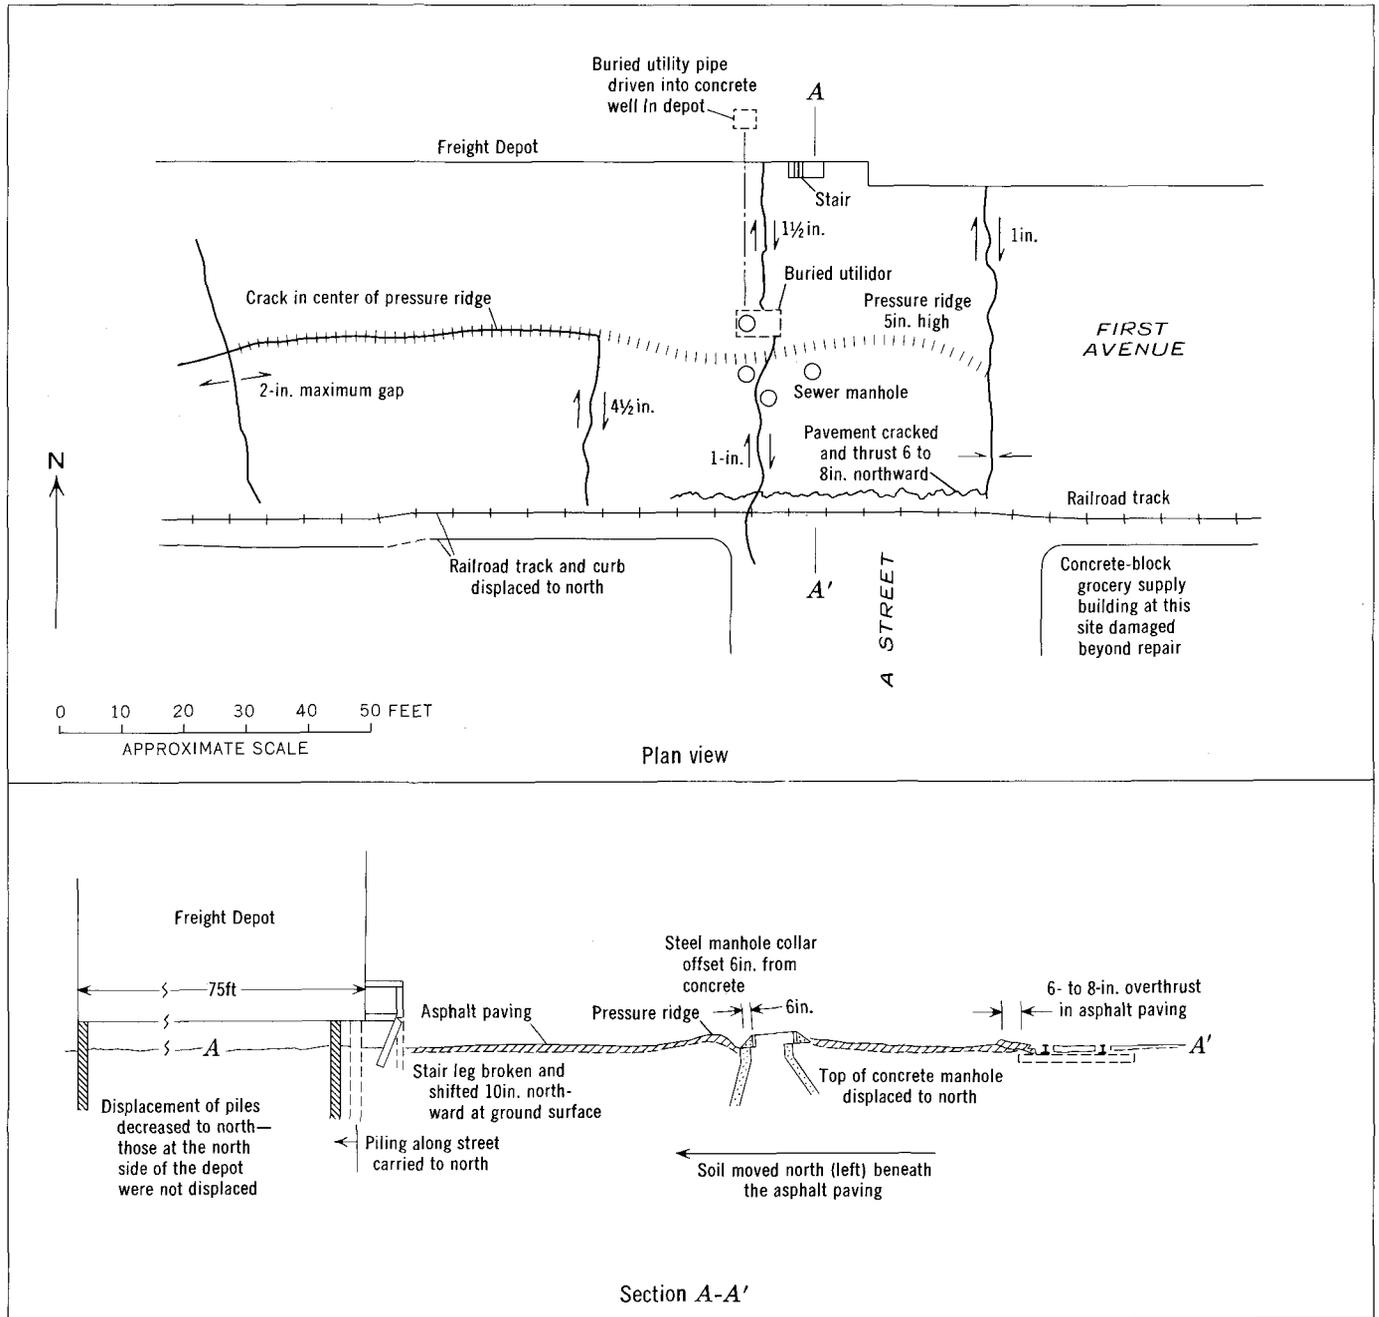
134.—Field sketches (plan and cross section) of landslide features on First Avenue along the south edge of the railroad Freight Depot. Sediments beneath the pavement moved to the north, displacing the concrete well of a sewer manhole and the porch support and wood pile foundation of the Freight Depot. The pipe from the utilidor (plan view) was thrust 16 inches into the concrete well under the depot.

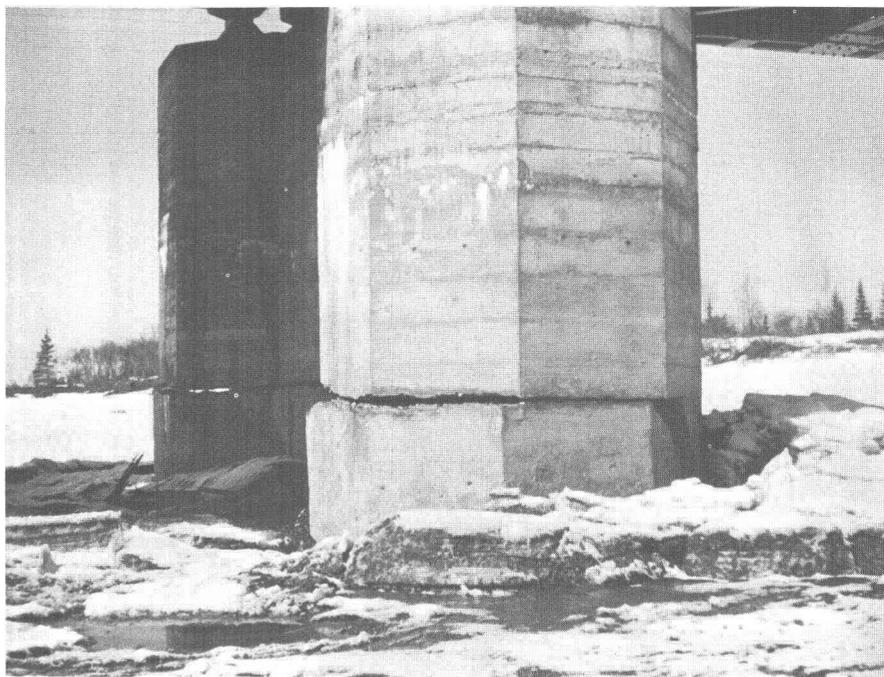
138.—Shearing at a pour joint of a concrete pier at bridge 147.1, Knik River.
