Public-data File 85-37

EROSION ALONG THE KENAI RIVER

M.W. Inghram

September 1985

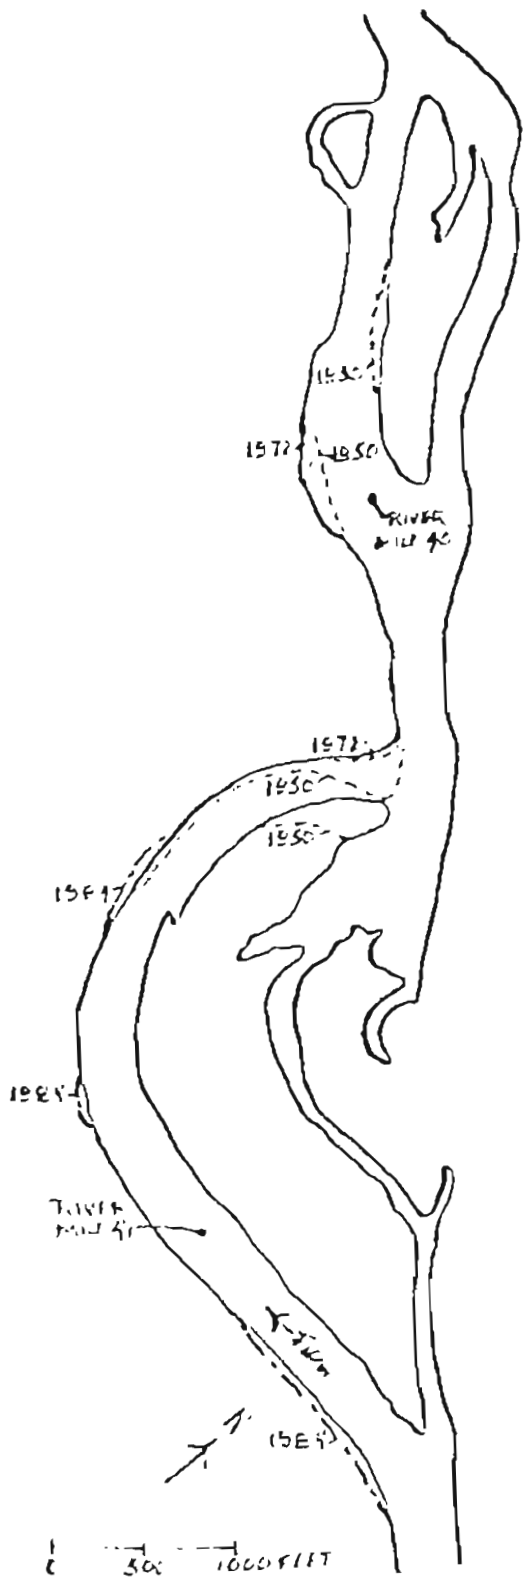
Figures 1 and 2 depict two of the sites mapped by Scott. The solid lines represent the channel as it appeared in 1977. The dotted lines represent channel locations in specified years. In figure 1, near river mile 41, only two areas noted toward the upstream end of the reach have shown noticeable erosion since 1977. Figure 2 near river mile 10 shows a few areas of erosion near the downstream end of the mapped reach. This reach is under tidal influence, and the bed and bank materials are therefore finer than upstream.

No noticeable increase of erosion rates of since 1977 are visible in these two sites. Rivers are dynamic systems, both eroding and redepositing continually. Erosion and deposition are mapped at both sites, however not at an apparently increased rate. At some locations there appeared to be more erosion prior to 1977.

Figure 1. River reach near mile 40. Solid line is bank position in 1977.

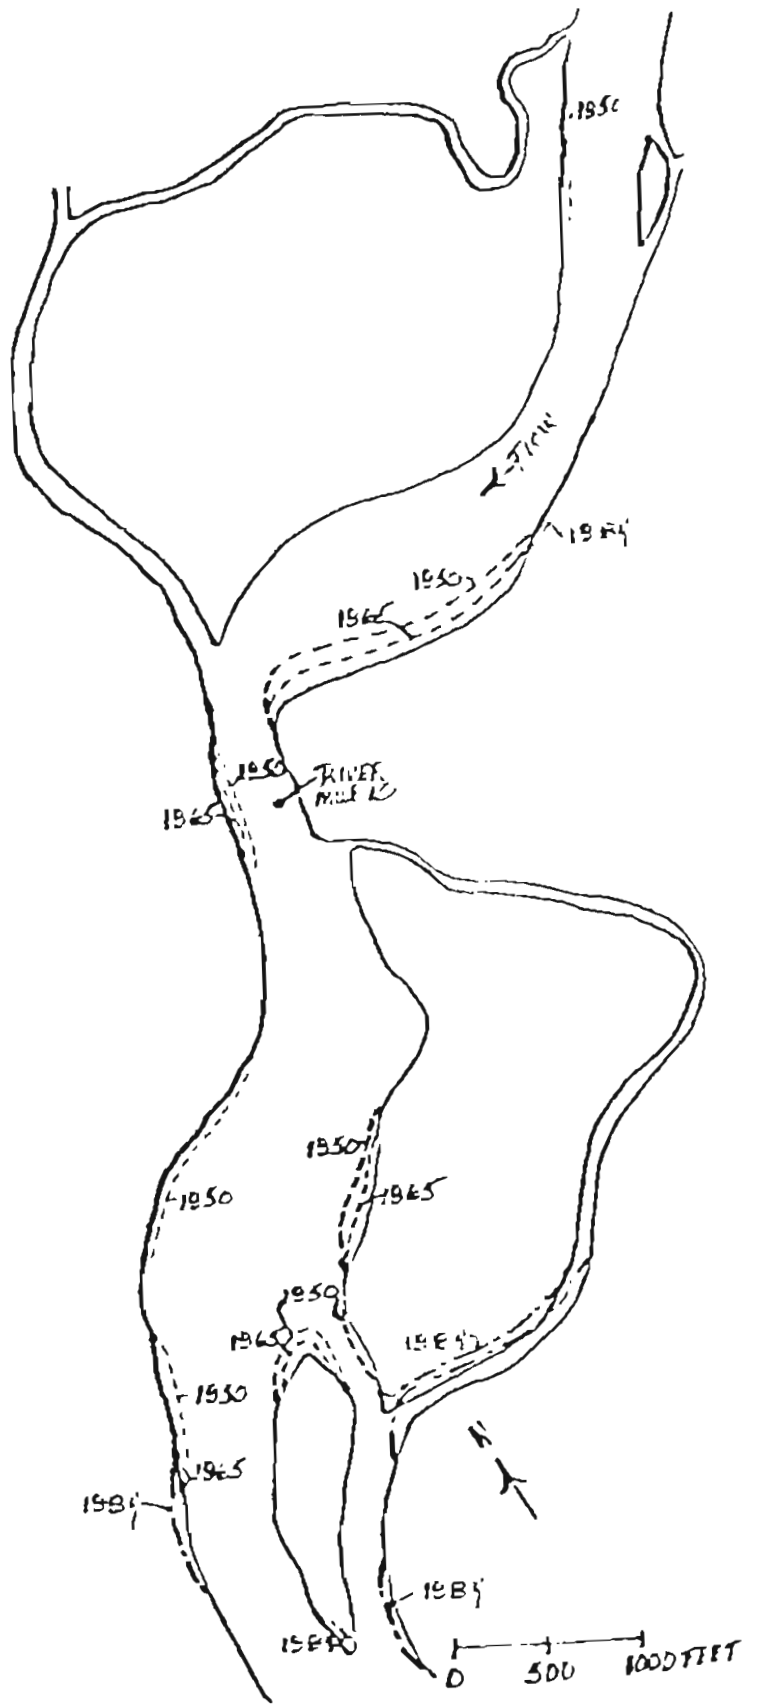
Figure 2. River reach near mile 10, close to Beaver Creek. Solid line is bank position in 1977.

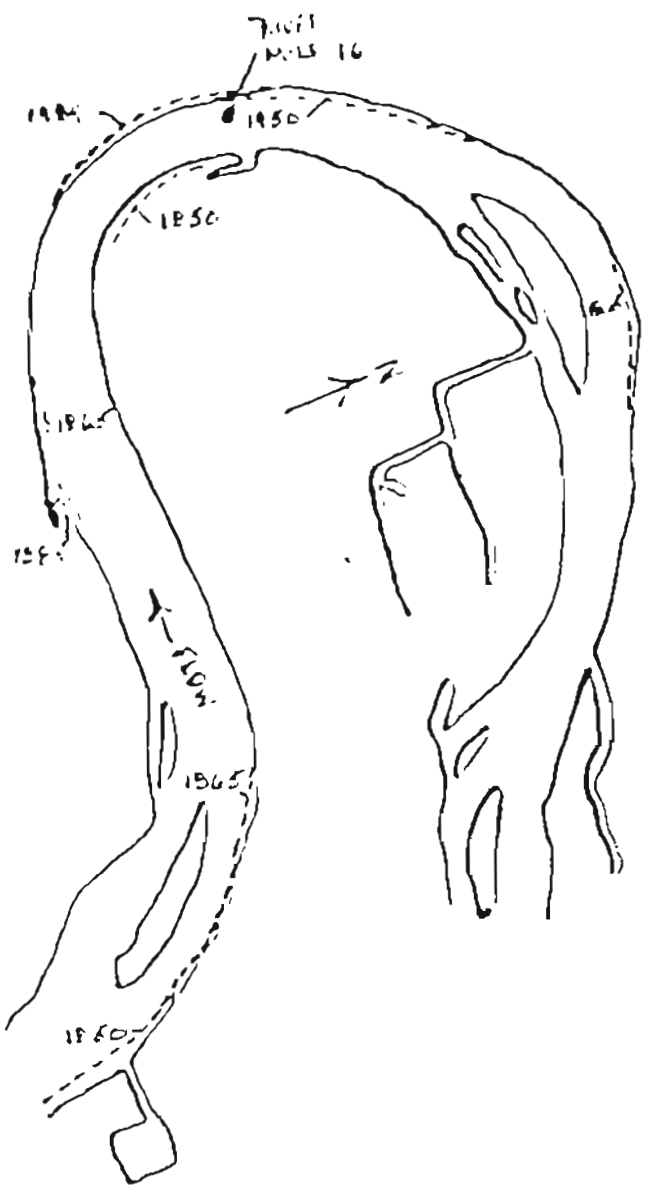
Several more reaches of the river mentioned, though not mapped by Scott, as experiencing possible increases in the erosion rates were next mapped. The results are shown in figures 3 and 4. Figure 3 is meander 3-H near mile 16. This sharp meander bend is frequently mentioned as one with both heavy use and heavy erosion. Scott uses meander 3H as a prime example of increased erosion on the Kenai River. Specifically, Scott discusses a number of fresh slide scars on the high banks at the outside of Meander 3-H. Figure 3 shows that erosion occurred on the outside of Meander 3-H between the years 1950 and 1977, as well as some point bar development. The figure also shows that additional erosion has occurred since 1977.

Figure 3. River reach near mile 16, on meander 3-H. Solid line is bank position in 1977. From aerial photos it appears as if the height of the cut bank on the outside of the meander has increased since 1965.

Banks on the outside of meander bends are exactly where rivers are expected to erode. The inside of meanders is where rivers deposit material. The outside of meander 3-H is inherently unstable. Photos dating back to 1950 clearly show high unvegetated banks. Aerial photography also shows a definite progression of abandoned meander scars migrating toward the outside of meander 3-H. The outside of meander 3-H is eroding, however, photographic comparisons do not show it eroding at a noticeably faster rate since 1977.

Meander 3-G is the sharp meander bend on figure 3 immediately upstream of meander 3-H. Measurable erosion has occurred near the Poachers Cove to Riverside camper park area. Most erosion seems to have happened in the 1950 to 1977 time period. At Poachers Cove a large harbor or inlet has been built. These intense type of river bank activities strip the bank of vegetation and expose potentially less erosion resistant materials to flowing water. Riverside campground has riprapped its bank to slow erosion.

The erosion being experienced at both meander 3-G and 3-H is in locations erosion would be expected. The photographic comparisons of 1950 through 1984 do show that erosion has occurred. However, they do not show a clear indication of increased erosion since 1977.

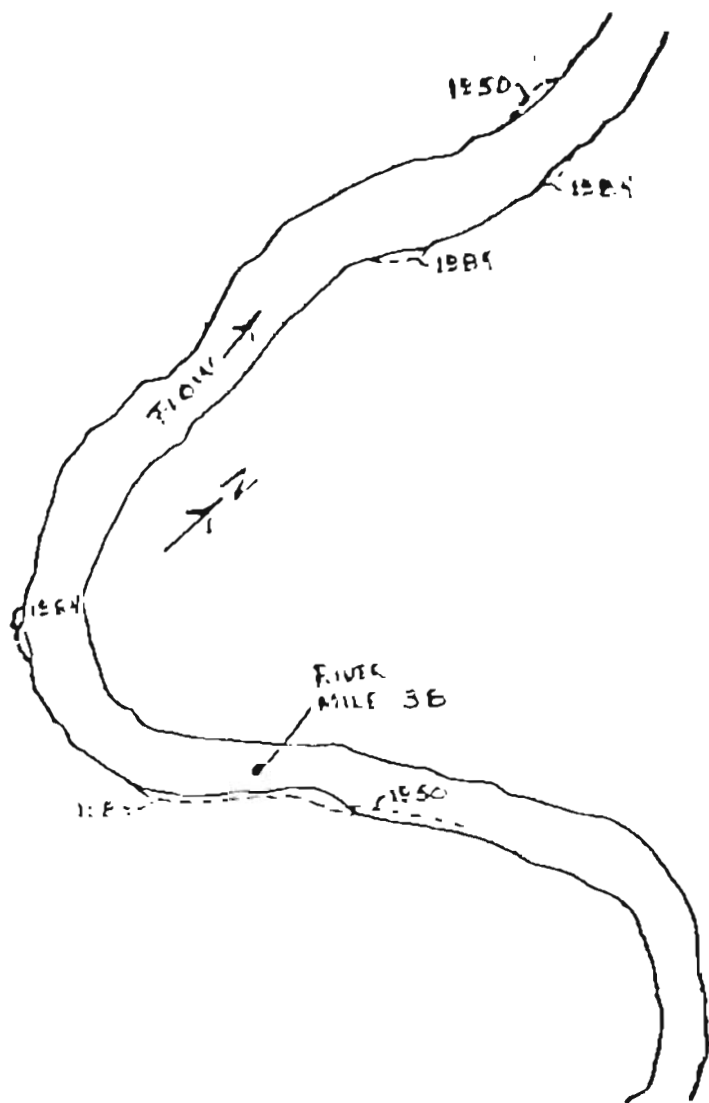
Figure 4. River reach near mile 38, on meander 1-P. Many groins are built into the river at this bend.

Figure 4 is meander 1-P near river mile 38. This reach was examined using aerial photography because of the groin construction on the inside of the meander. Some areas of erosion are noted, with the most change

occurring after 1977. Some of this erosion may be the result of groin construction. This reach deserves more detailed study.

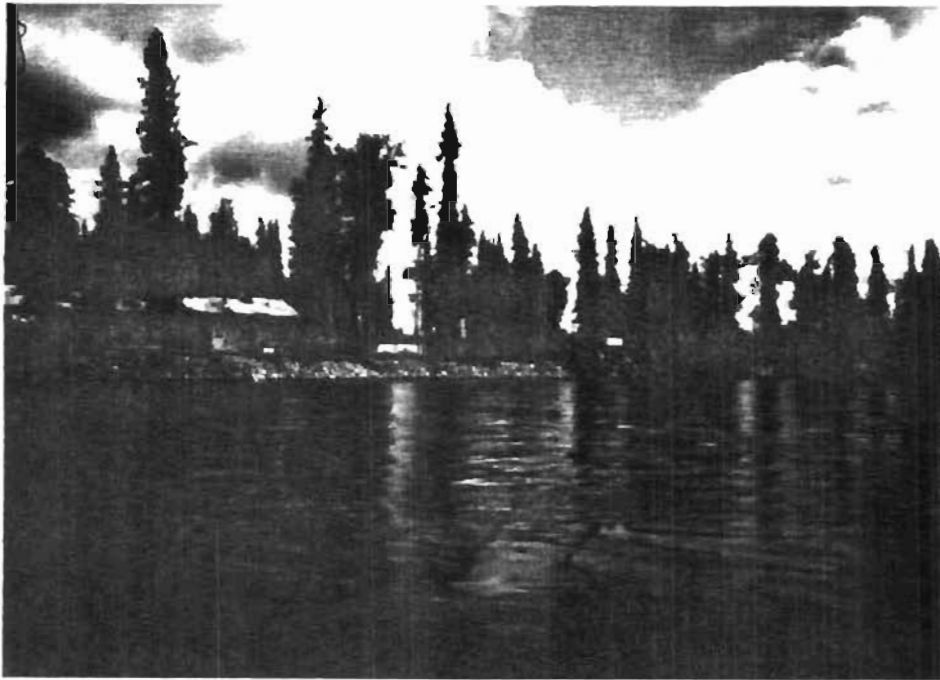
Photo #1 is at the upstream end of the Kenai Keys area near mile 44. This site was riprapped in early 1985 due to erosion which reportedly endangered the structures built near the shore. At the resolution available in the aerial photography analysis no erosion was apparent. The location of this reach is between two sharp meanders, near the transition from the outside of one meander and the inside of the next. It is questionable whether erosion would be expected at this site. This reach is therefore a likely candidate for one in which man has induced a more rapid rate of erosion.

The Kenai Keys area receives heavy boat traffic. Yet, areas immediately upstream and downstream of the riprapped reach are not experiencing any heavy erosion. The river bank in this reach has been extensively disturbed by man. A harbor or inlet has been excavated, stripping a portion of the bank of vegetation and possibly its natural armor, and exposing it to erosion. Clearing the land for home construction, and subsequent recreational activities on the river bank likely exposed still more bank material to erosion. It appears as if man's activities along the shore are the primary causes of an apparent increase in the rate of erosion. If boats alone were to blame, the erosion would likely be more widespread. Boats may, however, have aggravated the situation.

Photo # 1: Photo taken near Kenai Keys near mile 44. Note riprapped bank and inlet construction.

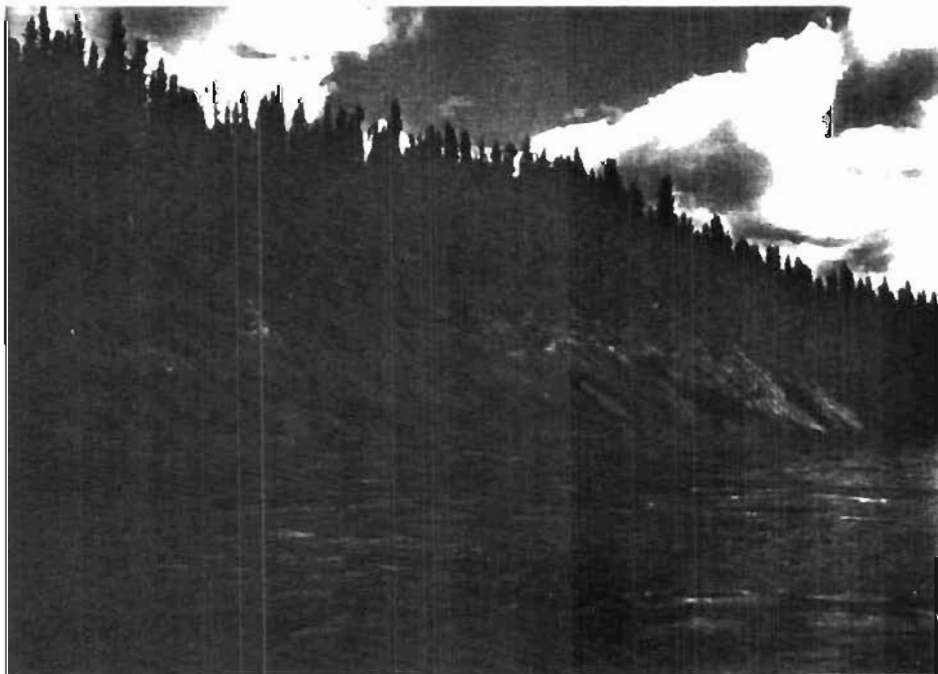
Photo #2 was taken a short distance downstream near mile 43, at meander 1-1. The Division of Parks described this reach as a "steep gravel slope sliding down into the river". Aerial photography study indicates that the downstream end of the bank may have increased in height from 1975 to 1984, however, there was no indication that the base of the bank has moved. 1950

Photo # 2: Photo taken downstream of Kenai Keys, near mile 43.

photography also shows this bank as bare and unvegetated. Cut banks such as this are not uncommon in river systems the size of the Kenai.
