REPORT ON THE PRELIMINARY EXAMINATION OF A PROSPECT ON
STEAMBOAT CREEK, FAIRBANKS DISTRICT, LIVENGOOD QUADRANGLE K-279
280

SAMPLING AND GEOCHEMICAL PROSPECTING AT STEAMBOAT CREEK,
FAIRBANKS DISTRICT, 1961

WORK AT THE STEAMBOAT CREEK PROSPECT,
FAIRBANKS DISTRICT, IN 1962

WORK AT THE STEAMBOAT CREEK PROSPECT, FAIRBANKS DISTRICT,
IN 1963

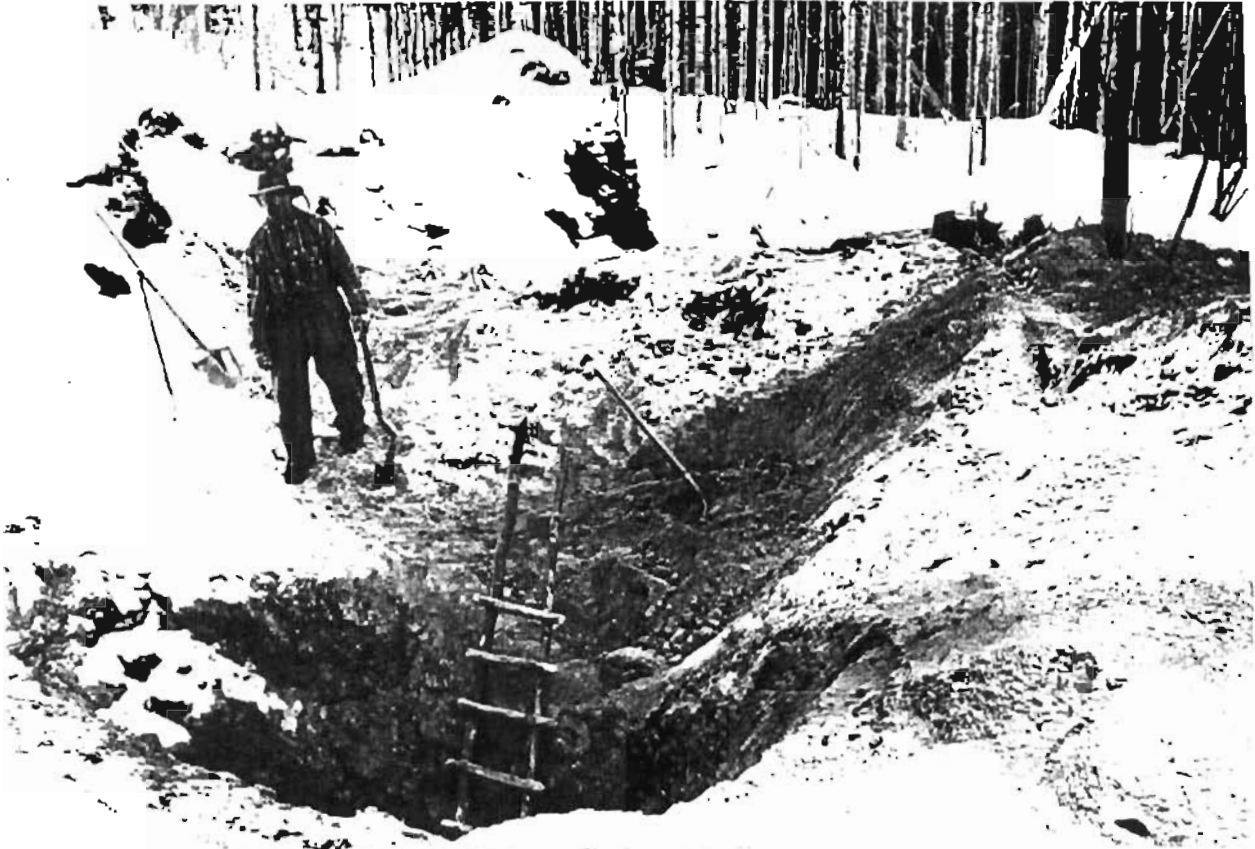
Fig. 1. Pete Smith and his prospect shaft. The ladder leans against the south side of the shaft.

The iron-stained shear zone where the shaft was sunk appears to strike north-south and to dip vertically. The shaft is five feet wide, and the zone is at least that wide. The rock within the shear zone is Birch Creek schist; aside from the conspicuous iron stain and numerous slippage planes, it appears to be the same as the wallrock. Lenses and irregular masses of quartz are scattered thinly throughout the zone. The two small veinlets that Pete was following appear to strike east-west and to dip vertically.

a wide dike. The drift, if continued eastward in the intrusive rock, most likely would not encounter the veinlets again; I advised Pete of this.
