Contemporary Shoreline Retreat Rates at Meshik in Port Heiden, Alaska

Executive Summary

*by Alexander Gould and Lauren Southerland
September 16, 2014*

Alaska Division of Geological & Geophysical Surveys
 Preliminary Interpretive Report 2014-1
Contemporary Shoreline Change (1957-2013)

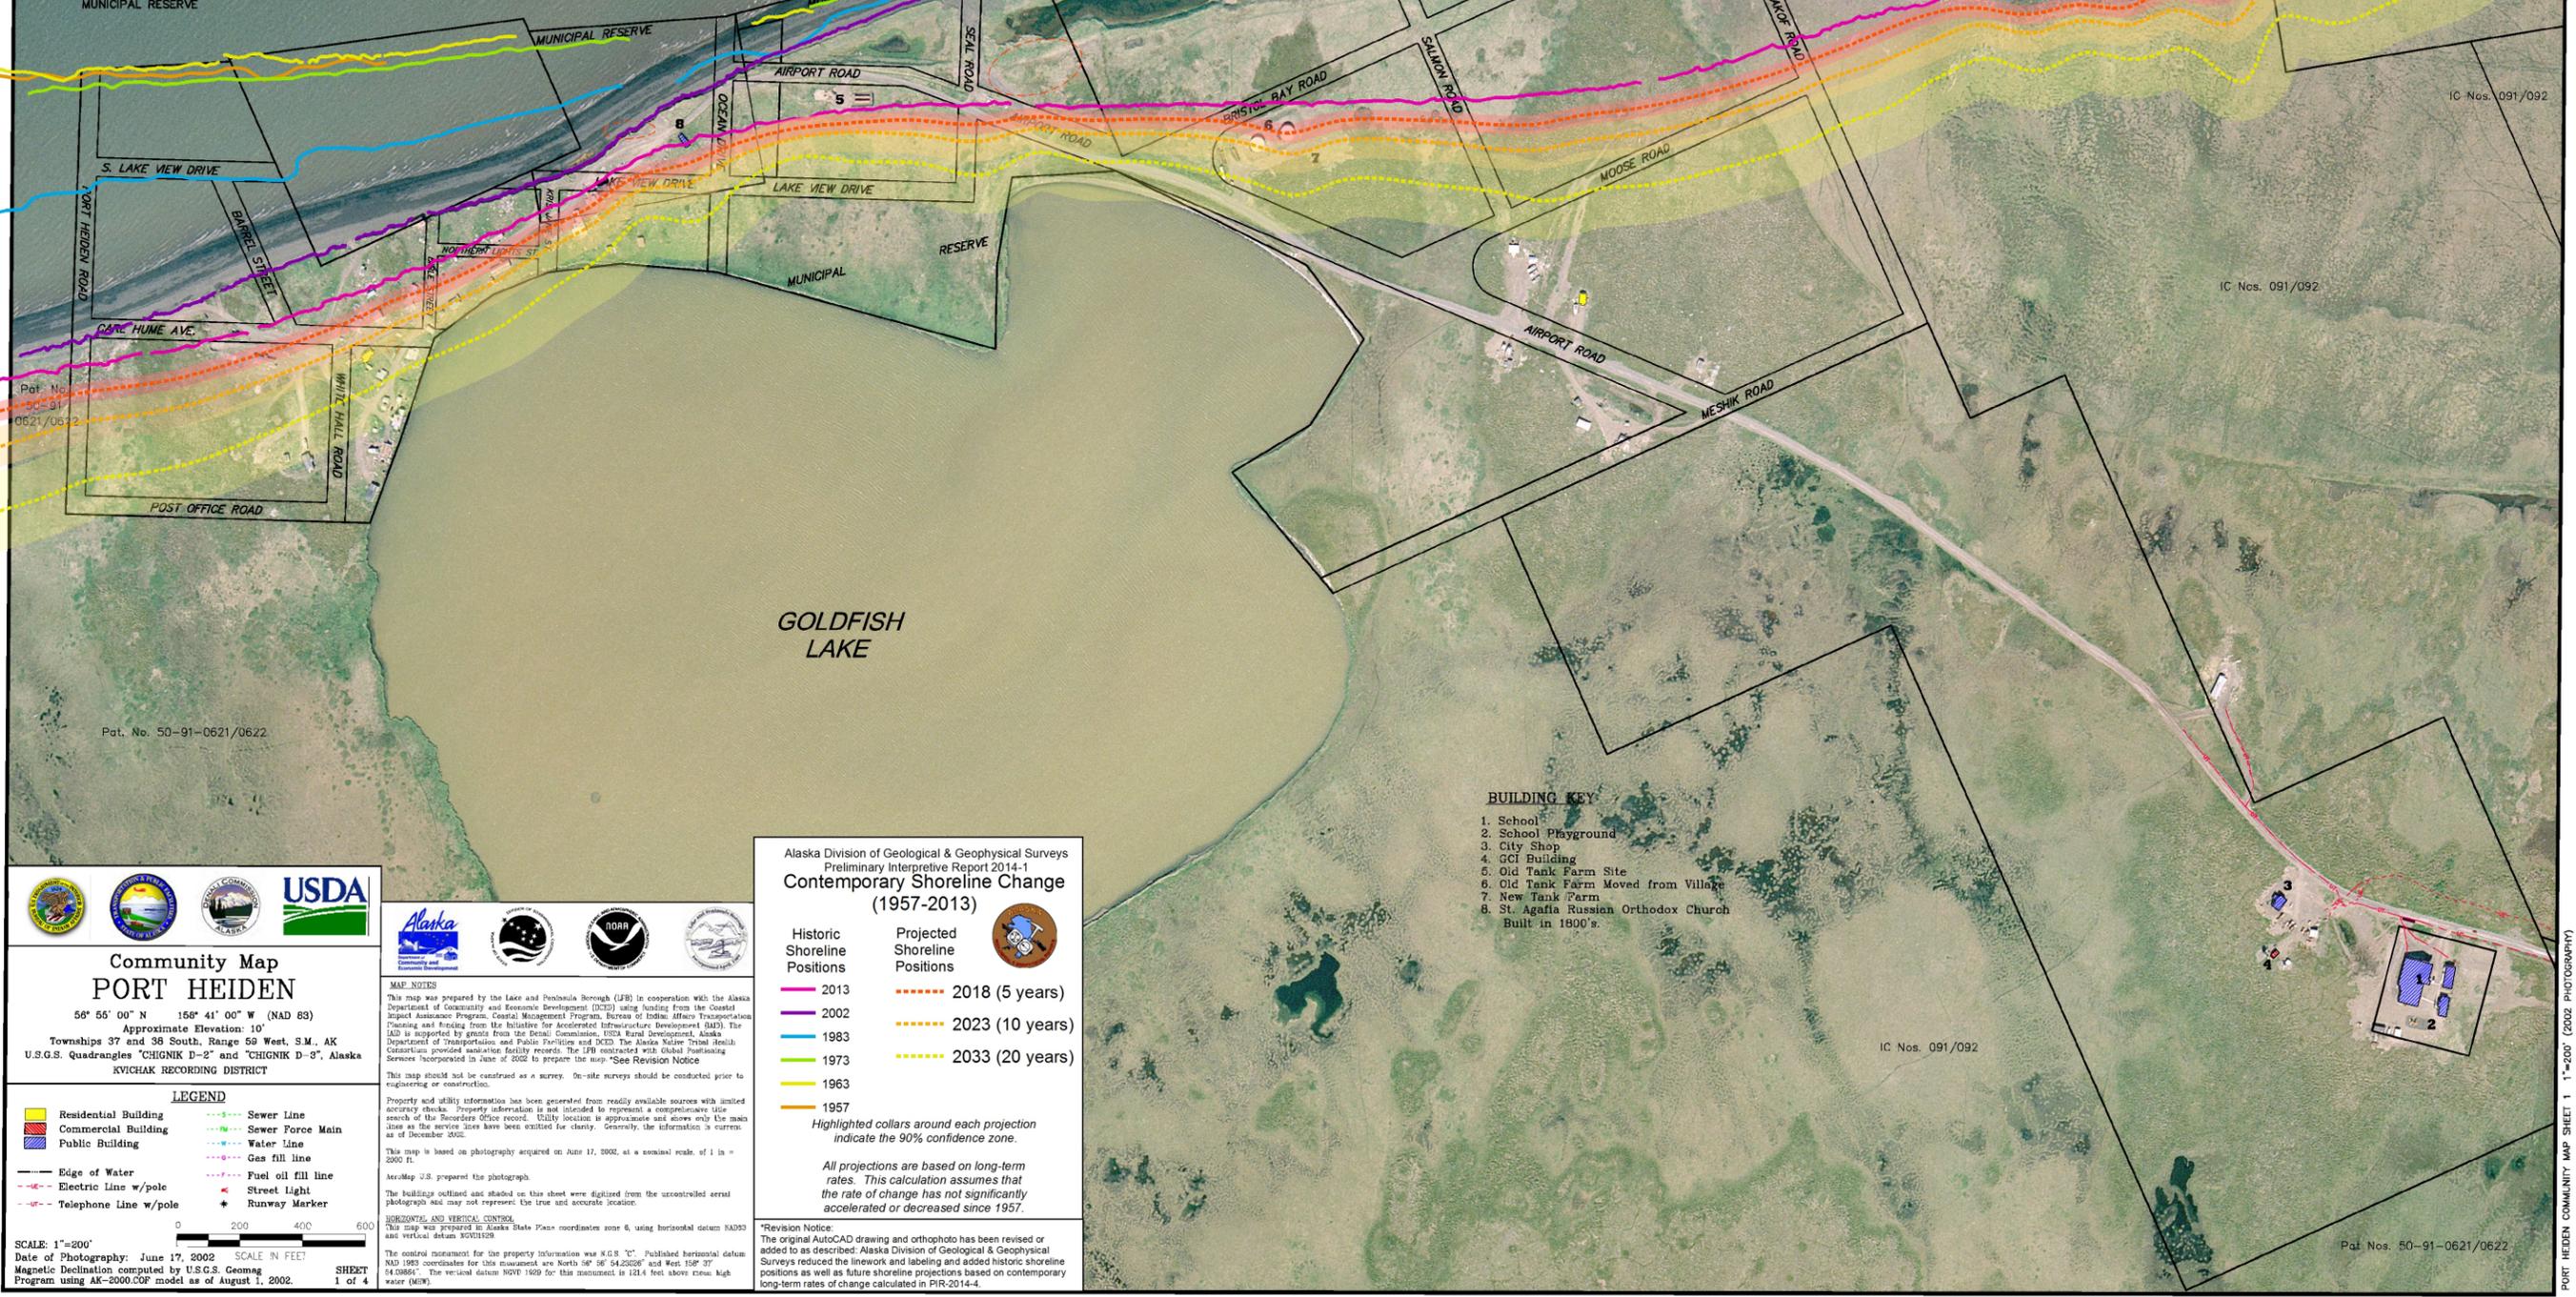
Community Map PORT HEIDEN
 56° 55' 00" N 156° 41' 00" W (NAD 83)
 Approximate Elevation: 10'
 Townships 37 and 38 South, Range 59 West, S.M., AK
 U.S.G.S. Quadrangles "CHIGNIK D-2" and "CHIGNIK D-3", Alaska
 KVICHAK RECORDING DISTRICT

Historic Shoreline Positions	Projected Shoreline Positions
2013	2018 (5 years)
2002	2023 (10 years)
1983	2033 (20 years)
1973	
1963

Highlighted collars around each projection indicate the 90% confidence zone.

All projections are based on long-term rates. This calculation assumes that the rate of change has not significantly accelerated or decreased since 1957.
