VALDEZ GLACIER ICE-DAMMED LAKE: JUNE 2018 GLACIAL LAKE OUTBURST FLOOD

Preliminary Interpretive Report 2019-4

April 2019
State of Alaska
Department of Natural Resources
Division of Geological & Geophysical Surveys

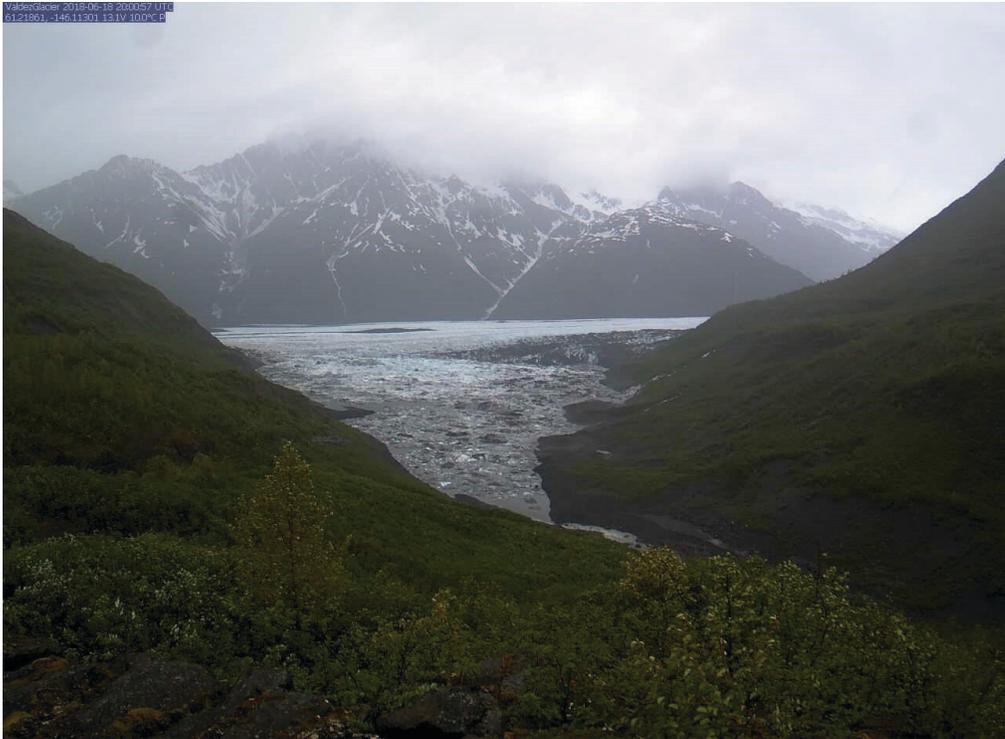
Figure 2. Water level of Valdez Glacier Ice-Dammed Lake before outburst, observed on 06/18/2018. Looking west toward Valdez Glacier.

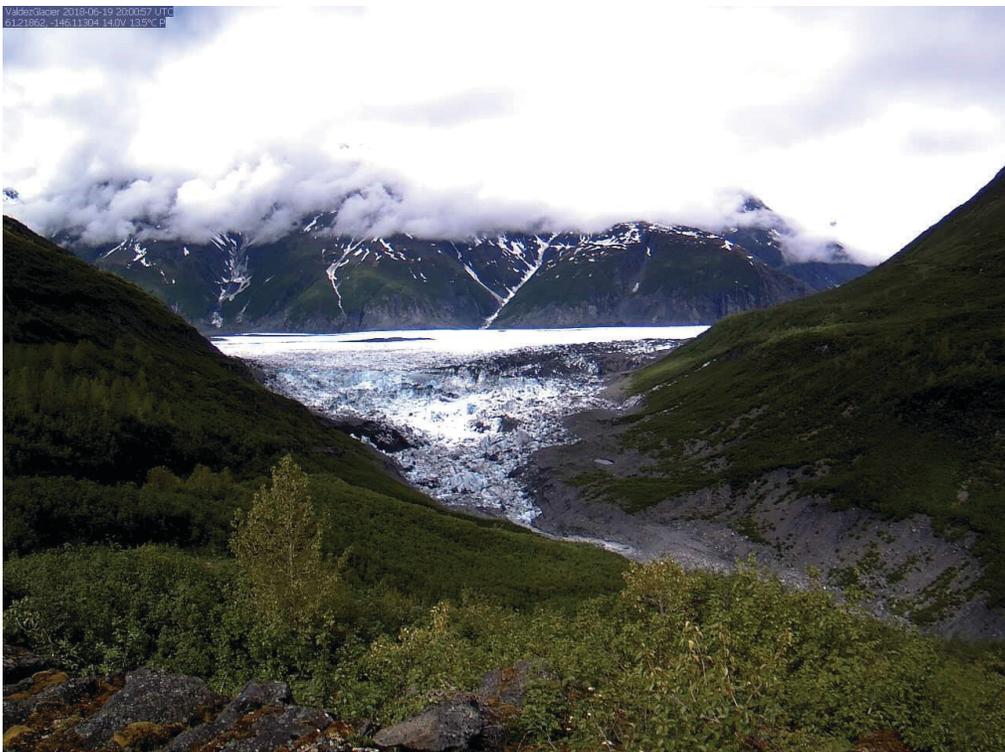
The volume of the ice-dammed lake prior to each outburst event varies. We estimate volumes by identifying water level position with respect to reference markers on telemetered images from an automatic remote viewer camera (see location of remote viewer camera in fig. 1). To calculate lake volume, we define an elevation plane based on highest IDL level achieved prior to outburst and integrate the elevation values of each cell between that plane and the empty lake basin surface as defined by a recent (10/15/2014) photogrammetry-derived high-resolution digital surface model (DSM; Wikstrom Jones and Wolken, in press). This year we observed the highest IDL level on June 18 (fig. 2), and an empty IDL basin on June 19 following very rapid release of water during the evening hours (fig. 3).

Figure 3. Empty ice-dammed lake basin, observed on 06/19/2018. View west toward Valdez Glacier.

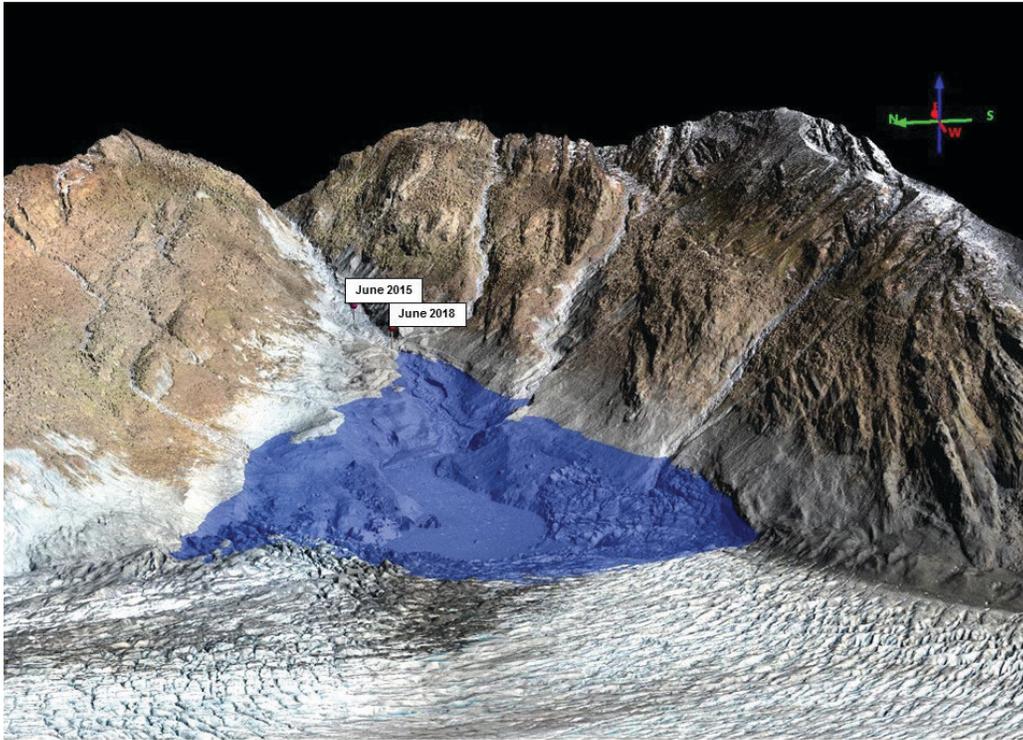
Based on the highest lake level on 18 June 2018, we estimated a lake volume of 19,700,000 m³ (approx. 25,800,000 cubic yards = 7,880 Olympic-size swimming pools), 9.4 percent larger than the 2017 IDL volume, but smaller than the 2015 pre-outburst lake volume estimated at 32,500,000 m³ (approx. 42,500,000 cubic yards) (see fig. 4; Wolken and Wikstrom Jones, 2017). While IDL volumes were similar in 2017 and 2018, there was a marked difference in the draining and discharge rates. In 2017, the slow outburst lasted for almost four days with peak discharge rates of approximately 425 m³/s (15,000 ft³/s) and maximum gage height of approximately 2.2 m (6.7 ft). In 2018, the IDL was completely emptied within 6–12 hours, with peak discharge rates of approximately 963 m³/s (34,000 ft³/s; fig. 5) and a maximum Valdez Glacier Lake gage height of approximately 2.7 m (8.2 ft) (fig. 5). Flooding was reported along Valdez Glacier Stream, but no injuries were reported and infrastructure and property damage were minimal (figs. 6–7).

Figure 4. Blue polygon showing estimated lake volume on 06/18/2018 (before the outburst) and points showing estimated level of Valdez Glacier ice-dammed lake on 06/18/2018 and 06/15/2015, projected on orthoimage and DEM data acquired 10/15/2014. This perspective view is toward the east.

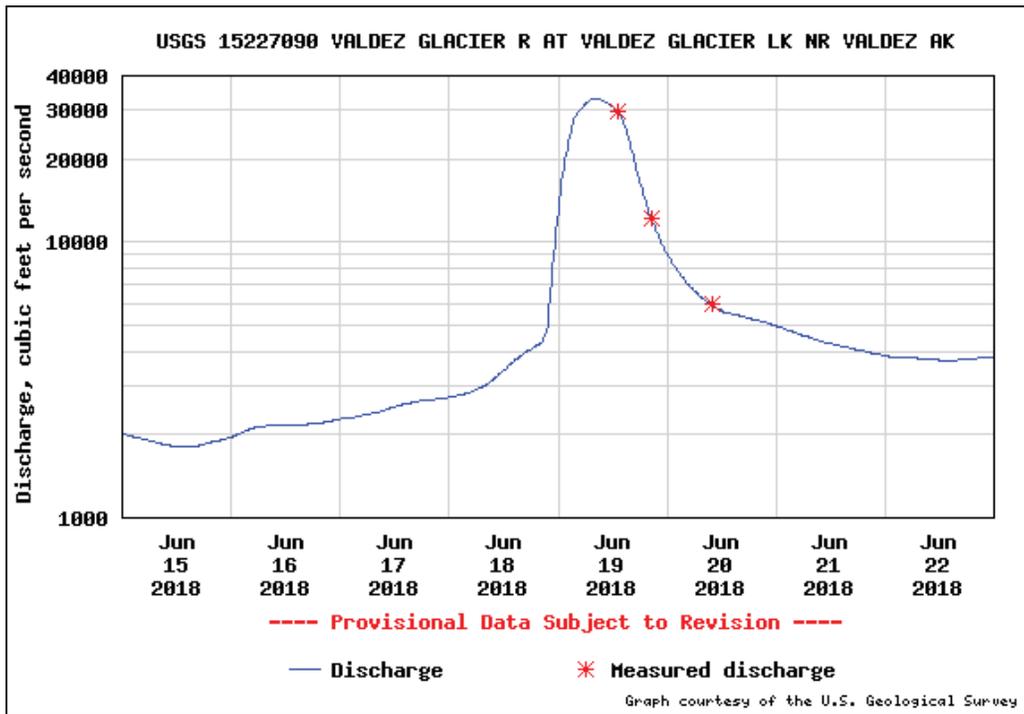
Figure 5. Discharge (cubic feet per second) of Valdez Glacier Stream, June 14–21, 2018 (USGS Water Resources, 2018).

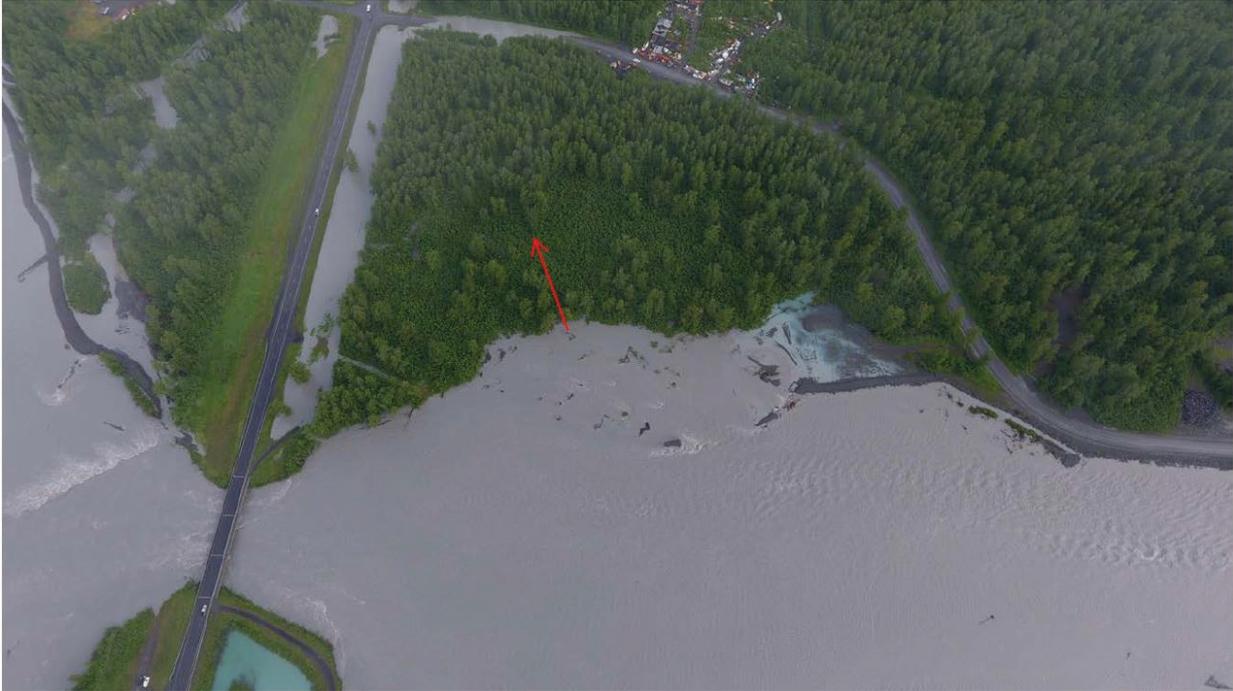
Figure 6. Flooding near the Richardson Highway bridge at Valdez Glacier Stream. Arrow indicates the path of floodwaters from the river bank toward town (City of Valdez, written commun., June 2018).

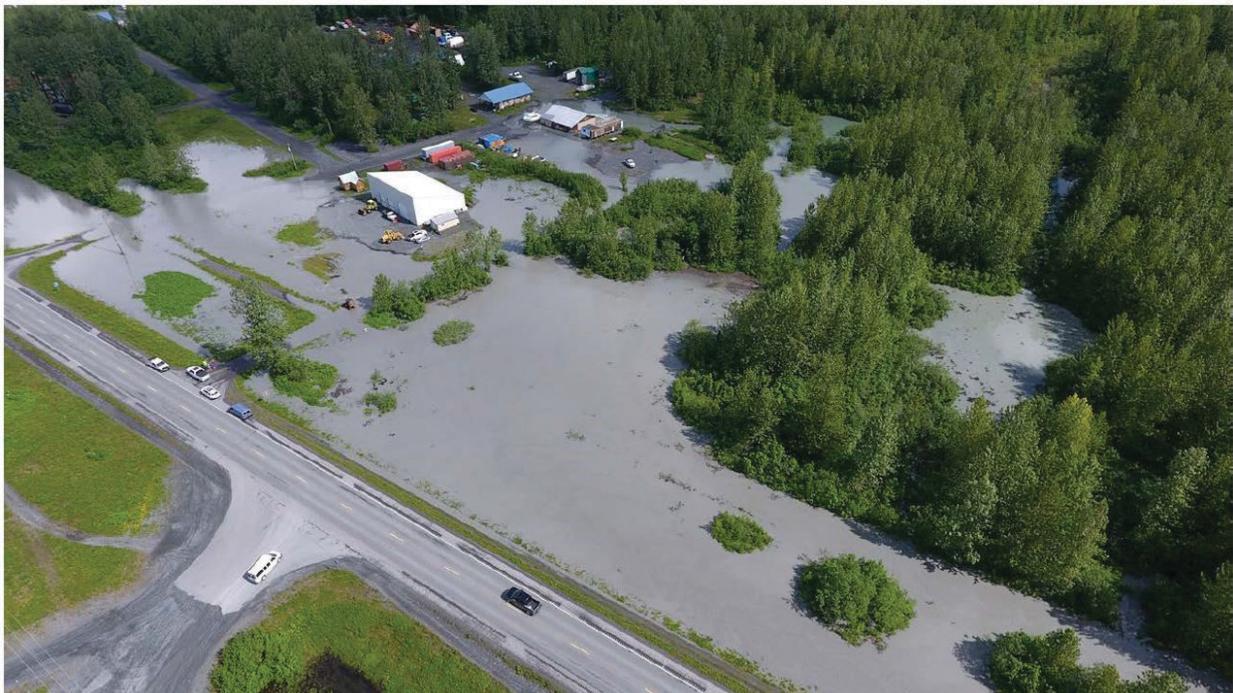
Figure 7. Flooded area near 9th Street in Valdez (City of Valdez, written commun., June 2018).
