# Geologic Investigations of Proposed Powersites at Baranof and Carbon Lakes Baranof Island, Alaska

G E O L O G I C A L   S U R V E Y   B U L L E T I N   1 0 3 1 - B

*A description of the proposed dam,  
tunnel, and reservoir sites on each lake,  
with conclusions and recommendations*

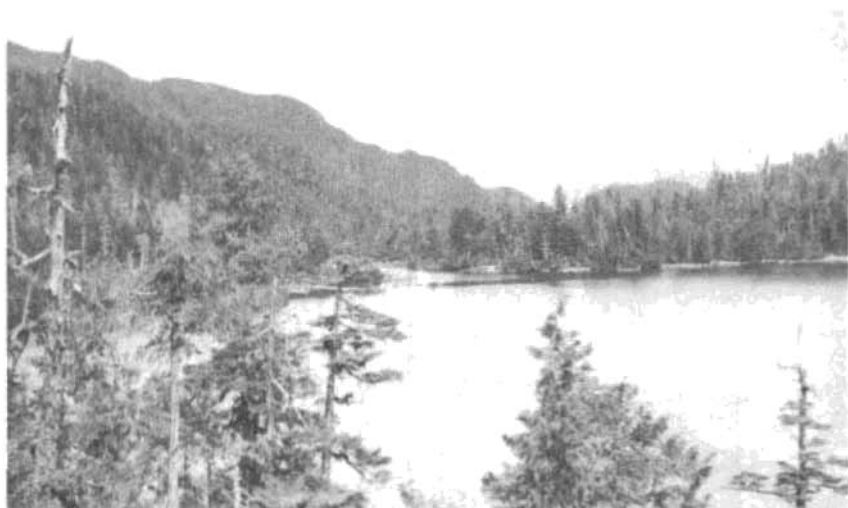
The damsite is immediately downstream from the lake outlet. (See pl. 5 and figs. 3 and 4.) Near the possible axis line of the dam shown in section A-A' (pl. 5) the valley is 110 feet wide at the river surface at altitude 145 feet; 150 feet wide at 150 feet; 790 feet wide at 200 feet; 1,040 feet wide at 240 feet; and about 2,300 feet wide at 300 feet.

FIGURE 3.—East end of Baranof Lake. Outlet of lake is slightly left of center of view.

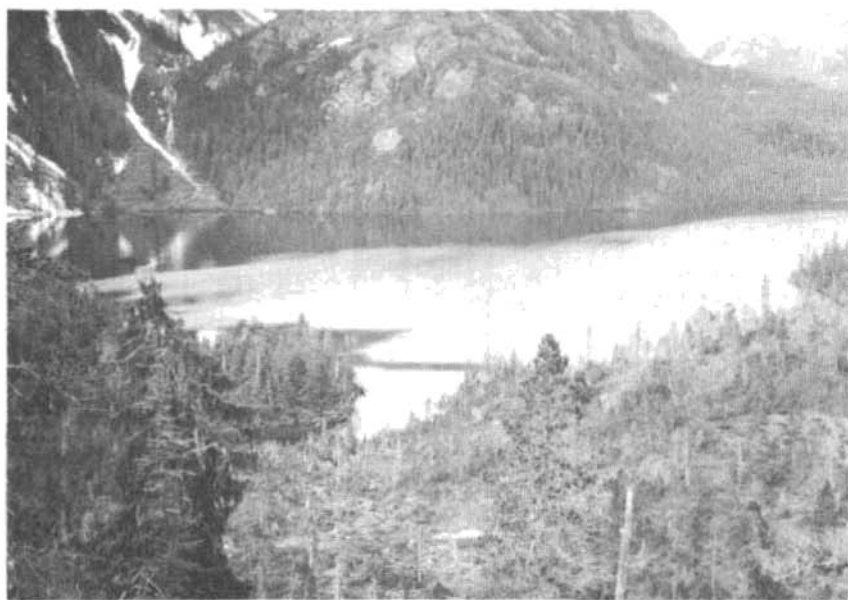
FIGURE 4.—View southwestward across lower end of Baranof Lake. Lake outlet in lower left center of view.

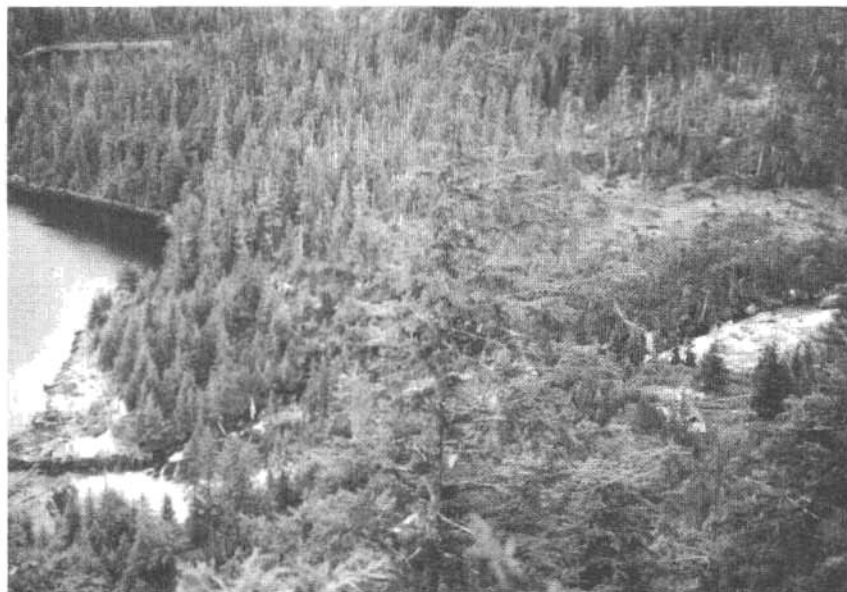
FIGURE 5.—Shore of Warm Spring Bay south from mouth of Baranof River. Note lagoon in upper left part of view.

Baranof River the conduit (pipeline) would cross the bench in the cleared area above the river on the right side of the view in figure 5. If the powerhouse were located on the lagoon, water would be conveyed to it from the lake by a tunnel through the ridge shown in the upper right part of the view.

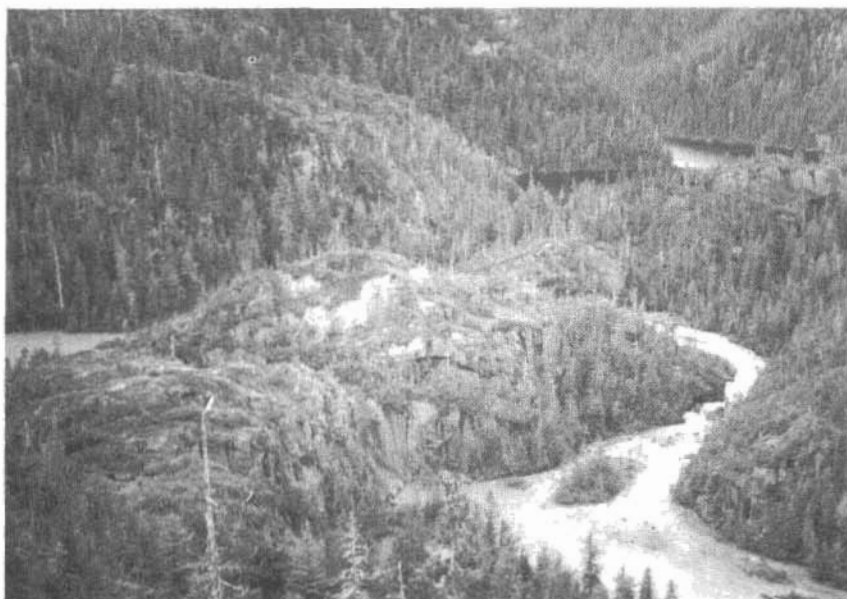
FIGURE 6.—Rock ridge at east end of Carbon Lake. Lower end of Carbon Lake in left edge of view. Unnamed lake in upper right part of view drains into Coal Creek 650 feet downstream from Carbon Lake outlet.

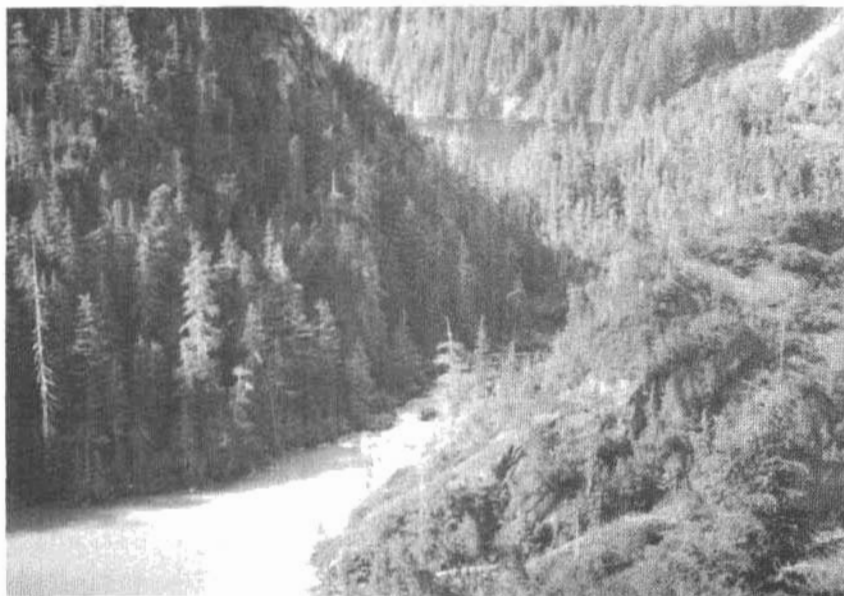
The control of Carbon Lake would in addition to a main dam on Coal Creek require two auxiliary dams in the saddles described on page 58. If the lake is raised to an altitude of more than about 280 feet, these three dams would be connected and become a single structure with an overall length of about 950 feet. The main dam would be located 300 feet downstream from the lake outlet. The geologic conditions along the axis of the main dam as well as of the two additional dams are shown by section C-C' (pl. 5). The left (west) abutment is formed by a hill that rises to altitude 1,095 feet. The right (east) abutment for the main dam would be formed by the rock knob that rises to altitude 331 feet. (See fig. 7.)

FIGURE 7.—Carbon Lake outlet. Probable axis for dam would cross channel at upper end of rapids. Unnamed lake in upper center part of view drains into Coal Creek 650 feet downstream from Carbon Lake outlet.
