# Geologic Reconnaissance of the West Creek Damsite near Skagway, Alaska

GEOLOGICAL SURVEY BULLETIN 1211-A

*A description of the geologic conditions  
which might affect the feasibility of  
powersite development on West Creek,  
a tributary of the Taiya River  
northwest of Skagway, Alaska*

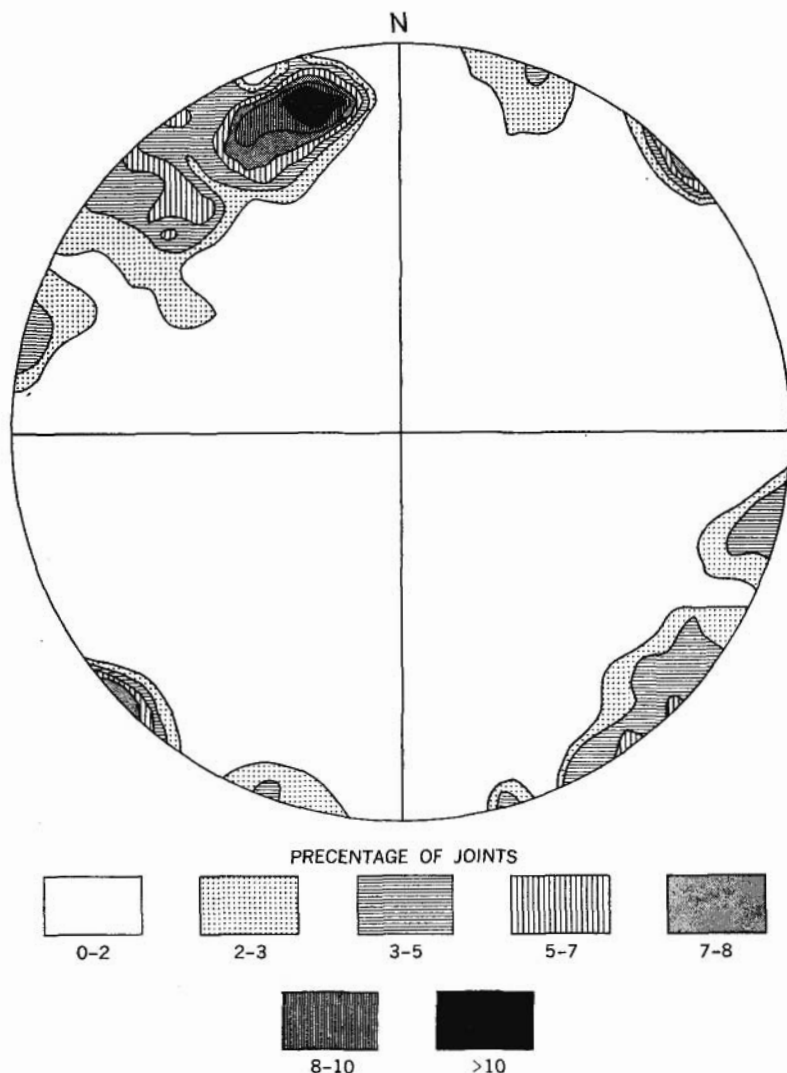
The joint system in the granodiorite is well developed and consists of steeply dipping or vertical conjugate joints typical of massive granitic rocks. As indicated by the equal area diagram (fig. 2) of 60 joint poles, the system consists of two northeastward-trending sets, one striking N. 60°-80° E., the other striking N. 40°-50° E., and both dipping from 65° south to vertical. A third set strikes about N. 45° W. and has consistently vertical dips. The northeastward-striking joints are most abundant, and can be traced as far as 2 miles on the aerial photographs (pl. 1). Spacing between joints is variable, but the average is on the order of 10 to 20 feet. No slickensides or crushed rock were observed along any of the joints in the immediate damsite area.

FIGURE 2—Equal-area diagram of poles of 60 joints measured in West Creek damsite area. Poles plotted on lower hemisphere. Contoured on percentage of joints per 1 percent of area of circle.

In the design, construction and maintenance of a dam, the north-eastward-striking joints could present some problems. The course of West Creek in the upper part of the gorge parallels the major joint set (N. 60°–80° E.). The direction of thrust of an arch dam would be roughly parallel to the joint direction. The design of such a dam should take possible local slippage along the joints into consideration. Leakage under the dam along joints belonging to the major set should

also be considered. Leakage is also likely along joints of both north-eastward-trending sets through the left abutment, particularly in the saddle areas where both ice plucking and glaciofluvial erosion were joint controlled. Leakage might also be expected along the gulch east of the right abutment that roughly parallels the major joint direction. Only drilling and pressure testing would determine whether joints and sheeting fractures are open at depth.

The stability of the left abutment during and after excavation might be locally affected by the southward-dipping joints of the major set unless care is taken to prevent undercutting.
