Unevaluated Reconnaissance Report (December 1948)
on Geology of Lower Eagle River Valley,
Alaska

By A. F. Bateman, Jr.

Open-File Report 80-275

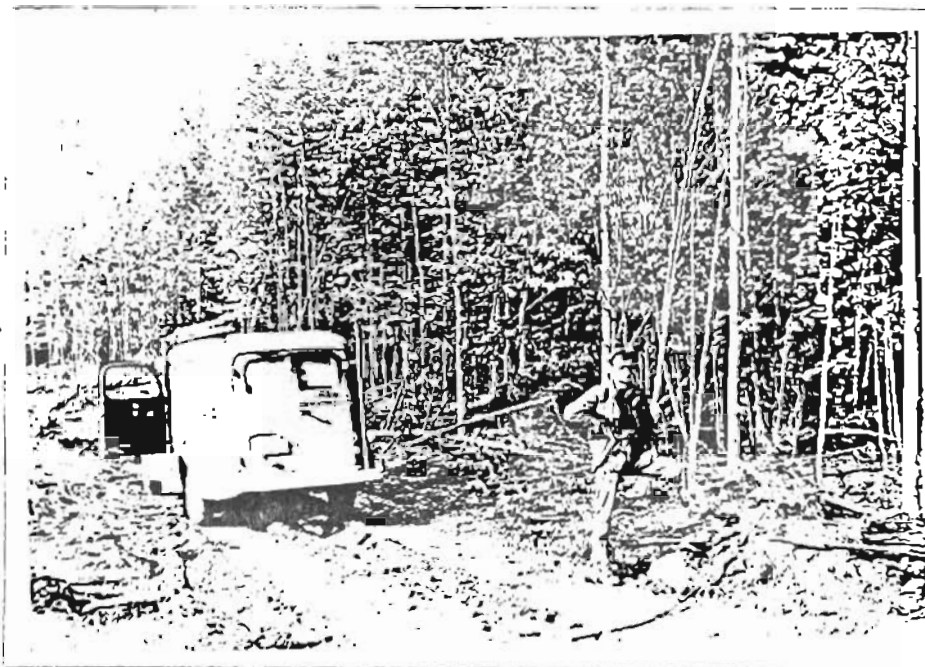
The valley fill that chokes the lower Eagle River valley is covered with a dense growth consisting chiefly of birch, but with alder, aspen, and poplar. Underbrush is rather thick and consists of high bush cranberry and other shrubby plants. Plate 1A shows a typical stand of this growth. Dam site mapping would be on ground with this type growth except for the river bottom where there is considerable black spruce. The reservoir area is flat and swampy, and for the most part is covered with black spruce.

A. TYPICAL FOREST COVER ON FILL SURFACE, LOWER EAGLE VALLEY

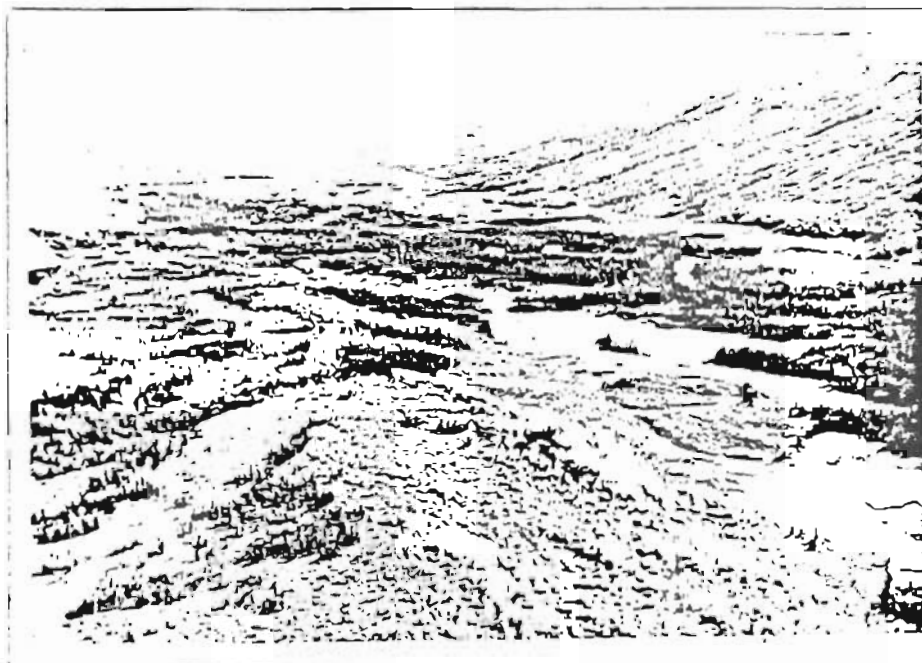
B. OBLIQUE AERIAL VIEW OF RESERVOIR AREA LOOKING UPSTREAM FROM ABOUT 1,000 FEET OVER A POINT OPPOSITE MOUTH OF SOUTH FORK EAGLE RIVER. In foreground is upstream end of mass of glacial debris that partially fills lower valley. Eagle Glacier can barely be seen at upper end of valley.

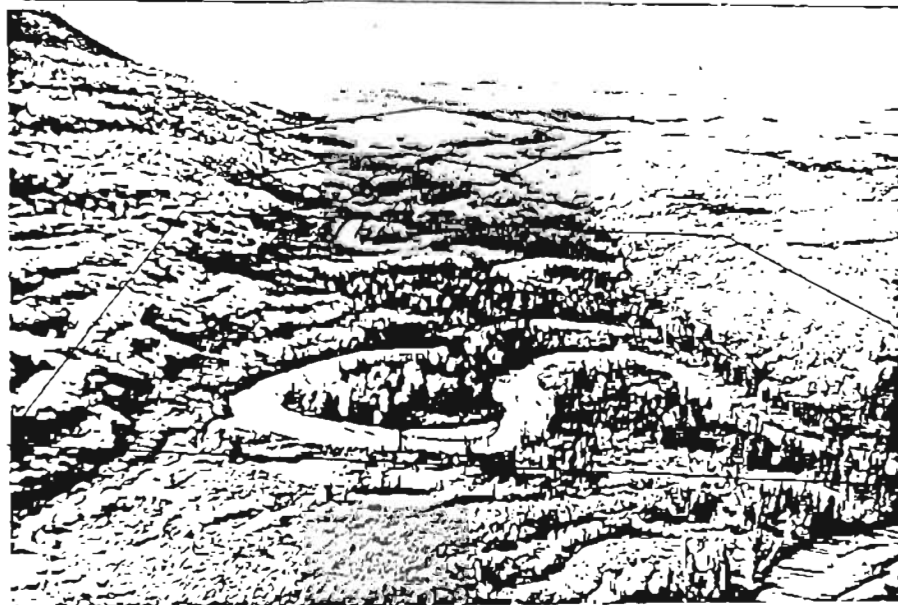
The fill surface is relatively flat and smooth except for a number of low ridges elongated parallel to the axis of the valley, and a depression lying between the mass of fill and the left wall of the valley. (See plate 2B.) This depression, which narrows gradually as the lower end of the valley is approached, was probably occupied by the last ice remnant, and so was not filled with outwash. Eagle River now occupies this depression from about the mouth of South Fork to the vicinity of R.P. 5 (see figure 1), where it turns and breaches the mass of glacial debris. This breach and that part of the depression not occupied by Eagle River are shown on plate 3.

B. OBLIQUE AERIAL VIEW DOWN EAGLE RIVER VALLEY FROM ABOUT 1,000 FEET ABOVE A POINT 6.6 MILES UPSTREAM FROM RAILROAD BRIDGE.
 Notice large mass of glacial debris in right middle and background and depression between this mass and left valley wall. Eagle River occupies this depression in foreground (dam site area No. 1), but in middle ground leaves it to cut through the debris mass. Dam site area No. 2 is in this cut. Knik Arm is in background.

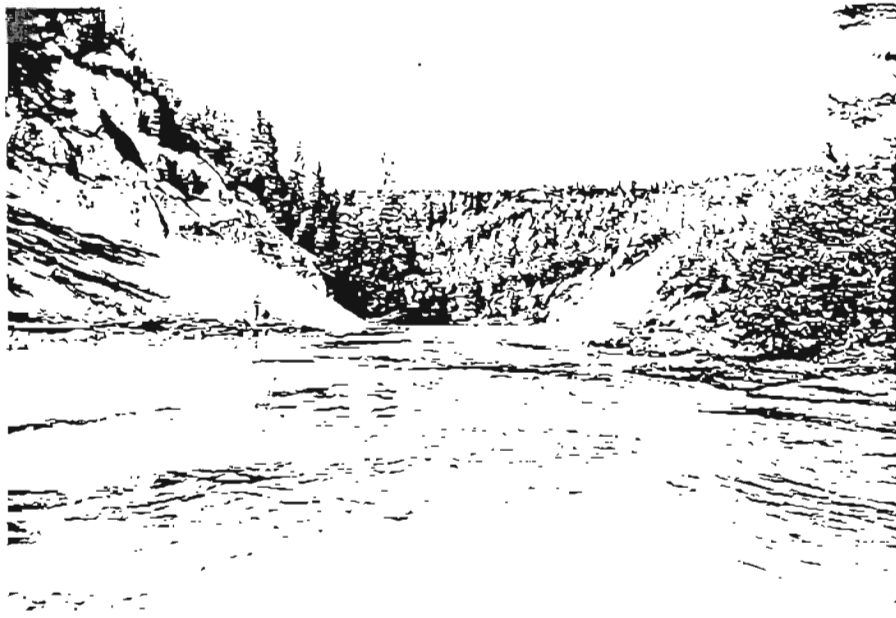
These gravels vary in texture from coarse to fine; appear to be fairly well-graded; have a silty sand matrix; and in attitude are horizontal or dip at low angles toward the center of the valley and downvalley. Beds of till from 2 to 10 feet thick are interbedded with the gravels in several exposures. Lenticular beds of cleaner, more permeable gravels and of clean, even-grained sands varying in texture from coarse to fine fill channels cut into the gravels. Plate 4A shows these gravels with an interbedded till layer and a channel filled with sands and clean gravels.

A. LOOKING DOWN EAGLE RIVER FROM LEFT BANK, 3.55 MILES ABOVE RAILROAD BRIDGE.

Note cliff of glacial deposits. This is at upper end of dam site area No. 2.

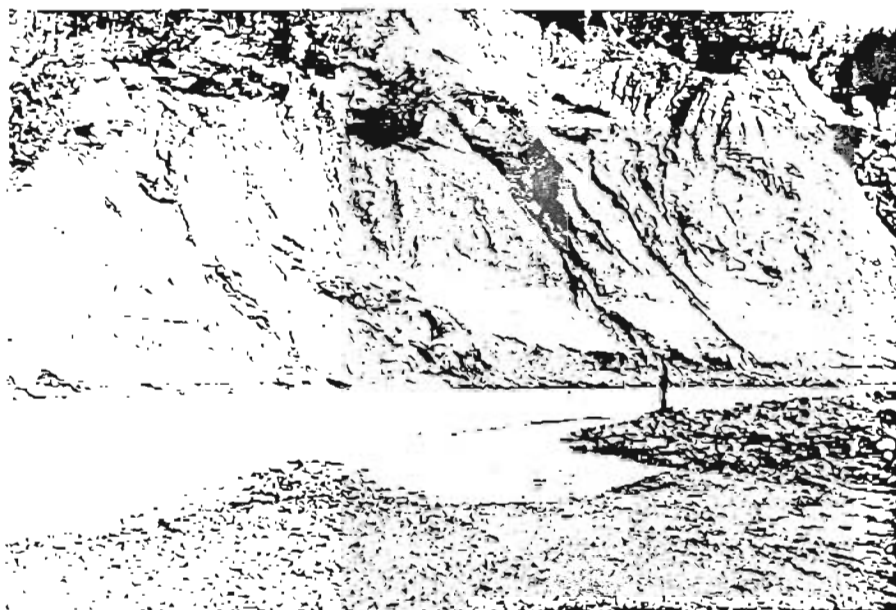
From 3.2 to 3.4 miles above the railroad bridge in the right bank of the river are some deposits of gravels and sands that are slumped and contorted, contain interbedded masses of till and show extreme range and abrupt changes in grain size (plate 4B). These are interpreted as ice-contact deposits.

B. GLACIAL DEBRIS IN RIGHT BANK EAGLE RIVER, 3.25 MILES UPSTREAM FROM RAILROAD BRIDGE, DAM SITE AREA NO. 2.

Several feet of thinly laminated, nearly horizontal, bluish-gray clays are exposed just above the water level in left middle ground. Remainder of deposit is mostly folded and faulted gravels with interbedded masses of sand, silts, and till.

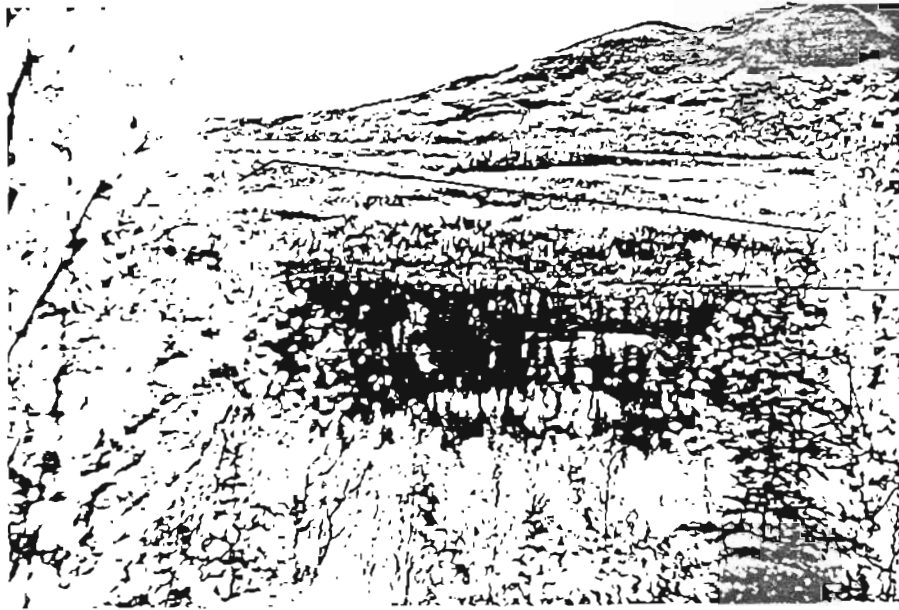
Dam site
area No. 1

Dam site area No. 1. - Views of each abutment are shown on plate 5A and B, and a general view of area No. 1 in the center of plate 2B, from one-fourth to one-half of an inch below the horizon. Glacial sediments exposed in cut banks along the river consist of silty gravels with minor amounts of interbedded sands and silts in small lenticular beds. A view of these deposits is shown in plate 6A. Permeability of these deposits as a whole is probably medium to low. The extent of these gravels back into the abutments is unknown, but the fact that till was found on the fill surface between the river and the right valley wall, plus the smooth form of the fill surface that is entirely lacking in kettle and kame topography, suggests that this mass might be largely till. Extensive drilling will be required to establish the relationship and extent of these deposits and to establish their permeability characteristics.

A. LOOKING ACROSS AND SLIGHTLY DOWN EAGLE RIVER VALLEY TOWARD RIGHT BANK FROM POINT ON LEFT WALL OF VALLEY 0.4 MILE UPSTREAM FROM R.P. 16 AT 428 FEET ALTITUDE.

Note abrupt change in slope between fill surface and right wall of valley.

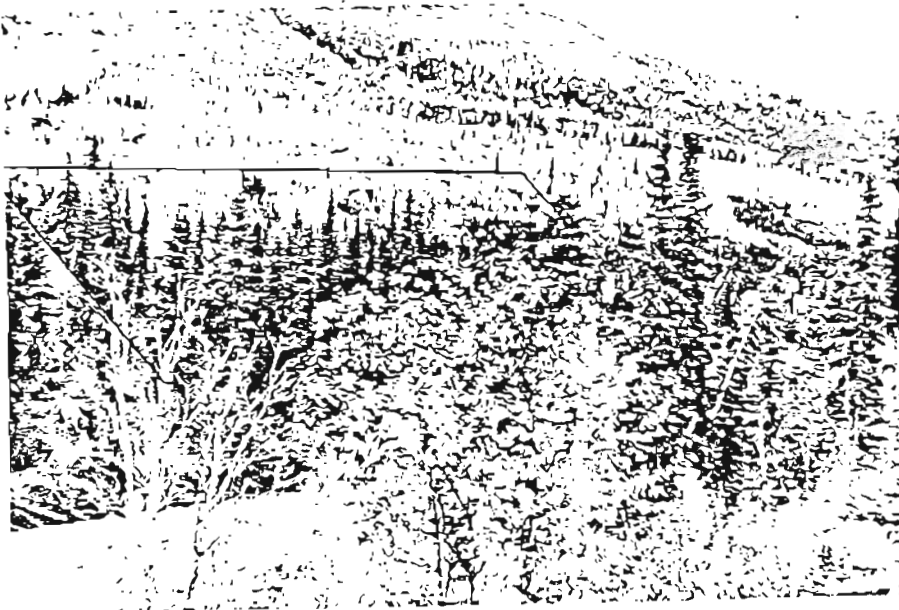
Dam site
area No. 1

B. LOOKING ACROSS AND DOWN EAGLE RIVER VALLEY TOWARD LEFT BANK OF RIVER FROM RIGHT BANK OF RIVER 5.65 MILES UPSTREAM FROM RAILROAD BRIDGE.

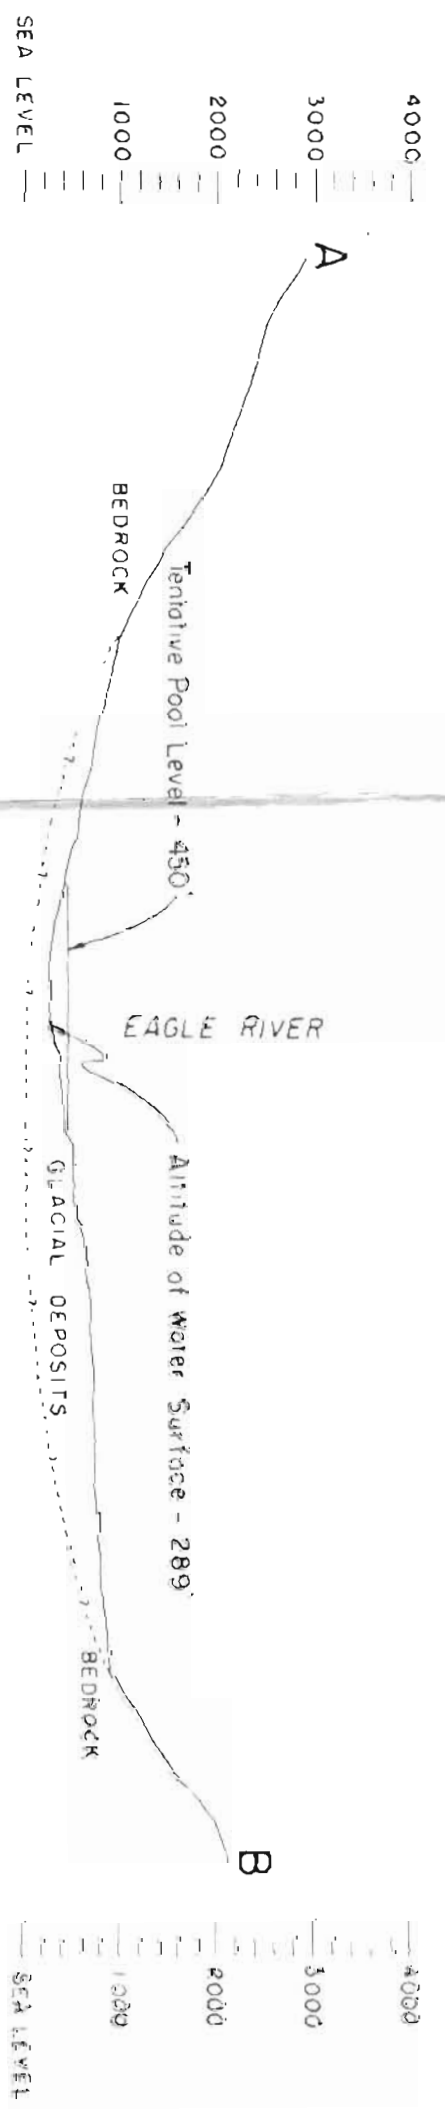
GEOLOGIC CROSS SECTION
EAGLE RIVER VALLEY, ALASKA
DAM SITE AREA NO. 1

A geologic cross section of Eagle Valley through each area is shown on figure 2.

In either area, a dam would have to be founded on unconsolidated glacial deposits. The probable general relationship of these deposits to a possible dam and to the valley as a whole is shown on the cross sections of figure 2.
