Public-data File 85-37

EROSION ALONG THE KENAI RIVER

M.W. Inghram

September 1985

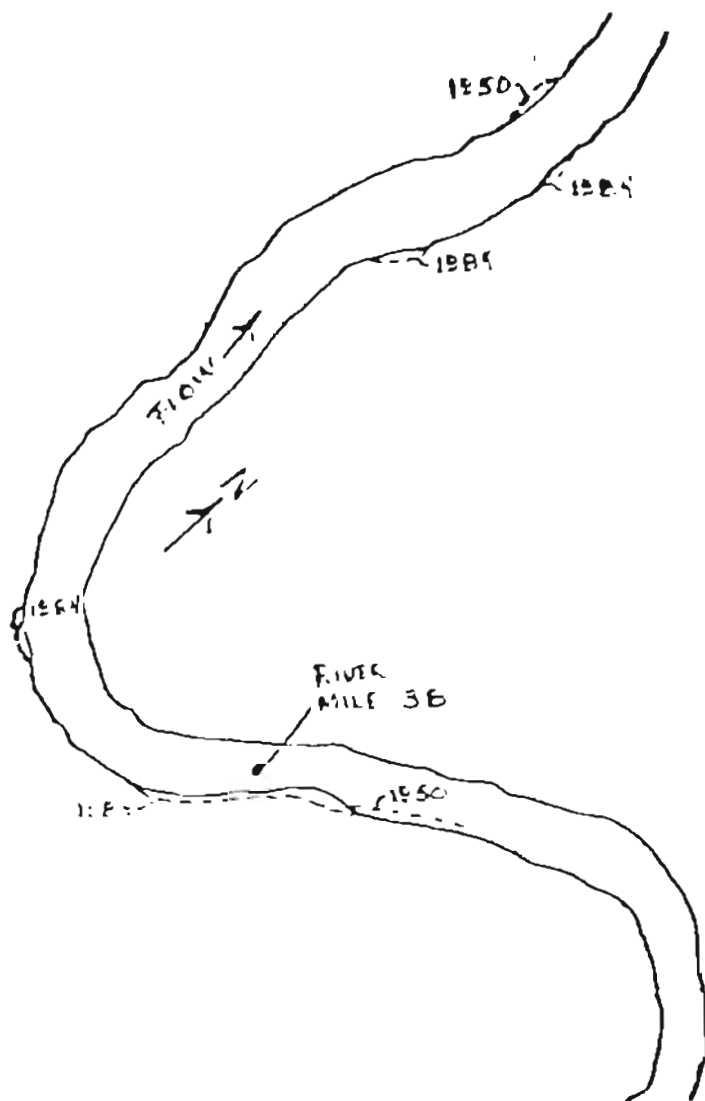
Figure 4. River reach near mile 38, on meander 1-P. Many groins are built into the river at this bend.

Figure 4 is meander 1-P near river mile 38. This reach was examined using aerial photography because of the groin construction on the inside of the meander. Some areas of erosion are noted, with the most change

occurring after 1977. Some of this erosion may be the result of groin construction. This reach deserves more detailed study.
