RECONNAISSANCE REPORT ON GEOLOGY OF EKULINA LAKE DAM SITE AND CONDUIT ROUTE NEAR ANCHORAGE, ALASKA

A. F. Bateman, Jr.

**U. S. Geological Survey
Great Falls, Montana**

August 1947

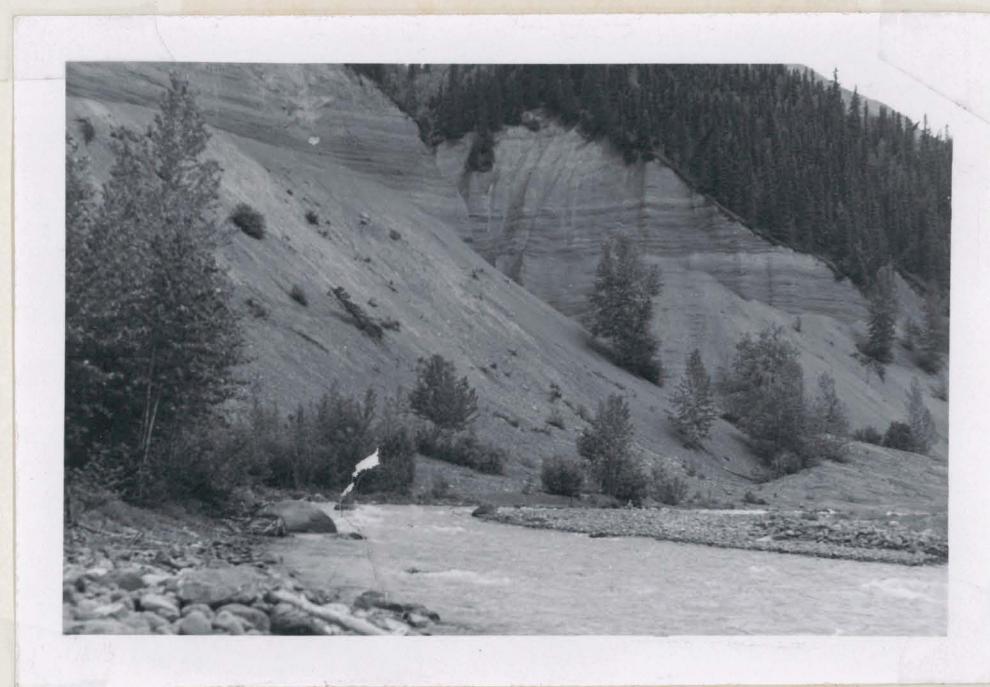
Plate V. Horizontally stratified deposits of
gravel exposed in lower part of
measured section No. 16.

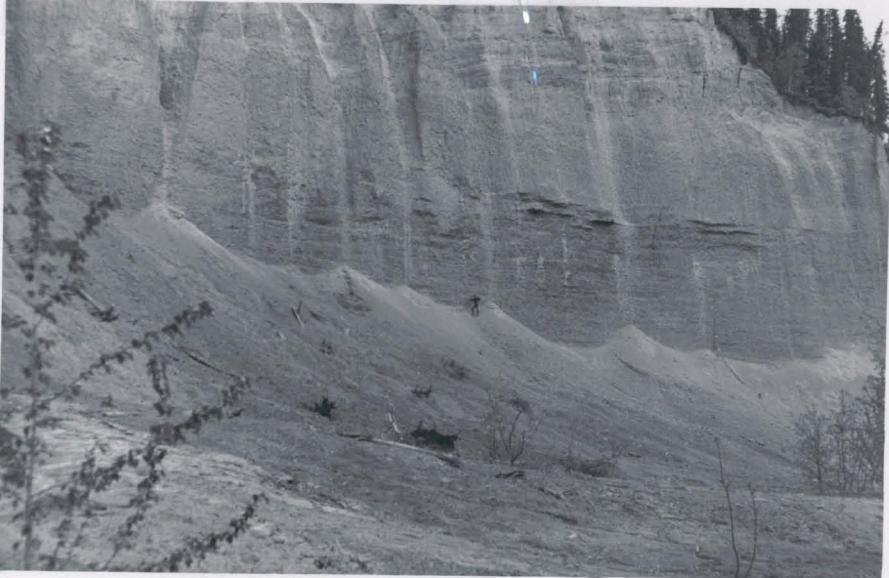
Plate VI. Horizontally stratified gravel deposits about two miles down Eklutna Creek from the lake outlet.

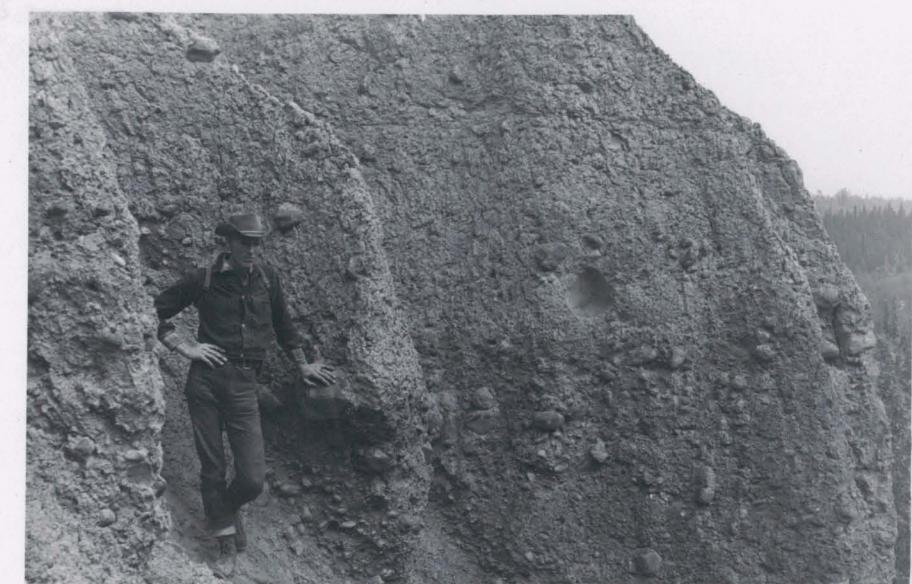
Plate VII. Contact between light yellowish-brown, horizontally stratified gravel and overlying bluish-gray till. Man's hand rests on boulder just below contact. Picture taken at measured section No. 13, altitude 884.

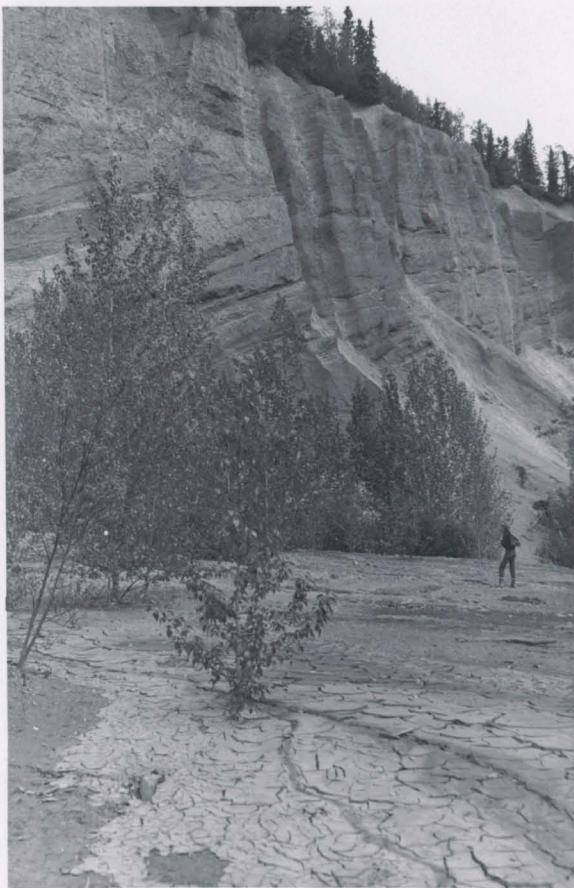
Plate VIII. Gravel deposits showing foreset cross-bedding dipping downstream at angle of about 20 degrees. Picture taken half a mile downstream from measured section No. 16.

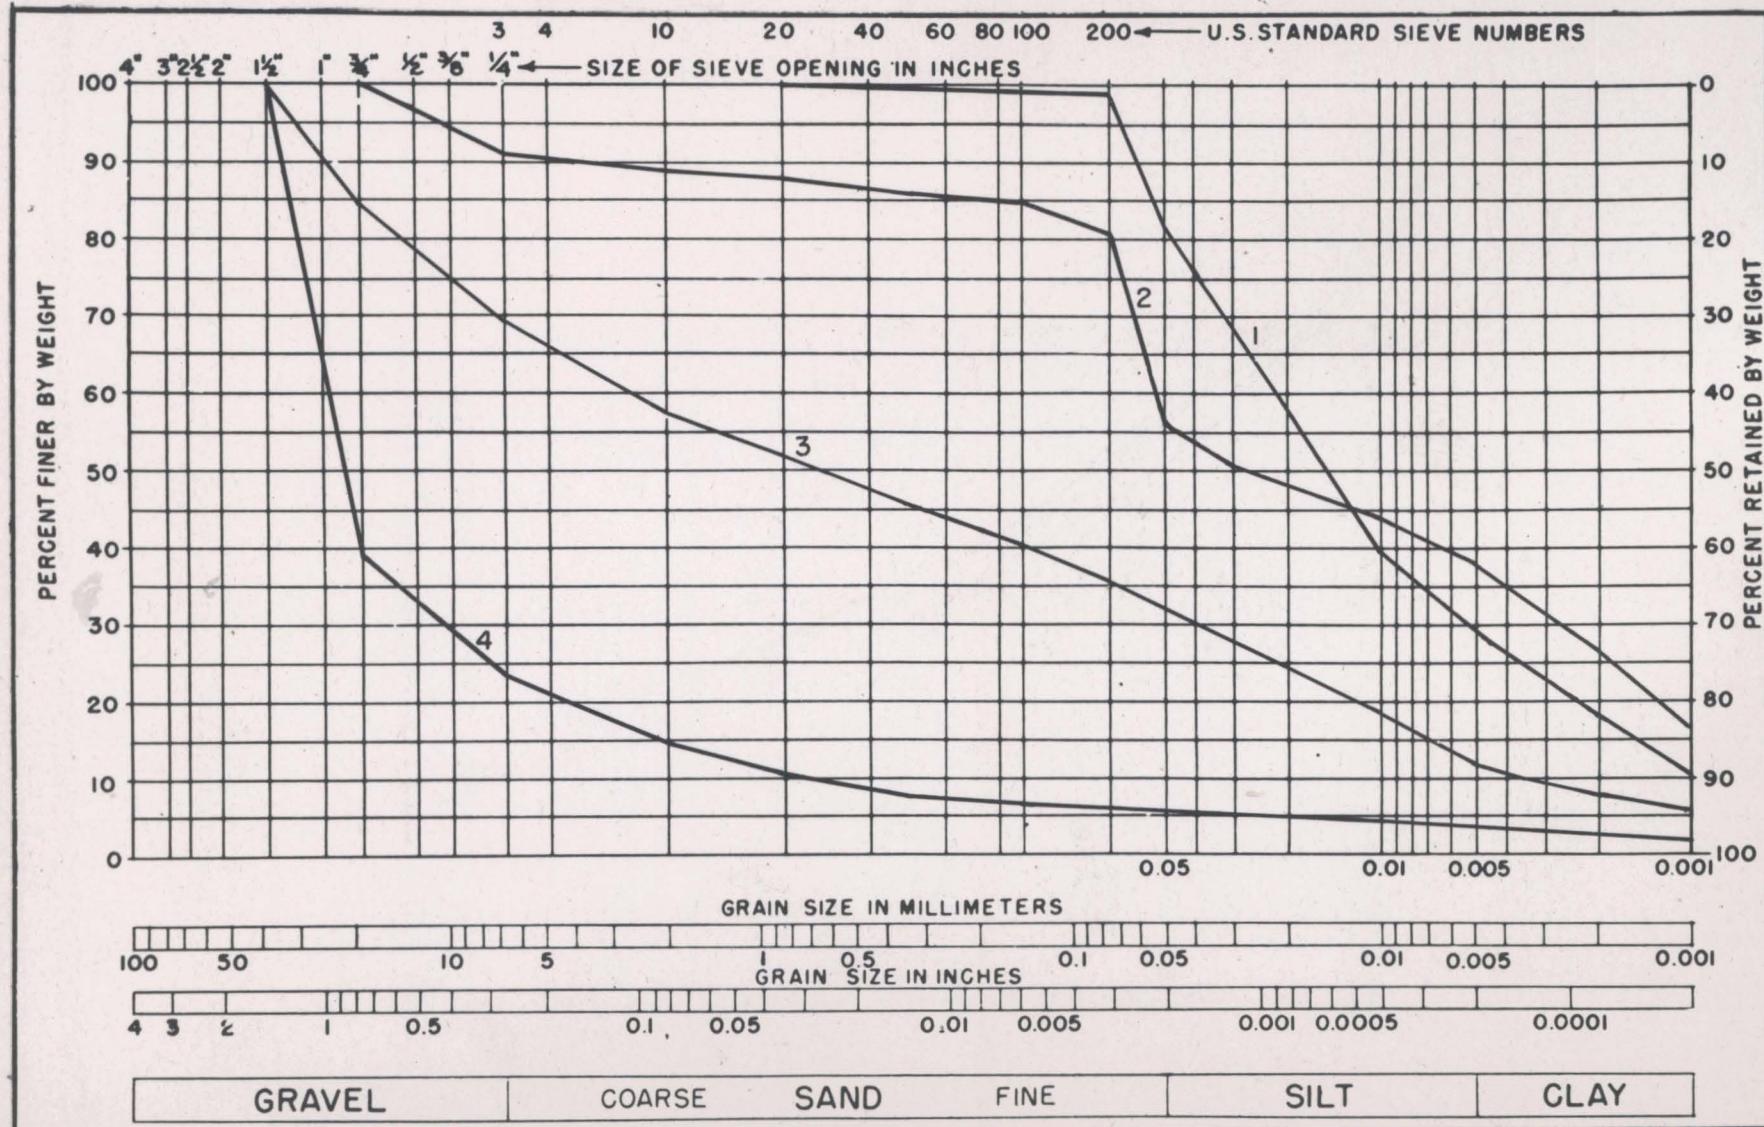
GRAIN SIZE DISTRIBUTION CURVES OF FILL MATERIALS

1. Thinly laminated clay, measured section no. 17, 43 to 127 feet
2. Massive clay, measured section no. 9, 33.4 to 42.9 feet
3. Till, measured section no. 2, 7 to 27 feet
4. Gravel, measured section no. 11, 17 to 68 feet

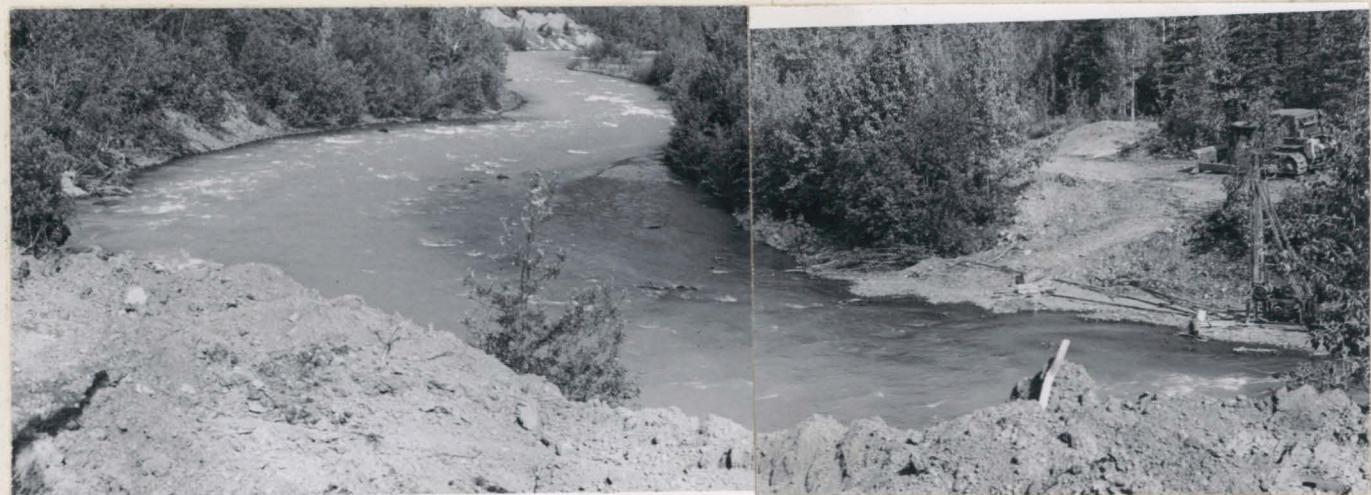
Plate X. View down Eklutna Creek at dam site,
taken from measured section No. 2.
Drill is set up on drill hole No. 2.

- (1) Continue test pit No. 1 by drilling to determine the depth and thickness of any impervious material underlying the right abutment.
- (2) Drill holes 3, 4, and 5 to determine the length of cutoff wall required beyond the end of the dam. If impervious material is not found above altitude 910 feet in these tests, another hole will be needed at a greater distance along the projected dam axis.

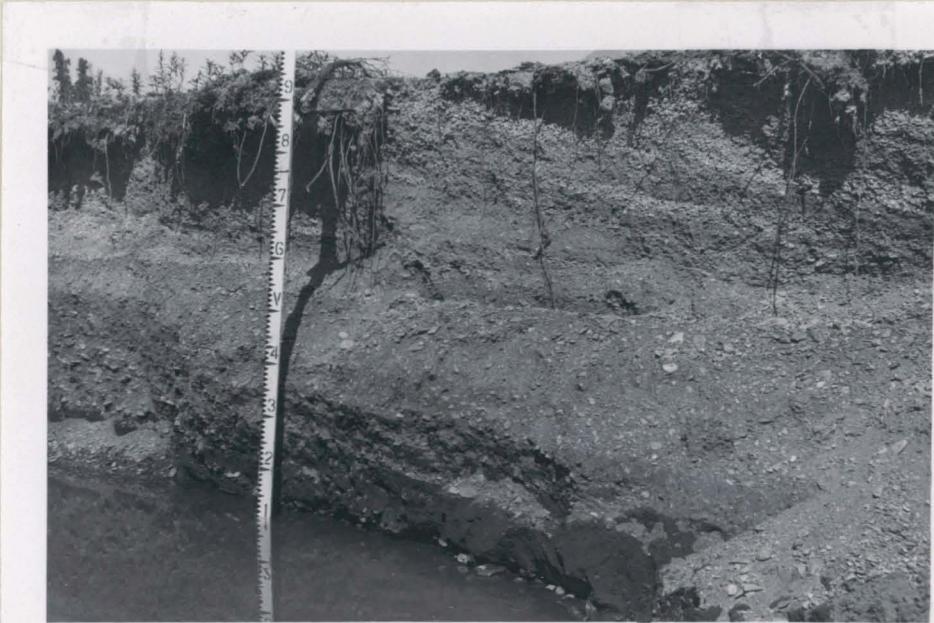
Plate XIII. View of gravel deposits exposed
in test pit No. 5.

The bed of the river and probably the left abutment are underlain by an unknown thickness of compact stony till. This till was also found in drill hole No. 1 below altitude 840. Further exploration will be required to determine whether or not it extends under the right abutment to the north wall of the valley. In the center of the dam site area between drill hole No. 1 and measured section No. 4, the till is overlain by 18 to 20 feet of loam, silty clay that in the vicinity of section No. 4 contains many fragments of carbonized wood. Overlying the clay are from 3 to 7 feet of fine-to-medium, poorly sorted to even-grained, clean sand; then 3.5 to 6.5 feet of loamy, clean, coarse gravel; and finally, 3 to 7 feet of the lake shore gravels. (See pl. XIII.)
