Icings along the Trans-Alaska Pipeline Route

By CHARLES E. SLOAN, CHESTER ZENONE, *and* LAWRENCE R. MAYO

GEOLOGICAL SURVEY PROFESSIONAL PAPER 979

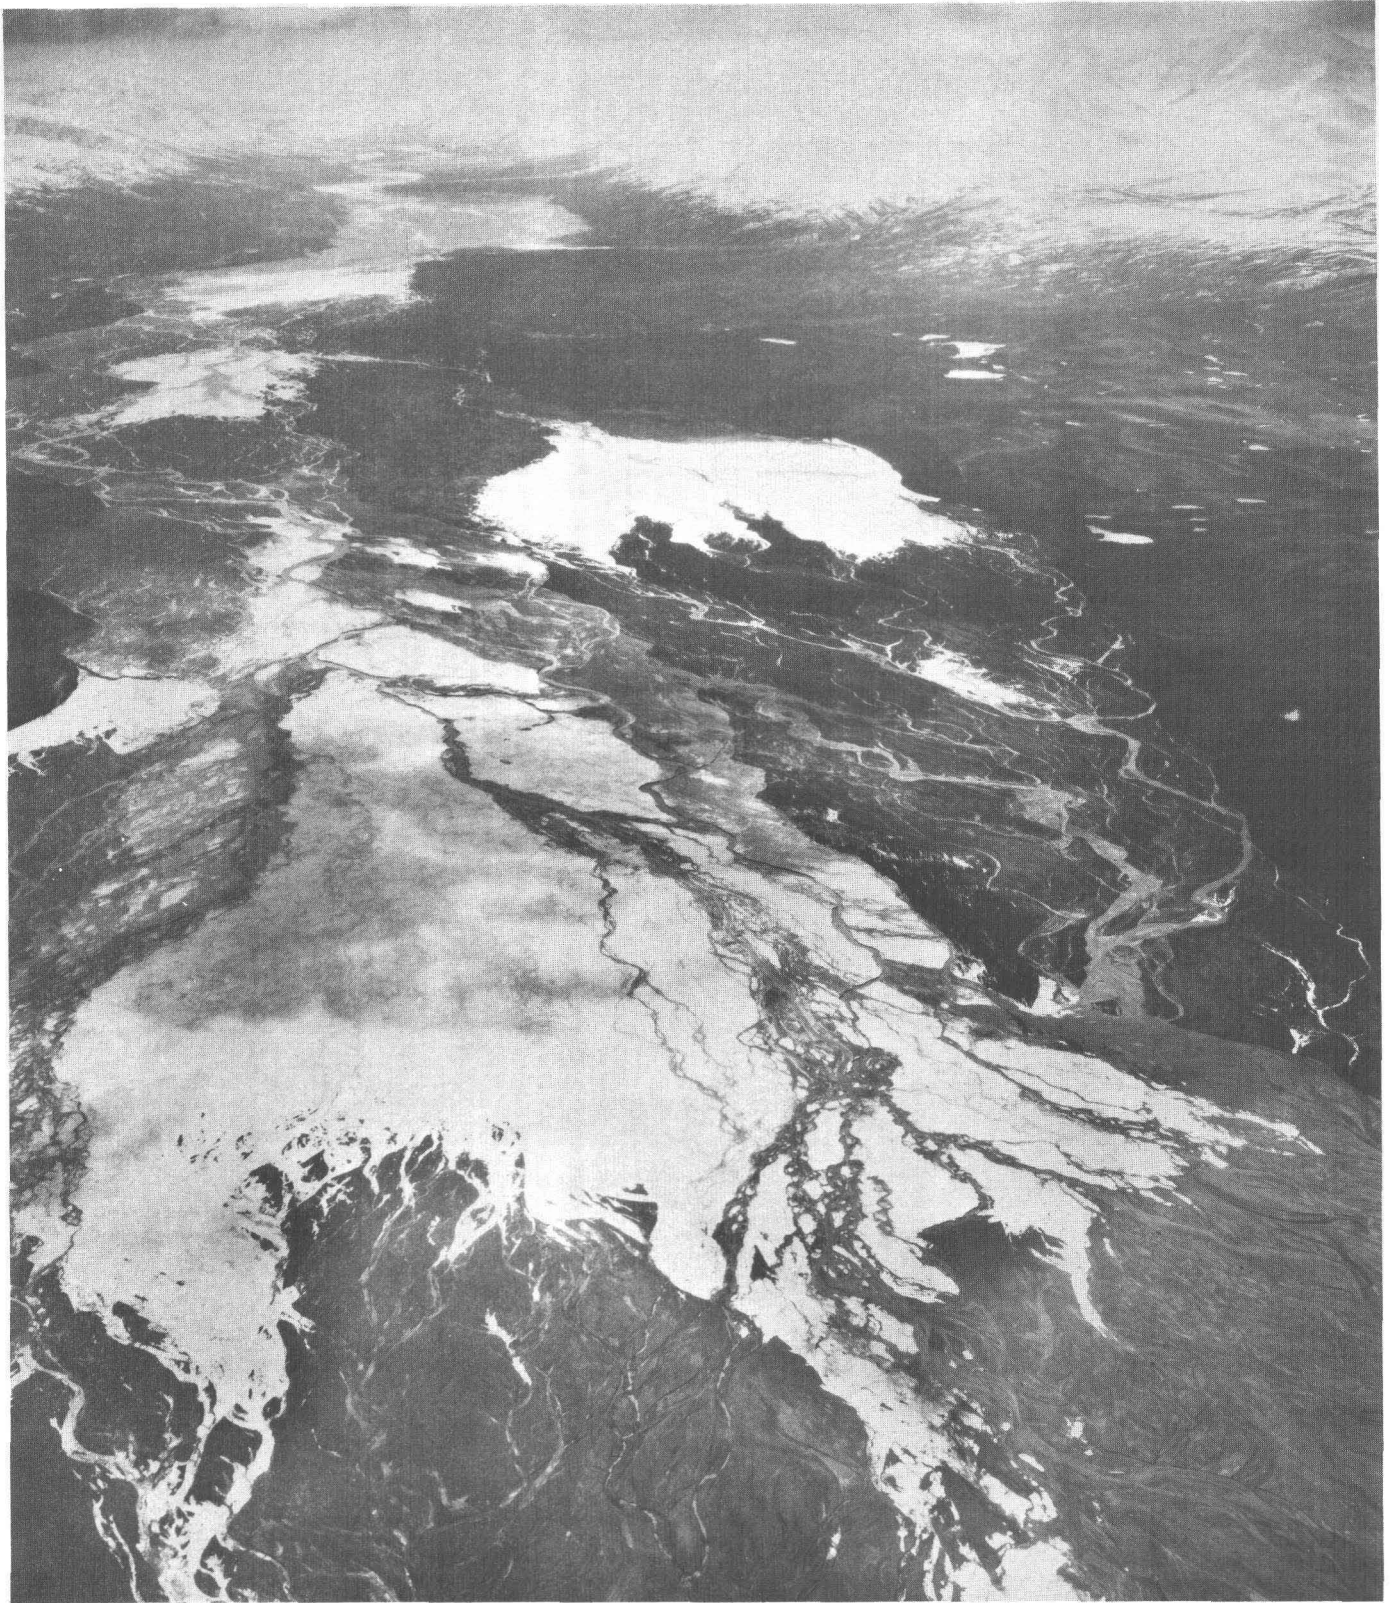
South of Black Rapids the pipeline crosses the active flood plain of the Delta River where extensive icings form annually.

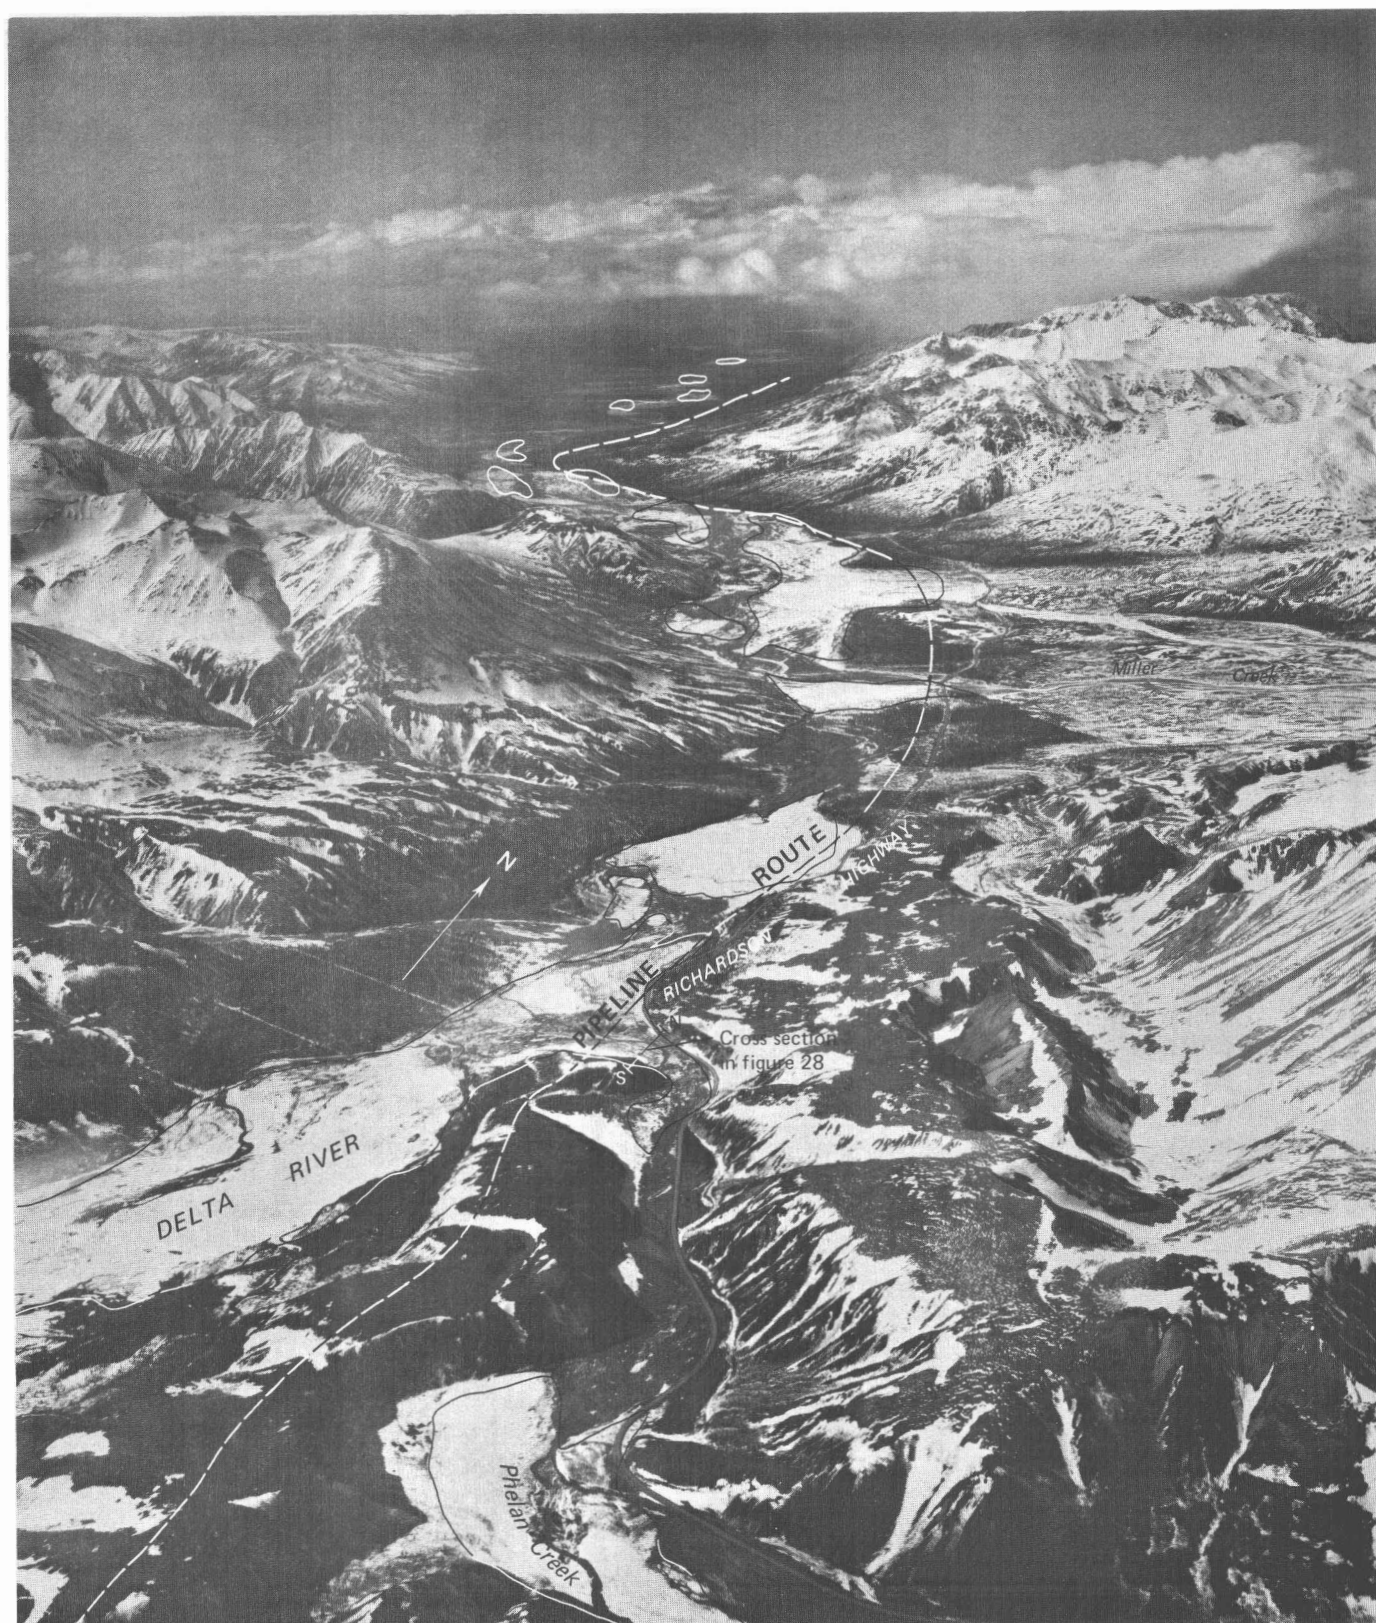
Thick flood-plain icings commonly form on braided rivers (fig. 2) because the channels are shallow and readily frozen. On the other hand, icings can be the cause of braided channels by diverting flow during spring breakup and also by inhibiting plant growth on the flood plain. Icings are not common on large rivers where the flow is confined to a narrow or single channel because of the greater channel depth. Icings form readily along small, single, shallow channels in those areas where winter streamflow is sustained by ground water. Large springs are the source of major icings in some river valleys. Small springs and seeps of ground water form small upland or hillside icings.

FIGURE 2.—Flood-plain icings on the Delta River and tributaries. View north along the pipeline route, May 22, 1972.

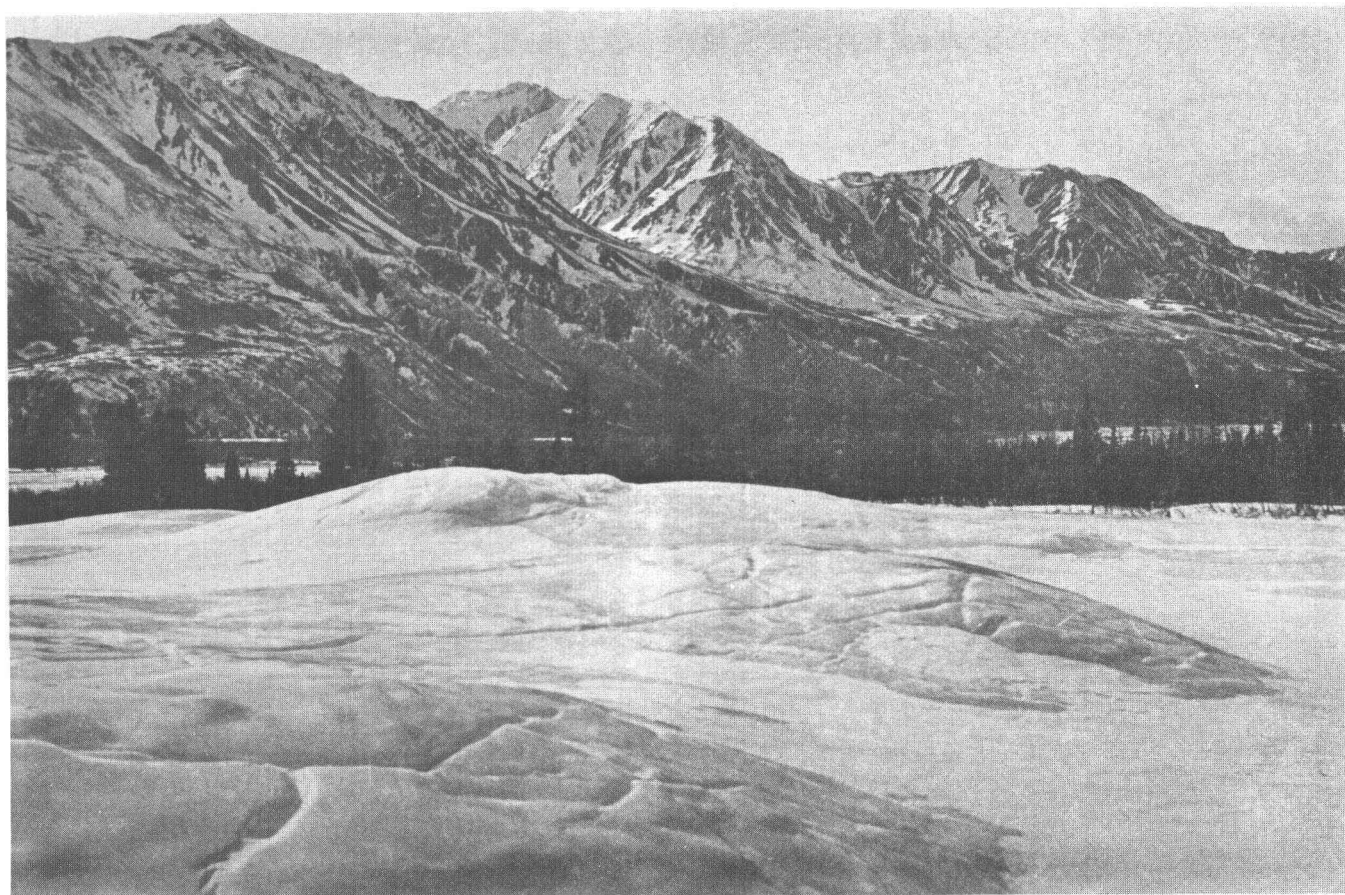
Icing mounds or hummocks are uplifted ice ridges, broad humps, or smaller conical domes (fig. 3) that are common features on large icings. As ice freezes downward, pockets of water may become isolated. The volume expansion that results from the freezing process in these pockets sharply increases the hydrostatic pressure. Doming may also occur when the hydrostatic pressure due to an increase in discharge or decrease in channel size is sufficient to deform the ice sheet upward at weak places. The pressure is relieved as water bleeds out through radial or circular cracks.

FIGURE 3.—Icing mounds on Trims Creek near pipeline crossing, Delta River valley, April 18, 1974.

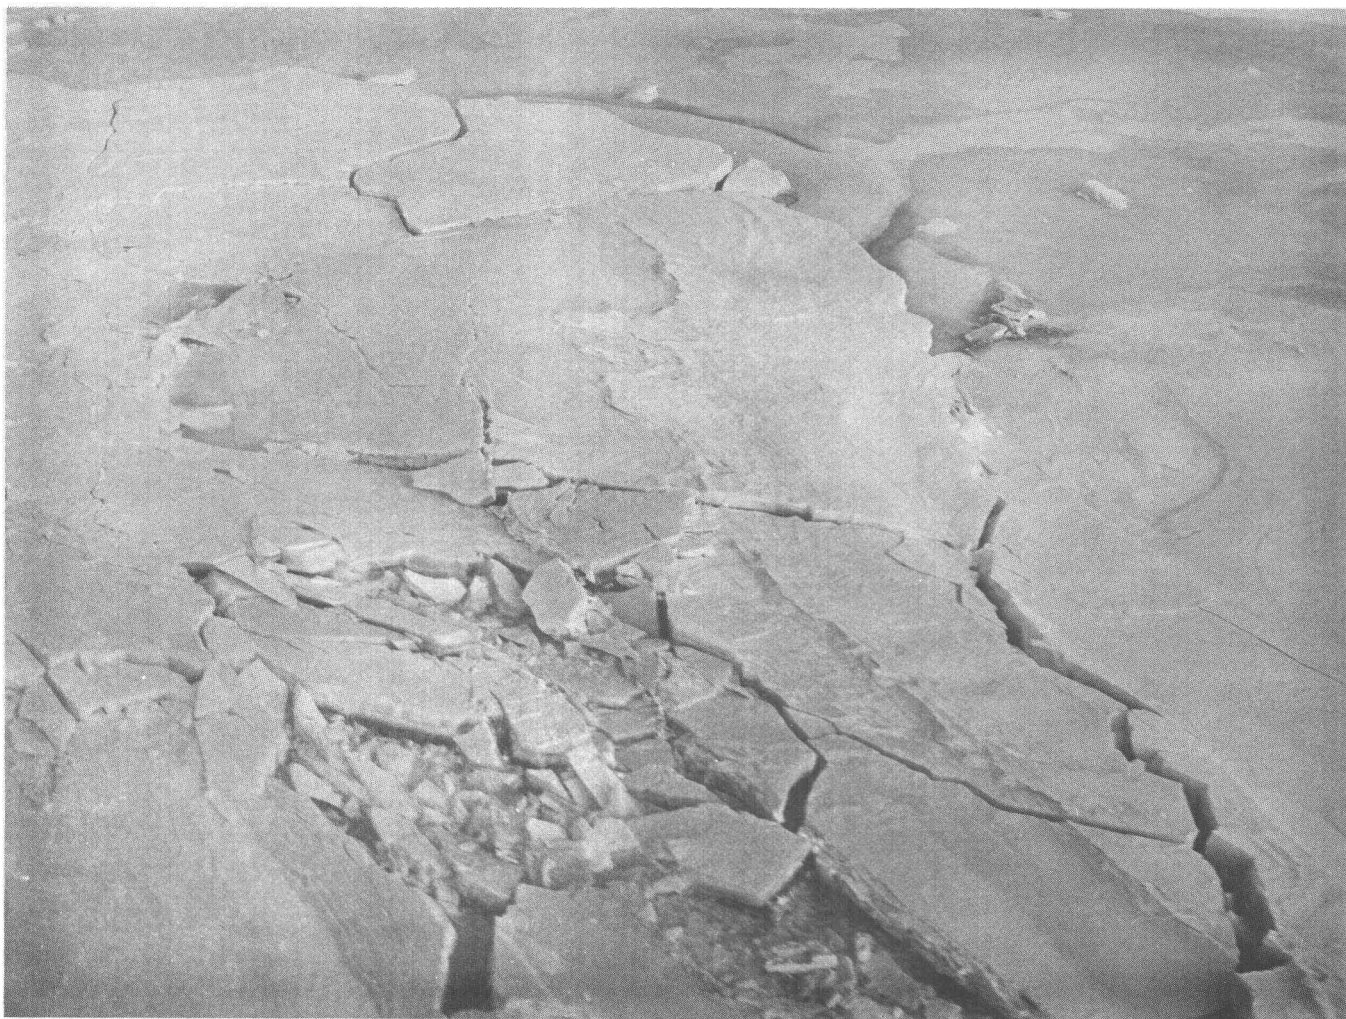
Pressure in icings can result from accumulations of entrapped gas, such as air or methane. Pockets of gas under pressure have been discovered by drilling into domes that show no evidence of overflowing water. Occasionally, relief of gas pressure can occur suddenly and explosively, resulting in displaced and shattered blocks of ice (fig. 4 and 5).

FIGURE 4.—Fractured icing mound on Dietrich River approximately 2 miles (3.2 km) downstream from confluence with Big Jim River, March 15, 1972. Explosive force scattered ice blocks for tens of feet.

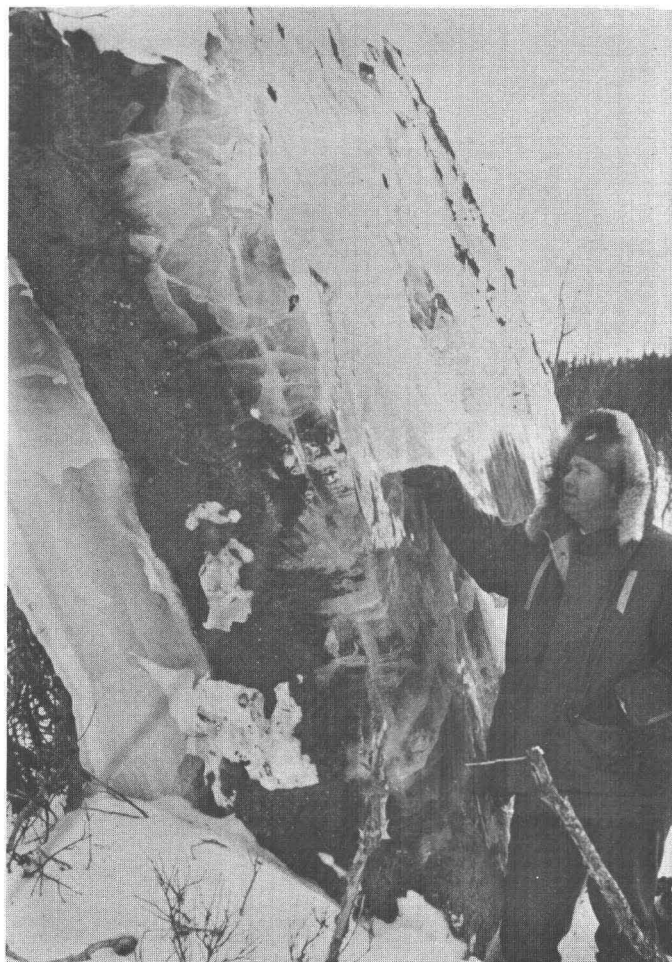
FIGURE 5.—Upheaved ice and soil block from exploded hillside icing mound north of Old Man camp in Fish Creek valley, March 21, 1974.

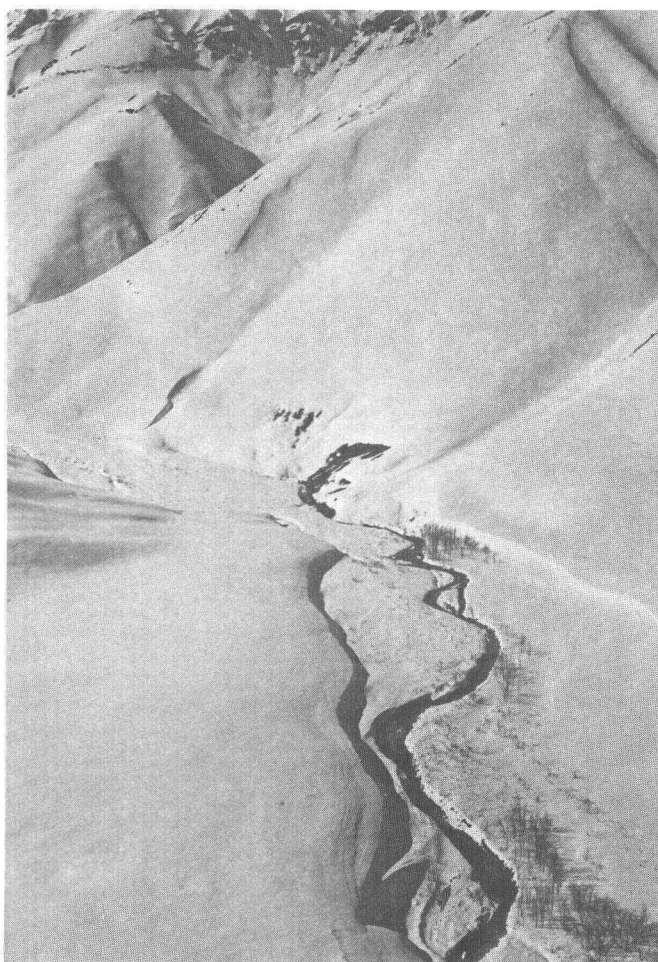
Large icings near the front of the Brooks Range are fed by springs discharging from carbonate bedrock directly to the river or alluvium in the river bed (fig. 6).

FIGURE 6.—Hillside spring in Brooks Range near Ivishak River, May 11, 1973. Balsam poplar are 30–40 feet (10–12 m) tall.

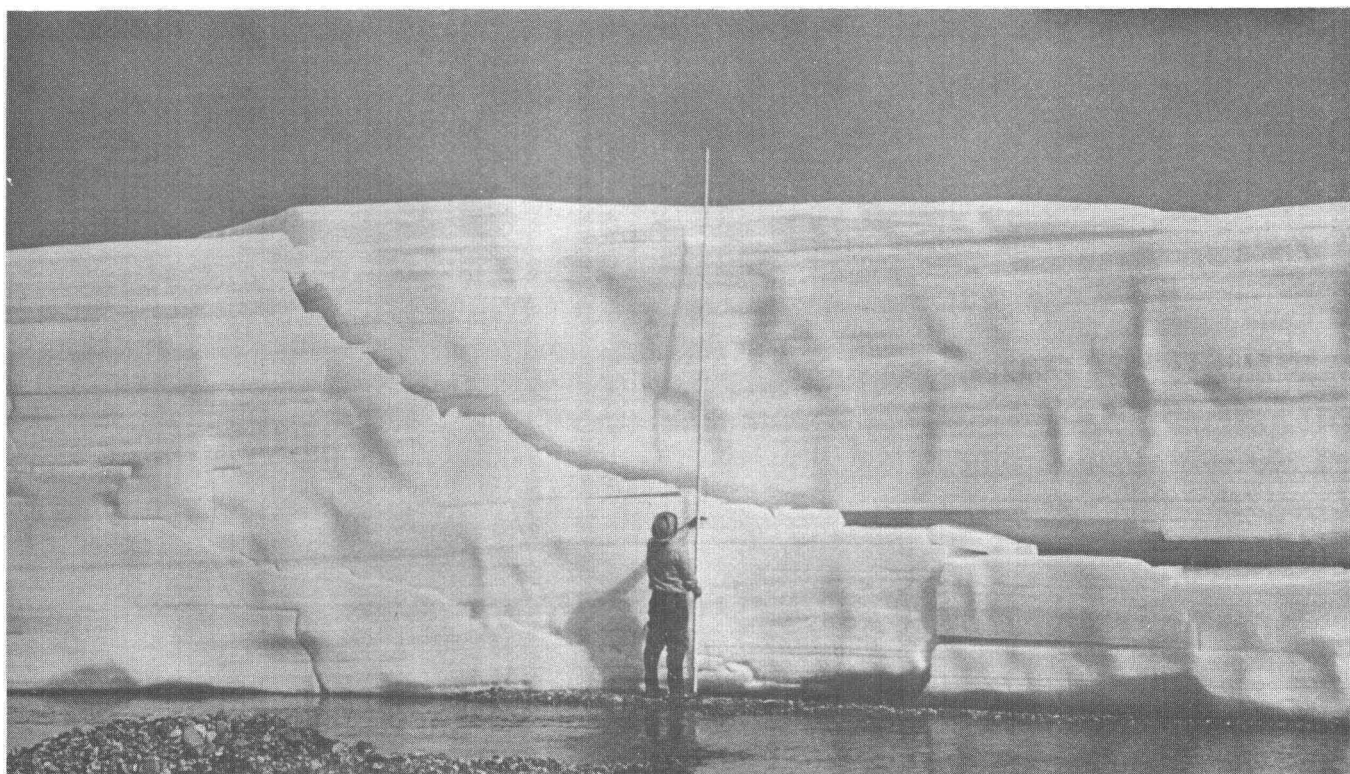
FIGURE 10.—Echooka River icing about 16 feet (5 m) thick, July 11, 1972. Layering in ice shows that numerous overflows make up the icing.

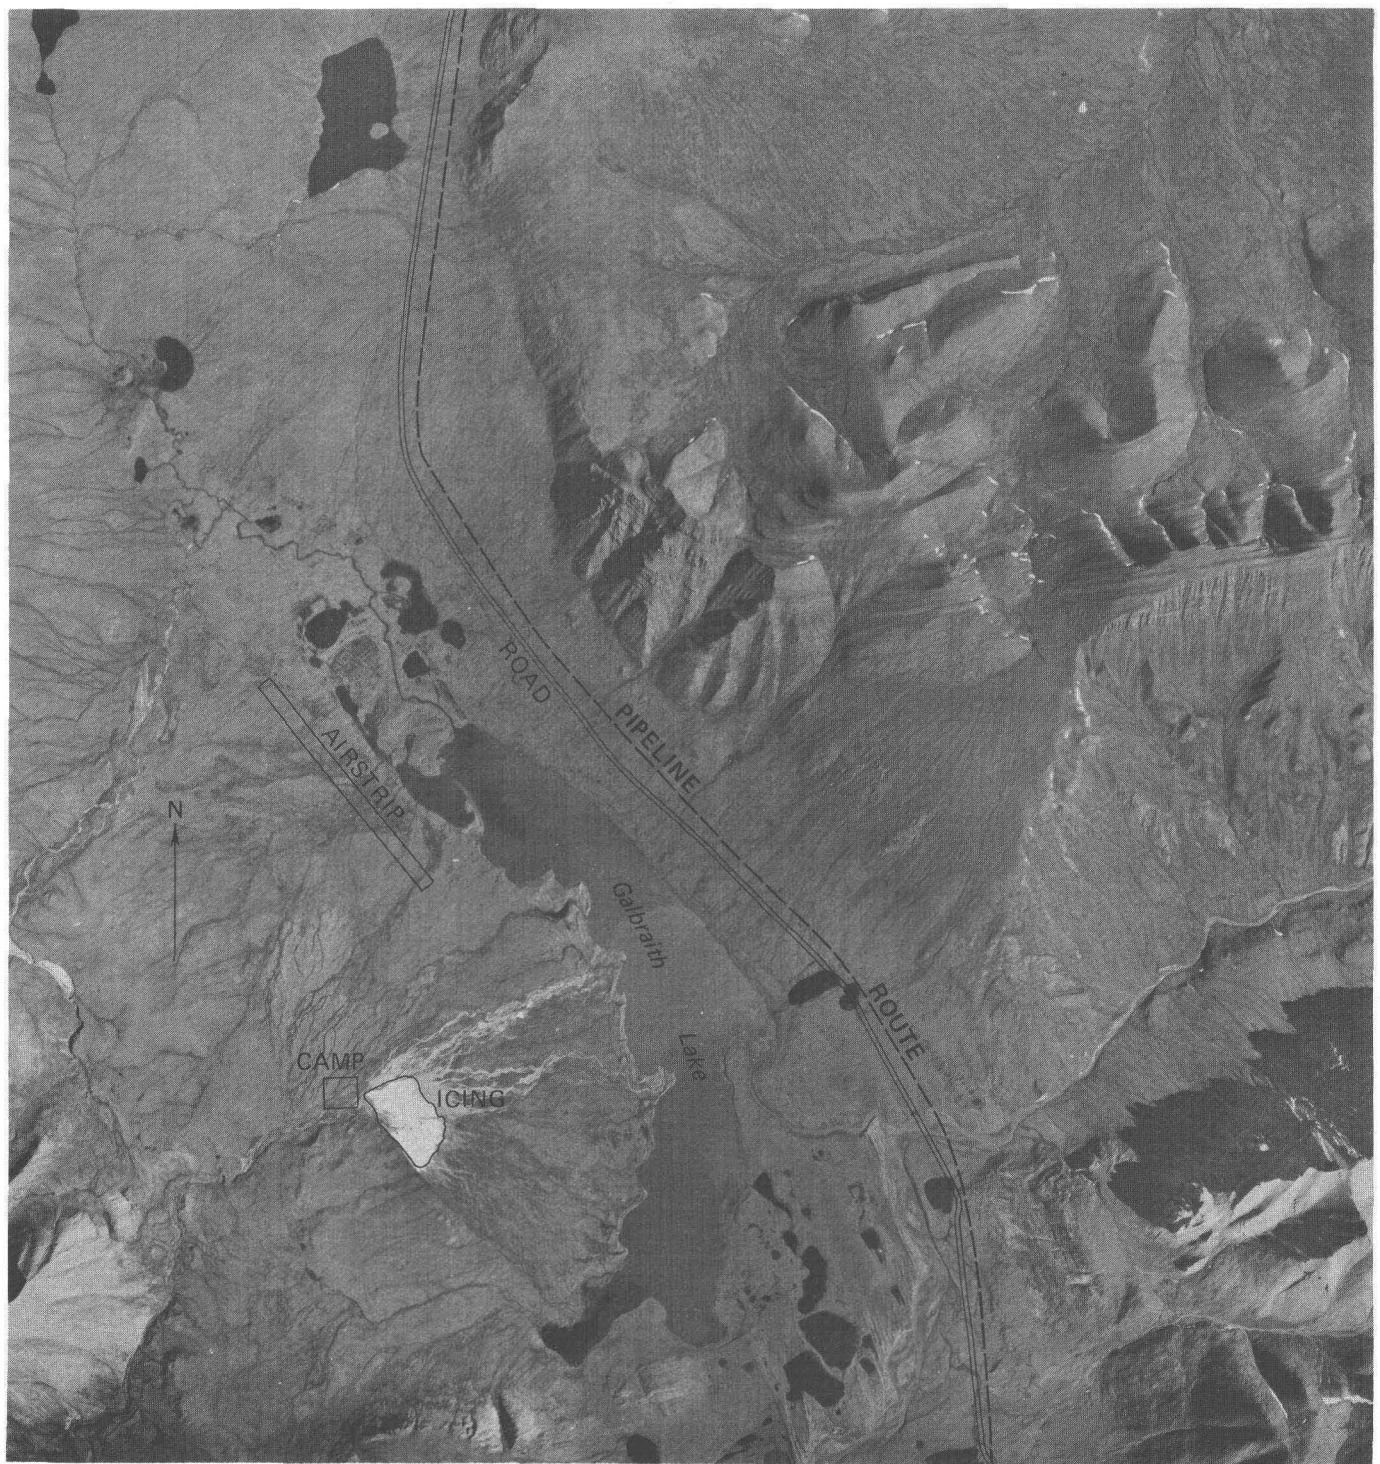
A large icing forms annually on the alluvial fan west of Galbraith Lake (figs. 11 and 12). Large icings also occur at wide, braided channel reaches of the upper Atigun River valley (figs. 11 and 13).

FIGURE 12.—Icing on alluvial fan at Galbraith Lake, July 21, 1956. (Approximate scale: 1 in.=4,000 ft or 1 cm=480 m.)

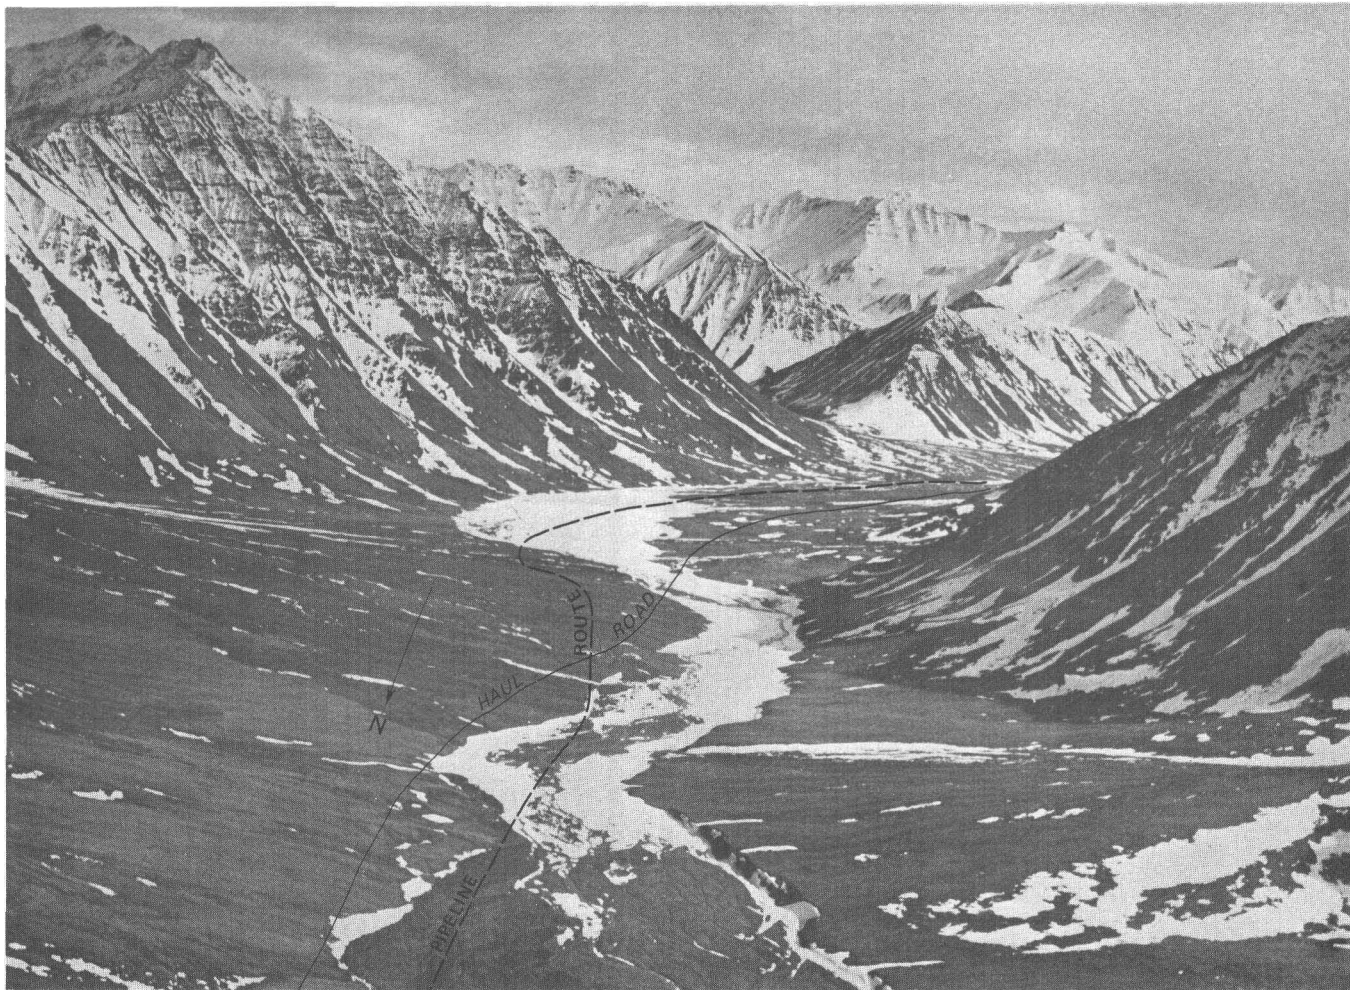
FIGURE 13.—Icings in braided reaches of Atigun River, May 29, 1973.

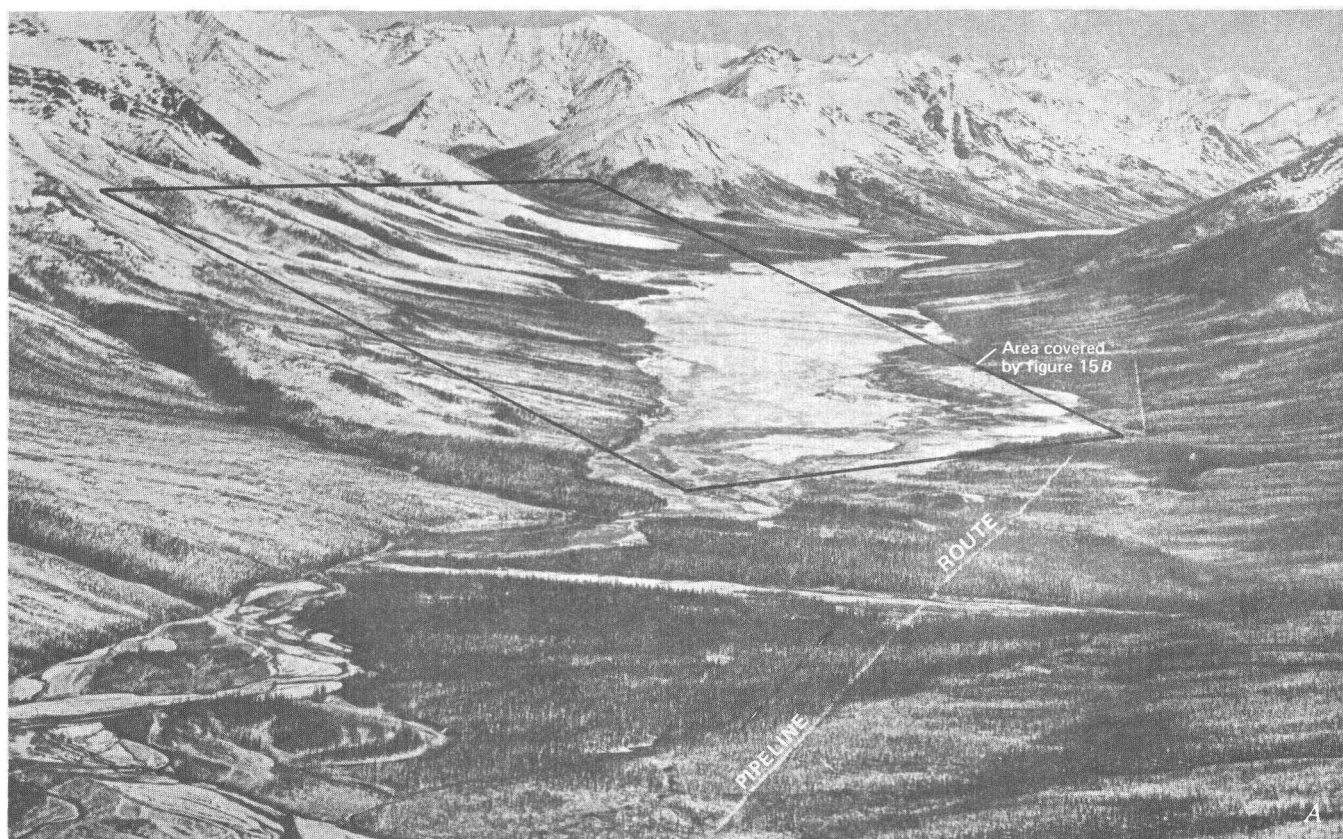
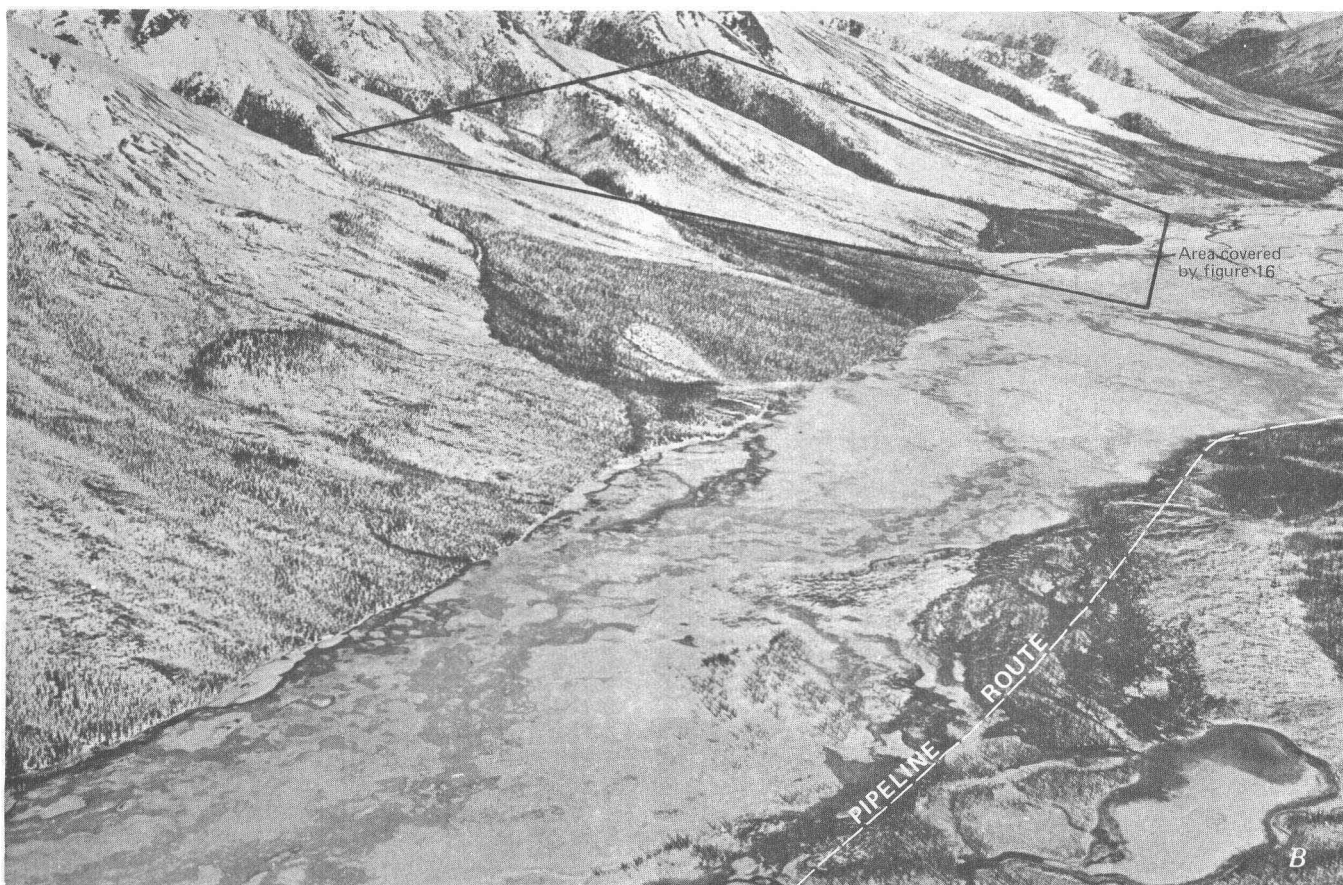
FIGURE 15.—Icings on the Dietrich River flood plain. A, Icing in Dietrich River valley upstream from Snowden Creek, May 1, 1974. B, Closeup view of part of icing shown in A.

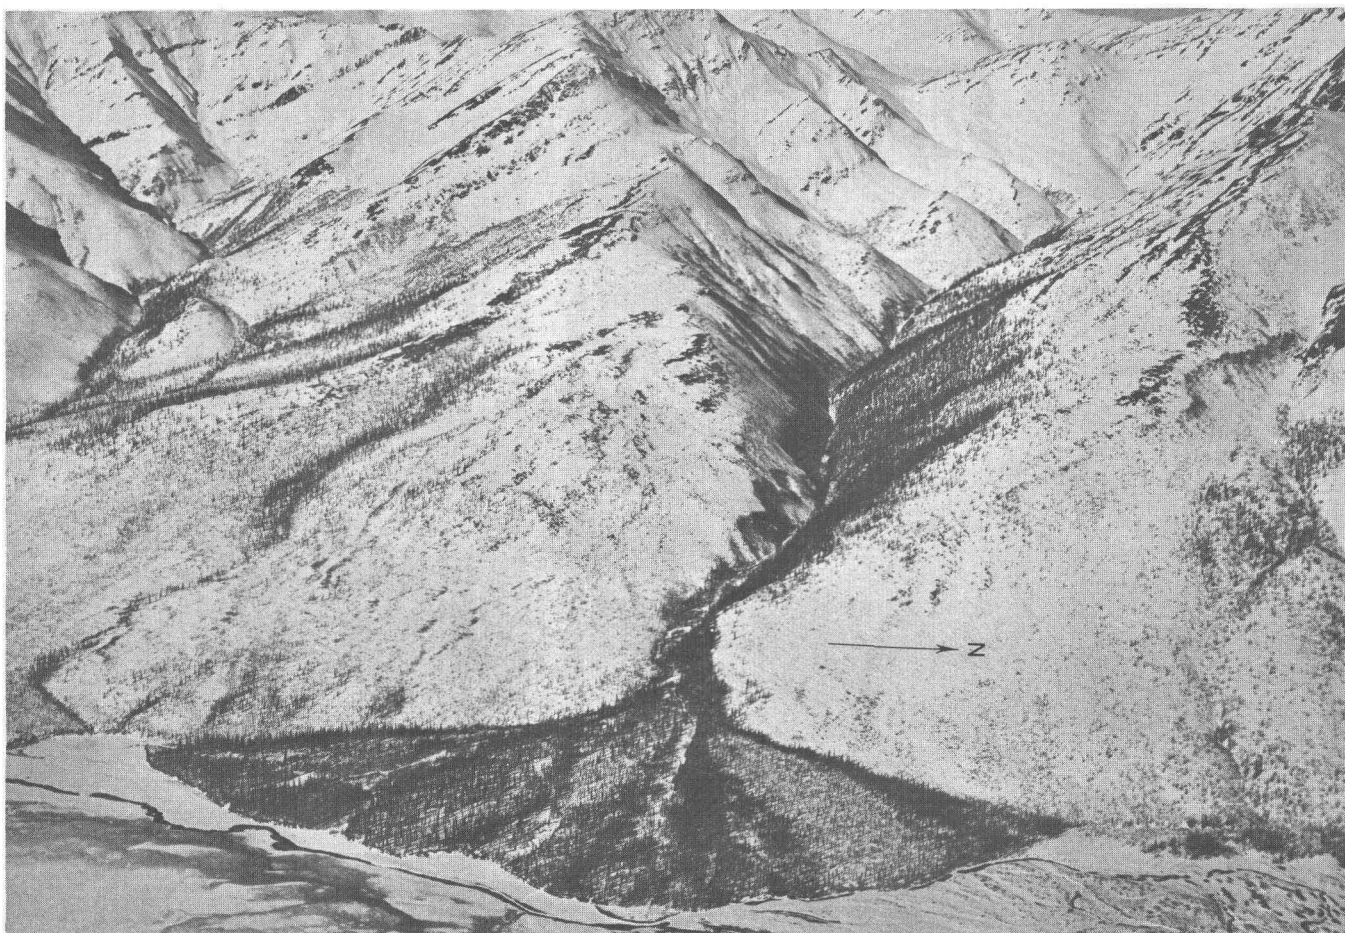
FIGURE 16.—Alluvial fan in Dietrich River valley upstream from Snowden Creek, May 1, 1974. Open leads at toe of fan are source of water for downstream icings.

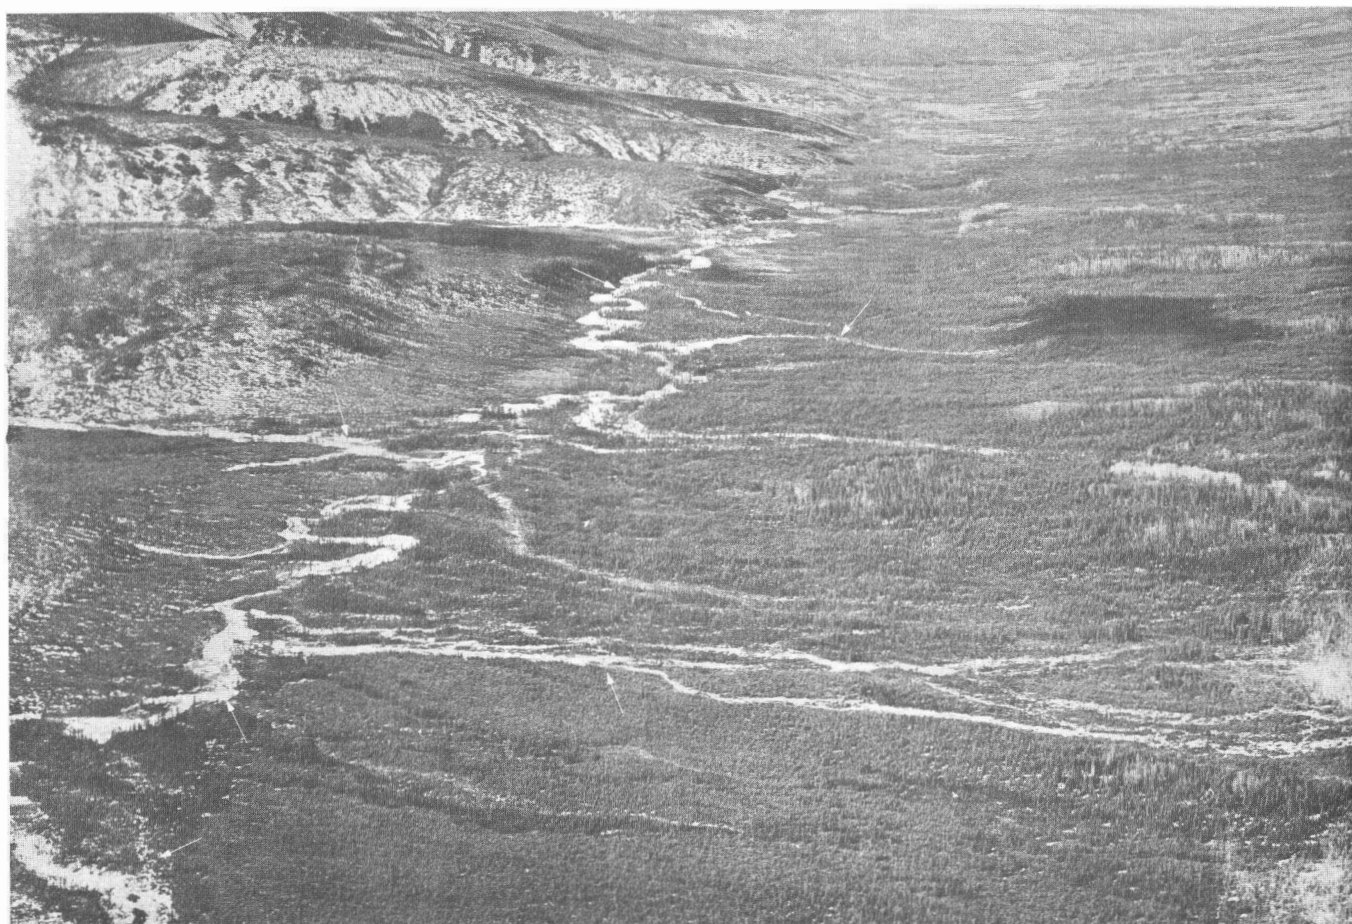
South of the Yukon River, narrow channel icings form on the small streams in the uplands (figs. 18 and 19). The source for these icings may be artesian water from bedrock drainage or from unfrozen ground above permafrost. The water emerges in small depressions or gullies that drain to the larger stream valleys.

FIGURE 19.—Channel and hillside icings along Aggie Creek in Yukon-Tanana Uplands north of Fairbanks, May 23, 1973.

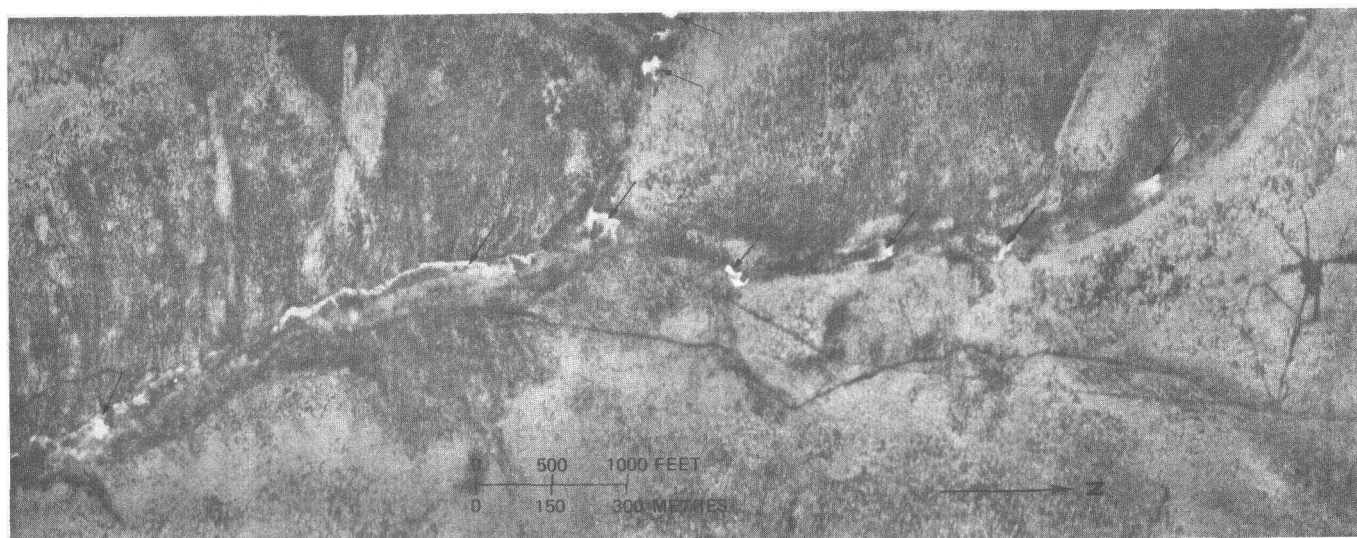
FIGURE 22.—Thermal infrared image of icings along Minton Creek, February 4, 1974. Water surfaces (arrows) contrast with snow and vegetation background.

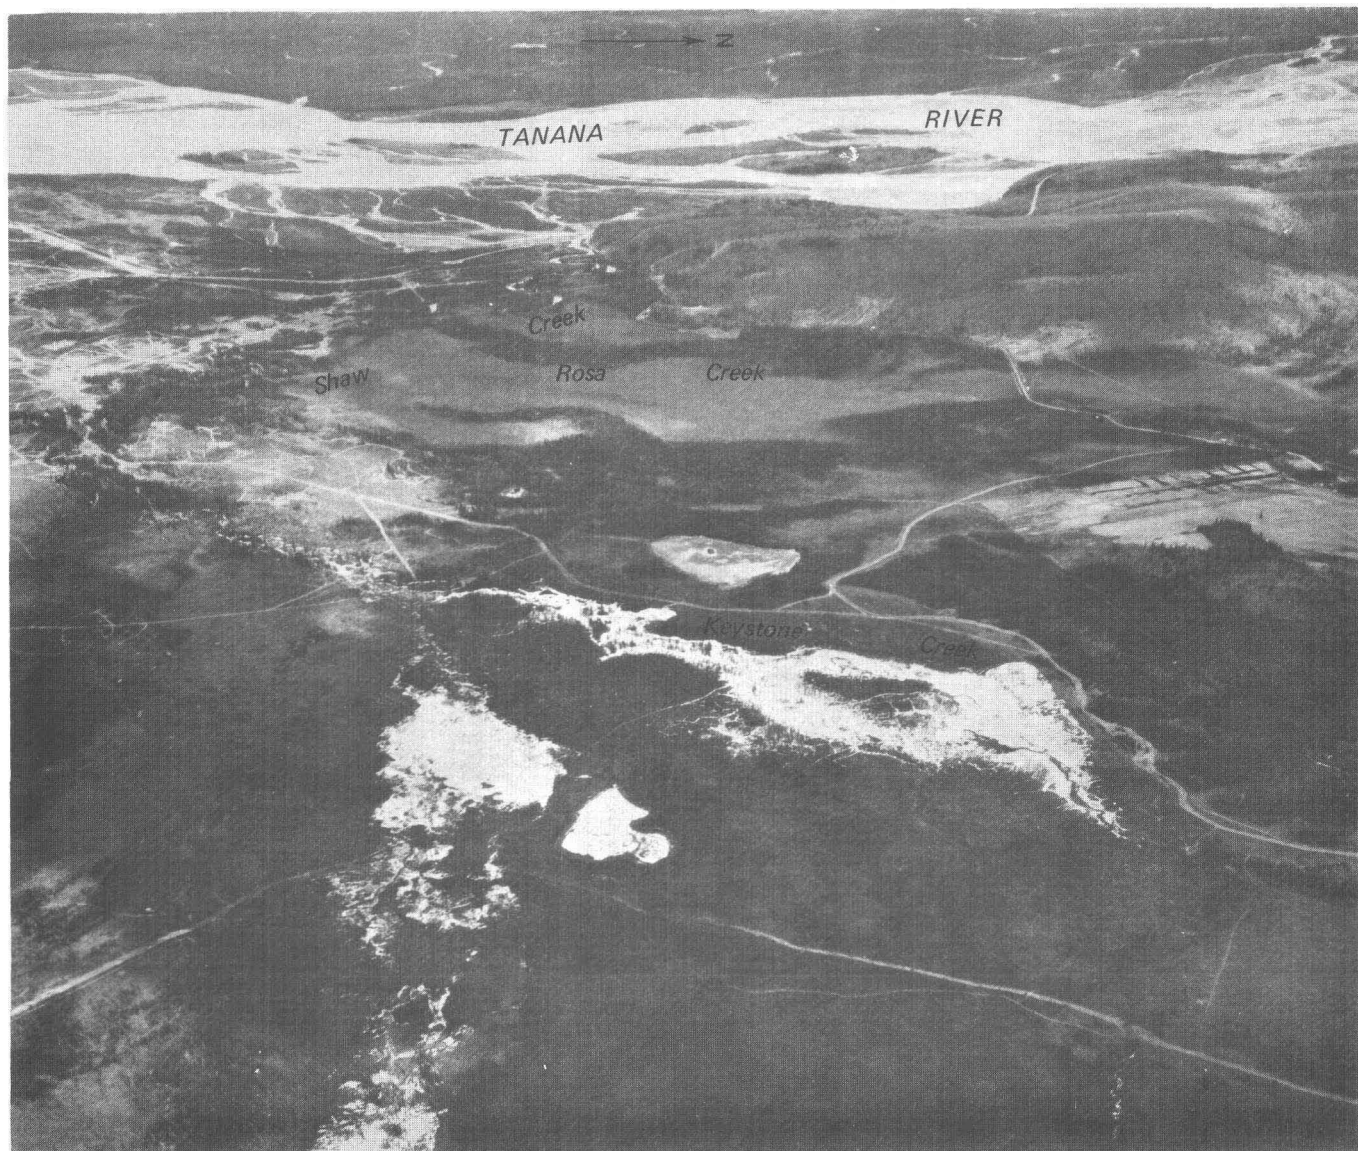
FIGURE 23.—Icings in flats north of Shaw Creek, May 22, 1972.

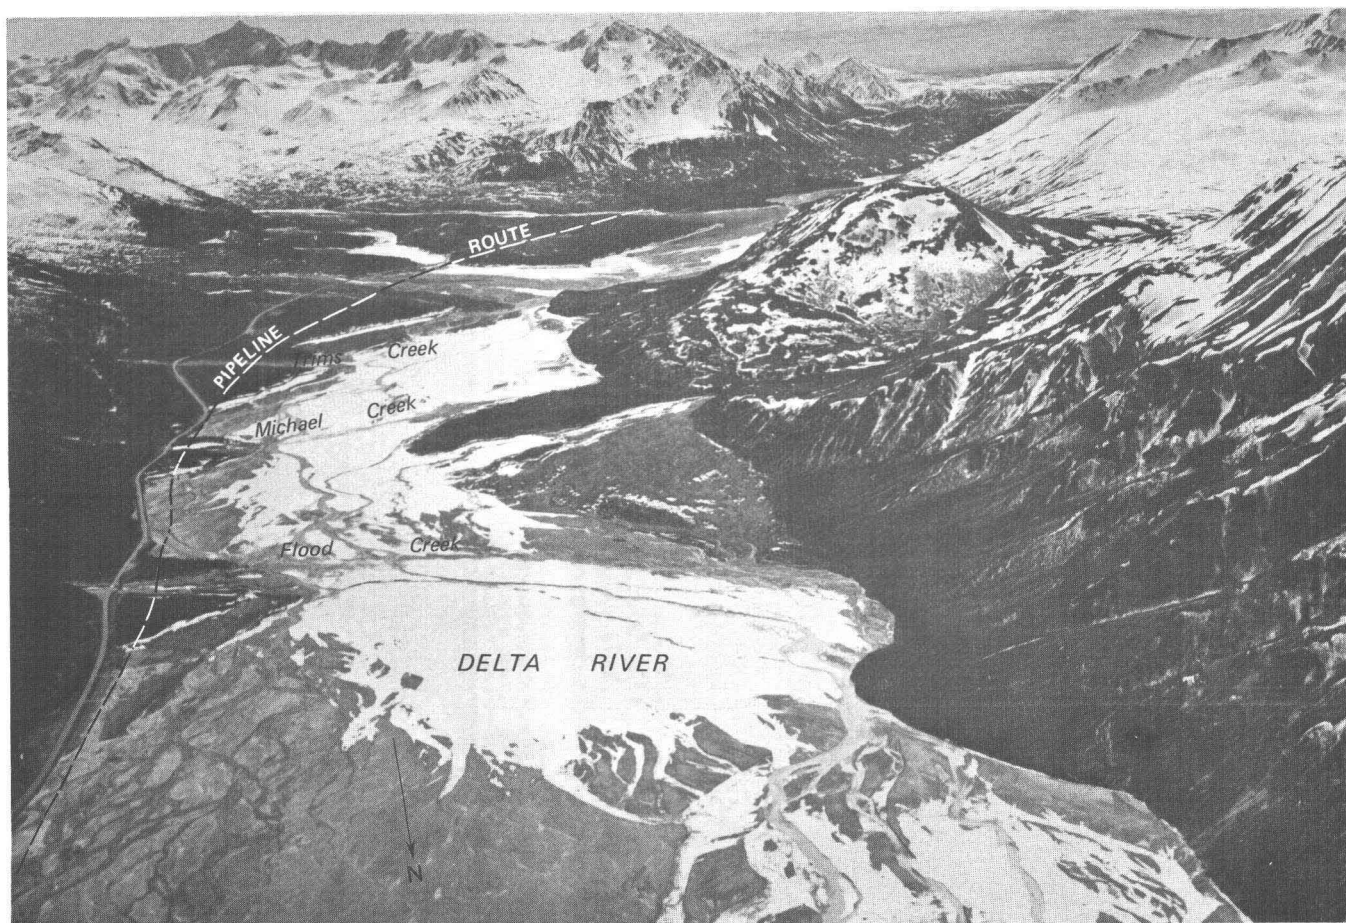
FIGURE 25.—Flood-plain icings along Delta River. Alluvial fans of Flood, Michael, and Trims Creeks in left foreground. View south (upstream) on May 29, 1973.

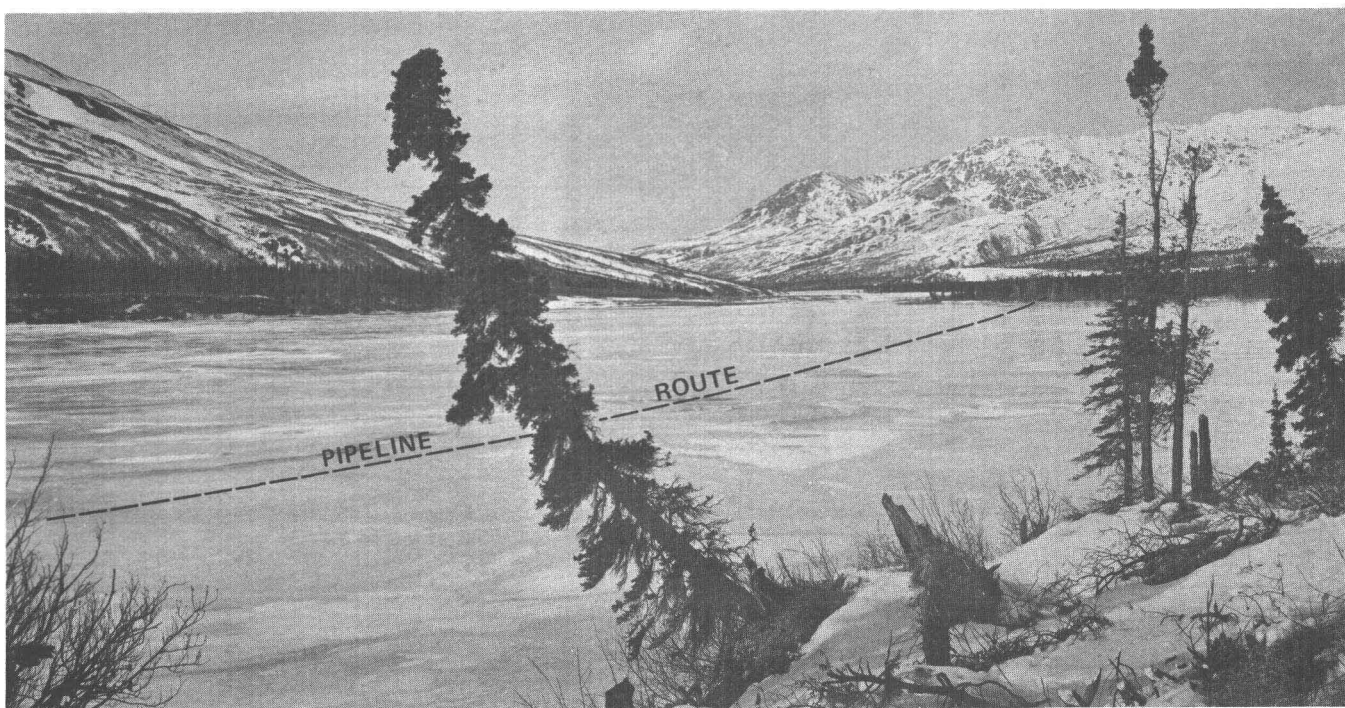
FIGURE 26.—Flood-plain icing in Delta River valley upstream from Miller Creek, April 18, 1974.
