Icings along the Trans-Alaska Pipeline Route

By CHARLES E. SLOAN, CHESTER ZENONE, *and* LAWRENCE R. MAYO

GEOLOGICAL SURVEY PROFESSIONAL PAPER 979

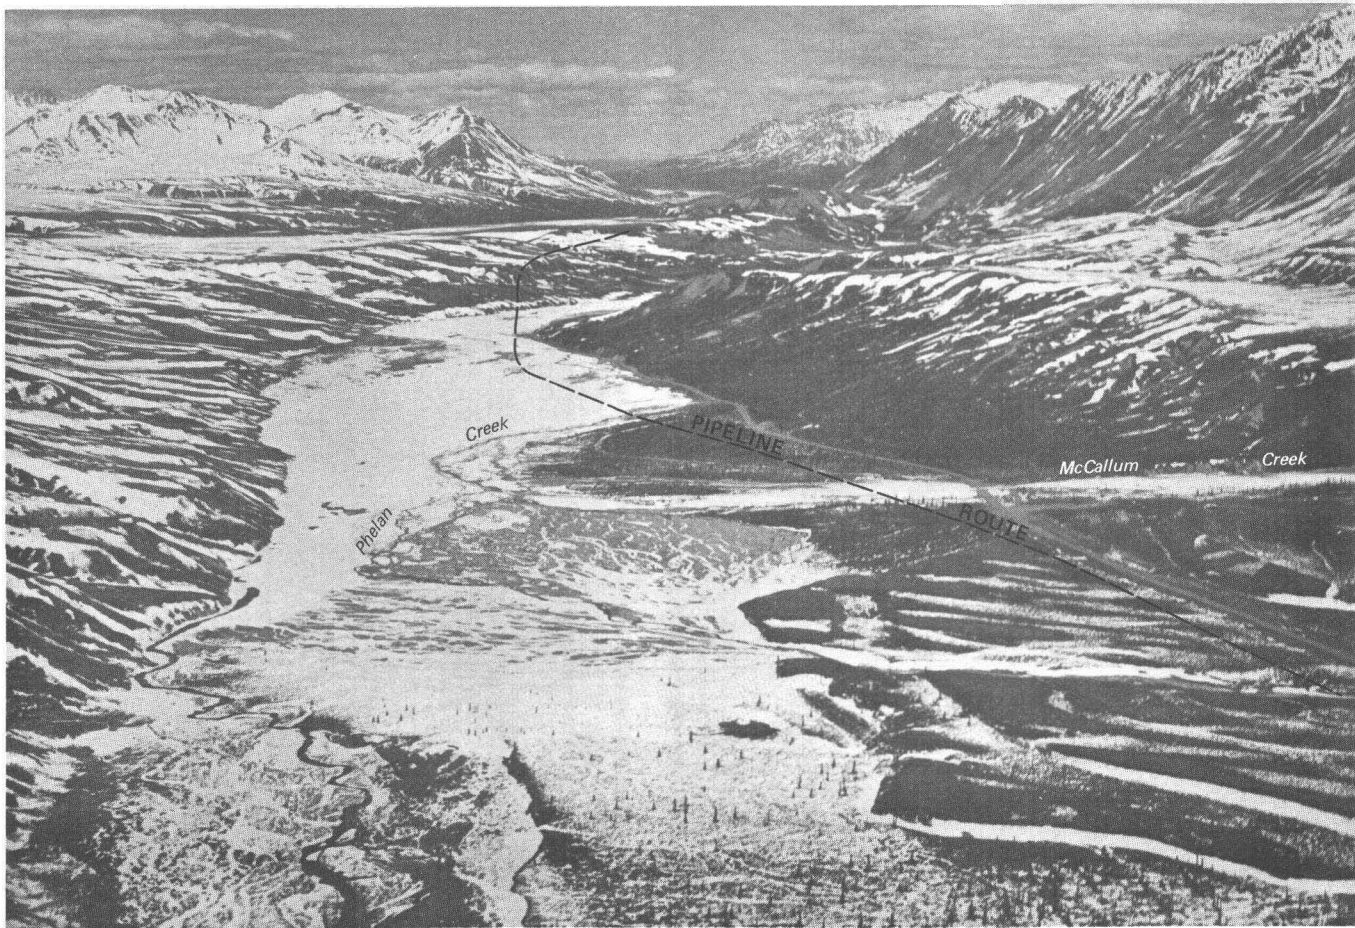
Castner Creek, lower Miller Creek, Miller Creek, Phelan Creek, and McCallum Creek (fig. 27), streams crossed by the pipeline.

FIGURE 27.—Icing in Phelan and McCallum Creeks, May 29, 1973.

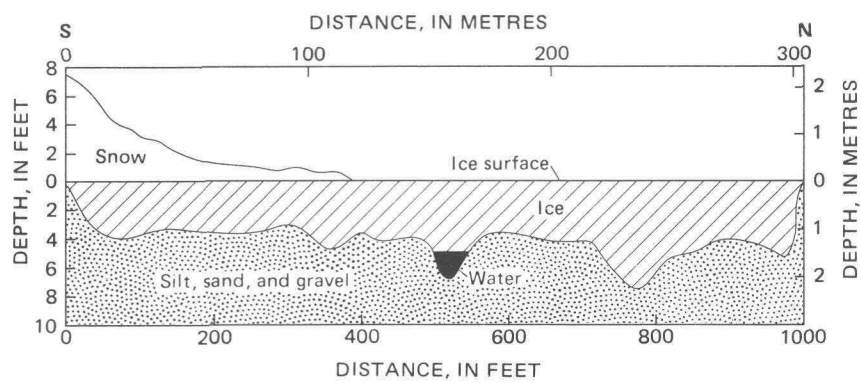
Borings were made through the Phelan Creek icing at the confluence of the Delta River and Phelan Creek on April 27, 1972 (fig. 28). The ice averaged about 5 feet (1.5 m) thick, and of 31 holes drilled along a 1,000-foot (305-m) section, only 1 reached water in a channel under the ice. In the remainder of the holes, ice was resting directly on sand and gravel channel deposits.

FIGURE 28.—Cross section through icing at mouth of Phelan Creek, April 27, 1972. (See location of section in fig. 2.)

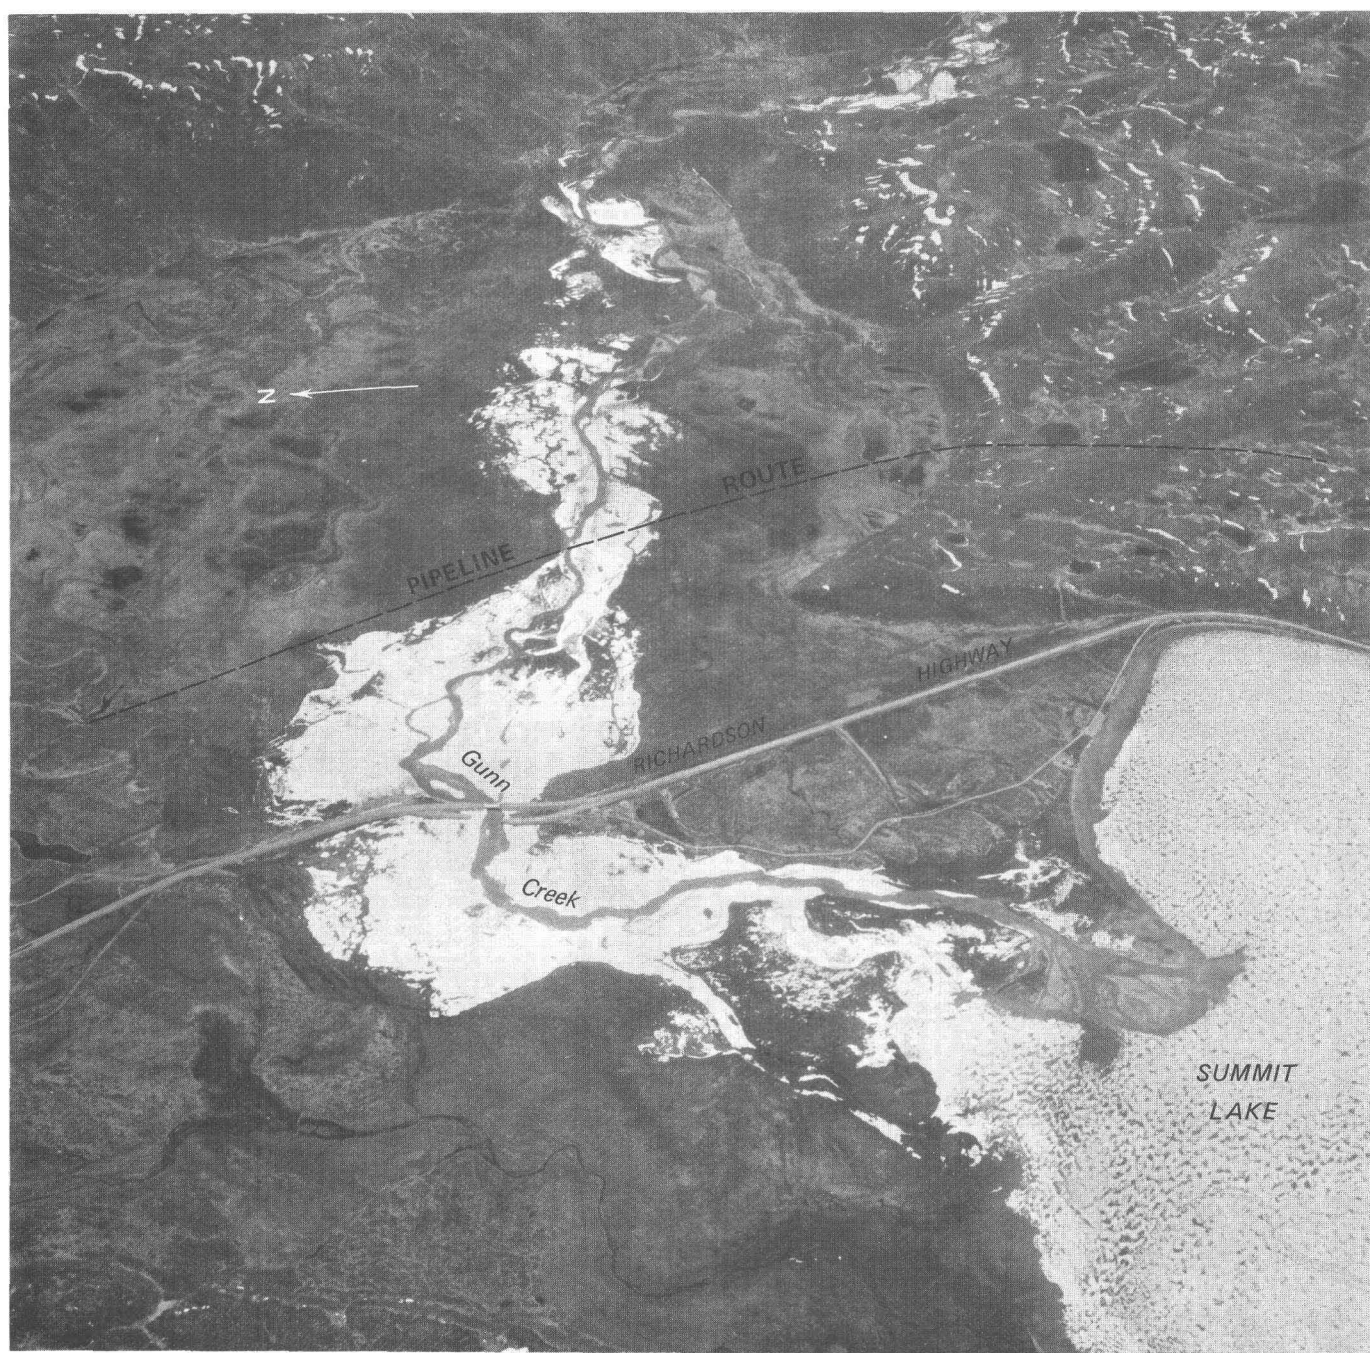
Near Isabel Pass a large icing forms annually on Gunn Creek at the Richardson Highway bridge (fig. 29).

FIGURE 29.—Icing on Gunn Creek at Richardson Highway and pipeline crossing, June 6, 1970.

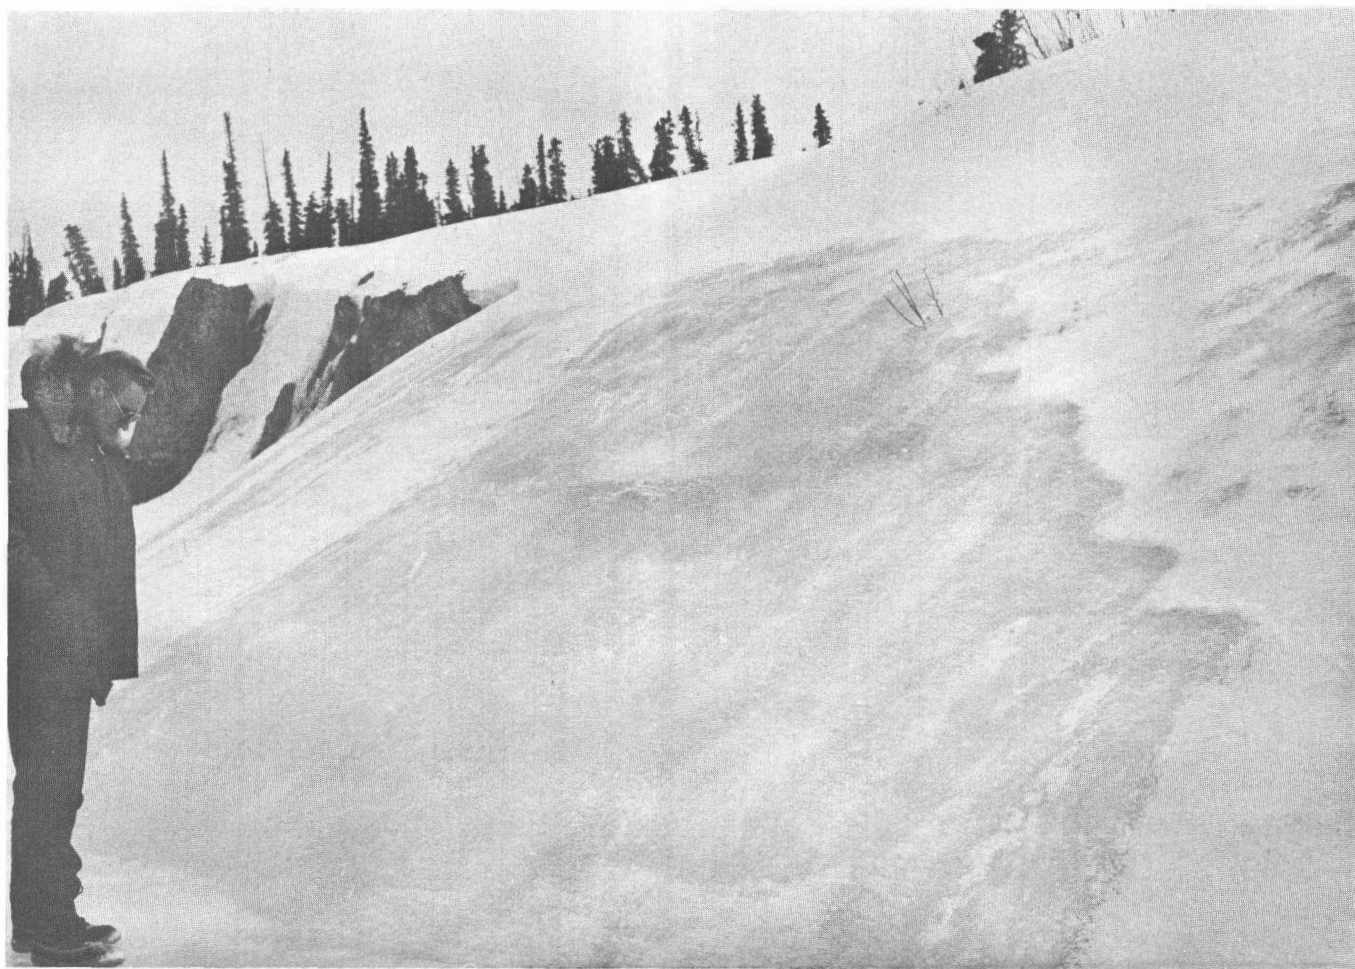
Hillside icings formed by seeps and springs in the Little Tonsina valley (fig. 32) have been particularly bothersome requiring repeated culvert maintenance by the Alaska Department of Highways. The occurrence of icings in the Chugach Mountains indicates that icings are not unique to the northern parts of Alaska. They are scattered along the entire length of the trans-Alaska pipeline route.

the albedo and snow cover, thereby affecting the thermal regime. In addition, a very thick fill might act as an insulator, causing aggradation of permafrost into the fill embankment (Ferrians and others, 1969). This permafrost dam constitutes a barrier to ground-water movement. Road and borrow-pit cuts (fig. 32) and trenches for the pipeline could intercept shallow ground water. In permafrost areas, a common result of deeper winter freezing, greater summer thawing, growth of frost dams on hillsides, and exposure of ground-water flow zones is a greater than normal flow of ground water to the surface (Eager and Pryor, 1945) with consequent growth of icings.

FIGURE 32.—Icing formed from ground-water seepage at face of gravel pit near Little Tonsina River, April 1, 1971.
