GEOLOGIC REPORT 57

SURVEY-MONITORING SYSTEM, PILLAR MOUNTAIN LANDSLIDE AREA,  
KODIAK, ALASKA

By  
Randall G. Updike

FAIRBANKS, ALASKA  
1988

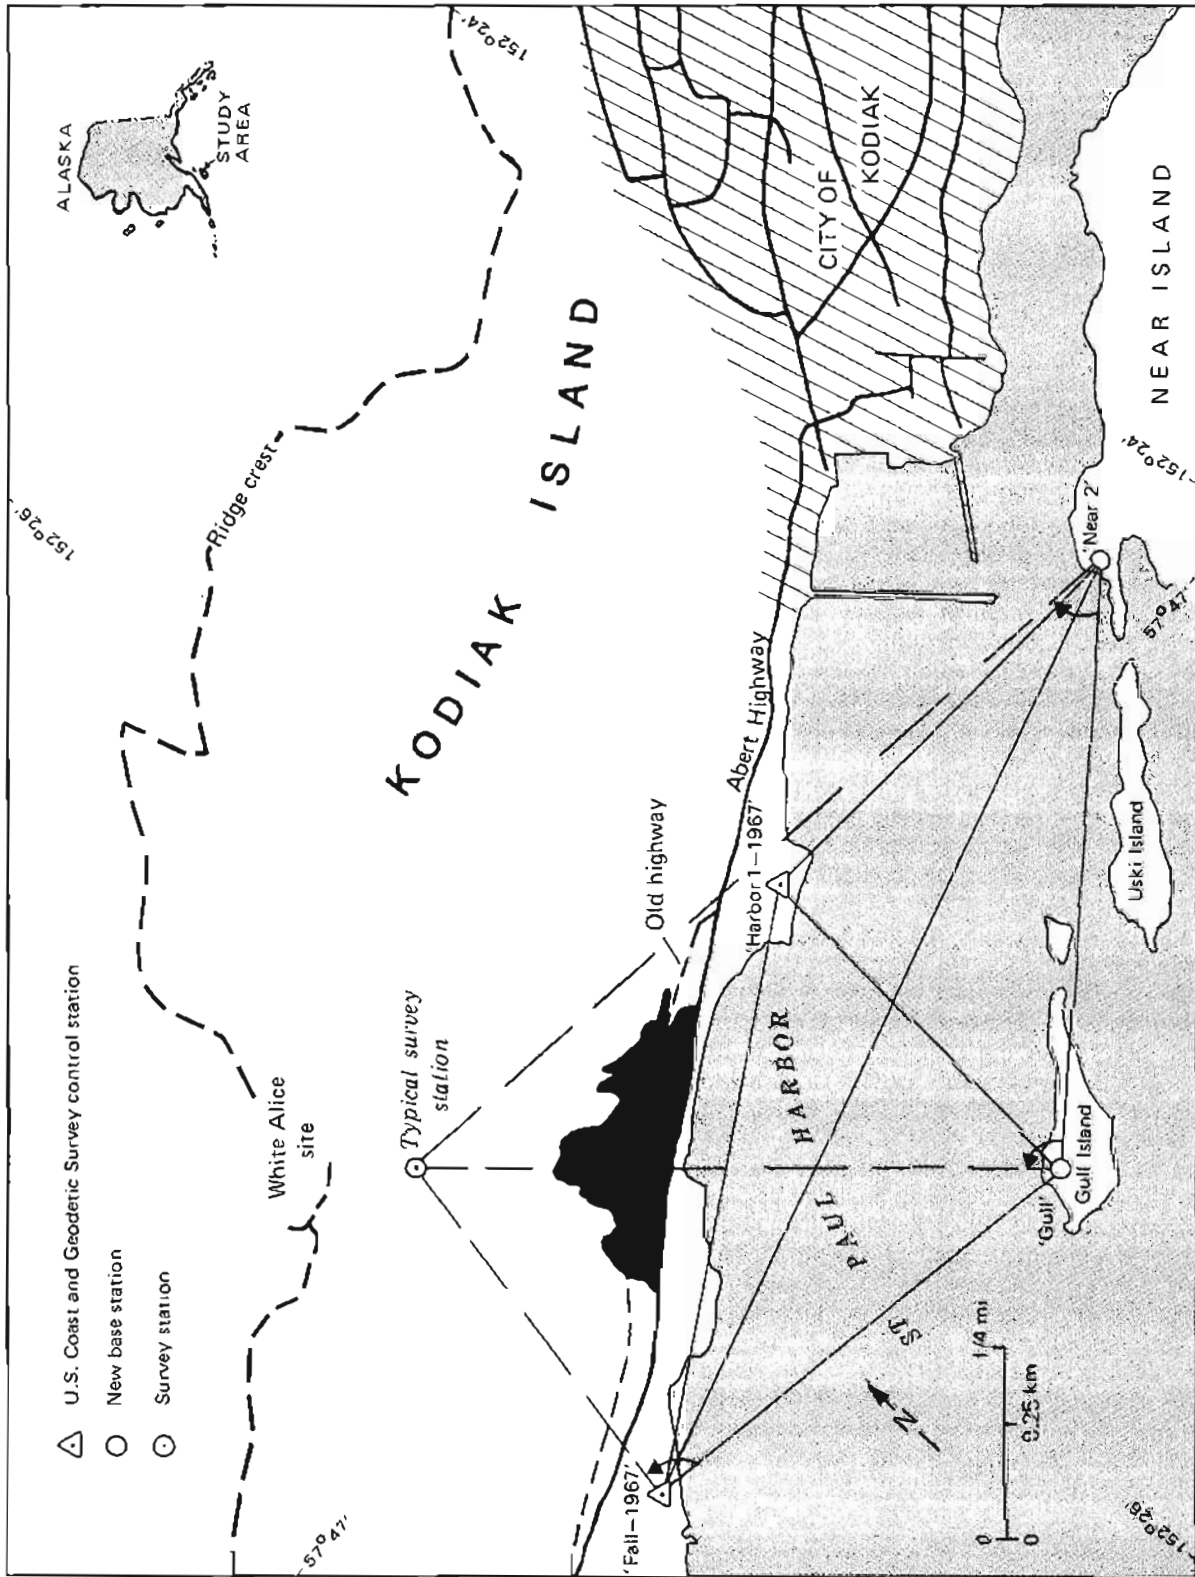
Figure 1. Diagrammatic map showing relative location of base stations and reference points.

Ecklund supervised the construction of permanent survey stations at the selected points (figs. 1 and 4). Climatic conditions--intense freeze-thaw cycles, high

(fig. 1, pl. 1). The control figures consisted of one adjusted quadrilateral based on the zone 5 state plane inverse between the USCGS stations. Elevations of 'Gull' and 'Near 2' were established by reciprocal leveling from 'Fall-1967' with an NI-025 Zena automatic level (accuracy,  $\pm 0.025$  ft/0.6 mi).

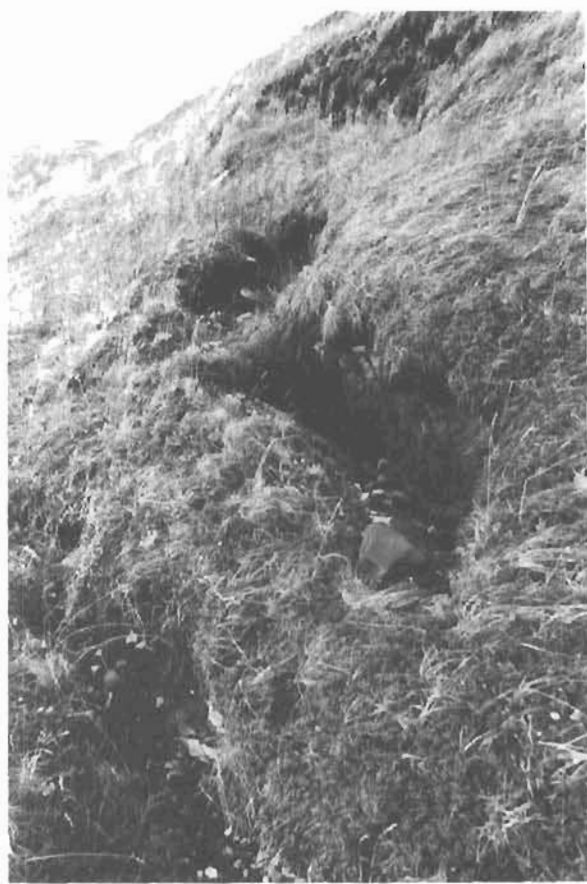
Figure 2. Typical open fissures regarded as active; intermediate slope of Pillar Mountain.

abrupt angular configuration of the many open fissures (fig. 2) indicate that they are active. Soil infilling and revegetation suggest that some fissures have been stable for several years. The configuration of the fissures is dictated by separation of bedrock along bedding and joint planes.

The field party concluded that a toppling-type failure was occurring over most of the mountain slope and that it was caused by gravity-induced separations along closely spaced metamorphic-rock cleavage that dips into the mountainside at a steep angle. Water entering and reemerging along structural lineaments also appeared to contribute to slope failure.

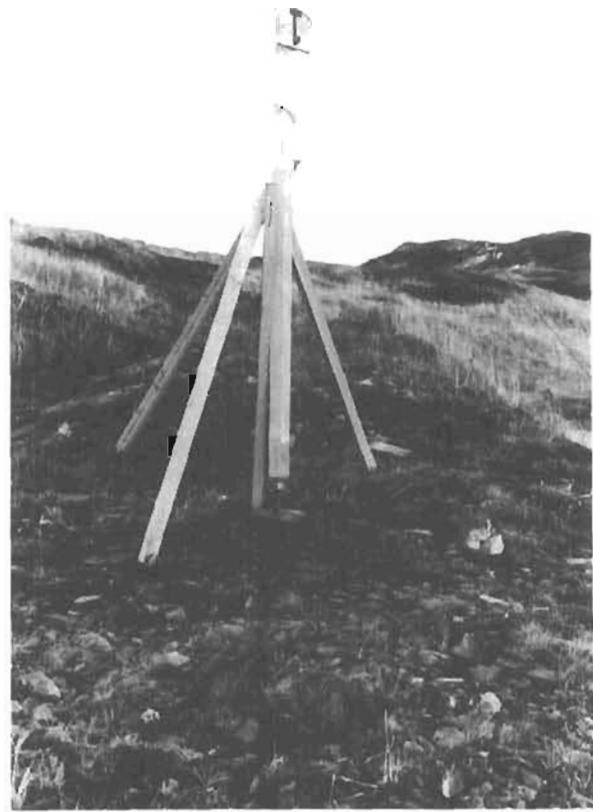
Figure 3. Survey station 1, typical of station installations

In 1978 Schaff secured state funds to install and operate a new survey monitoring system (fig. 3). A registered surveyor in Kodiak, Roy Ecklund, was contracted to operate the system.

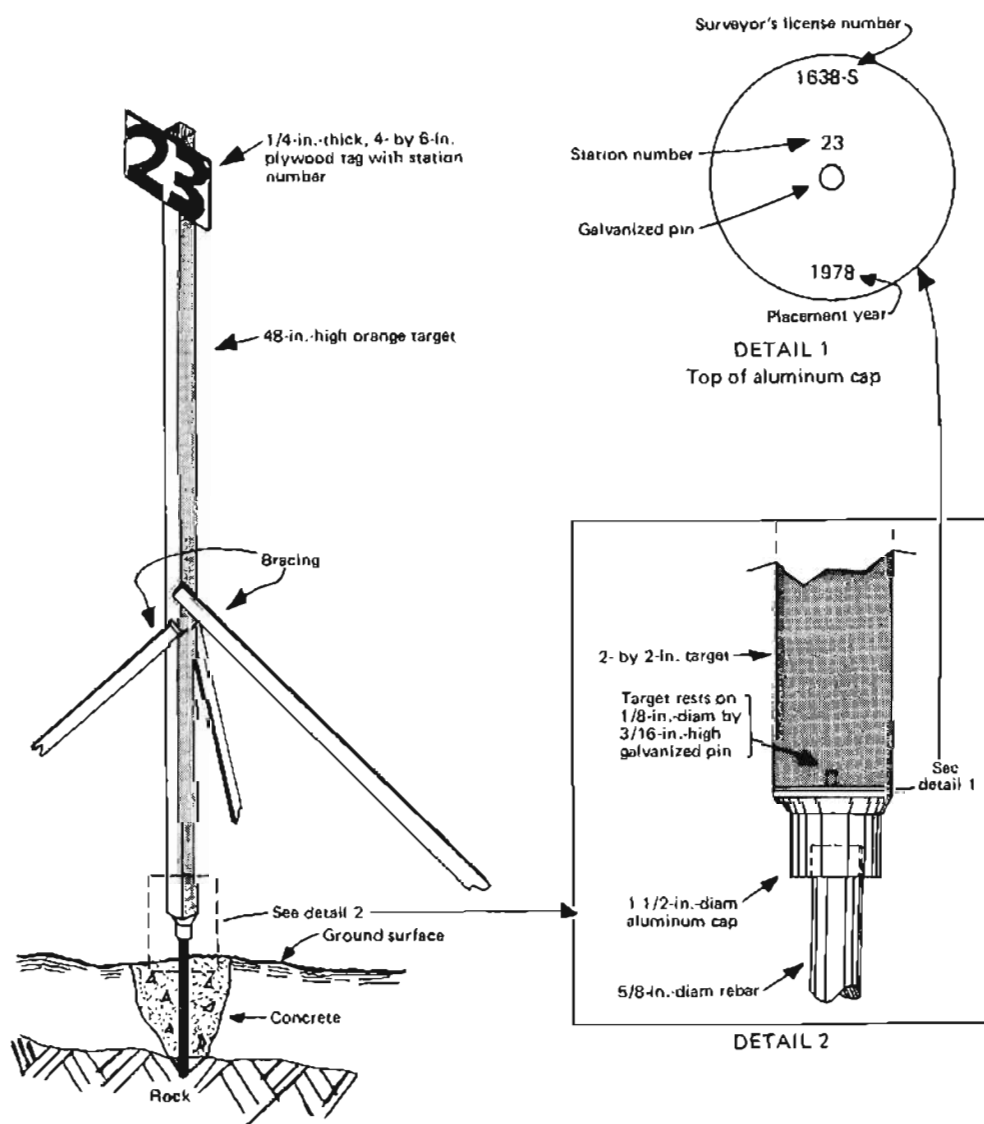
winds, occasional heavy snowfall--warranted unusual care in the installation of monuments. The stations consist of 5/8-in.-diam rebar, 24 in. long, set 20 in. into the ground, with at least 12 in. of the rod embedded in rock and reinforced with concrete (fig. 4). Before each set of readings was taken, the mountain was traversed and the integrity of each monument was confirmed.

Figure 4. Installation design, observation stations on Pillar Mountain.

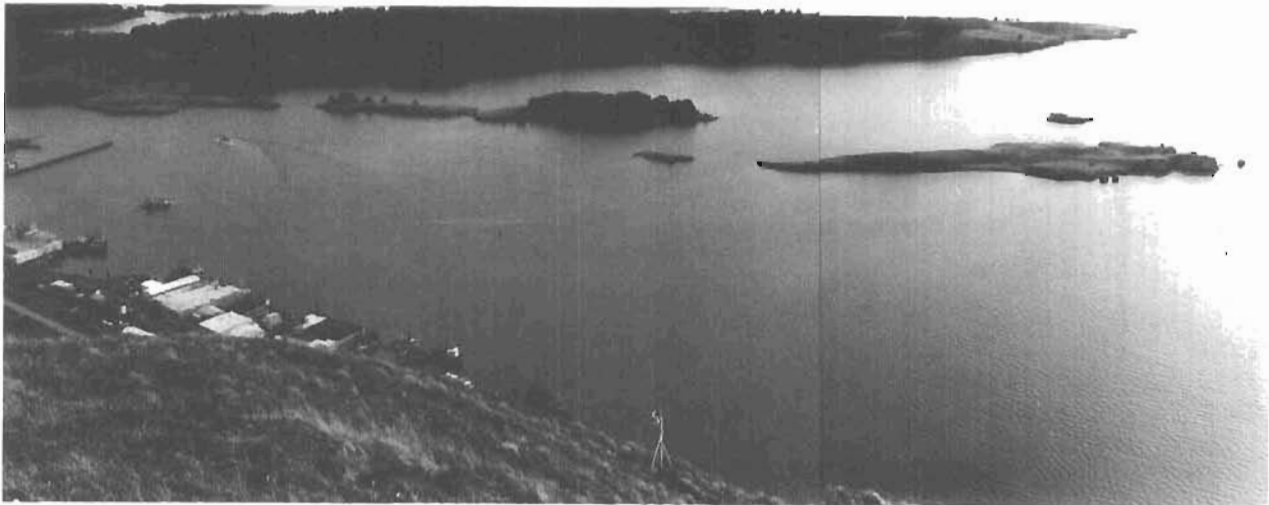
Figure 5. View from intermediate slope, Pillar Mountain, looking toward Near Island (left) and Gull Island (right), where base stations were located. Note survey station in foreground (center). Kodiak harbor headwater at extreme left.

The 'Gull' and 'Near 2' stations, 4,167.19 ft apart, form the base line of the survey network (fig. 5). During the initial survey, the state plane coordinates of the two stations were established (pl. 1). All measurements were made with 010 and 010A Zena theodolites (average

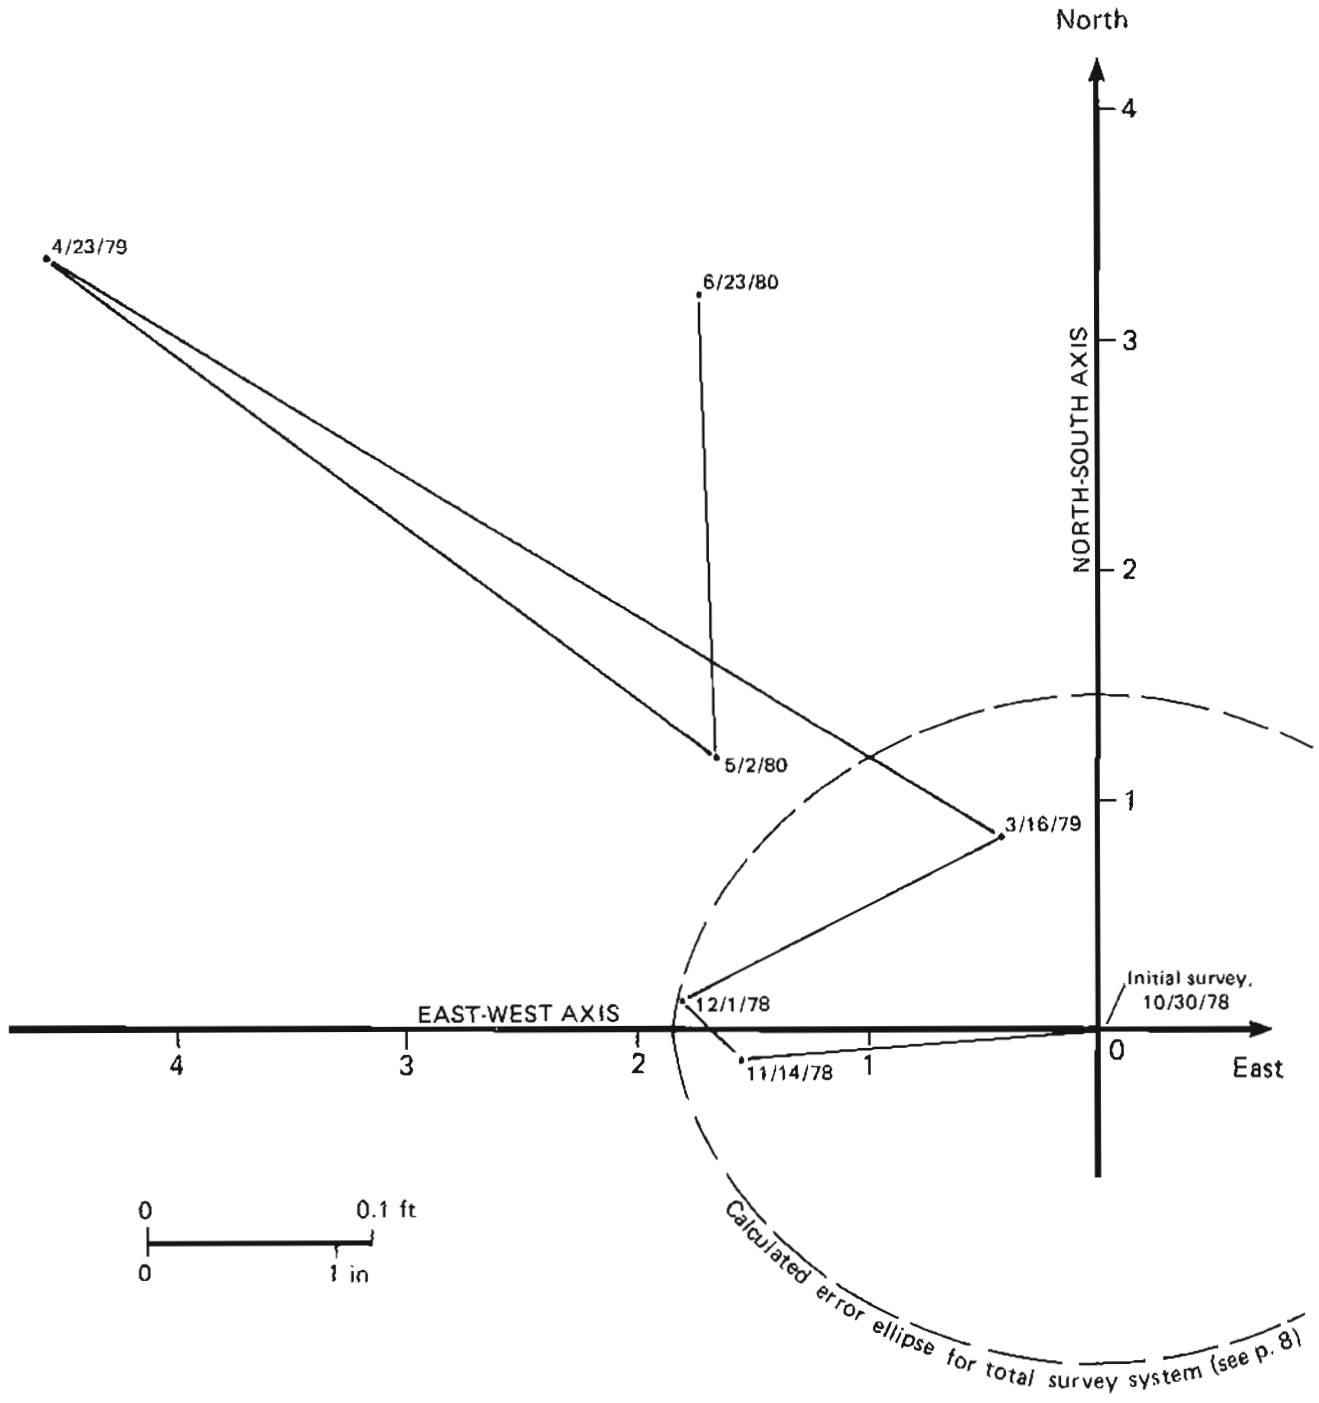
Figure 6. Apparent strain path of survey station 1 in the horizontal plane.

The apparent strain paths in the horizontal plane for each station are given in figures 6-40. The initial point is the origin for each graph and each point on the plotted curve correlates---with one exception---with subsequent variances from the initial coordinates. (Variances for July 6, 1979, are consistently out of context with both earlier and later readings; these data are not plotted on the figures.) The calculated mean error ellipse for the entire station array is superimposed on figures 6-40, with axes established by the preceding calculations.
