GEOLOGIC MAP OF AREA III, U.S. COAST GUARD RESERVATION, KODIAK, ALASKA

by
R.A. Combellick
1989

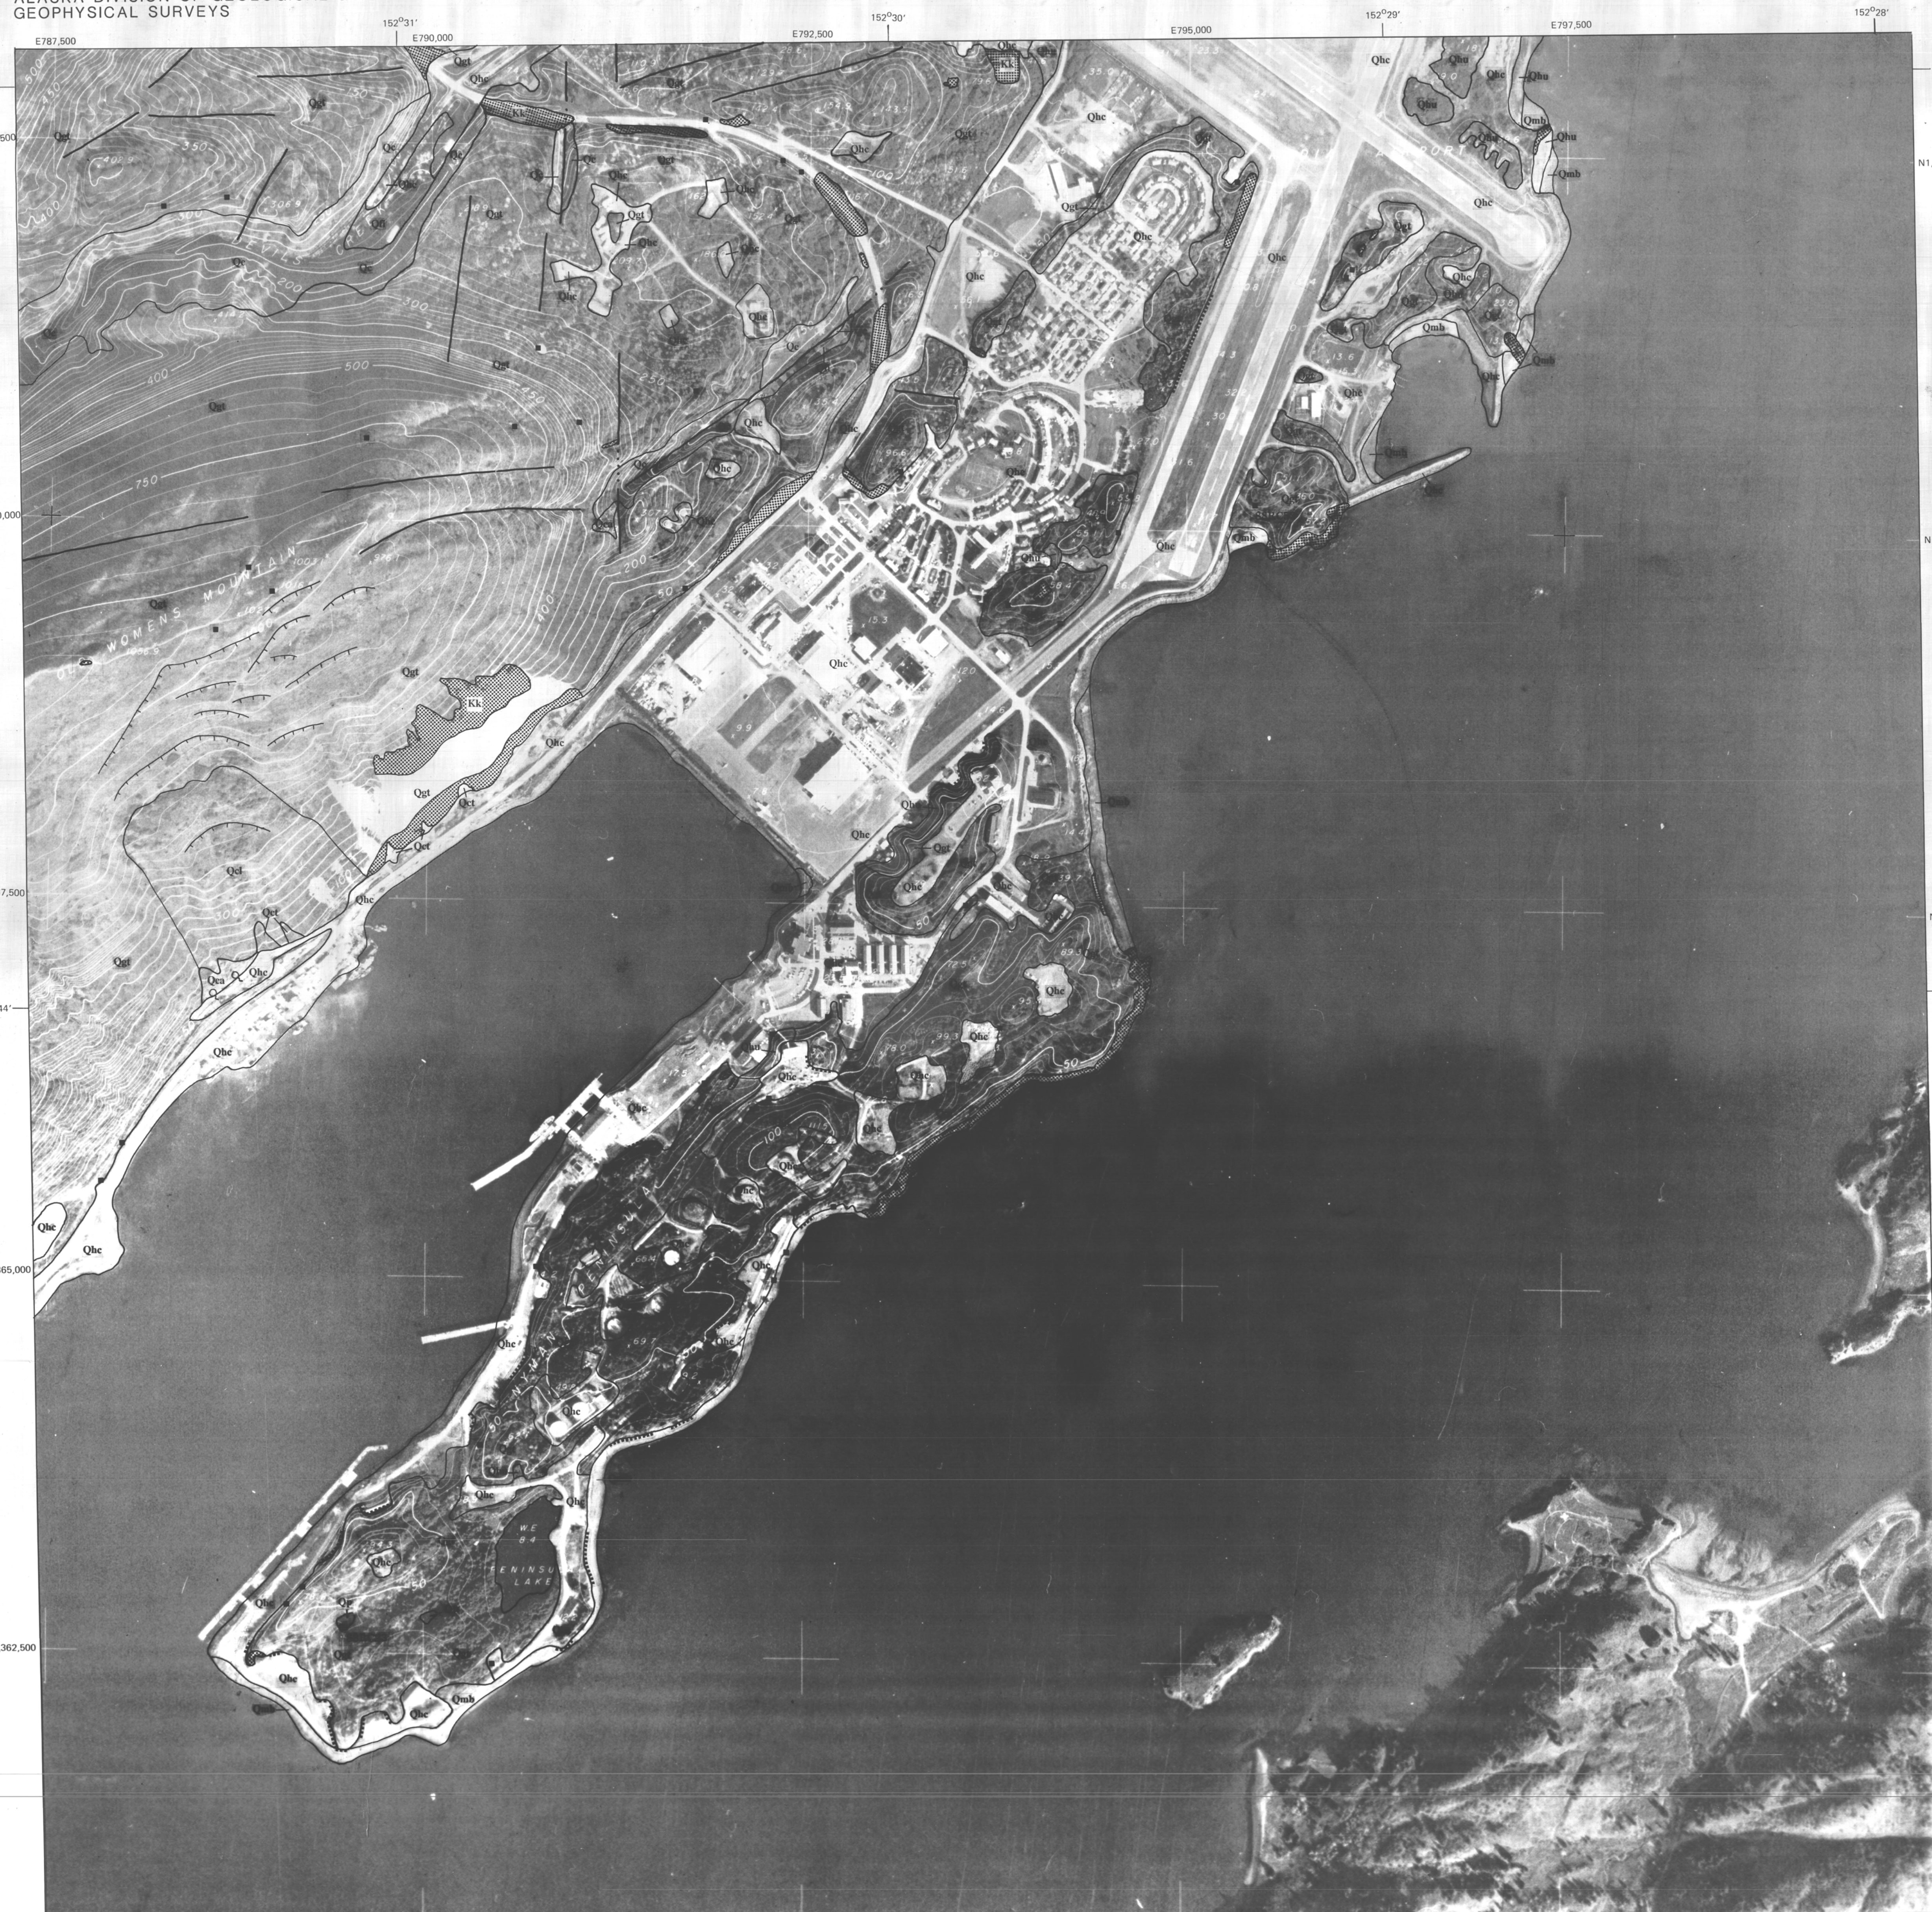
Qfi Fluvial deposits: Surficial deposits and bedrock exposures were mapped by interpreting 1:12,000-scale stereo aerial photographs and incorporating field observations made during a two-week period in August, 1988. Deposits are grouped into categories based on primary mode of deposition: fluvial, glacial, colluvial, paludal, marine, and artificial. Road-base fill deposits were not mapped except where they coincide with larger areas of fill (Qhc). Instead, geologic units were mapped across roads to indicate the materials that probably lie beneath the road fill.

Qhc Compacted artificial fill: Artificially emplaced or modified deposits, generally of sand and pebble-cobble gravel, that have been compacted to provide base material for structures, roads, parking areas, storage areas, or aircraft runways. Locally contain lenses of silt or volcanic ash. Roads are not mapped except where they coincide with larger areas of fill. Up to about 25 ft thick. Low to high permeability.

Qhu Uncompacted artificial fill: Artificially emplaced or modified deposits, generally of sand and pebble-cobble gravel, that are uncompacted or minimally compacted. Includes protective barriers for storage tanks and fuel pumps, shelters for aircraft, firewood, and spoil piles. Generally emplaced as mounds or ridges up to about 20 ft high. Moderate to high permeability.

Kk Kodiak Formation: Dark gray to black mudstone, siltstone, sandstone and minor conglomerate that have undergone varying degrees of compaction and low-grade metamorphism (Sole and Reifensuhl, 1989). Fine-grained rocks range from shale to slate, with a phyllitic shales locally. The ratio of sandstone to shale varies from 10:1 to 1:1, with very fine- to fine-grained sandstone the most abundant. Sandstone and shale layers are laterally continuous at outcrop scale without changes in thickness or grain size, but generally cannot be traced between outcrops. Bedding is generally thin (1 to 2 in.) and parallel-bedded. Bedding orientation is consistent throughout the study area, with most strikes between N30°E and N60°E and most dips between 75°W and 90°E. Cleavage is roughly parallel to bedding. All observed outcrops contain at least one set of fractures most contain two or more, but rarely are more than two sets well-developed. The most common fracture orientation is perpendicular to bedding/cleavage. Spacing of these fractures range from extremely close to wide (< 1/16 in. to > 3 ft), with generally closer spacing in finer-grained rocks.

Approximate geologic contact: Interpreted from aerial photographs; limited confirmation in field.

Photoincrement: Denotes surface expression of probable fault, fracture zone, or major difference in bedrock lithology visible in aerial photographs. All apparent fracture zones and prominent bedding lineations were mapped. Lineations that may be due only to surface processes, such as channel erosion, and probably not to subsurface discontinuities were not mapped. Dotted where inferred.

Landslide scarp: Denotes headwall of landslide failure surface. Tick marks indicate failure direction. See text above for more information on landslide area.

Spring: Natural flowage of water from rock or soil. Observed at one locality, in debris cone deposit along Chiniak Road on the southeast side of Old Women Mountain; other localities are likely.

0	Roof mat	88RC23	Roof mat	88RC53
10	Volcanic ash		Volcanic ash	
20	Peat	1.718 ± 75 yr bp	Organic-rich sandy silt	3.898 ± 85 yr bp
30			Till	
			Bedrock
