PE 95-11

Sketch Showing
Underground Workings
HIRSHEY MINE
Moose Pass-Hope District
Kenai Peninsula
Alaska

Samples & Sketch by,
J. C. Roehm
Associate Engineer

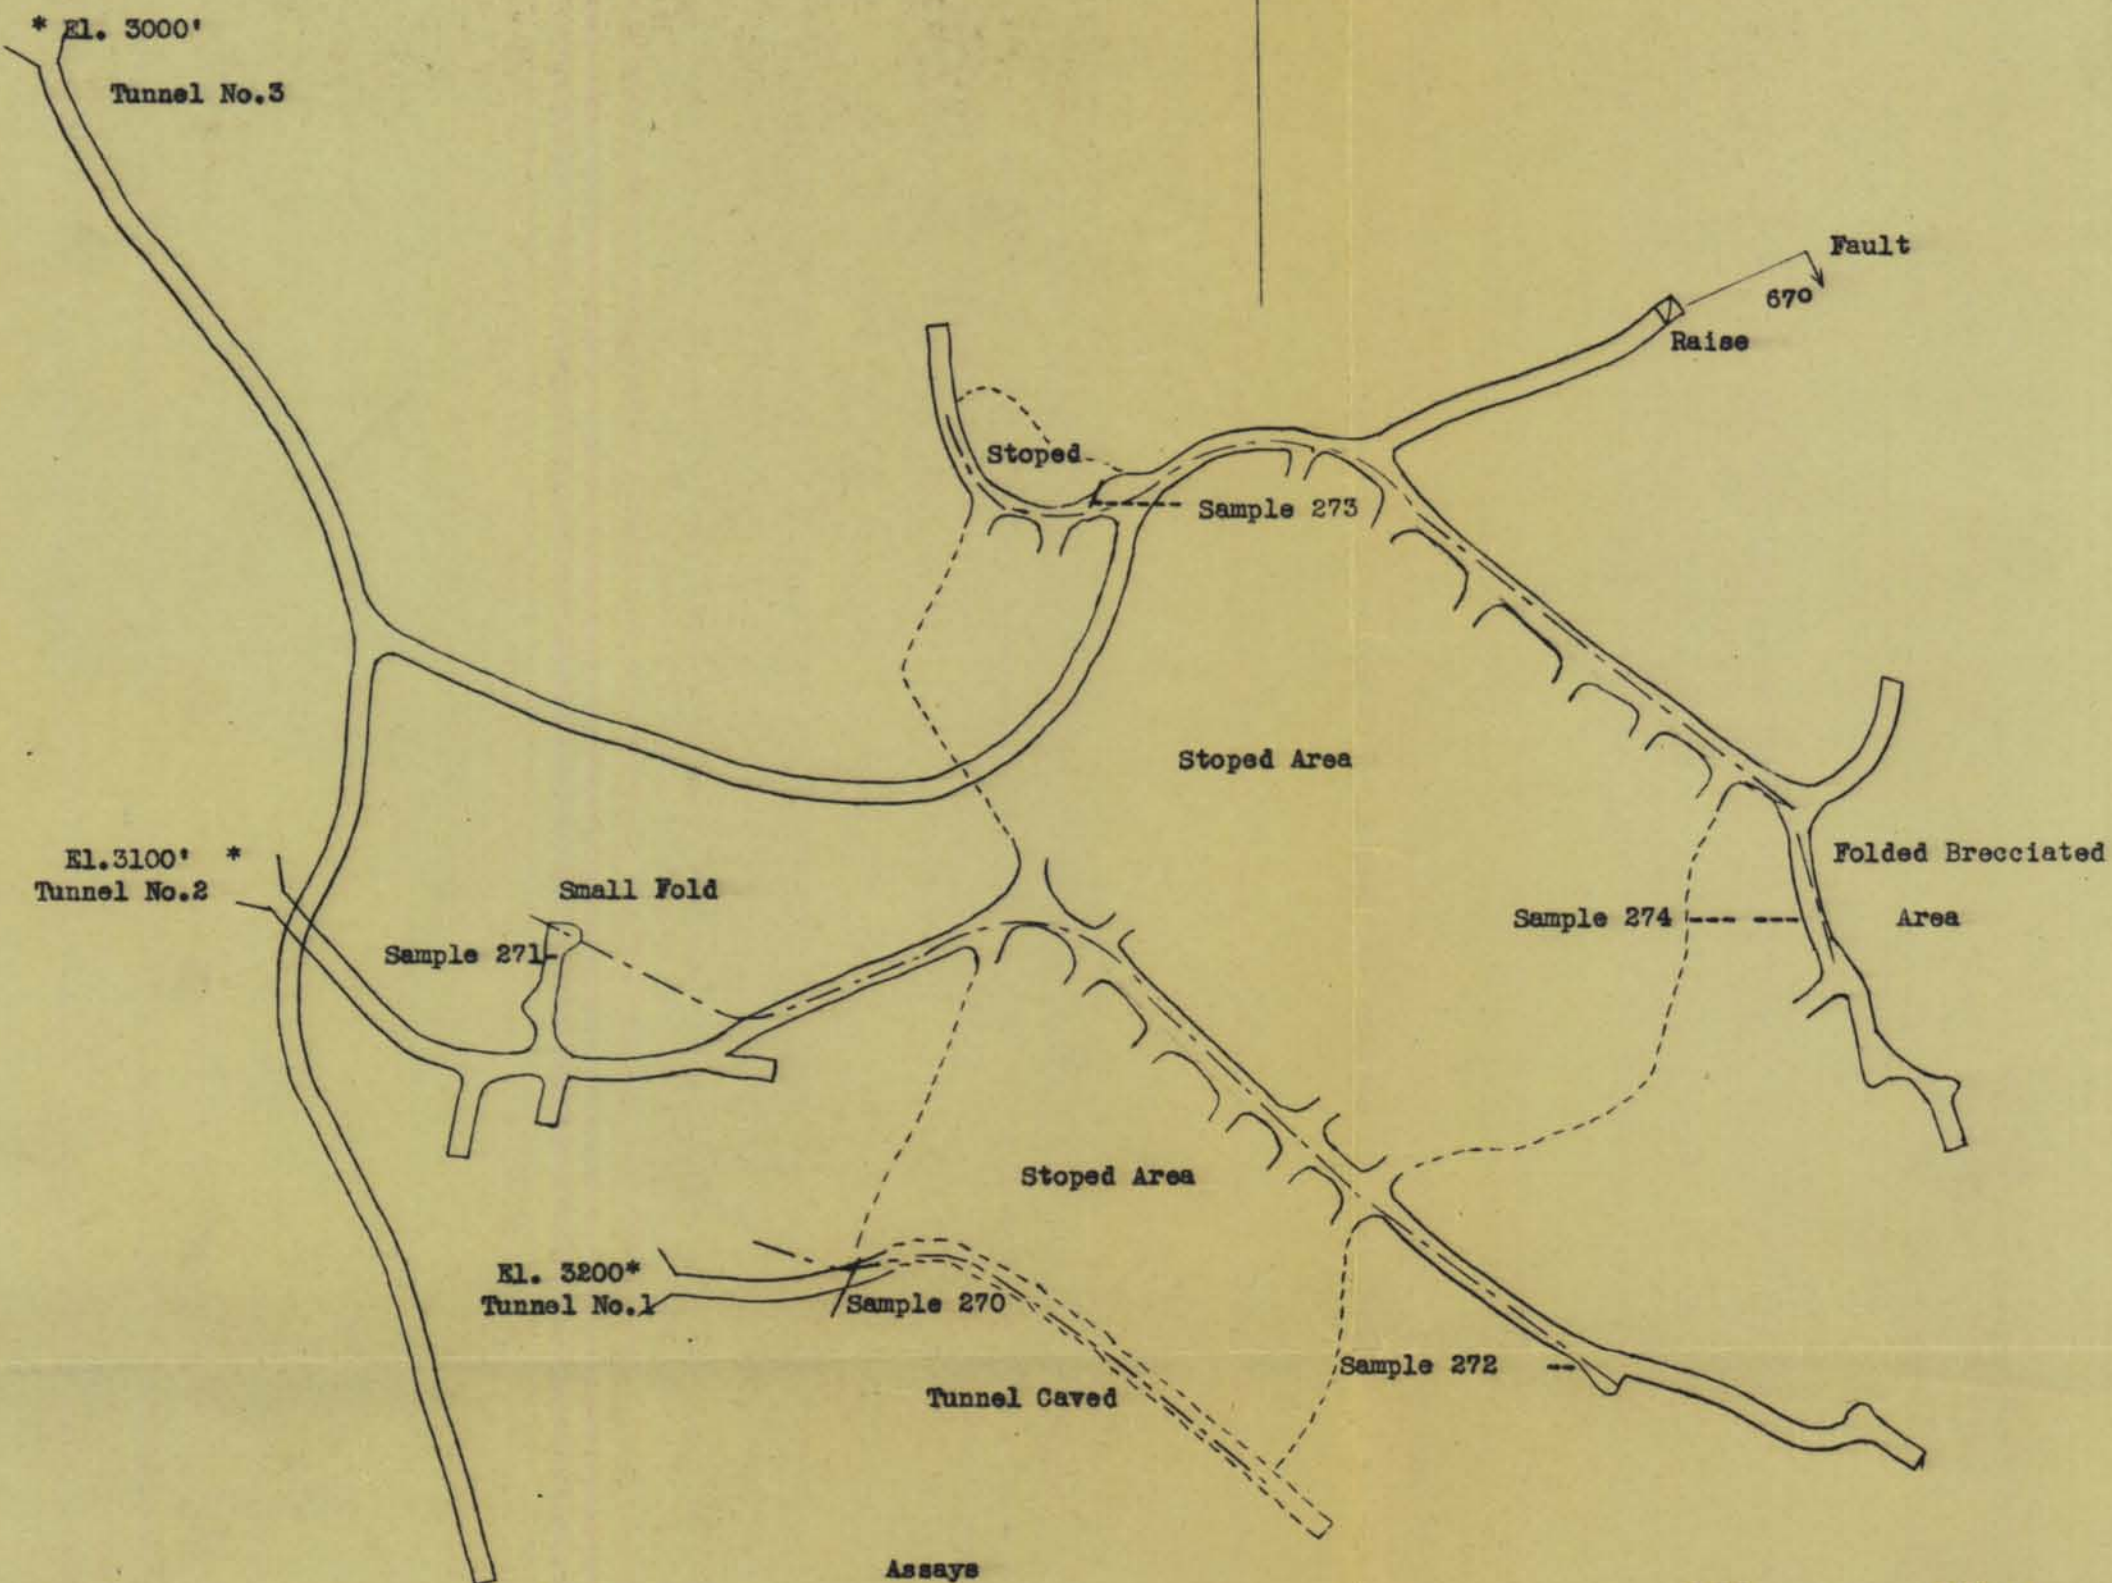
Sketch taken from mine maps
produced by Mrs. Hirshey.

Sample No.	Location	Description	Width	Gold Ozs. Per Ton	Silver Ozs. Per Ton
270	No.1 Tunnel. Intersection Drift & Vein. North Wall	Across Banded quartz vein	12"	1.46	2.8
271	No.2 Tunnel Cross-cut 90' From Portal. 10' Up.	Across folded & Banded Quartz vein	4'	0.02	Trace
272	No.2 Tunnel. 95' from End of Drift	Across Banded quartz Vein	4"	Trace	Trace
273	No.3 Tunnel. Intersection Drift & vein (pillar)	Across banded quartz. Center of shoot.	18"	0.58	0.02
274	No.3 Tunnel 255 S.E. of Sample 273	Brecciated and folded slate with quartz Stringers	6'	Trace	Nil
