DEPARTMENT OF MINES JUNEAU, ALASKA

MEMORANDUM REPORT

Examination of the K & T antimony prospect at Kenai Lake, Kx 95-24

Moose Pass-Hope District, Seward Recording Precinct,

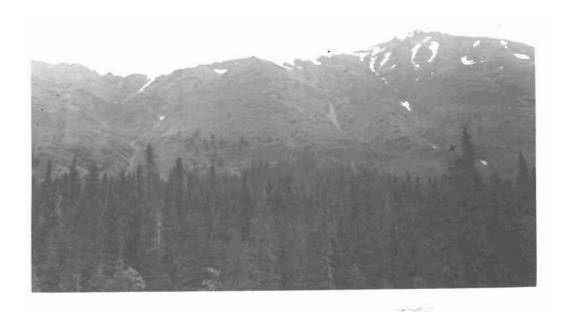
rigure 2. Location of prospect on hillside above menai Lake.

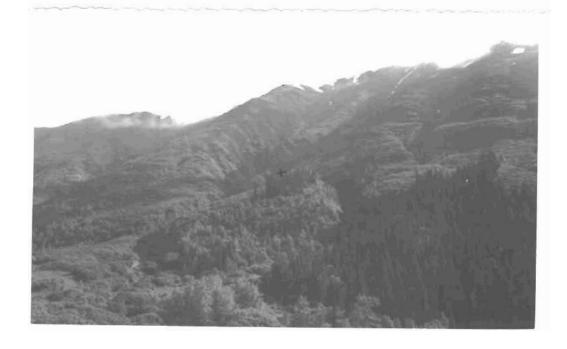
Figure 3. Another view taken from lake level of hillside showing location of prospect.

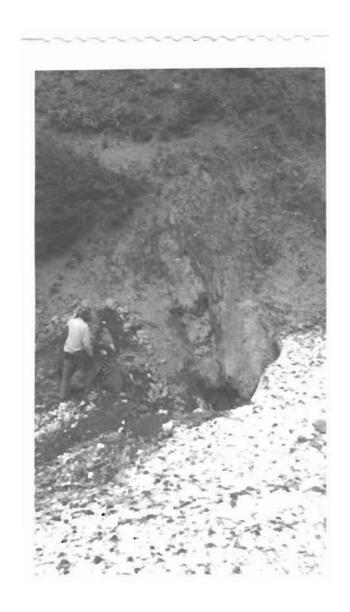
The country rock at the property is a poor grade of slate, striking N30°W and dipping approximately 60° to the NE. The beds, though tilted, are distorted very little. No local folding was noted. The mineralization is in the form of a silicious vein (possibly a sill (?)) which is impregnated rather evenly with fine-grained stibnite, pyrite, and minor amounts of pyrrhotite and sphalerite. A large amount of pyroxene is also present in the silicious material. The vein conforms to the bedding planes of the slate, as can be seen in Figures 4 and 5.

The only exposure available for sampling is shown in the photographs, where the vein was exposed for about twenty-two feet in depth and averaging about two feet in width. Channel samples were cut near the bottom and at about the center of the exposure, with the following results as reported by A. E. Glover, Department of Mines Assayer:

Figure 4. Photograph of exposed part of figure 5. Closeup view of stibnite stibnite vein. vein exposure.

In. Mnack was advised that if he wished to develop his prospect further, the best plan of action would probably be to attempt to follow the vein along the strike toward the other prospect by excavating crosscut trenches. Even with good values, a vein as narrow as this one would necessarily have to be followed for a considerable distance to develop a tonnage of stibnite ore that could be economically mined.

It is the writer's opinion that the vein is relatively consistant and can be followed, although the trenching may have to be deep. However, if better values are not obtained early in the exploration program, the venture should be abandoned. The writer also believes that if the owners expose the vein further, another examination by the Department is varranted.

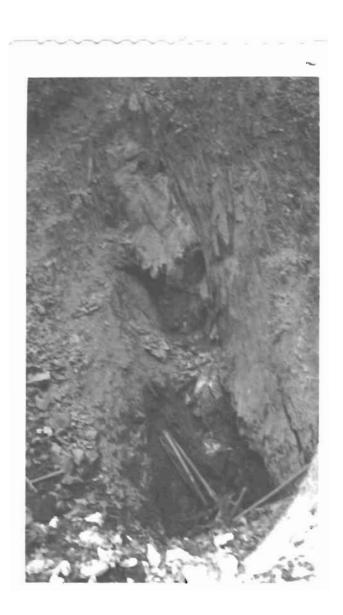
It will be noticed in the photographs that the vein pinches out at the upper extremity, but it had been traced in the next gulch to the left (see Figures 2 and 3). This exposure was now covered with slide and could not be immediately found. It was reported further that another stibnite showing was located in a gulch about 1200 feet to the NV which appears to be in a line with the strike of this vein. The relatively undisturbed slate should favor the formation of a rather consistant vein, since the vein is parallel to the bedding, and it is possible that there is a relationship between the two occurrences. Mr. Knaack reports the other prospect to be the one reported in USGS Bulletin 587, page 179. This reference is as follows:
