PRELIMINARY INTERPRETIVE REPORT 2014-1

**INVENTORY AND PRELIMINARY ASSESSMENT OF GEOLOGIC
HAZARDS IN THE PASSAGE CANAL–PORTAGE VALLEY AREA,
SOUTH-CENTRAL ALASKA**

by
Gabriel J. Wolken and Matthew S. Balazs

June 2014

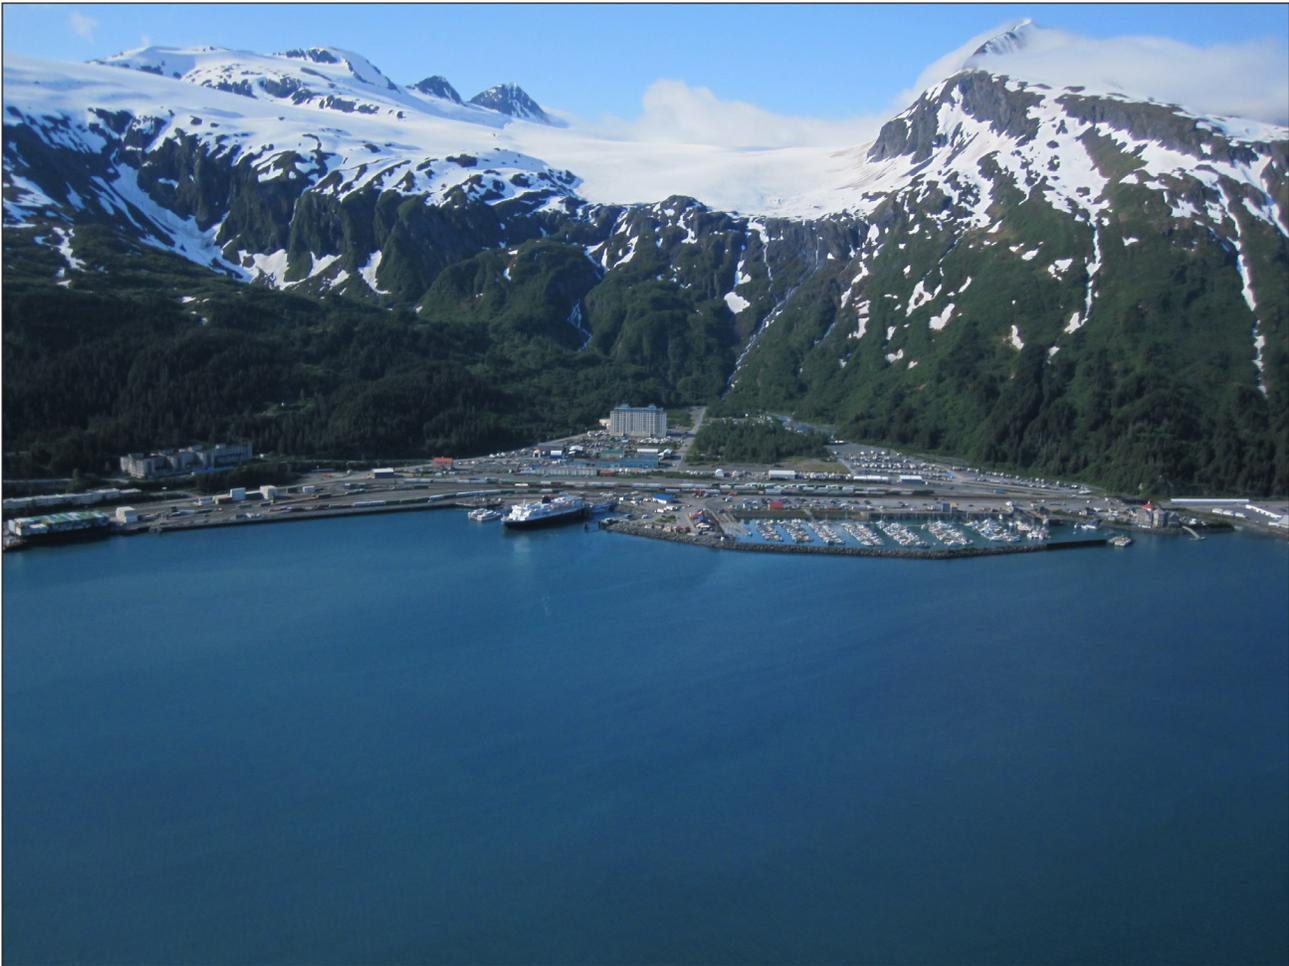
Figure 2. Whittier, Alaska, located near the head of the Passage Canal fjord and situated below Whittier Glacier on the subaerial part of the fan delta created by Whittier Creek. Photo by Gabriel Wolken.

tier is host to critical infrastructure for the state of Alaska; the ice-free, deepwater port is one of only two in Alaska that connects to the mainland by both rail and road (fig. 2). Earth-surface processes in the Passage Canal and Portage Valley area can threaten public safety and infrastructure and can lead to lengthy closures of important facilities and transportation routes. The economic impacts of such hazards, from the impedance of traffic in an important transportation corridor to the potential inundation of a crucial port, can be significant at local, state, and national levels. The aim of this project is to identify and understand the geologic processes that threaten the safety of people and infrastructure in the Passage Canal–Portage Valley area.

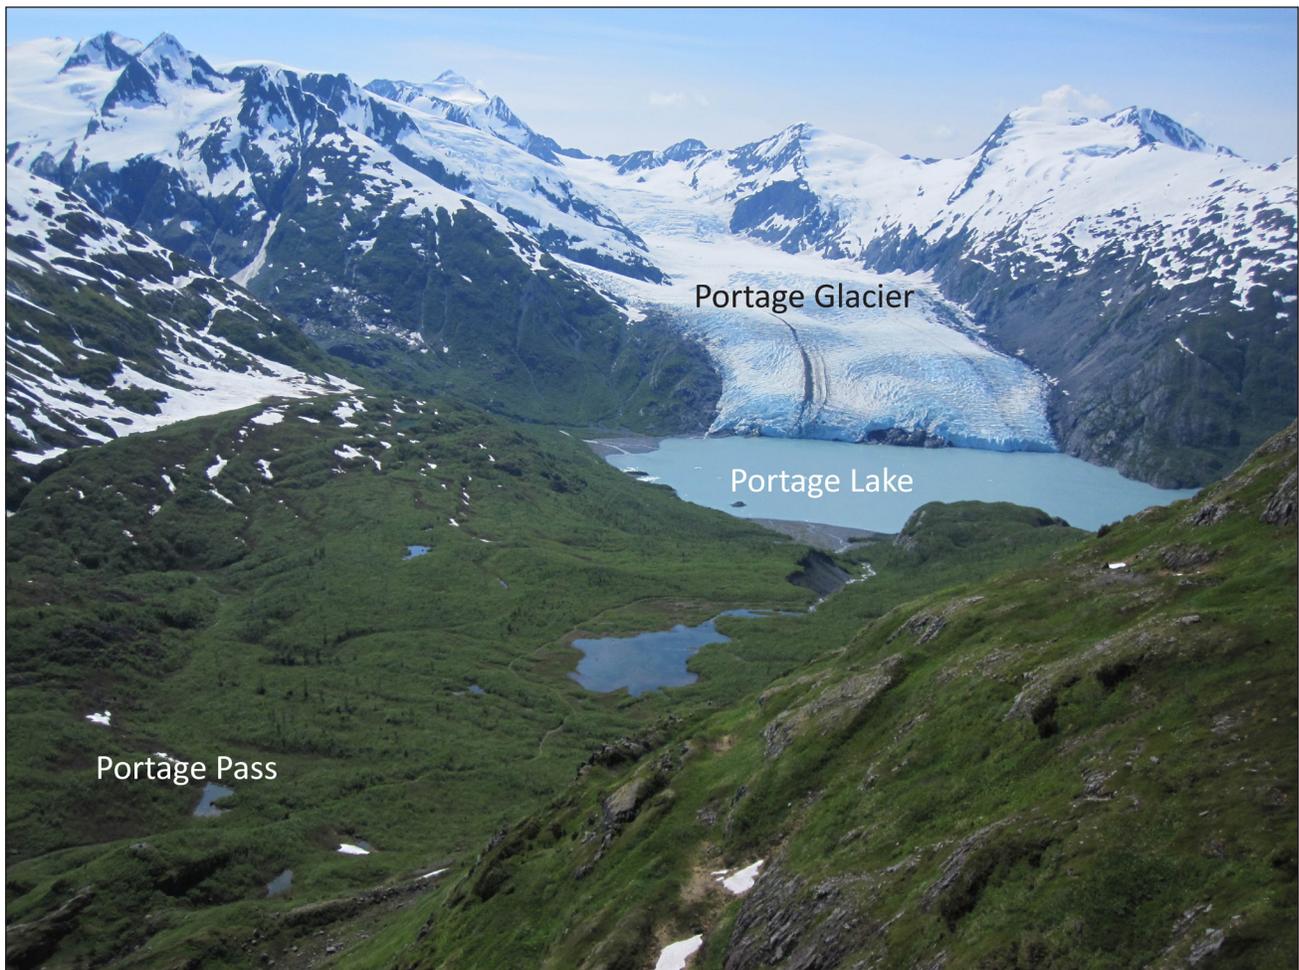
Figure 3. View to southwest, Portage Pass in the foreground and Portage Lake and Portage Glacier in the background. Photo by Gabriel Wolken.

The steep, glacier-carved valley walls surrounding Portage Lake are prone to rockfall (figs. 3 and 6). In the early 20th century, Portage Glacier occupied this valley and terminated on land near the current visitor's center. During the remainder of the 20th century, the terminus of the glacier retreated about 5 km to its present location. During this retreat, valley walls were exposed and lateral pressure, previously imposed on the walls, was removed. Countless fresh scarps, indicating the presence of active rock fall, are evident on the rock walls surrounding the lake. In the glacier-distal setting, few pockets of perched debris are identifiable along the valley walls; however, the number and size of these perched debris pockets increases near the present glacier terminus location. Much of this perched unconsolidated material can be linked to lateral moraines delineating the former height of the glacier; however, some pockets of debris appear to be suspended deposits from past landslides initiated at higher elevation. Rockfall and landslide events that enter the lake have the potential to generate large-displacement waves, creating potentially hazardous conditions for people and infrastructure both on and around the lake.

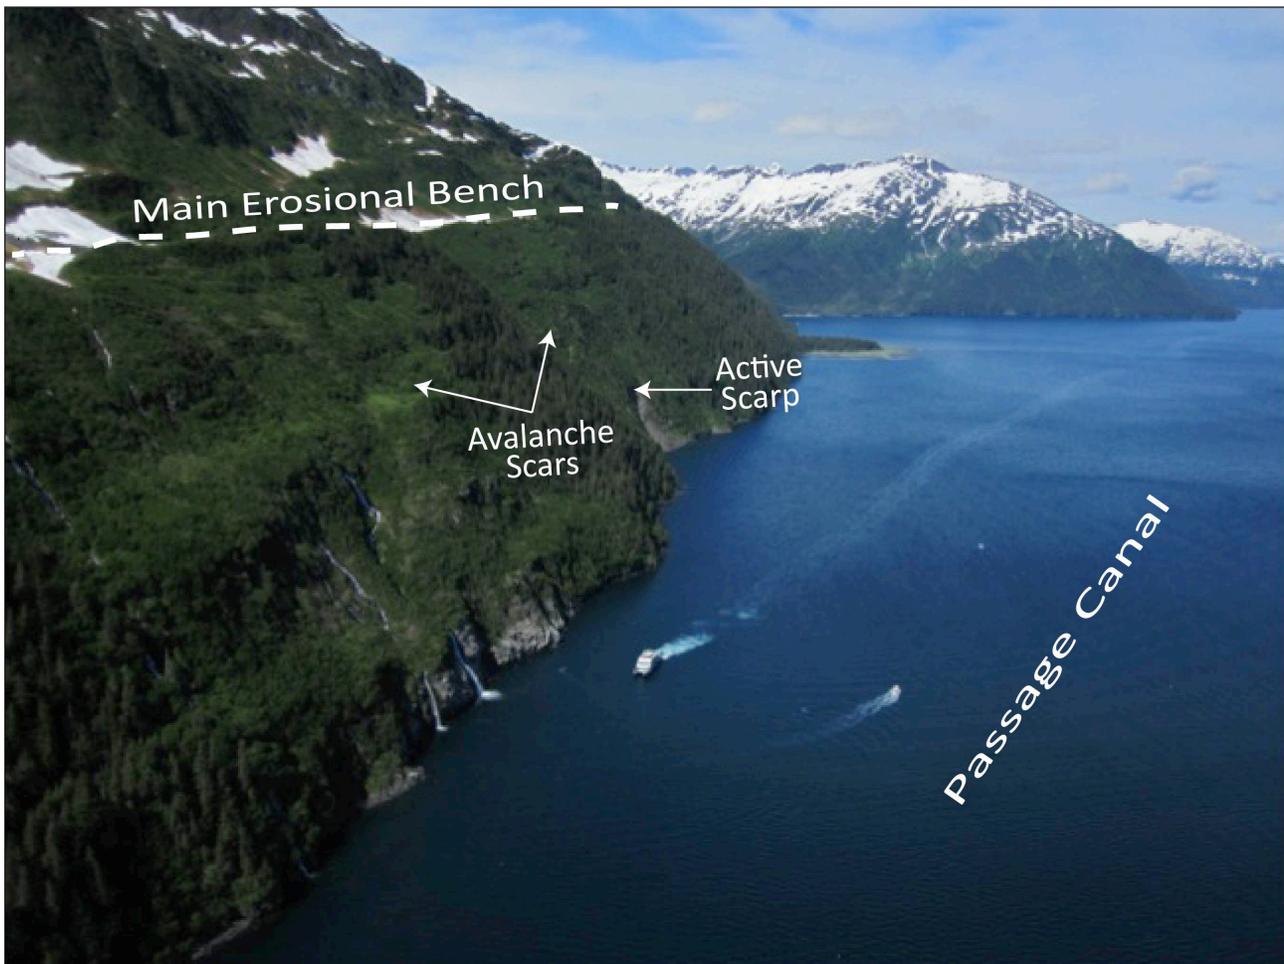
Figure 5. Photo showing the oversteepened valley wall that borders the north shore of Passage Canal. Avalanche scars and active scarps are visible in the image. Photo by Gabriel Wolken.

The alpine and subalpine slopes forming the north side of Passage Canal are highly unstable (fig. 6). From Learnard Creek to Billings Creek, numerous geomorphologic indicators provide abundant evidence of recent and historic mass movements along this section of the fjord. These indicators include fresh scarps, talus, debris slides and flows, deflating moraines, and large transported clasts. Future potential mass movements present direct hazards to marine vessels or indirect hazards to infrastructure across the fjord if displacement waves are generated (fig. 5).

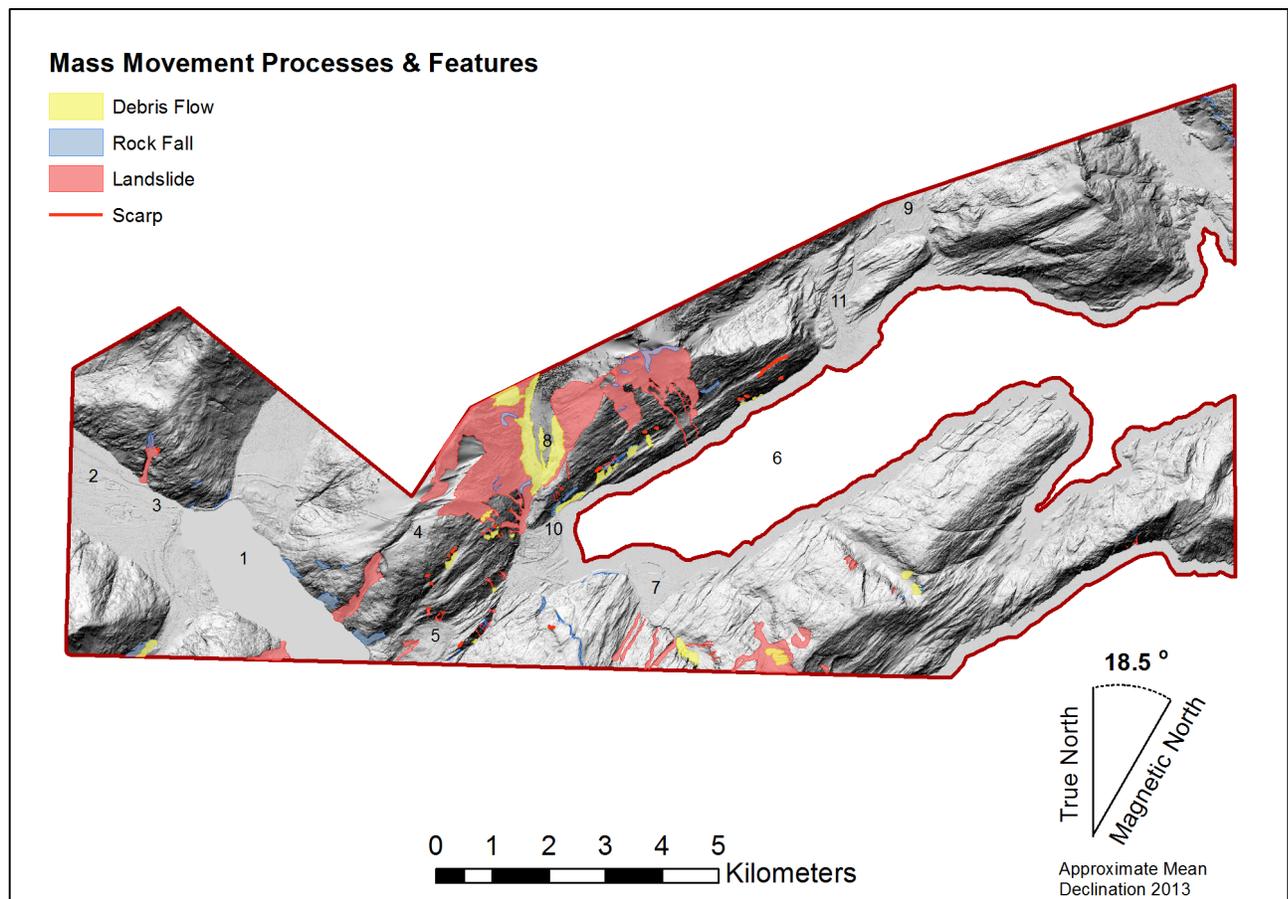
Figure 6. Preliminary map of mass movement processes and features in the study area. The locations of select geographic features are labeled and include: 1. Portage Lake; 2. Portage Creek; 3. Portage Glacier Highway; 4. Anton Anderson Memorial Tunnel; 5. Portage Pass; 6. Passage Canal; 7. Whittier; 8. Learnard Glacier; 9. Billings Glacier; 10. Learnard Creek; and 11. Billings Creek.

Unstable slopes are common throughout the study area (fig. 6). The highest concentration of mass movements occurs in northwestern Passage Canal, where the terrain has recently been deglaciated (post-LIA). Mass movements in this area are ubiquitous and multifarious, but are commonly initiated by heaving or toppling of fractured bedrock and are accompanied by large, mobile talus fields. Many of the talus fields show signs of creep or flow, depending on available moisture and slope. Areas adjacent to Learnard Glacier are highly active as a result of the interaction of multiple mass movement

processes (fig. 6). For example, rockfalls originating from high-elevation localities create debris fields on or above lateral moraines deposited against the valley walls, and in some cases pockets of till exist in higher locations, perched above steep slopes. These moraines are undoubtedly ice-cored and very unstable; thermally-controlled deflation leads to unpredictable collapse of the moraine, including superimposed debris accumulated from rockfalls (figs. 7 and 8). Slope instability in this area is responsible for one known fatality in recent years (oral commun, 2014, City of Whittier).

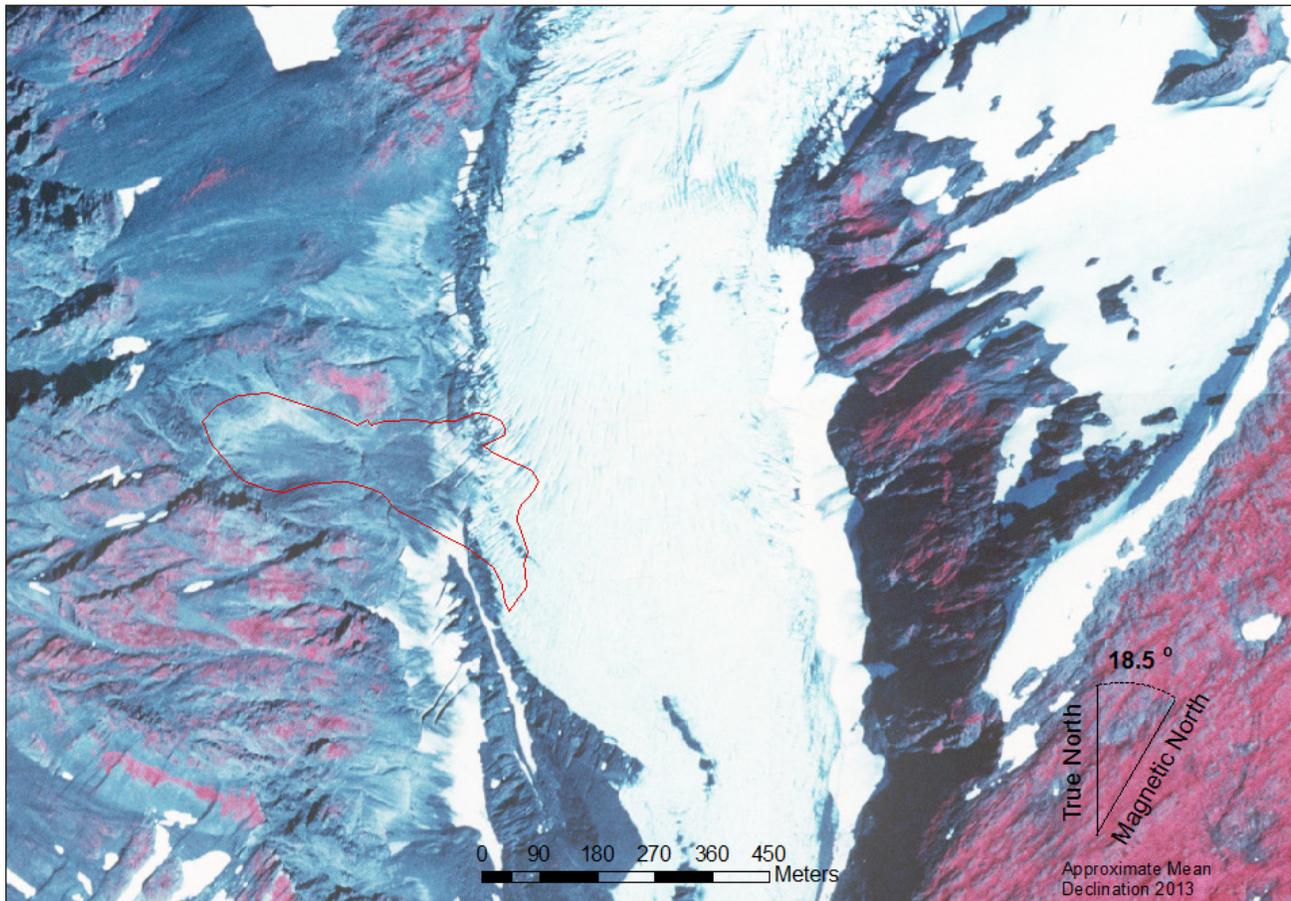
Figure 7. Orthorectified AHAP photo (1978) showing Learnard Glacier and an incipient debris flow superimposed on the west lateral moraine. Red outline shows extent of the subsequent debris flow, as mapped from 2010 imagery (fig. 8).

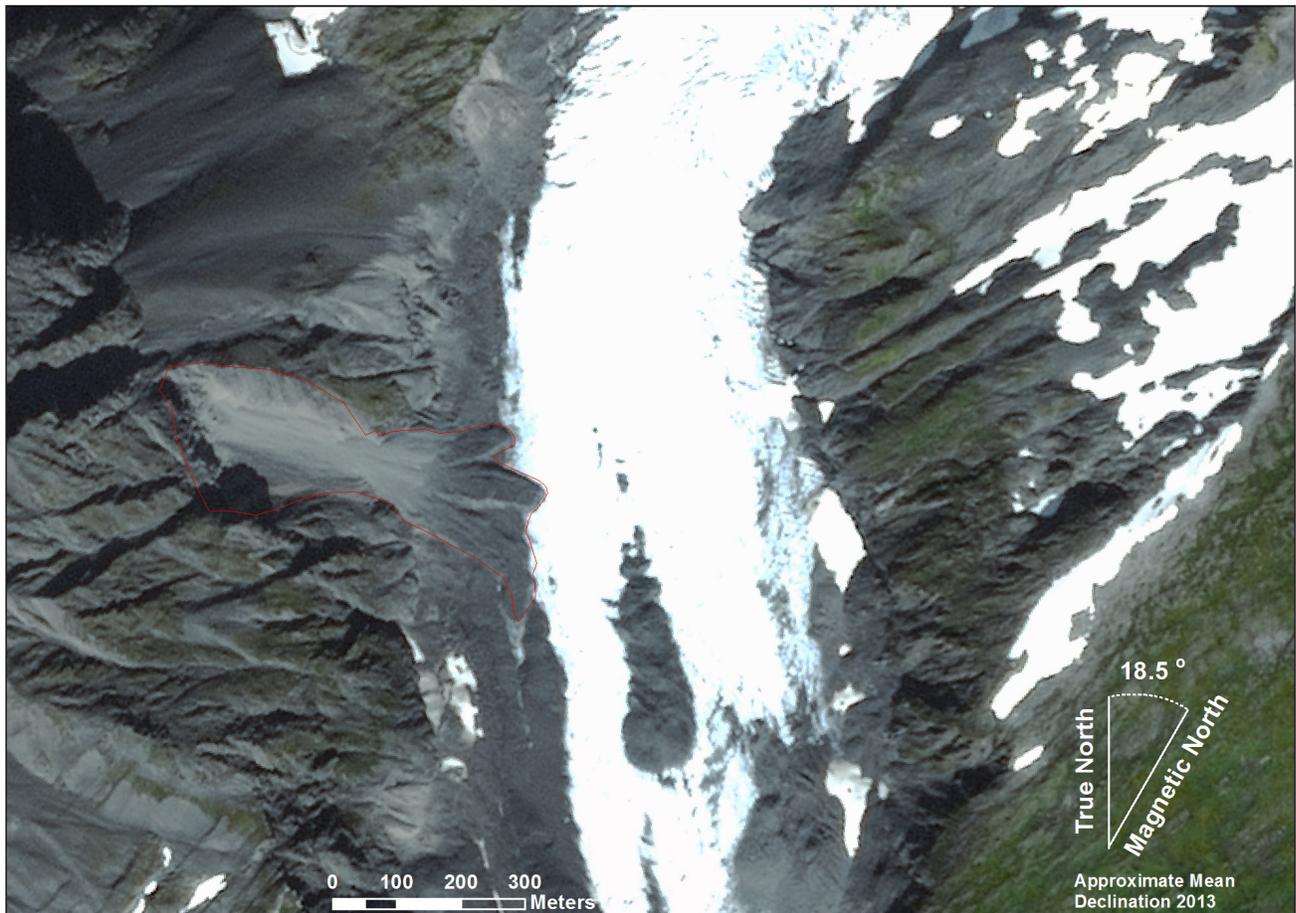
Figure 8. Orthorectified SPOT-5 image (2010) of Learnard Glacier and a debris flow (outlined in red) that incorporated material from the west lateral moraine and traveled onto the glacier. Active slope processes dominate the Learnard Glacier valley.

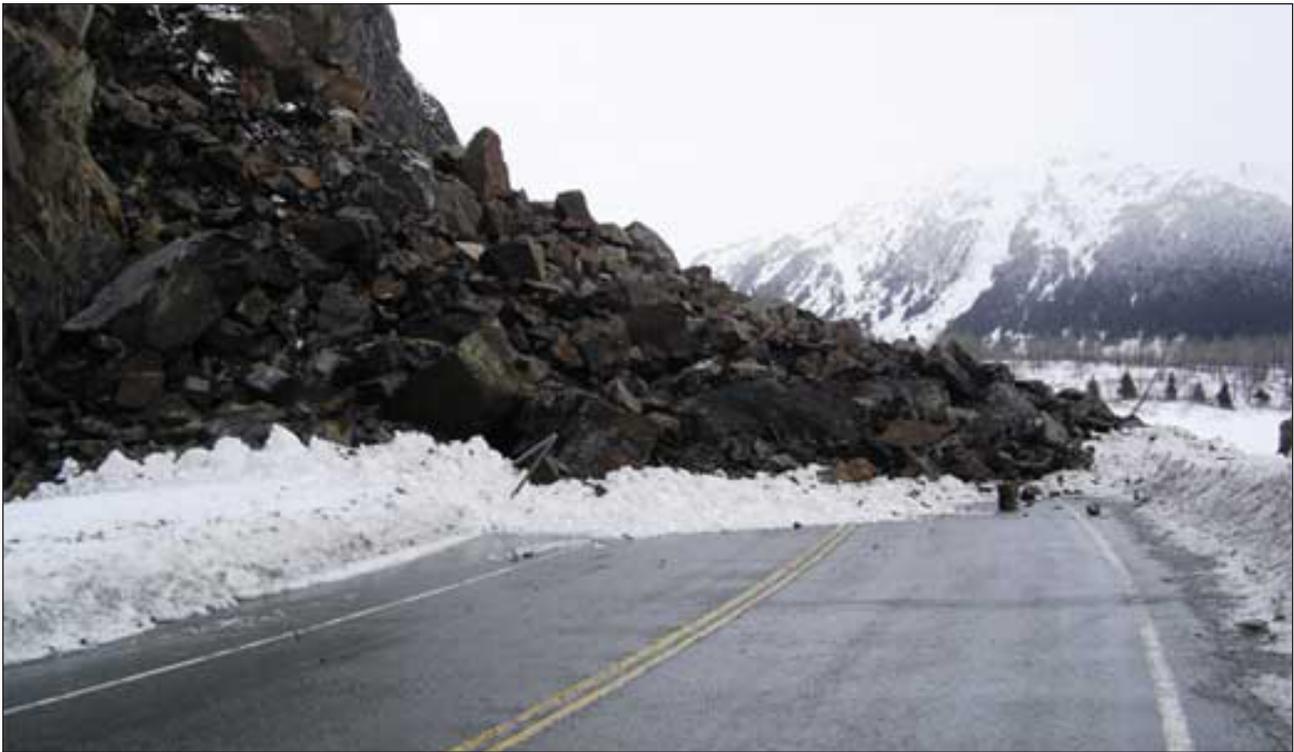
Figure 9. Rockfall debris on the Portage Glacier Highway, April 2009. Photo courtesy of the Alaska State Troopers.

At the northwestern end of Portage Lake, rockfall is common along the Portage Glacier Highway between the Portage Creek crossing and the Anton Anderson Memorial Tunnel connecting Portage Valley to Whittier (figs. 6 and 9), causing hazardous driving conditions for motorists and occasional multi-day closures of the highway.

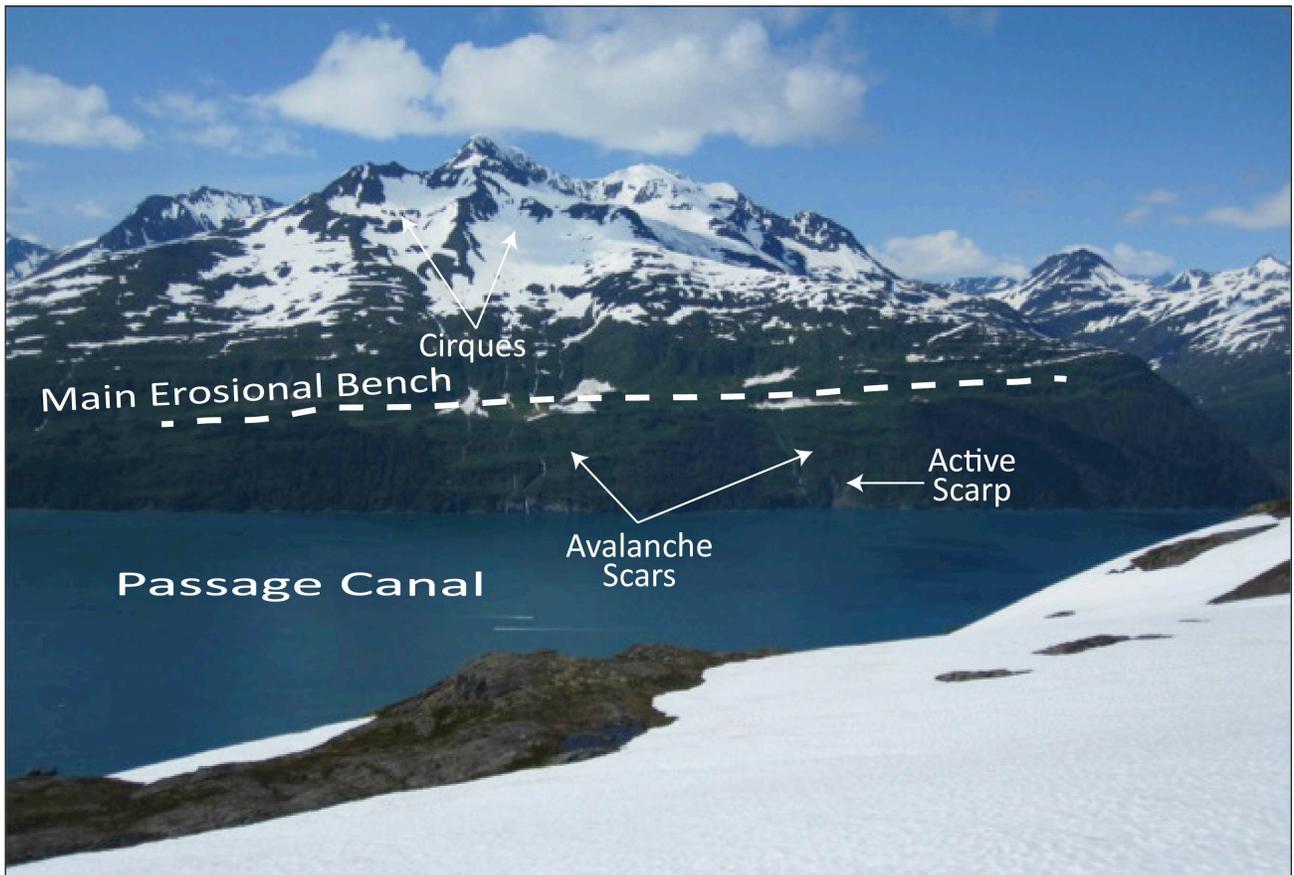
Figure 10. The glacier-carved steep terrain of the north side of Passage Canal. Photo by Gabriel Wolken.

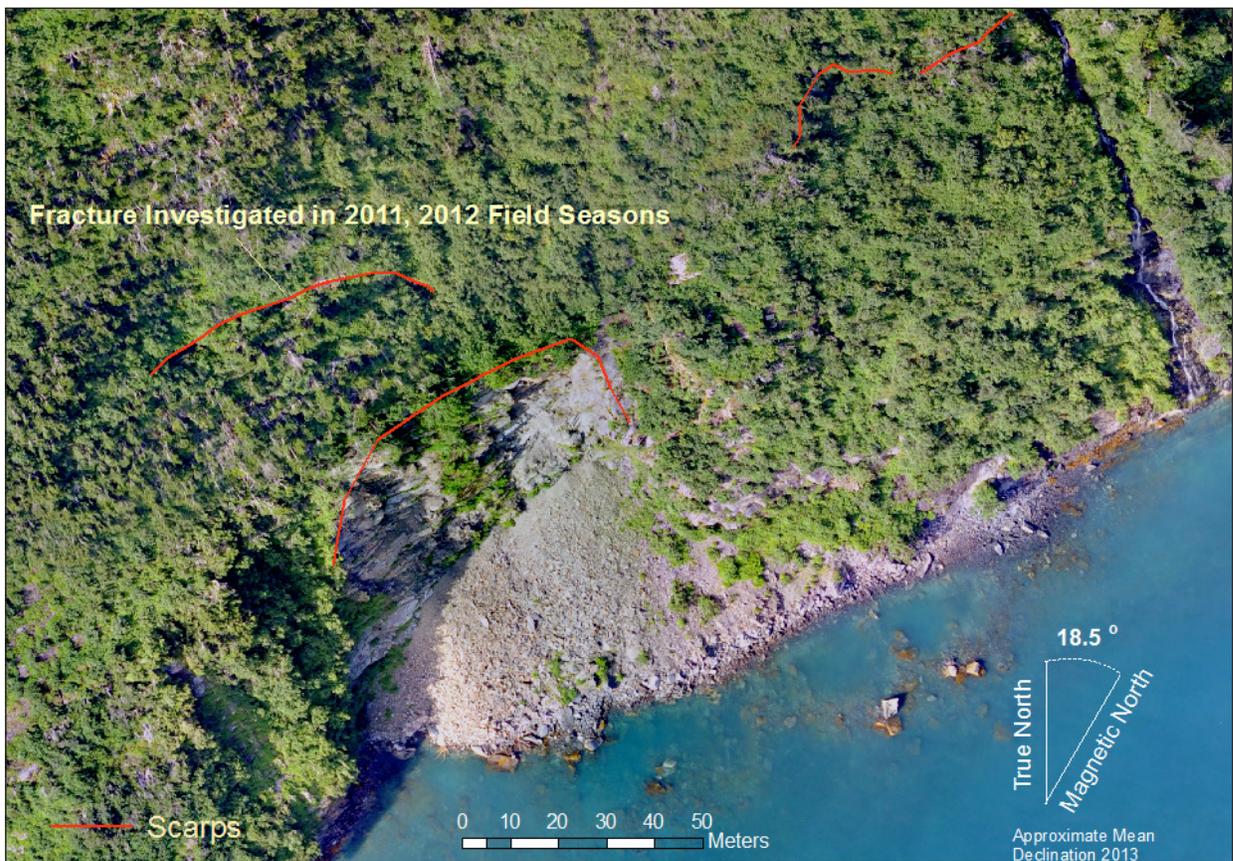
Figure 11. High-resolution orthomosaic (2012) of a major active rockfall on the north shore of Passage Canal. The upper red line indicates a fracture in the bedrock discovered during fieldwork conducted in 2011 and the lower red line traces the top of an active scarp. Red lines in upper right of image mark other significant scarps.

The alpine area at this location is dominated by two shallow, steeply-dipping cirques that funnel debris, via fall, slide, and flow events, to lower elevation areas (fig. 10). Most of the debris from these alpine sources is deposited on a prominent erosional bench (~280 m a.s.l.) as talus and debris fans that generally coarsen downslope. Large, angular blocks (~0.6–1 m long) were found at the most distal parts of these fans, near the downslope edge of the erosional bench, providing evidence of historic high-velocity mass movement events that undoubtedly delivered debris (of similar or greater size) to sea level. Below the erosional bench, which effectively delineates the transition between alpine and subalpine areas on this otherwise continuously steep slope (~60°; figs. 5 and 6), thick vegetation masks numerous scarps formed by the structural fabric of the bedrock, glacial scour, and the post-glacial dilational response of the bedrock (figs. 11 and 12). Rockfall scarps along the north shore of Passage Canal are abundant. The largest and most active rockfall scarp, which has released blocks up to ~3.0 m long (a-axis), is located approximately 3.2 km across the fjord from Whittier. An aerial survey (2011) of this rockfall area revealed a large bedrock fracture with a downhill-facing scarp approximately 55 m (ground distance) above the active rockfall scarp (fig. 13). The fracture is mostly obscured by dense vegetation and is only visible from the air, primarily in areas of snow-avalanche scars.

Combined ground and aerial observations, along with the analysis of lidar data acquired in fall 2012, indicate a fracture width of ~1.75–2.25 m and a length of ~160 m, with a maximum elevation above sea level of ~120 m (figs. 12 and 13). While the full length of the fracture remains unknown, the estimated surface area between the active rockfall scarp and the observed fracture is ~6,197 m². Based on these surface measurements and fracture depth estimates, informed by structural measurements, it is estimated that the total potential rockfall volume from this potential failure would be 1.2–1.8 million m³, considerably less than the estimated volume of the massive rockfall (30 million m³) that occurred during the 1958 Lituya Bay earthquake to the south (see Tsunamis section; Miller, 1960; Nicolsky and others, 2011b). Nonetheless, if mobilized, this rock mass has the potential to generate a local tsunami that could impact the community of Whittier and damage critical infrastructure in Passage Canal (Nicolsky and others, 2011b).

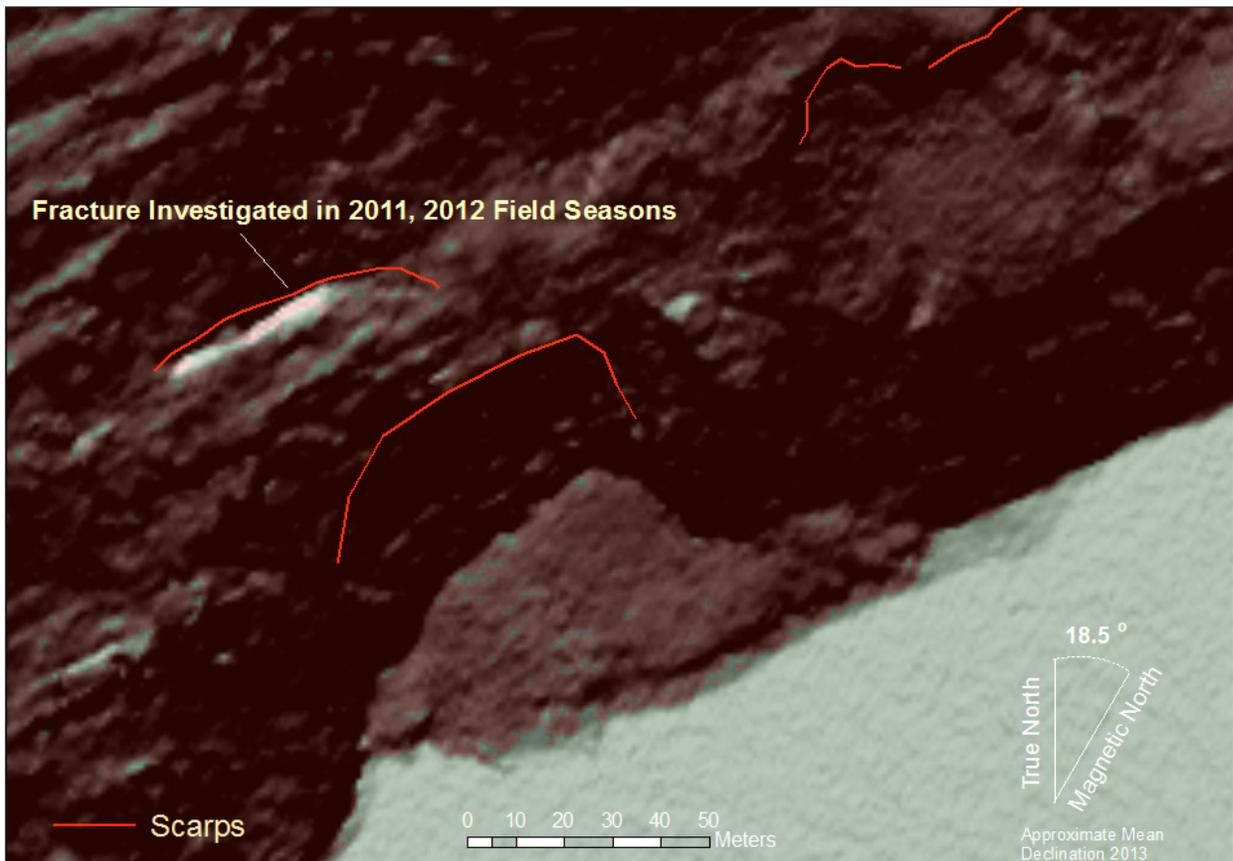
Figure 12. Bare-earth hillshade image derived from the September 2012 lidar data showing the major active rockfall on the north shore of Passage Canal. The image dimensions are the same as in figure 11. The labeled red line indicates a bedrock fracture discovered during fieldwork conducted in 2011 and the lower red line traces the top of an active rockfall scarp. Red lines in upper right of image mark other significant scarps.

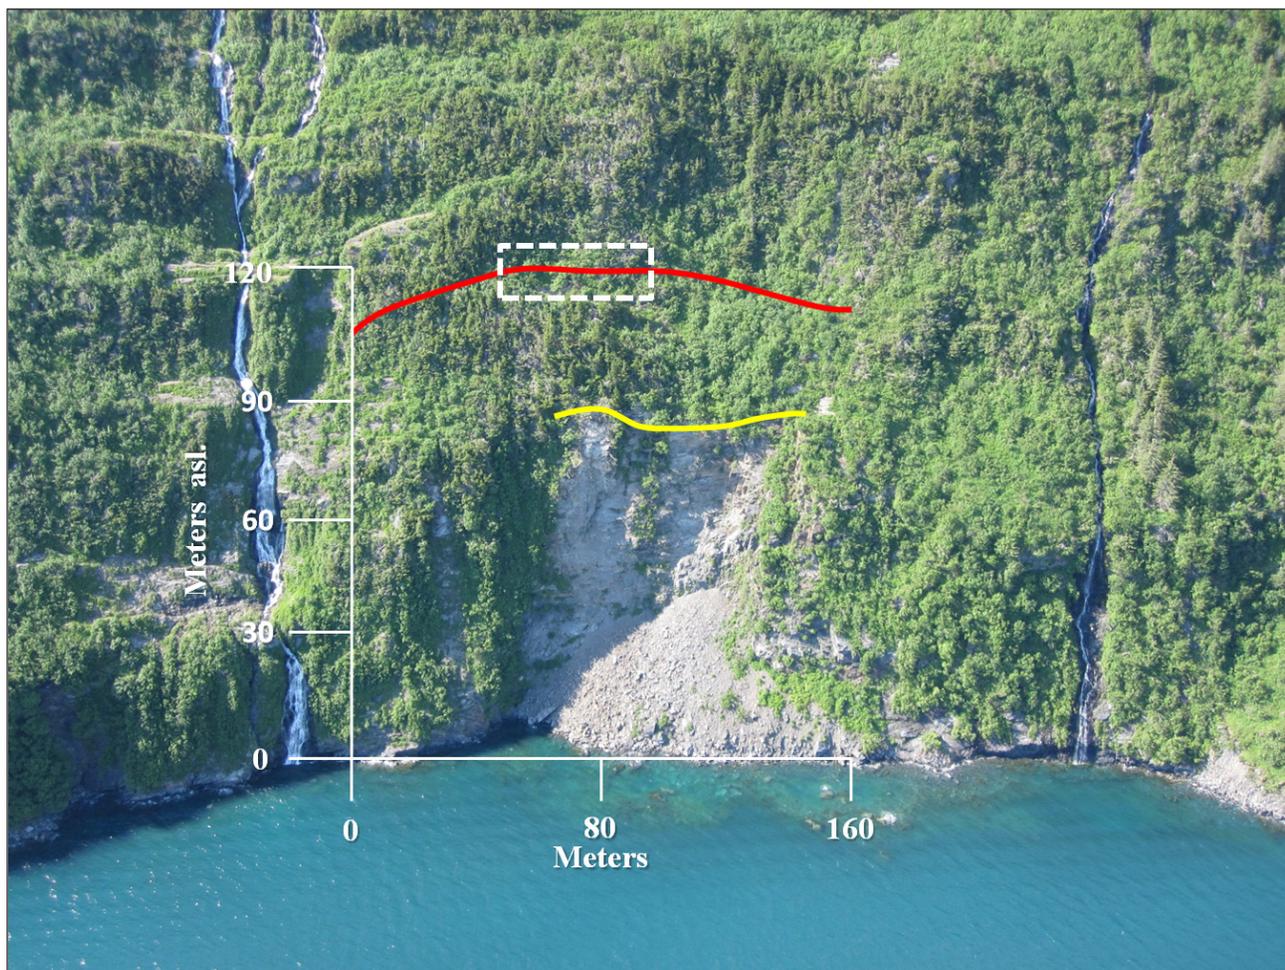
Figure 13. Photograph of the main rockfall and fracture above the north shore of Passage Canal. The yellow line shows the active scarp of the rockfall, the red line shows the position of the bedrock fracture, and the dashed white box indicates the location of the photographs in figure 14. Photo by Gabriel Wolken.

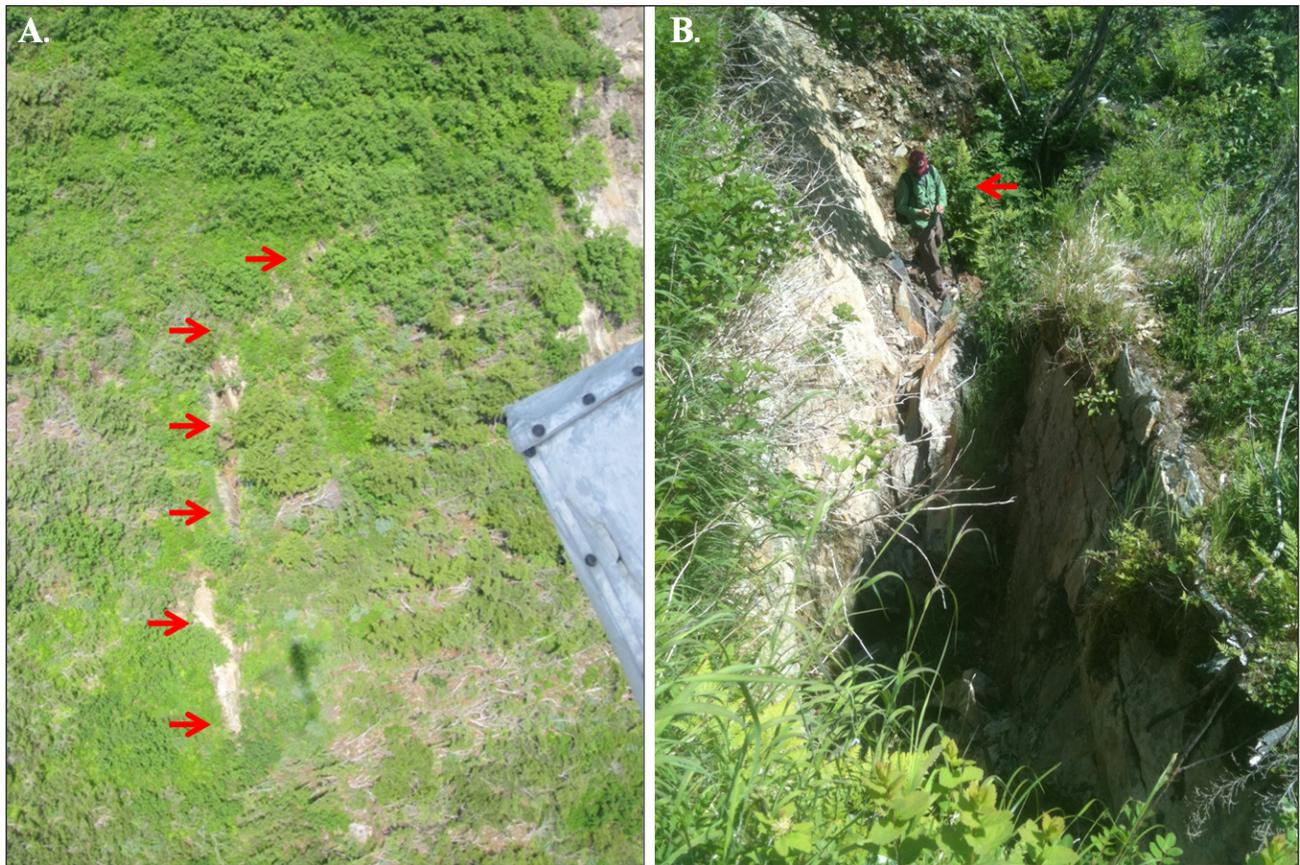
Figure 14. Photograph of the bedrock fracture from the air (A) and the ground (B). Red arrows in A show the location of the fracture. Red arrow in B identifies a person for scale. Photo by Gabriel Wolken.

lodged in the fracture, forming an intermittent false “floor” at a depth of ~2 m along the fracture’s widest segments, obscuring its true depth (fig. 14). The fracture has an arcuate, convex-up form, suggesting that its origin could be related to the mechanisms influencing the active rockfall below. No other cracks are visible between the fracture and the active rockfall scarp, indicating that the bedrock block below the fracture may have detached rigidly in response to the removal of lateral support from the mountain slope (glacier debuttressing), possibly in combination with external stimuli, such as seismic activity, rapid snowmelt, or intense rainfall.

The fracture exhibits relatively less weathering and oxidation compared to surrounding rocks and remains free of vegetation, suggesting relatively recent formation or movement (fig. 14). While the age of the fracture is unknown, evaluation of historic aerial photographs indicates that the main rockfall below the fracture occurred between 1950 and 1978. It is possible that the fracture formed during the 1964 earthquake (magnitude 9.2), which was centered over PWS.

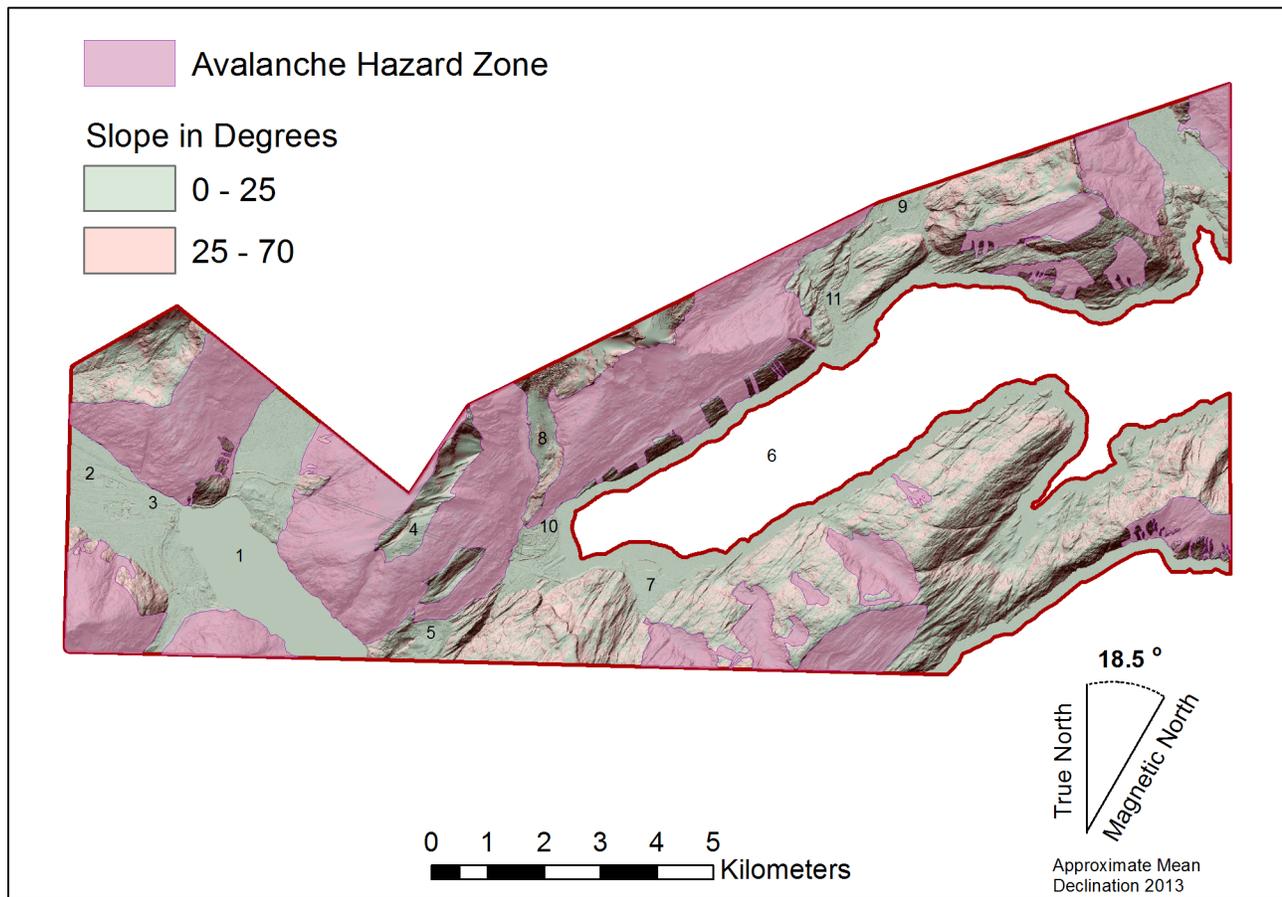
Figure 15. Preliminary map of snow avalanche hazards in the study area. The locations of select geographic features are labeled and include: 1. Portage Lake; 2. Portage Creek; 3. Portage Glacier Highway; 4. Anton Anderson Memorial Tunnel; 5. Portage Pass; 6. Passage Canal; 7. Whittier; 8. Learnard Glacier; 9. Billings Glacier; 10. Learnard Creek; and 11. Billings Creek.

Snow avalanches are a significant risk to people and infrastructure in the study area (fig. 15). The empirically derived slope thresholds used in this study define a large area of possible avalanche risk in the study area. Notable exceptions were found in the areas where slopes are less than 25° , and in areas where the structural features of the bedrock prevented snow avalanche release or reduced snow avalanche travel. The preliminary snow avalanche hazard zonation is consistent with the local climatology and the complex topography over which snow is distributed. The mean annual total snowfall for the period 1950–2011 in Whittier is 653 cm (Western Regional Climate Center 2014). Much of this annual snowfall is wet and wind-blown, allowing it to temporarily adhere to the area's steeper slopes more than the snow in mountains in a continental climate. Consequently, avalanche release zones in this area can occur on very steep slopes (up to 70°), many of which are located in high elevation areas where greater snow accumulation typically occurs.
