PRELIMINARY INTERPRETIVE REPORT 2014-4

**CONTEMPORARY SHORELINE RETREAT RATES
AT MESHIK IN PORT HEIDEN, ALASKA**

by
Nicole Kinsman and Alexander Gould

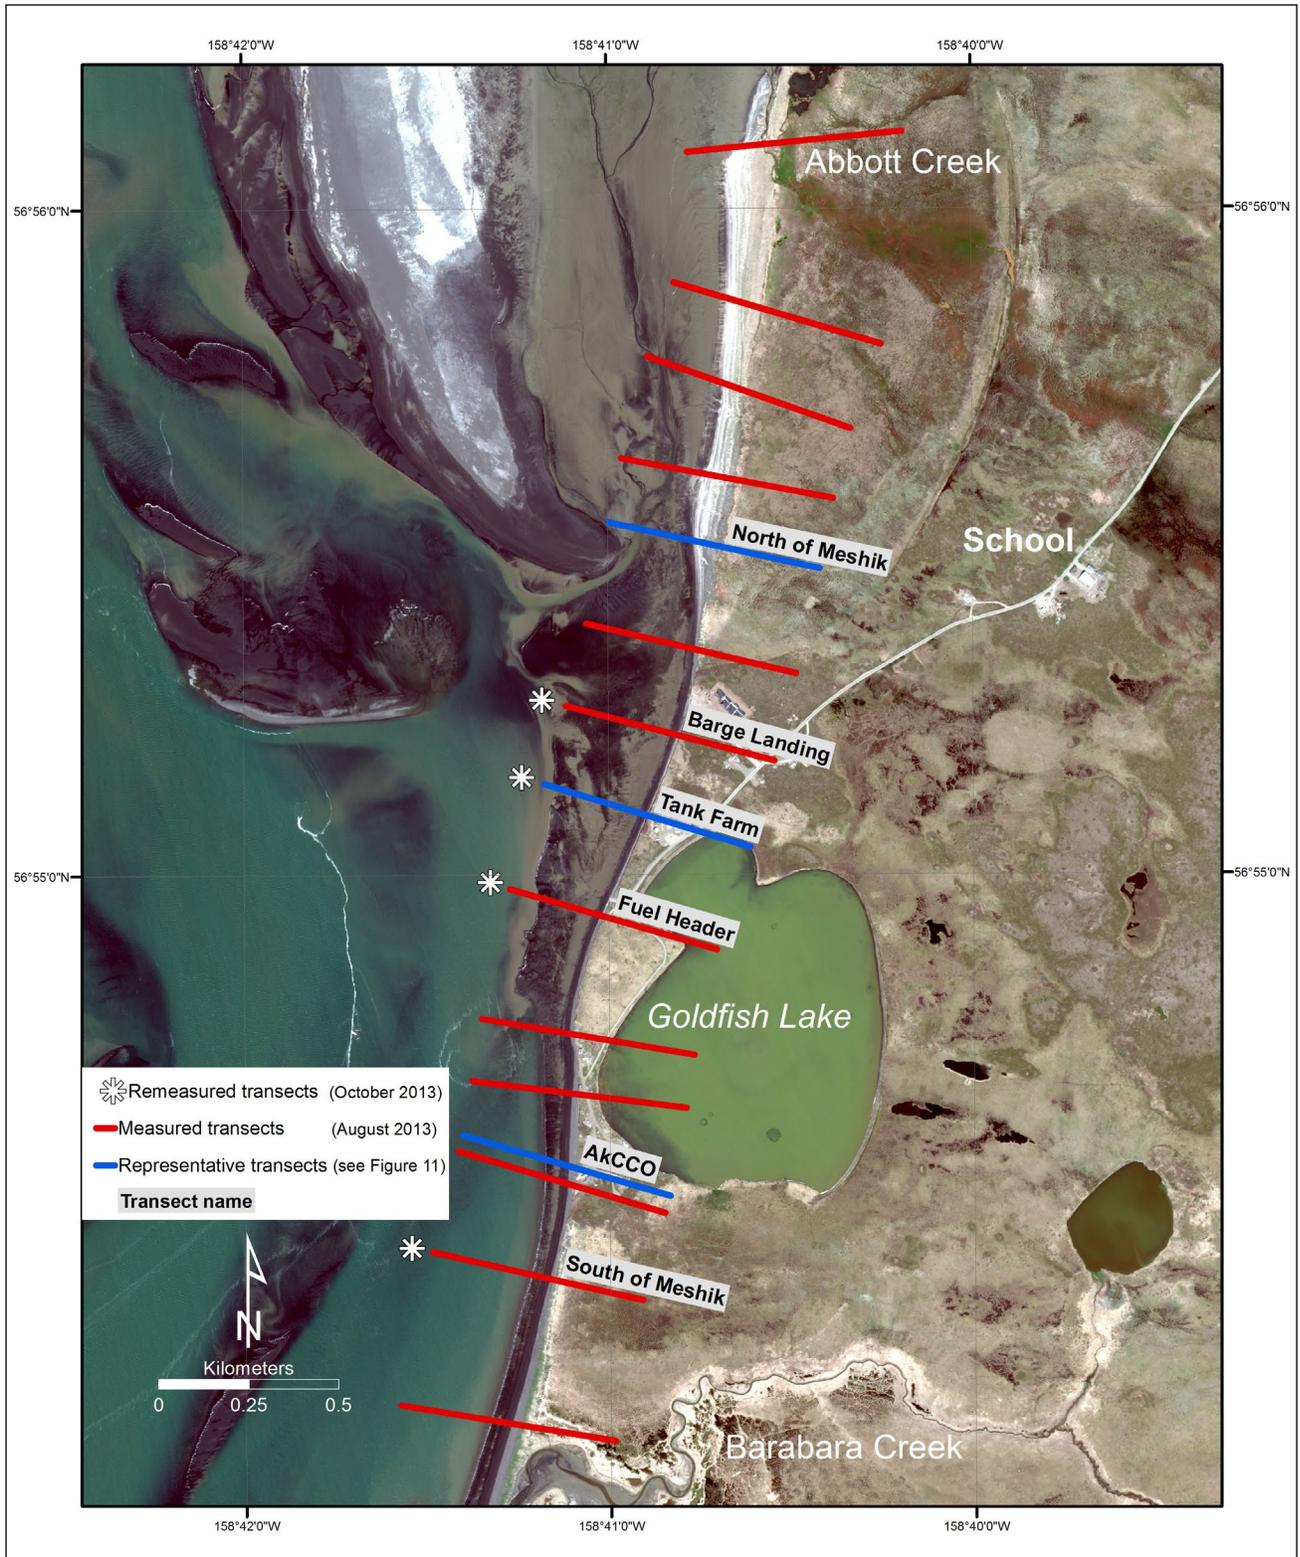
Figure 2. Map of Meshik study area, illustrating the locations of coastal elevation transects (red and blue) measured in August 2013. Profiles with asterisks (*) were re-measured in October 2013, partially into the storm season; these measurements are plotted in figures 8 and 9. Blue indicates representative transects that exhibit typical alongshore variation in the shoreline change rates; detailed plots of these rates are shown in figure 11. The base map is a Worldview-2 satellite image taken June 17, 2013.

In this study, shoreline change was quantified by identifying the position of the shoreline in a series of eight vertical image sets spanning the period 1957–2013 (table 2). This assessment incorporates all publicly-available imagery that meets minimum resolution requirements. Alongshore rates of change were calculated using a linear regression technique in a Geographic Information System (GIS) environment with the Digital Shoreline Analysis System (DSAS v. 4.3; Thieler and others, 2009) tool developed by the U.S. Geological Survey. This tool constructs regularly-spaced virtual transects that intersect a set of temporal shoreline vectors. A 3.8 km segment of the coast from Abbott Creek to Barabara Creek was examined in this analysis of the Meshik study area, and rates were calculated at 50 m intervals (fig. 2).

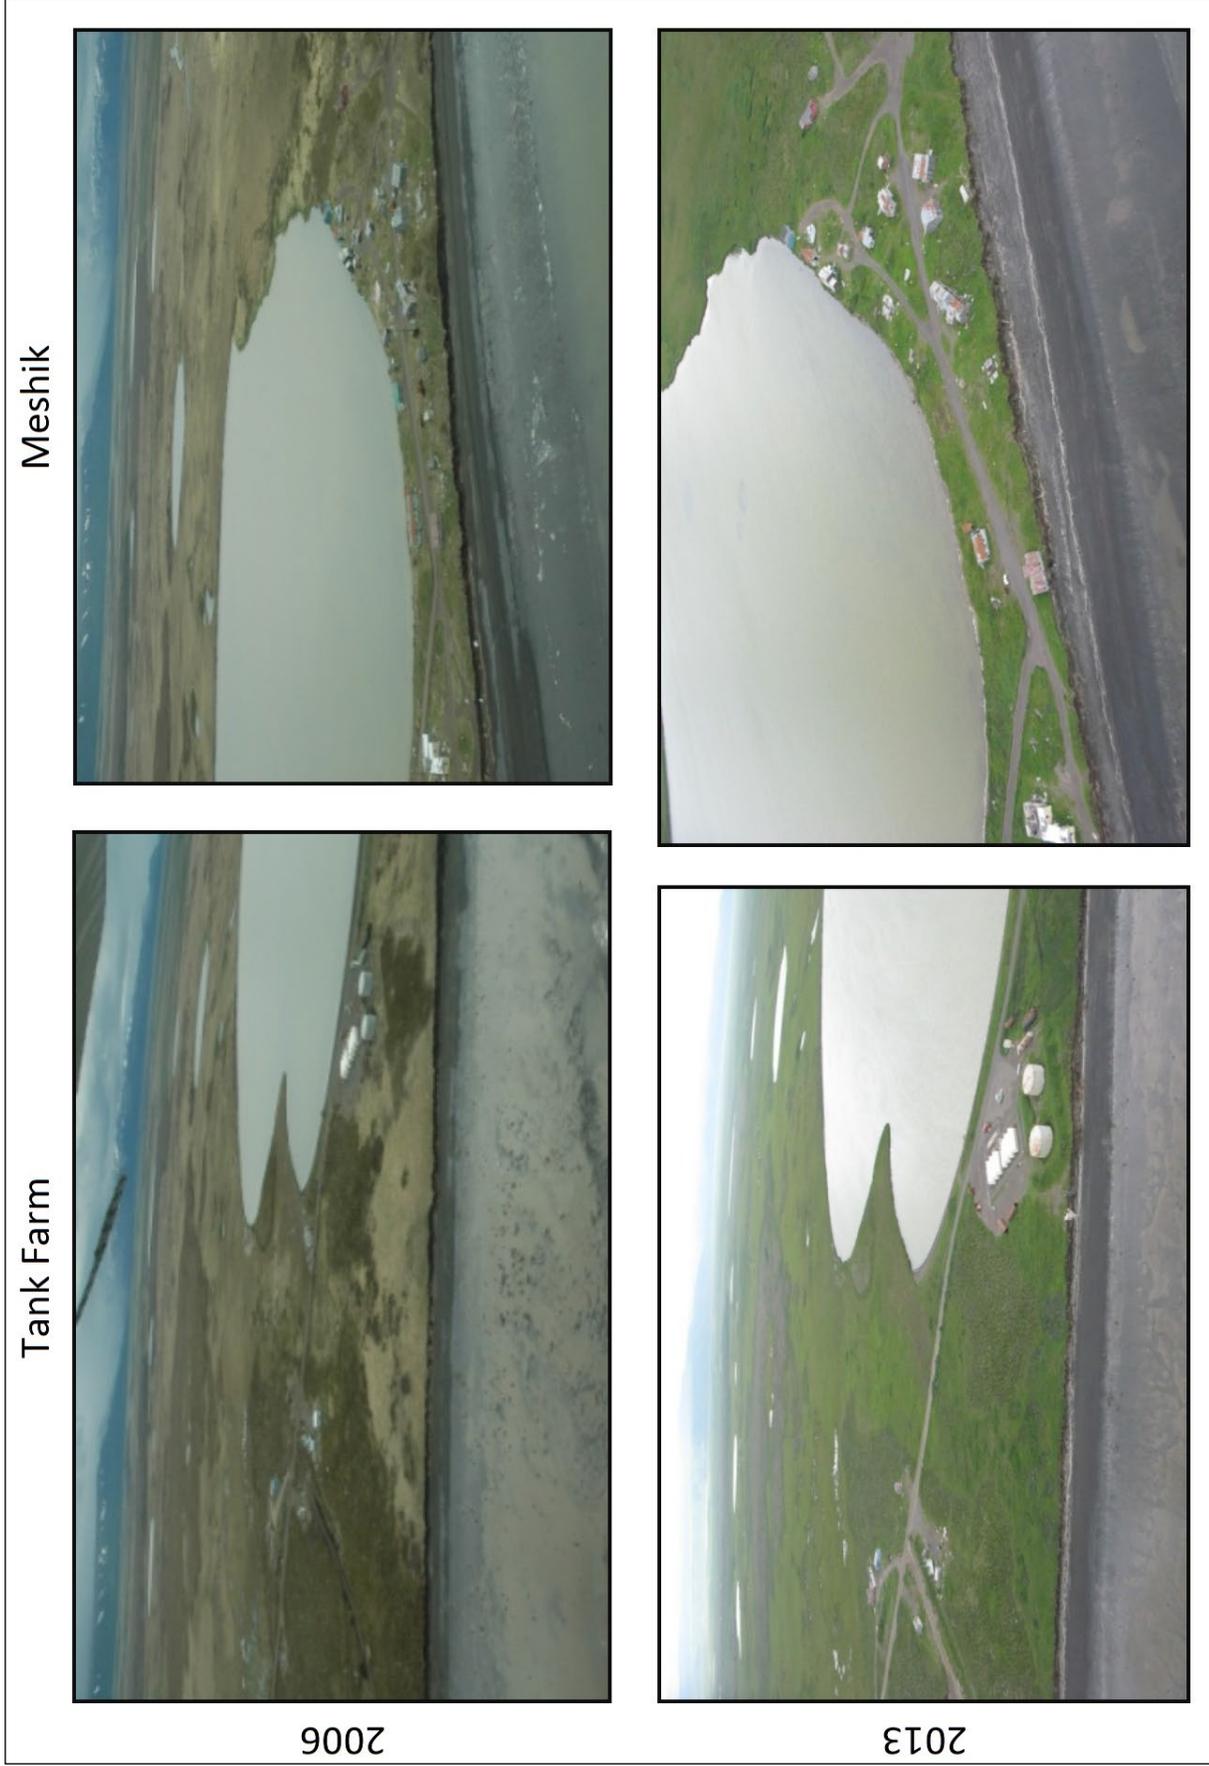
Figure 3. Repeat oblique aerial photographs of the Meshik coastline in 2006 (NOAA) and 2013 (Gould and Kinsman). The inland translation of the bluff edge over this 7-year period is apparent when viewed relative to the structures.

A rapidly retreating coast at the Meshik site continues to impact Port Heiden (fig. 3). Approximately two dozen vacant and deteriorating structures and associated debris remain at Meshik and a 2008 environmental report recognized the site as having unknown volumes of potentially hazardous materials present in the debris that could present a risk to human health and the environment (Iliaska Environmental, 2008). Additionally, critical Port Heiden city resources remain at Meshik today. These include the fuel header, fuel storage tanks, barge landing site, and road access to the primary boat haul-out area to the south. Two above-ground fuel storage tanks were moved from an eroding marine terminal area in 1982. A new tank farm with new storage tanks, a pump house, and distribution pipes was constructed in 2002 (Iliaska Environmental, 2008). In fall 2013, the old storage tanks had to be relocated farther inland once again (Scott Anderson, 2013, oral commun.).

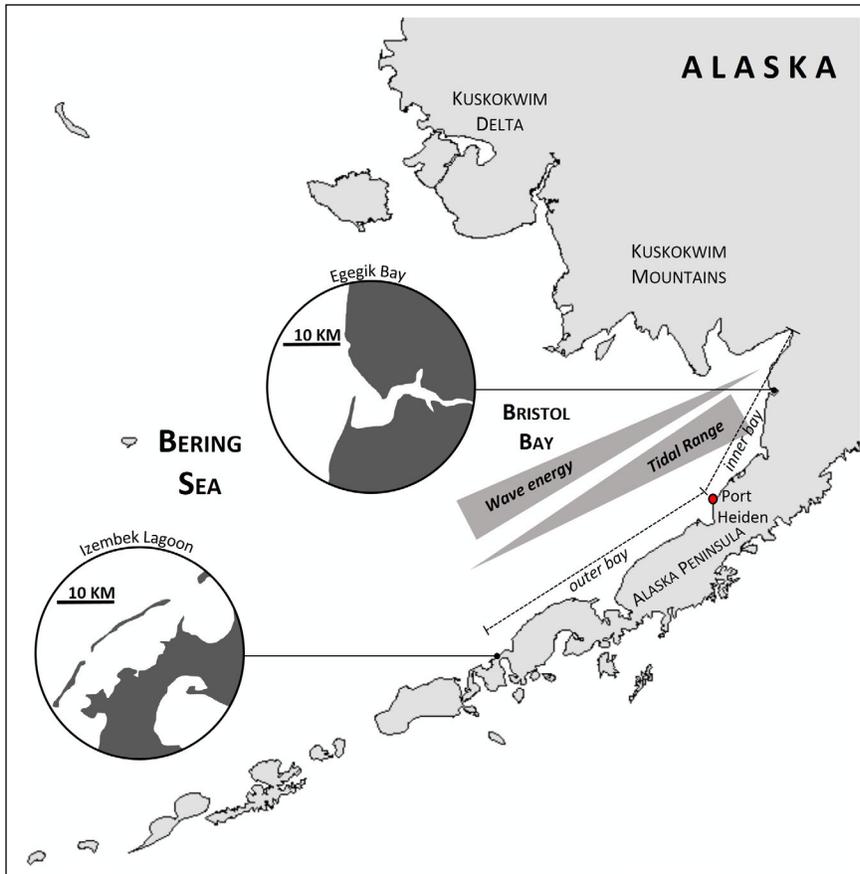
Figure 4. Graphic representation of the relative strength of component marine energy (tide and wave) in Bristol Bay, and the characteristic barrier morphologies in the outer (well-developed barrier islands, such as Izembek Lagoon) and inner bay (barrier spits at embayment mouths, such as Egegik Bay).

On a regional scale, significant wave heights decrease from the mouth of Bristol Bay toward the head (fig. 4). In this part of Bristol Bay winds prevail from the northwest, with stronger and more northerly winds occurring in the late fall to

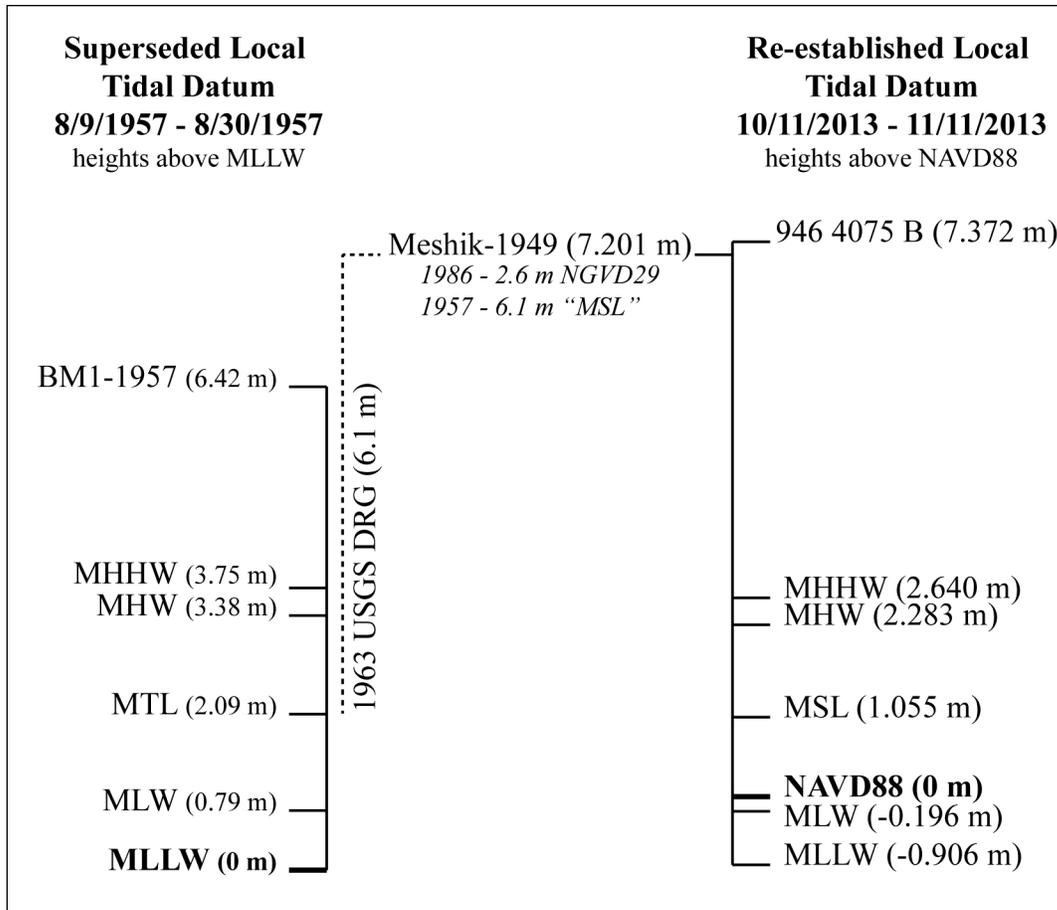
Figure 5. Comparison of the 1957 (NOAA, 2013) and 2013 tidal datums for Port Heiden, aligned through a common benchmark (Meshik-1949) of known elevation.

To assess trends in the position of relative sea level at Port Heiden, we used the best available data to align the superseded datum values with the new measured values (fig. 5). For this region the only benchmark with tide-coordinated geodetic heights for both 1957 and 2013 is ‘Meshik–1949’ (PID UW1437) near Goldfish Lake. Alignment of the two datums using this common benchmark suggests that the relative sea level has remained stable during this time period. This is corroborated by preliminary measurements of insignificant vertical land movement (observed rates of change from 1994 to 2014 are less than the measurement uncertainties of ± 0.3 mm/year; oral commun., Kimberly Tweet, 2014) and a minimal local sea surface trend of approximately -1 to 0 mm/year in central Bristol Bay (1993–2012 rate derived from satellite altimetry; Sea Level Research Group [SLRG], 2013).

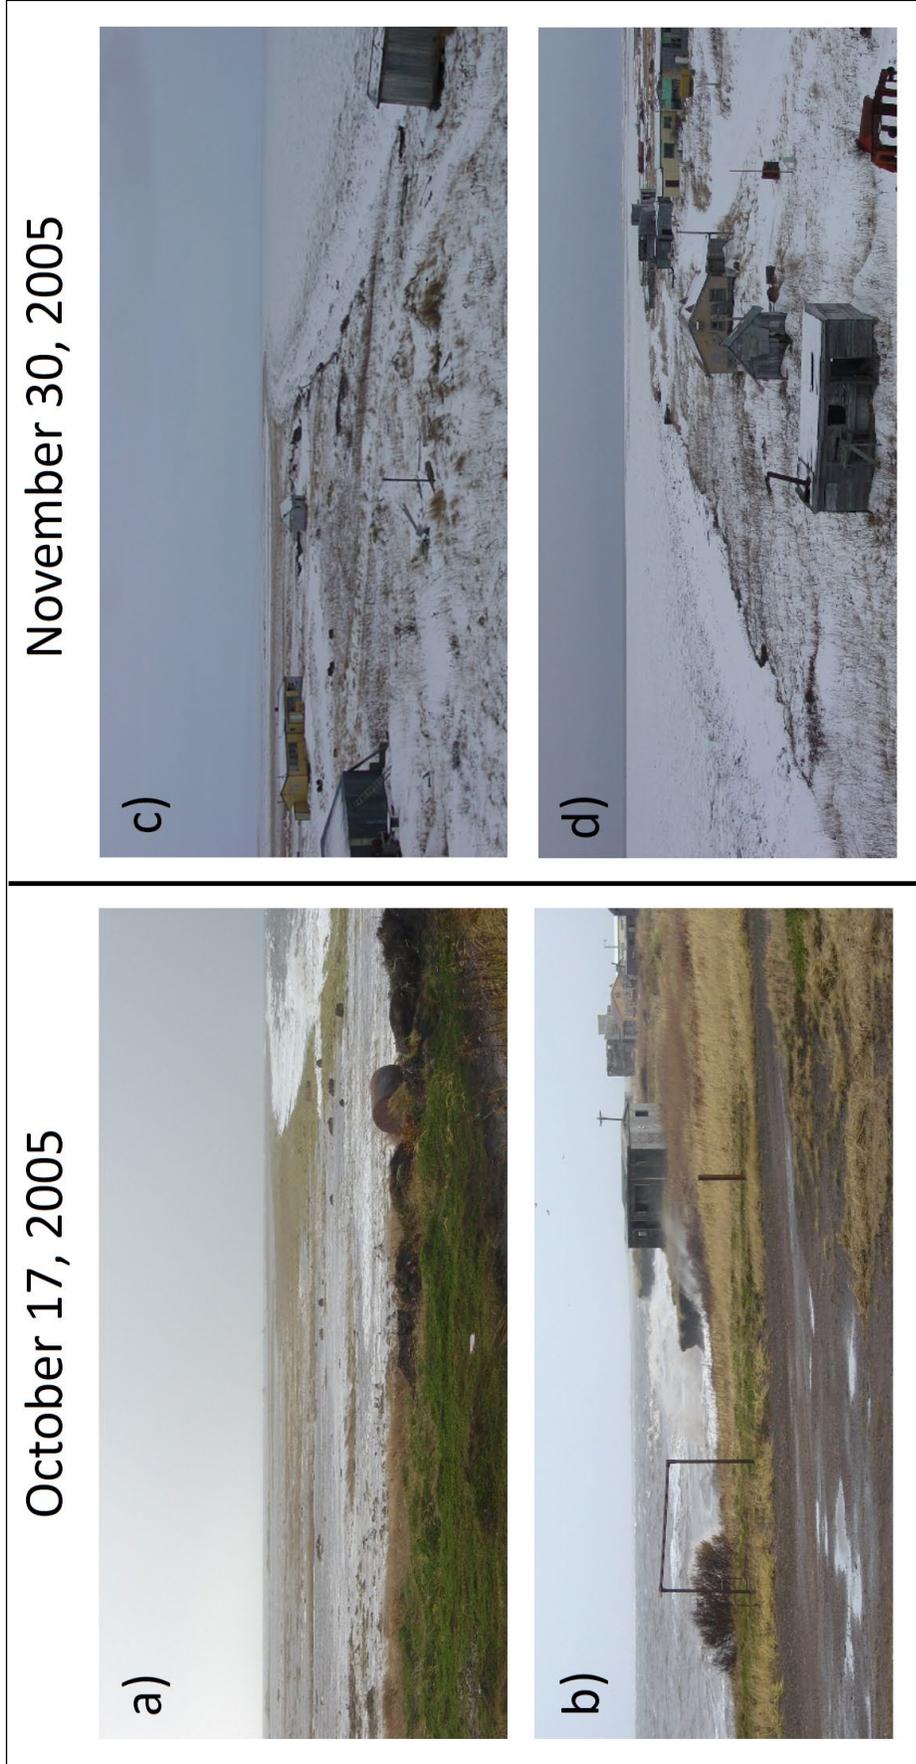
Figure 6. Photographs taken in Meshik of the low-lying barrier spit to the south (a, c) and the bluffs at the site (b, d) during storms in 2005 under both ice-free conditions (October) and in the presence of shore ice (November). Note the over-topping and inundated back-barrier region (a) as well as the waves breaking directly against the bluffs (b) during the ice-free conditions (photos by Scott Anderson).

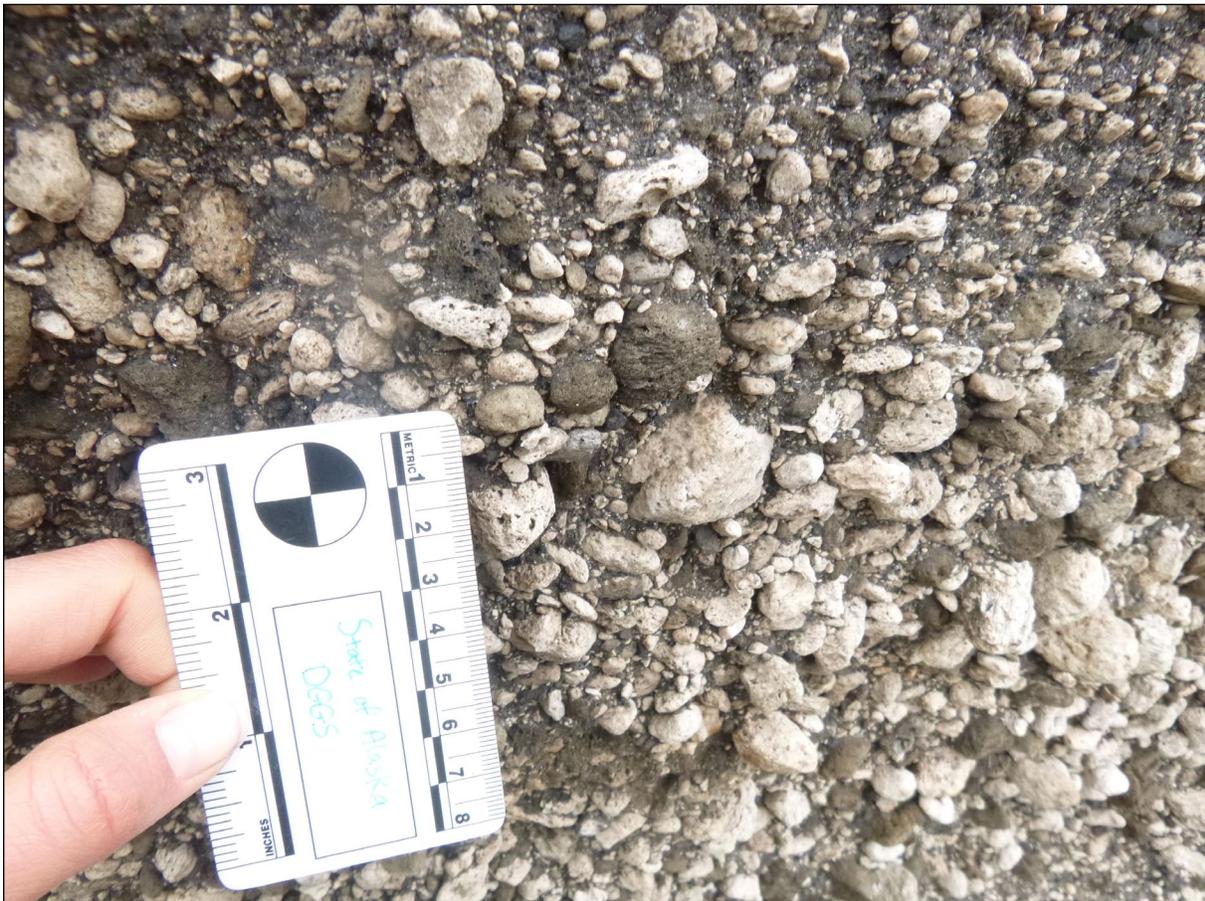
Figure 7. A close-up image of the pumice-rich bluff-forming unit.

- (2) Blanketing and abutting these glacial deposits are extensive pyroclastic flow (ignimbrite) and fall deposits, in irregular layers of varying thickness composed of unconsolidated and non-welded pumice and coarse ash. The most massive of these volcanic deposits are associated with the caldera-forming eruption of Aniakchak $3,595 \pm 4$ yrs BP (Pearce and others, 2004). These bluffs at Meshik are composed of a highly erodible pumice-rich unit (fig. 7) capped by a thin organic layer.

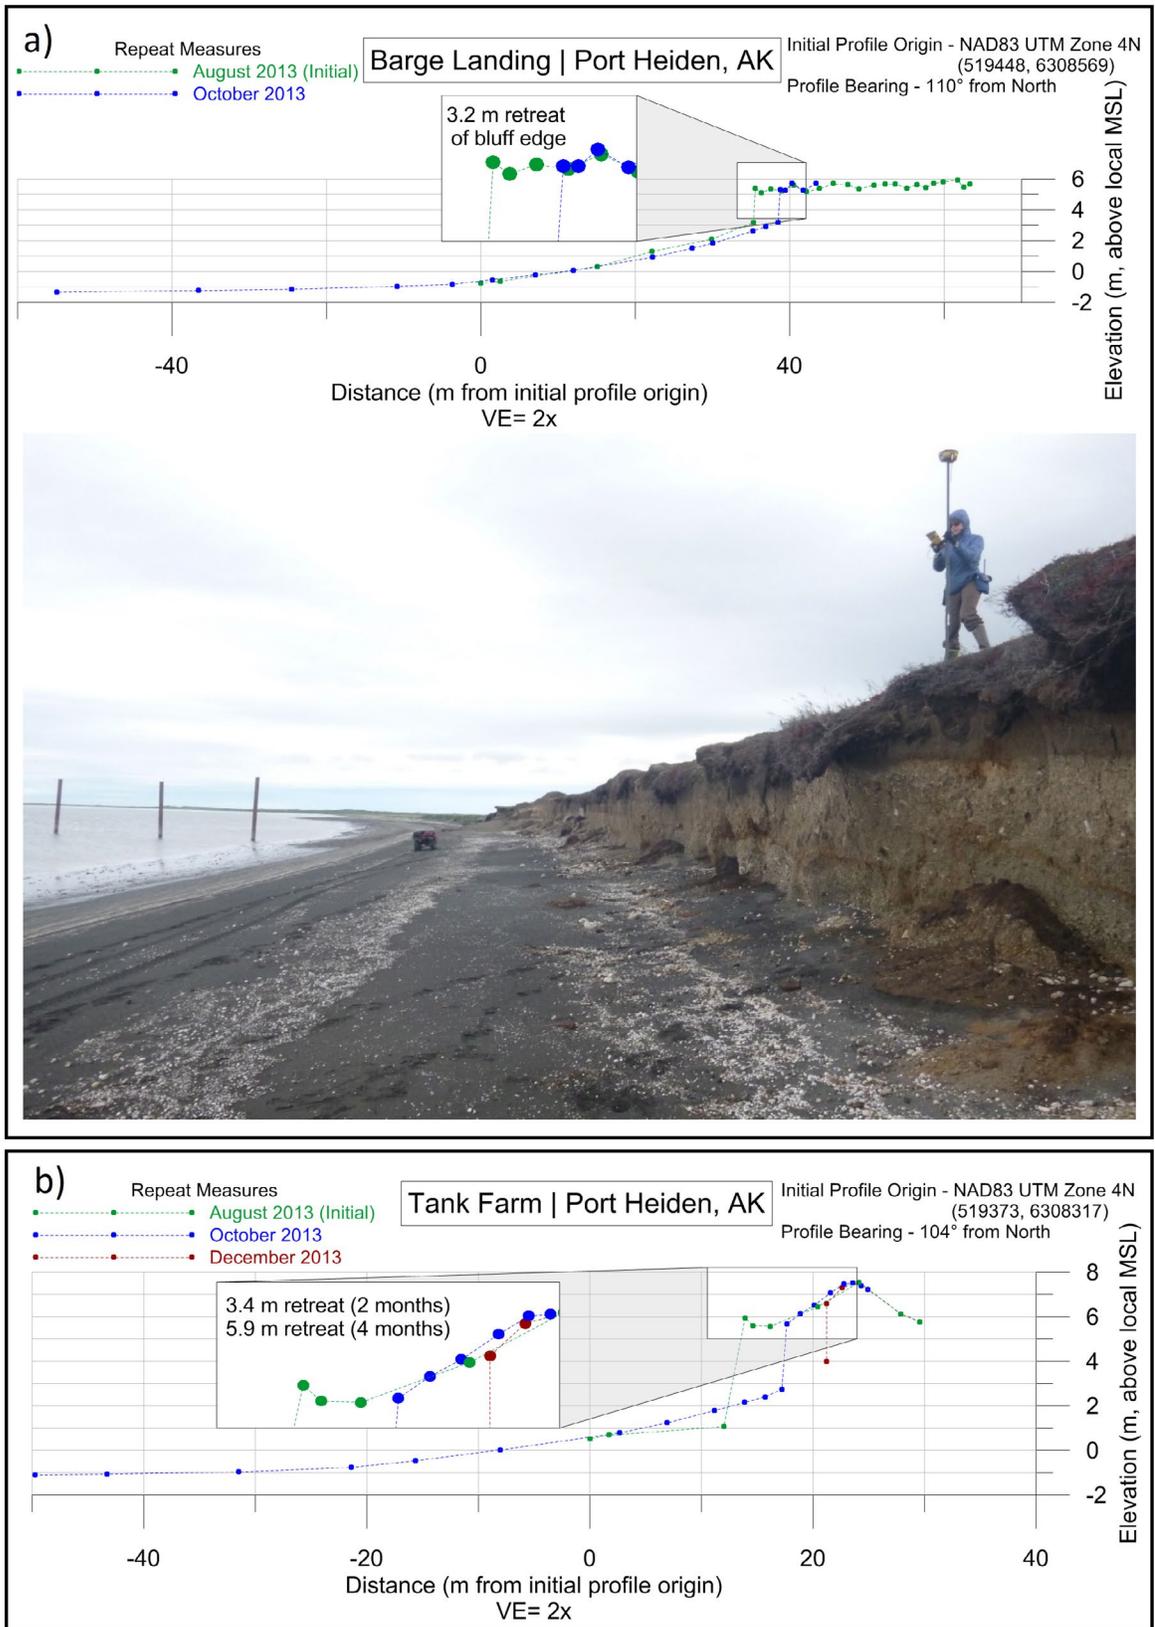
Figure 8. Plots of repeat coastal elevation profiles at the (a) Barge Landing and (b) Tank Farm transects (see fig. 2 for locations). The plot of the Barge Landing transect is accompanied by a photograph taken during the August survey.

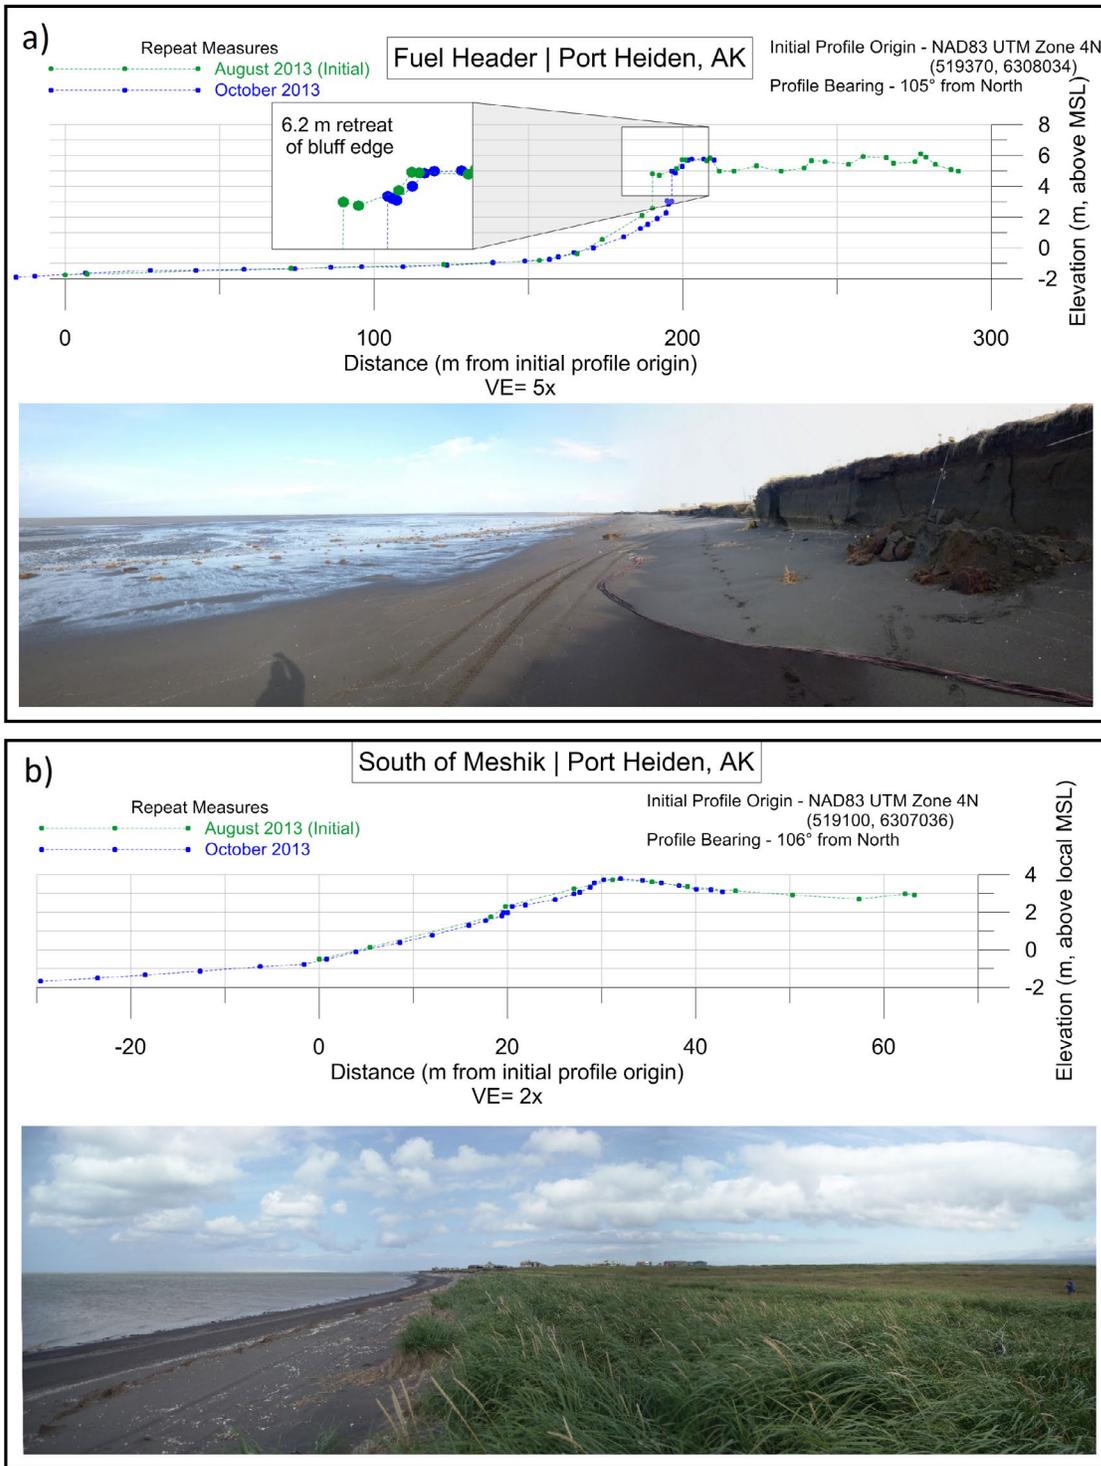
Figure 9. Plots of repeat coastal elevation profiles at the (a) Fuel Header and (b) 'South of Meshik' transects (see fig. 2 for locations). The plot of the Fuel Header transect is accompanied by a photograph taken during the October survey; recent block failures are visible at the toe of the bluff. The plot of the 'South of Meshik' transect is accompanied by a photograph taken during the August survey; this transect is south of the bluffs in a low, dune-backed environment on the southern spit.

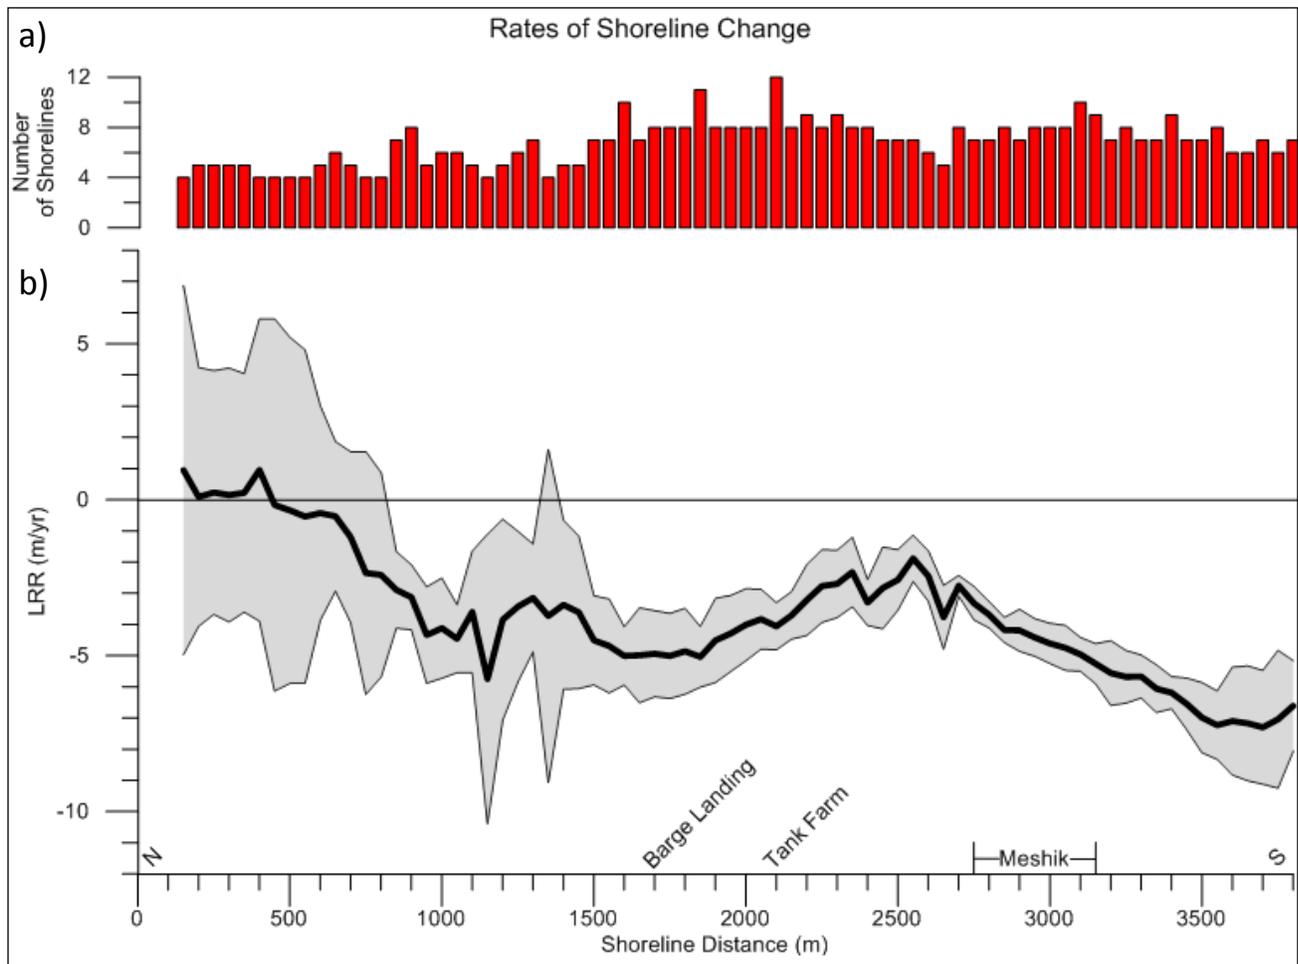
Figure 10. (a) Number of viable shoreline proxy positions at each virtual transect position from north (N) to south (S) in the study area. (b) Alongshore linear regression rates (LRR) of long-term shoreline change with associated uncertainty shown in gray. Uncertainty is higher in non-bluff areas where the vegetation line is both more variable and more difficult to identify, as well as in areas with fewer valid shoreline vectors. Positive linear regression values represent progradation and negative values correspond to erosion.

The long-term (56-year) shoreline change rate at each transect is the slope of the calculated linear regression through all viable shoreline positions (fig. 10). This rate-of-change calculation is widely employed in shoreline change studies, and linear regression performs well in environments where unidirectional shoreline change prevails and the positional uncertainties are similar across the fulltime series (Dolan and others, 1991; Himmelstoss, 2009). A drawback to the use of linear regression rates is that a constant rate of change is assumed across the entire time series. To assess possible acceleration or deceleration of erosion rates through time, a simple annualized end-point rate was calculated across each time step in the dataset at three representative transects in the study area (fig. 11).

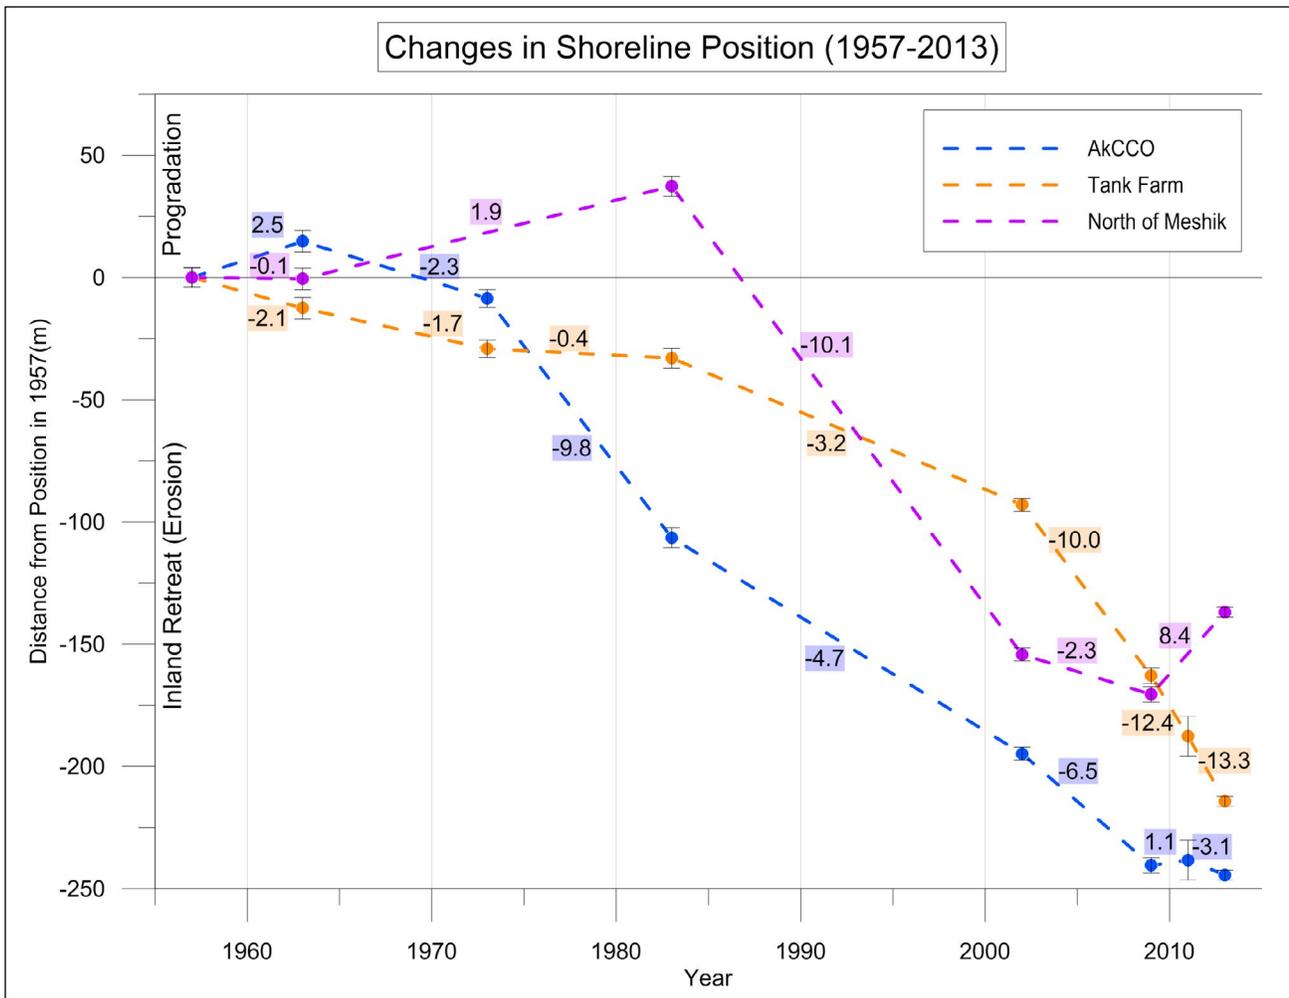
Figure 11. Position of the shoreline through the entire time series relative to the position in 1957 at three representative transects (see fig. 2). The slope of each line segment is the short-term or annualized endpoint rate for each time step, shown as m/y in the adjacent colored boxes.

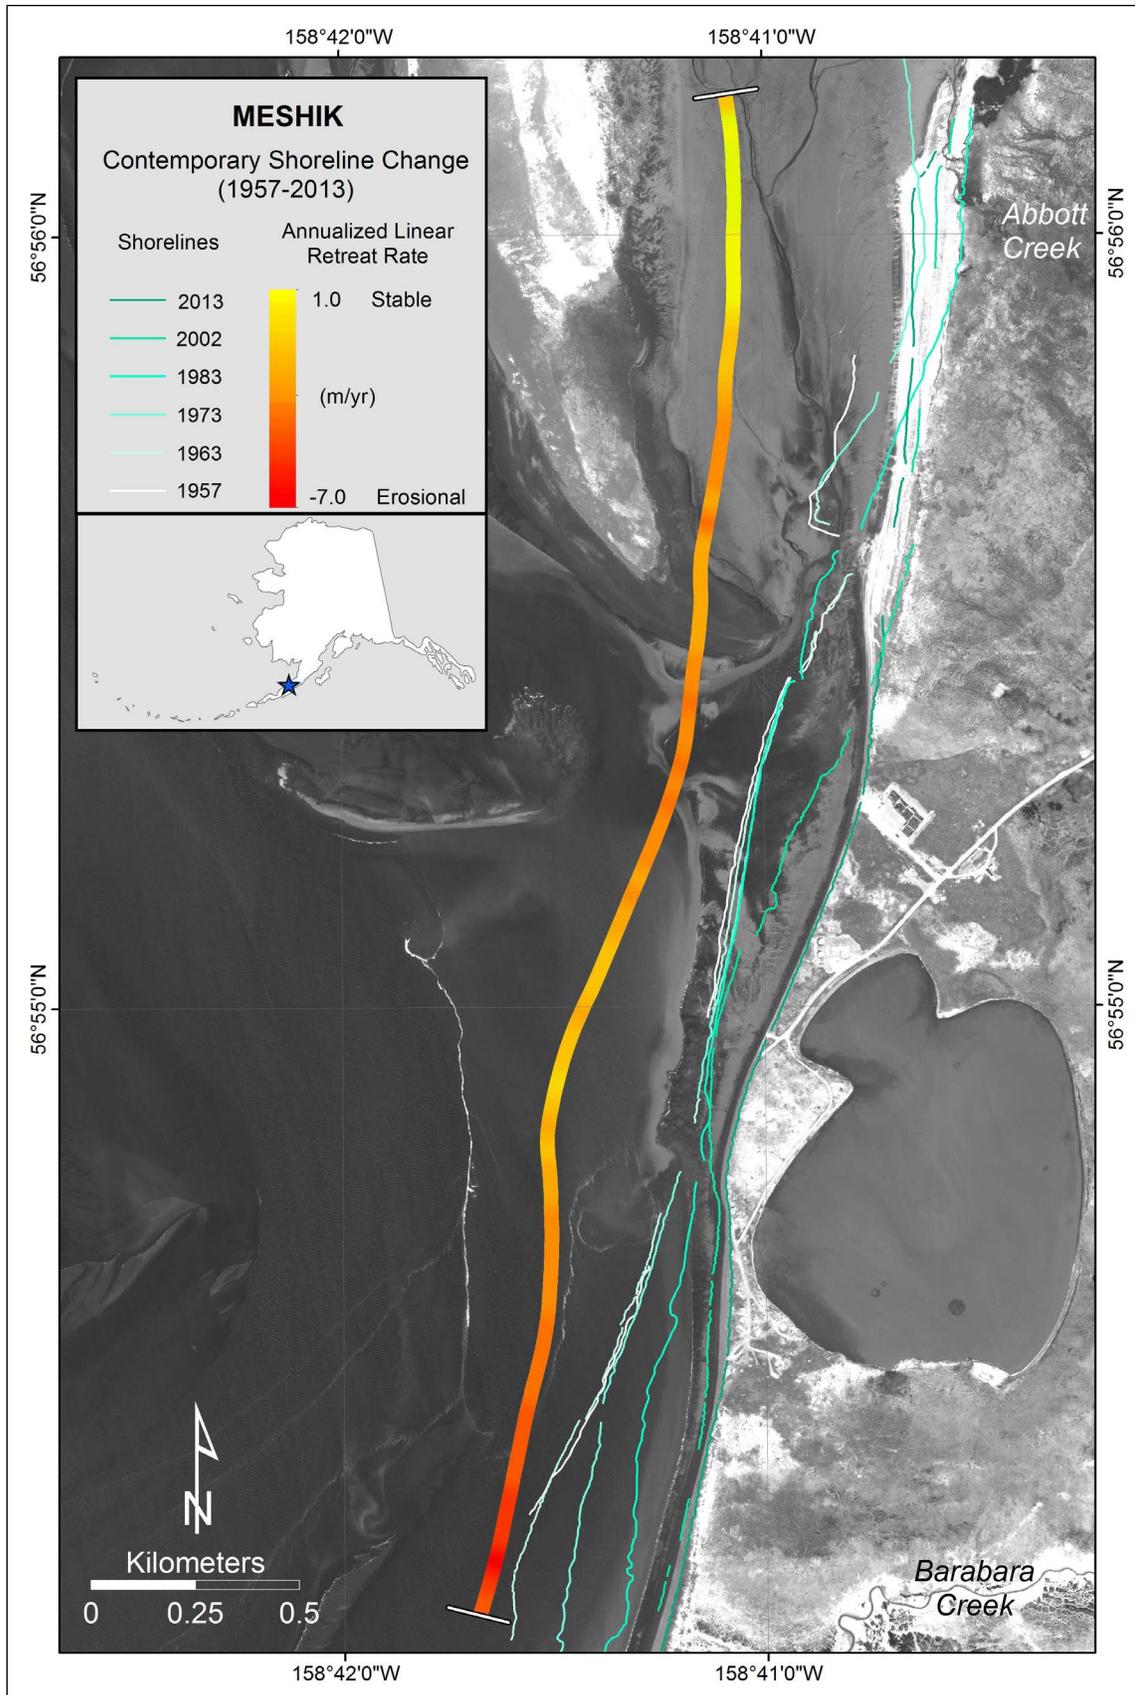
Figure 12. Long-term shoreline change rates for the entire study area, presented as a graphical band along the coast. A subset of the shoreline vectors used in the underlying analysis are plotted in shades of green.

For ease of interpretation, all of the calculated long-term shoreline change rates are presented in map view as a graphical band along the coast (fig. 12). At most of the virtual transect locations the change in the position of the shoreline proxy

was unidirectional throughout the entire time series. Peak long-term rates of shoreline change in this study area (retreating 7.3 ± 1.8 m/yr) are found south of Meshik, near Barabara Creek at the proximal end of the southern barrier spit. Negligible rates of long-term change are present in the lee of the northern barrier spit, near Abbott Creek.

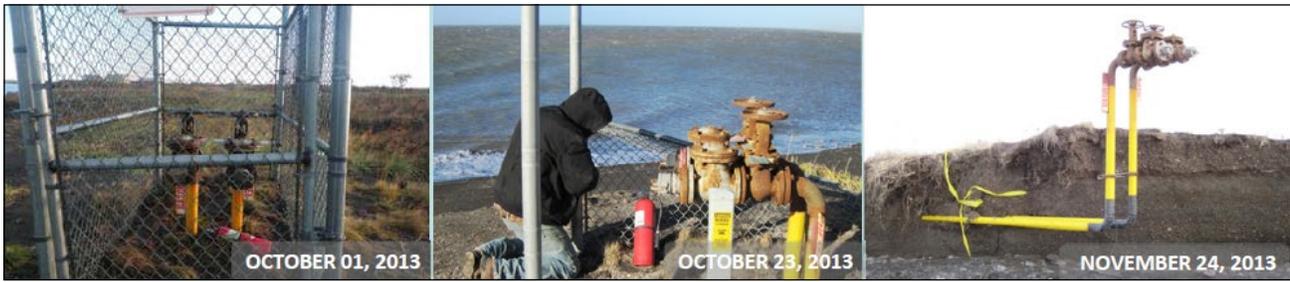
Figure 13. Fuel header pipes for Port Heiden's bulk fuel farm undercut by the eroding bluff during the 2013 storm season (photos by Linda Anderson, LEO).

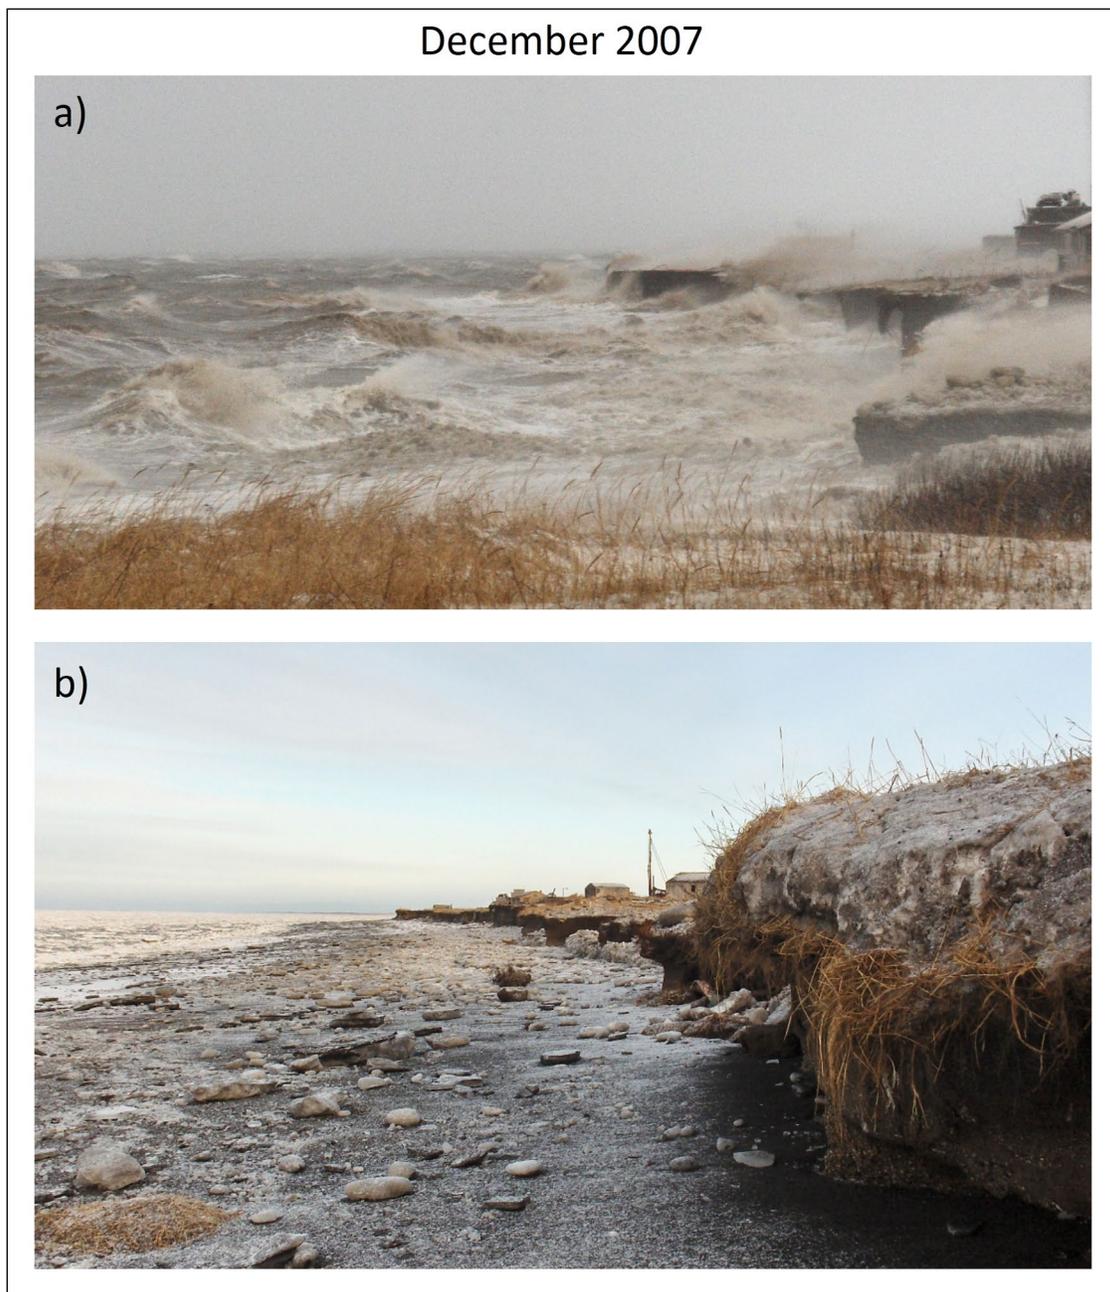
Figure 14. Photographs of the Meshik bluffs both (a) during and (b) immediately after a December 2007 storm. Note the undercutting at the base of the bluff from direct wave impact (photos by Scott Anderson).

direct and sustained wave impact to the face of the bluff (fig. 14). During these storms, the pumice-rich bluffs are readily steepened and undercut by the hydraulic wave action and abrasion, and a single location may experience more than one slip or block failure in the same storm event.

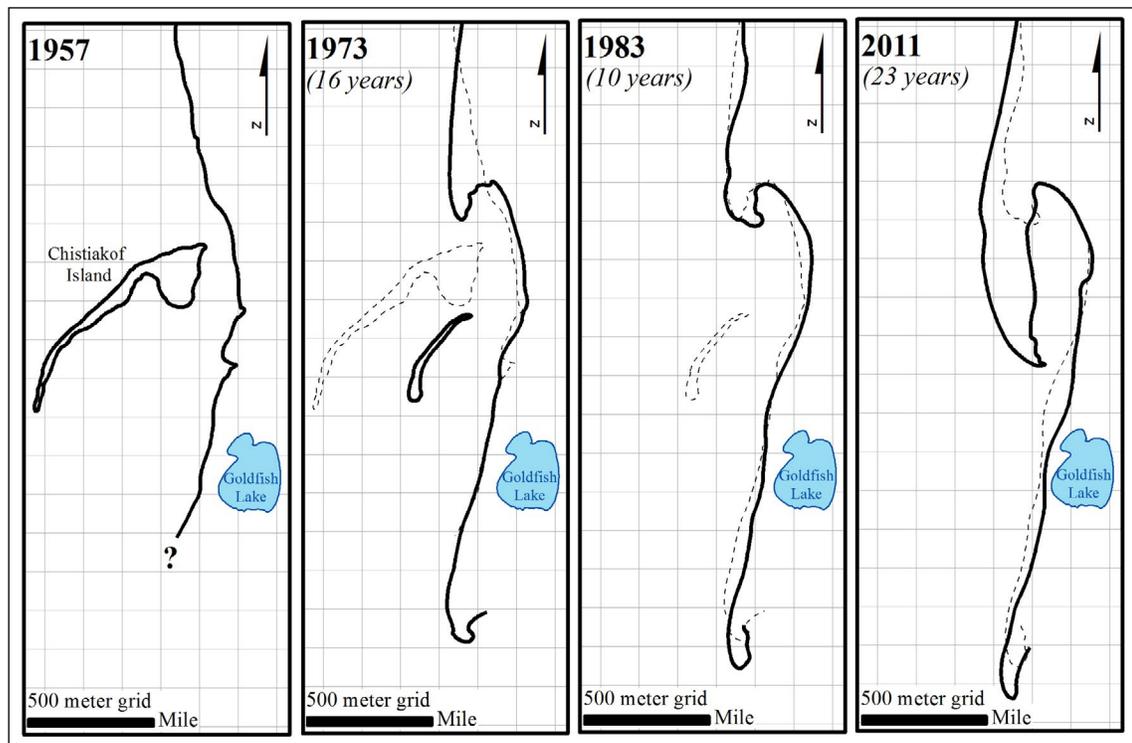
Figure 15. Diagrammatic series of shorelines (digitized from the instantaneous water line) in and around the Meshik study area from 1957, 1973, 1983, and 2011 that illustrate the reworking of the barrier system. Each time step after 1957 depicts the previous shoreline position as a dashed line. Goldfish Lake is shown to orient the reader to Meshik.
