POST-LANDSLIDE ELEVATION CHANGES DETECTED FROM MULTI-TEMPORAL LIDAR SURVEYS OF THE NOVEMBER 2023 WRANGELL, ALASKA, LANDSLIDES

Preliminary Interpretive Report 2024-2

Landslides identified by lidar data after the November 20, 2023, precipitation event in Wrangell, Alaska.

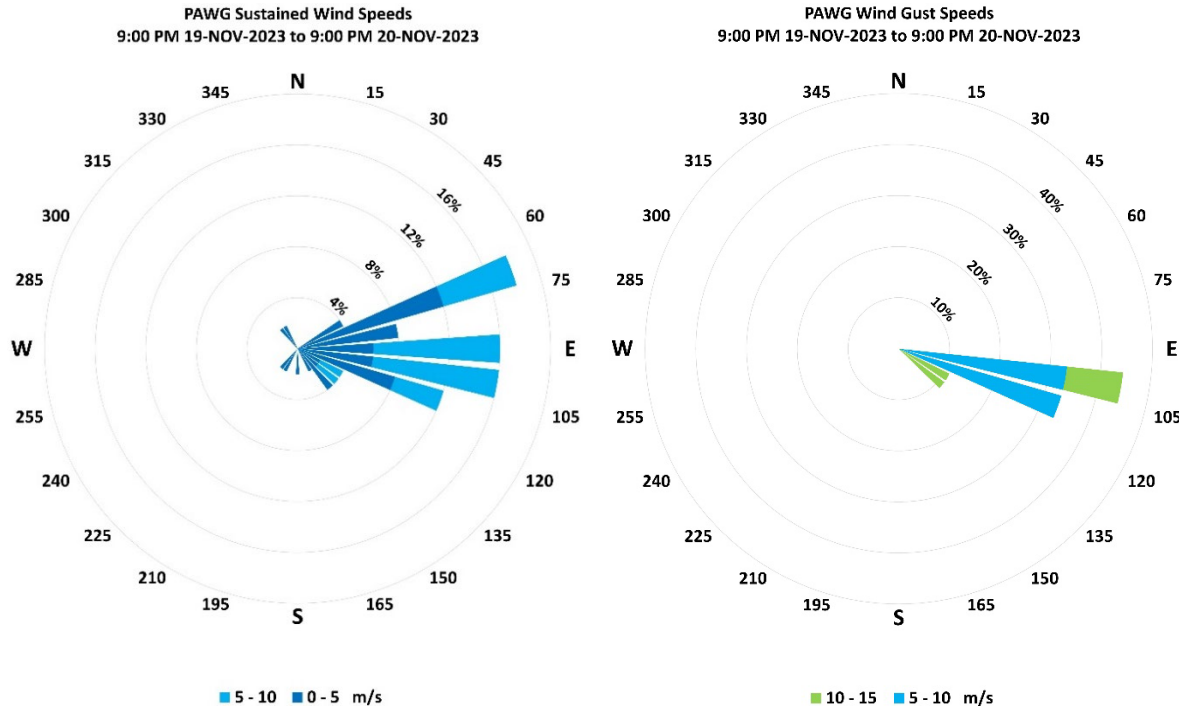
Figure 4. Weather station PAWG November 19–20, 2023, wind data: direction and sustained speeds (left), and direction and gust speeds (right).

Table 2 summarizes weather station PAWG's average historical wind data and the data covering the 24 hours preceding the landslides; the data are visually depicted in wind roses in figures 3 and 4. Table 3 summarizes weather station LCNA2's average historical wind data and the data covering the 24-hour period prior to the landslides. Although wind may have been a factor, it is not interpreted as having a meaningful impact on landslide initiation during this event.

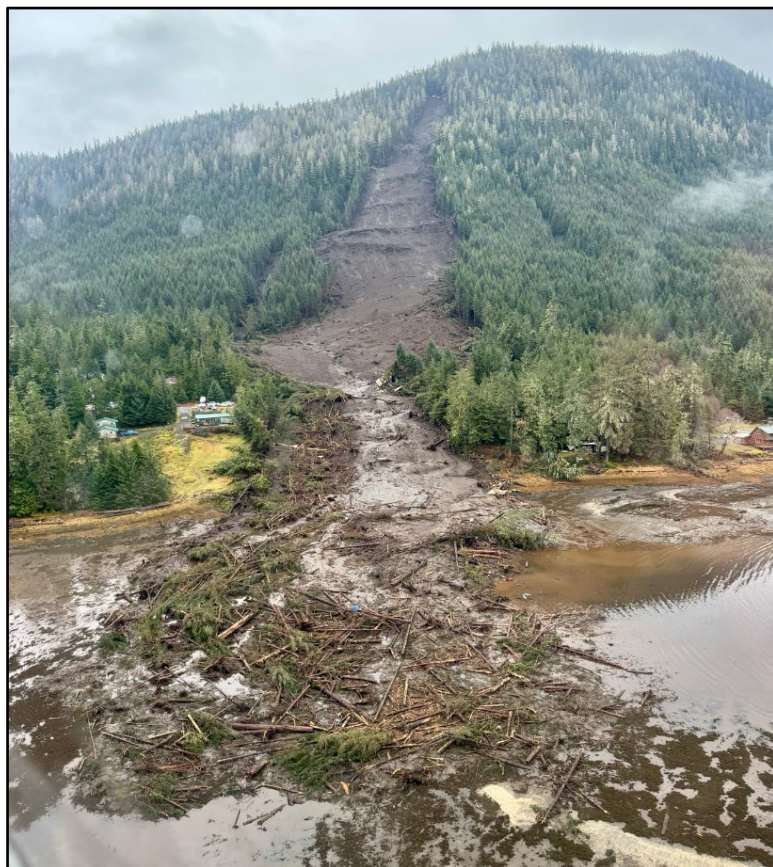
DGGs geologists flew helicopter reconnaissance over the MP11.2 landslide on November 22 and 26 to document and assess the landslide source area and flow path. There is a distinct head scarp at 1,490 ft (450 m) asl and several bedrock benches at various elevations that trend roughly perpendicular to the path of the landslide. The soil cover in the steep source area is thin, with potential for thicker soil development in the flat areas above the bedrock benches. The landslide debris is primarily comprised of saturated soils and large wood debris, with minimal rock material. The landslide spanned approximately 3,750 ft (1,140 m) from head scarp to shoreline, with roughly an additional 500 ft (152 m) extending into Zimovia Straight

(fig. 5). The landslide was approximately 350 ft (106 m) wide where it crossed the highway, wider in other sections further upslope, and it tapered to about 100 ft (30 m) at the head scarp.

Figure 5. Zimovia Highway milepost 11.2 landslide (photo taken looking east by Barrett Salisbury, November 22, 2023).

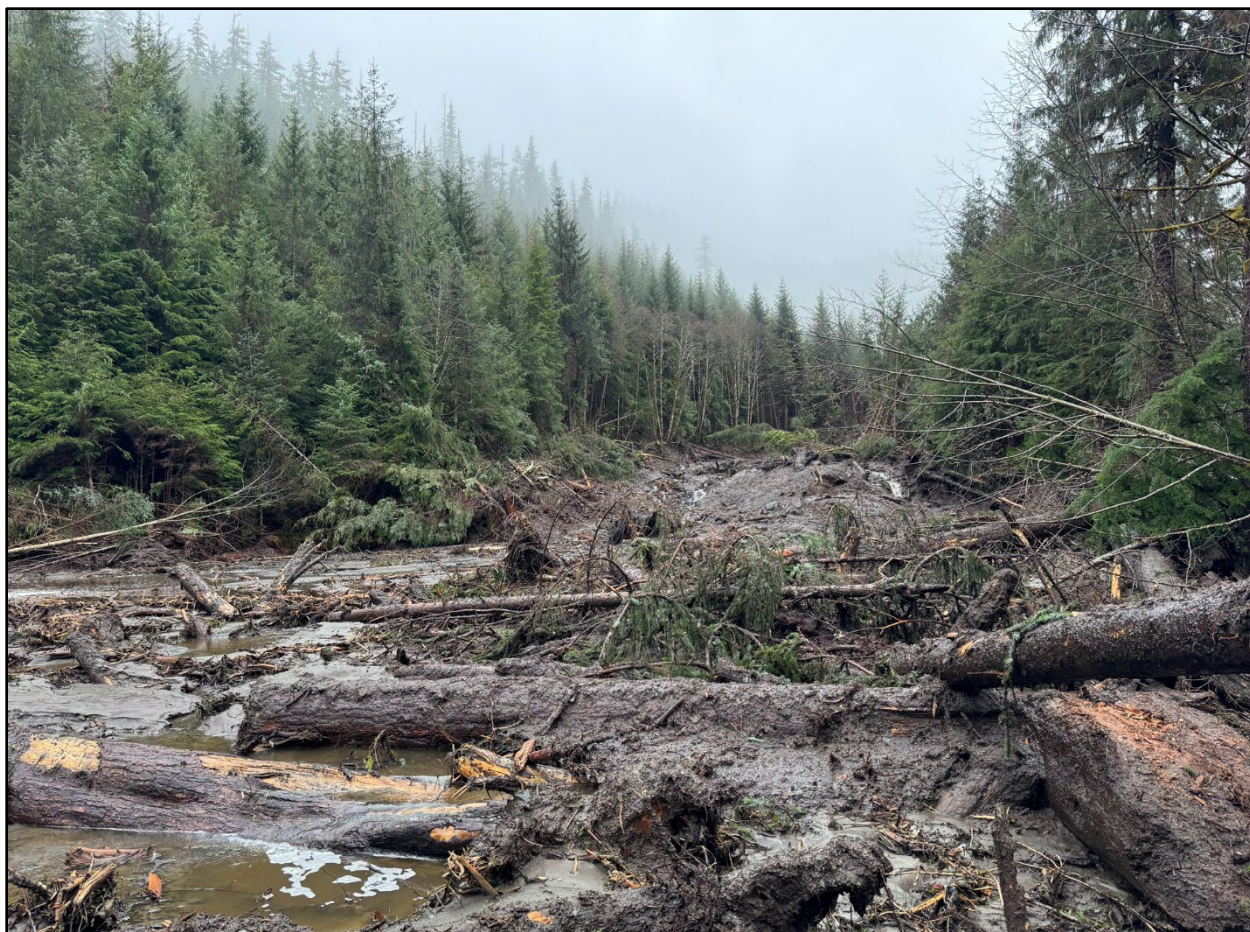
The Middle Ridge Road landslide occurred within one to two hours after the MP11.2 landslide, based on information given by the resident who was temporarily trapped by this landslide. DGGs geologists accessed the toe of the landslide to document and assess the debris composition. This lower section of the landslide was estimated to be approximately 150 ft (50 m) wide and covered approximately 600 ft (180 m) of Middle Ridge Road (fig. 6). The Southeast Power Authority flew a drone survey over the landslide on November 24, 2023, which helped determine the location of the source area and the flow path downhill. The landslide crossed Middle Ridge Road in three places and followed an already established stream channel resulting in significant erosion and entrainment of material in the V-shaped channel. From head scarp to toe, the landslide was approximately 3,600 ft (1,100 m) long and more than 100 ft (30 m) wide, with similar composition to the MP11.2 landslide: primarily large wood debris and saturated soils with very little rock.

Figure 6. Toe of the Middle Ridge Road landslide where it covers the road (photo looking south by Barrett Salisbury, November 24, 2023).

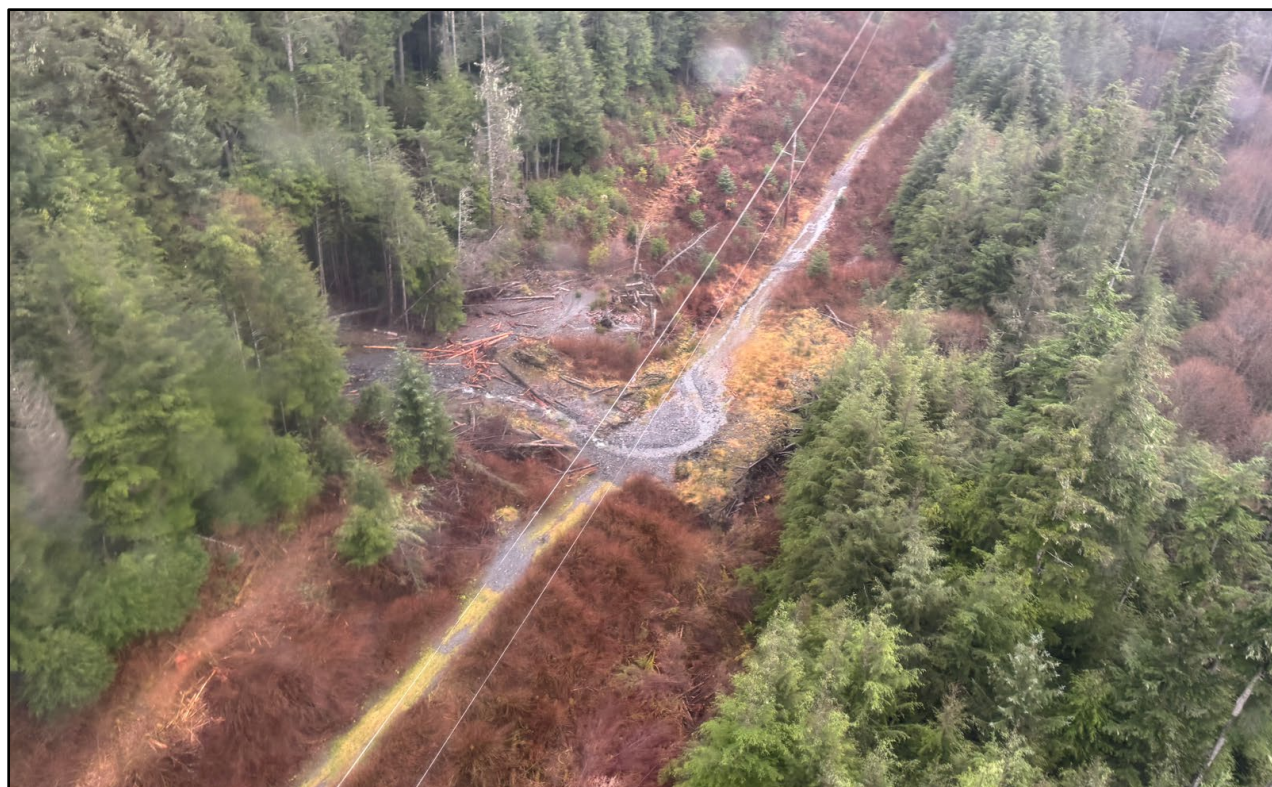
On November 21, 2023, residents of the Nugget Trailer Court, located at approximately MP3 of the Zimovia Highway, reported an unusually large volume of water flowing through the neighborhood drainages and down Phillips Street, as well as sediment accumulation in an unusual location. According to several residents, a landslide that occurred upslope of the neighborhood in 2021 or 2022 (date undetermined) deposited rocks and sediment onto the powerline right-of-way (confirmed with Google Earth historical imagery). On November 23, DGS geologists flew helicopter reconnaissance over the area, took aerial photographs (fig. 7), and visited the MP3 slide area on foot with the City of Wrangell Public Works Director and a local resident. We observed new mass wasting material in the channel and on the powerline right-of-way, which we associated with the November 20 precipitation event, and identified potential stream channels directing water flow toward the trailer court.

Figure 7. Aerial image of the landslide deposition zone, looking southeast, located upslope from the Nugget Trailer Court (photo by Barrett Salisbury, November 23, 2023).

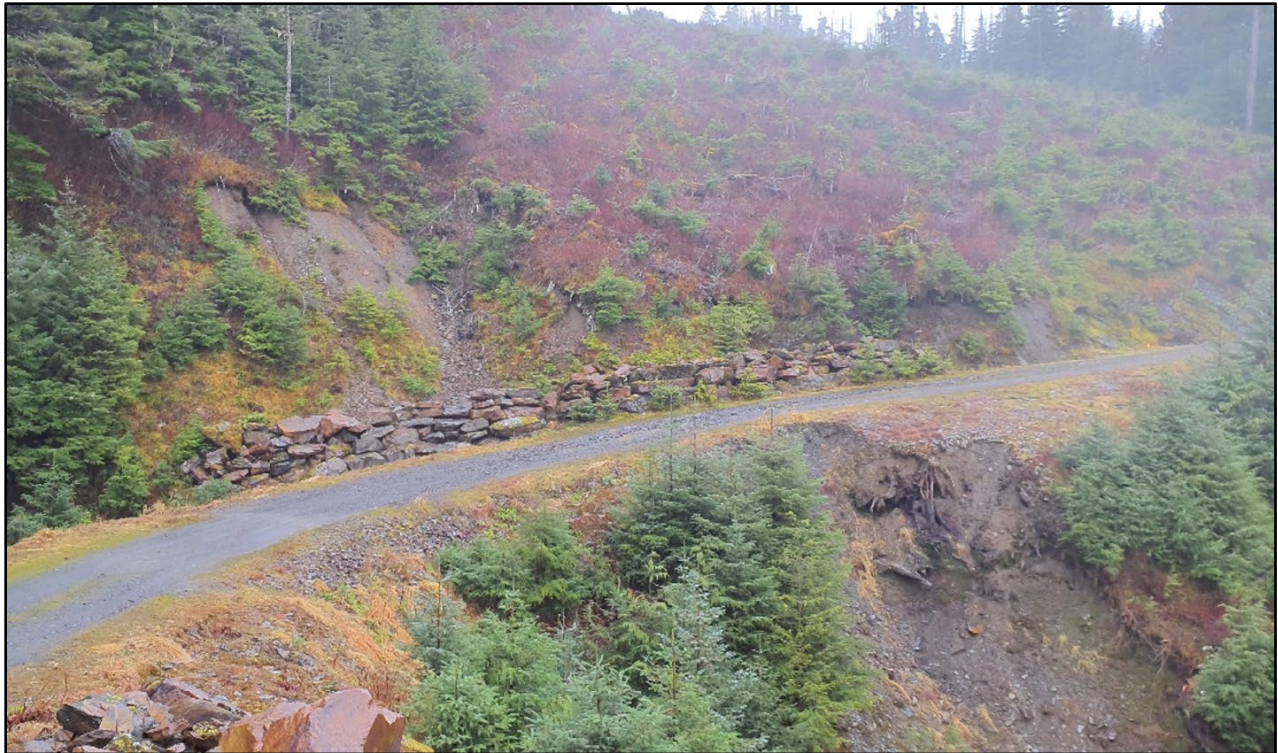
We joined a U.S. Forest Service officer to investigate additional landslide activity along the logging road network accessible north of the MP11.2 landslide road closure (forestry roads 50051, 50052, and 50055). The higher elevations were cloud-covered so visibility was limited, but no new landslides were identified near the roads. An existing landslide originating at forestry road 50052 and crossing forestry road 50051 was visited to investigate for possible reactivation (fig. 8).

Figure 8. Existing landslide on forestry road 50052 (photo by Jillian Nicolazzo, November 25, 2023).

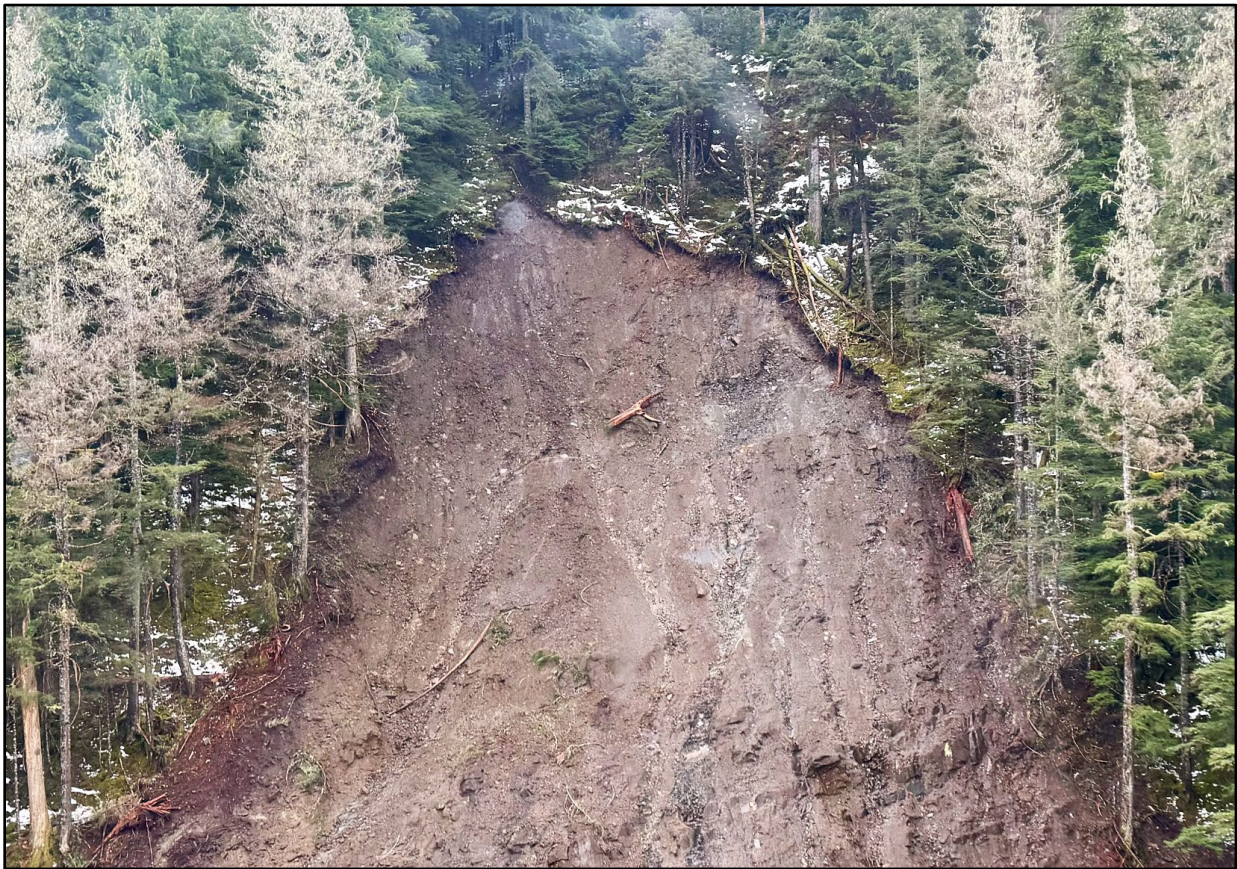
A 150-ft- (45-m-) long head scarp shaped like an inverted “U” is visible at the top of the MP11.2 landslide (fig. 12) at approximately 1,500 ft (455 m) asl. The lidar differencing suggests that roughly 2.8 million ft³ (80,000 m³) of material was released/eroded and approximately 1.7 million ft³ (48,000 m³) was deposited by the landslide (fig. 13). The DOT&PF had already removed debris from the road at the time of the November lidar survey and that removed volume is not part of the deposited volume stated here. In addition, this landslide ran into the ocean and deposited sediment in the water. Additional bathymetric lidar or sonar is necessary to calculate this deposition volume (not currently planned).

Figure 12. MP11.2 landslide head scarp (photo by Barrett Salisbury, November 23, 2023).

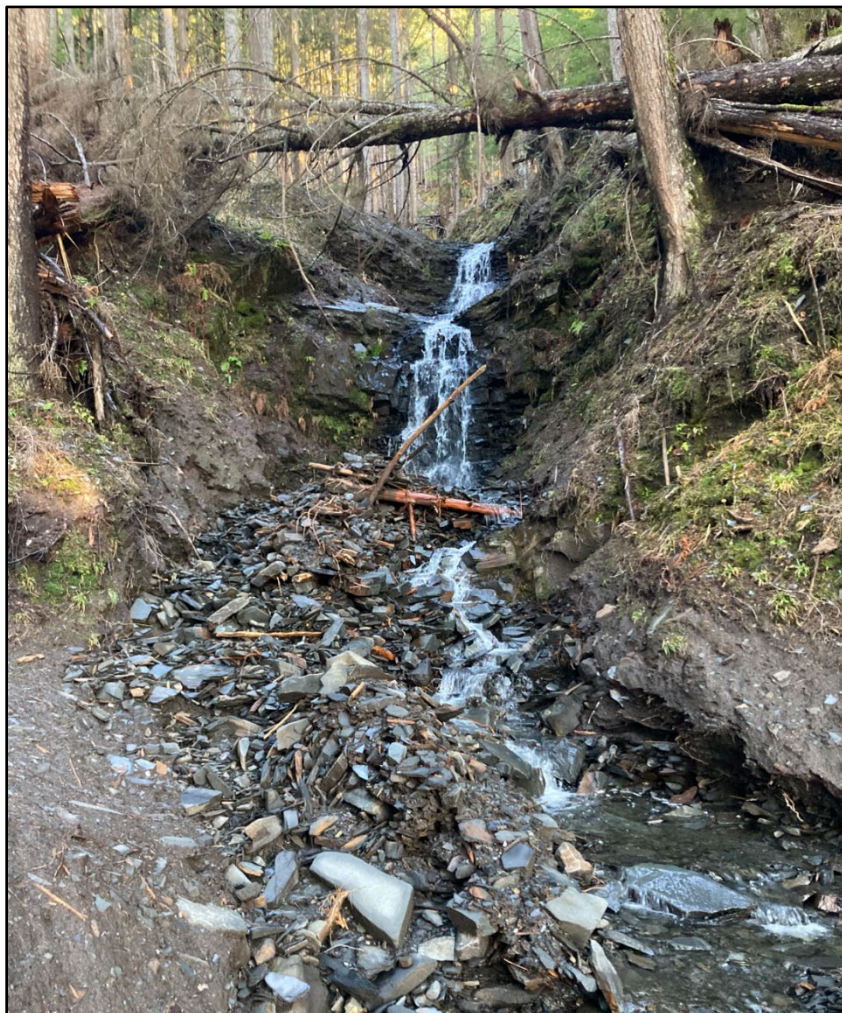
Loose rock occupies the drainages in the upper elevations on the hillside (fig. 16) and is mobilized during heavy rains. Smaller sands and gravels are more easily transported by flowing water than larger gravels and cobbles, which require a heavier and faster flow. Recent sand deposits were noticed in several areas along this section of the logging road; it is likely this will continue. Differencing of the two lidar datasets did not show any significant volume change between acquisition dates.

Figure 16. Angular bedrock debris in stream channel that feeds into the debris fan upslope from Nugget Trailer Court (photo by Tom Wetor, City & Borough of Wrangell, December 7, 2023).
