Hydrological Studies on Alaska's Western North Slope - In support of ASTAR

Justin Germann¹ and Ronald Daanen¹

¹Alaska DNR Division of Geological & Geophysical Surveys

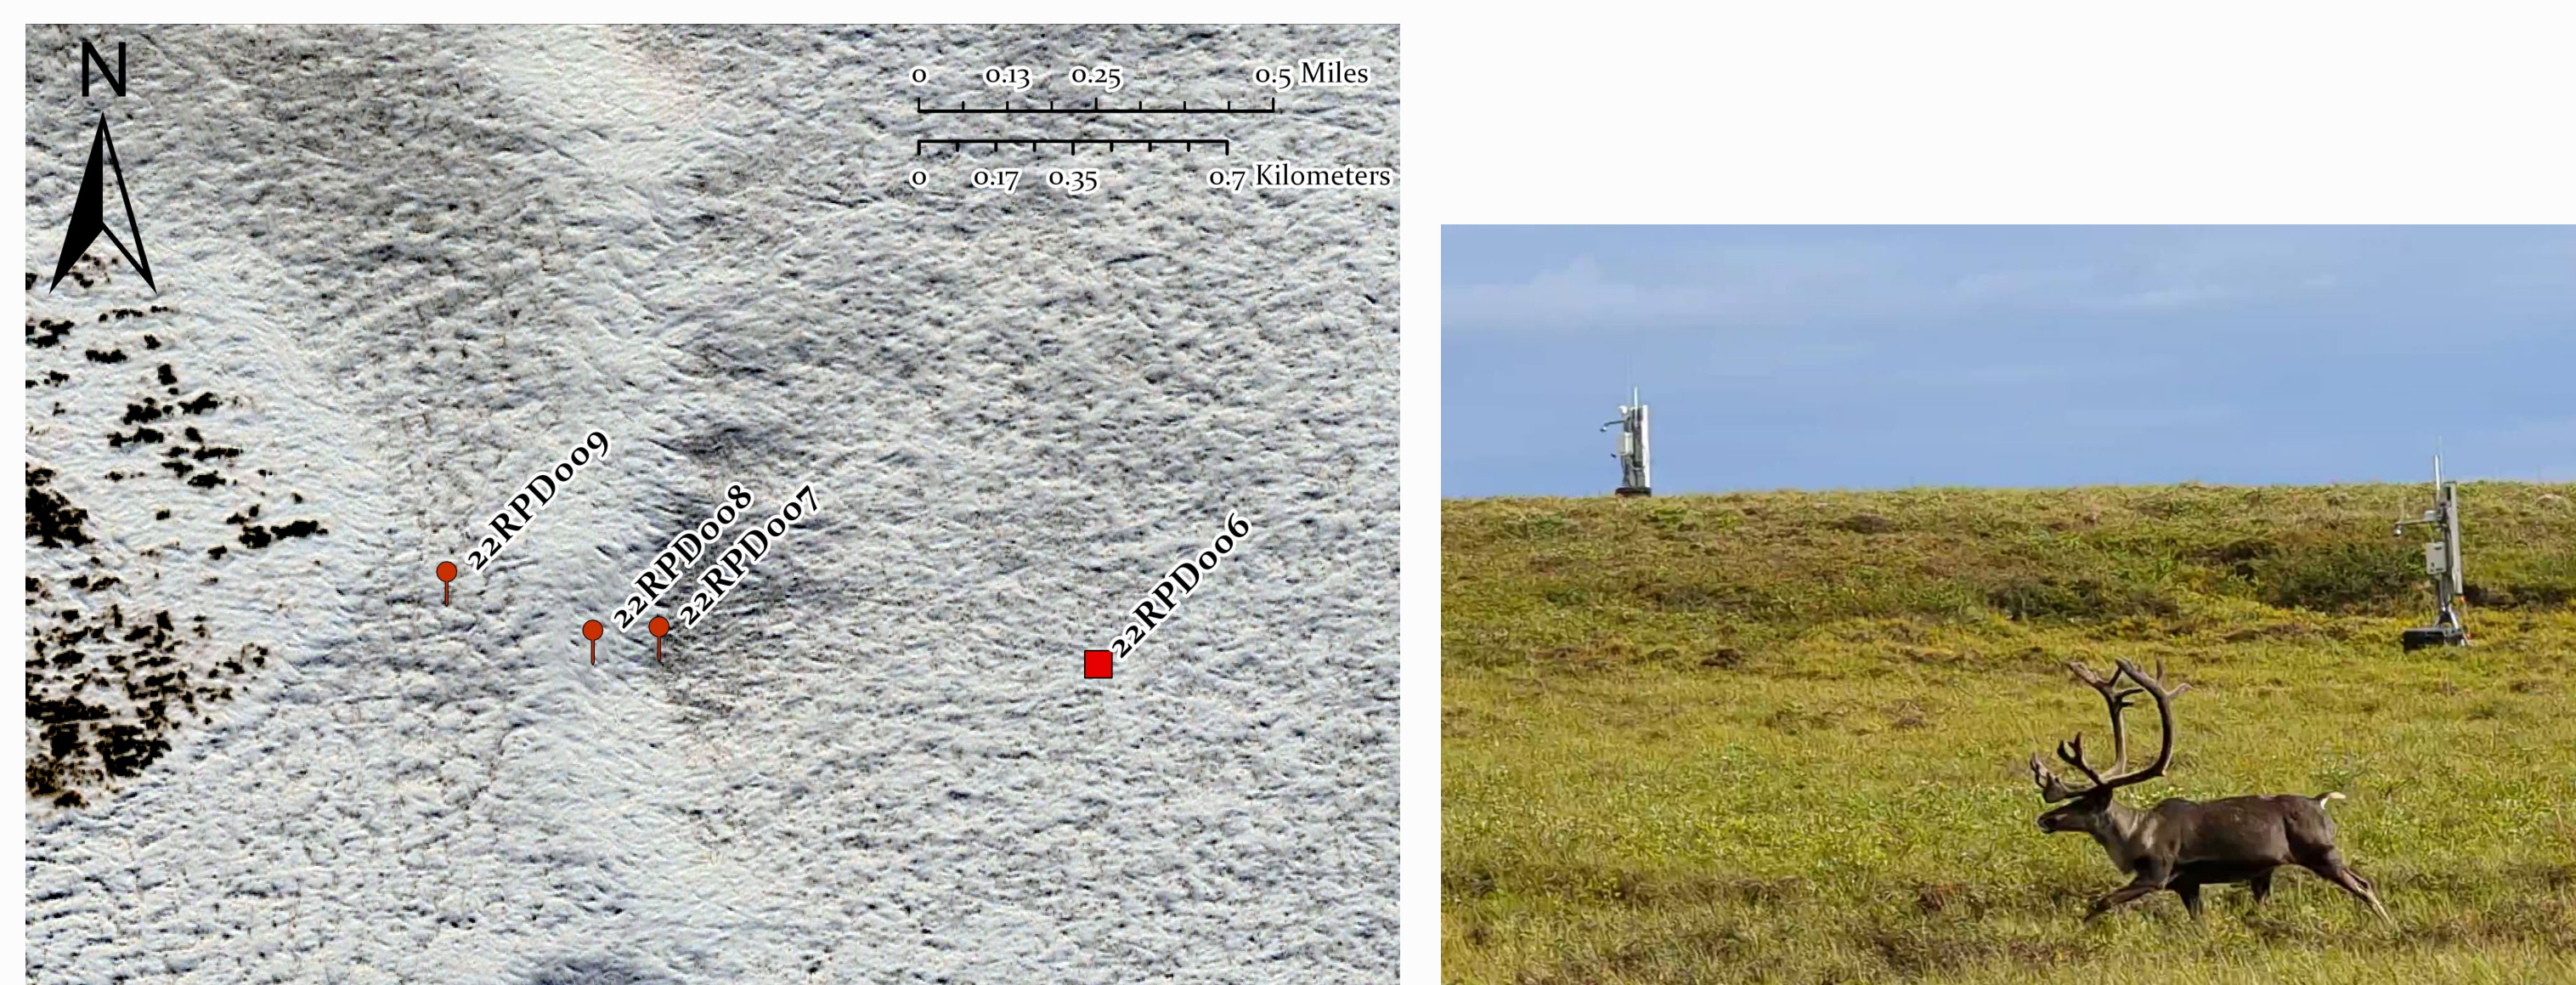
Figure 1. Left. Three snow nodes associated with weather station 22RPD006. Snow stations were strategically placed to measure variability along ridgeline surrounding small lake. **Right.** Caribou passing by snow nodes 22RPD007 (background) and 22RPD008 (foreground) showing clear ridgeline from the ground.

The installed weather towers were accompanied by three snow nodes within one mile from the weather station tower. The snow nodes were strategically placed in locations that would measure variability in snow accumulation (fig. 1) to better capture on-the-ground variation in the snowpack.

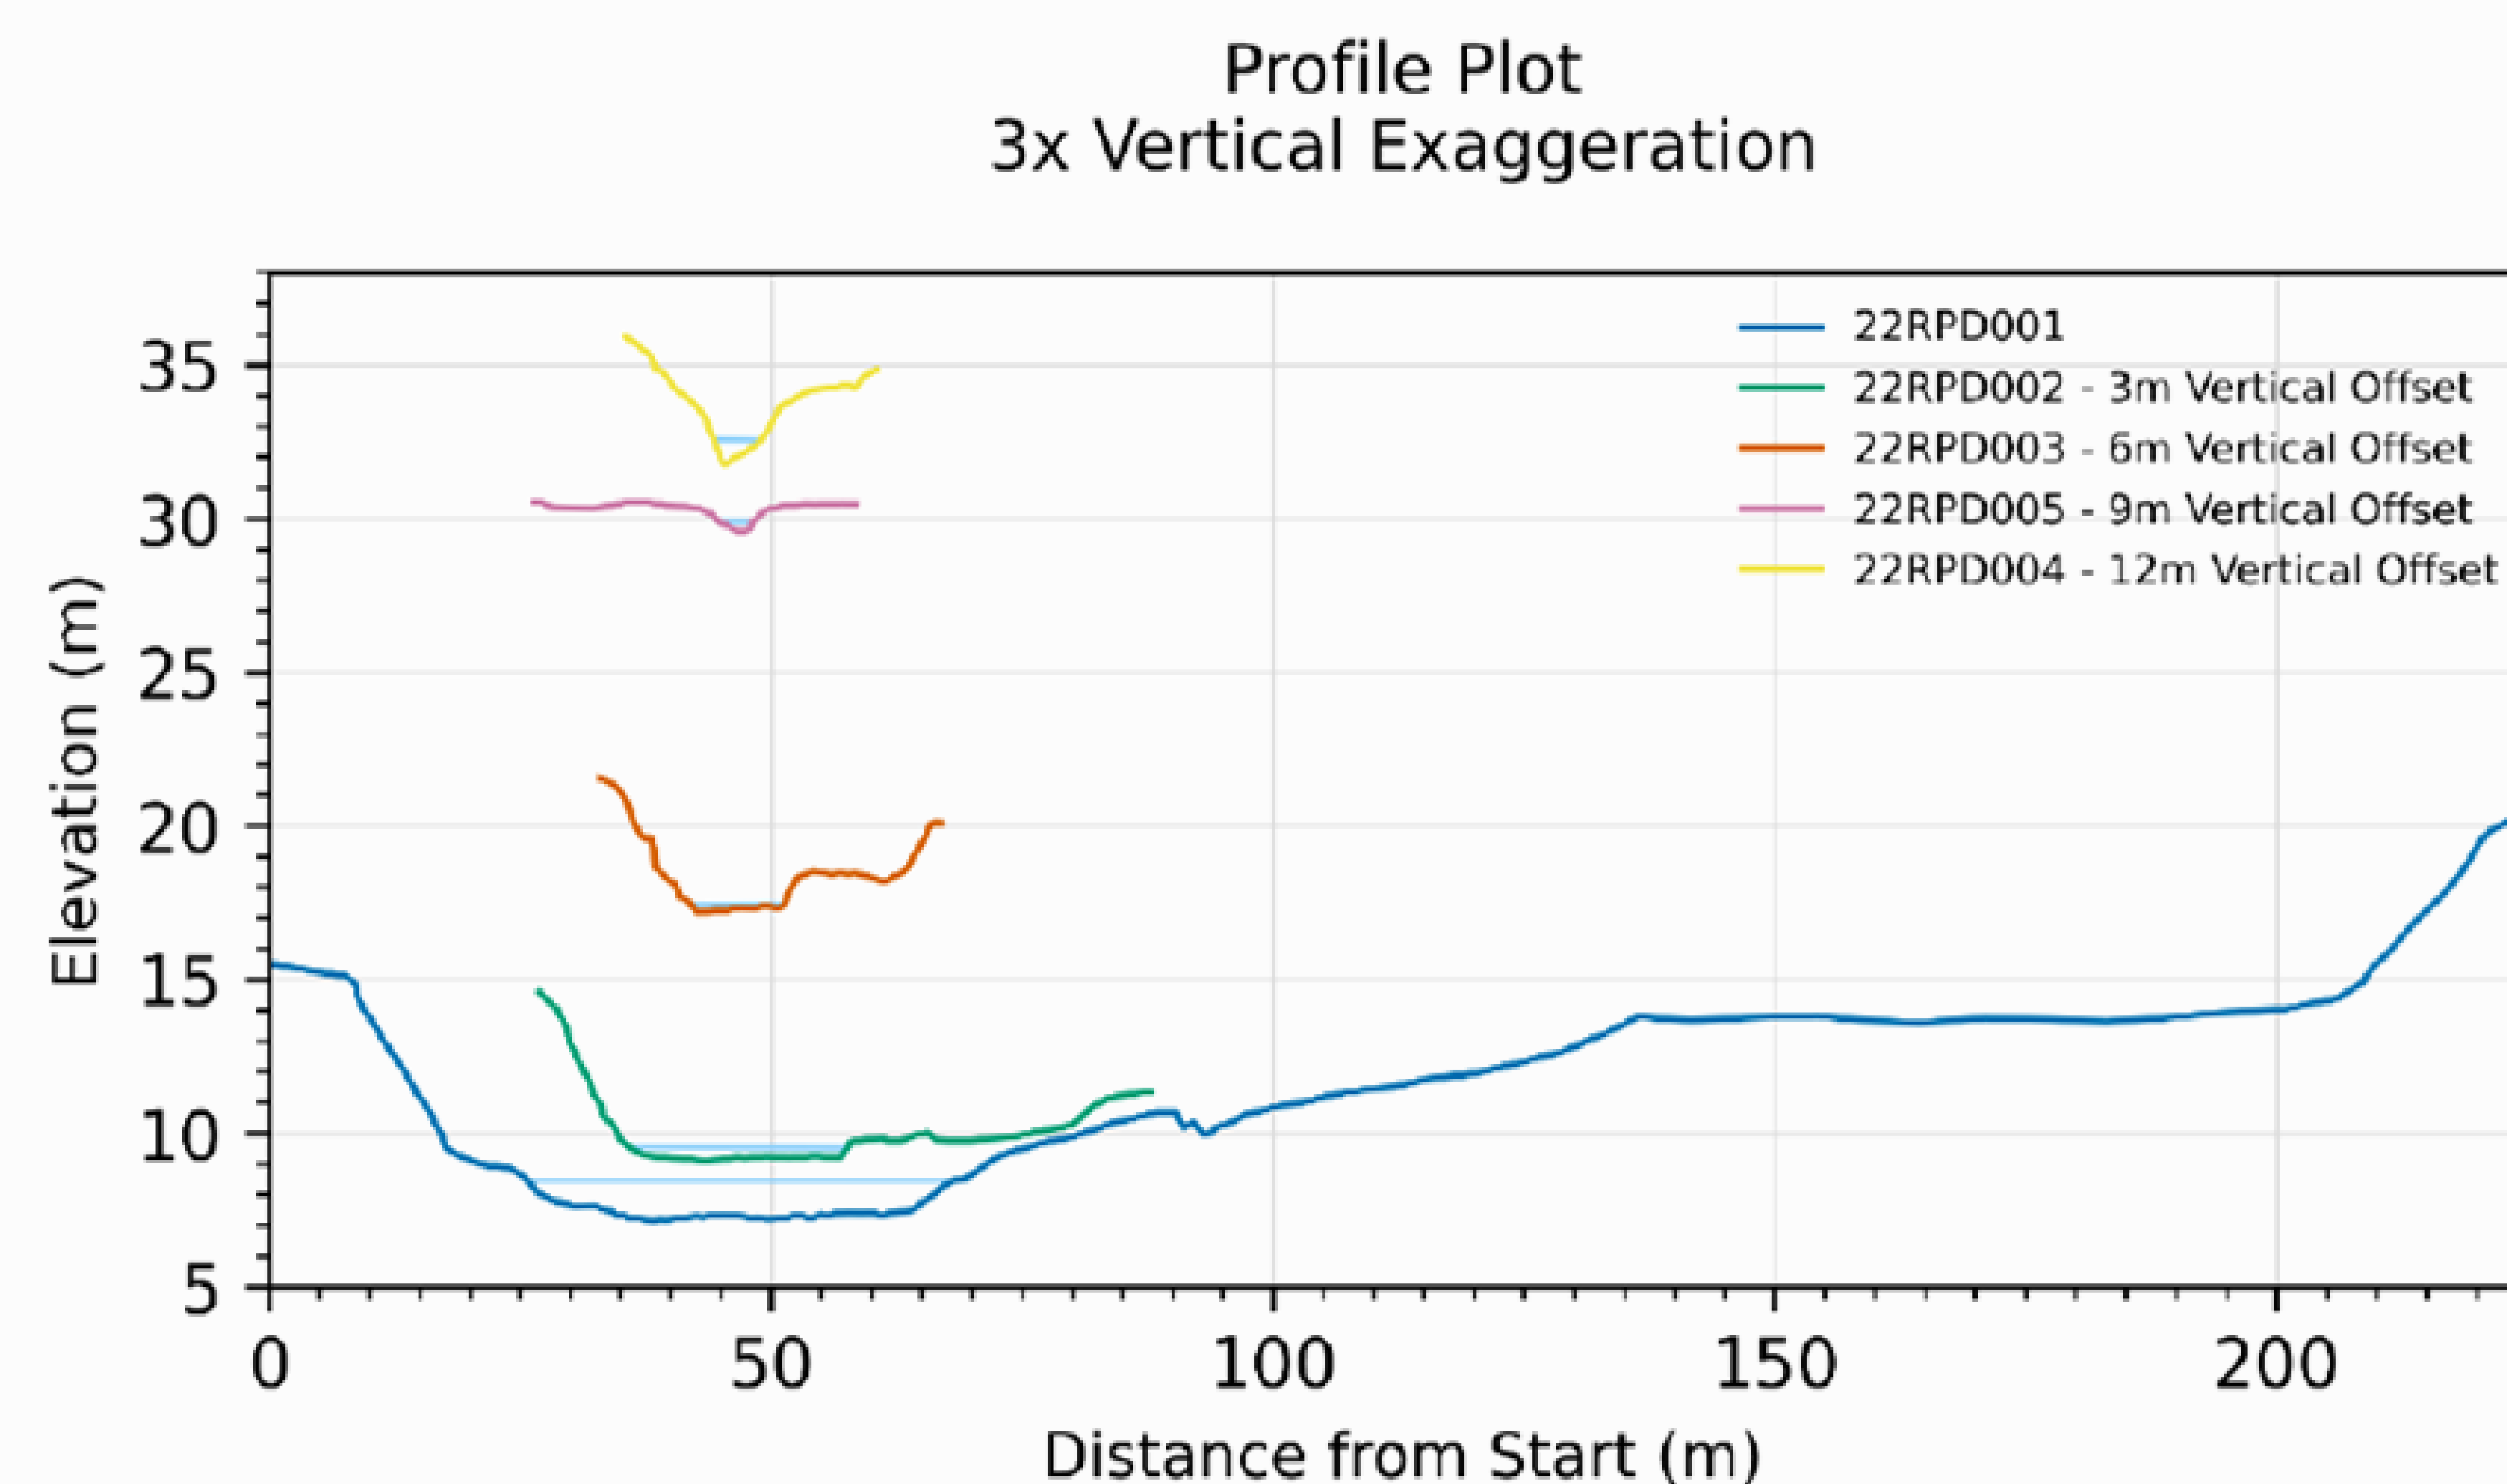
Figure 3. Stream profile measurements collected during installation of stream gage. A 2x vertical exaggerating is applied as well as an offset applied to stations 22RPD002-005 to avoid overlaps.

Installation took place in August 2022 as it was assumed that waterways would be in low flow stage during the summer. The primary source of water in this region is snow-pack melt and rainwater run-off, so staff also measured the channel profile using a differential GPS for centimeter-accurate measurements while installing the gage equipment and calculated the discharge of each waterway using an OTT Hydromet MF Pro (fig. 3). detailed information on the river profile and discharge data can be found in our recent publication (Germann and Daanen, 2022).

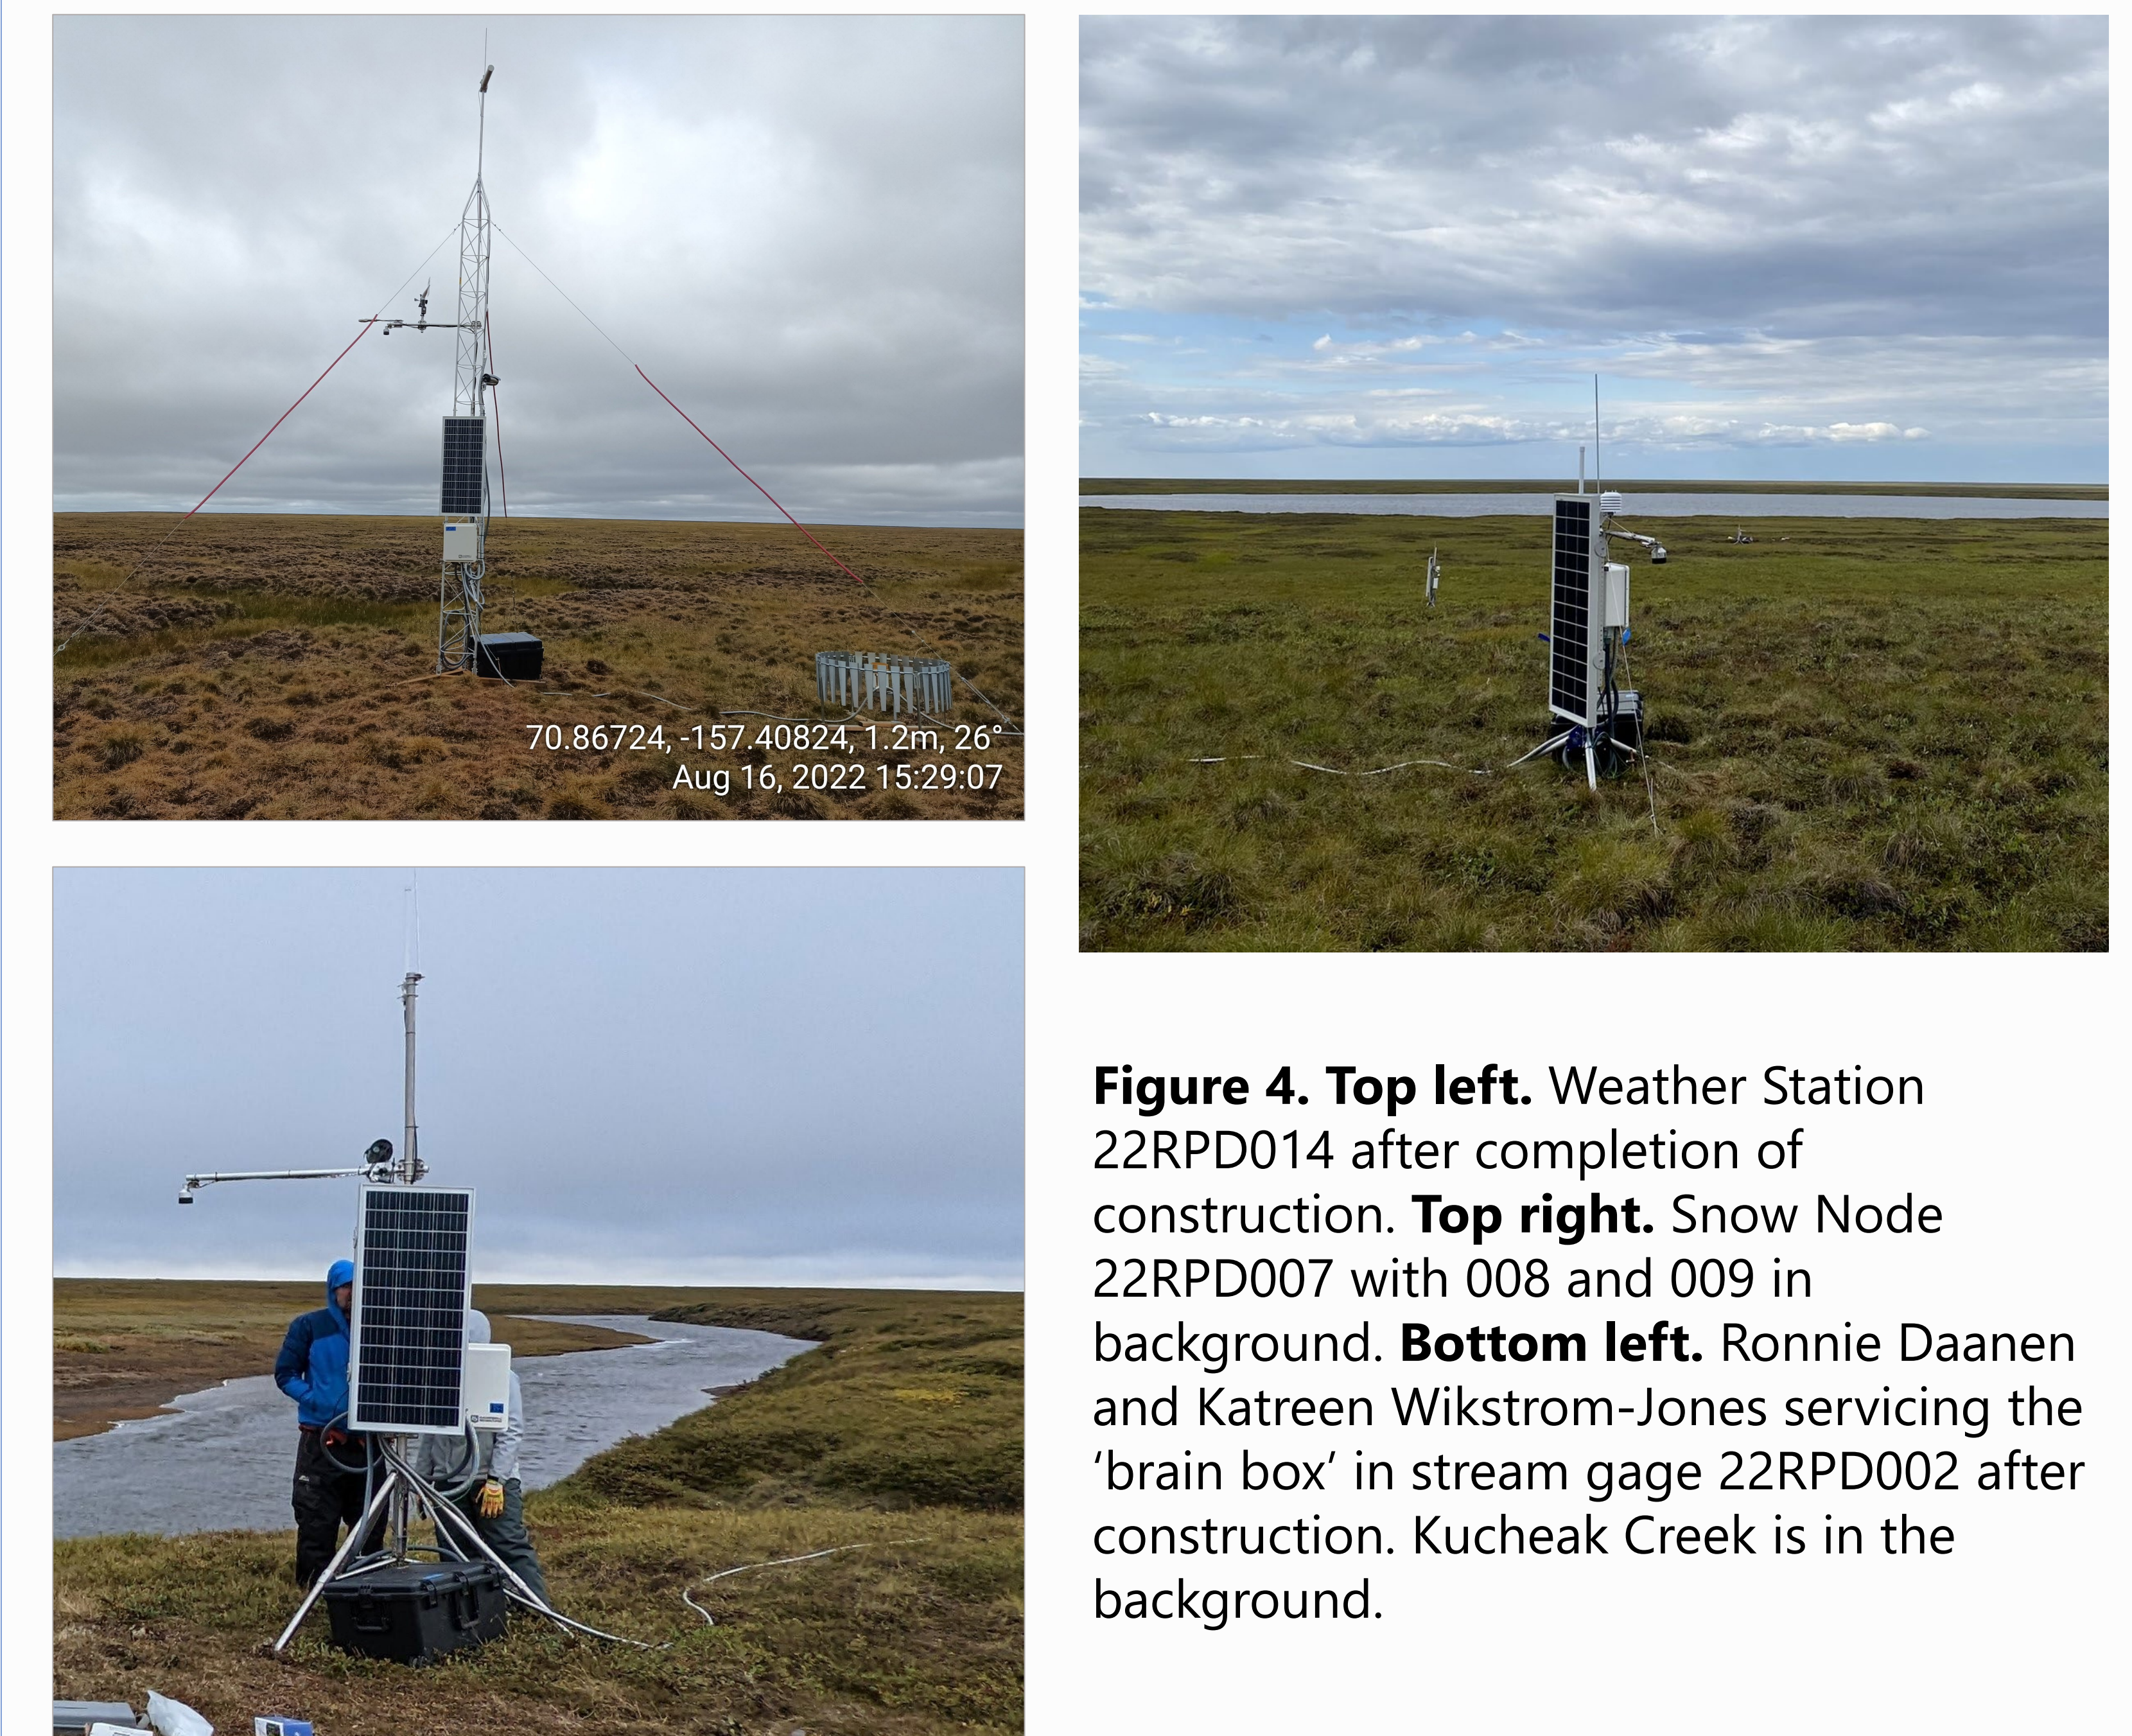
Figure 4. Top left. Weather Station 22RPD014 after completion of construction. **Top right.** Snow Node 22RPD007 with 008 and 009 in background. **Bottom left.** Ronnie Daanen and Katreen Wikstrom-Jones servicing the 'brain box' in stream gage 22RPD002 after construction. Kucehak Creek is in the background.

All stations are powered by several batteries maintained by a solar panel. Environmental sensors such as air temperature, ground temperature, ground moisture, and downward firing acoustic distance sensors (used to measure snow accumulation) are included on each station. Weather stations also include a suite of environmental sensors, including radiation sensor, wind vein, barometer, ground temperature profiler, a tipping bucket precipitation gauge, and humidity sensor.
