Monitoring Event-driven Erosion in Wainwright, Alaska

The importance of high-resolution data for capturing change on
the Arctic Coast.

Keith Horen, Nora Nieminski, Autumn Poisson, and Jessie Christian
October 27, 2023

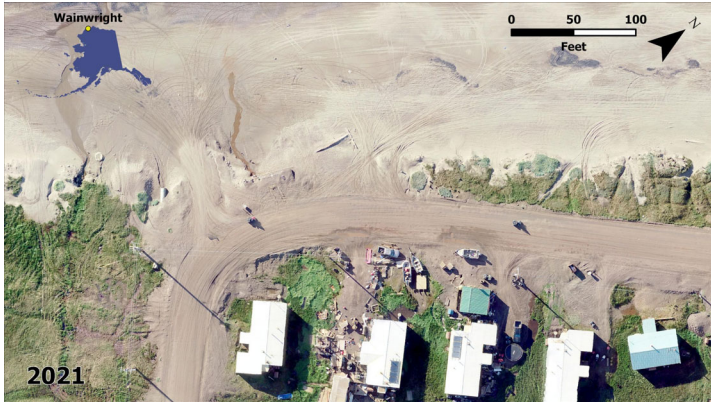
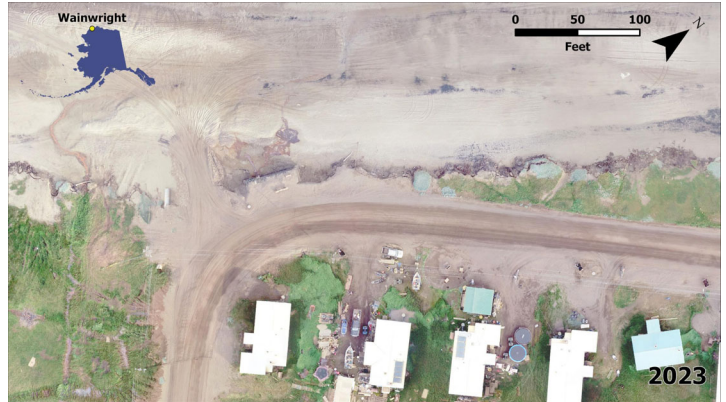
Repeat high-resolution aerial imagery is useful for visually assessing change. Comparing 2021 and 2023 imagery of the beach and bluffs at the southern end of Wainwright shows dramatic change caused by the October 2022 storm. From this imagery it is evident that erosion is encroaching on roads and other infrastructure, and impacting access to the beach. Subsistence hunting and fishing off the northern coast are vital to the culture, economy, and health of Wainwright's citizens (Brubaker and others, 2014).

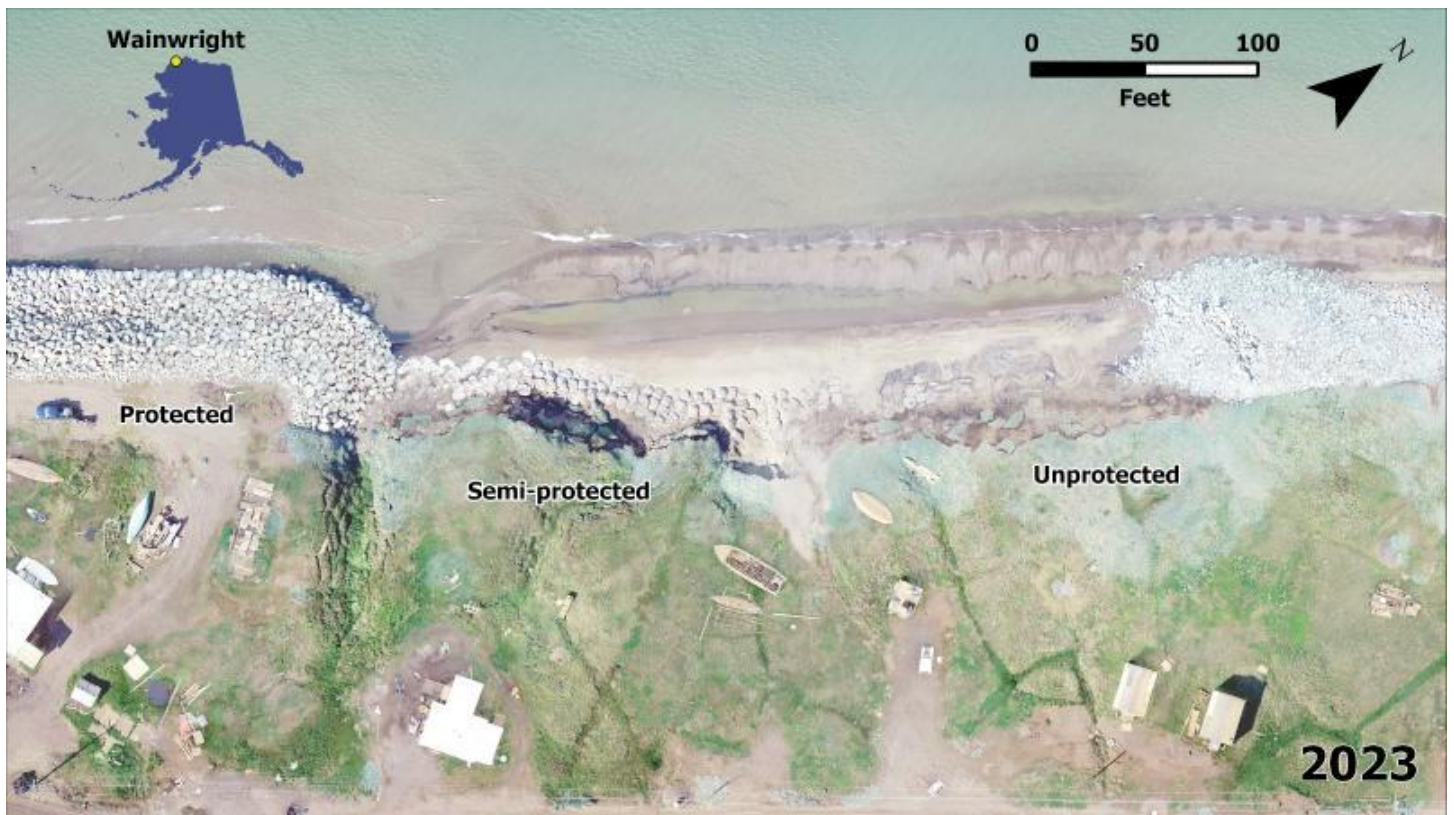
Areas of protection, semi-protection, and no protection were visually identified by DGGS to allow each level of erosion mitigation to be analyzed separately. A cut-fill analysis was then run against the 2021 and 2023 DSM for each area.

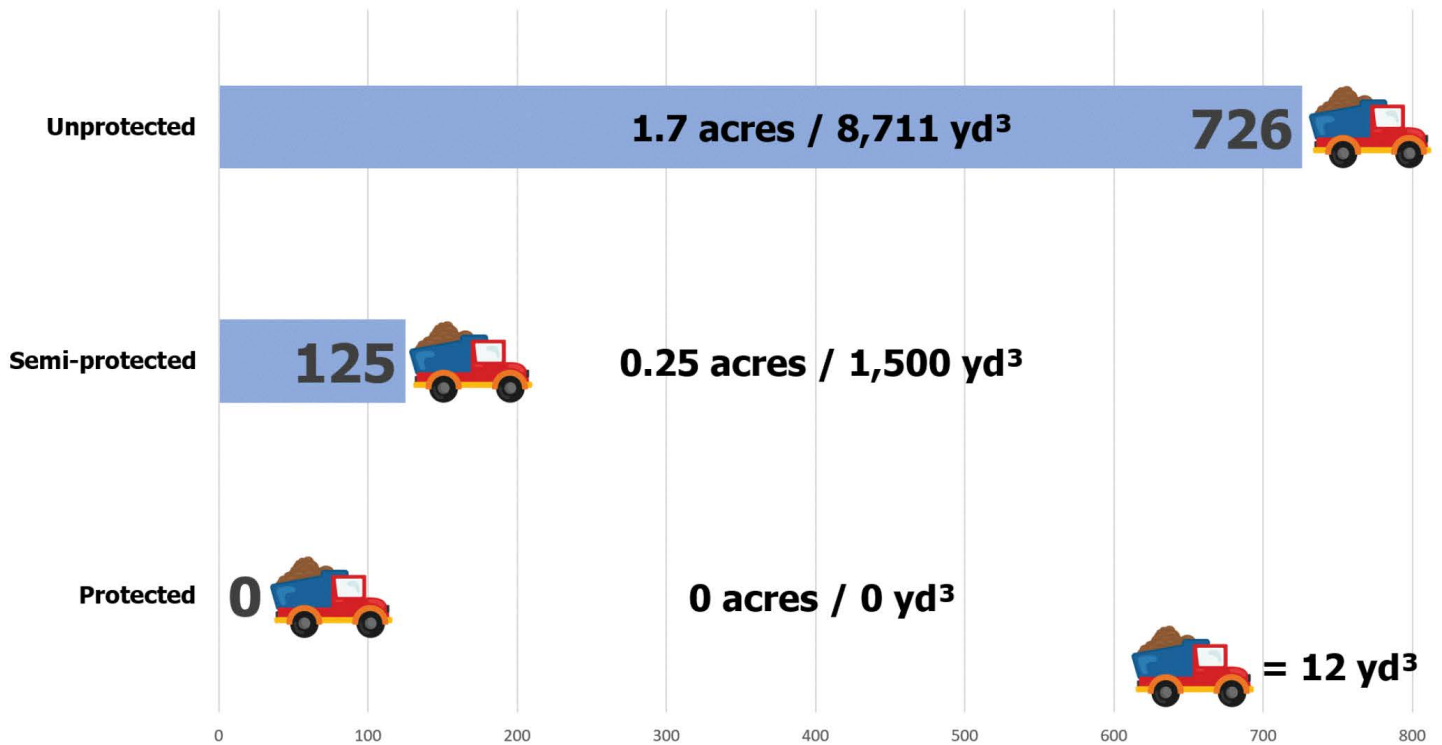
Truckloads of material loss by protection type

Engineered protections cover approximately 0.14 miles of the 1.1-mile-long study area, with semi-protected bluffs accounting for roughly 0.25 miles, and unprotected bluffs making up the remaining 0.71 miles.

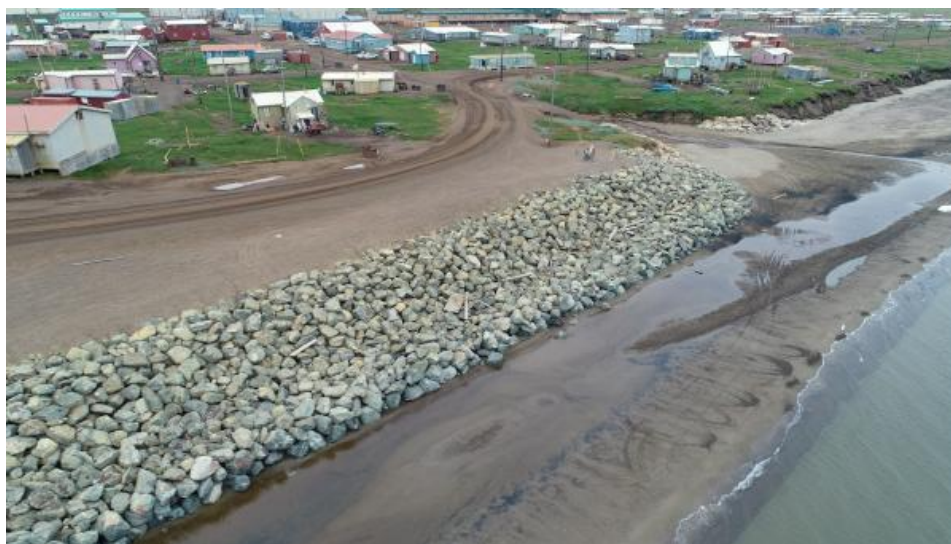
Oblique imagery of the rock revetment protection in Wainwright, Alaska (DGGs, 2023)

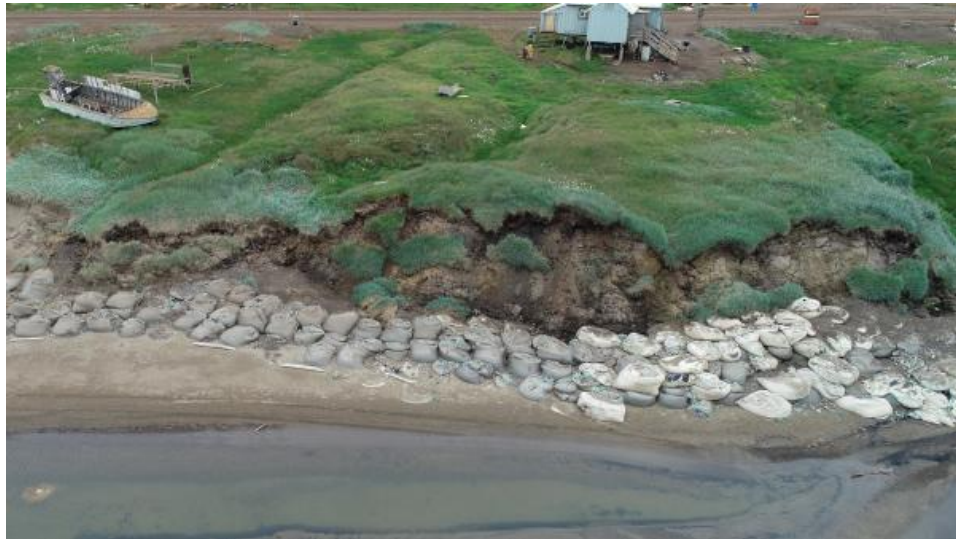
Oblique imagery of sandbag semi-protection in Wainwright, Alaska (DGGS, 2023)

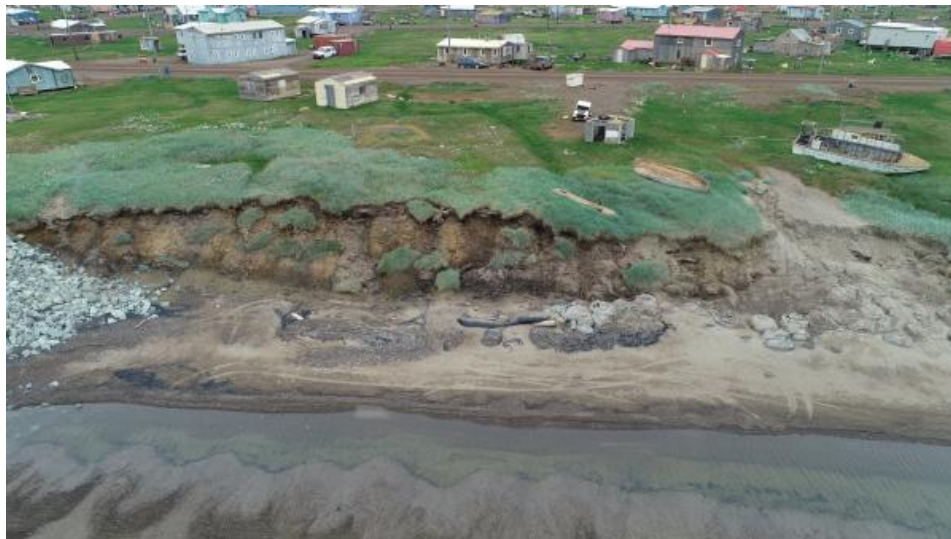
Oblique imagery of an unprotected bluff in Wainwright, Alaska (DGGs, 2023)

Unprotected bluffs are subject to the full force of incoming waves, leaving them especially vulnerable to event-driven erosion. Areas without protection are prone to faster rates of erosion than

protected portions of the bluff (Buzard and others, 2021a). Such unprotected areas in Wainwright experienced significant erosion between 2021 and 2023, which included retreat of the bluff edge.

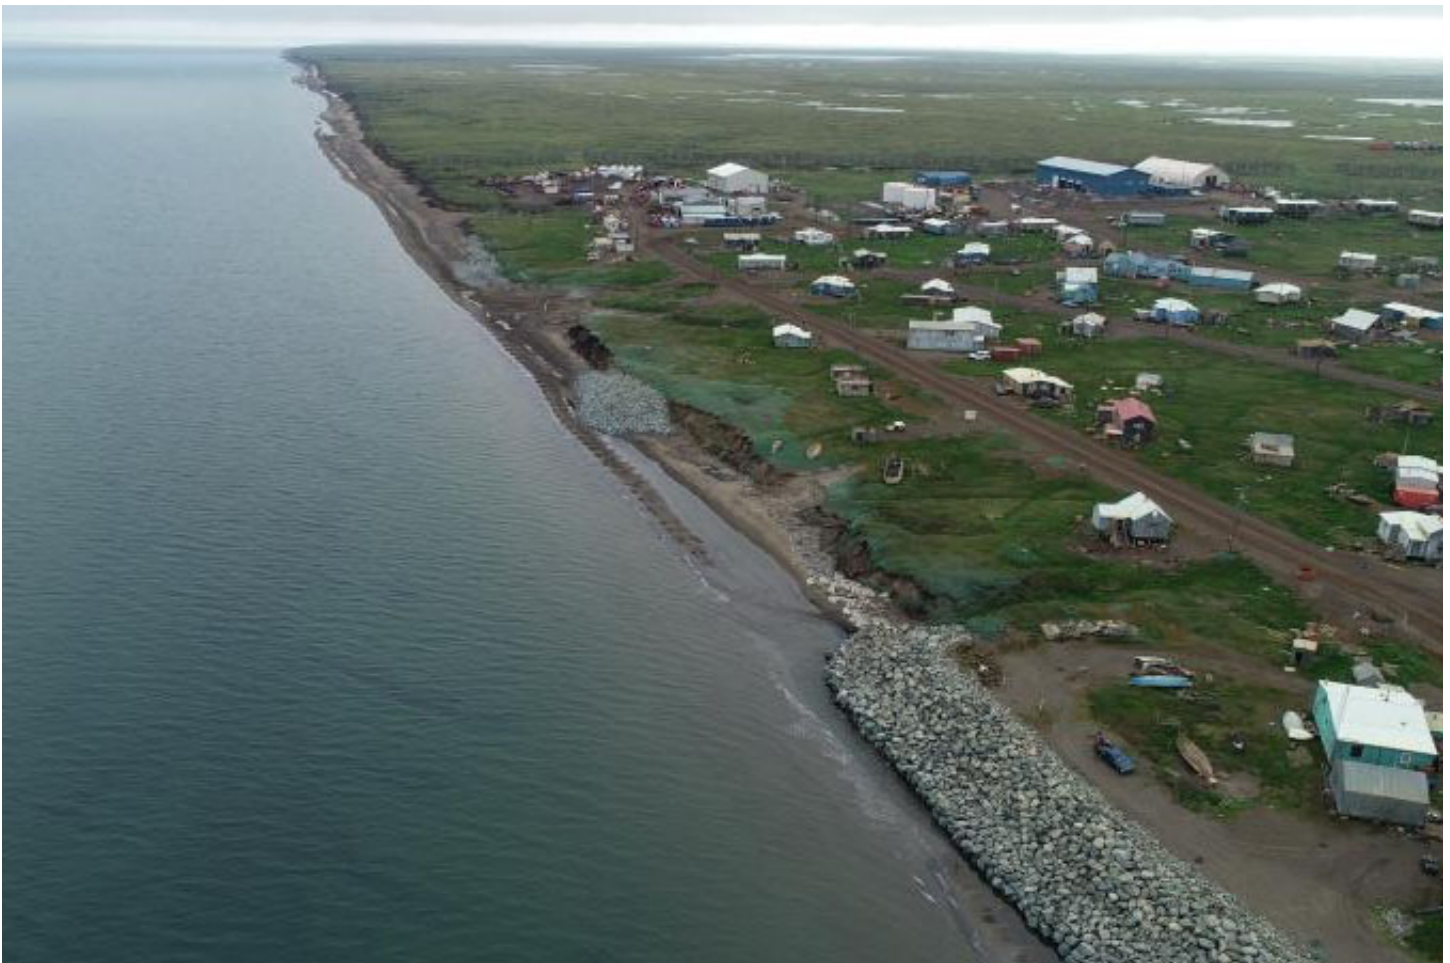
An elder directed our attention to the scarps and overhangs that make up the exposed bluff edge, telling us it used to be at least twenty feet further out before the October 2022 storm.
