PHOTOGRAMMETRY-DERIVED ORTHOIMAGERY AND ELEVATION FOR ALAKANUK, ALASKA, COLLECTED JULY 11, 2021

Raw Data File 2021-17

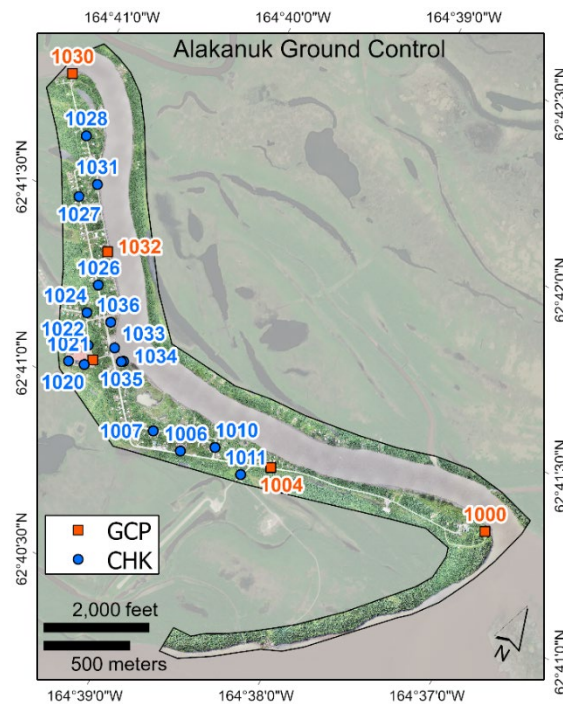
Figure 2. Location of photo-identifiable ground control points (GCPs; red) and check points (CHK; blue).

We quantify the horizontal accuracy of the DSM and orthoimage by comparing the known locations of 16 photo-identifiable check points measured with GNSS against their modeled locations in the photogrammetric products (fig. 2). X and Y errors are calculated as the root-mean-square (RMS) error of offsets. The total horizontal error is the root-sum-square error of X and Y RMS errors, 0.048 m (table 1).

We assess the vertical accuracy of the DSM using the same check points. The RMS error of Z offsets is 0.041 m (table 1). The total error of the DSM (X, Y, and Z) is 0.063 m.
