INSTALLATION OF ENVIRONMENTAL AND HYDROLOGICAL MONITORING STATIONS—UTQIAGVIK-WAINWRIGHT-ATQASUK REGION, ALASKA, AUGUST 2022

Raw Data File 2023-21

DIVISION OF GEOLOGICAL & GEOPHYSICAL SURVEYS

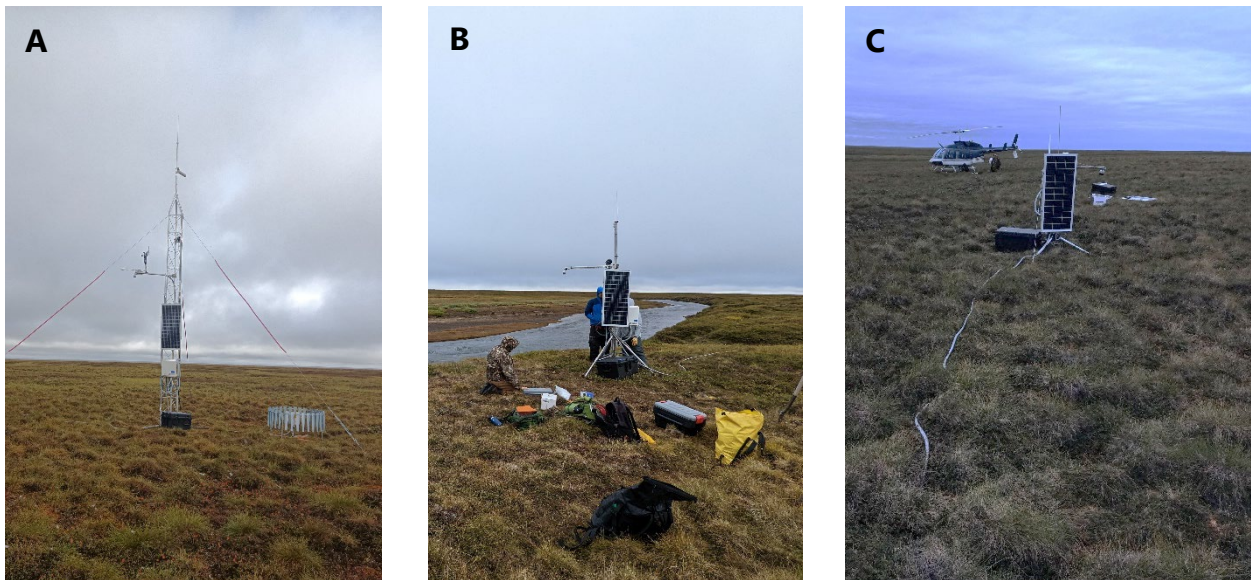
Figure 2. Examples of each installed station type. **A.** Weather Tower station 22RPD006. **B.** Gage station 22RPD002. **C.** Snow node station 22RPD007.

We constructed seventeen stations between August 8 and 21, 2022, which consist of three 7-m weather towers (fig. 2A), five 3-m tripod stream gage systems (fig. 2B), and nine 2-m tripod snow nodes (fig. 2C). Location information for each station is detailed in table 1. Each weather tower hosts environmental sensors, a camera, and communication equipment; see accompanying digital data and table 2 for detailed information. Each weather tower is accompanied by three snow-measurement nodes within one mile of the tower. The snow nodes are equipped to measure local snowpack variability using downward-facing sonic sensors. However, environmental sensors such as air- and ground-temperature probes and ground-moisture sensors are also included on the snow nodes. Snow nodes were placed at locations that experience variability in snow accumulation to capture local snow drifting or wind scouring most effectively. For example, figure 3 demonstrates snow cover variability within a relatively small area near weather tower 22RPD006.

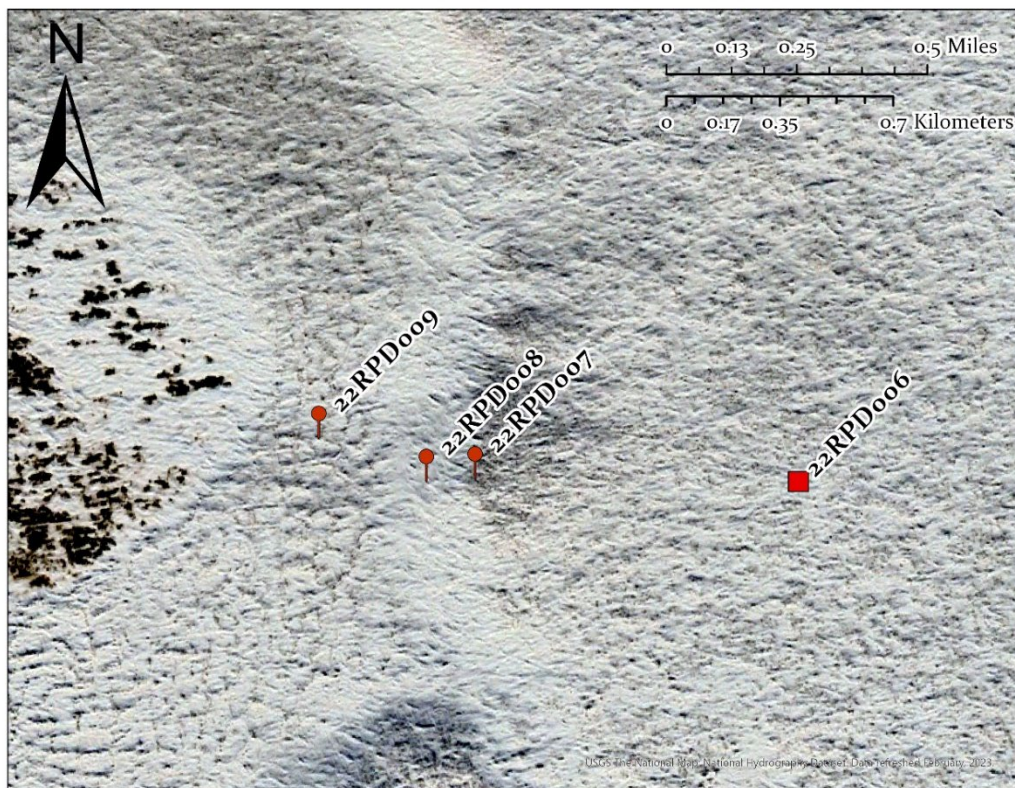
Figure 3. Location of the weather tower (22RPD006) and nodes (22RPD007, 22RPD008, 22RPD009) overlain on visible color imagery, captured by Maxar Technologies Inc. on March 20, 2021, and hosted by Google Earth Pro V. 7.3.6 accessed on December 6, 2022. This figure demonstrates how each node can measure a variety of depths in the snowpack across a relatively small area: 22RPD007 is located on wind-scoured terrain,

22RPD008 sits slightly below the wind-scoured ridge where drifts commonly form, and 22RPD009 is situated in polygonal-ground terrain with tall graminoids which protect the landscape from wind-scouring.
