Report of Investigations 84-26 LIQUEFACTION-SUSCEPTIBILITY ANALYSIS FOR FOUNDATION SOILS, KNIK RIVER BRIDGE, GLENN HIGHWAY, ALASKA

by
Randall G. Updike
In cooperation with the
U.S. Geological Survey
Office of Farthquake Studies

### LIQUEFACTION-SUSCEPTIBILITY ANALYSIS FOR FOUNDATION SOILS, KNIK RIVER BRIDGE, GLENN HIGHWAY, ALASKA

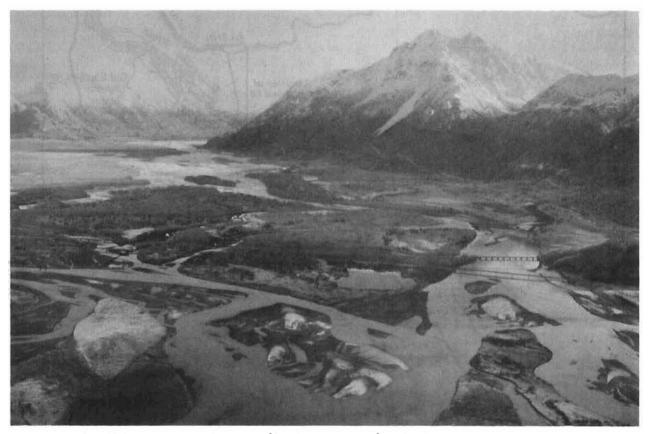
Figure 2. Oblique aerial view (looking south) of the Knik River bridge, new Glenn Highway, Alaska. The Alaska Railroad bridge is visible at upper left (1983).

The new Glenn Highway Knik River bridge (fig. 2) is a critical link in the highway corridor leading north to the interior of the State. Within the design life of the structure, major seismic events related to the underlying subduction zone or the nearby Border Ranges fault system, which shows

evidence of activity in Holocene time (fig. 3), are anticipated. The bridge is a masonry and girder superstructure on piers over steel piles. The piles are driven into saturated, fine- to medium-grained, cohesionless soils. These factors promote substantial concern for the seismic safety of the bridge during its period of use and, in particular, warrant an evaluation of liquefaction susceptibility at the site.

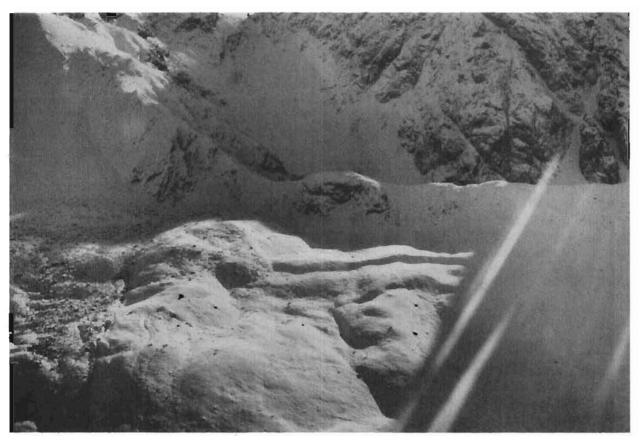
Figure 3. Aerial view (looking south) of an active segment of the Border Ranges fault system (the Twin Peaks fault) that extends from left to right in the center of the photograph (Updike and Ulery, 1983). This locality is within 3.5 mi (6 km) of the Knik River bridge (1982).

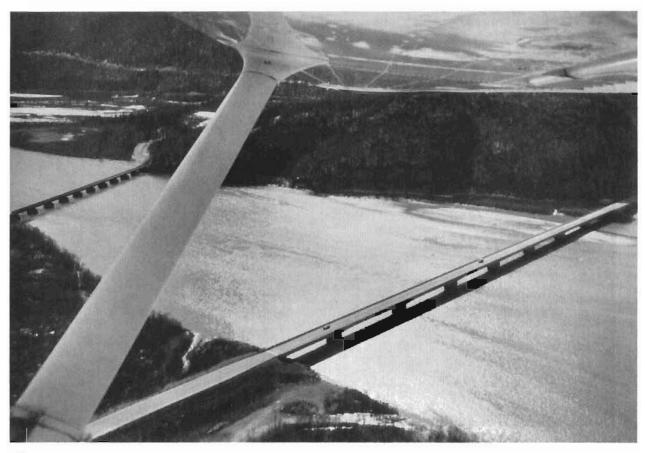
Figure 4. Regional view of the Knik River bridge (right center) and the Knik River flood plain. The Alaska Railroad bridge is directly unstream from the highway bridge, and Pioneer Peak is in the center background. The old Glenn Highway Knik River bridge is out of view beyond the left corner of Pioneer Peak. Most of the flood plain in this view was extensively fissured during the 1964 earthquake (1983).

The new Glenn Highway Knik River bridge is located near the mouth of the Knik River, approximately 25 mi (40 km) north of Anchorage, in the NE½ sec. 15, T. 16 N., R. 1 E., of the Seward Meridian, Anchorage B-7NE Quadrangle (fig. 4).

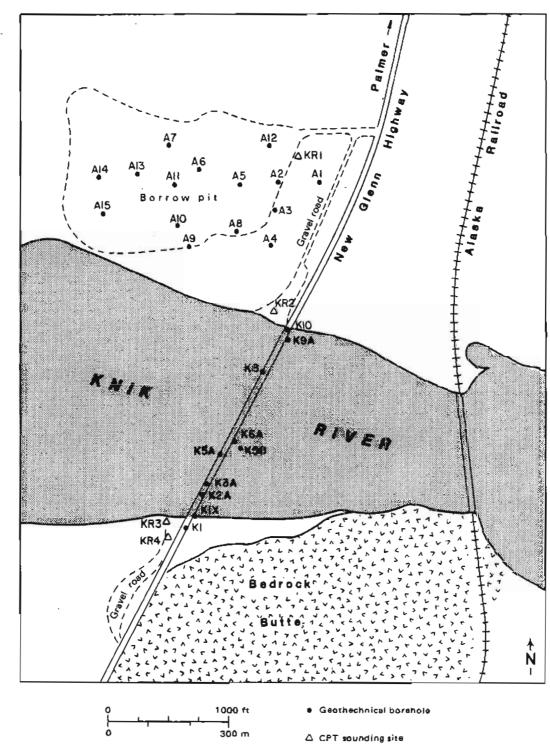
Figure 5. Map showing the location of the Knik River bridge and points of subsurface-data acquisition. Points with 'A' prefix are construction-materials-site borings, points with 'K' prefix are foundation-investigation borings, and KR triangles are cone-penetration-test sites.

contain borehole logs and supporting laboratory data for 25 holes. The locations of these boreholes are given in figure 5.

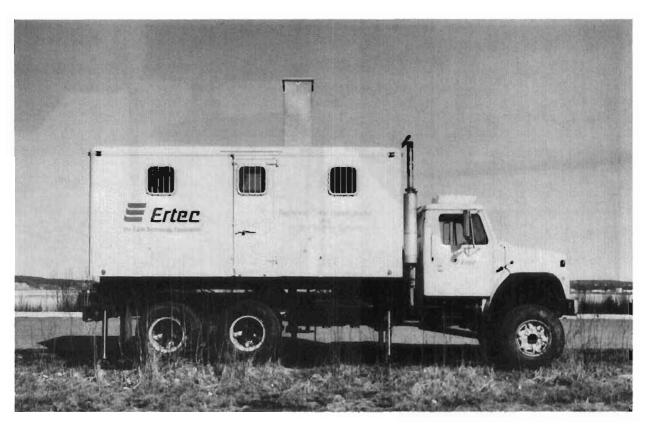
Figure 6. Electric-cone-penetration-test laboratory truck with hydraulic jacks extended before initiating sounding (1982).

The cone-penetration test (CPT) consists of pushing an instrumented, cone-tipped probe into the soil and continuously recording the soil's resistance to penetration. The tests were conducted in accordance with American Society for Testing and Materials specifications (ASTM-D3441-79) using an electric-cone penetrometer. The test equipment consists of a cone assembly, a series of hollow sounding rods, a hydraulic frame to push the cone and rods into the soil, an analog strip-chart recorder, and a truck to transport the test equipment and provide the needed 20-ton thrust-reaction capacity (fig. 6). The cone penetrometer (figs. 7 and 8) consists of a conical tip with a 60° apex angle and a cylindrical friction sleeve above the tip. The cone assembly used on this project has a cross-sectional area of 2.32 in.2 (15 cm<sup>2</sup>) and a sleeve-surface area of 31 in.<sup>2</sup> (200 cm<sup>2</sup>). The device's interior (fig. 9) is instrumented with strain gauges that allow simultaneous measurement of cone and sleeve resistance during penetration. Continuous electric signals from the strain gauges are transmitted by cable in the sounding rods to the recorder at ground surface.

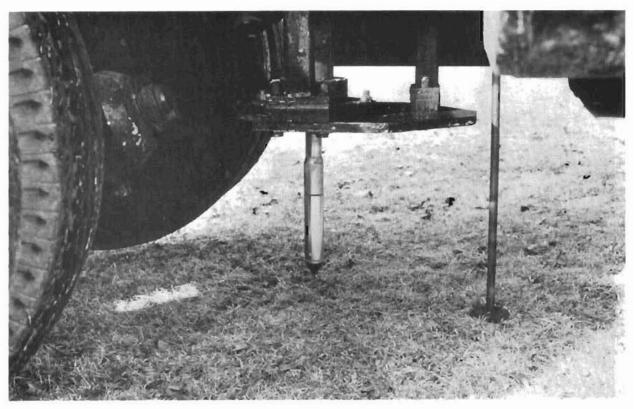
Figure 7. Cone-penetration-test probe in position to initiate sounding. Rod at right is used to calibrate distance between truck and ground level during sounding (1982).

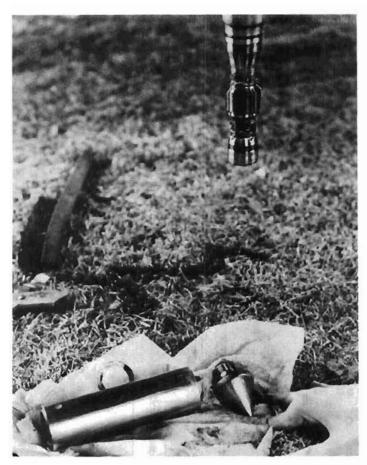
Figure 8. Cone-penetration-test probe with disassembled conical tip and friction sleeve (1982).

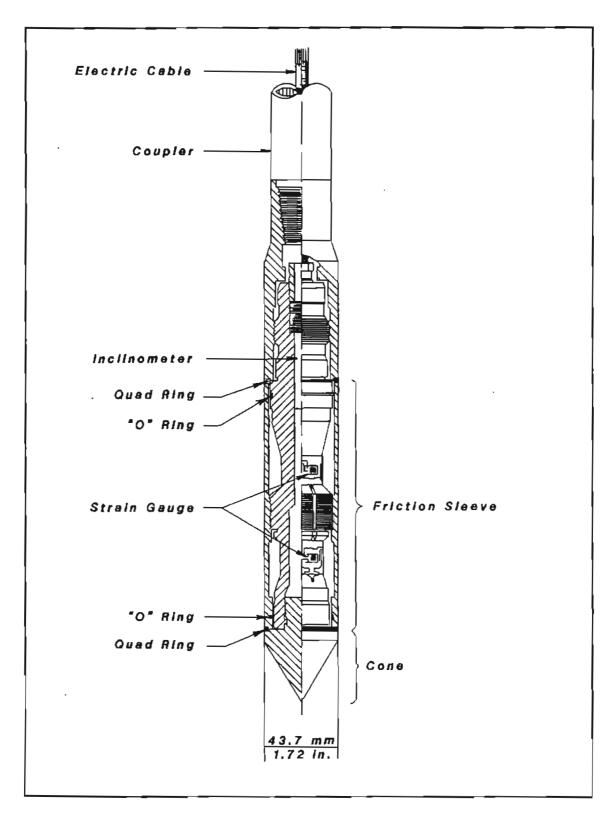
Figure 9. Cross section of CPT instrument package used in this study.

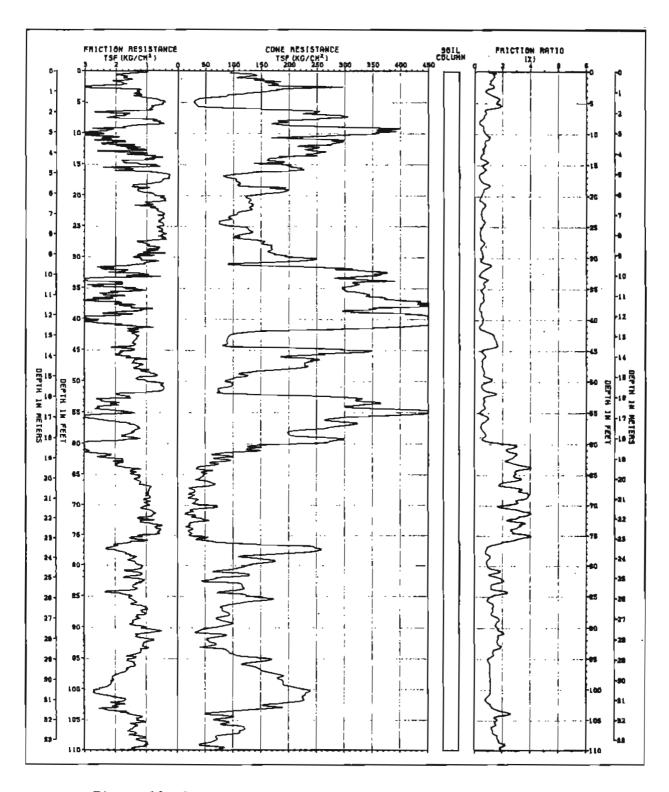
Figure 10. Cone-penetration-test sounding log for site KR-1.

Four CPT soundings that were made at the Knik River bridge on April 9, 1982, ranged in total depth from 59 ft (17.8 m) to 109 ft (33 m). The resultant soundings (figs. 10-13) include the friction resistance (sleeve friction, f, in ton/ft²), cone resistance (end bearing, q, in ton/ft²), and friction ratio ( $R_f = f_s/q_c$ ).

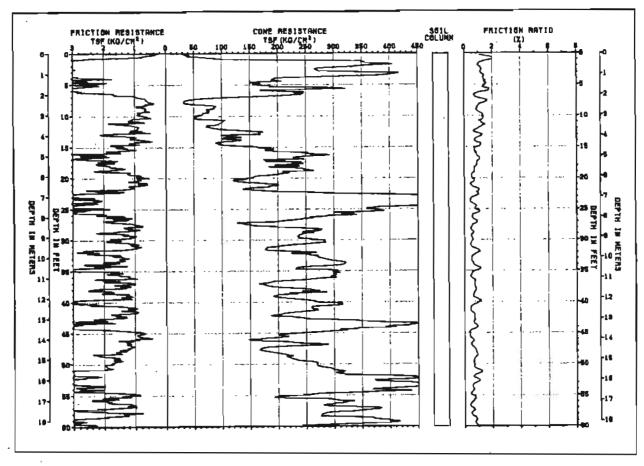
Figure 11. Cone-penetration-test sounding log for site KR-2.

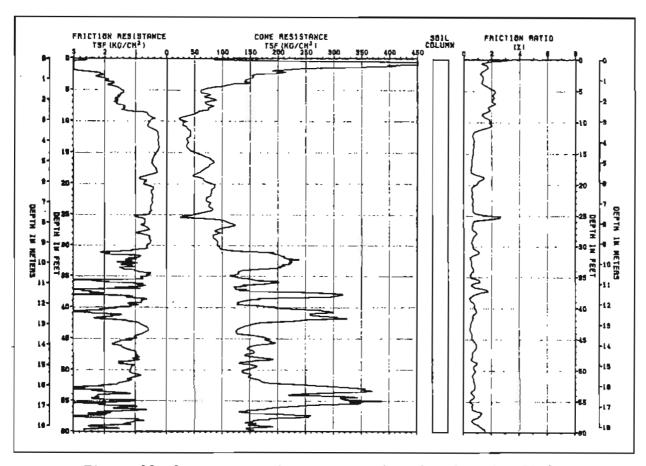
Figure 12. Cone-penetration-test sounding log for site KR-3.

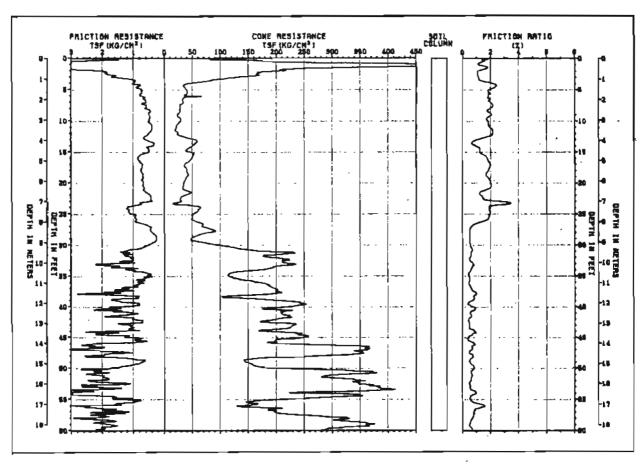
Figure 13. Cone-penetration-test sounding log for site KR-4.

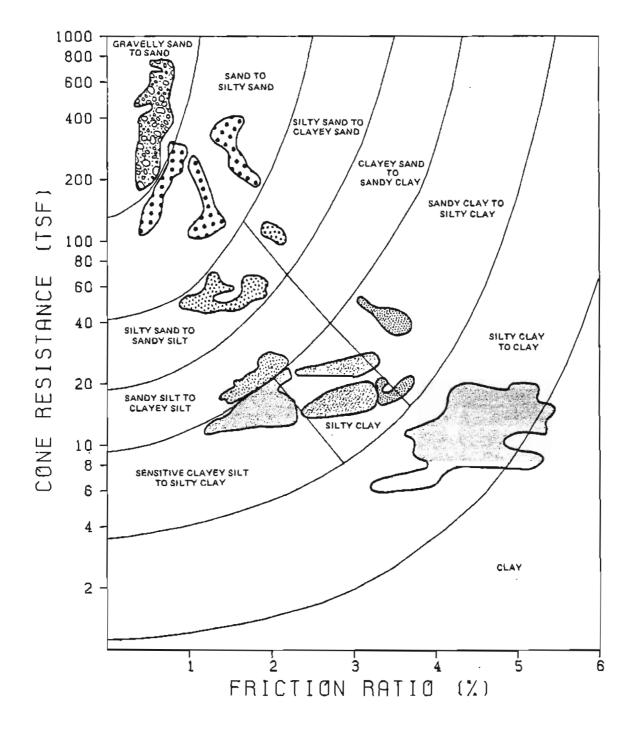
Figure 14. Soil-classification chart used for prediction of soil-behavior types tabulated in appendix A.

CPT soil-behavior predictions are tabulated in appendix A. The Ertec computer program estimates soil types by tracking the cone-end bearing and average friction ratio at each requested depth based on guidelines of a classification chart (fig. 14) that evolved from the work of Begemann (1965),

Schmertmann (1971), Sanglerat (1972), and Searle (1979). The chart was calibrated to project equipment by Douglas and Olsen (1981). An example of the computer tracking for certain intervals in three soundings is shown in figure 15. Correlation of the computer trackings to the classification chart is the basis for the predicted soil-behavior types tabulated in appendix A.

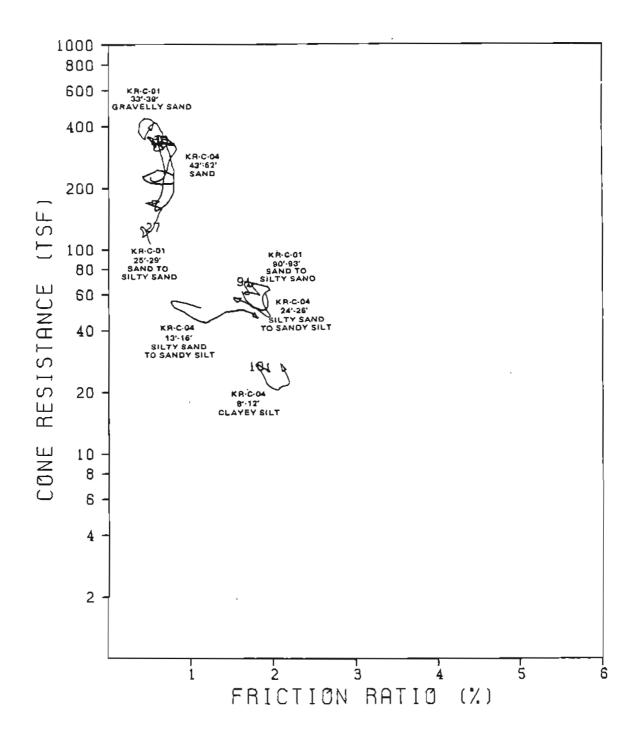
Figure 15. Example of computer tracking of selected intervals of CPT soundings KR-1 and KR-4 in plot of friction ratio vs cone resistance.

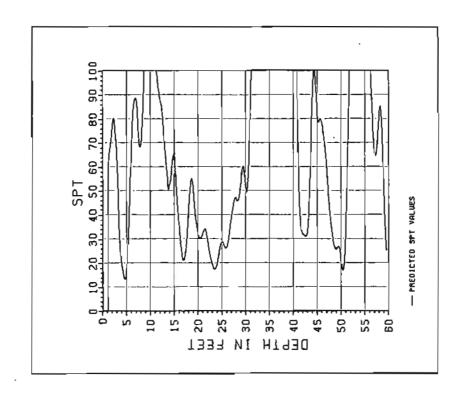
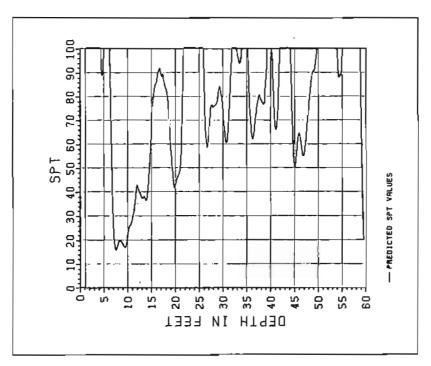
Figure 16. Predicted SPT values vs depth for Knik River bridge, new Glenn Highway, using CPT data. Sounding for KR-1 at right and for KR-2 at left.

As previously mentioned, the standard-penetration test is the commonly used method for assessing <u>in-situ</u> soil conditions. Currently, the resultant N values are used as a basis for liquefaction-potential analyses throughout the United States. Bennett and others (1981) and Douglas and others (1981) have successfully correlated penetration data derived from CPT and SPT techniques at a given site. The mathematical derivation of this correlation, which is beyond the scope of this report, is explained in Douglas and others (1981). From the relationships derived in that report, a computer program was designed using the CPT logs of the four sites, and the computer generated a predicted equivalent SPT profile for each site (figs. 16 and 17). Although actual SPT values are obtained with a sampler and therefore can only record a series of vertical data points with intervening data gaps, the CPT-equivalent technique provides a continuous predicted SPT profile with respect to depth. All SPT predictions were performed using the following equation:

$$N = 12.5 E_D^{1.3}$$

where N is the predicted blow count and  $E_D$  is the energy expended during soil penetration of the SPT sampler. Evaluation of the constants that relate the energy-dissipation function ( $E_D$ ) to the SPT values in carefully monitored borings shows a good correlation between predicted and real SPT values using a low-energy, trip-hammer technique. This correlation of the profiles in figures 16 and 17 is most applicable to the liquefaction-potential analyses of noncohesive soils based upon the trip-hammer, SPT method. The constants relating N and  $E_D$  depend on the energy-transfer efficiency of the specific SPT hammer-anvil-rod-sampler system used. If the SPT data that uses some other system is correlated with the curves in figures 16 and 17, a conversion factor may be required. This calibration of measured and predicted SPT values specific to equipment has been successfully used by Douglas and others (1981).

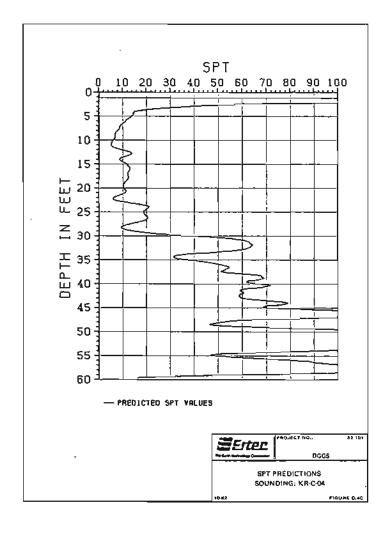
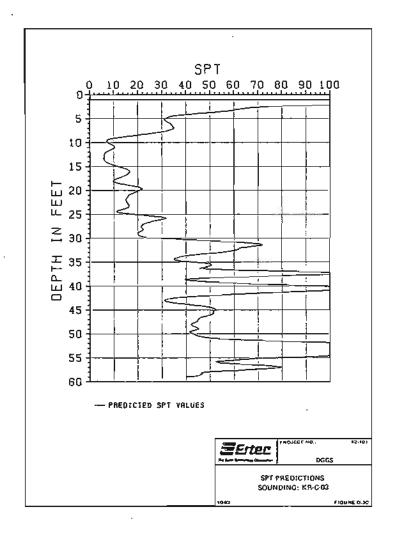
Figure 17. Predicted SPT values vs depth for Knik River bridge, new Glenn Highway, using CPT data.

Sounding for KR-3 at right and KR-4 at left.

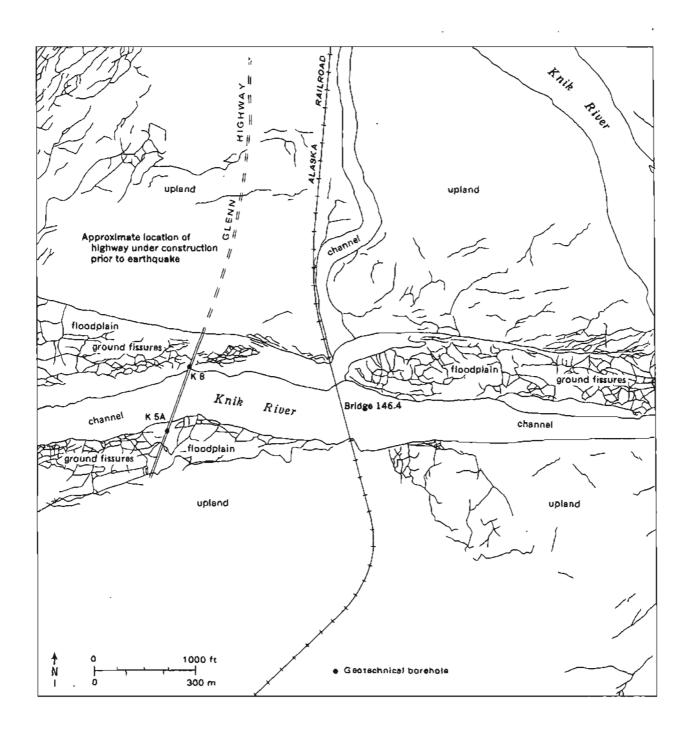
Figure 18. Map of distribution of ground fissures in the Knik River flood plain that resulted from the 1964 earthquake (McCulloch and Bonilla, 1970).

Numerous ground fissures developed in the exposed flood plain of the Knik River (McCulloch and Bonilla, 1970; fig. 18) and, to a lesser degree, on the adjacent uplands. The configuration of the fissures suggests that at least the surface sediments underwent liquefaction and lateral spreading; data on the depth of failure were not available.

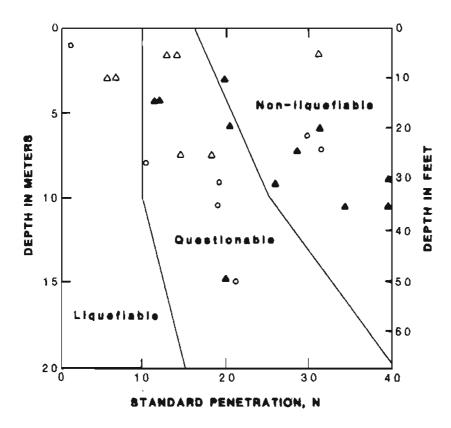
Figure 19. Plot of standard-penetration test (in blows/ft) vs depth showing domains of liquefaction susceptibility (modified from Nishiyama and others, 1977). Data points are from the Knik River bridge area, new Glenn Highway. Circles are actual SPT values, open triangles are silty sands predicted by CPT, and solid triangles are sand predicted by CPT.

If the criteria of depth, texture, and saturation are met, a more accurate assessment of liquefaction susceptibility can be derived from SPT data (N-values). Because the SPT is an in-situ method of empirically determining liquefaction susceptibility and relative density, several investigators have drawn correlations between N-values and liquefaction susceptibility. Nishiyama and others (1977) published a simple graph based on the relationship of depth, N-values, and observed liquefaction (fig. 19). Two data sets for the Knik River bridge were examined: 1) SPT values for which there is available soil-texture data from the Alaska Department of Transportation and Public Facilities foundation report (1963a), and 2) SPT-equivalent data, which were computer generated based on the CPT soundings and checked against the soil-behavior predictions in appendix A. When the resultant N-values vs depth were plotted on the Nishiyama diagram (fig. 19), there was no convincing evidence for liquefiable soils. However, a number of points lie within a 'questionable' intermediate domain, most at depths less than 35 ft (10.5 m) below ground surface. This diagram suggests that under saturated conditions, these soils could liquefy if subjected to severe cyclic-loading conditions during major earthquakes. Because the graph is not quantified based on factors such as ground-acceleration values or effective overburden pressures, the conclusion must remain generalized.

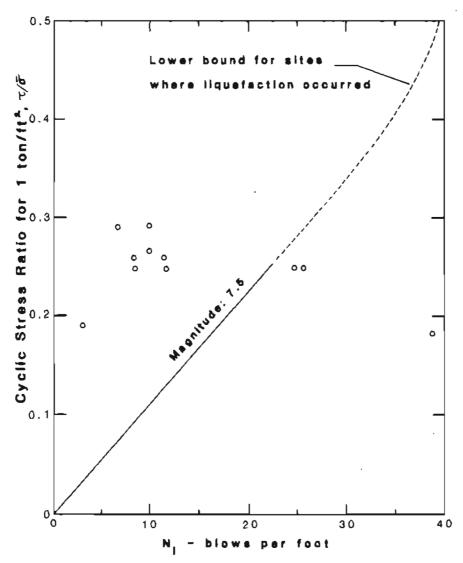
Figure 20. Plot of modified SPT blow count  $(N_{\parallel})$  vs cyclic-stress ratio (Seed and others, 1983). Points represent values calculated for Knik River bridge samples, assuming a peak surface-ground acceleration of 0.3 g. Note that eight values plot in the liquefiable domain and three values plot in the nonliquefiable domain.

On the basis of the above calculations and assumptions, the cyclic-stress ratio for 0.3 g peak ground acceleration is plotted against the modified penetration resistance (fig. 20). The boundary line on that graph (Seed and others, 1983) defines the transition from liquefiable to non-liquefiable soils for Richter magnitude 7.5 earthquakes on the basis of field observations and data collection from sites where liquefaction has occurred. Eight samples fall well within the liquefaction domain and show clustering that probably reflects the consistency of soil characteristics.
