GEOLOGIC MAP AND SECTIONS OF STEPovich MINE, FAIRBANKS DISTRICT, ALASKA

Maps of workings compiled from U. S. Geological Survey, U. S. Bureau of Mines, Territorial Department of Mines, and Cleary Hill Mines Co

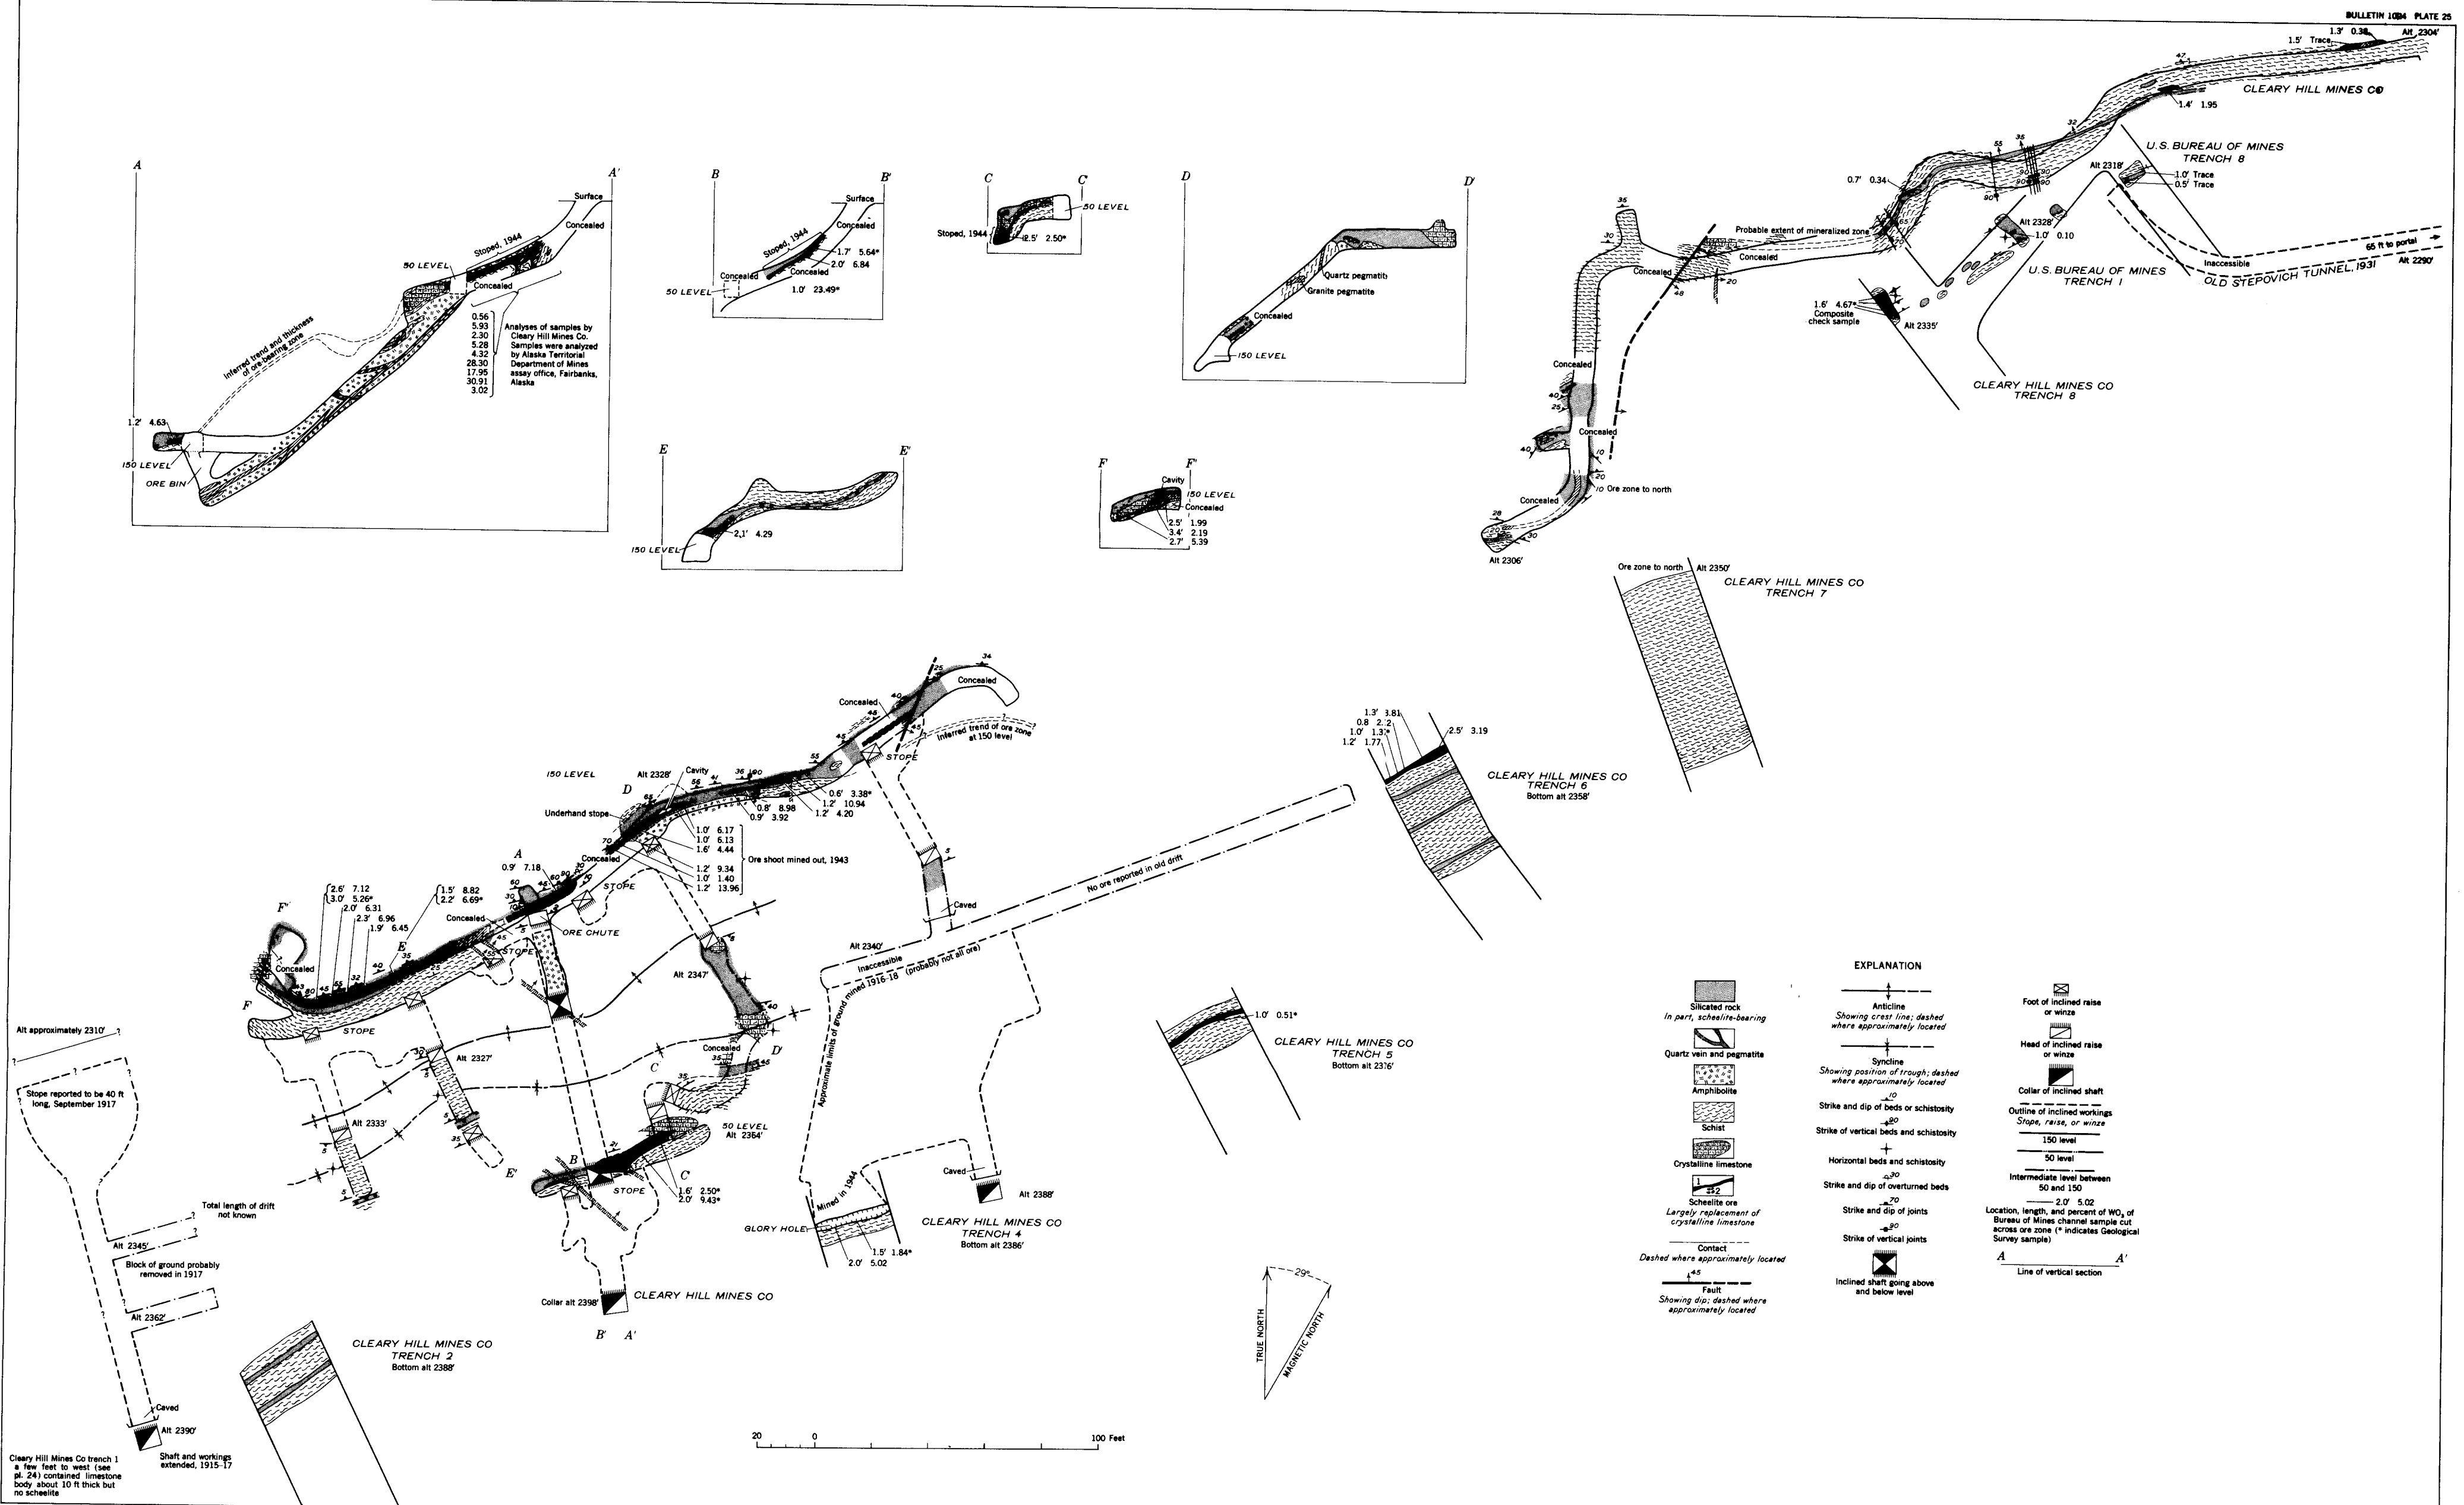
Cleary Hill Mines Co trench 1 a few feet to west (see pl. 24) contained limestone body about 10 ft thick but no schistite

Shaft and workings extended, 1915-17

Block of ground probably removed in 1917

Slope reported to be 40 ft long, September 1917

Total length of drift not known
