MAPS AND SECTIONS OF SCENERY LAKE, SWAN LAKE, AND RUTH LAKE POWERSITES

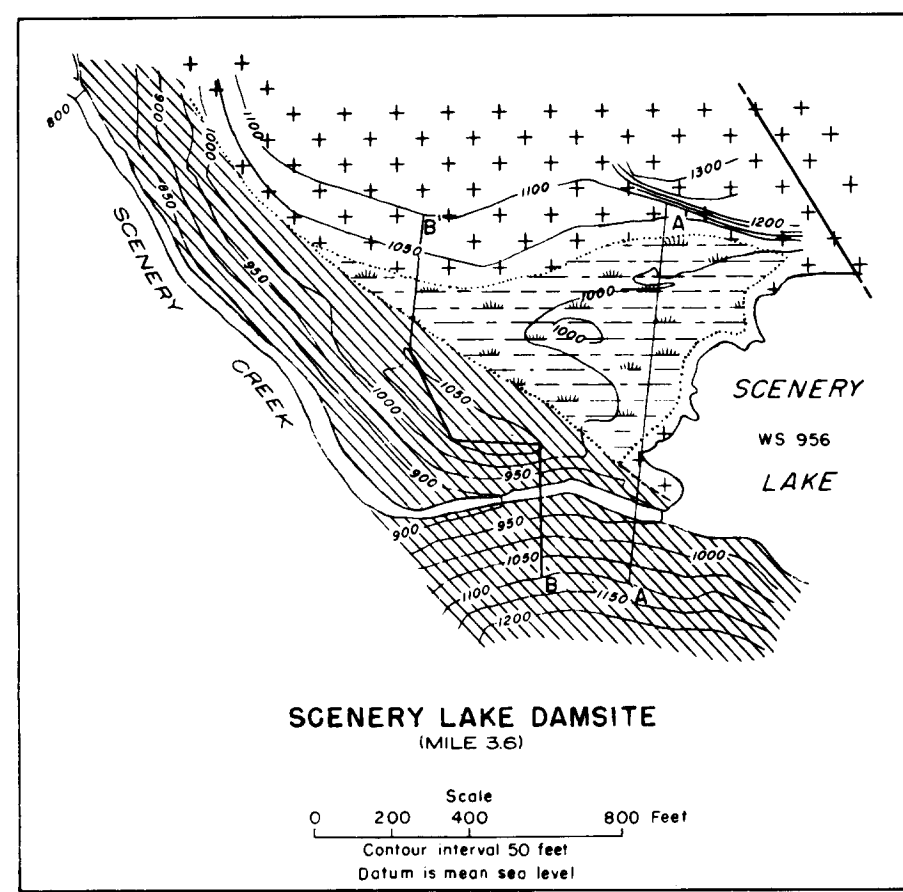
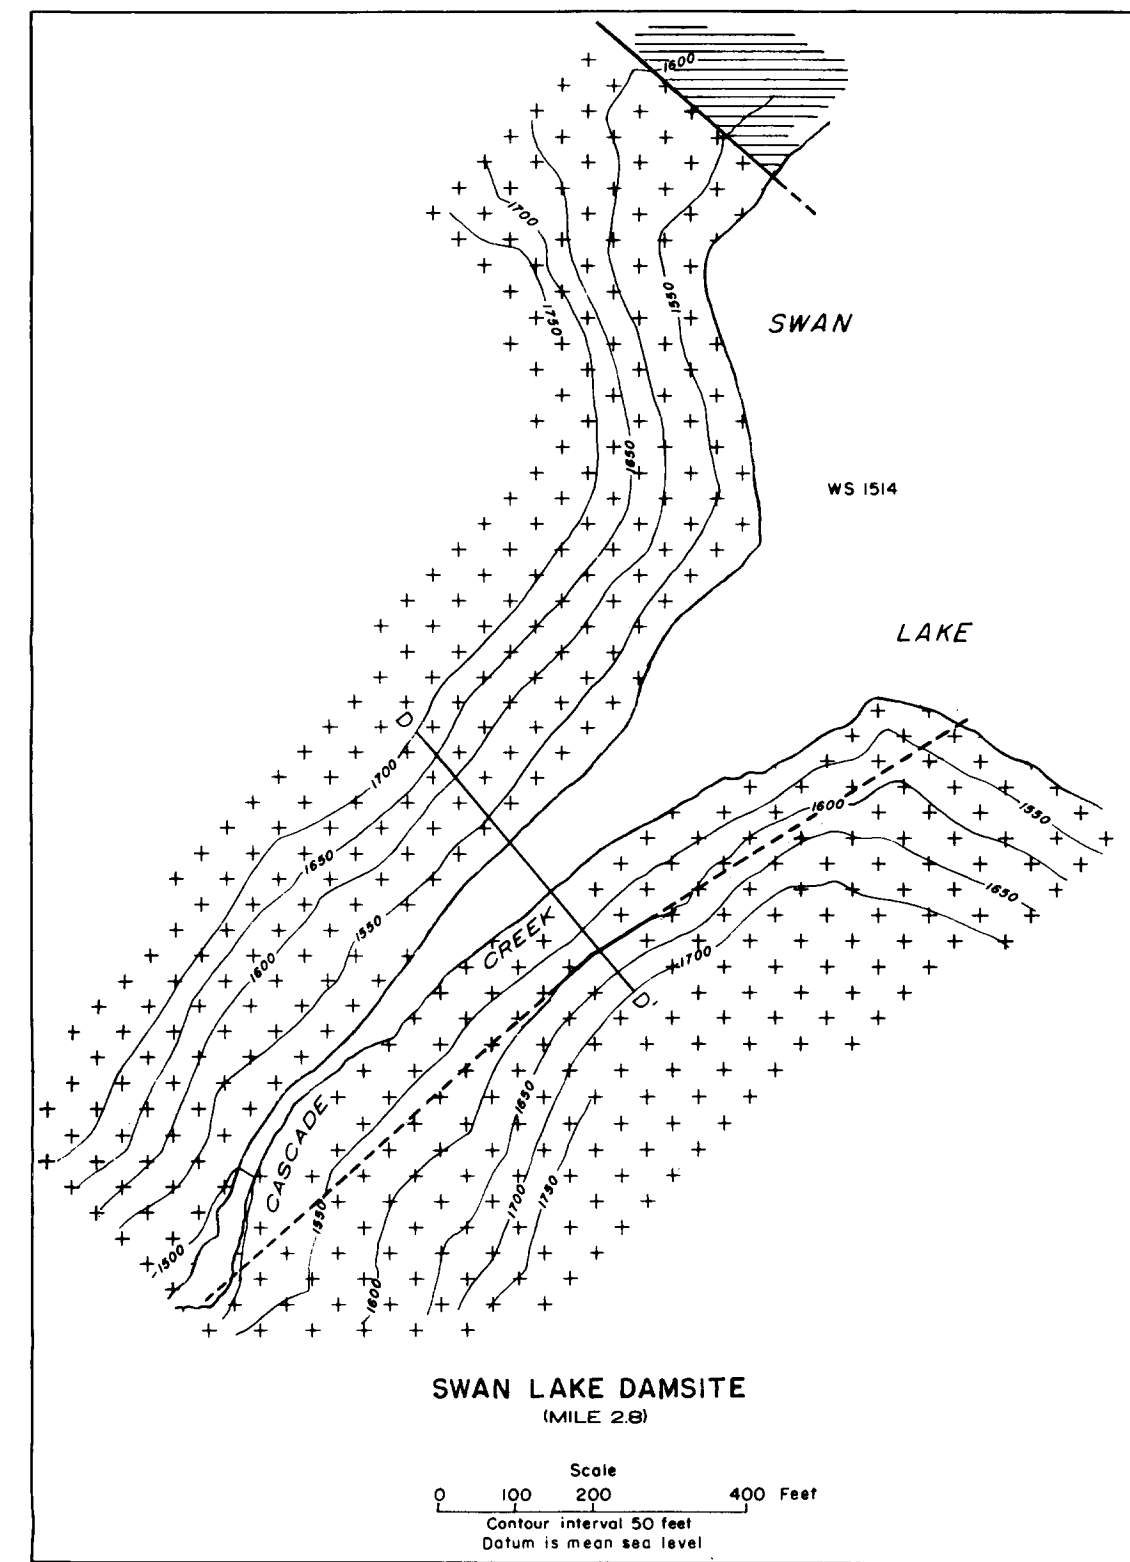
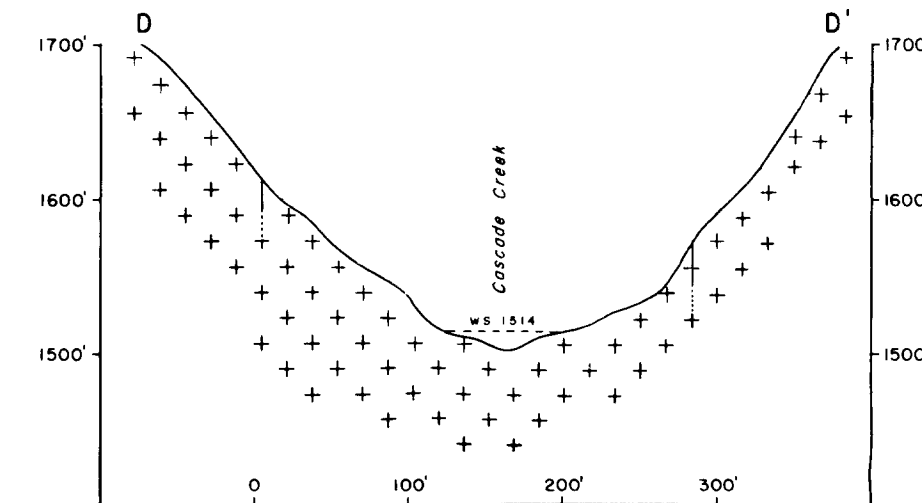
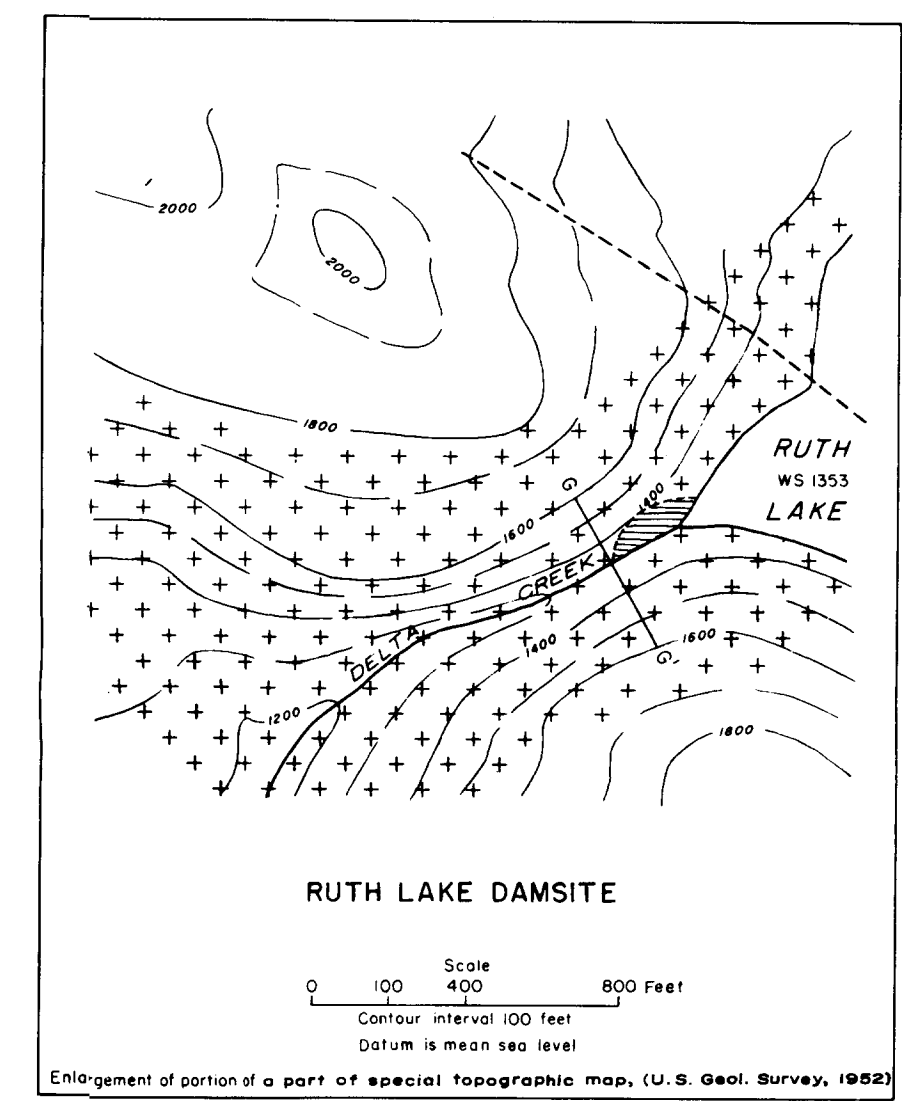
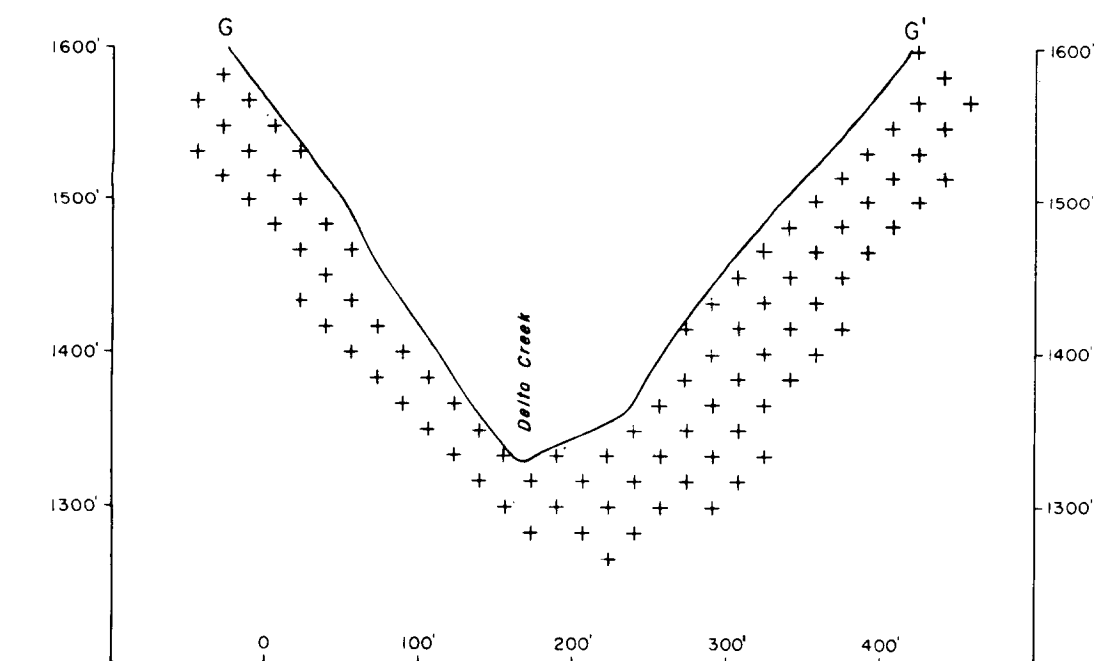
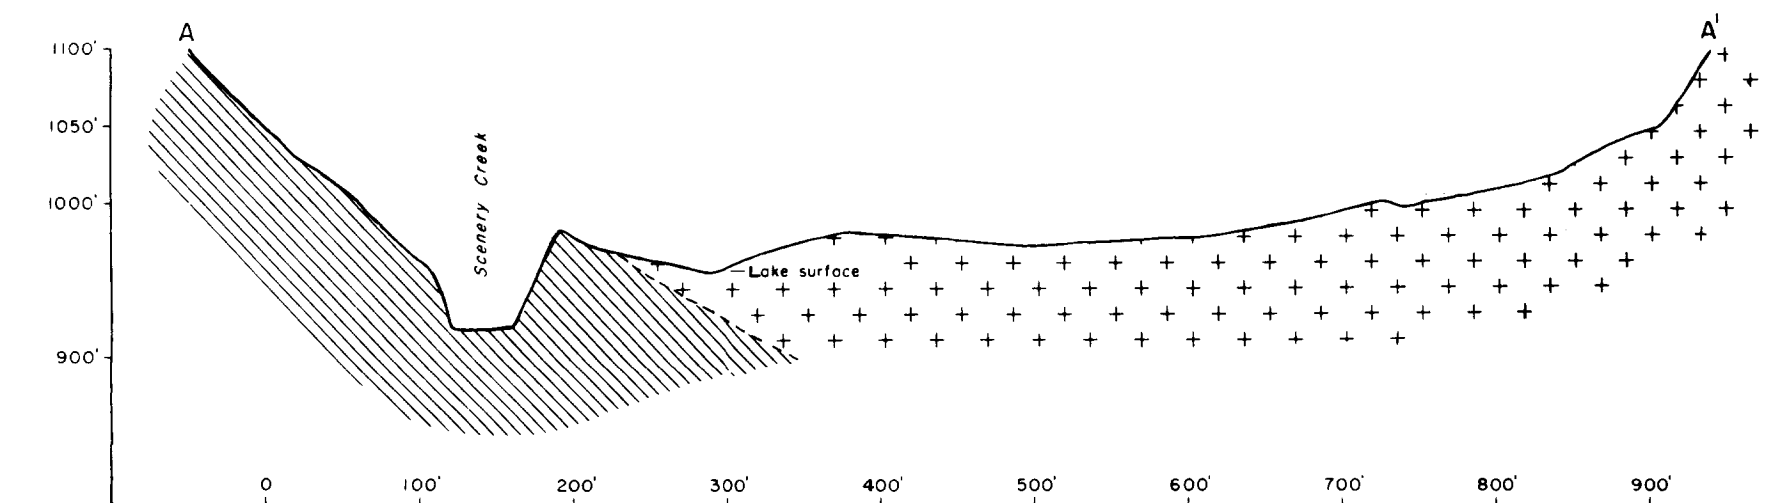
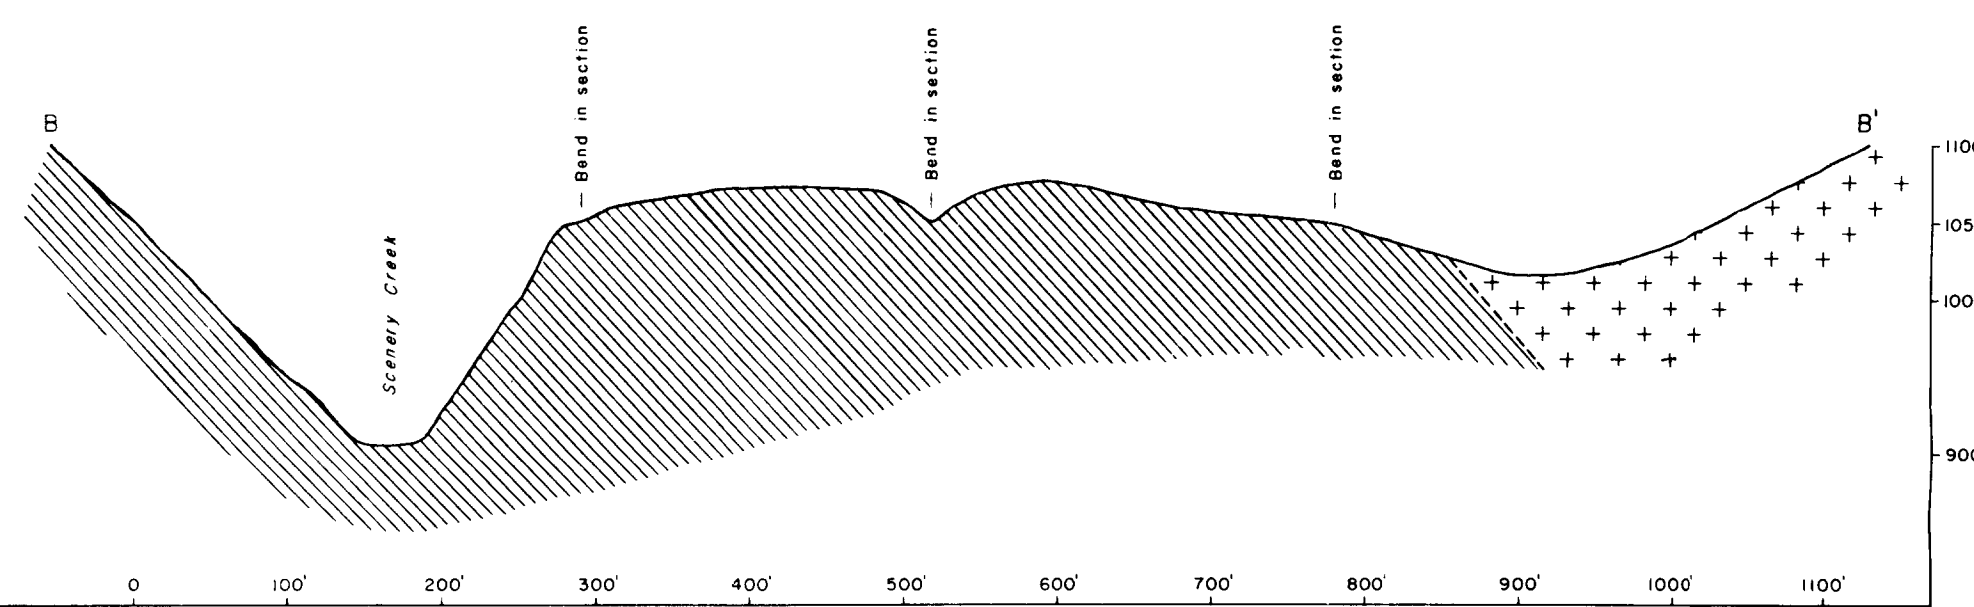
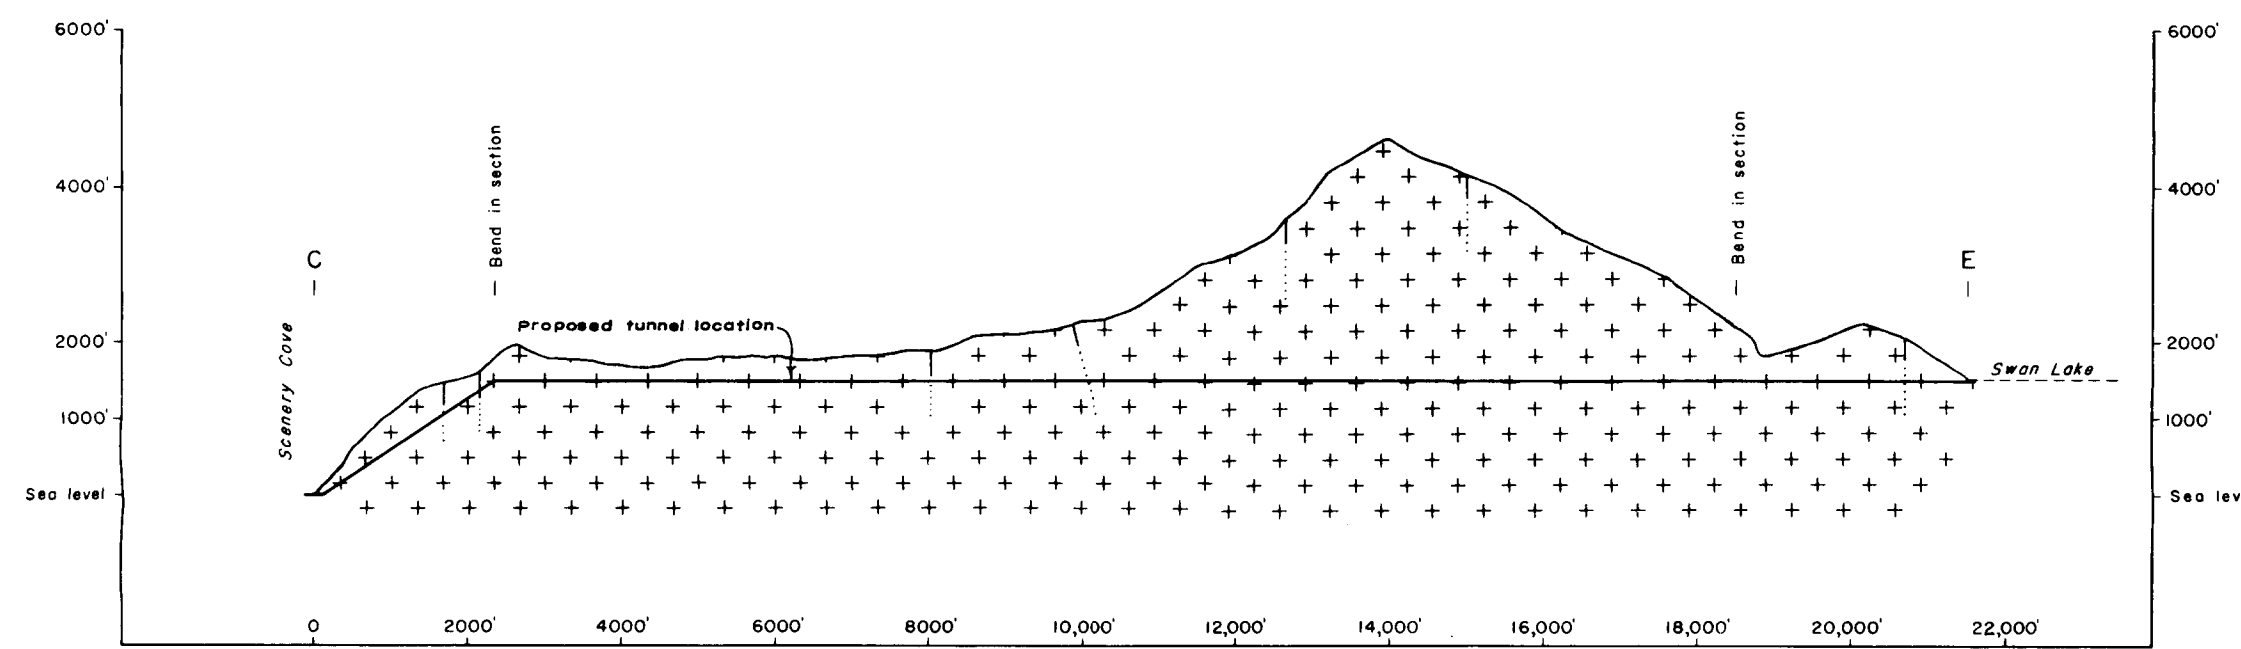
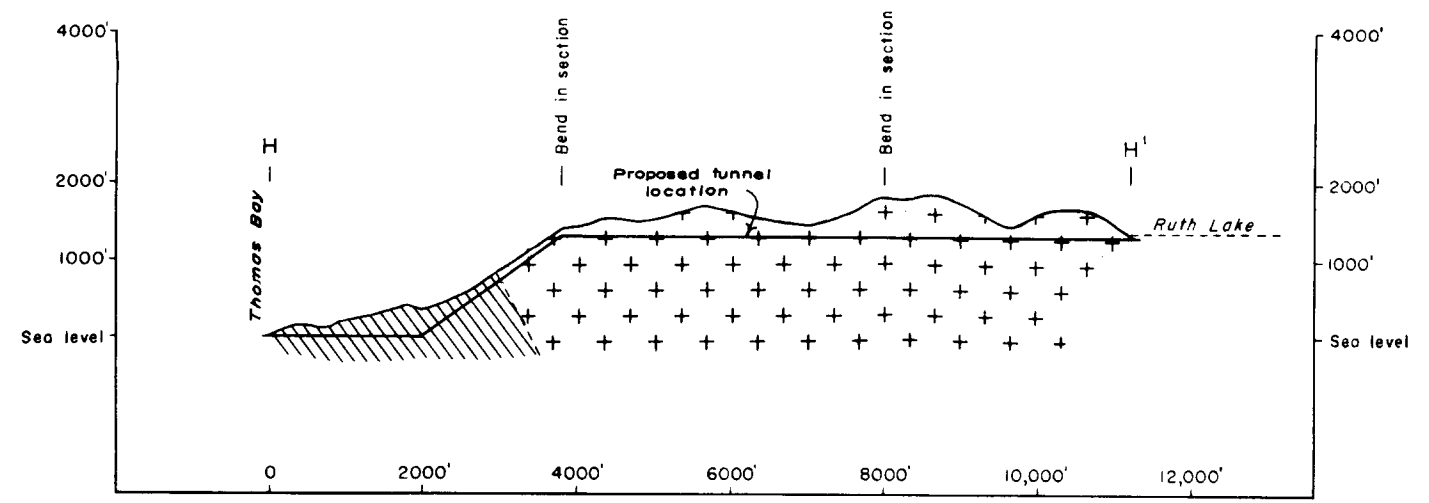
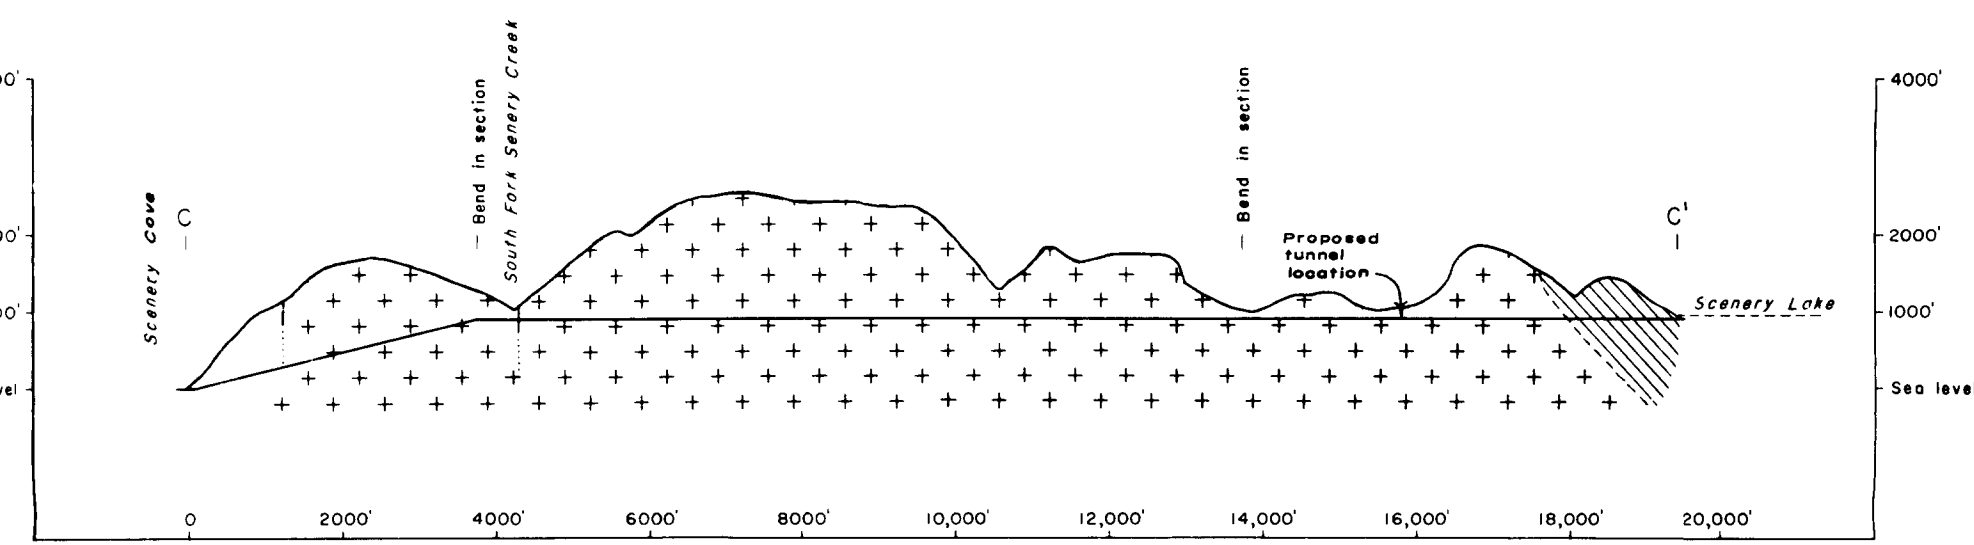
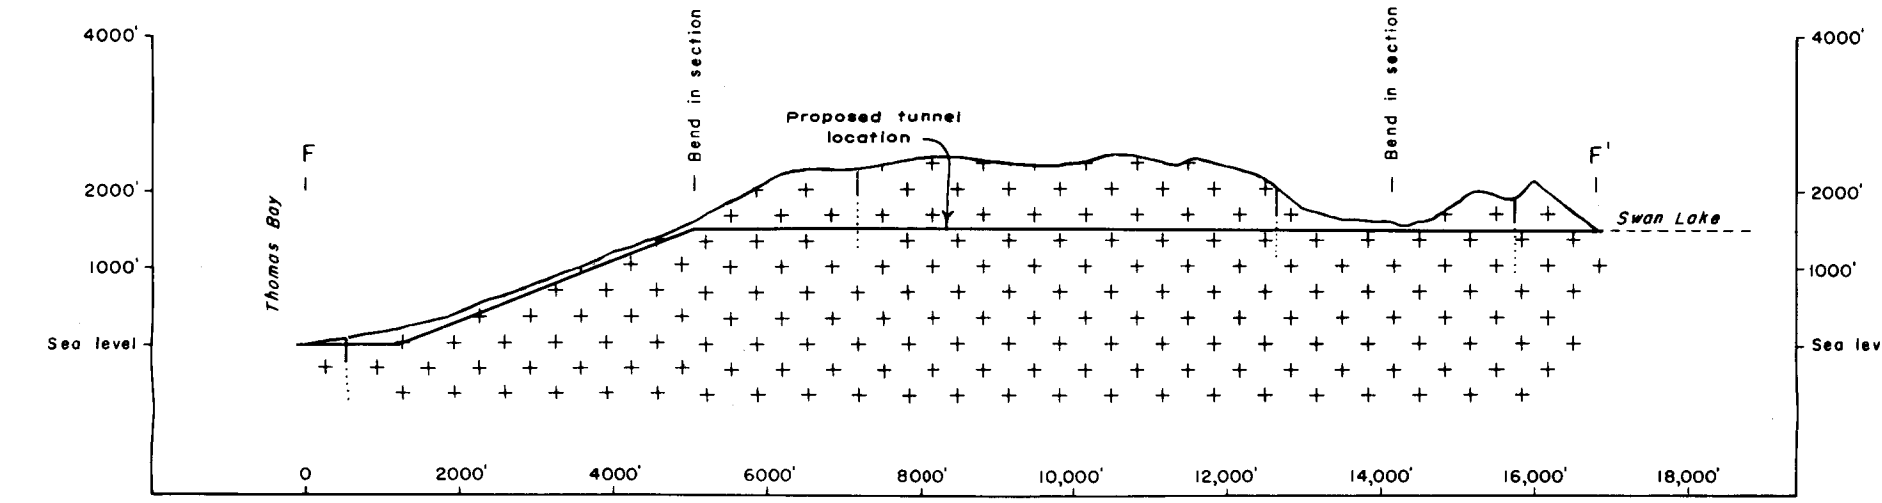
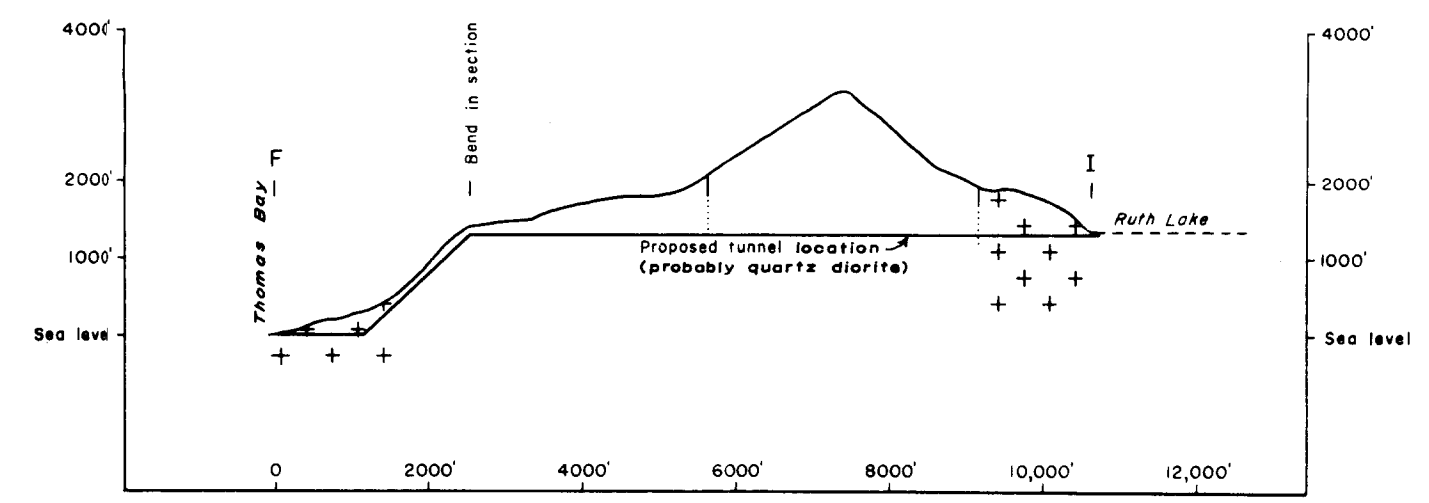
- EXPLANATION**
- Quartz diorite
  - Plagioclase gneiss
  - Calcareous gneiss
  - Hornblendite
  - Indefinite contact
  - Concealed contact
  - Lineament determined from aerial photographs. Dashed where inferred
  - Projection of surface trace of lineament
  - Depth of fracture not known

See Plate 8 for location of lines of sections C-C', C-E, F-F', H-H', and F-I
