ALASKA'S GOOD FRIDAY EARTHQUAKE, MARCH 27, 1964
A Preliminary Geologic Evaluation

Arthur Grantz, George Plafker, and
Reuben Kochadoorian

Geological Survey
THOMAS B. NOLAN, DIRECTOR

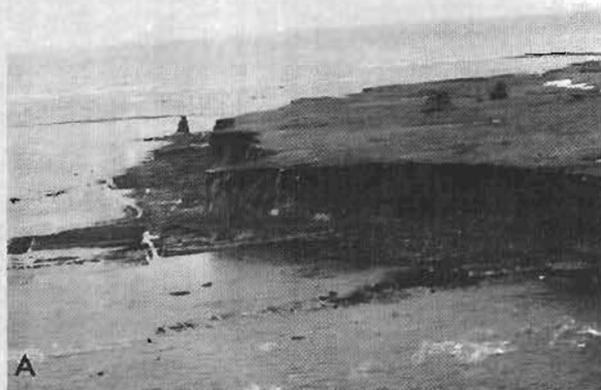
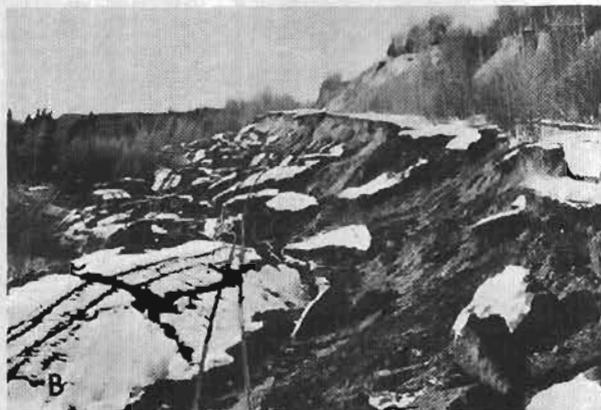
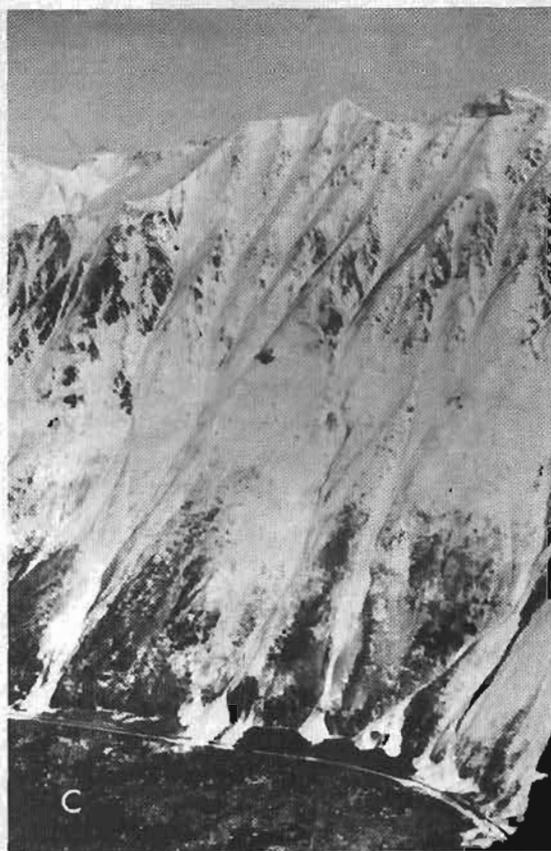
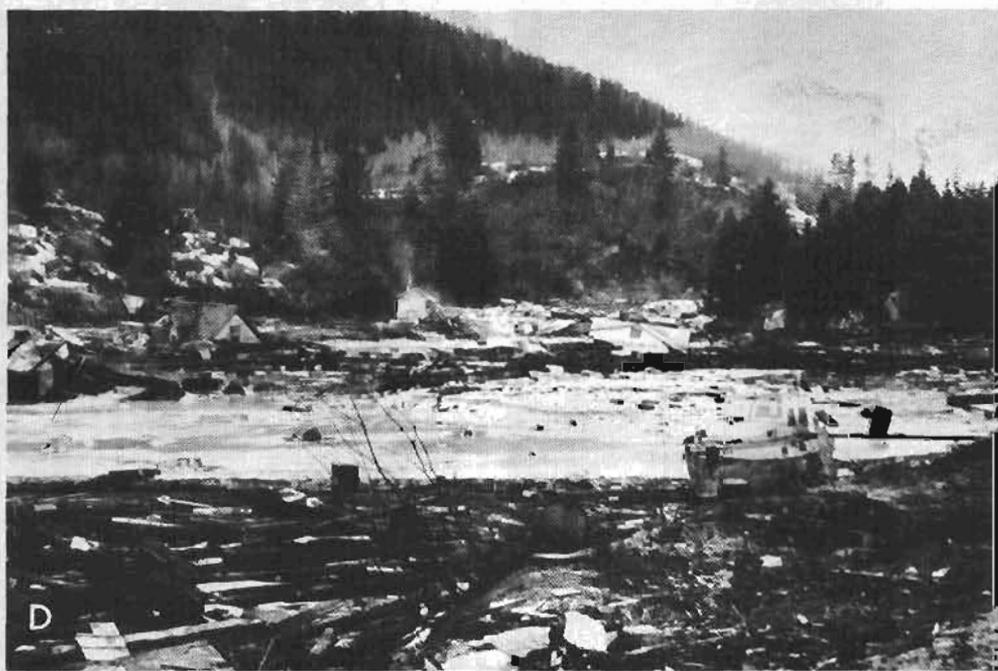
Figure 4. Photographs of some geologic effects of the earthquake. A, South coast of MIDDLETON ISLAND showing broad uplifted surf-cut reef at base of cliff. B, Landslide damage to The Alaska Railroad near POTTER. C, Avalanches across railroad and highway, TURNAGAIN ARM. D, Seismic sea wave debris at SEWARD. Note wave trim line on hillside at left.

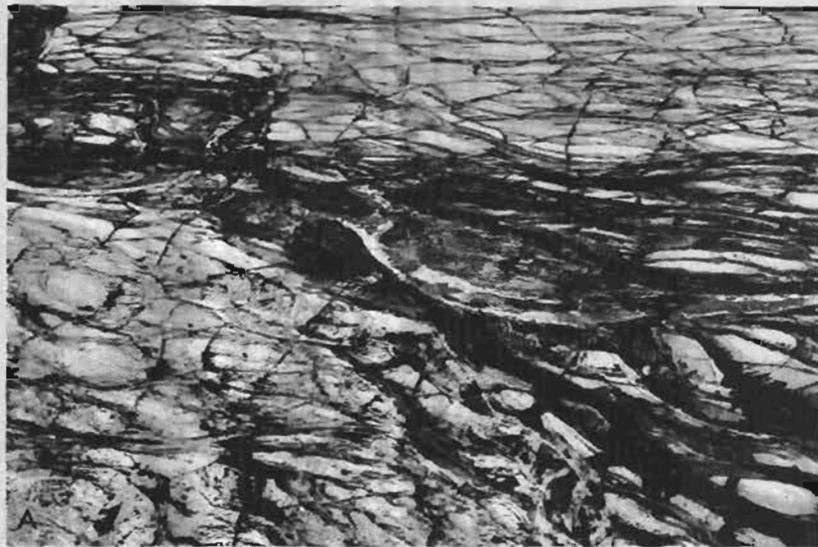
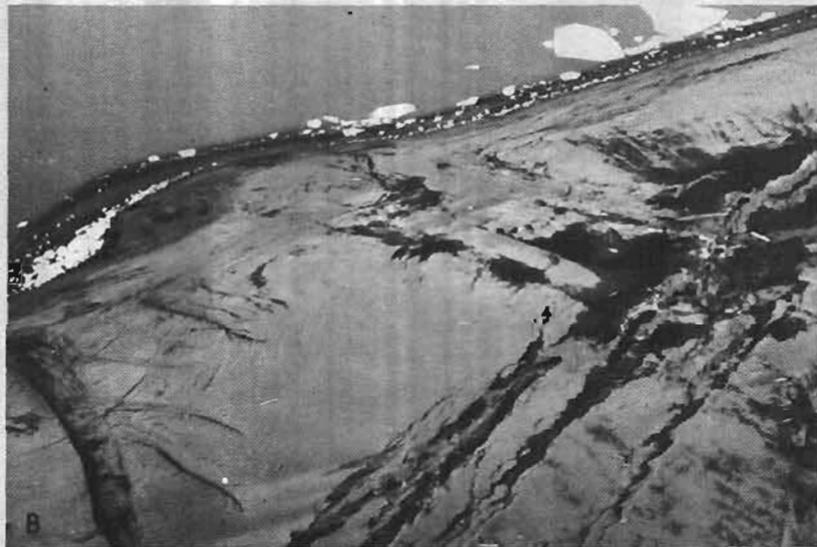
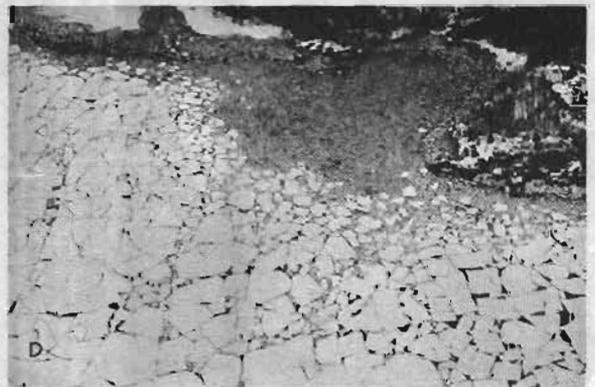
Figure 5. Photographs of fractures and mud spouts in unconsolidated deposits and fractures and pressure ridges in lake ice produced by the March 27 earthquake. A, In glaciofluvial deposits near SKILAK GLACIER. B, In tidal flat alluvium south of BERING GLACIER. C, On lake in northern KENAI lowland. D, At the head of SKILAK LAKE, Kenai Peninsula.

Numerous ground cracks, areas of subsidence, and mud spouts occurred throughout the zone of damage (figs 5A,B). Cracks were reported as far away as Kaliakh River, near Cape Yakataga, about 190 miles east-southeast of the epicenter. Cracks also occurred in the Copper River delta area, Kodiak, Glennallen, Anchorage, Kenai Lowland, and in other low-lying areas closer to the epicenter.

Spectacular mud spouts were observed at Portage, in the Copper River delta area, at Controller Bay, and near the Bering Glacier (fig. 5B). Mrs. George Larson of Portage reported that she saw a small mud fountain grow into a sheet of mud about 75 to 100 feet high and about 100 feet long. She also saw geysers of water as much as 50 feet high coming from fractures. Mr. Larson saw a mud and water geyser, estimated to be about 100 feet high, which bubbled for some time after receding.

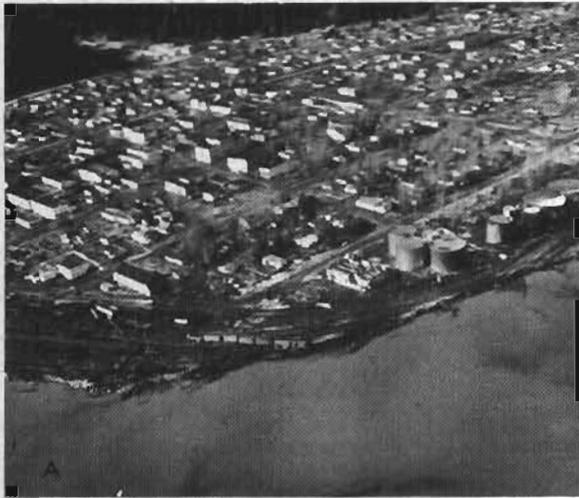
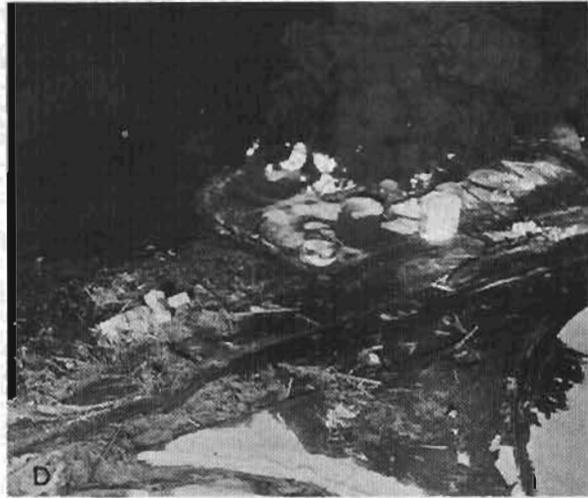
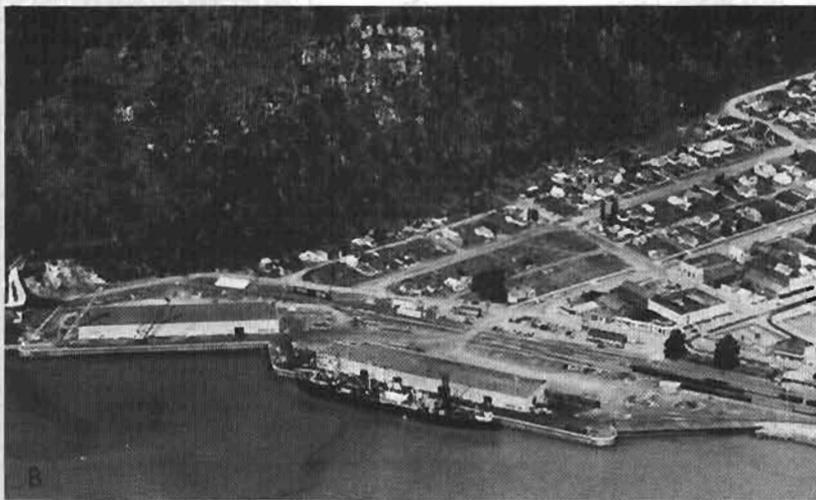
Figure 8. Photographs of wave and submarine landslide damage at SEWARD and WHITTIER. A, Waterfront at SEWARD, showing damage produced by submarine landslides (right side) and large waves (U. S. Army Mohawk photograph). B, C, The Alaska Railroad marginal docks at the south end of SEWARD before and after they were hit by large waves (U. S. Army Mohawk photograph). D, Waterfront at WHITTIER, showing area flooded by large waves (U. S. Army Mohawk photograph).

The earthquake was strongly felt at Seward, but damage from ground motion was minor compared to the massive destruction and 13 deaths inflicted by submarine landslides and large waves (figs. 8A,B,C).

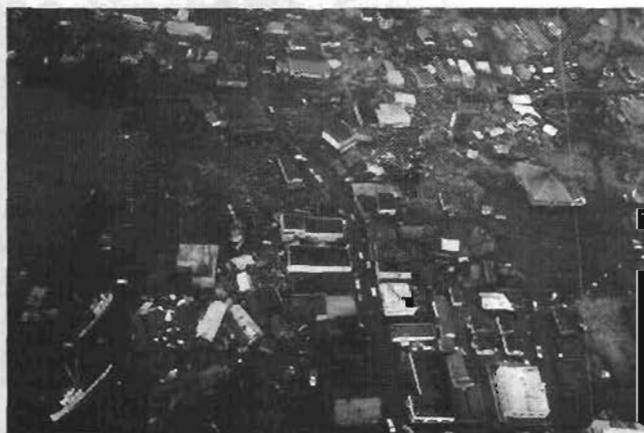
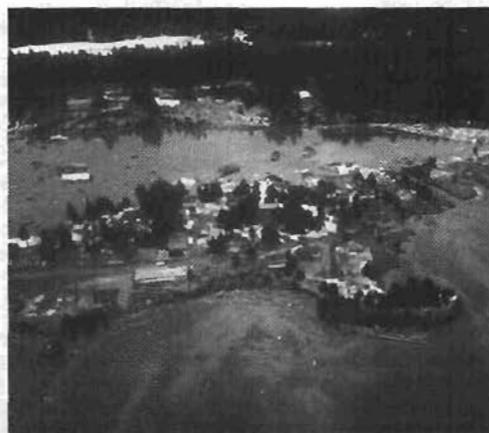
Figure 13. Map and aerial photographs of KODIAK and vicinity showing damage by waves. Dashed line on map shows highest level reached by waves. Arrows show direction of seismic waves.

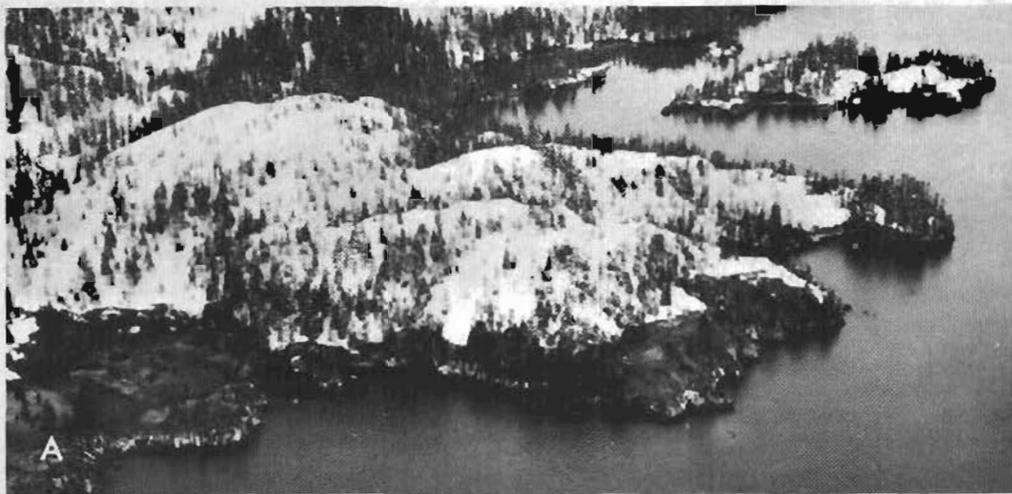
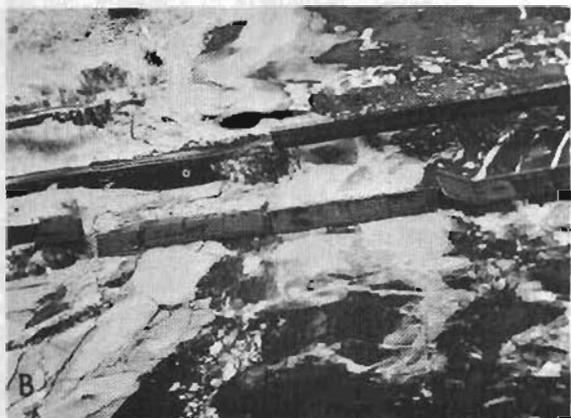
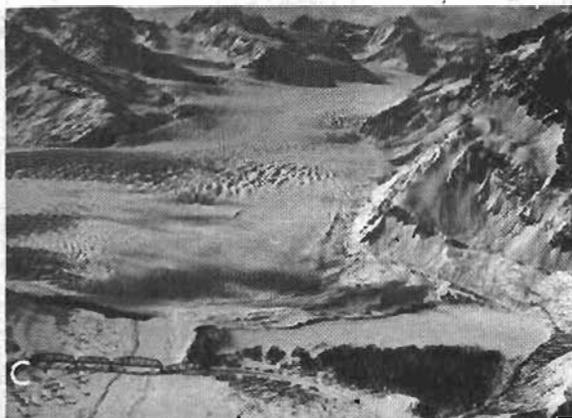
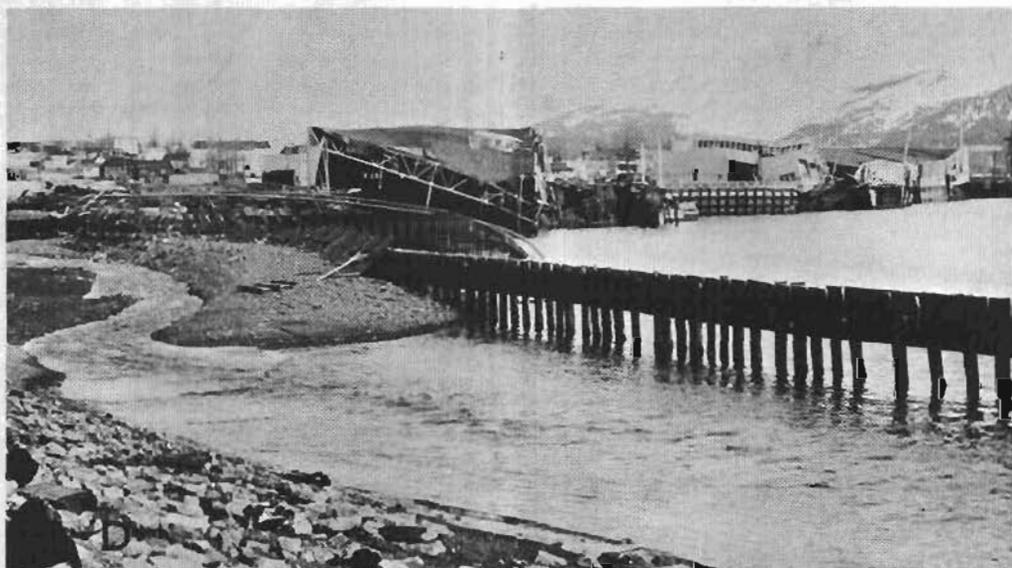
Figure 14. Photographs of damage to transportation routes and effects of large sea waves. A, Wave trim-line on north-facing bluffs of CULROSS ISLAND. B, Damage to railroad and highway bridge areas, 20-MILE RIVER. C, Damage to steel bridge crossing COPPER RIVER near Miles Glacier. D, Seismic sea wave damage at SEWARD.

At Port Nellie Juan, where 3 people are missing, dock facilities were apparently damaged by a surge of water that came from the south end of Cullross Passage immediately north of Port Nellie Juan (loc. 11 on fig. 7). Paul Selanoff, who was in a boat near the north end of Cullross Passage at the time of the earthquake, witnessed an ebb-current of "water down through the passage like a big waterfall about 8 to 10 feet high" for a period of about 30 minutes after the earthquake. Evidence of the violence of the southward surge of water at the north end of Cullross Passage is clearly visible locally along the shoreline (fig. 14A).

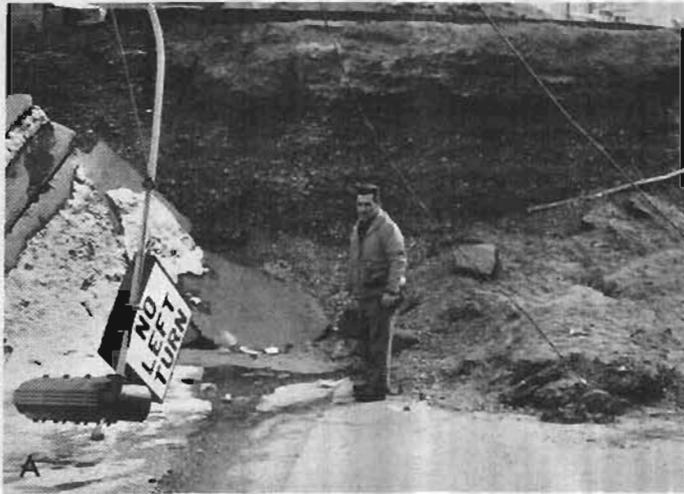
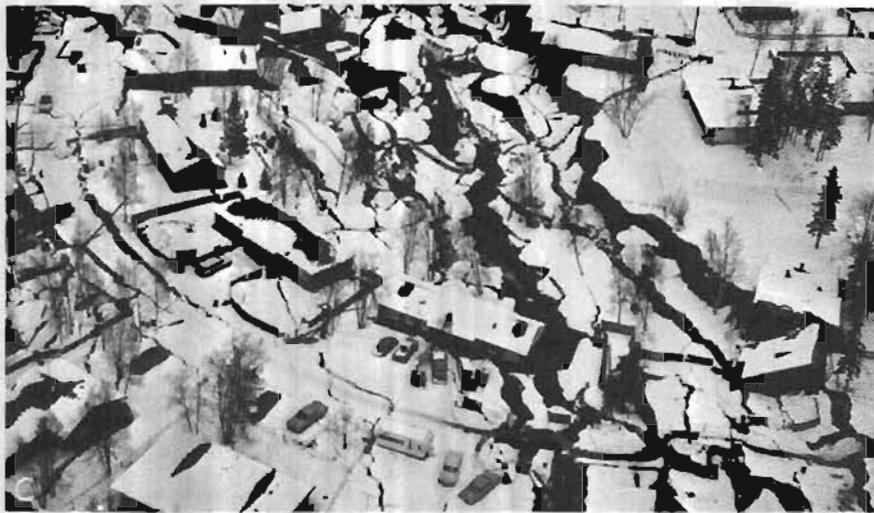
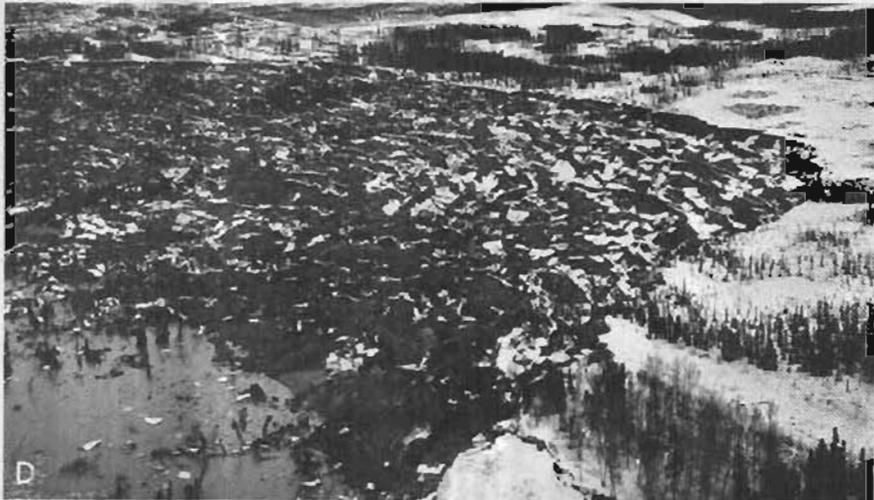
Figure 17. Photographs of destructive landslides in ANCHORAGE. A, Subsidence in the graben at the head of the Fourth Avenue slide. B, Landslide near Alaska Native Hospital. C, D, East and west parts of the Turnagain slide.

The earthquake triggered 11 landslides large enough to show on figure 15. Three of these, the Turnagain Heights, L Street, and 4th Avenue slides, caused most of the casualties and catastrophic damage in Anchorage (figs. 17 and 18). A fourth slide destroyed the Government Hill Grammar School.

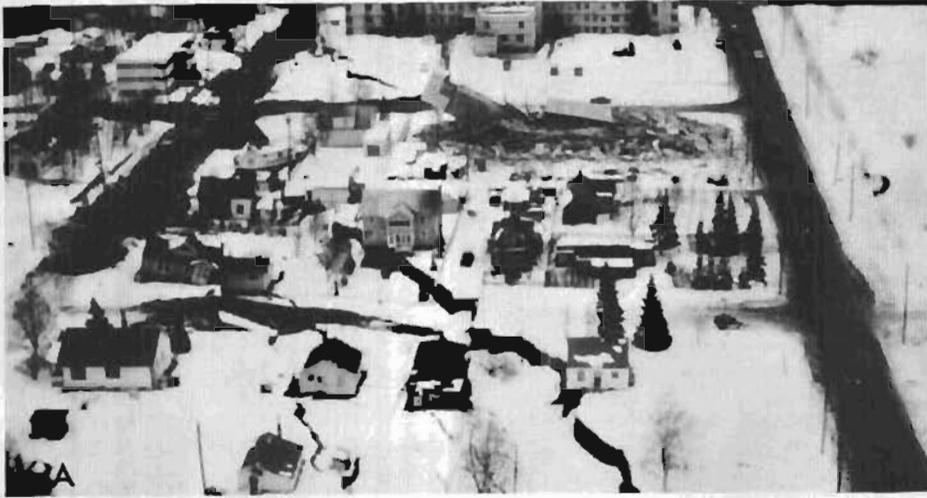
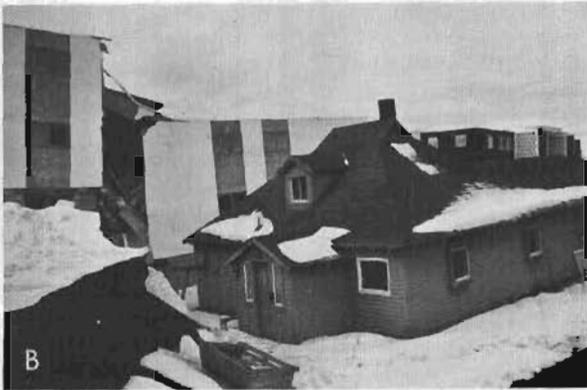
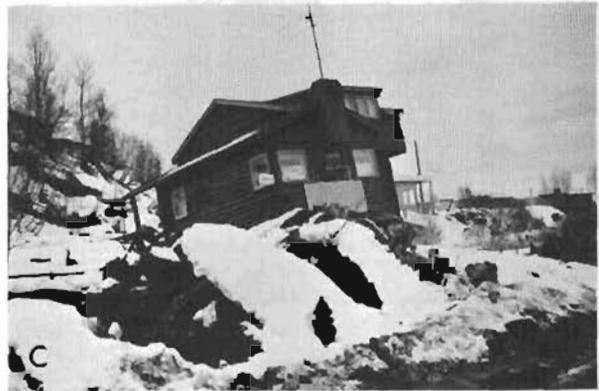
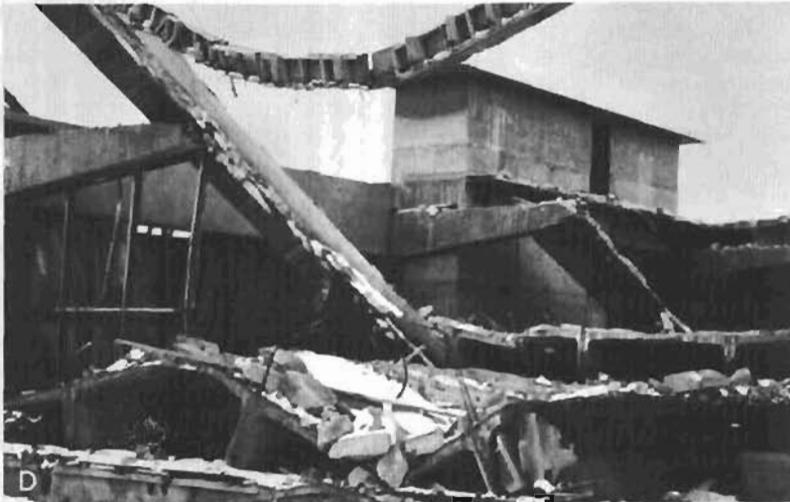
Figure 18. Photographs of destructive landslides and damage in ANCHORAGE. A, B, Graben at head of L Street landslide. C, Compressional ridge formed at toe of L Street landslide. D, Destruction by seismic shock of a partially complete concrete structure on unconsolidated deposits.

The L Street slide, that at 4th Avenue, and the one that destroyed the grammar school moved laterally as relatively coherent masses (fig. 16). The heads of these slides were zones of tension into which strips of ground as much as 150 feet wide subsided as much as 15 feet along near-vertical fractures. Narrow zones of compressional buckling at the toes of the slide also caused extensive destruction (fig. 18C).

All structures in Anchorage were subjected to intense seismic shaking during the earthquake. Many of the steel and concrete structures were severely damaged and one collapsed (fig. 18D). Some
