Report
QIE
75
065
no. 60-11

The Alaska Railroad

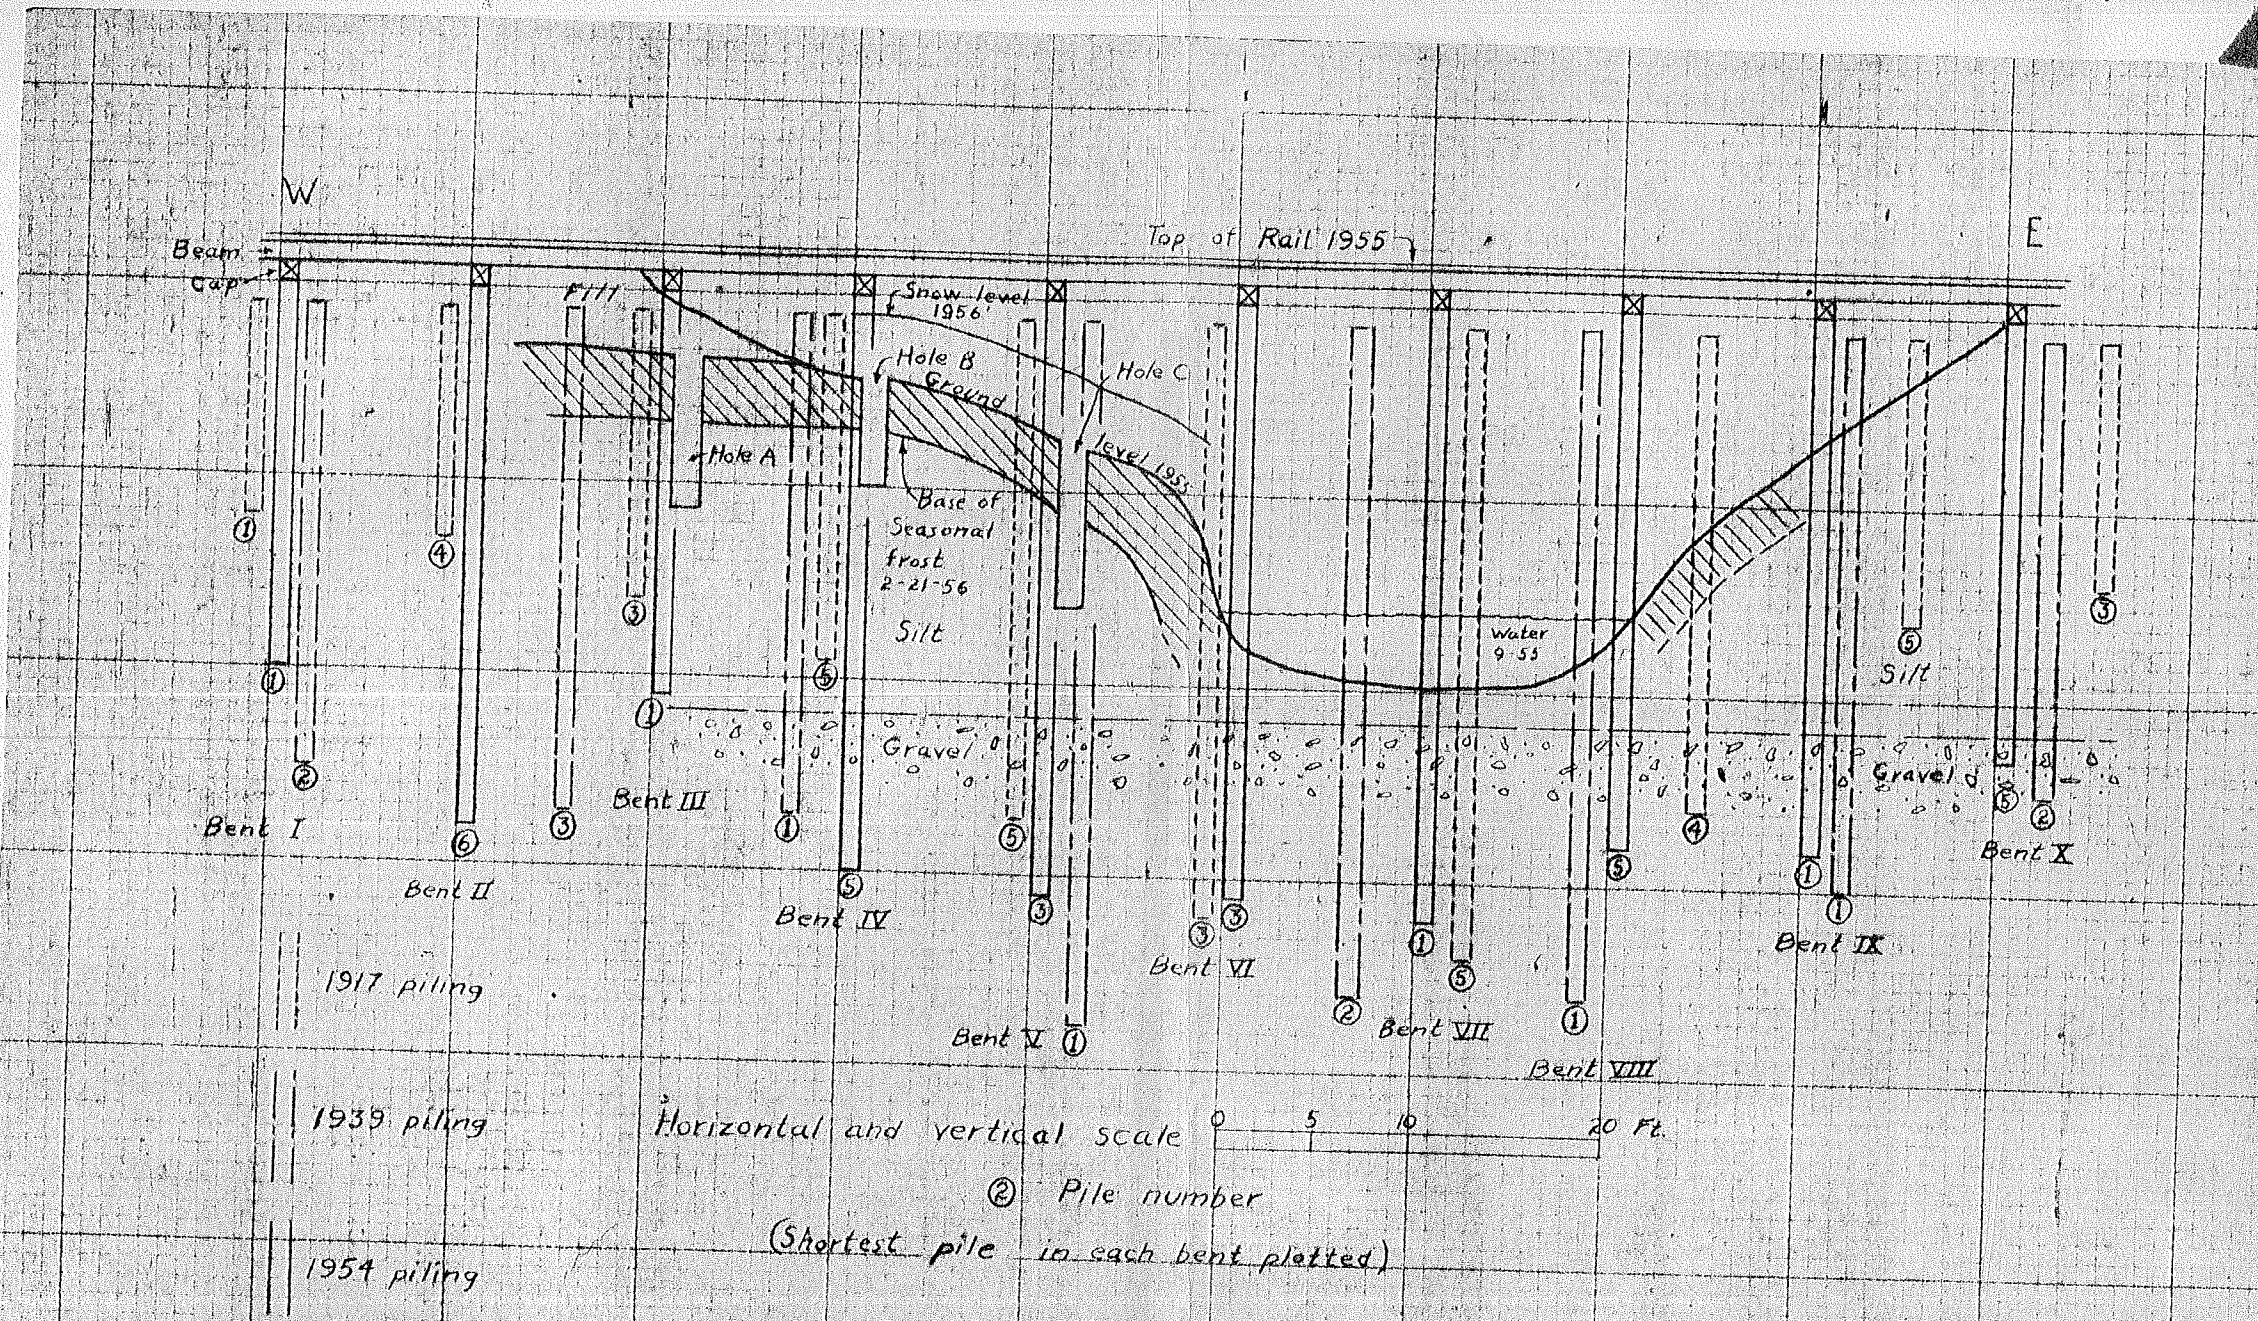
Fig. 25.--Geologic cross section at bridge at Mile Post 460.4 over Goldstream Creek near Fairbanks, Alaska
