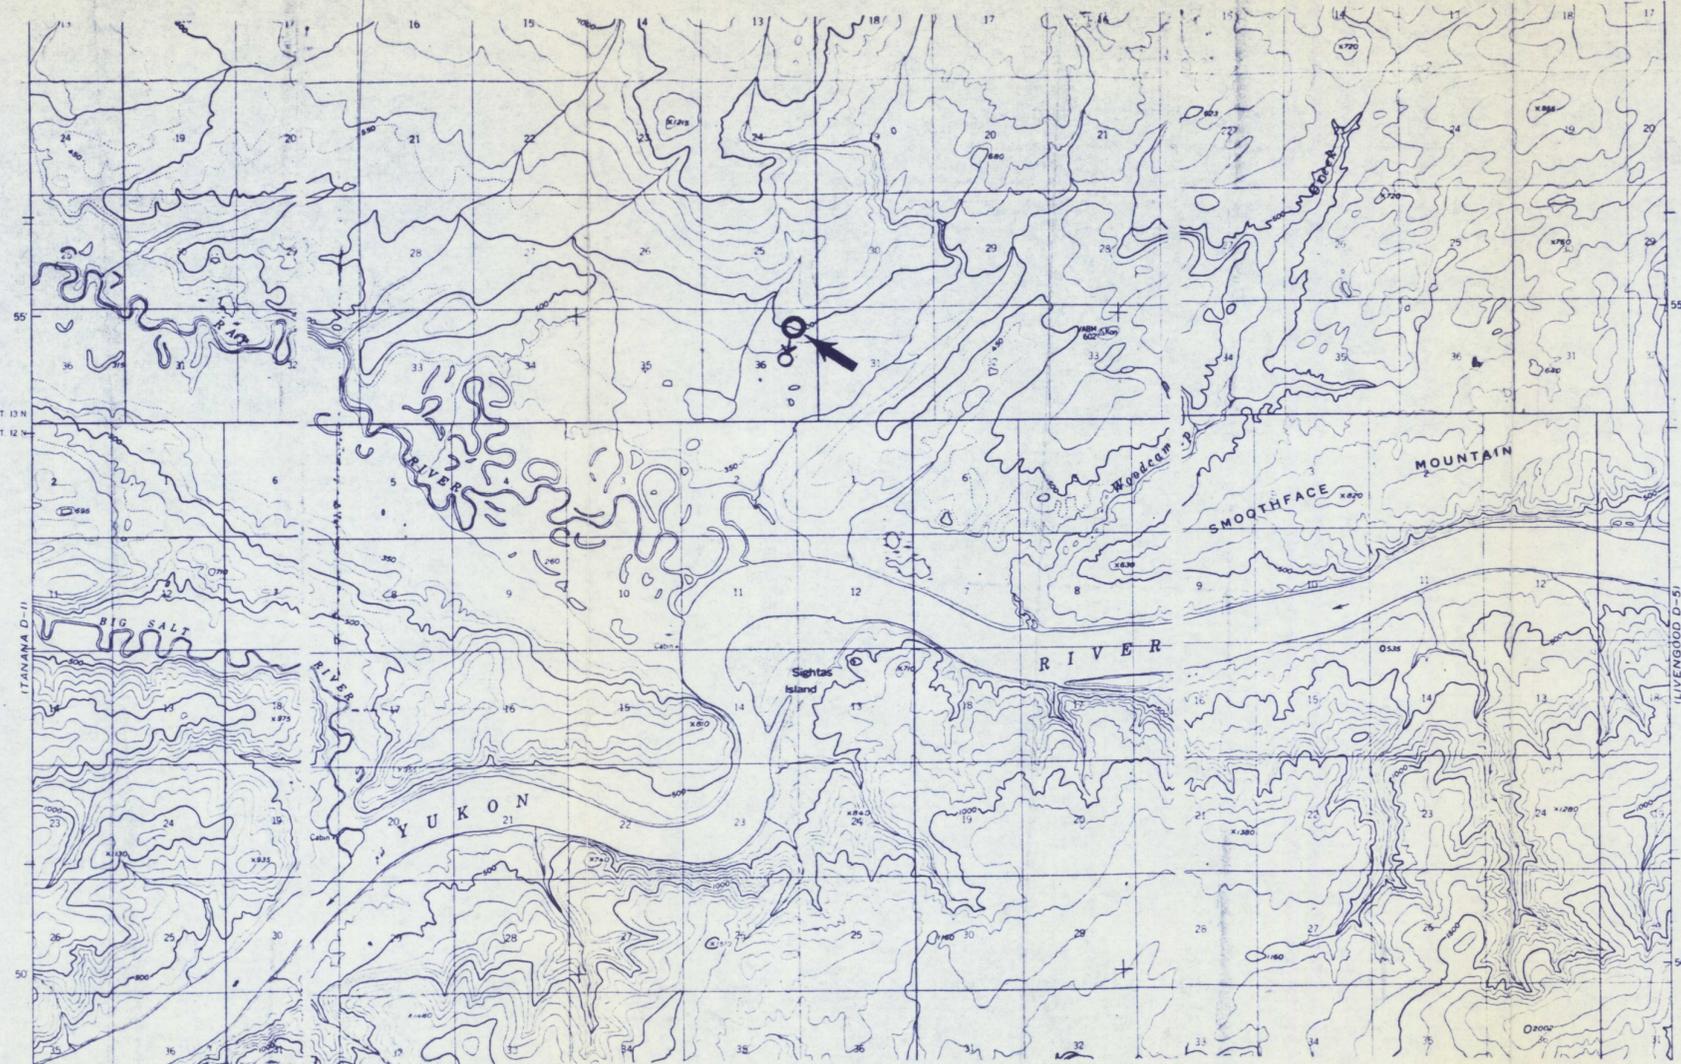
2 C

Figure 2C. Livengood D-6 quadrangle sheet showing area of icing in section 36 T13N R11W.

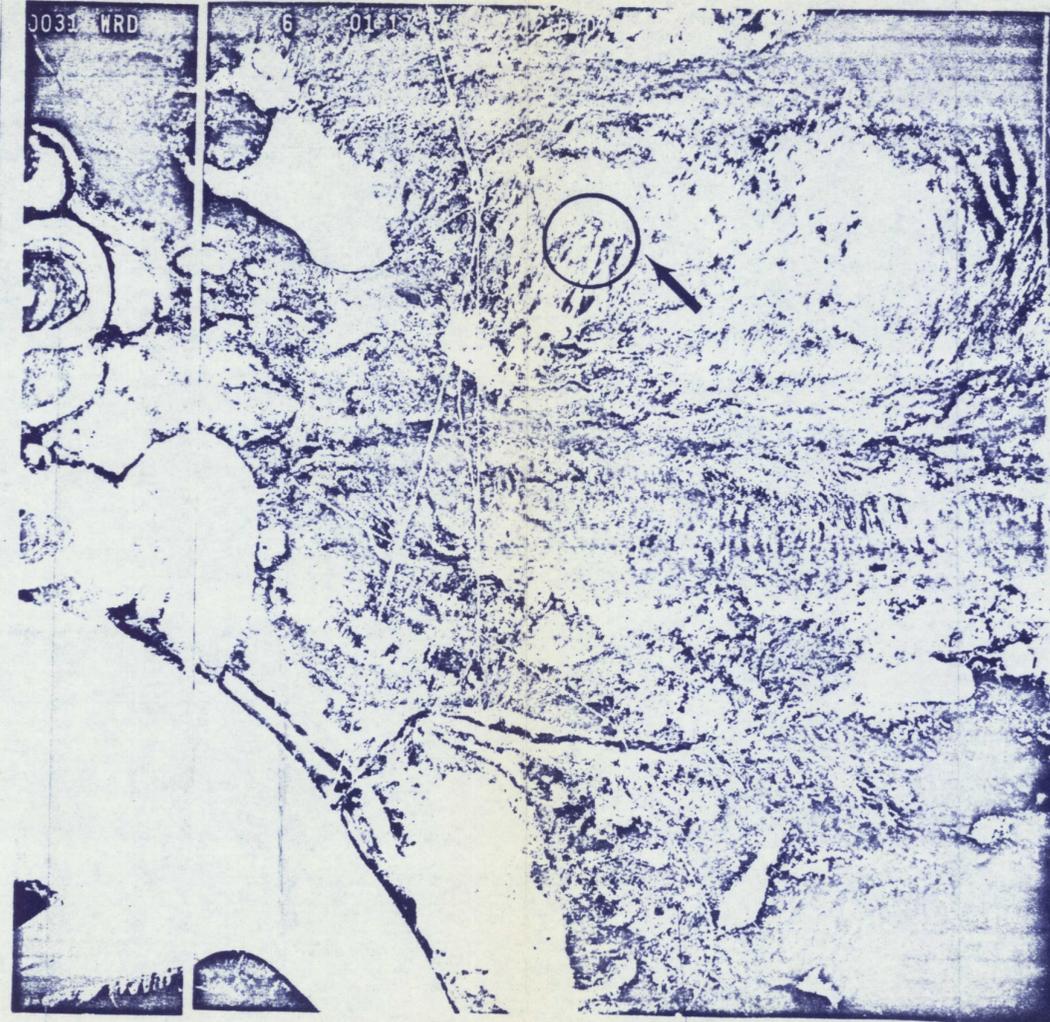
2 D

Figure 2D. Planimetric photo showing these channels leading from icing site.
