U.S. GEOLOGICAL SURVEY

An Atlas of Facies Microfabrics of the Bootlegger Cove Formation
Using the Scanning Electron Microscope

Open-file Report 87-60

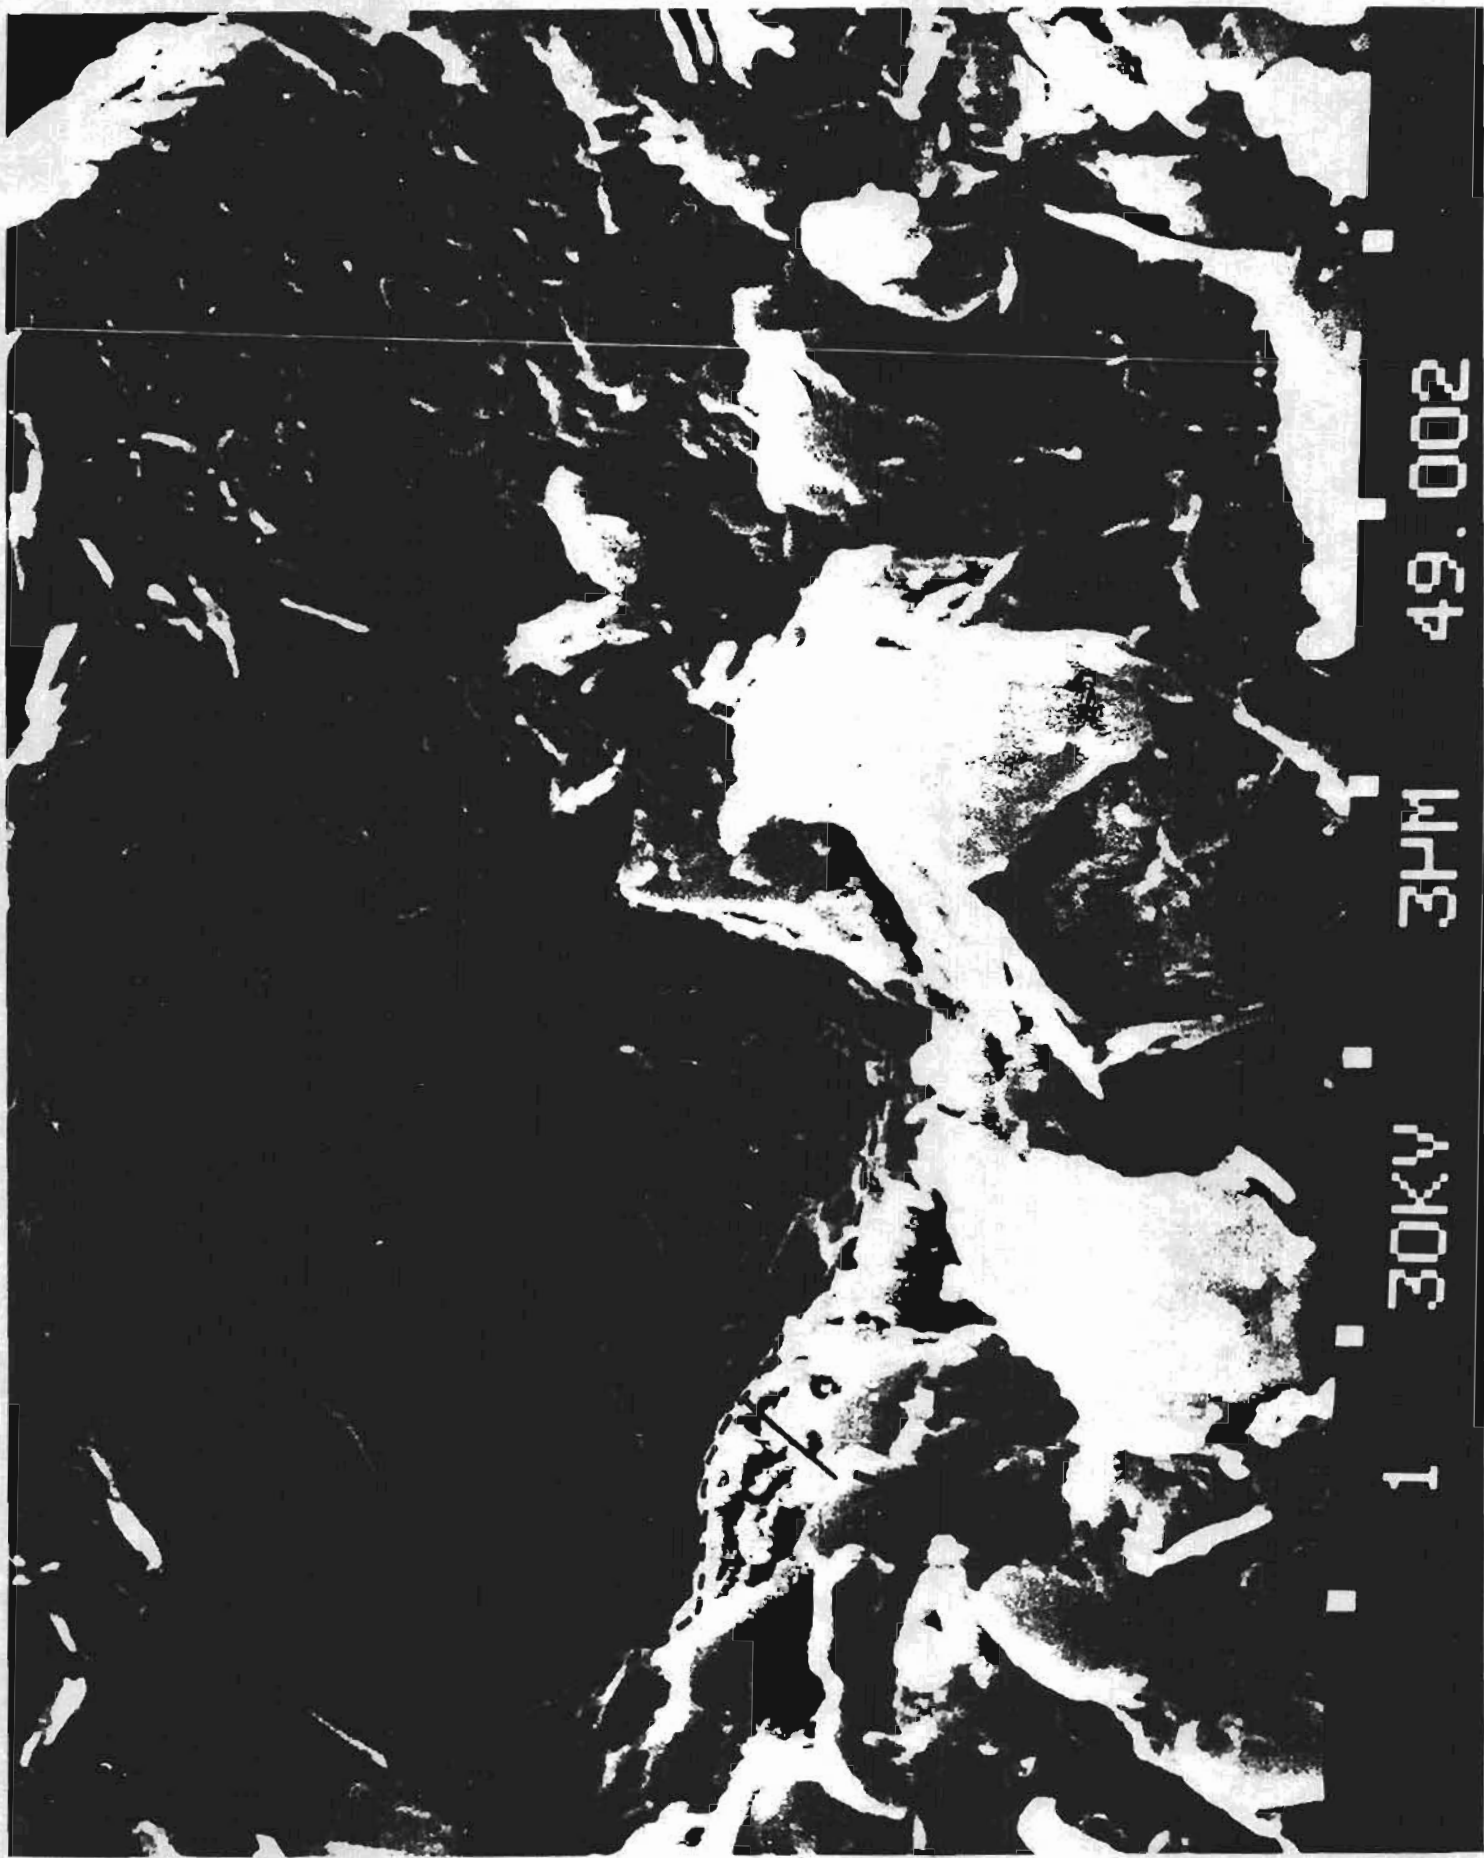
Figure 22. Facies F.III, detail from figure 21, mag. = 15000X. Numerous clay grains normal to plane of image which contribute to metastable fabric.

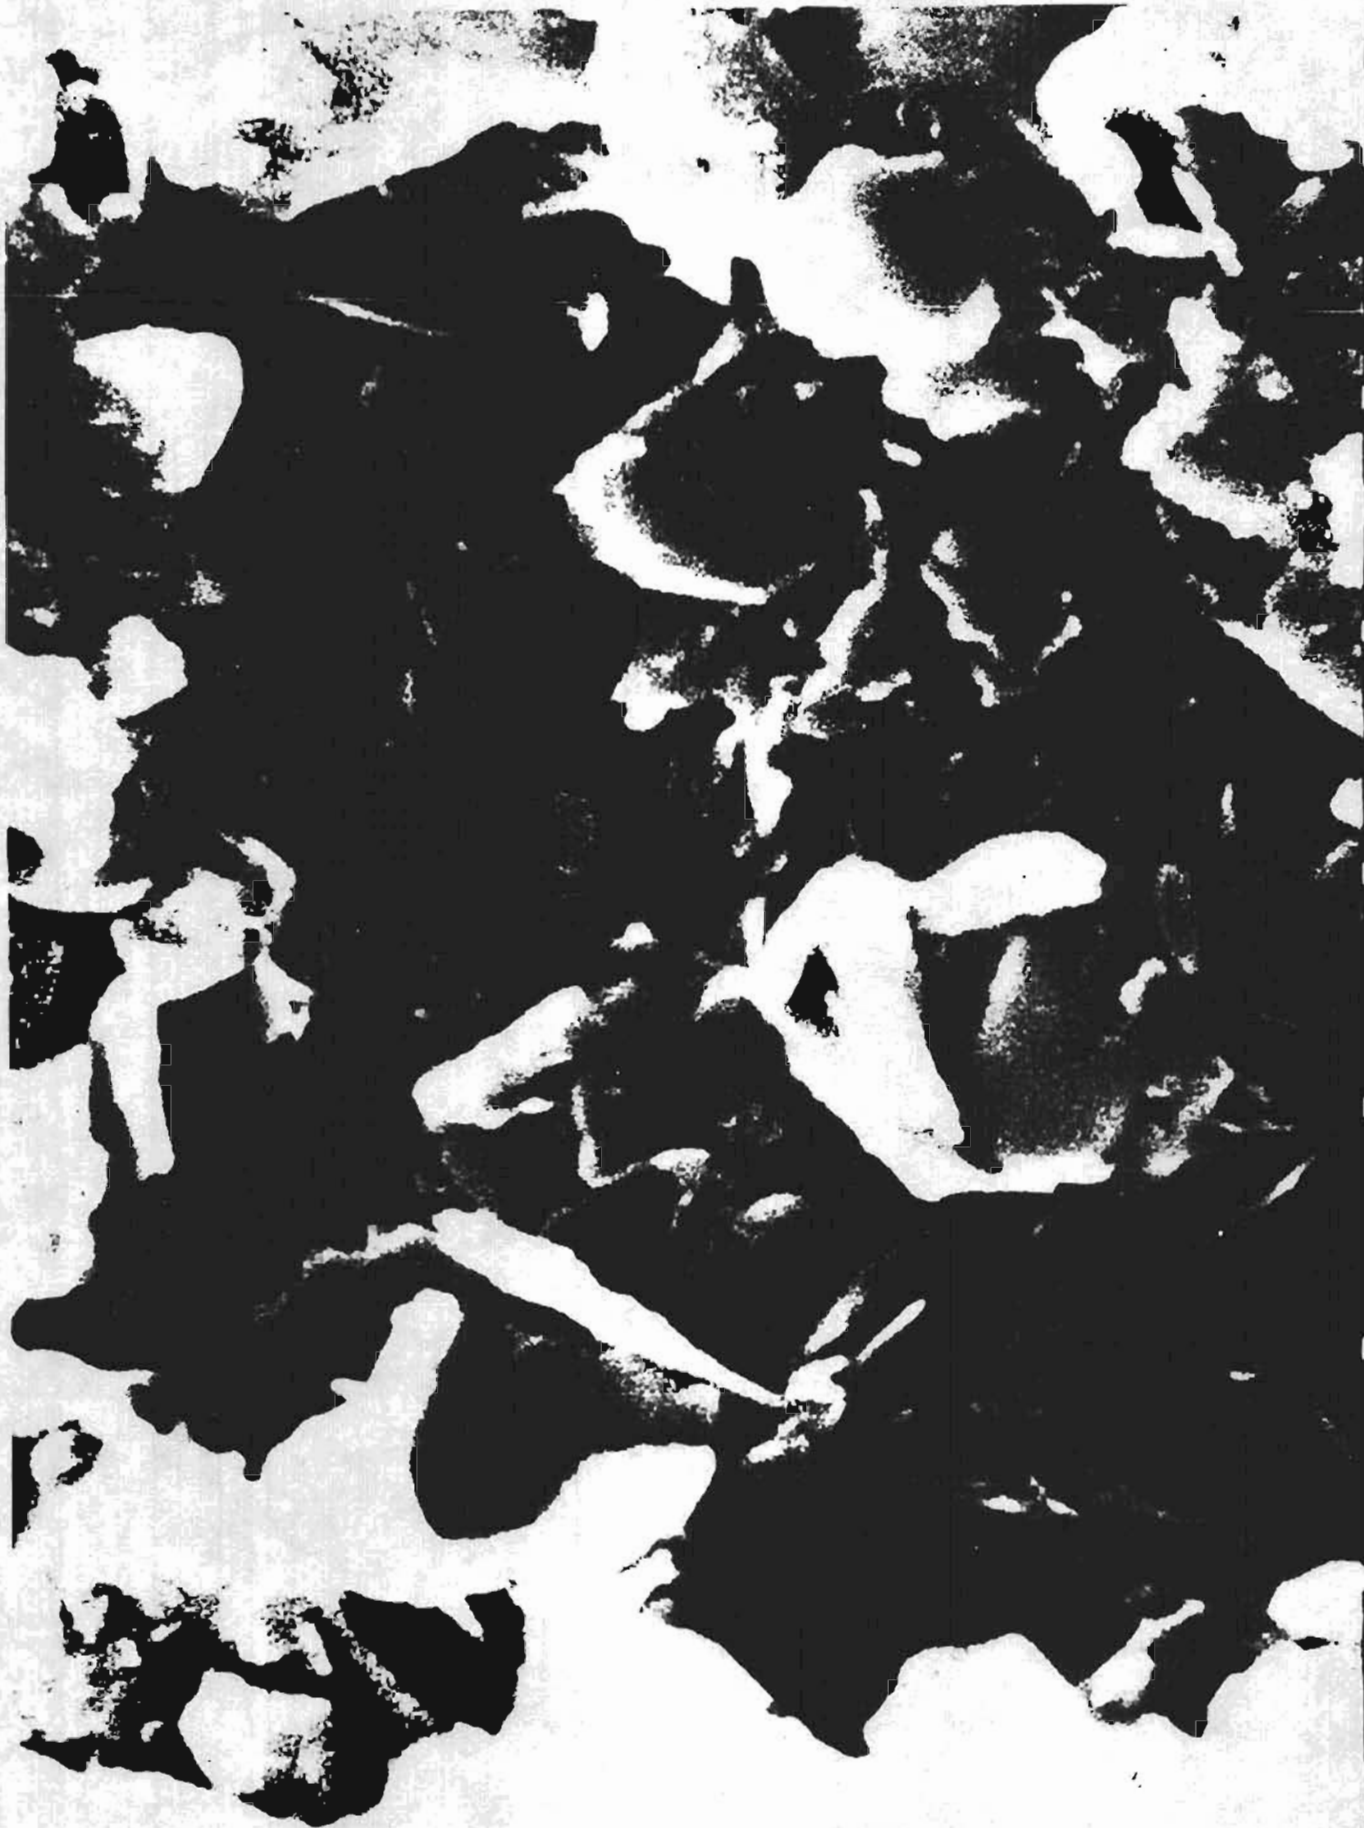
Figure 23. Facies F.III, parallel to bedding planes, mag. 2590X. General view showing silt grains (s) surrounded by open flocculated clay assemblages (of).

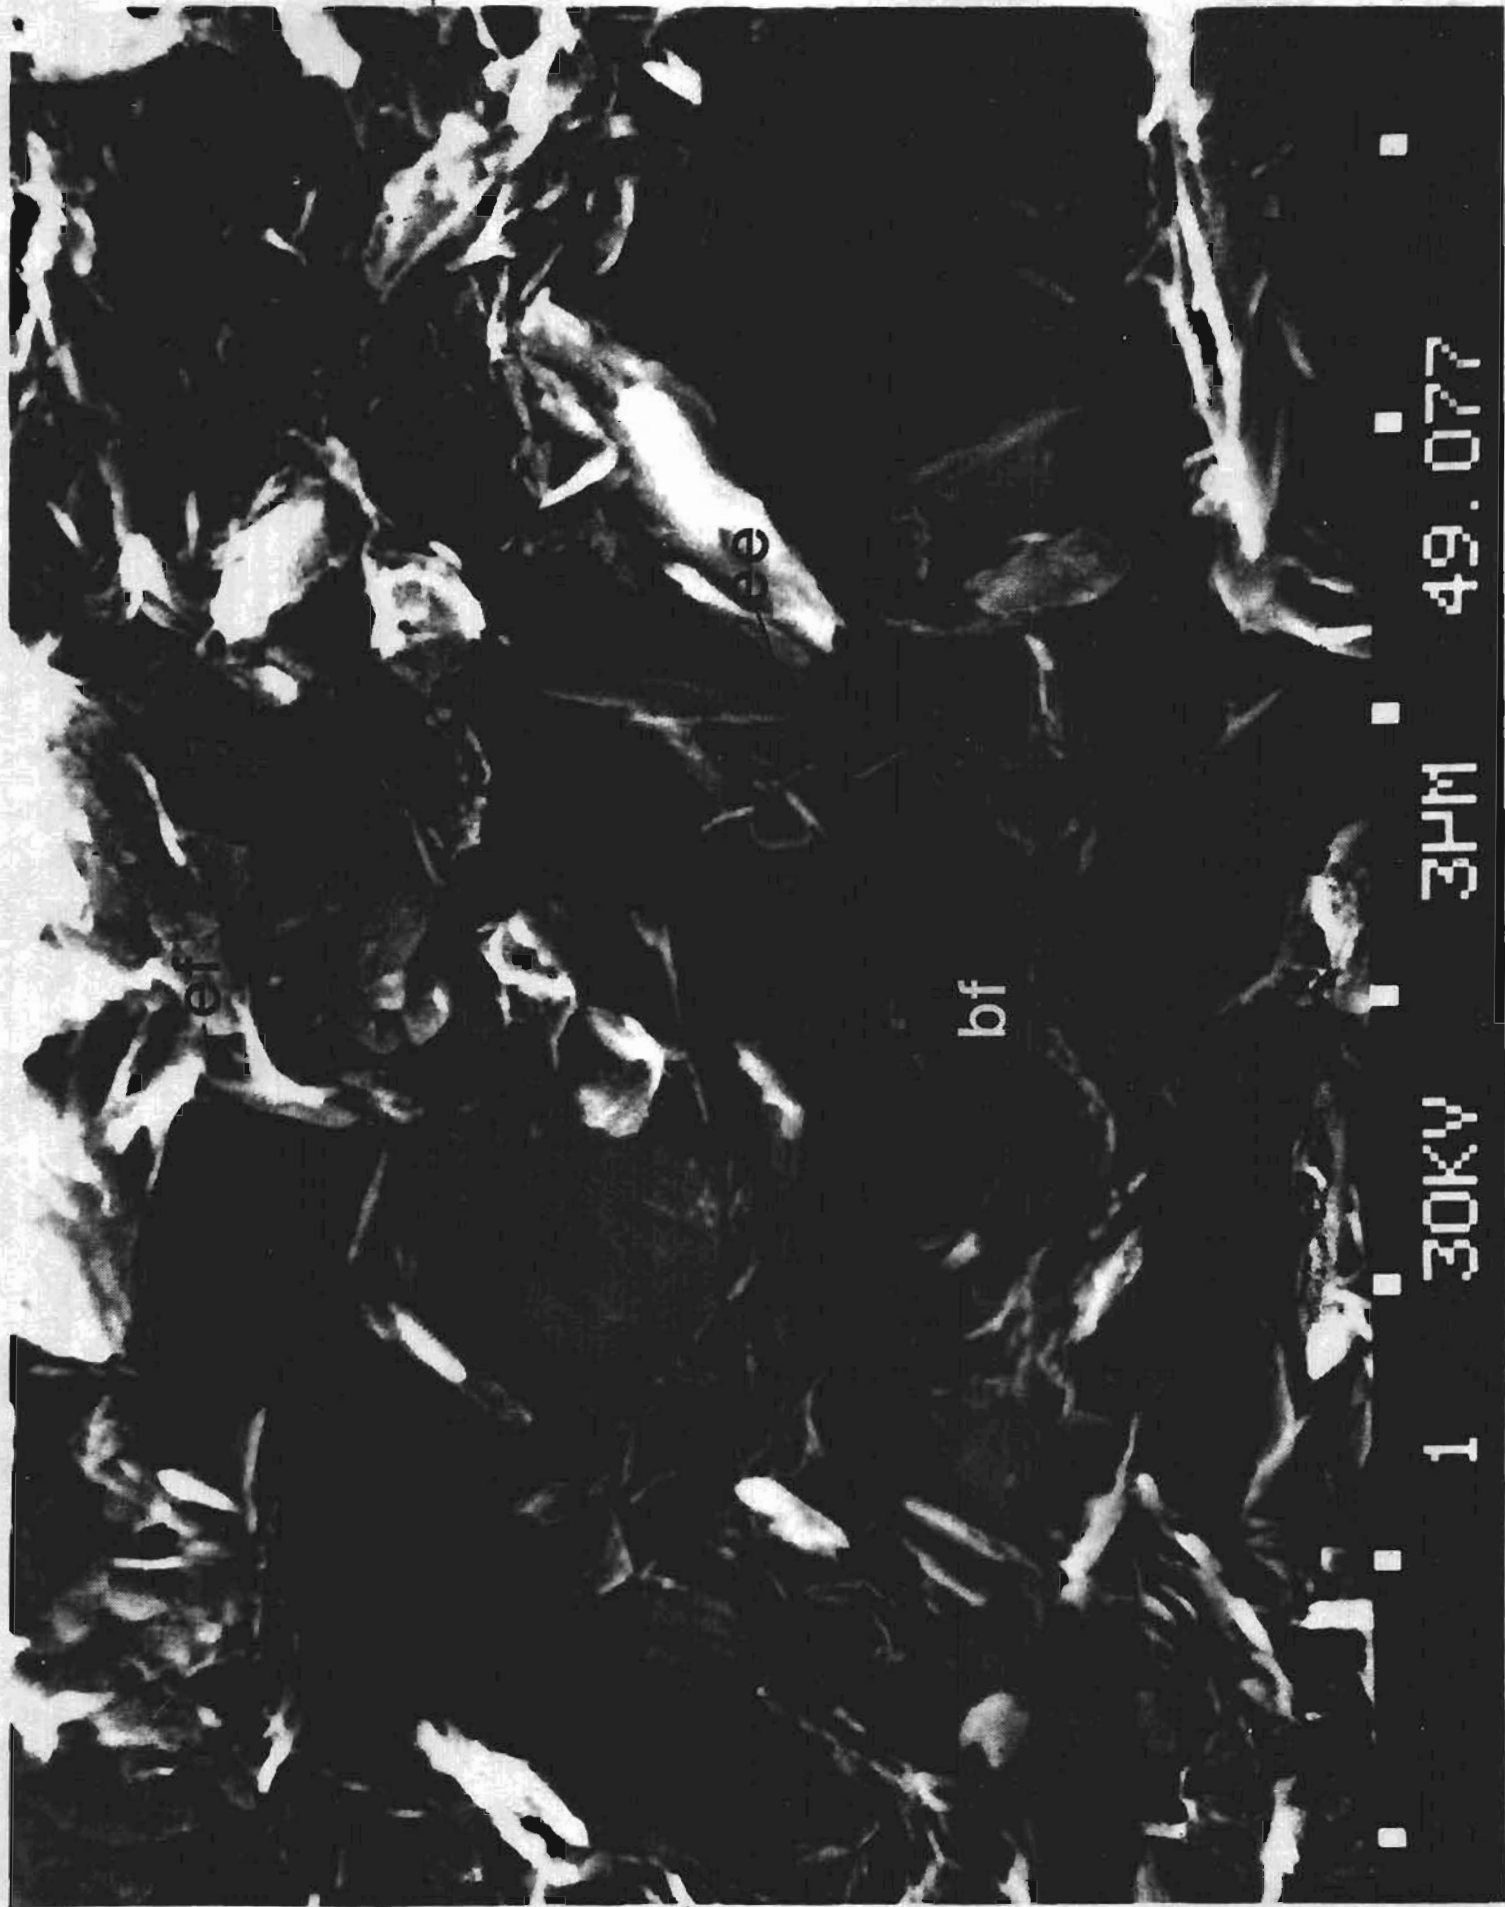
Figure 29. Facies F.III, parallel to bedding planes, mag. = 10,000X. High sensitivity sample consisting of clay-coated silt grains (s) surrounded by flocculated clay fabric with edge-to-face (ef) and edge-to-edge (ee) contacts forming boxwork structure (bf).

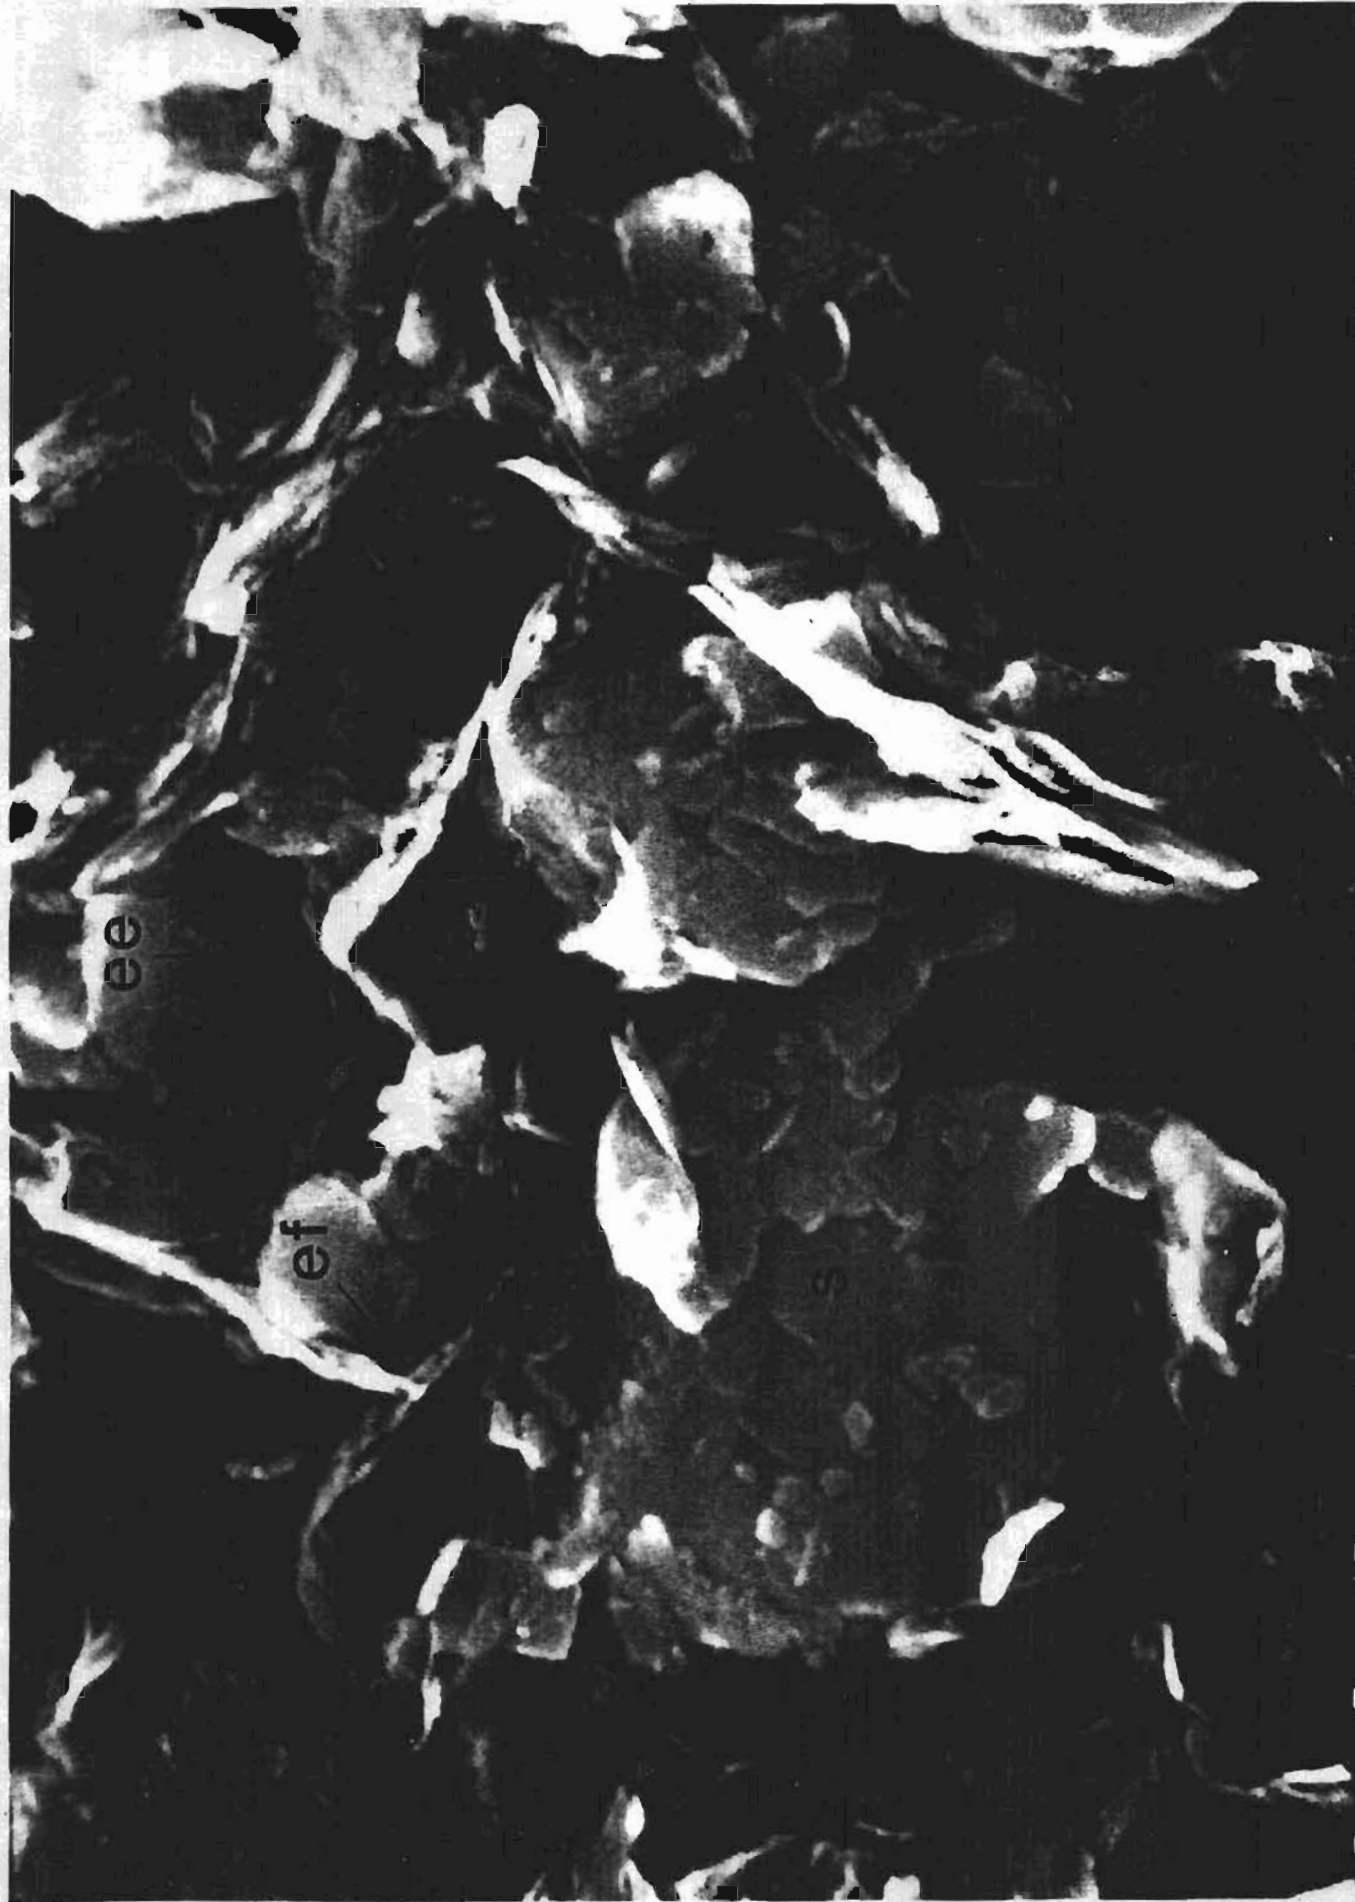
Figure 30. Facies F.III, parallel to bedding planes, mag. 11,000X. Boxwork fabric (bf) consisting of edge-to-edge (ee) and edge-to-face (ef) contacts. Collapsed zone (cz) may represent shear plane.
