Overview of Environmental and Hydrogeologic Conditions at Dillingham, Alaska

Open-File Report 94-482

FEDERAL AVIATION ADMINISTRATION

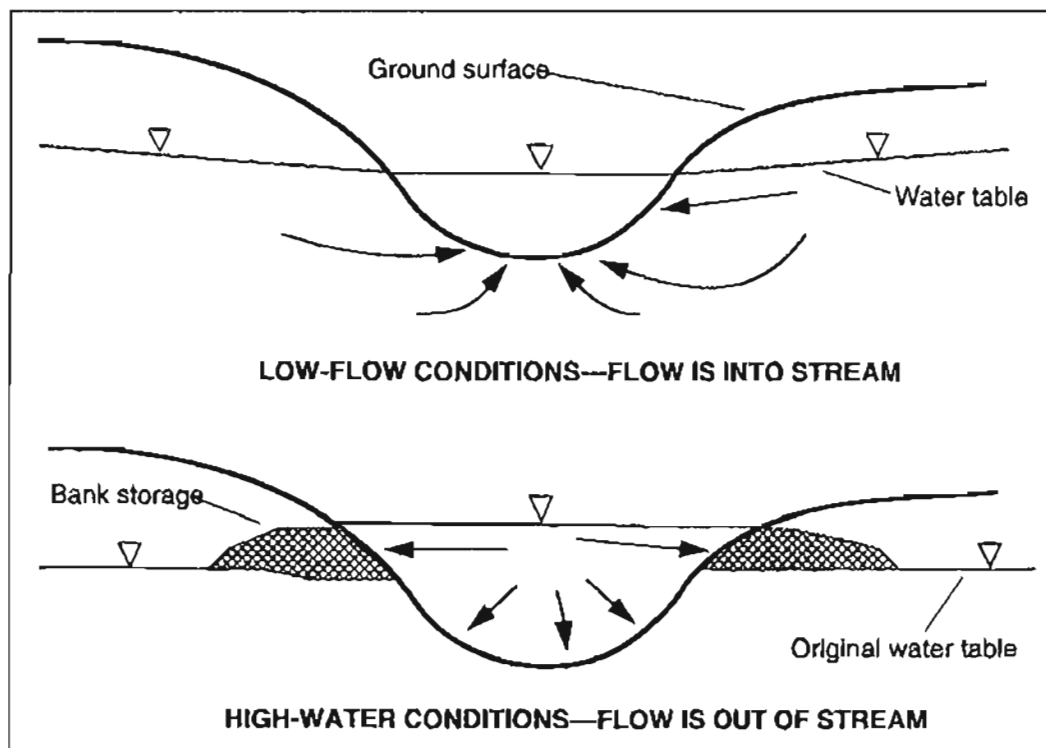
Figure 4. Ground-water/surface-water Interactions.

Adjacent to the local streams and rivers, shallow ground water flows into and out of the banks as the elevation of water in the river or stream (stage) rises and falls. Seasonally, the stream fluctuates from maximum flow and stage in late May or early June to minimum flow in late April or early May. The stream rises also during late-summer rainstorms. The water table generally rises and falls in response to these fluctuations. The water-table fluctuations, however, are attenuated with distance from the stream. This flow of water into and out of the aquifer in response to changing stage of the stream is termed "bank storage effects" (Linsley and others, 1982) (fig. 4).
