THE ALASKA EARTHQUAKE, MARCH 27, 1964:
REGIONAL EFFECTS

Slide-Induced Waves, Seiching
And Ground Fracturing
Caused by the Earthquake
Of March 27, 1964
At Kenai Lake, Alaska

GEOLOGICAL SURVEY PROFESSIONAL PAPER 543-A

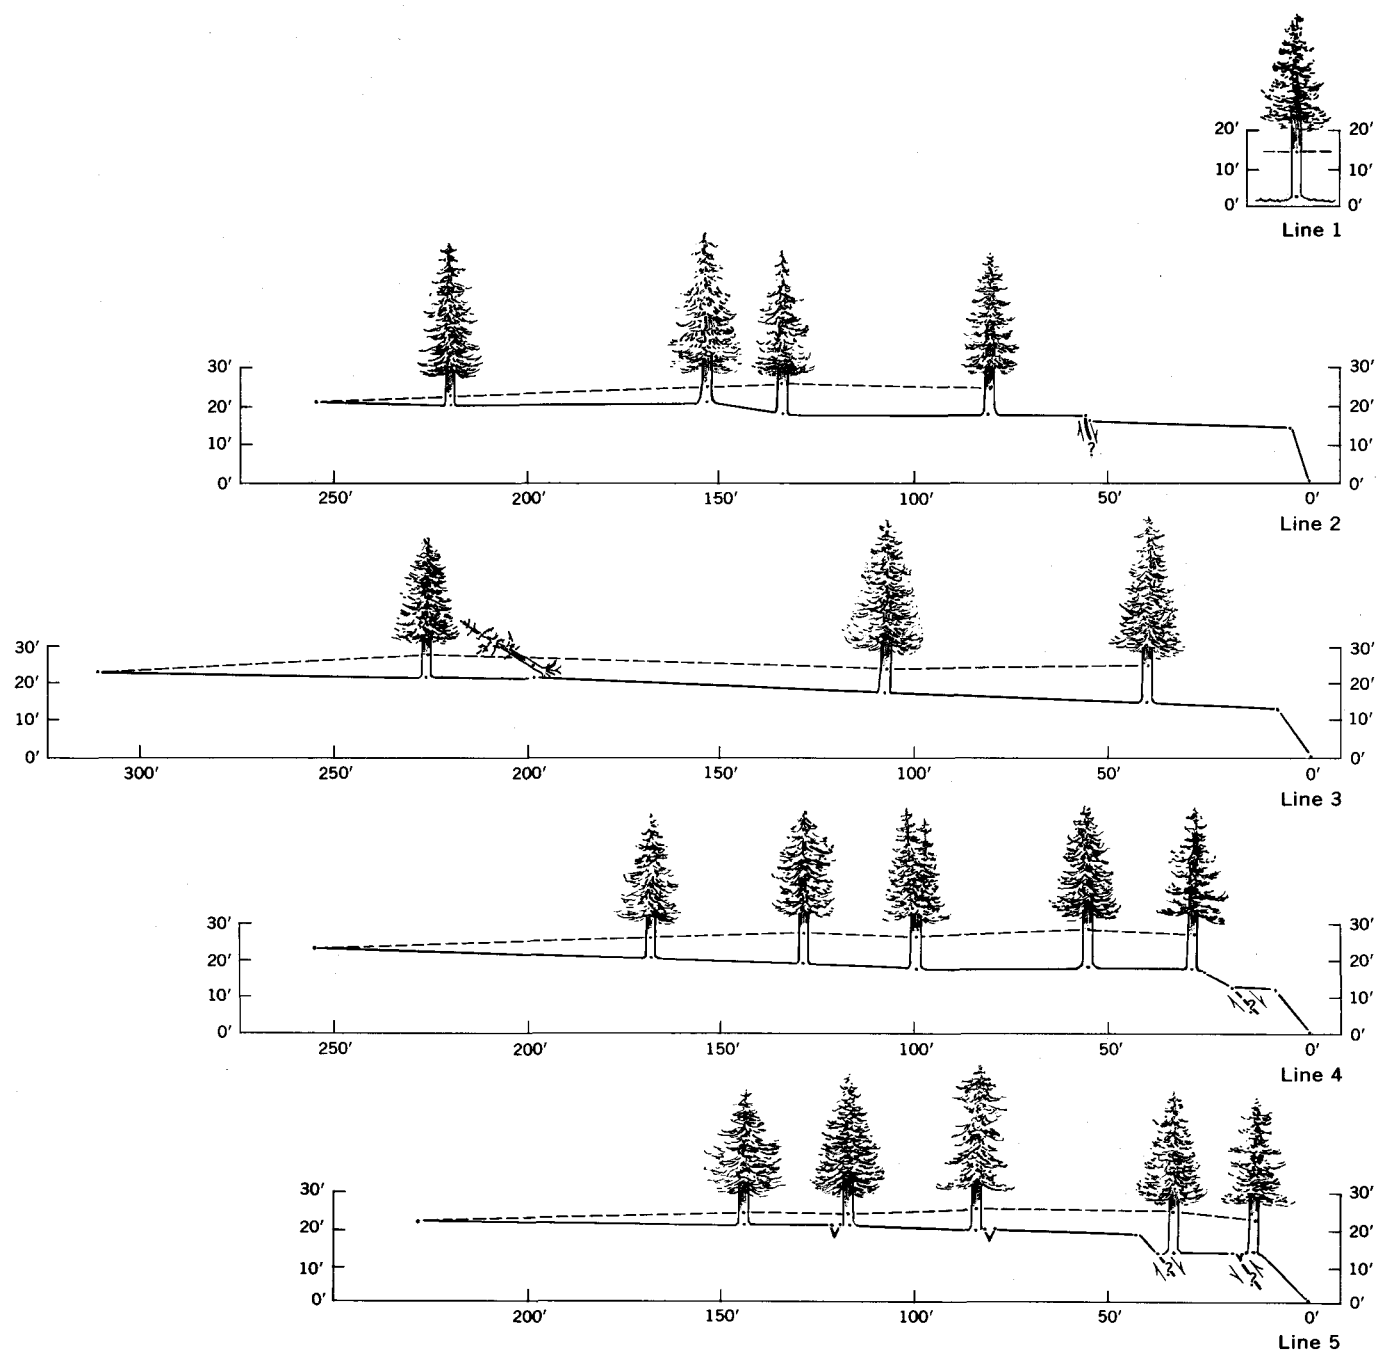
8.—Upper limit of backfill wave damage along traverses run parallel to wave travel direction on Lakeview delta. Location of traverses shown on figure 7.

To determine the altitude of the crest (runup) of the backfill wave as it ran up on shore, the height of the damage to trees was recorded. Four traverses were run from the toe of the scarp in the direction of wave travel on the delta (figs. 7 and 8). Horizontal distances were determined by pace, and altitudes were measured with a stadia rod and hand level. Altitudes were also recorded for the base of the damaged trees and for the heads and toes of small scarps. The lake level was 437.0 feet when the traverses were run, and these altitudes have been adjusted in fig-

ure 8 to the altitude of the lake at the time of the earthquake (431.6 ft). The height of the wave above the lake surface may have been somewhat greater or less than indicated by these altitudes, for the lake might have been seicheing at the time the wave was formed. The crest of the backfill wave was about 10 feet above the delta surface as the wave crossed the scarp. The height of the wave decreased inshore but the altitude of the highest damage rose and fell somewhat with the changing slope of the delta surface.

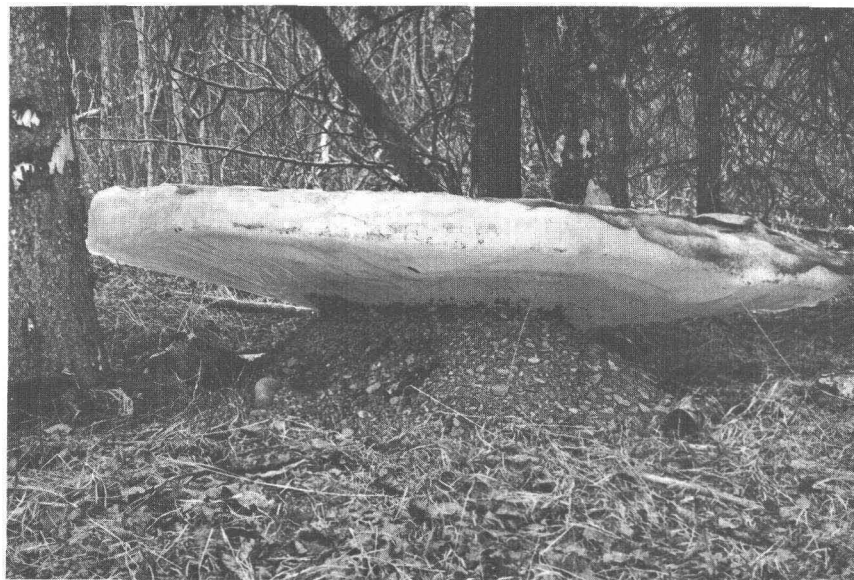
15.—A large block of lake ice to which sediment was frozen when carried ashore by the wave.

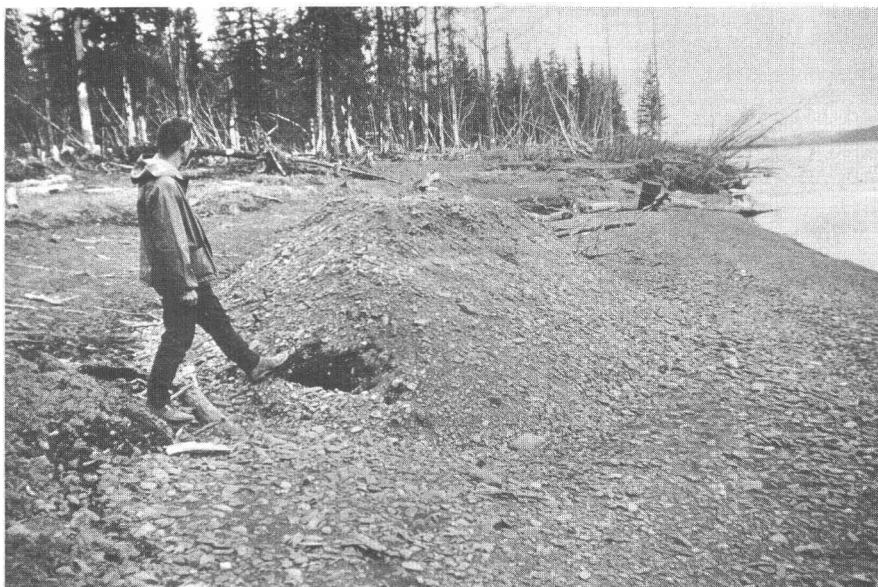
16.—Large block of bedded sandy pebble gravel carried ashore by the wave at Lawing. The slide scarp forms the boundary of the beach to the right; debarked trees in the background.

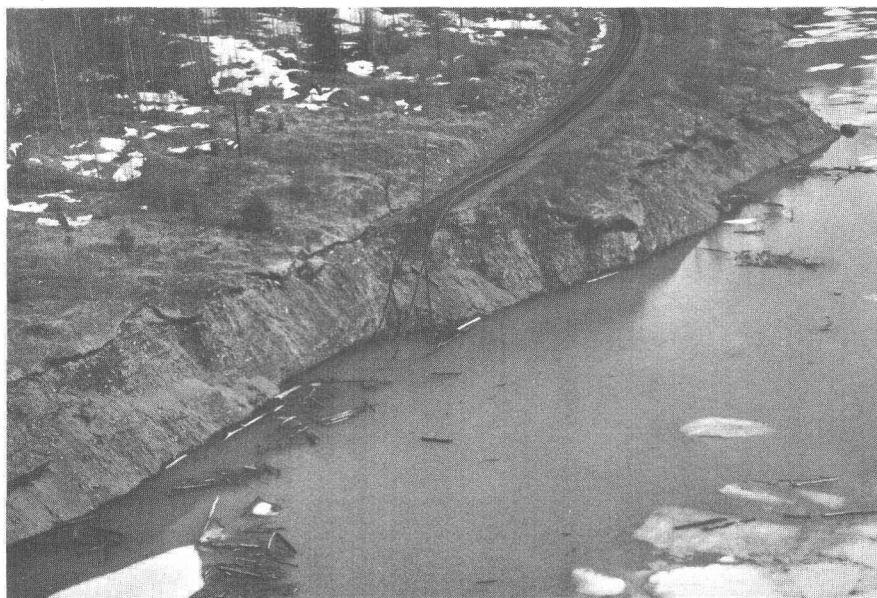
19.—Scarps along the front of Rocky Creek delta produced by many small slump-type slides. The gently dipping coarse sediment is clearly visible. With the exception of the sandy lens at left, most of the sediment is dry.

Rocky Creek has a steep gradient, falling about 4,500 feet in 2 miles. The sediments exposed along the scarps are therefore coarse, poorly sorted sand and sandy gravel. Most of the apparent dips visible on the scarps were estimated to be less than 10°. In mid-May and early August the face of the scarp was dry, except for a few wet lenticular sandy silt beds of short lateral extent and about 6 inches thick (fig. 19). The gravel is composed primarily of angular and subangular tabular pebbles and some cobbles of slaty shale. About 150 feet upslope from the scarp of the slide that carried away the rail line, 8 feet of very sandy gravel is exposed in a shallow borrow pit. The coarse sediment seen in these outcrops is probably representative of the delta as a whole.

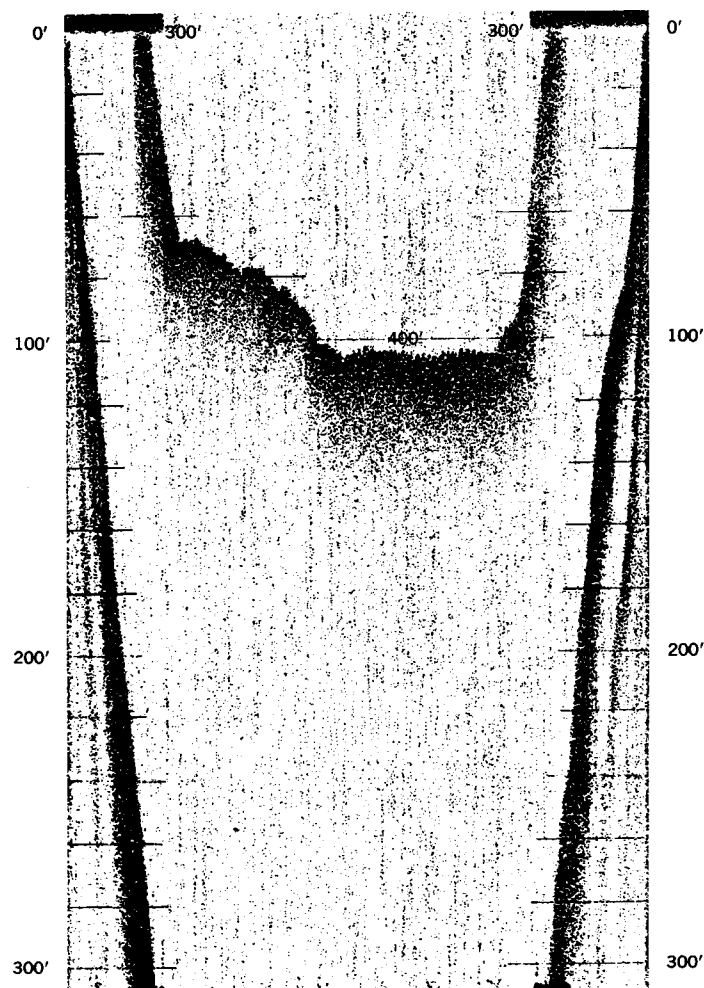
FATHOGRAM RECORDED ON LINE 89

PROFILE ALONG FATHOMETER LINE 89

Note: Because of the large vertical exaggeration on the fathogram, this profile, which has no vertical exaggeration, is also shown

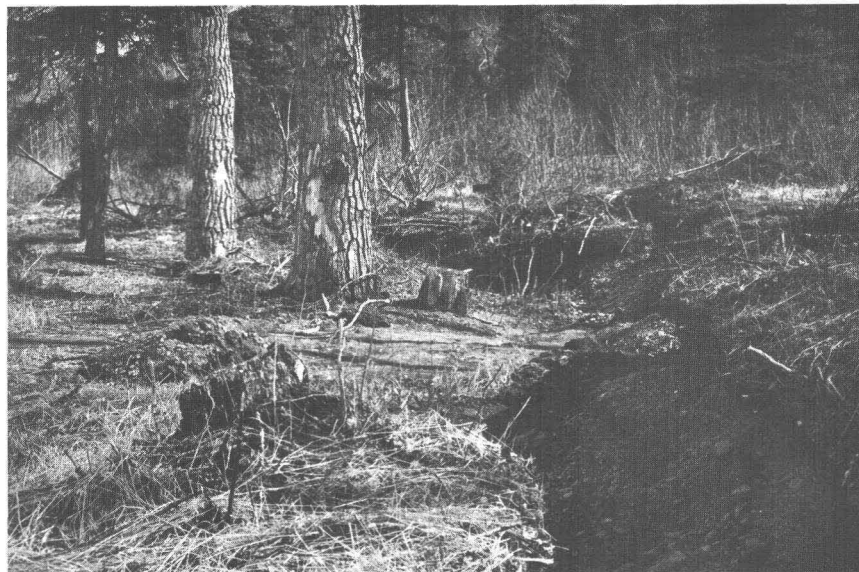
30.—Five-foot high scarp along the back of a rotational slump on Lakeview delta. Kenai Lake lies to the left. The slide-induced wave deposited the small pile of sediment on the dirt road displaced by the scarp and debarked the trees.

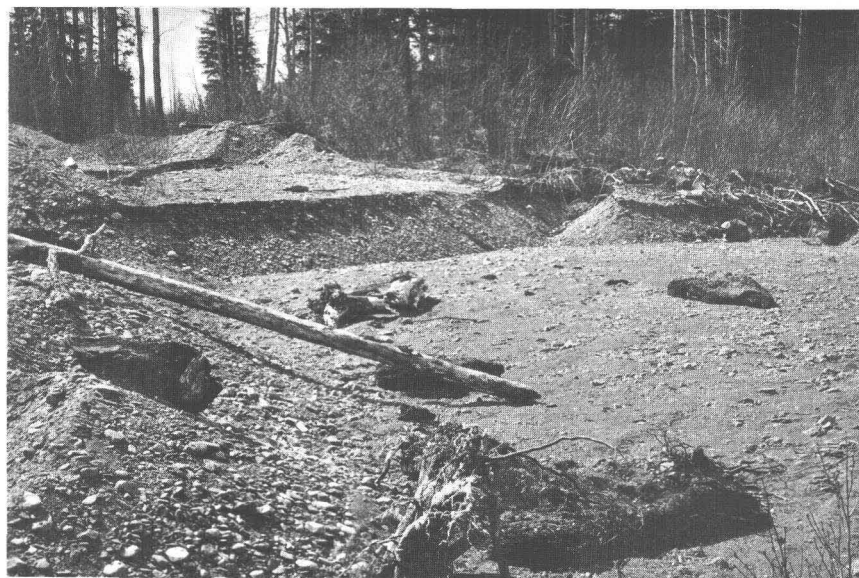
31.—High scarp (4½ ft) of a rotational slump on the south side of Victory Creek on Lakeview delta.

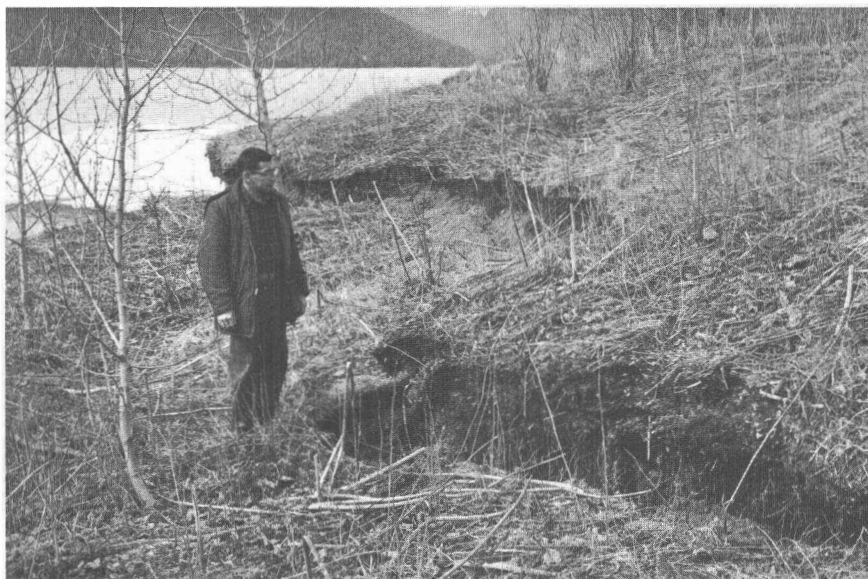
32.—Slump block having some rotation and horizontal separation at the edge of Rocky Creek delta.
