THE ALASKA EARTHQUAKE, MARCH 27, 1964:  
REGIONAL EFFECTS

Geologic Effects of the  
March 1964 Earthquake  
And Associated Seismic  
Sea Waves on Kodiak  
And Nearby Islands  
Alaska

By GEORGE PLAFKER and REUBEN KACHADOORIAN

GEOLOGICAL SURVEY PROFESSIONAL PAPER 543-D

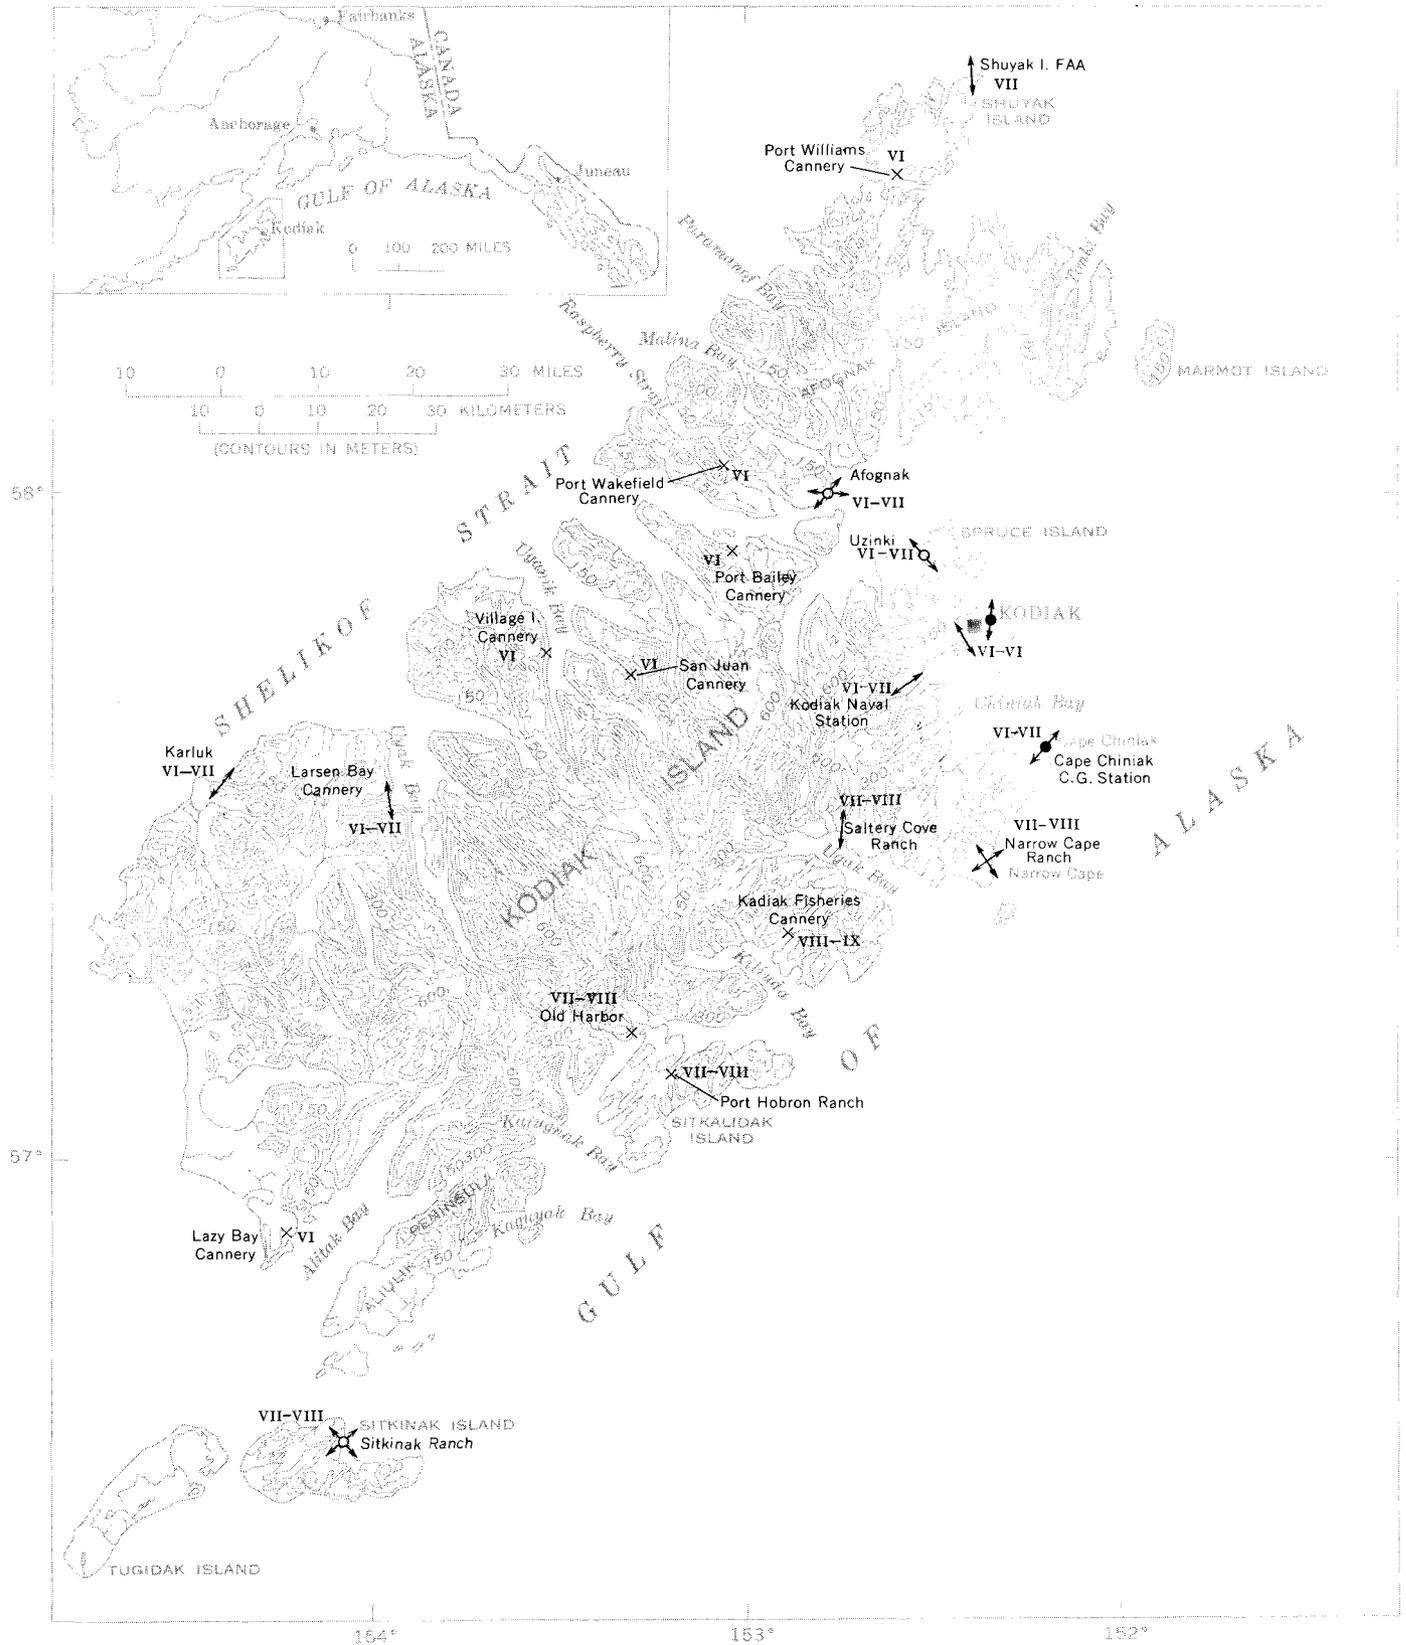
5.— Reported ground motion, sounds, ground waves, and assigned Mercalli intensities on Kodiak and nearby islands. The directions of reported ground motion are shown by arrows; localities at which sound was reported are shown by solid circles, localities at which ground waves were reported by open circles, and assigned Mercalli intensities by Roman numerals.

Estimates of the Mercalli intensity of ground shaking in the area, based on the reported effects on people and inanimate objects, are shown on figure 5. Ground-water effects, landsliding, and avalanching, which were widely distributed and bore no clearcut relationship to structural damage, were not considered as suitable criteria for intensity estimates. Except as noted, assigned intensity ratings are according to the abridged Modified Mercalli Intensity scale of 1931, in which the violence of ground motion is separated into 12 categories of increasing destructiveness from I to XII (Hodgson, 1964, p. 58-59).

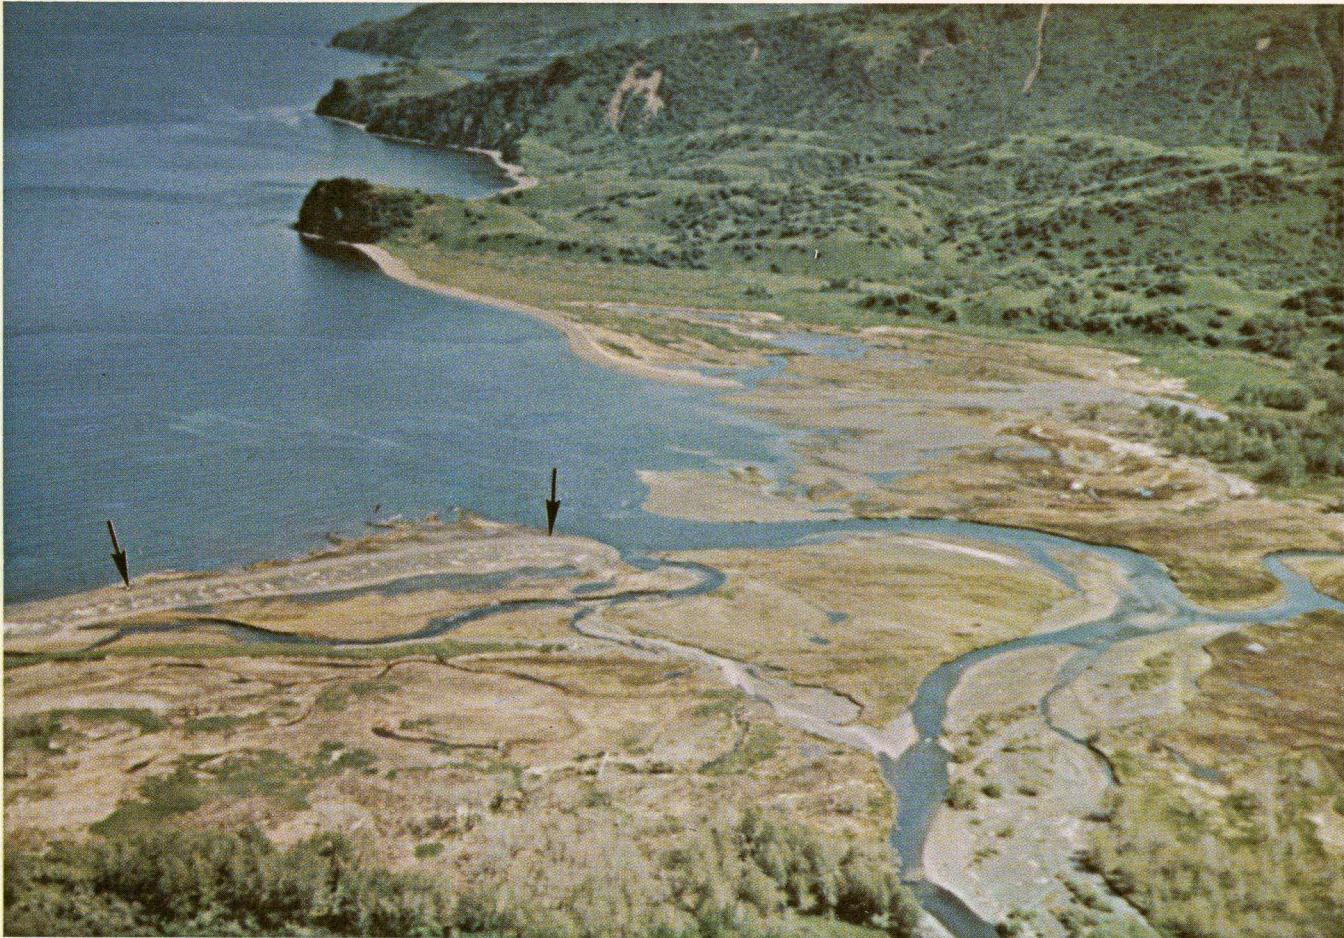
#### DROWNED STREAM ESTUARY AT EAGLE HARBOR ALONG SOUTH SHORE OF UGAK BAY

Extensive brown area of terrestrial vegetation has been killed by salt-water immersion after 4 feet of tectonic subsidence and an unknown amount of surficial subsidence. The gray ridge of beach gravel in the left part of view (arrows) has been eroded back and built up in adjustment to the new higher base level of deposition. The fact that the effects of inundation are scarcely visible along the steep bedrock shore in the background suggests that much of the subsidence at the estuary deposits was surficial rather than tectonic.

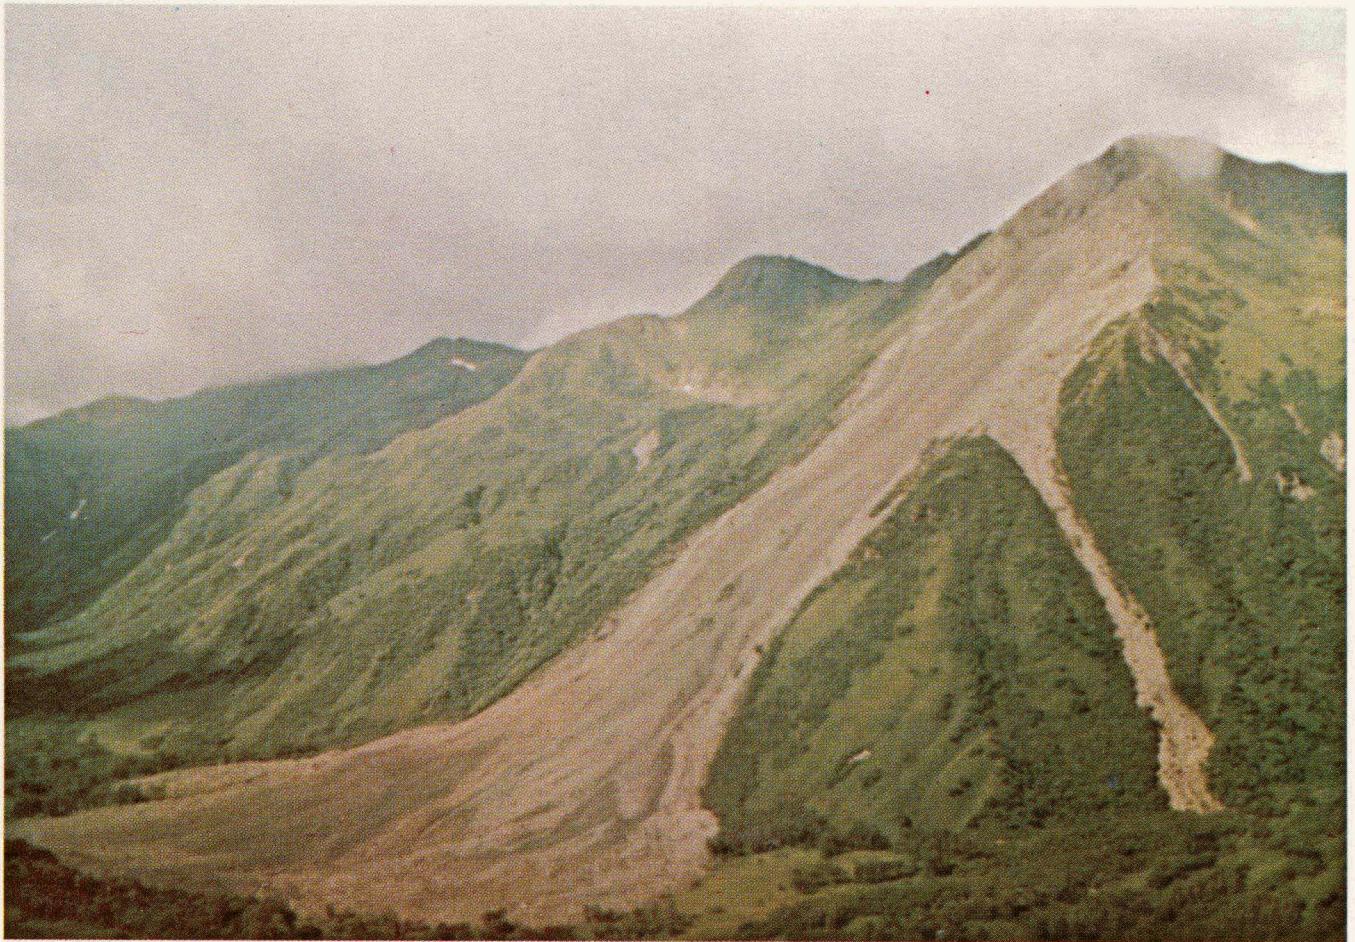
DEBRIS AVALANCHE ON THE PENINSULA BETWEEN UGAK AND KILIUDA BAYS

A slide of Tertiary rocks from the 1,500-foot-high peak at upper right flowed into the uninhabited valley below at about 300-foot altitude where it spread out as a debris lobe roughly 1,500 feet across. The narrow streak of light-colored debris in the lower right corner is part of the slide mass that overflowed the near flank of the landslide scar.

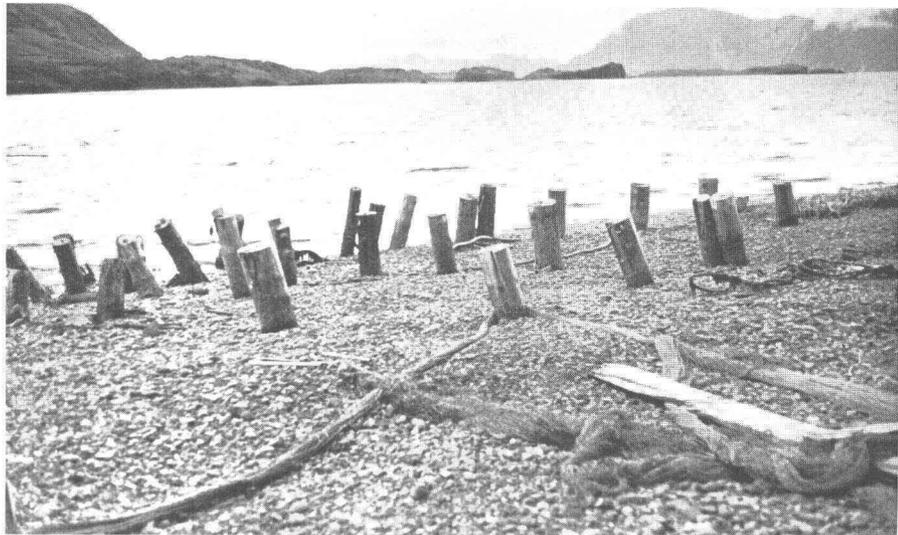
7. — Timber pile foundation at Kodiak Fisheries cannery site. Pronounced tilting of unbroken piling is indicative of lateral motion of the piling through 10–15 feet of beach gravel. Piling tops formerly level are now 7.8 feet lower at the seaward end of the cannery site than in the foreground owing to local settlement of the distal part of the beach cusp. Bent drift pins in the piling tops indicate that the cannery moved southward (away from the observer) off the piling.

ed subsidence was  $5\frac{1}{3}$  feet at the shipway piling to the right (north) of the cannery buildings. This subsidence, 2 feet more than that at a bedrock site 1 mile to the south, indicates surficial settlement of about 2 feet relative to bedrock. Furthermore, measurement of the difference in height of the tops of the piling that previously supported the destroyed part of the cannery indicates that an additional 7.8 feet of surficial settlement occurred towards the tip of the cusp (fig. 7).

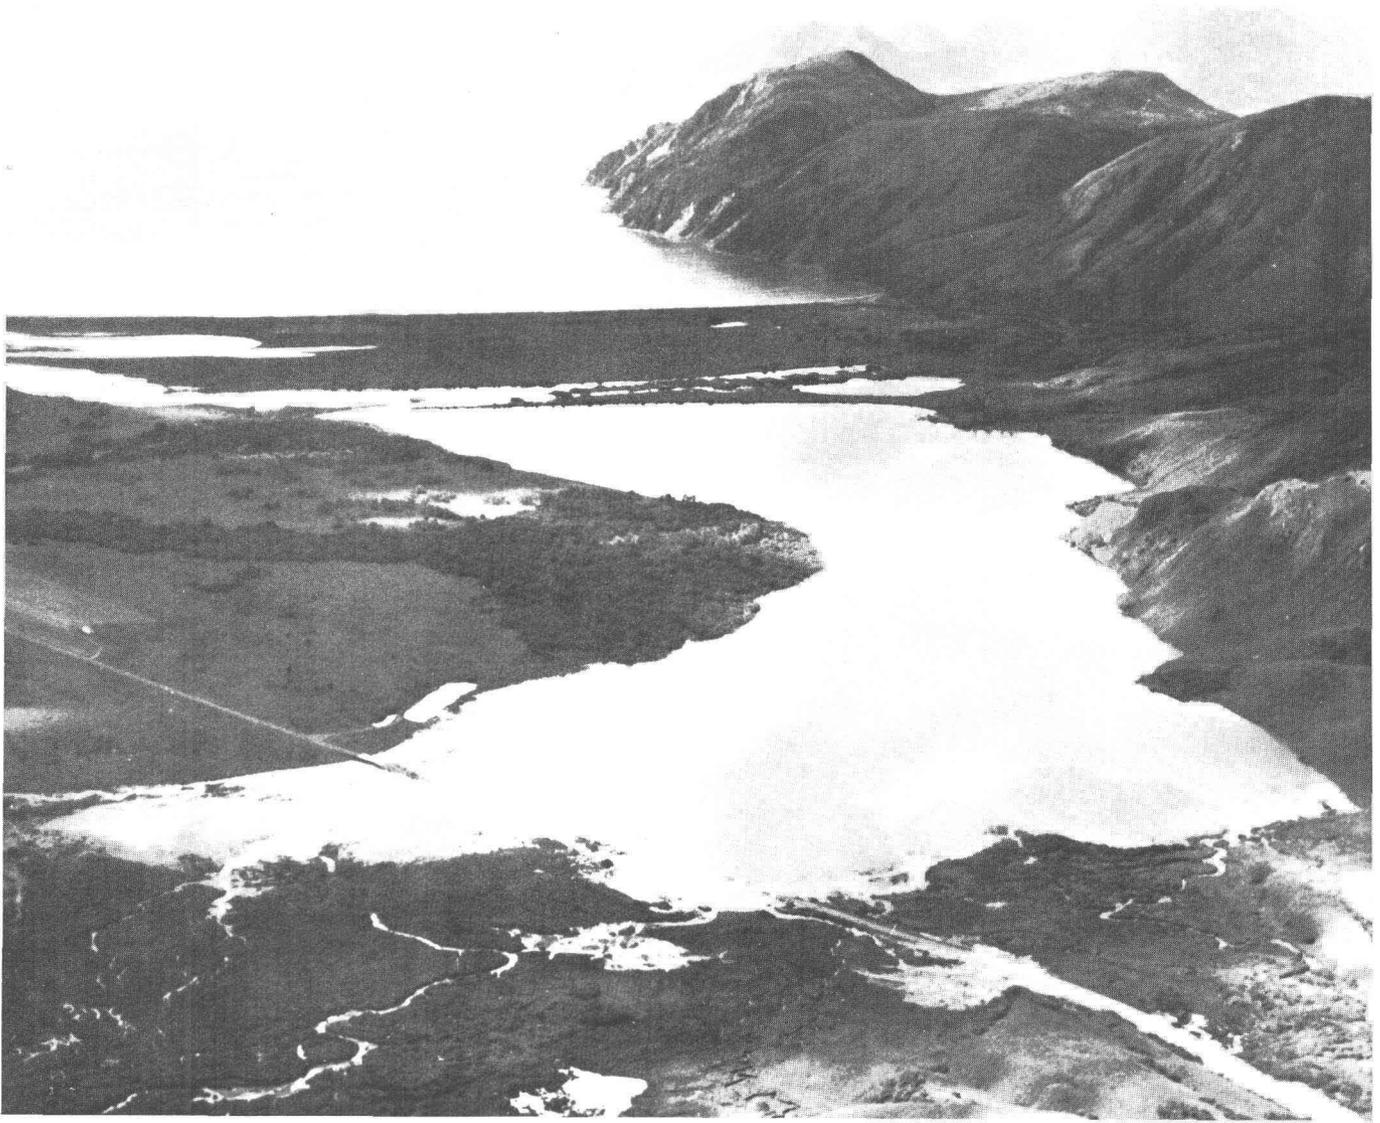
8. — Road near the head of Lake Rose Tead submerged by about 5 feet of surficial subsidence of inlet-stream deltaic deposits. Ugak Bay is visible in the background. Photograph by Alaska Department of Fish and Game.

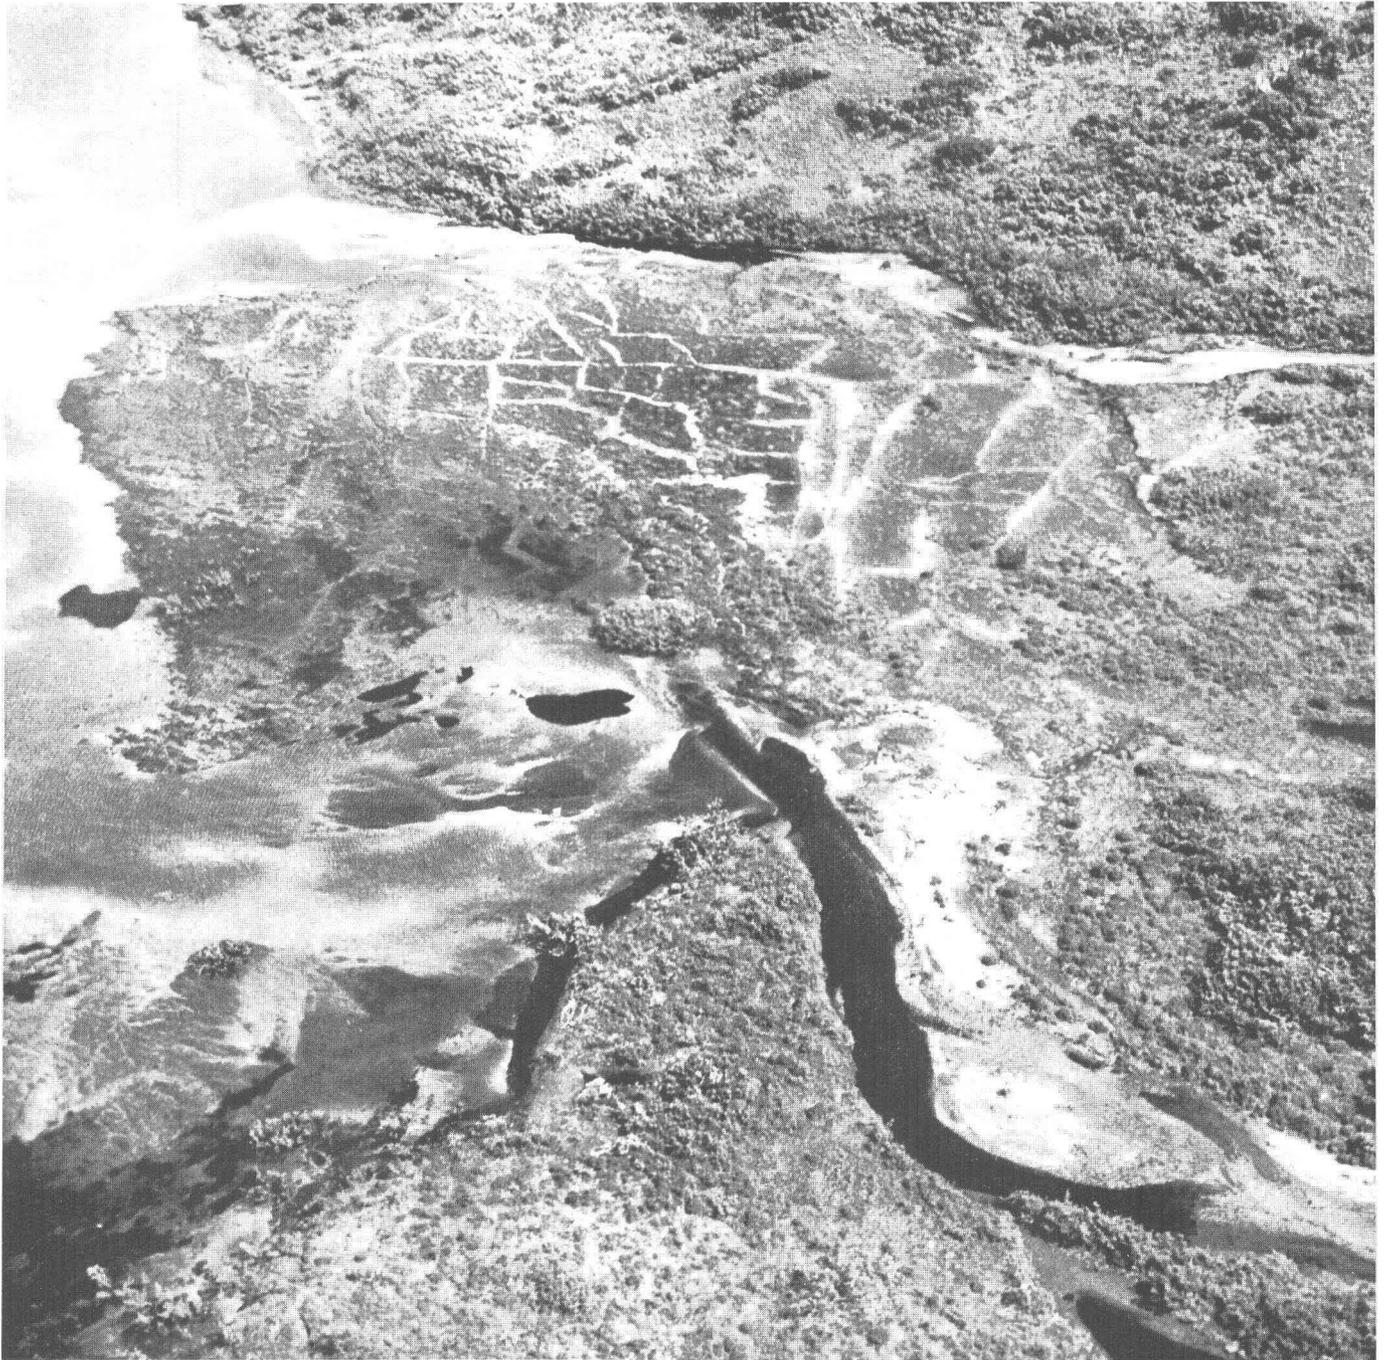
9. — Inlet delta at the head of Terror Lake showing inundation of slumped and cracked delta margin and linear cracks defined by light-colored pumiceous ejecta. Photograph by F. O. Jones.

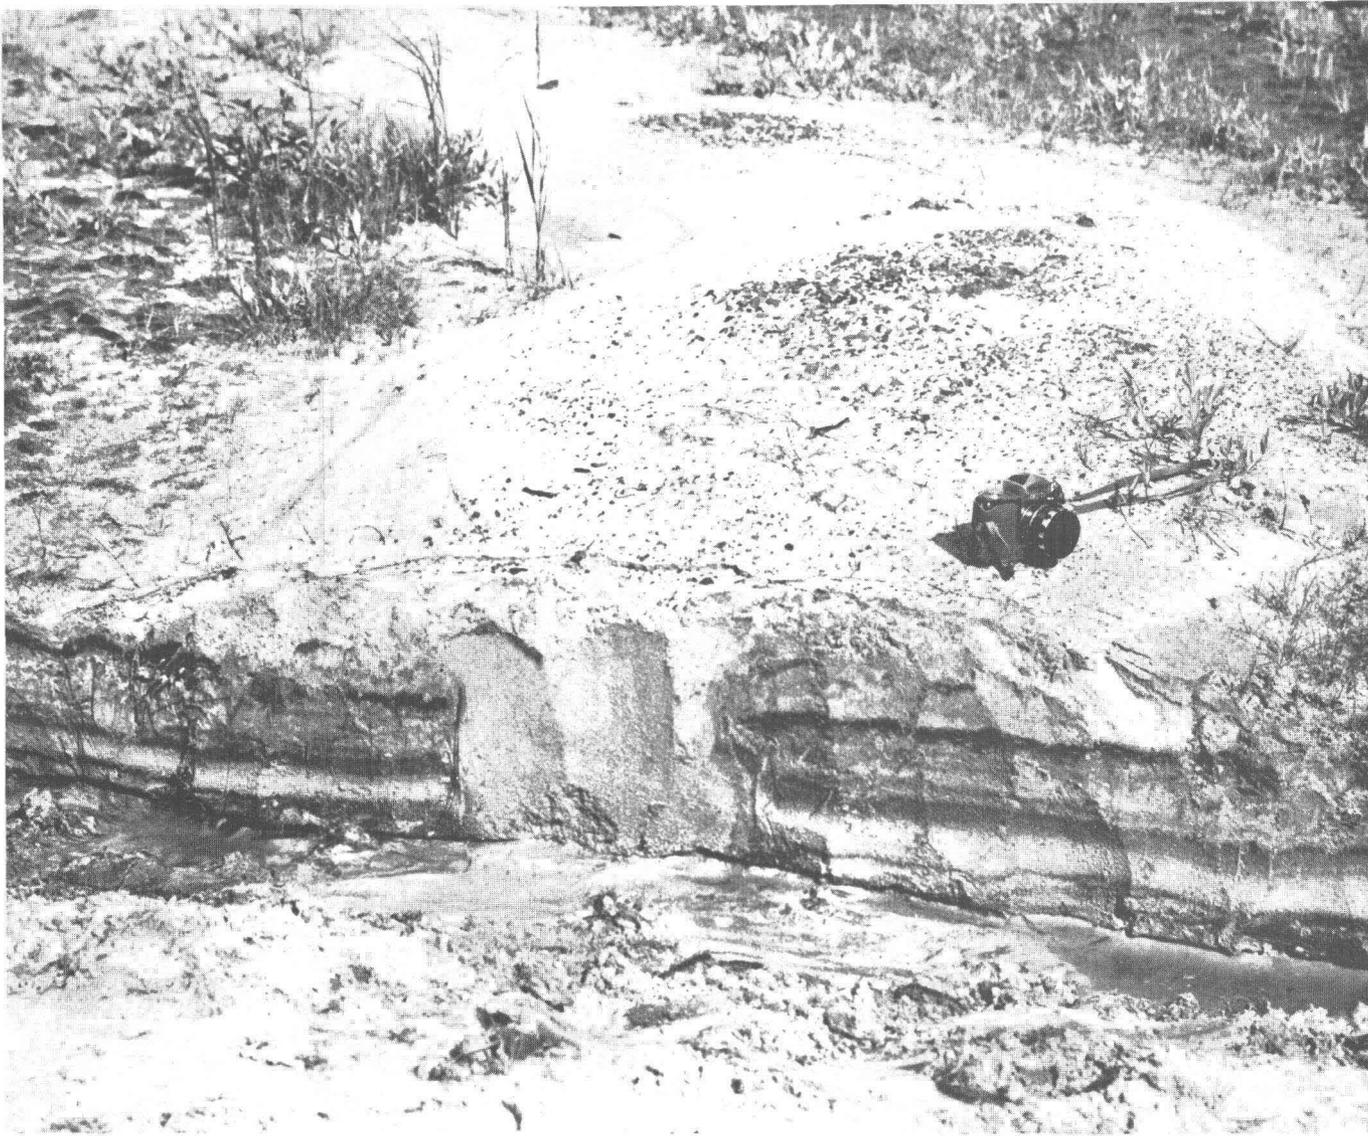
10.— Sectioned extension crack 1 foot wide at head of Terror Lake showing light-colored fine- to medium-grained pumiceous sand ejecta at surface and subsurface clastic dike. Photograph by F. O. Jones.

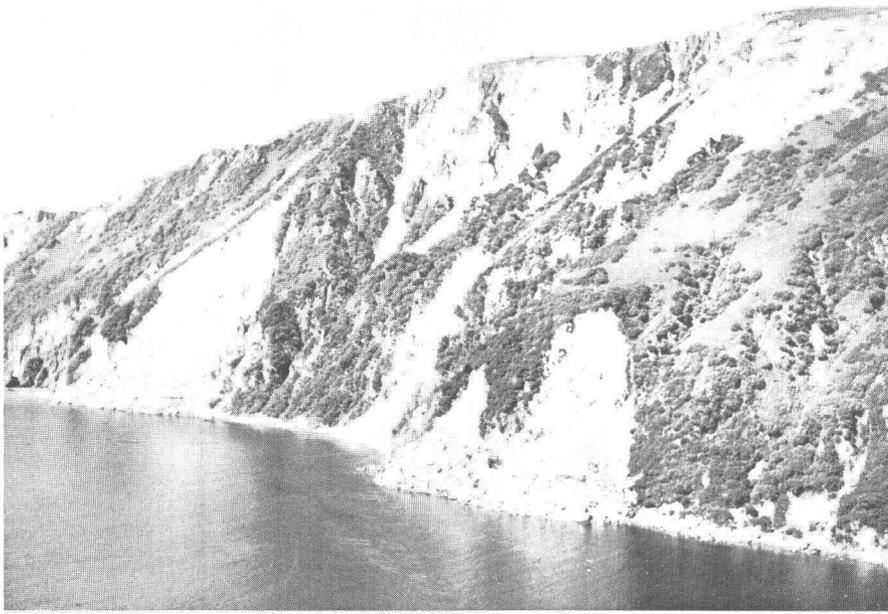
12. — Rockslides in tightly folded blocky sandstone along north shore of Ugak Bay, Kodiak Island. Bluff is about 1,000 feet high and is exposed to surf from Gulf of Alaska.

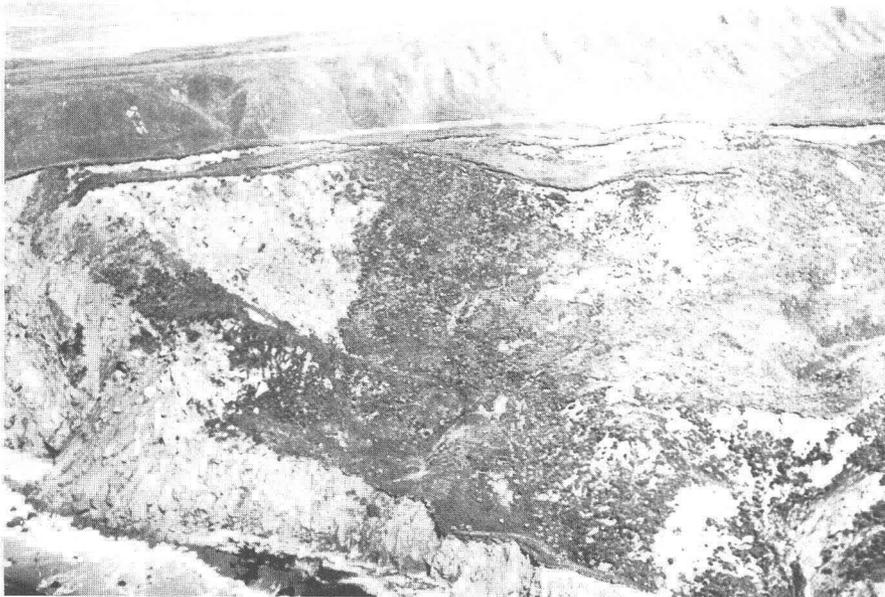
13. — Reactivated large debris slide in sedimentary rocks of middle Tertiary age along the south shore of Sitkinak Island. Note the characteristic steplike transverse scarps, displacing surface vegetation at head of the slide. A small rockfall covers part of the beach in lower left of photograph. Vertical height of slide mass is approximately 300 feet.

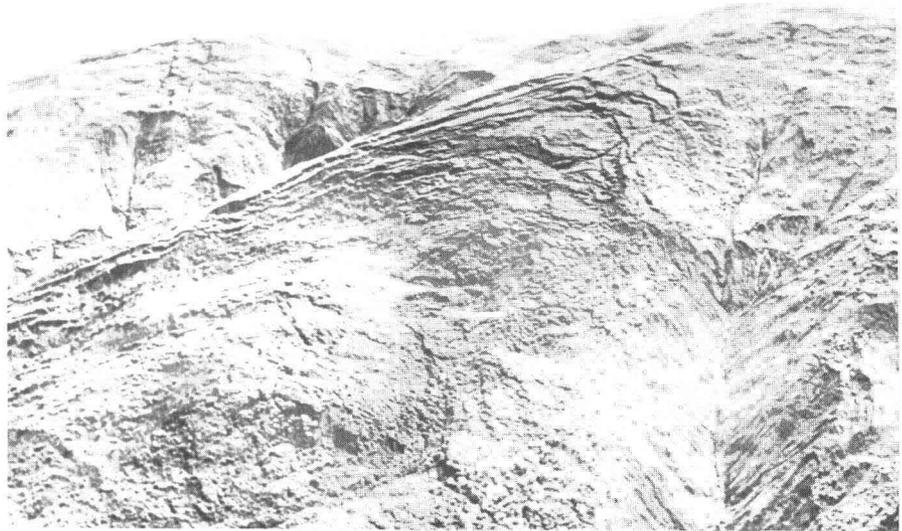
14. — Earthflow resulting from soil slip or slump in deeply weathered Tertiary sedimentary deposits along the north shore of Sitkinak Island. The head of the slide is marked by numerous small scarps; the foot is the hummocky bulbous mass in the lower left corner.

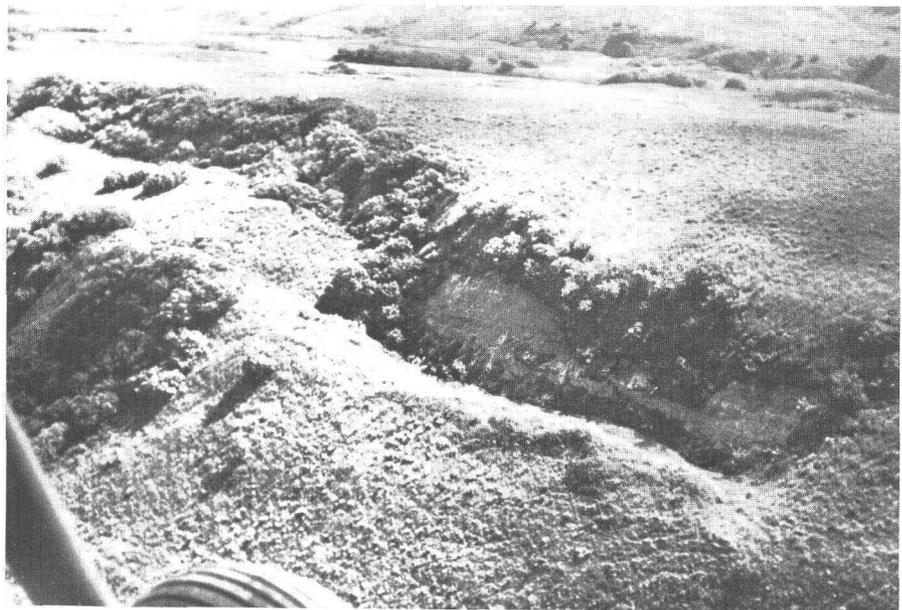
15. — Main scarp at the head of a large rotational slump in Tertiary deposits on Narrow Cape, Kodiak Island. The landslide is approximately 1,400 feet long and 125–150 feet high. The rock mass at the left slid 8–15 feet downslope along a surface of rupture, the main scarp of which trends diagonally across the photograph. Note the headward tilt of the original surface on the upper part of the slide mass and draping of the vegetation mat over the crown of the main slide.

The Narrow Cape landslide involved moderately dipping, poorly indurated sedimentary rocks of late Tertiary age. It occurred on slopes of  $15^{\circ}$ – $35^{\circ}$  along a structurally controlled northeast-trending linear valley that is incised 125–150 feet into a flat-lying erosion surface. The main scarp of the slide (fig. 15) broke at the top of the southeast valley wall along a distance of roughly 1,400 feet. The slide mass slumped down on the northwest side as much as 15 feet with headward tilting along a surface of rupture that intersected the surface on the valley floor 125–150 feet be-

low. Open tension cracks and shallow grabens are abundant on the erosion surface headward from the main scarp. The slide toe is characterized by transverse pressure ridges and small overthrusts in the surface mat of muskeg vegetation. The brush-covered hummocky topography of the lower part of the slide surface and the chaotic internal structure suggest that earlier gravity movement has taken place.

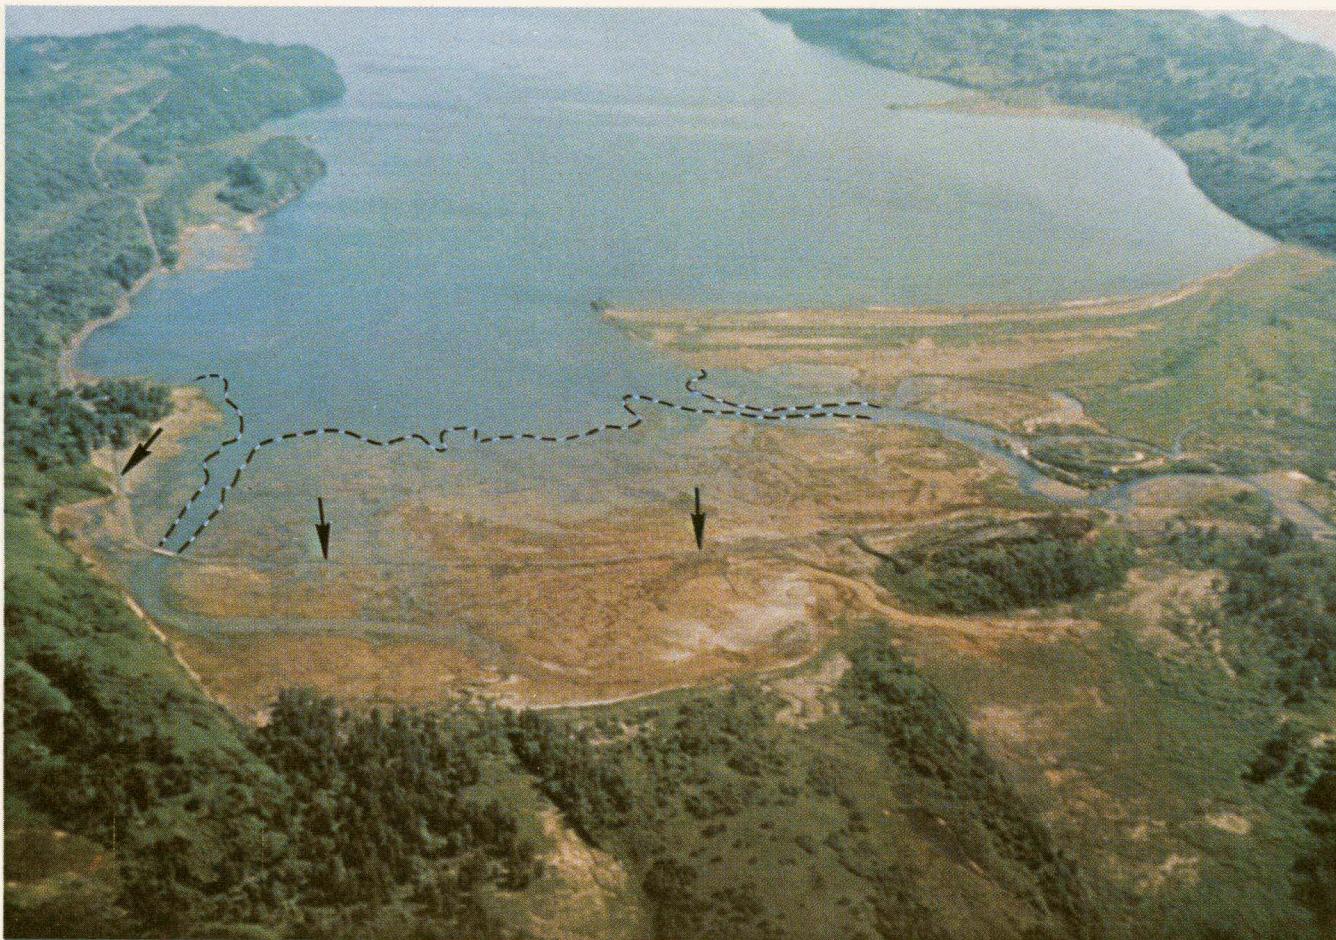
#### SUBSIDENCE AT MIDDLE BAY

Extensive inundation at the head of Middle Bay resulting from 5 feet of tectonic subsidence and an unknown but substantial amount of surficial subsidence. Arrows indicate the approximate location of remnants of the Kodiak-Chiniak highway. Dashed line shows the approximate preearthquake mean high-water shoreline which has been shifted about half a mile landward.

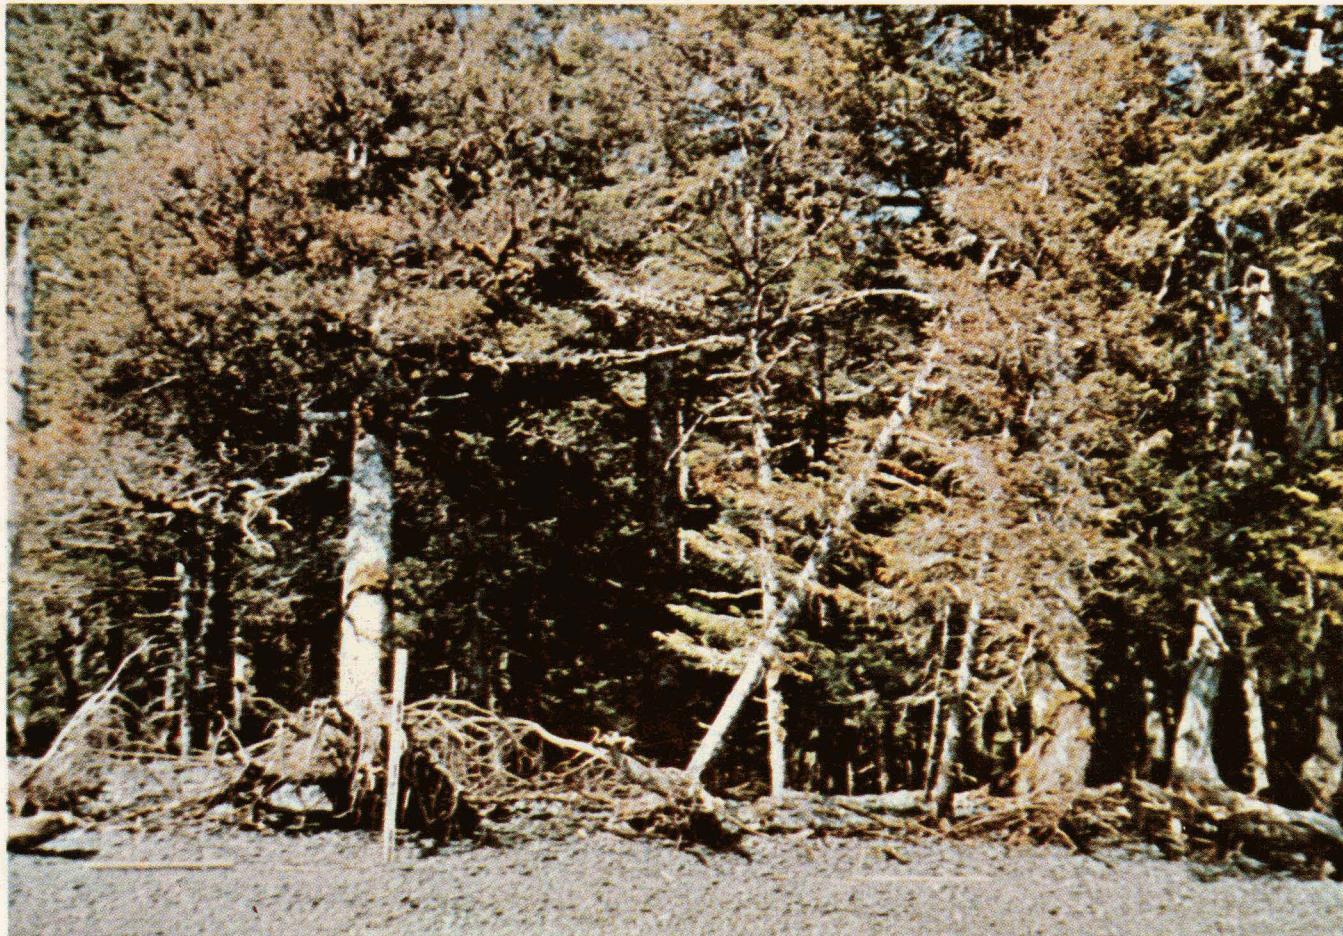
UNDERMINED TREES ON BARRIER BEACH IN IZHUT BAY, AFOGNAK ISLAND

Accelerated wave erosion in an area of about 5 feet of tectonic subsidence caused this damage. Foliage of trees along shore has turned brown from salt-water immersion of the roots.

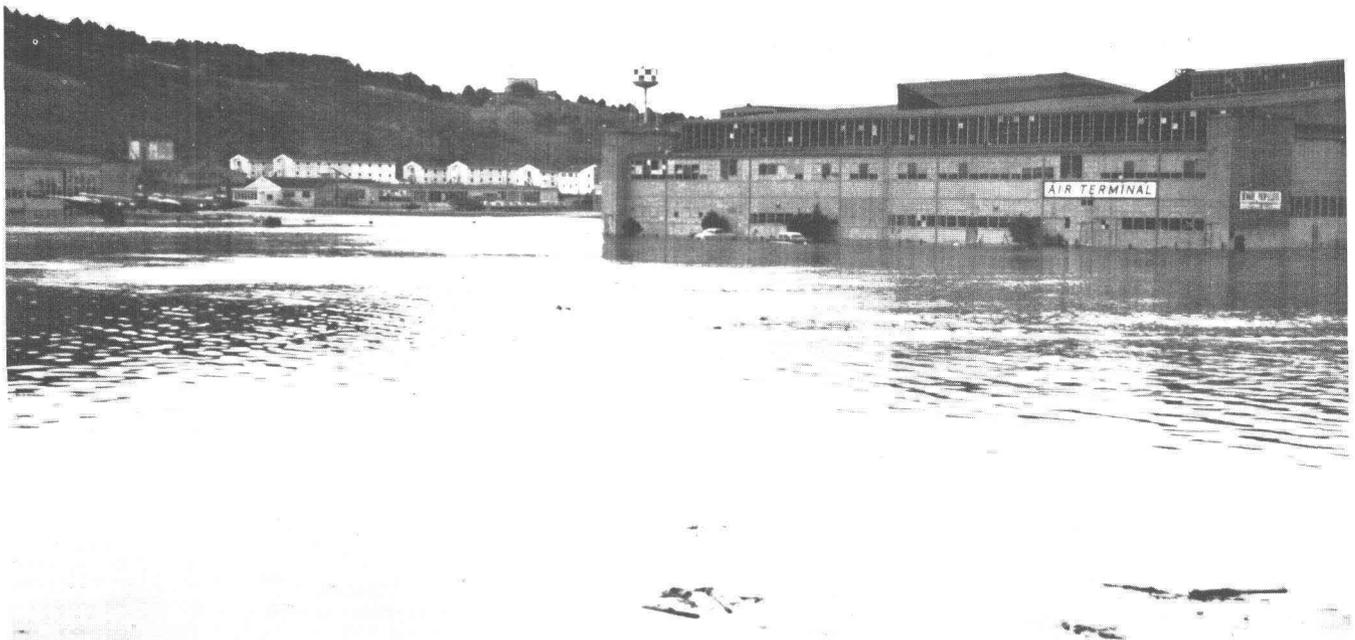
19. — Seaplane ramp at Kodiak Naval Station along shore of Womens Bay showing approximate high-water level reached by first wave. Note calm water surface. Aircraft parked in front of hangar at left center were later moved to high ground and saved. Photograph by U.S. Navy.

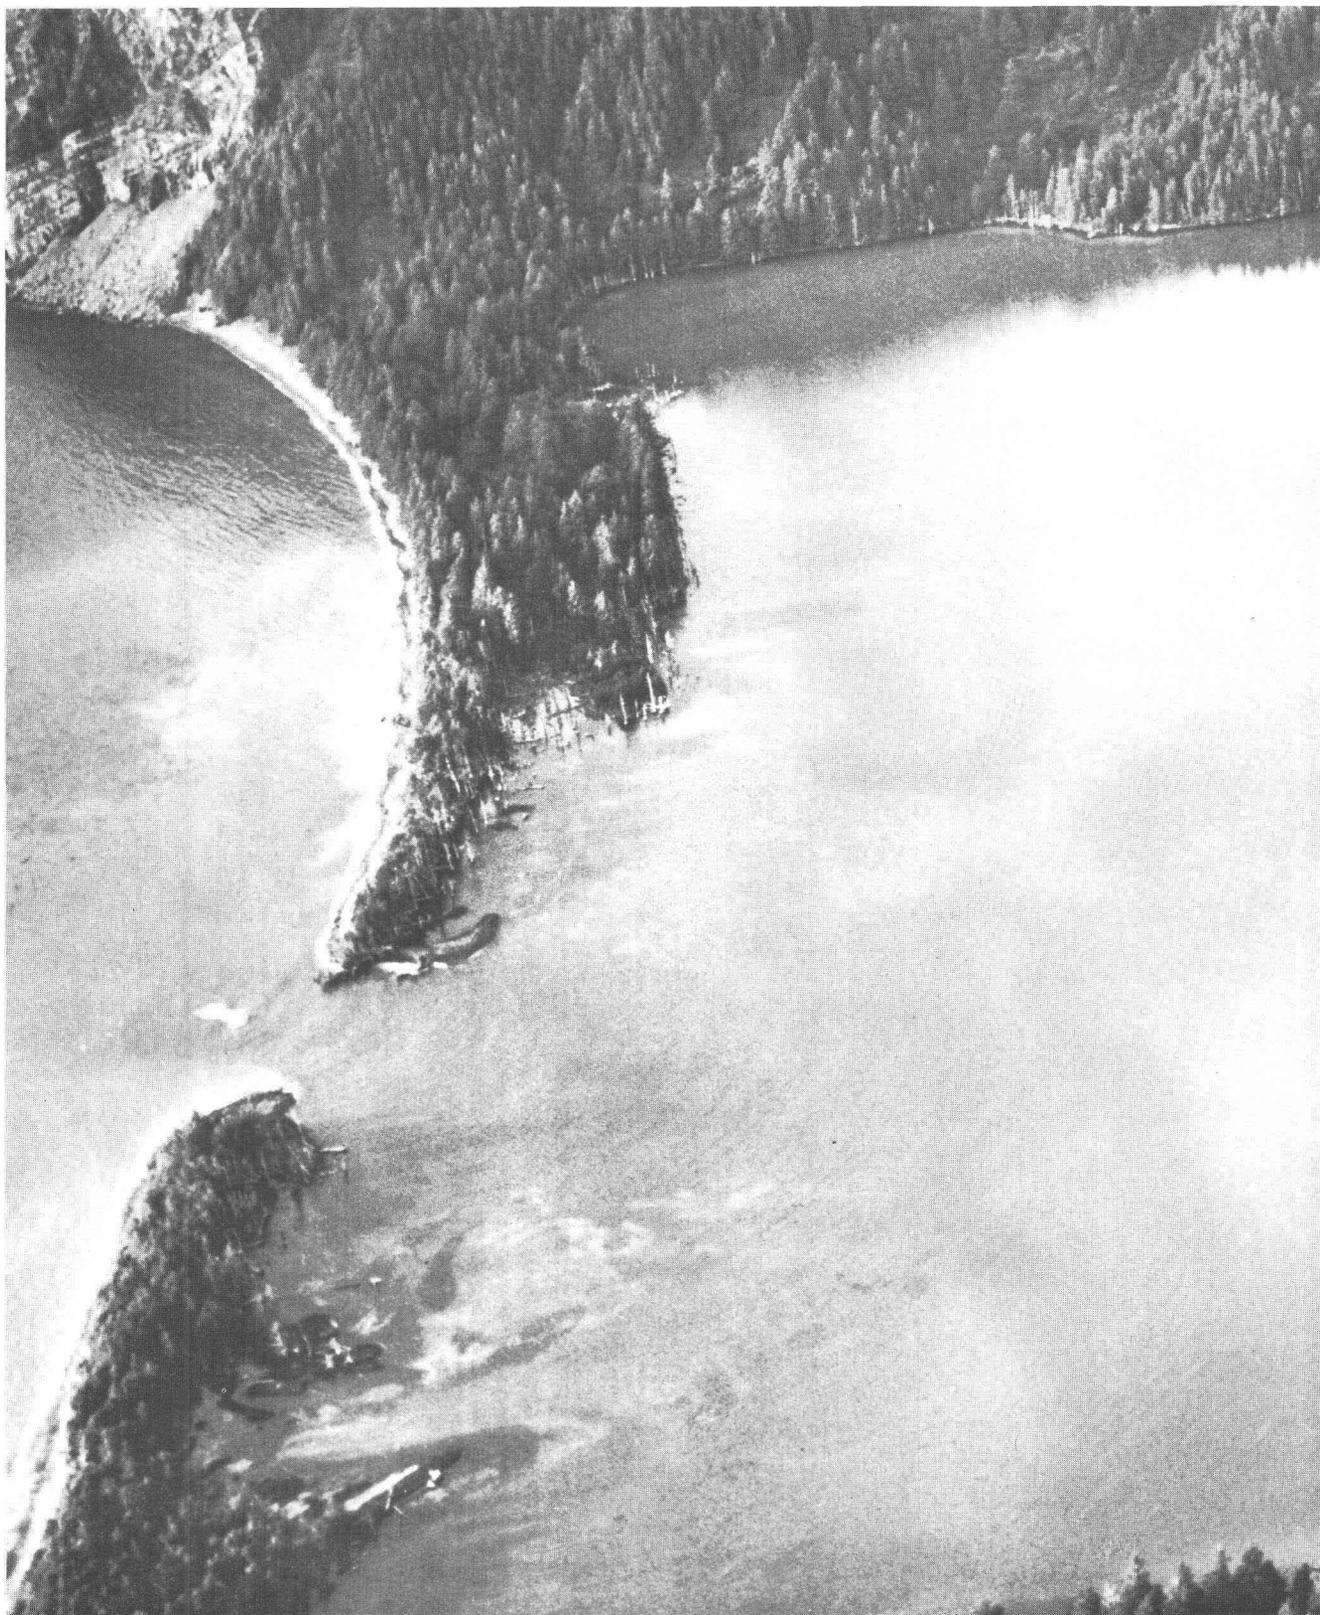
20. — Opening torn by seismic sea waves in the barrier beach of a large lake along the shore of Izhut Bay on Afognak Island. Channel scour and subsidence of at least 6 feet permit sea water to enter the basin at all stages of tide. Note partially submerged trees along inner margins of the beach spits, and small new rockslide along bluff in background. Photograph by Alaska Department of Fish and Game.

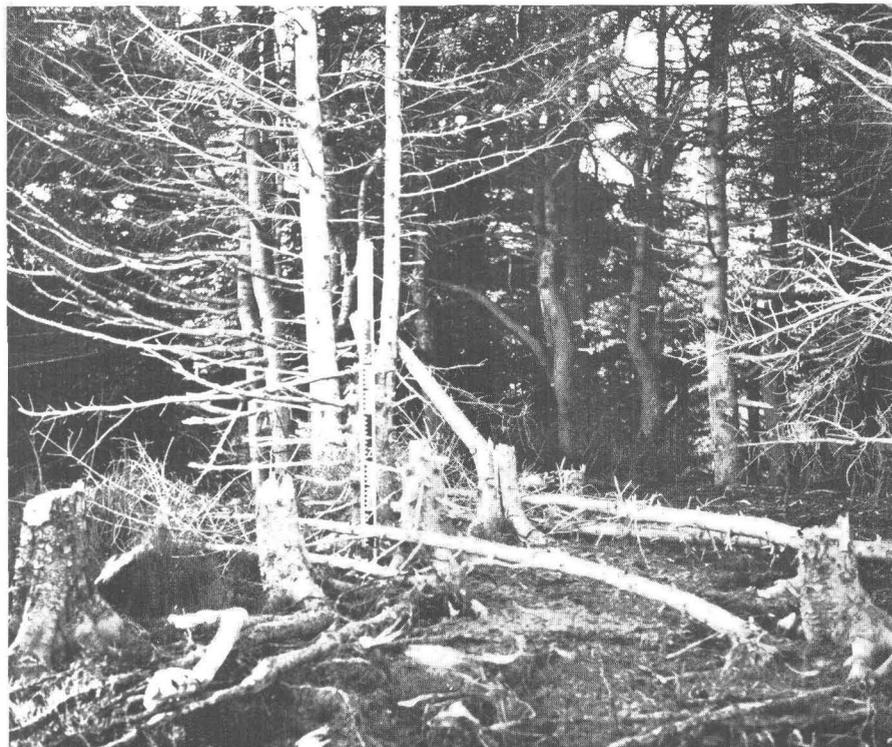
21. — Shoreline damage between Narrow Cape and Cape Chiniak caused by driftwood-laden seismic sea wave. Spruce trees as much as 8 inches in diameter were broken off at about 30 feet altitude. Limbs were broken and trunks scarred to a measured altitude of 42 feet above lower low water. Crowns of downed trees point in direction of water movement.

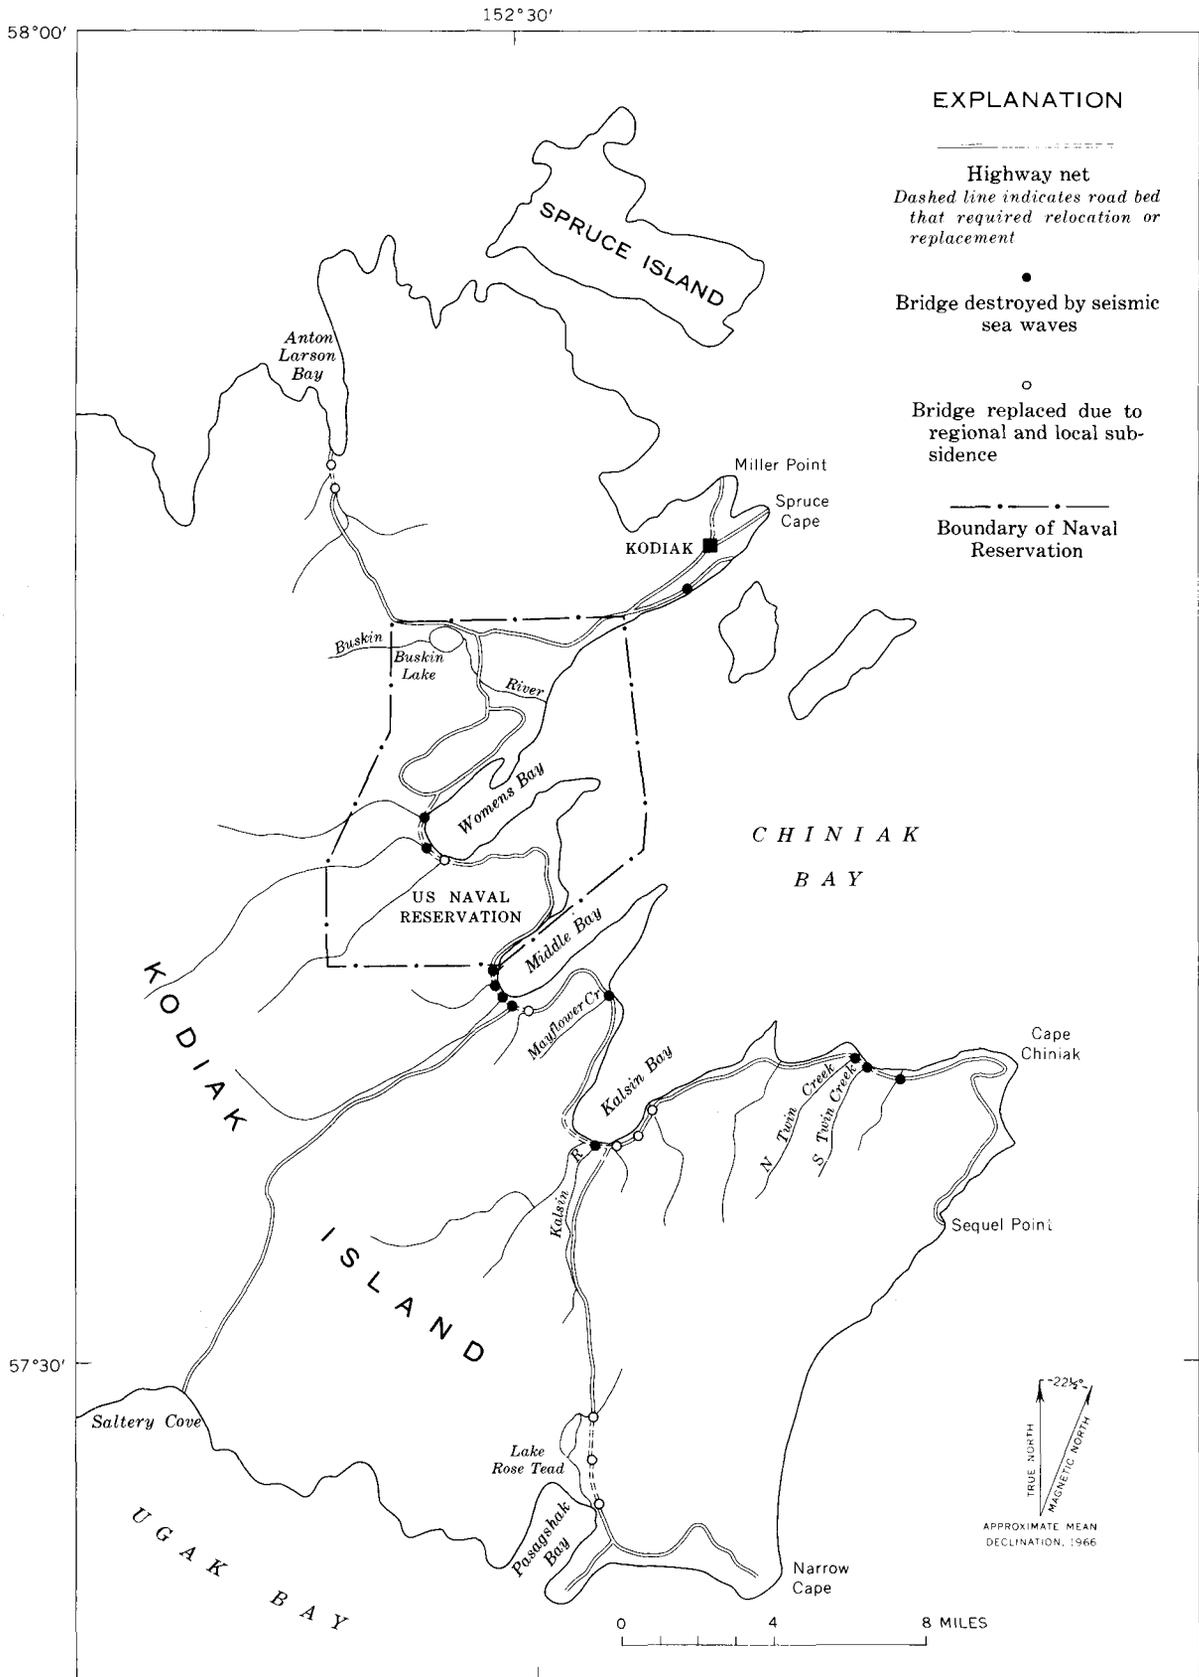
22.— Earthquake damage to major highway routes on Kodiak Island.

In addition to those that were destroyed, five bridges on the Chiniak highway had to be replaced either because they were underwater during high tide or because their approaches needed realignment. The bridges that required replacement (indicated by open circles on fig. 22) are at Womens Bay, Middle Bay, and Kalsin Bay.
