THE ALASKA EARTHQUAKE, MARCH 27, 1964:  
REGIONAL EFFECTS

Geologic Effects of the  
March 1964 Earthquake  
And Associated Seismic  
Sea Waves on Kodiak  
And Nearby Islands  
Alaska

By GEORGE PLAFKER and REUBEN KACHADOORIAN

GEOLOGICAL SURVEY PROFESSIONAL PAPER 543-D

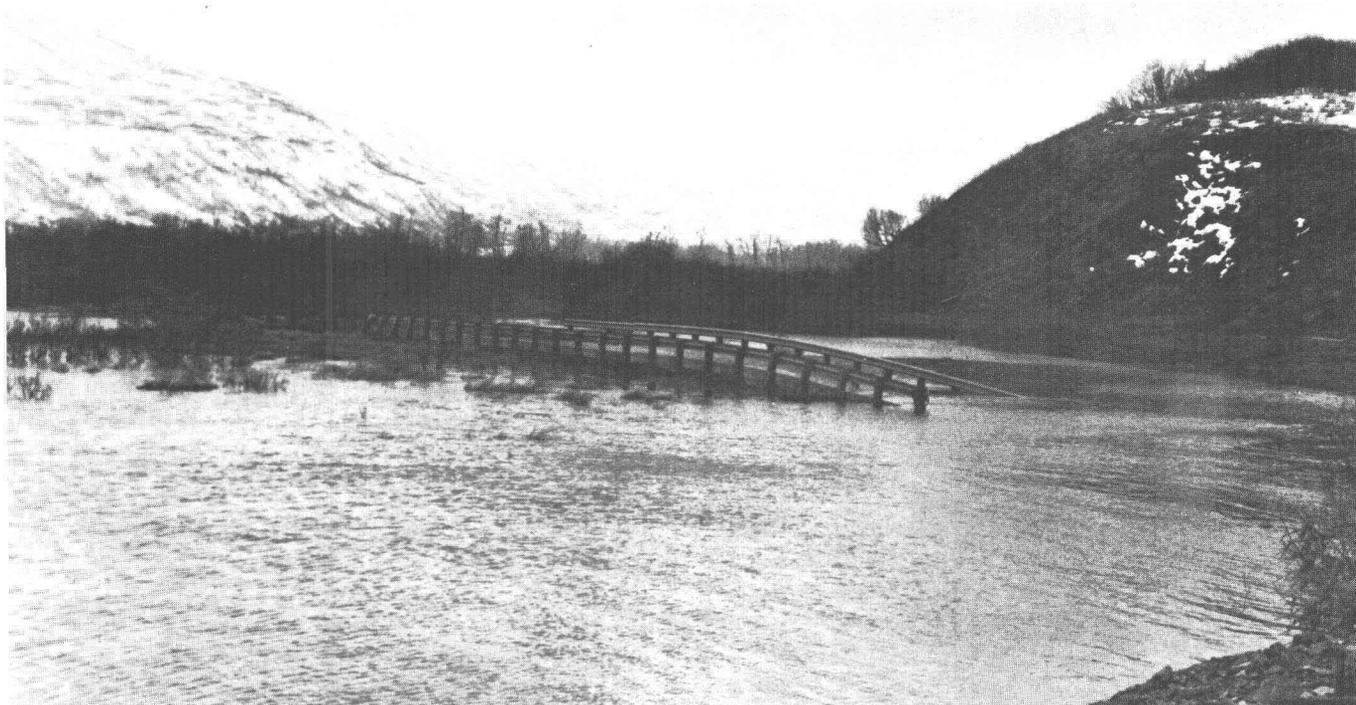
23. — Bridge at Womens Bay destroyed by seismic sea waves. Deck of bridge collapsed owing to destruction of piles. Compare with fig. 24. Photograph by U.S. Navy, March 30, 1964.

Eyewitness accounts of the seismic sea waves indicate that the bridges were not destroyed by the incoming water of the first wave, but by the outgoing wave and by the more violent incoming and outgoing subsequent waves. Figures 23 and 24 (p. D41) show seismic sea-wave damage to two bridges.

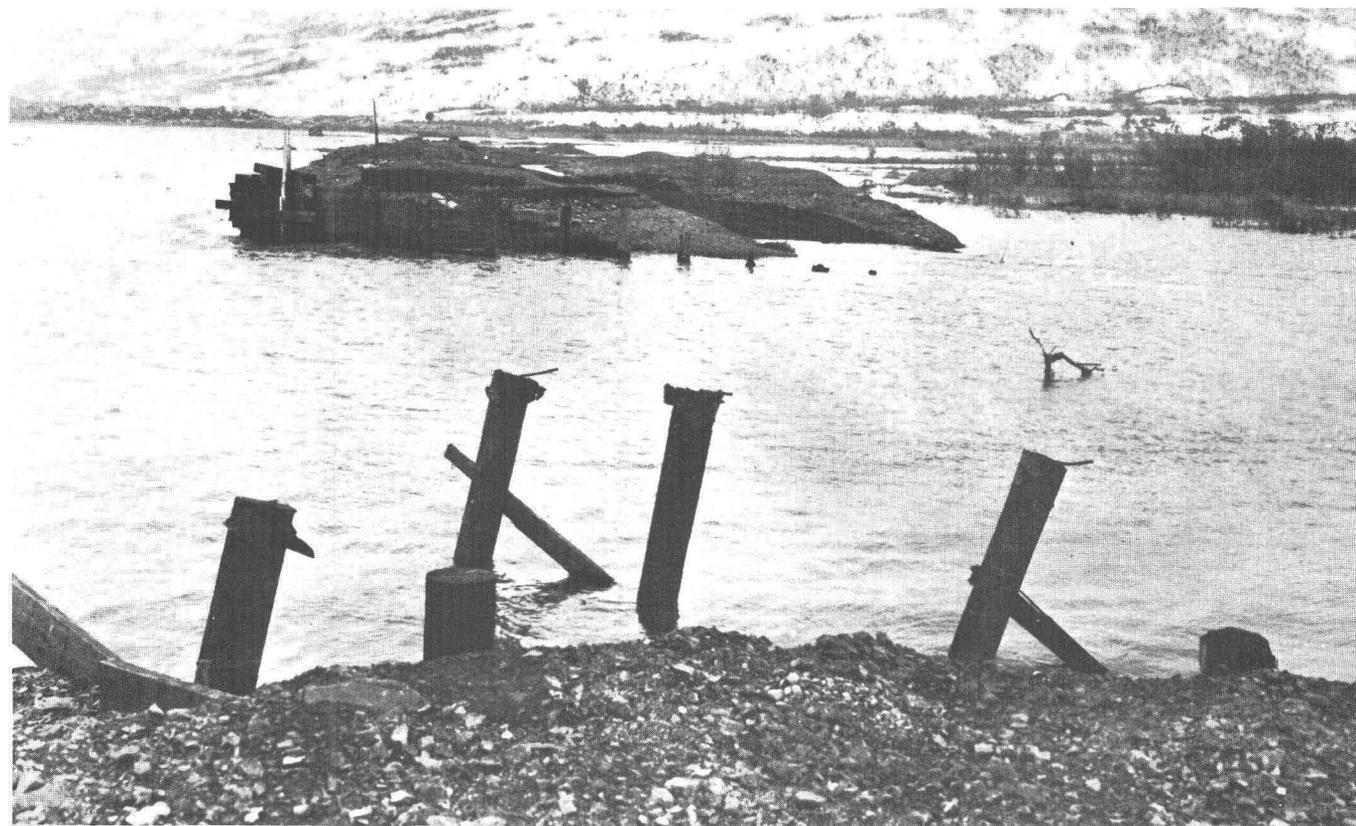
24. — Deck of highway bridge at Womens Bay washed away by seismic sea waves. Photograph by U.S. Navy, March 30, 1964.

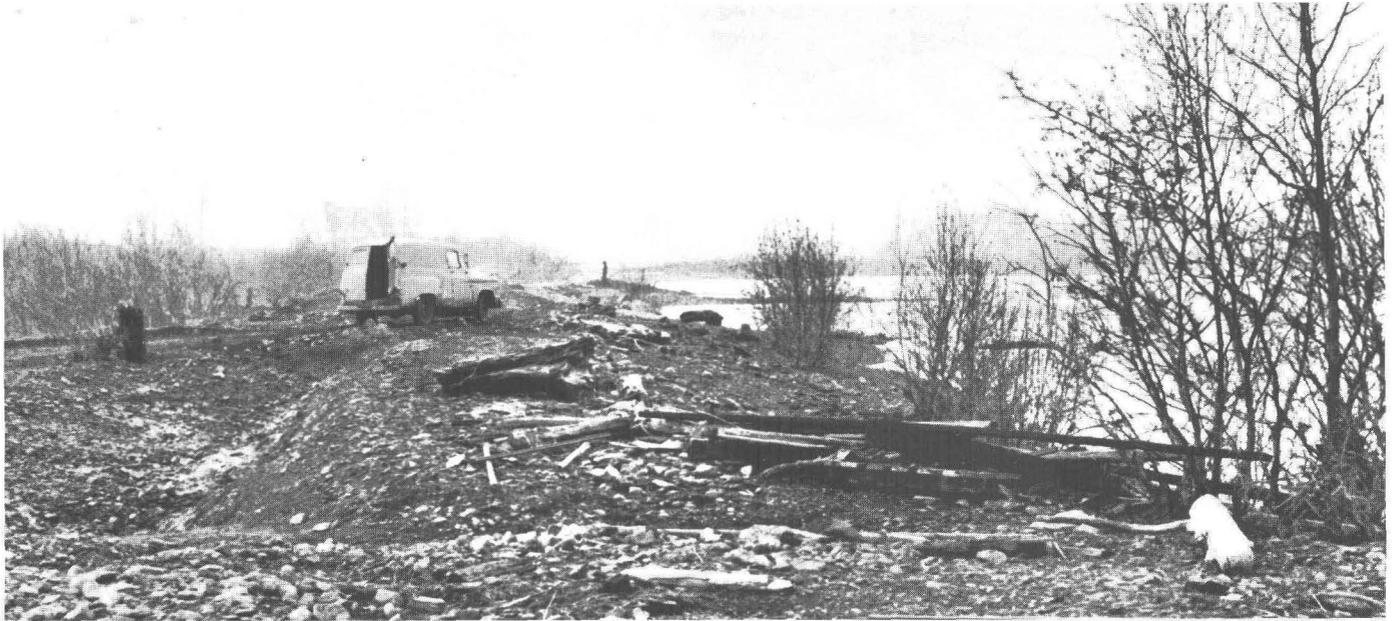
25. — Section of roadway along Chiniak highway at Womens Bay destroyed by seismic sea waves. Photograph by U.S. Navy, March 30, 1964.

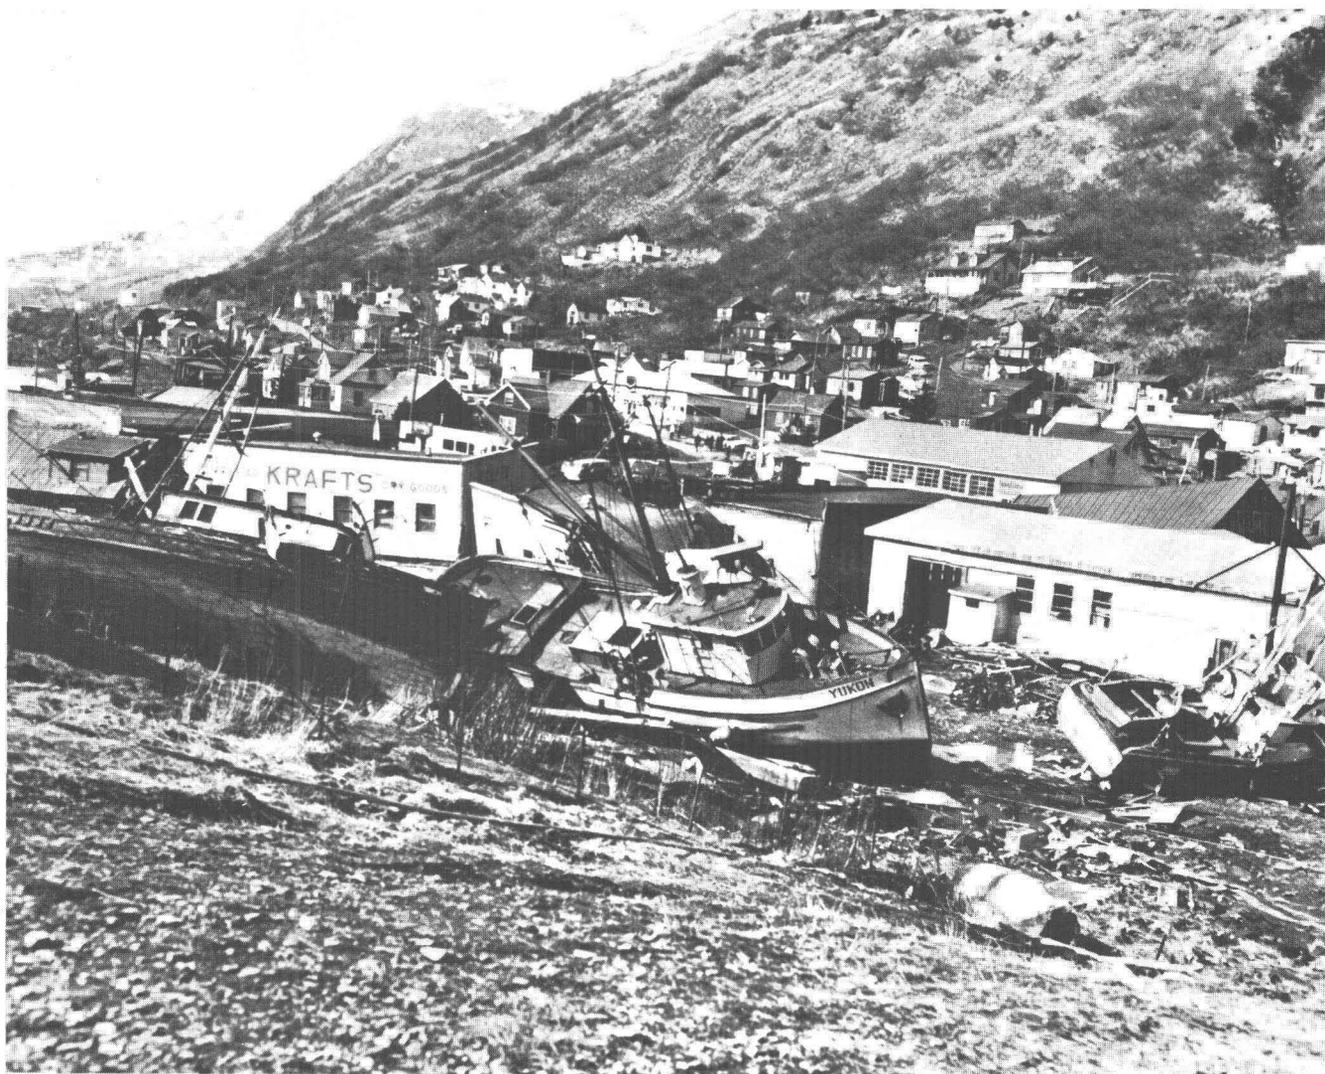
26. — Chaotic condition of the commercial section of the city of Kodiak following inundation by seismic sea waves. The small-boat harbor, which was in the left background, contained an estimated 160 crab and salmon fishing boats when the waves struck. Photograph by U.S. Navy, March 30, 1964.

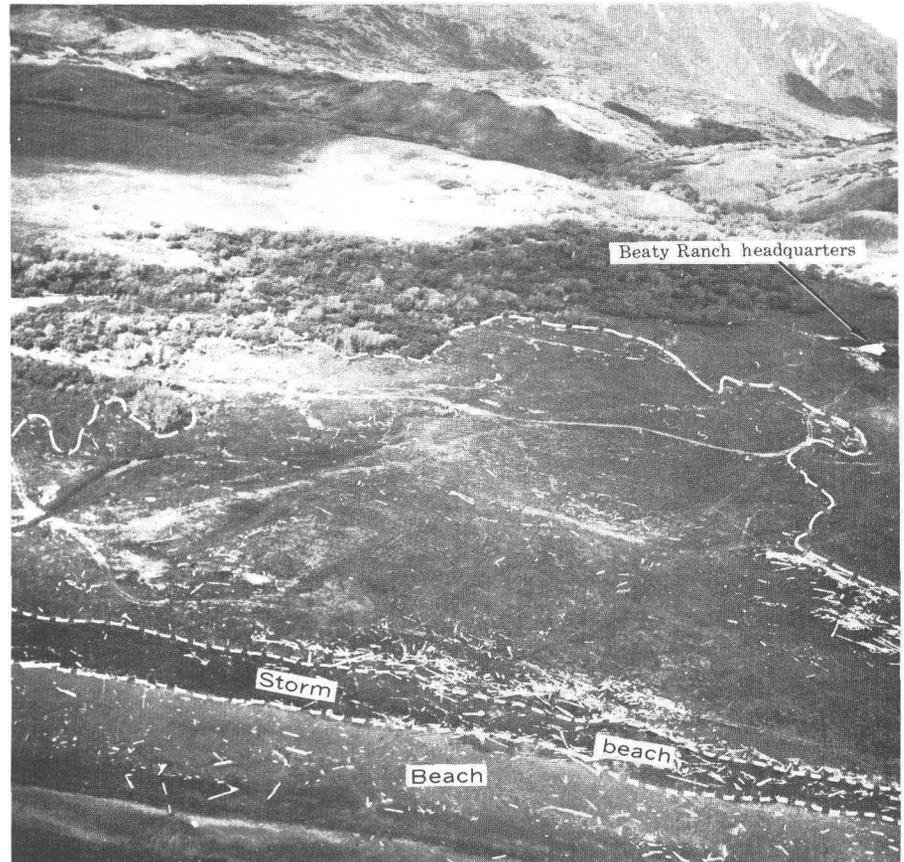
27. — Part of Beaty Ranch showing extent of wave inundation, as indicated by light-colored debris. Ranch buildings are a quarter of a mile from the shoreline.
