THE ALASKA EARTHQUAKE, MARCH 27, 1964:  
REGIONAL EFFECTS

Ground Breakage and  
Associated Effects in the  
Cook Inlet Area, Alaska,  
Resulting from the  
March 27, 1964, Earthquake

GEOLOGICAL SURVEY PROFESSIONAL PAPER 543-F

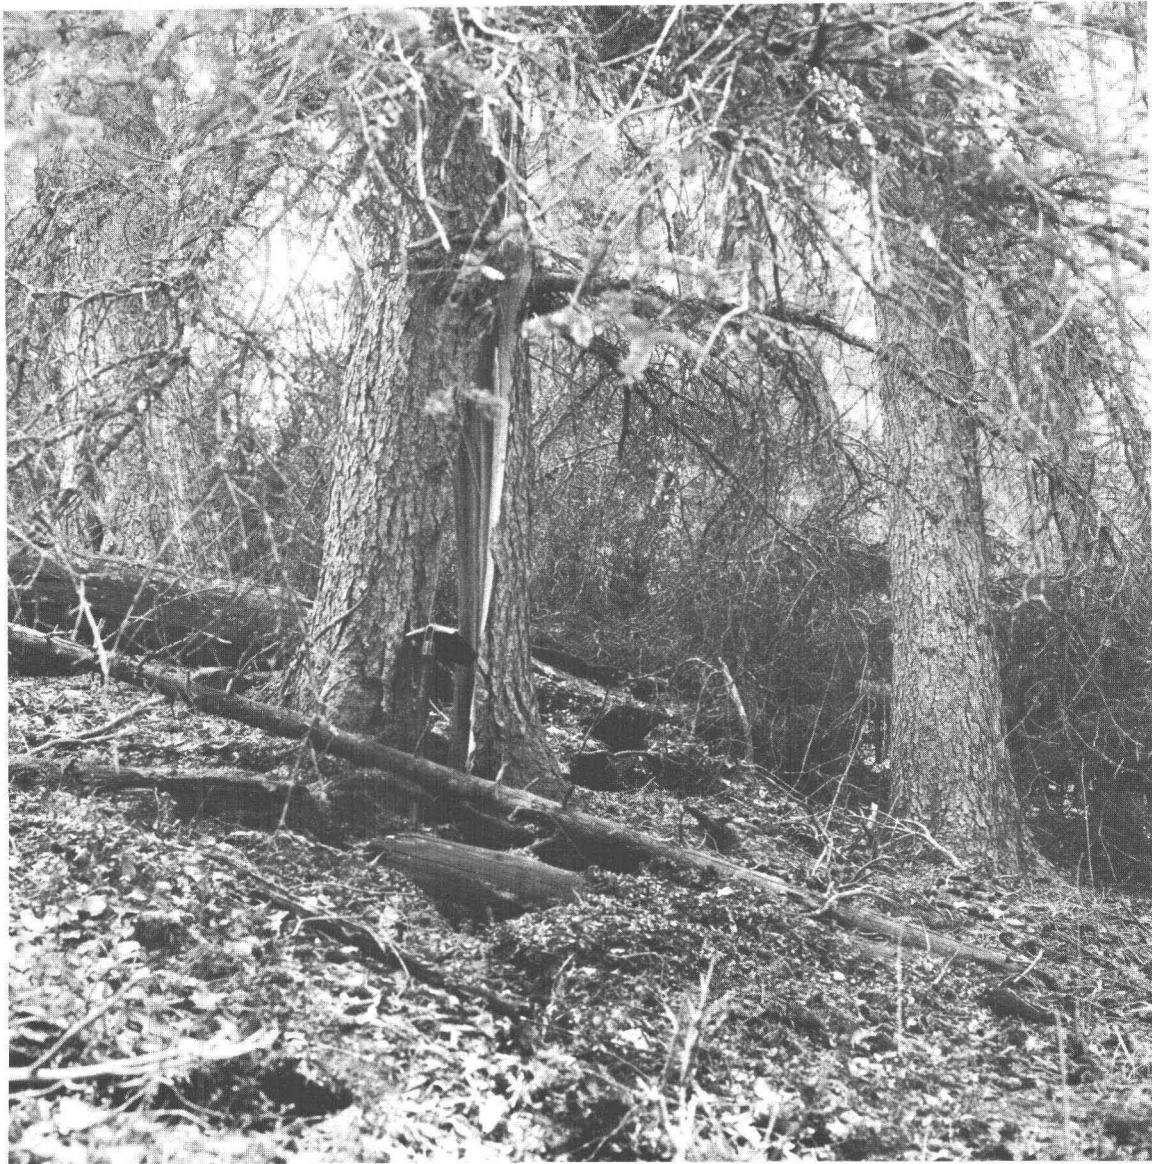
5.—Tree split by ground cracking (loc. 2, pl. 1), Kenai Lowland. The ground crack which trends into the split in the tree (loc. A, fig. 4) cuts across the top of a small knoll in moraine.

and N.  $75^{\circ}$ – $80^{\circ}$  W. (fig. 2). Examples of broken ground patterns within the zone are shown in figures 3 and 4. In forested areas, cracking of the ground split numerous trees (fig. 5).

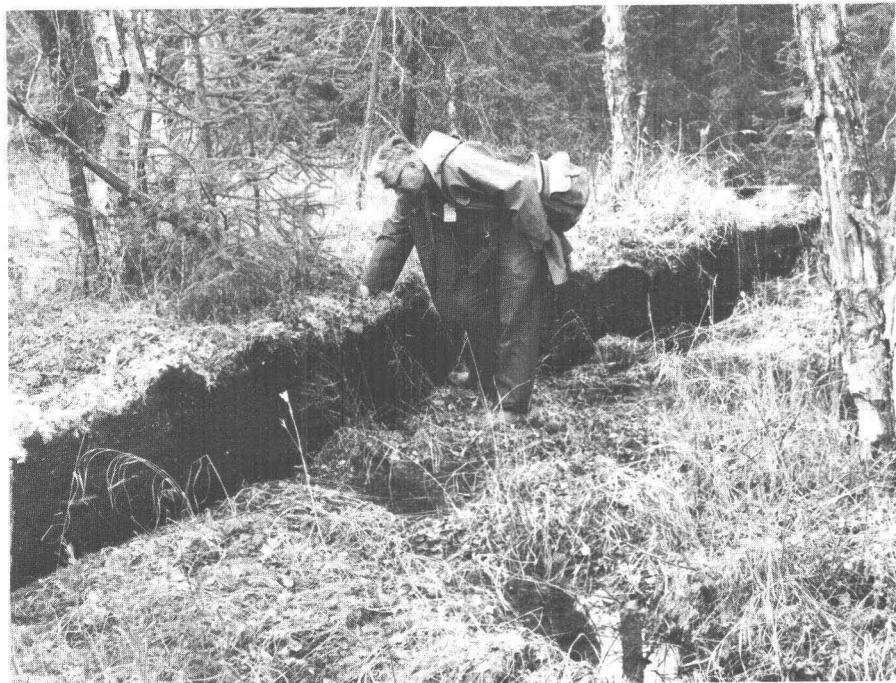
7.—Vertical displacement (loc. 2, pl. 1). A scarp more than 200 feet long and 2 to 3 feet high was produced in a thick section of frozen peat and organic silt (loc. B, fig. 4). Crack at the base of the scarp was 6 inches to 1 foot wide. Another crack intersects scarp at right angles; this displacement probably resulted from differential compaction and downslope extension of silty deposits in a muskeg bordering a small lake.

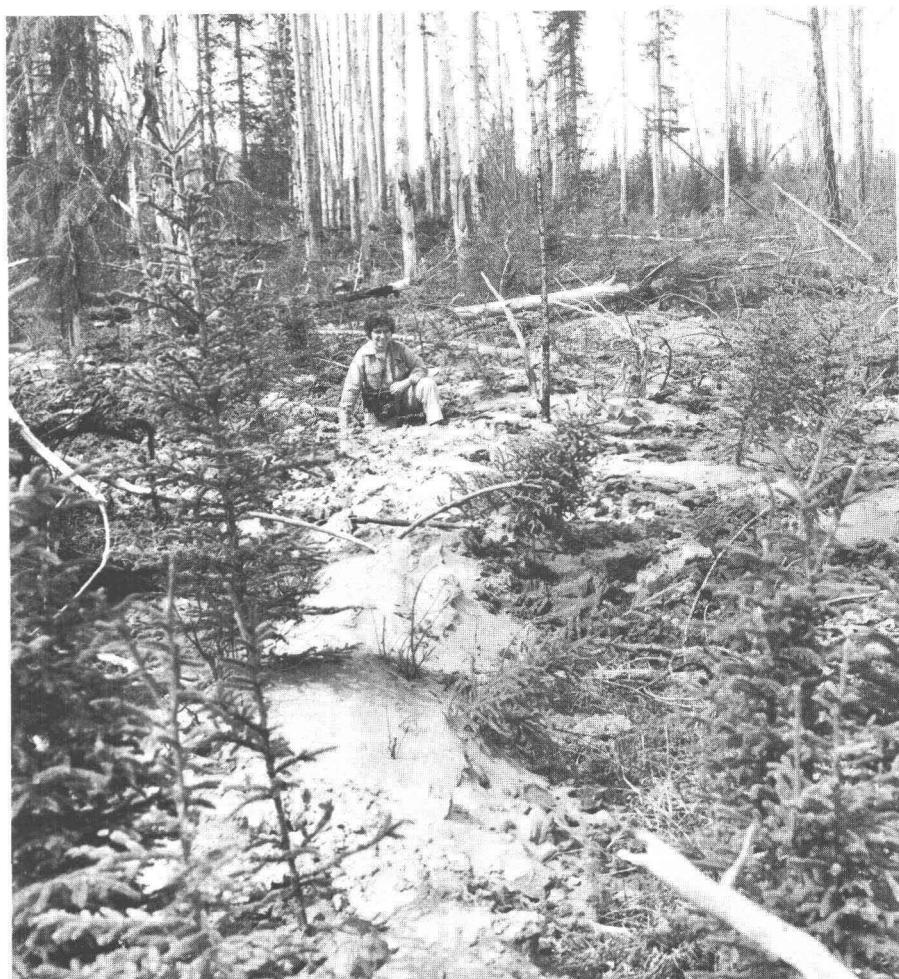
8.—Sand ridges deposited along a ground crack (loc. 2, pl. 1) by eruption of ground water during the earthquake. A sand ridge on the right side of the picture intersects the main ridge at nearly right angles. Person has right leg in deep crack (loc. C, fig. 4).

Features associated with ground-water eruptions were common throughout the zone. These features included ridges and mounds of sand aligned along cracks (fig. 8); sand sheets as much as 2 feet thick, locally covering acres of ground associated with the cracks (fig. 9); vents from which erupted sand either spread in all directions or was extruded primarily in one direction—and made a sand apron extending from the vent; collapse pits, as much as 30 feet in diameter; and fissures as much as 20 feet wide and 25 feet or more deep (figs. 9, 10), resulting from the removal of material by copious outpouring of ground water. In a few places great outpourings of sand were followed by small extrusions of watery silt which formed low (2 to 3 inches high) silt ridges and mounds and irregular microrelief features on the surface of the sand (figs. 11, 12). These silt extrusions must have occurred in the very last stages of the ground-water eruptions and after the main shaking

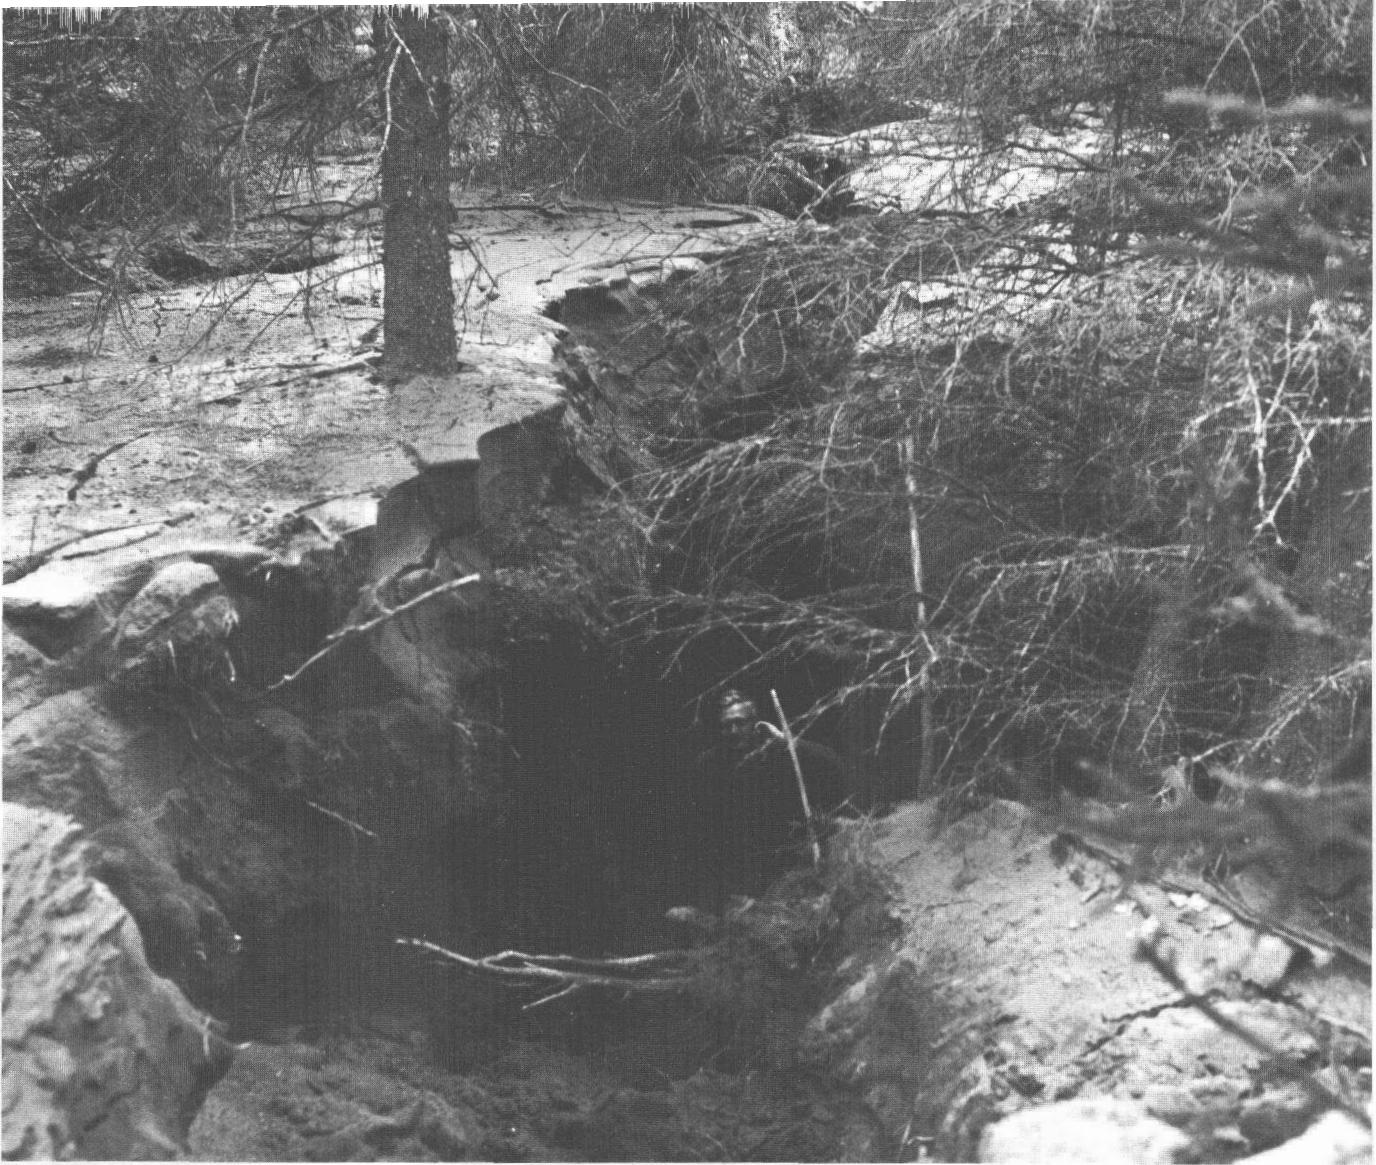
9.—Large fissure at locality 2 (pl. 1). This fissure was 25 or more feet deep and as wide as 20 feet in places. A thickness of 2 or more feet of sand which was extruded from the fissure can be seen around the tree. Photograph was taken at locality D (fig. 4).

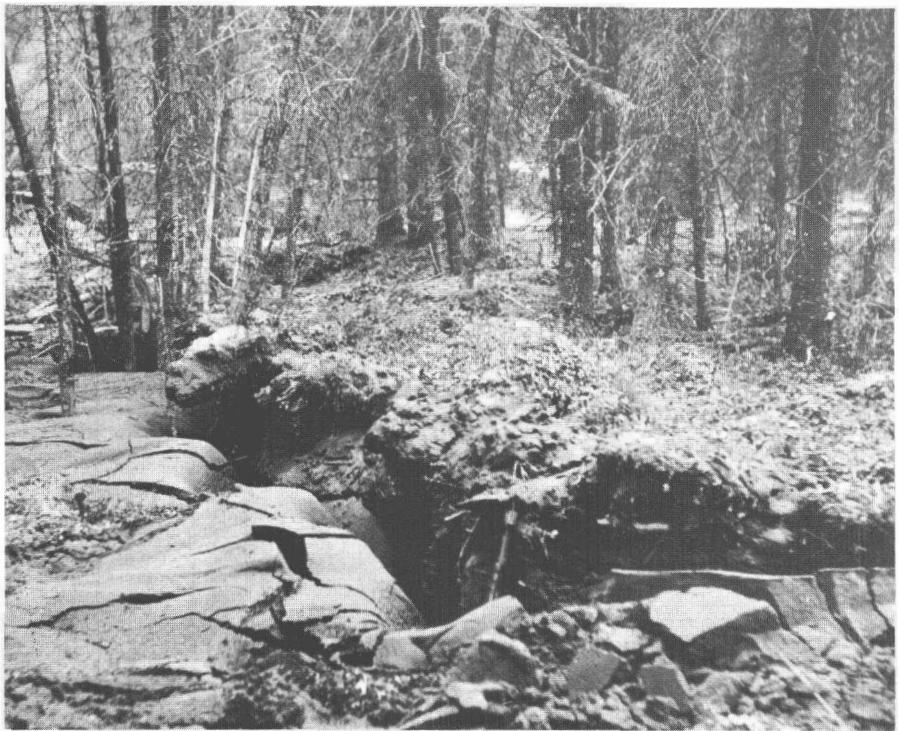
10.—Large ground crack with vertical displacement (loc. 2, pl. 1). Thick deposits of sand border the left side of the crack. Photograph was taken near E (fig. 4).

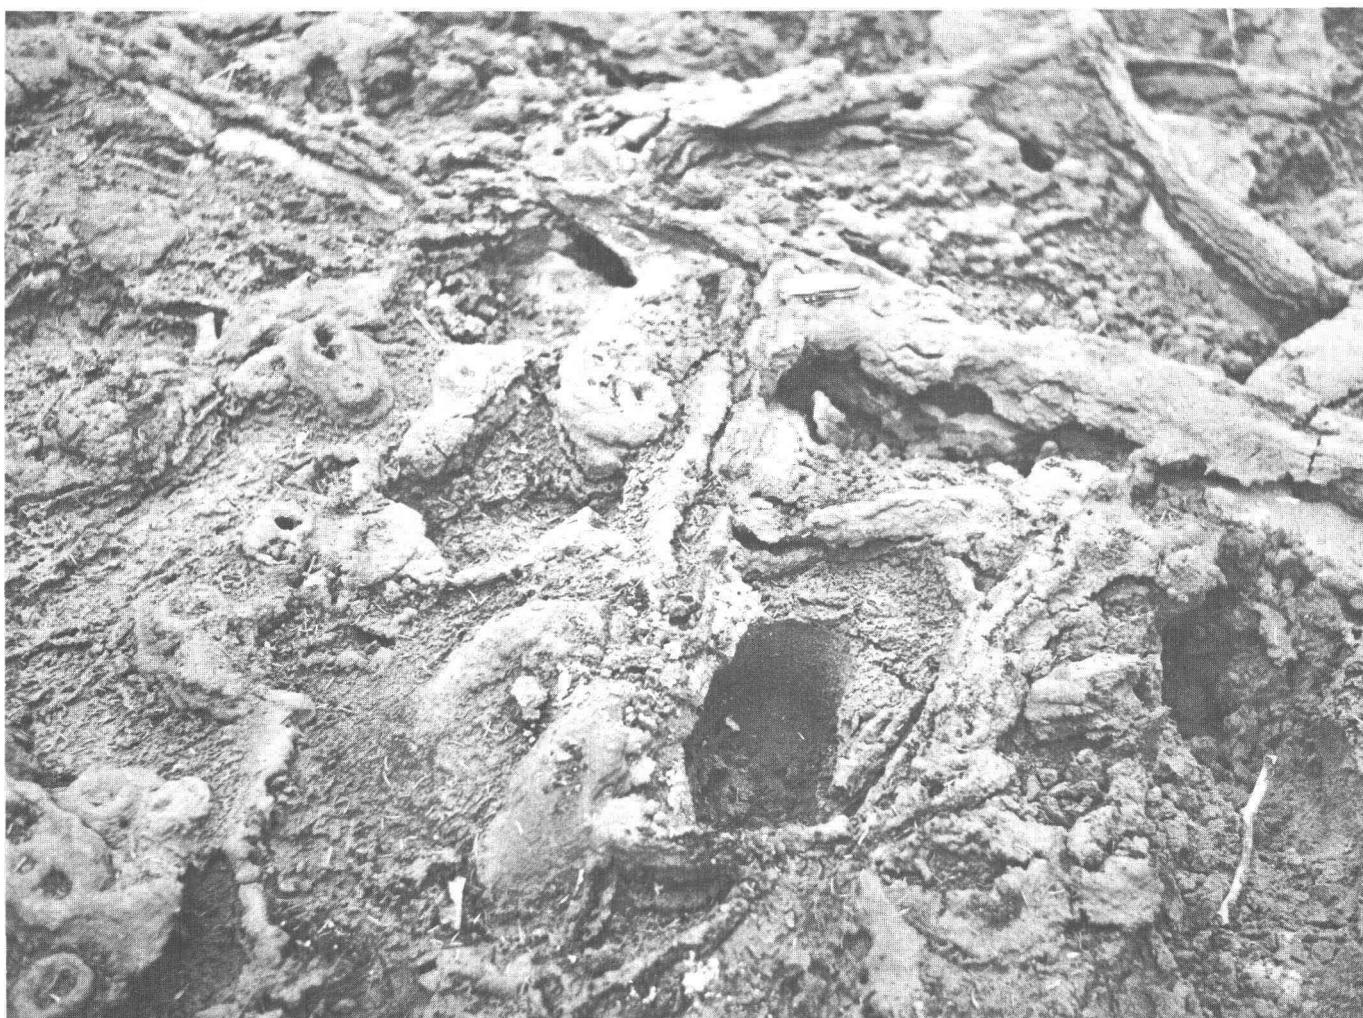
11.—Microrelief features formed in extruded silt (loc. 2, pl. 1). Area pictured is about 48 inches wide (3-inch-long jackknife is slightly above center of picture). The delicate silt mounds and ridges were formed in the last stages of ground-water eruption on the surface of previous sand extrusions.

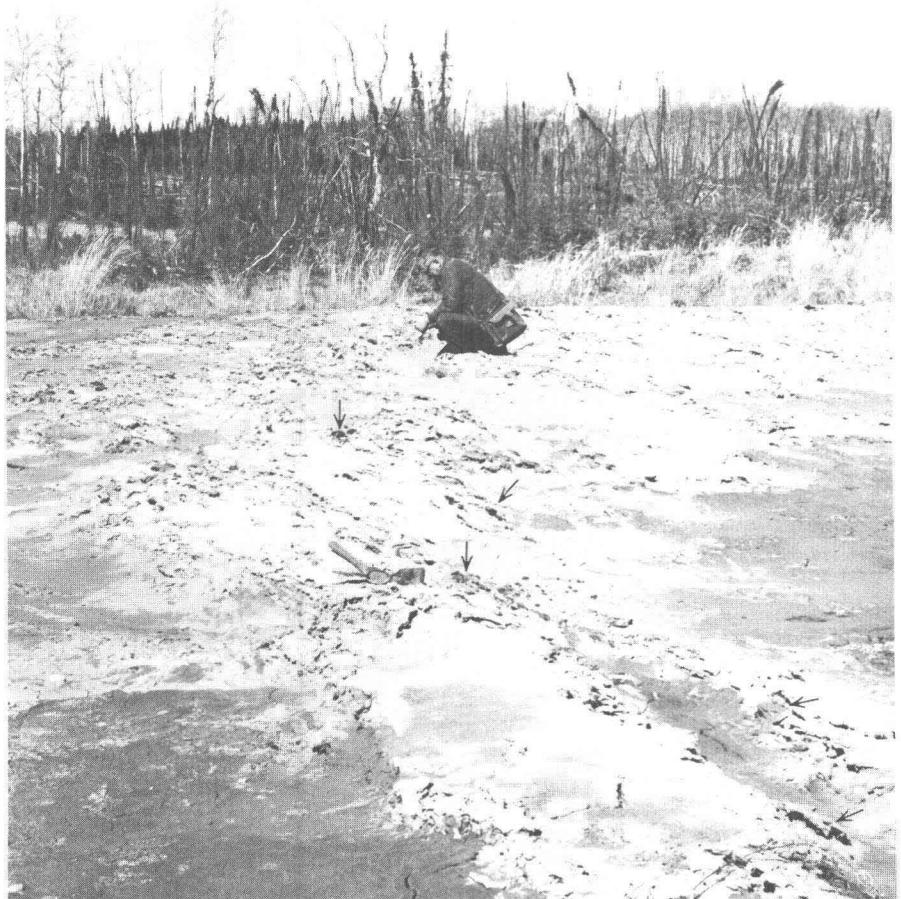
13.—Detrital coal extruded with sand (loc. 1, pl. 1). Copious amounts of sand were extruded from a fissure cutting a gravel road (loc. B, fig. 3). Pieces of coal and lignite as long as 6 inches (some indicated by arrows) were extruded with the sand.

The deposits laid down by ground-water eruption within the zone are predominantly fine- to medium-grained sand. In most localities the sand contains scattered pebbles and cobbles of detrital coal and lignite as much as 6 inches long (fig. 13). The largest amounts of sand and much of the coal were commonly concentrated at the intersection of two or more major cracks or at the intersection of a wide and a narrow one. Many, if not all, of the coal fragments carried to the surface during the earthquake by ground water could have been derived from near-surface deposits that contain detrital coal originally derived from underlying Tertiary coal beds. However, derivation of some of the coal from the Tertiary coal beds at depths of several hundred feet, though unlikely, is not excluded as a possibility by present evidence.

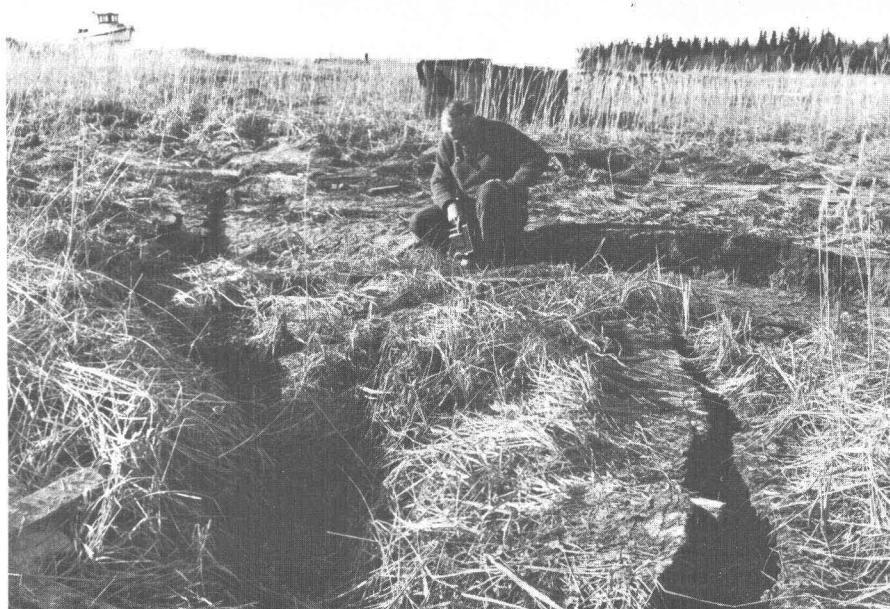
14.—Ground cracks at Kasilof in elevated beach deposits. Cracks were as much as 1 foot wide. Vertical displacement is evident along crack near man. Considerable clastic coal was brought up from beneath the surface and deposited with the sand.

At Kasilof, which is approximately in line with the northeast-trending zone of ground breakage previously described (p. F3), cracks as much as 1 foot wide were formed. The cracks were traceable for several hundred feet and cut sand dunes and beach deposits at the coast (fig. 14). Crack walls were generally sharp—in fact, exceptionally sharp for occurrence in loose sand. Some had small vertical displacements as much as 10 inches high. They had the usual pattern of many branches and cracks intersecting from several directions. Collapse occurred along some cracks where large amounts of sand had been extruded (fig. 15). Pressure ridges a few inches high and 2 to 3 inches across were noted in silt on tidal flats; some radiated from a central point in several directions for distances of 25 feet or more.

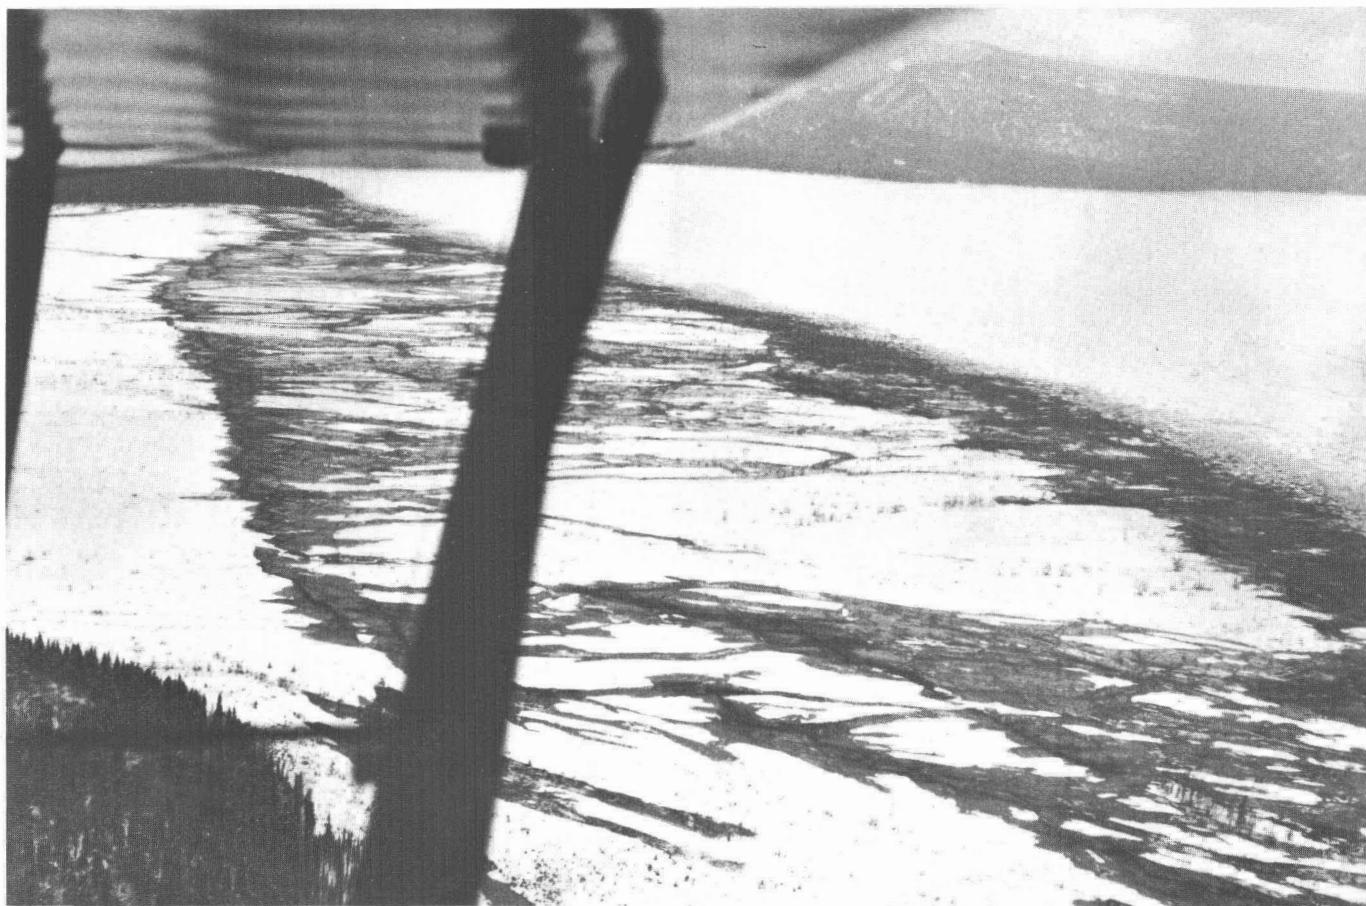
16.—Outwash delta at head of Tustumena Lake a few days after the earthquake. View is south (pl. 3). The ground was snow covered, and water and sand erupted along major cracks (dark-gray areas) partly removing the snow and covering the ground surface with sand. The cracked ice-covered lake surface is to the right. A major fissure system paralleling the delta front is seen to the left of center. Photograph by Avery Thayer, Fish and Wildlife Service, Kenai, Alaska.

Photographs obtained after the earthquake (fig. 16) indicate that a major zone of fissures oriented N. 5°–10° W. formed subparallel to the southern delta front about half a mile from the lake shore. This break defined the inland margin of the part of the delta most disrupted by the earthquake. Much sand was extruded along this fracture zone and flowed out upon the snow-covered surface (fig. 16).

The southern edge of the outwash delta is bordered by a low forested terrace (pl. 3, fig. 16). Cracks 3 to 4 feet wide and 2 to 3 feet deep spaced at intervals of 10 to 50 feet cut through the forested area in a north-south direction along the lake edge. Many trees were split and offset along cracks, the offset indicating a right-lateral ground displacement of 1 to 3 feet. The walls of the deeper cracks exposed the following terrace stratigraphy from top to bottom: vegetation mat and organic silt about 1 foot thick over stratified pebble-to-boulder gravel containing lenses and beds of sand and silt.

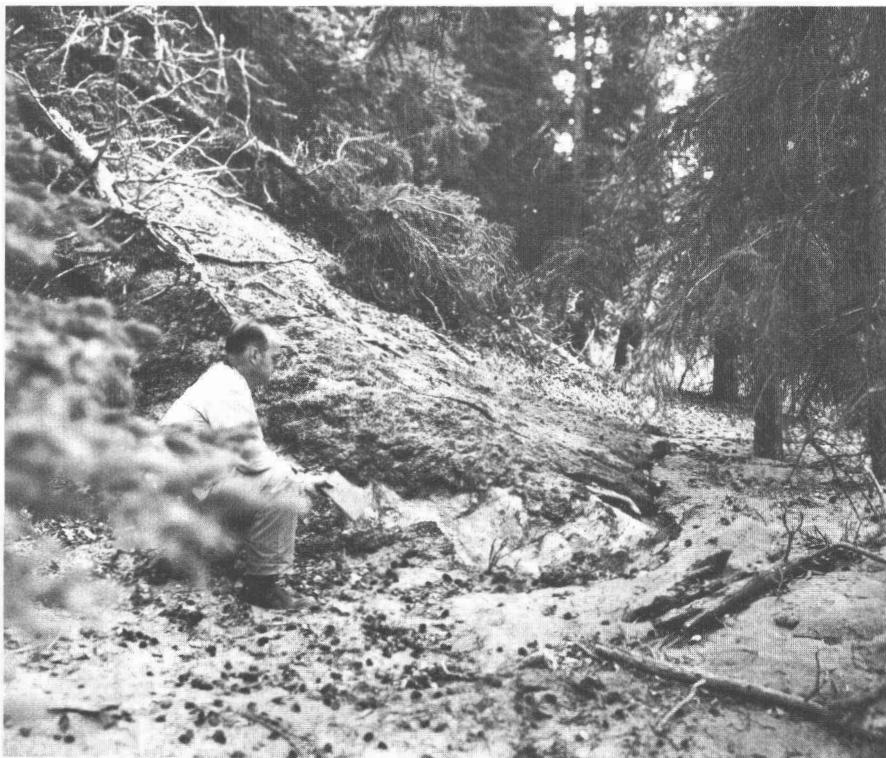
17.—Crack between delta front and bedrock at Tustumena Lake (loc. A. pl. 3). A wedge of outwash deposits pulled away from the stable bedrock face during the earthquake shaking.

The ground cracks in the outwash delta ranged in width from a fraction of an inch to 4 feet (fig. 17). Most cracks showed no vertical displacement, but a few indicated subsidence of several inches to 1½ feet on the lake side. Little overall evidence of subsidence of the delta front was observed, and it is estimated to have been less than 10 feet.

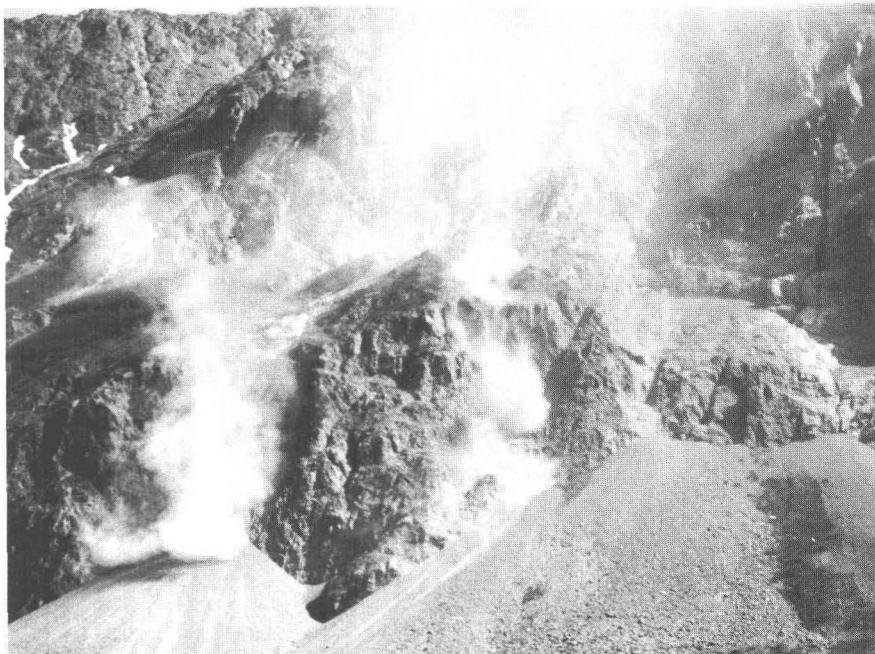
21.—Sites of avalanche activity in Eklutna valley. These talus cones were present before the earthquake but have been enlarged by avalanche activity since the earthquake. The dust clouds are created by the avalanching.

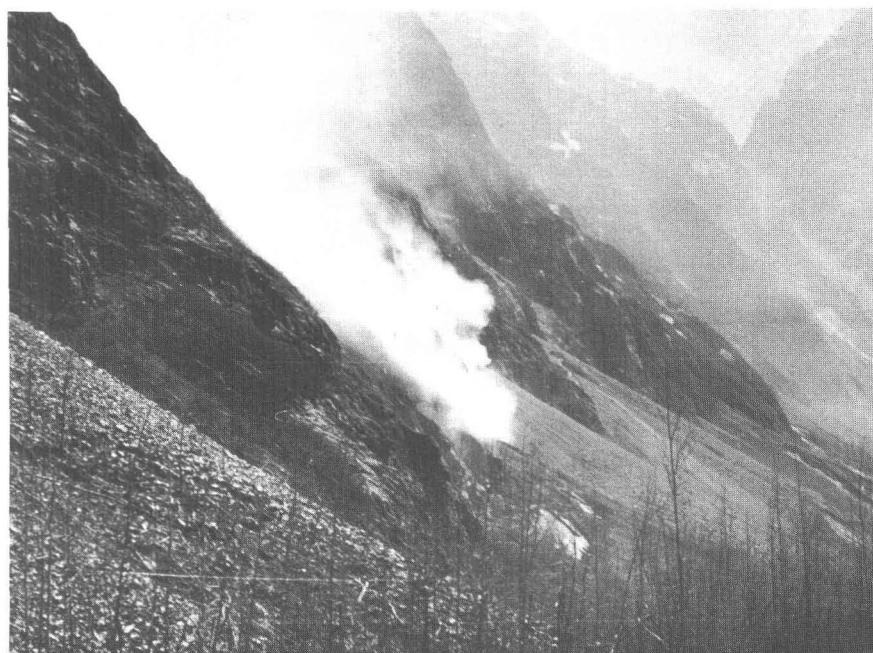
22.—Dust cloud in Eklutna valley caused by avalanche activity. The avalanching has been persistent during the summers since the earthquake.

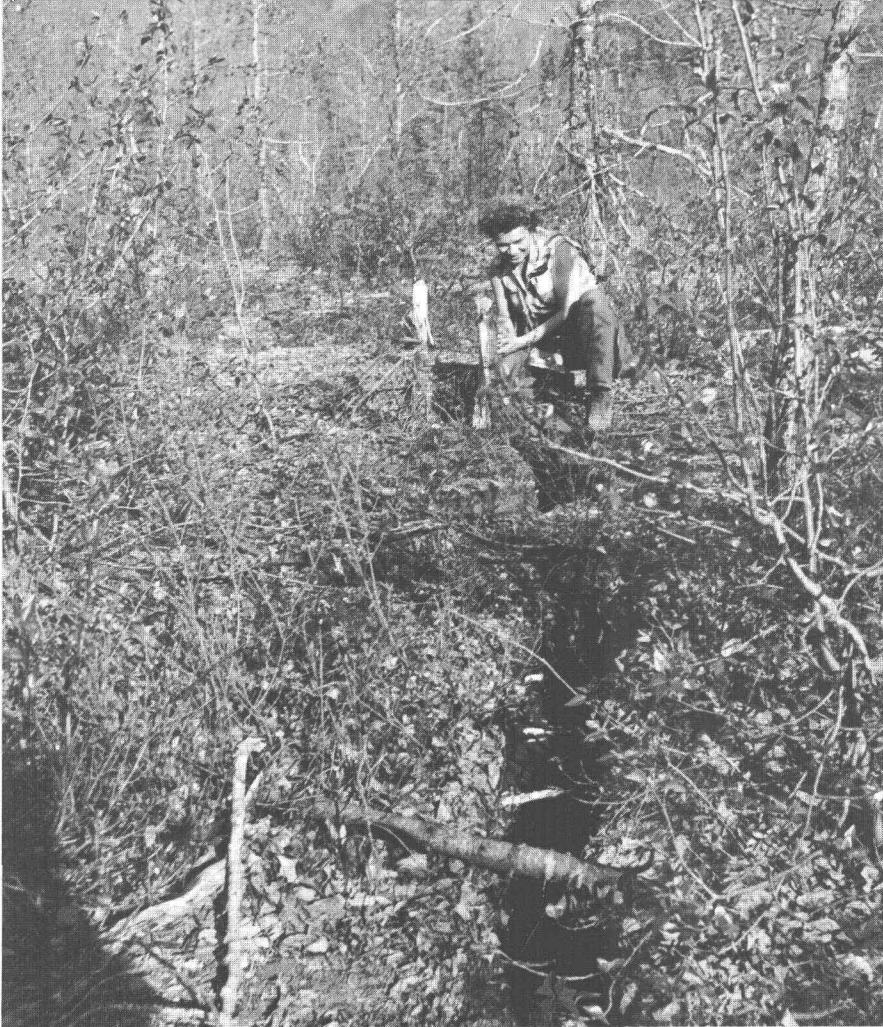
23.—Crack in gravel outwash in Eklutna valley. Crack was about 10 inches wide and split a tree stump. The two halves of the stump were offset about 14 inches.

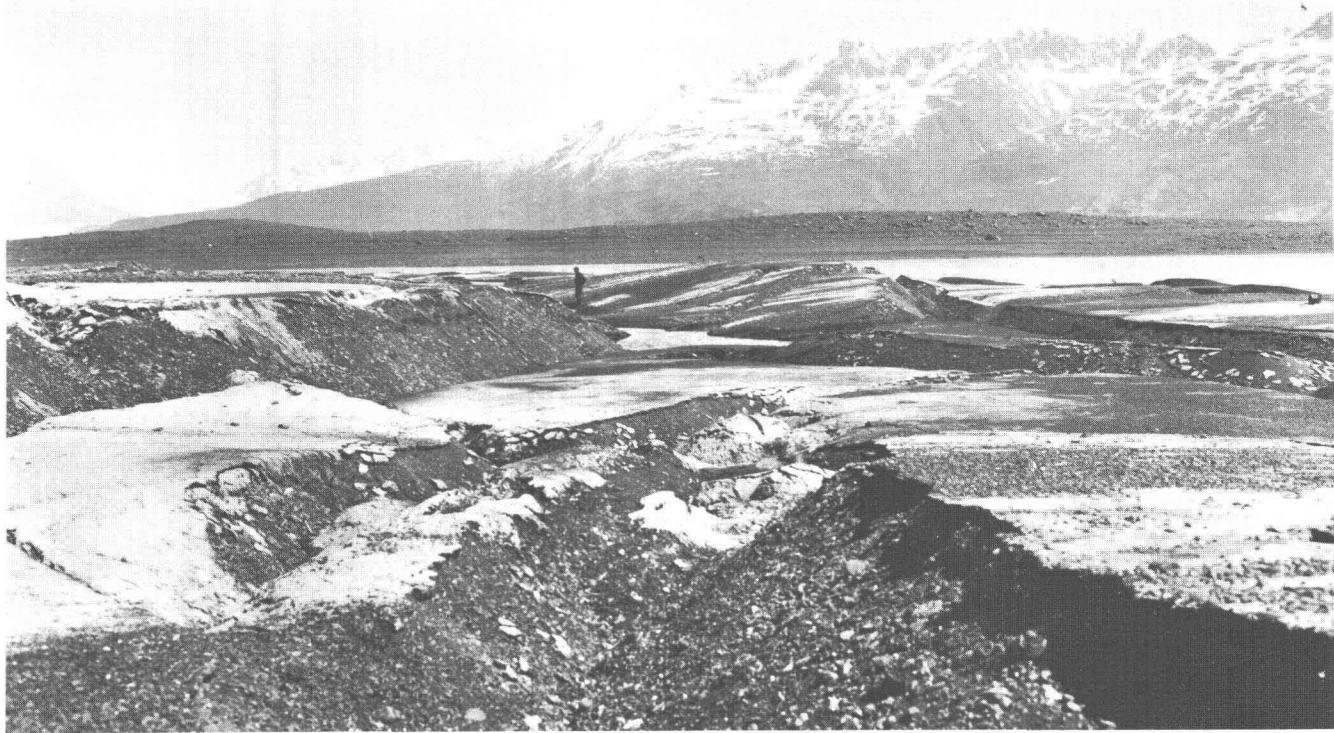
24.—Failure of the delta front at Troublesome Creek, Lake George (loc. C, fig. 25). Man is standing on a large slumped and rotated block that is bounded front and back by large fissures.

cracking associated with eruptive deposits of emerged bottom sediments at the head of the lake. The most extensive disruption occurred along the front of the Troublesome Creek delta where slumping caused lakeward rotational displacements of frozen gravel blocks as much as 20 feet wide and 100 feet long. Chaotic topography resulted (figs. 24, 25). The delta at the mouth of a creek entering the south end of upper Lake George failed by cracking along the margin of the delta front. Lateral extension, however, was slight, minor vertical or lateral displacements being evident along the cracks.

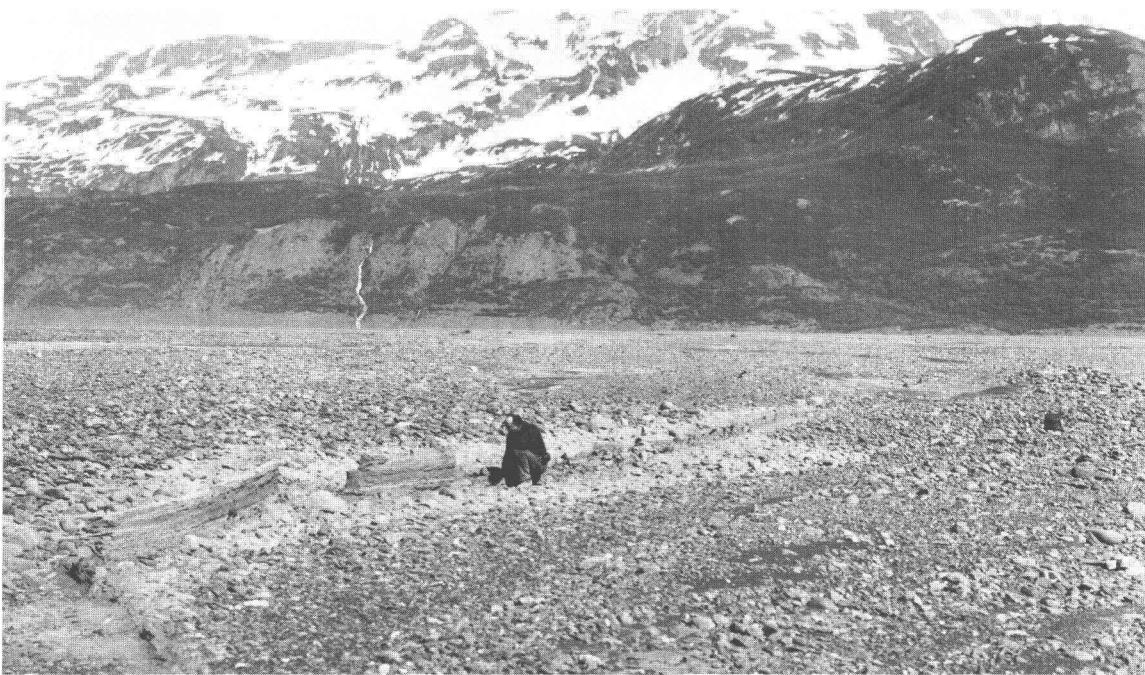
26.—Wall of silt punched up on the emerged bottom of Lake George. The wall was 8 to 24 inches high, 30 feet long, and 6 inches wide (loc. B, fig. 25).

Lake silt was squeezed out of the underlying water-saturated sediments and erupted through cracks in the seasonally frozen surface layer. At one locality a wall of frozen silt, 6 inches wide and about 30 feet long, was punched up 8 to 24 inches by pressures in the underlying unfrozen materials during the earthquake (fig. 26). The undisturbed structure of the fine laminated silts exposed in the wall indicated that the silt must have been rigid and frozen at the time of displacement. Disruption and minor dislocation of the wall along northeast-trending cracks indicate subsequent development of and minor displacements along cracks that cut transversely the northwest set of parallel fractures that defined the wall structure itself. At several locations, mounds of silt 1 to 2 feet high and 2 to 3 feet in diameter and showing internal flow structure formed at the intersection of the cracks. Unfrozen silt was squeezed up as ridges along some of the cracks (fig. 27). On the north side of the moraine along the south side of lower Lake George, some sand eruption occurred at the contact of the moraine with the lake sediments through cracks transecting the moraine.

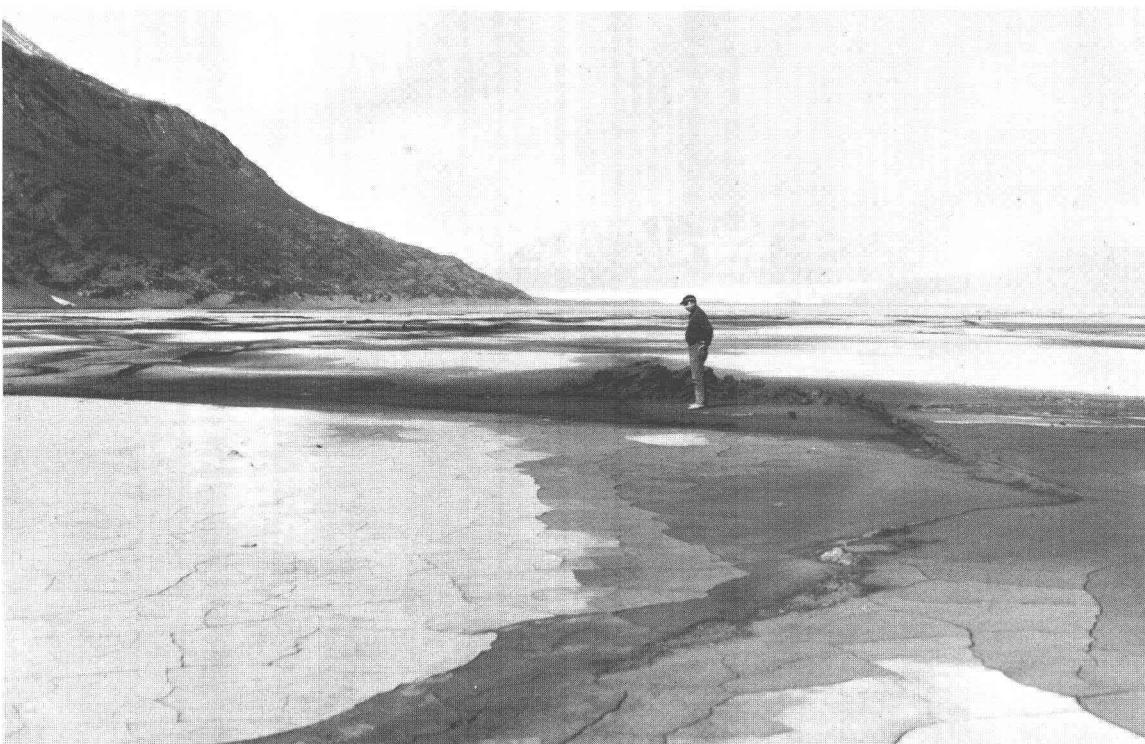
27.—Ridges of silt squeezed up along cracks in the emerged bottom sediments of Lake George (loc. A, fig. 25).

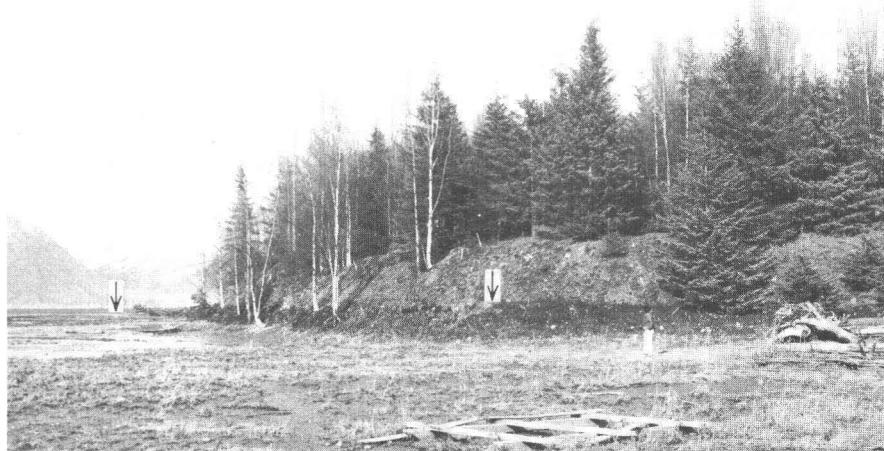
28.—Postearthquake high-tide mark along Turnagain Arm sea bluffs near Hope. Arrows indicate the pre- and postearthquake high-tide positions. The vertical distance of about 5 feet between these two positions approximates the amount of crustal subsidence that accompanied the 1964 earthquake.
