THE ALASKA EARTHQUAKE, MARCH 27, 1964:
EFFECTS ON TRANSPORTATION, COMMUNICATIONS, AND UTILITIES

Effects of the Earthquake Of March 27, 1964, on Air and Water Transport, Communications, and Utilities Systems In South-Central Alaska

By EDWIN B. ECKEL

GEOLOGICAL SURVEY PROFESSIONAL PAPER 545-B

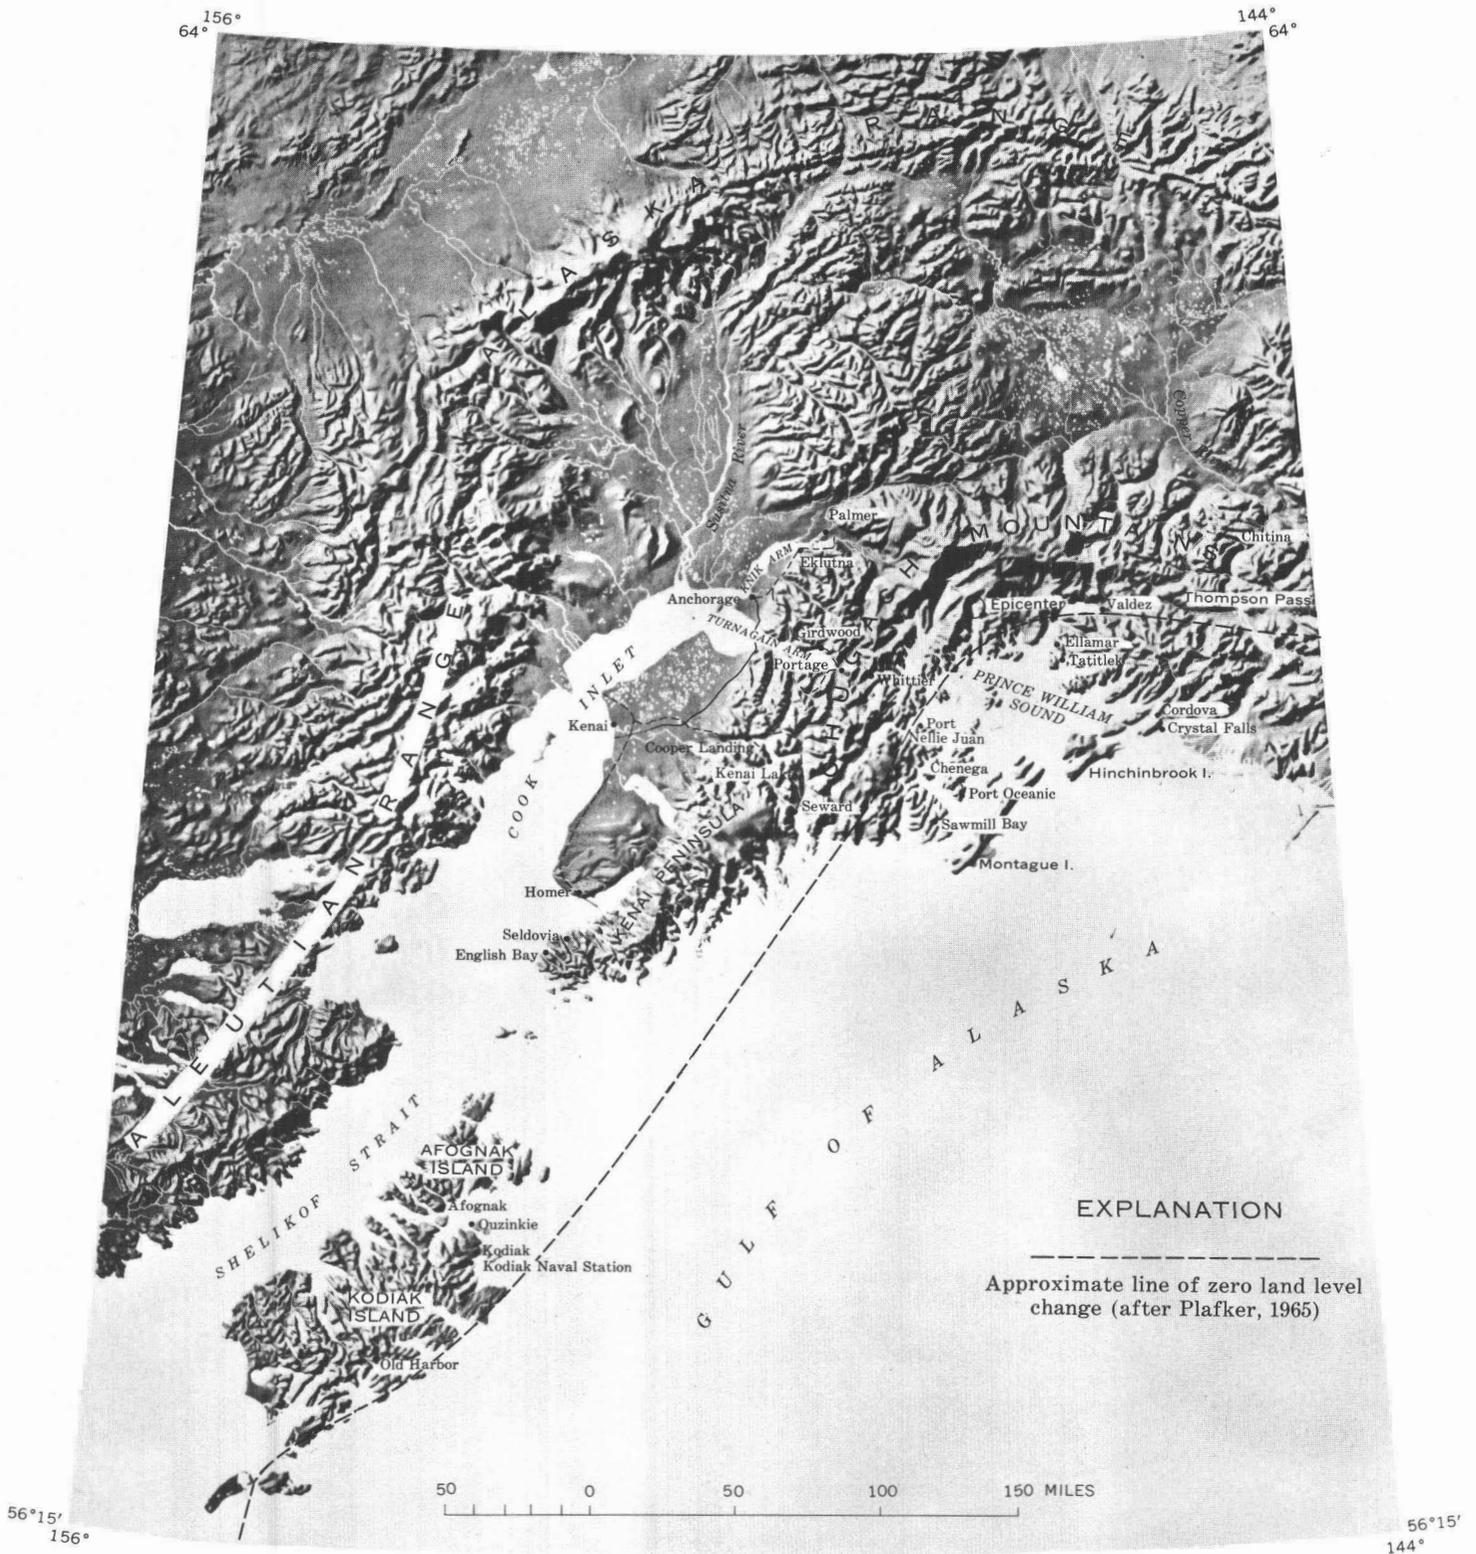
1.—South-central Alaska, showing main power (short-dashed) and gas-transmission (solid) lines and principal communities whose ports, airports, or utility systems were damaged by the earthquake. Land to left of zero land level change line was generally lowered; land to right of line was raised.

The tectonic uplift that affected most of the Prince William Sound area resulted in shoaling of waters that had been navigable before the earthquake (fig. 1); during the first weeks after the quake some small craft were grounded or damaged by hidden rocks or were stranded by low tides. At least one cannery in the area of uplift—the Crystal Falls cannery at Mountain Slough, not far from Cordova—became inaccessible to fishermen and was declared a total loss (Alaska Dept. Fish and Game, 1965).

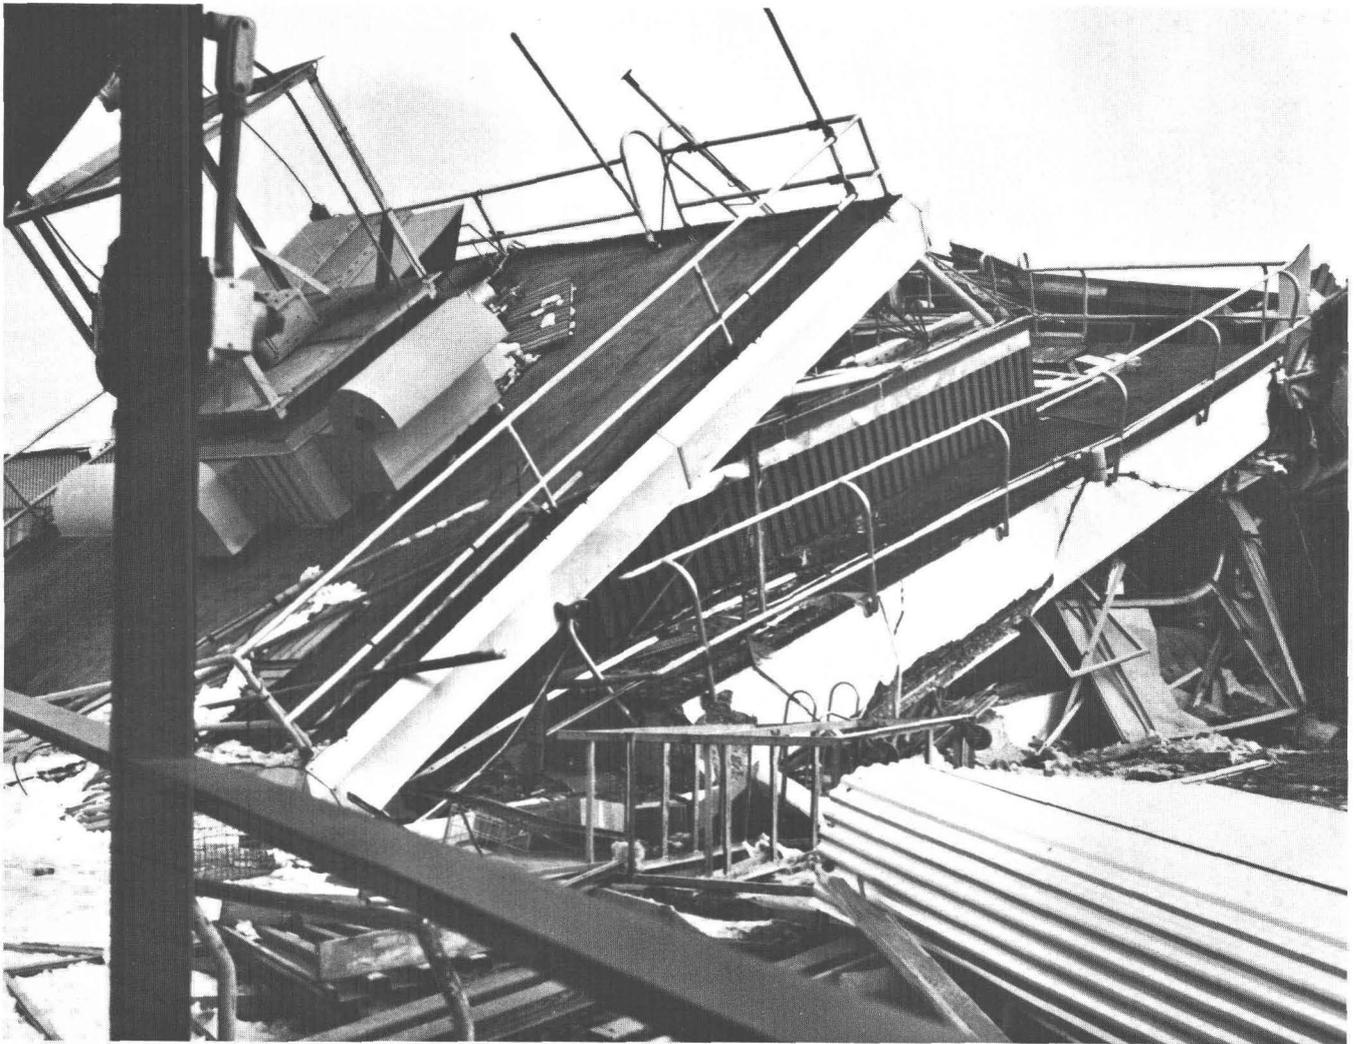
2.—Control tower at Anchorage International Airport, collapsed by earthquake shaking. Photograph by Federal Aviation Agency.

were damaged and their utilities disrupted by seismic shaking. The wrecked control tower at Anchorage International Airport was one of the greatest single losses, caused by vibration, that directly affected the aviation system (figs. 2, 3). Some subsidiary buildings, however, such as the military hospital at Elmendorf Air Base, sustained greater damages in terms of total repair costs. Many runways, aprons, and taxiways were cracked and made uneven by shaking and the resultant differential consolidation of alluvial materials or artificial fill. Hangars, seaplane ramps, and parts of the runways at Kodiak Naval Station were flooded by a series of seismic sea waves, and a few smaller airstrips were either destroyed by waves or were subjected to partial flooding by high tides due to regional subsidence. Despite all these difficulties, total damage to Alaska's air facilities amounted to only a few million dollars, as compared with more than \$100 million worth of damages to the water, rail, and highway systems. More significant than the relatively small dollar losses, perhaps, is the fact that nearly all air facilities were partly or wholly operational within a few hours after the earthquake. This made possible the enormous air transport of people, food, and supplies that were required at once.

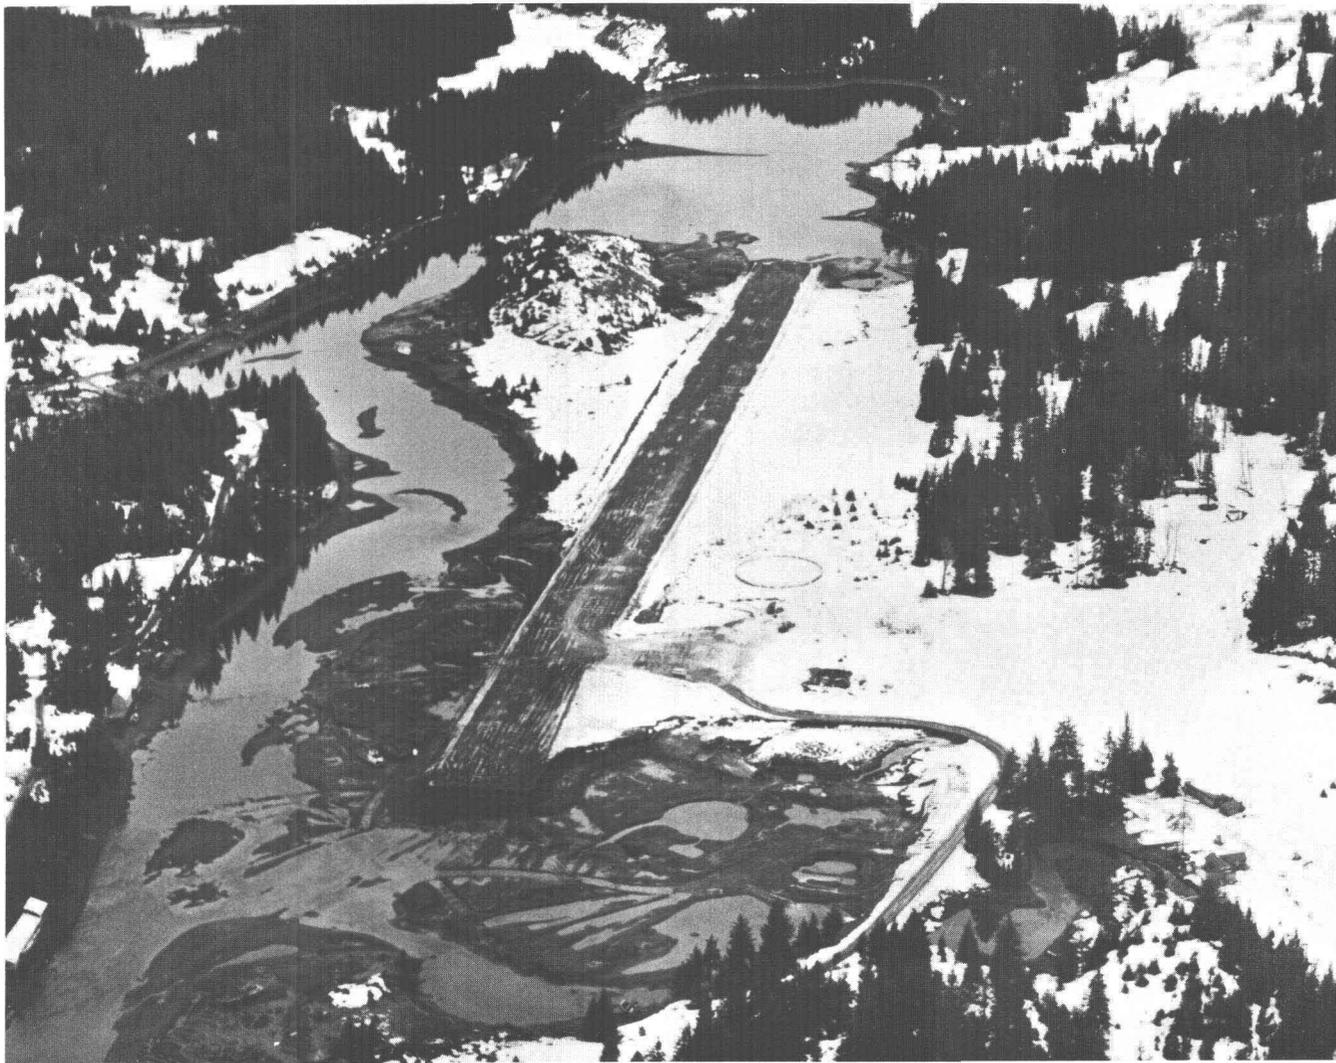
4.—Tectonic subsidence required raising of airstrip at Seldovia. U.S. Army photograph.

be built up as much as 4-5 feet, at an estimated cost of \$600,000, to raise the strip above tide level (fig. 4). Runways at Ninilchik, Kenai, Soldatna, and Hope sustained minor cracks. The airport at Homer was undamaged, but new construction work there was delayed, and made more costly, when the once-ample source of gravel on Homer Spit became difficult to obtain because of tectonic subsidence and consolidation of the spit materials. The only undamaged airstrip on the Kenai Peninsula was the one at Lawing.

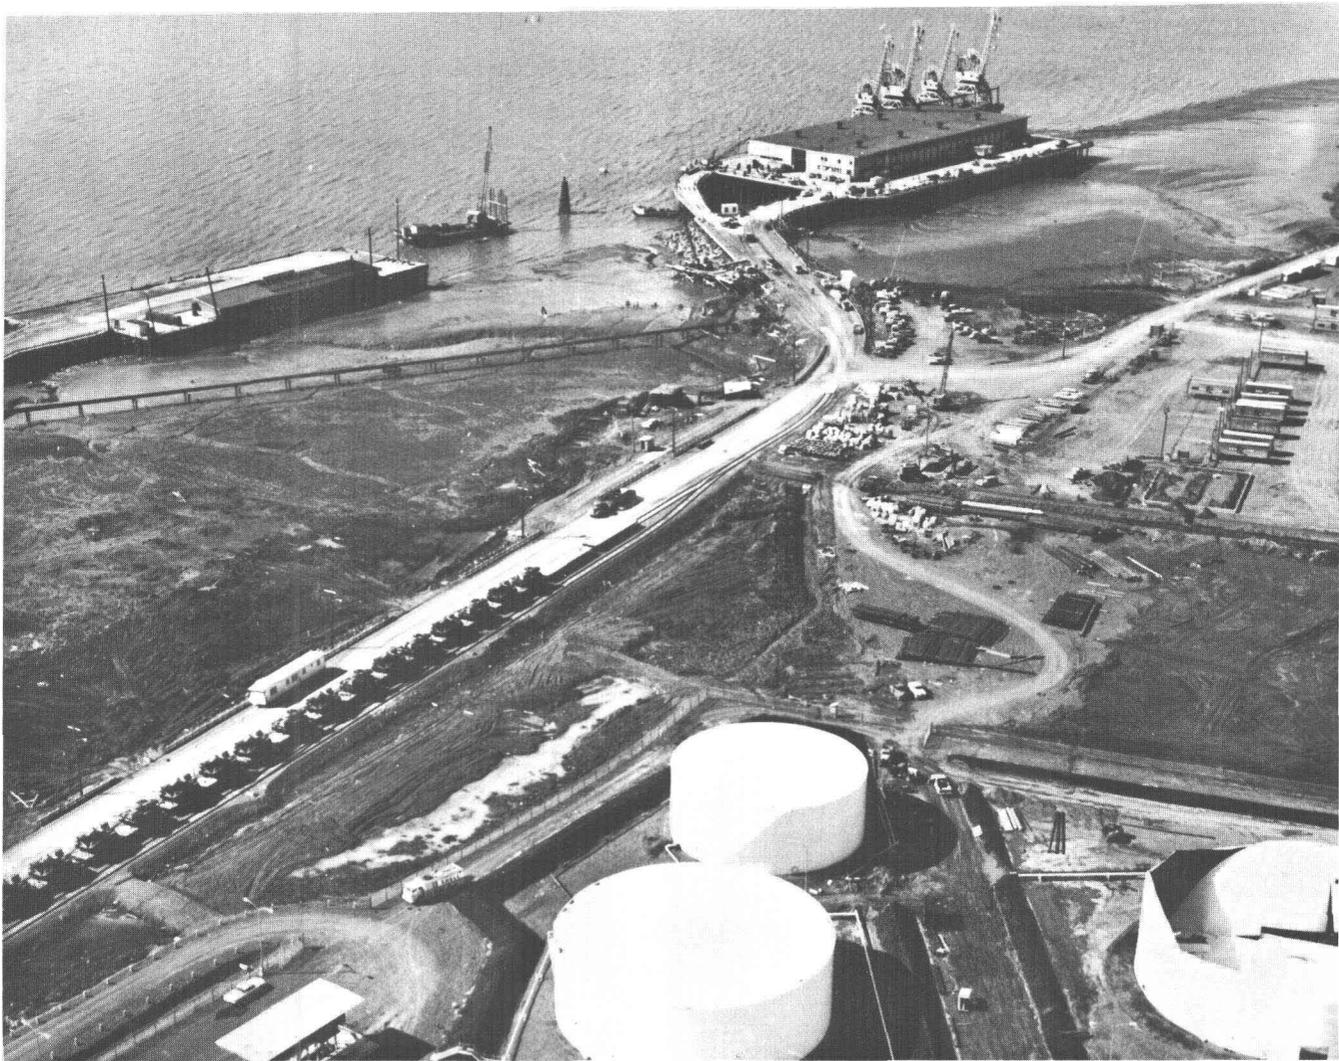
5.—Anchorage municipal wharf area shortly after the earthquake, at low tide. The main dock was only slightly damaged, but the older Army dock (upper left), was ruined. Vibration and ground fractures damaged some structures in the port area, including the petroleum tank (lower right). U.S. Army photograph.

The municipally owned Anchorage wharf is the largest port structure (fig. 5). It consists of two adjacent reinforced-concrete docks on concrete-filled tubular piles. The joint between the two docks was opened 4–12 inches; all four cranes were shaken off their tracks, and their undercarriages and counterweight arms were damaged. The steel-frame transit shed was cracked and twisted but only to a minor degree. Some steel piles broke at their caps; battered H-piles were sprung out of line when the main dock structure shifted its position (Berg and Stratta, 1964; Alaska Construction Consultant Committee, 1964).

The so-called old Army Dock (fig. 5), a timber structure that was already much deteriorated, was made unusable for offloading of private and military petroleum supplies; a temporary petroleum dock was built to replace the old Army Dock, but it was severely damaged by ice and did not last through the following winter. Petroleum pipelines and approach roads and rail lines were broken or twisted by settlement and vibration. A cement bin, 30 feet high and 30 feet in diameter, collapsed on its pedestal. The walls of several petroleum storage tanks developed bulges at ground level. Berg and Stratta (1964) suggested that the bulges may have been caused by an earthquake-induced swirling of the tank contents, which in turn induced large vertical forces acting over a small zone at the base of the cylinder.

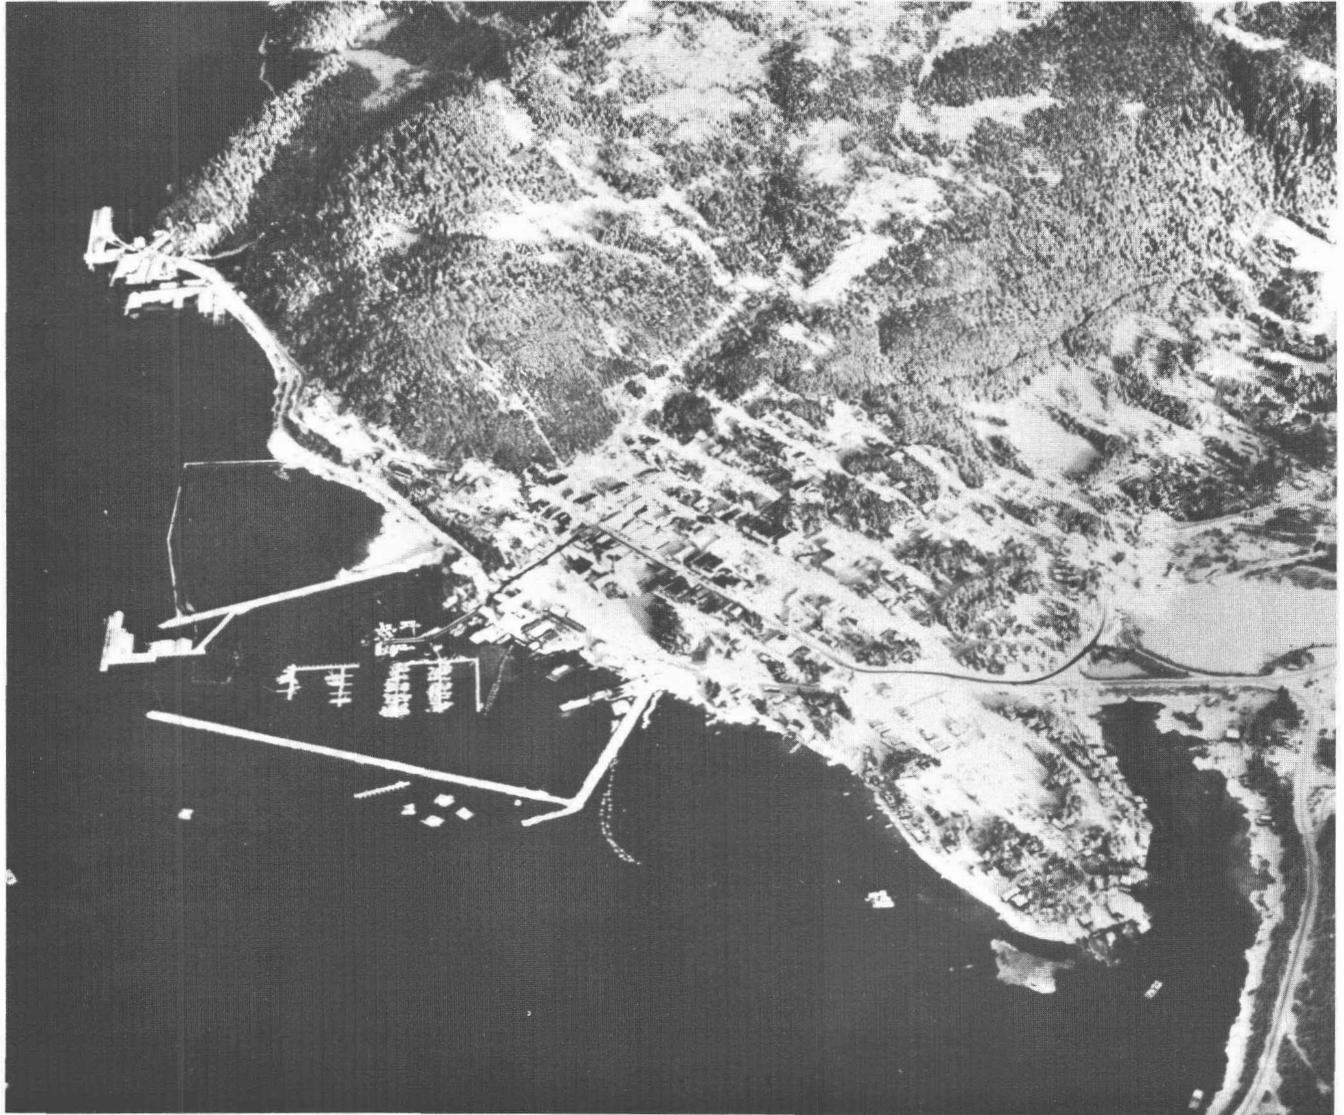
6.—Cordova harbor as it appeared in February 1965. Tectonic uplift left docks inaccessible to ships except at very high tides. Reconstruction involved dredging of harbor and rebuilding of docks and small-boat basin. U. S. Army photograph.

The Cordova area was raised about 6 feet by tectonic uplift, and the docks were thereby made inaccessible to ships except at very high tides. The deck of the main city dock was lifted and displaced by seismic sea waves and was battered by ships tied up to it. The ferry terminal dock was also damaged by waves, but these damages were insignificant

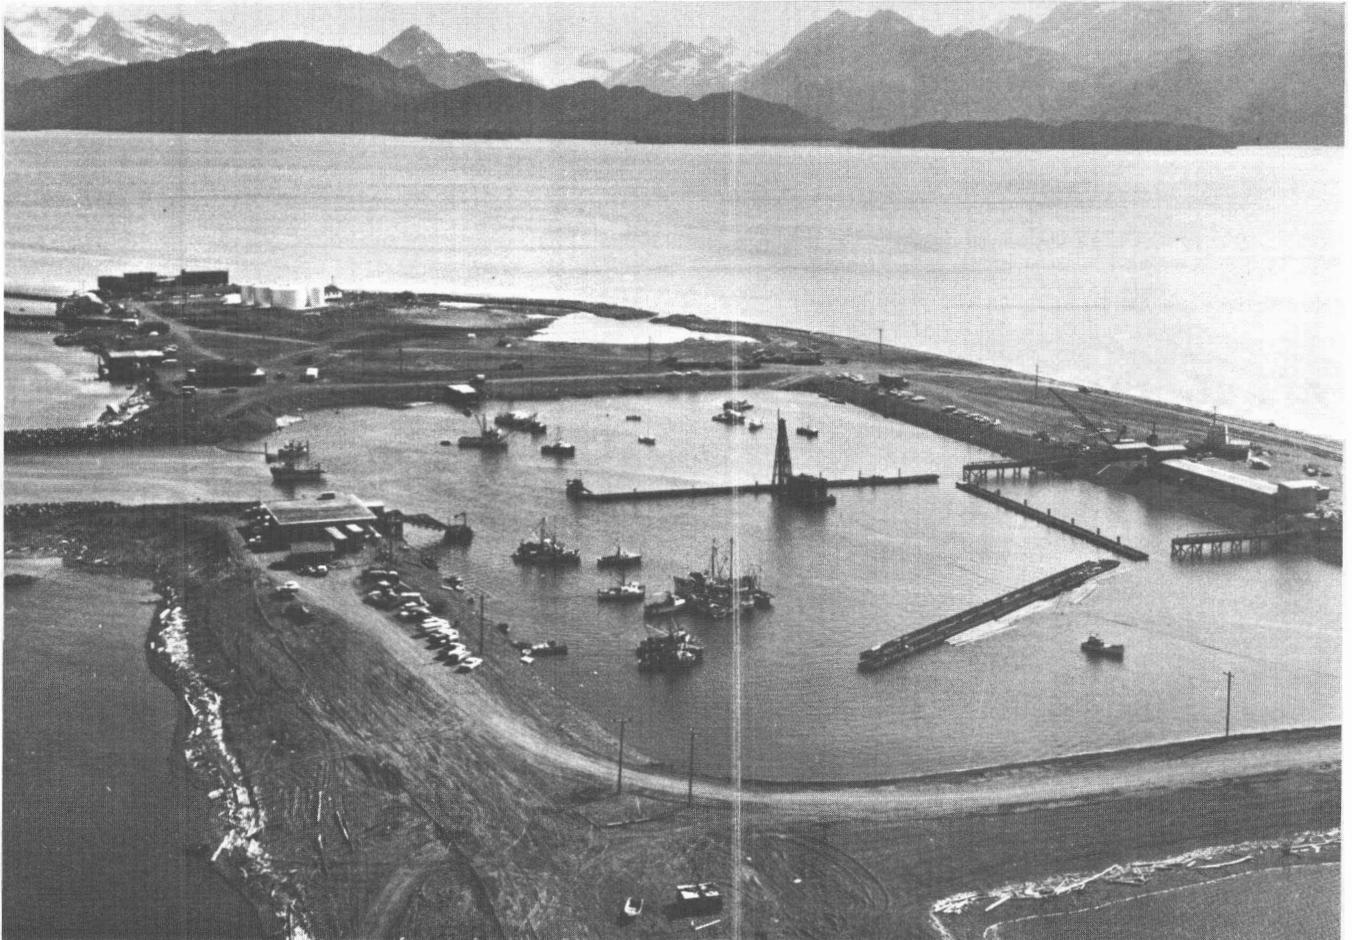
7.—New small-boat basin, excavated in end of Homer Spit. Former basin, on left side of the spit, was destroyed by a small offshore slide. The fact that the entire end of the spit is submerged by high tides because of tectonic subsidence and compaction necessitates dikes around new basin. U.S. Army photograph.

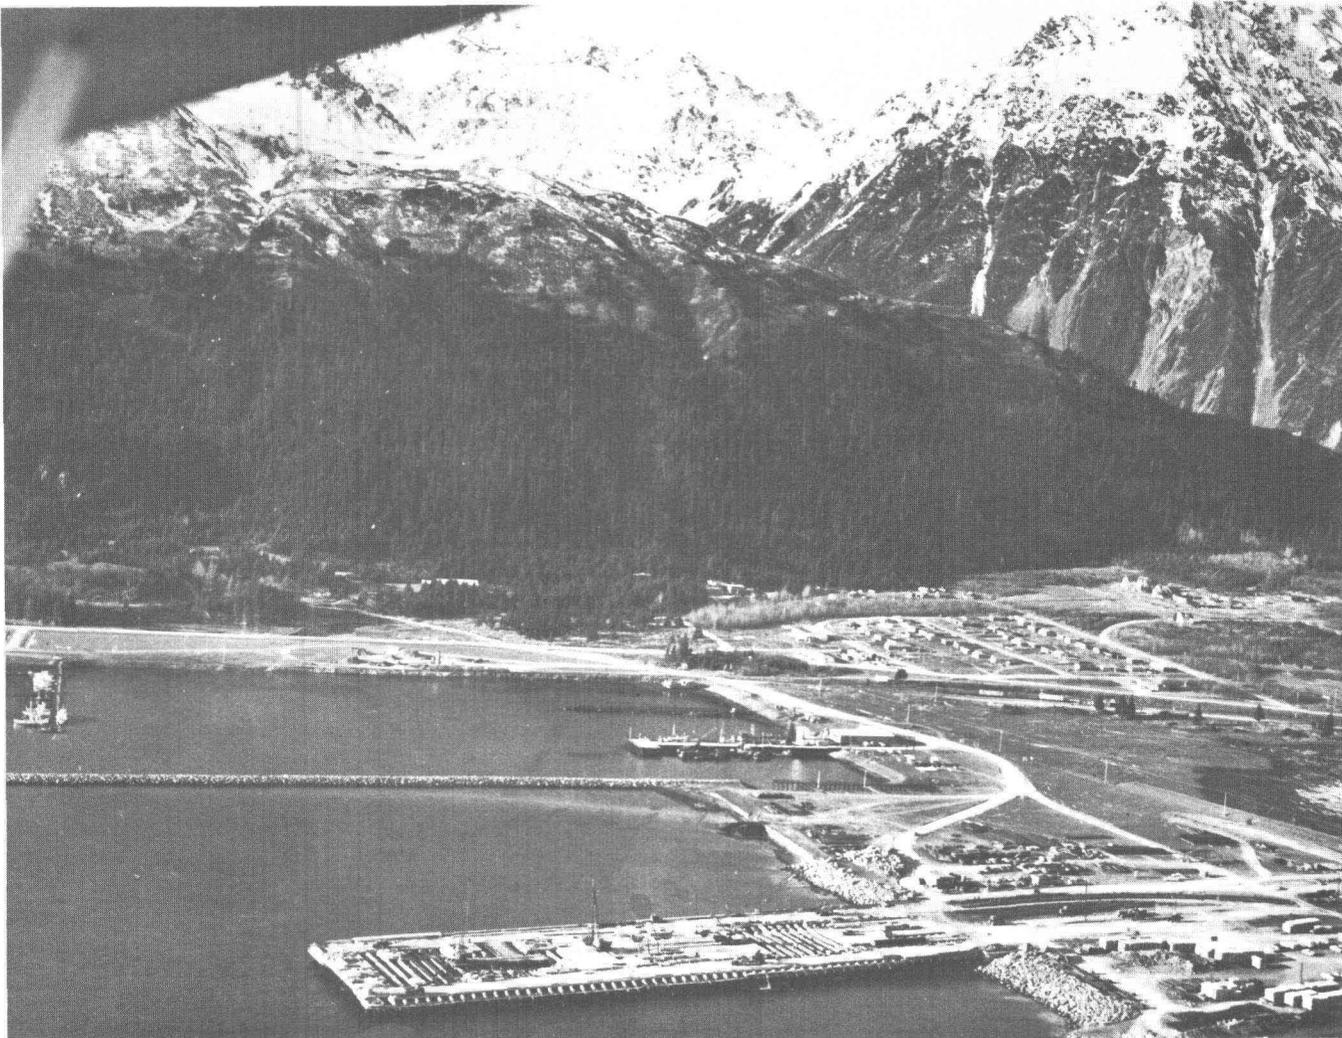
8.—Part of new small-boat basin and nearly completed railroad dock at Seward, November 1965. All former Seward waterfront facilities (to left of picture) were destroyed by submarine slides, waves, and fire. U.S. Army photograph.

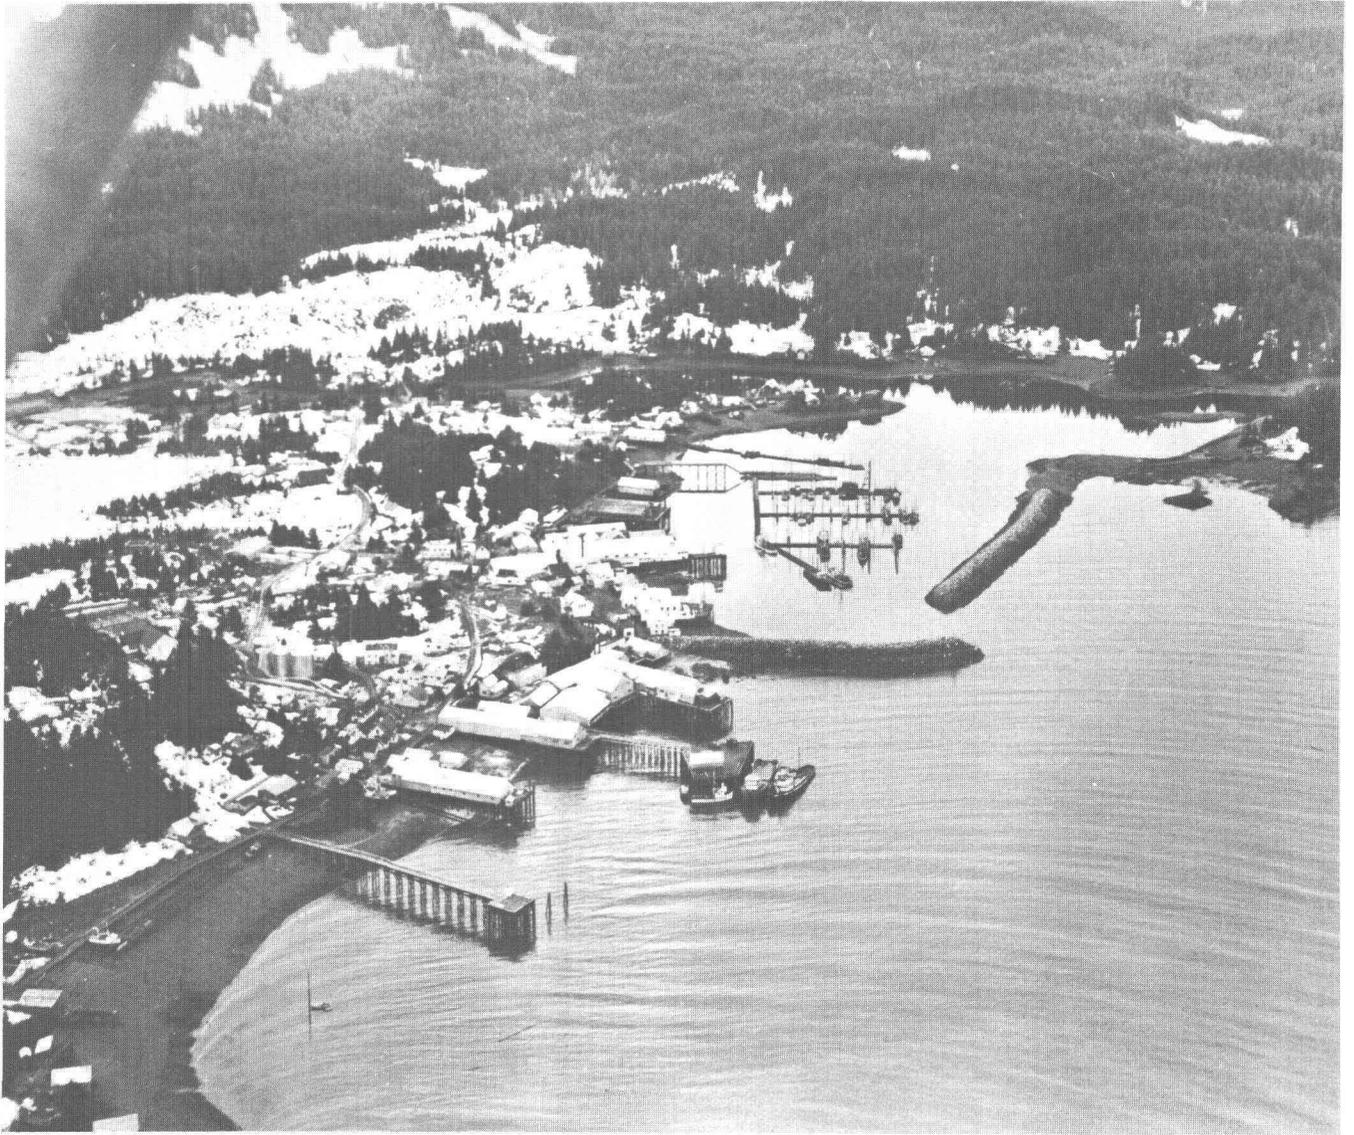
9.—Seldovia at low tide in March 1965, with raised breakwater and small-boat basin in use. Tectonic subsidence submerged boardwalk (curving structure at shore end of docks in foreground) at high tide. The boardwalk has been replaced on new fill. Urban renewal project will alter buildings and utilities to conform with higher water levels. U.S. Army photograph.

protected harbor between Seward and Anchorage that can accommodate ocean vessels (fig. 1). Tectonic subsidence lowered the area about 3.5 feet so that most harbor facilities, including the mile-long boardwalk on which the business section of the town is built, were awash at high tides. The Corps of Engineers built a new breakwater, raised docks, and restored the small-

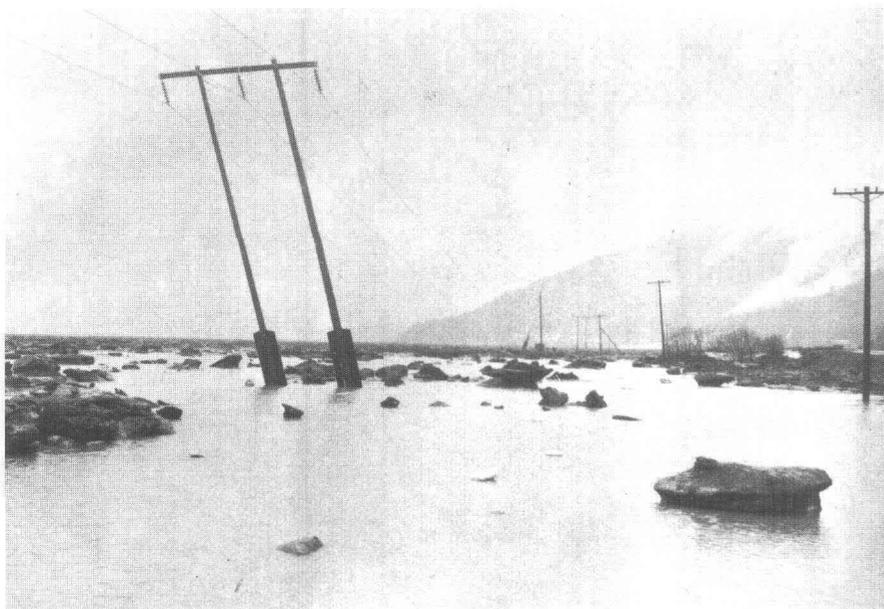
12.—Power and telephone poles along Turnagain Arm were tipped when the silt in which they were embedded was liquefied by earthquake vibrations. Photograph by Chugach Electric Association, Inc.

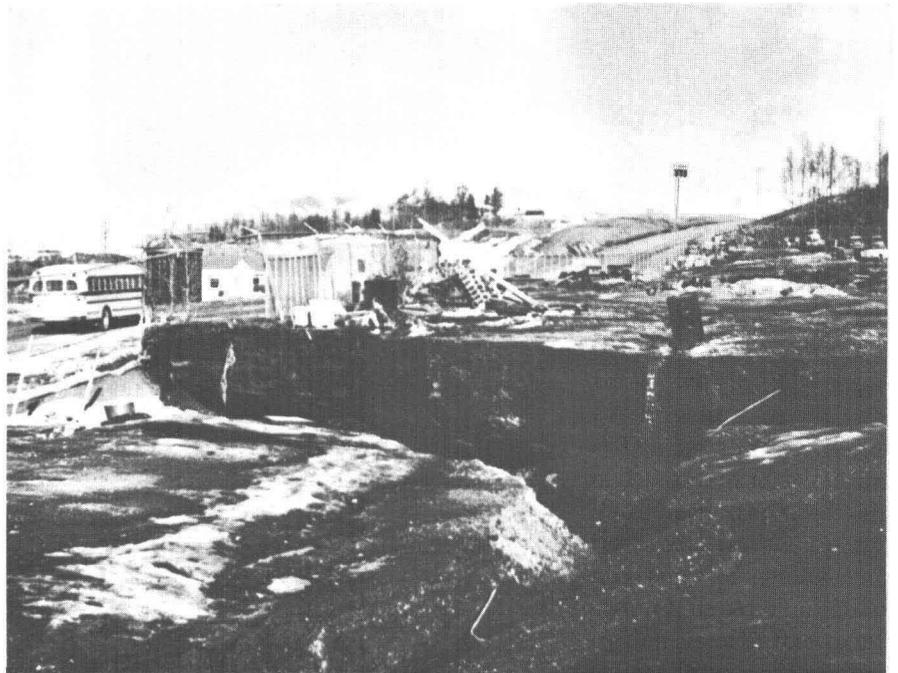
15.—Twelve-inch gas main, supplying fuel for municipal powerplant, was ruptured by landslide at Third Avenue and Post Road, Anchorage. Photograph by W. J. Stump.
