# Coastal Erosion Monitoring Port Heiden, Alaska

Transect 1  
LAST UPDATED 2022

Transect 7  
LAST UPDATED 2022

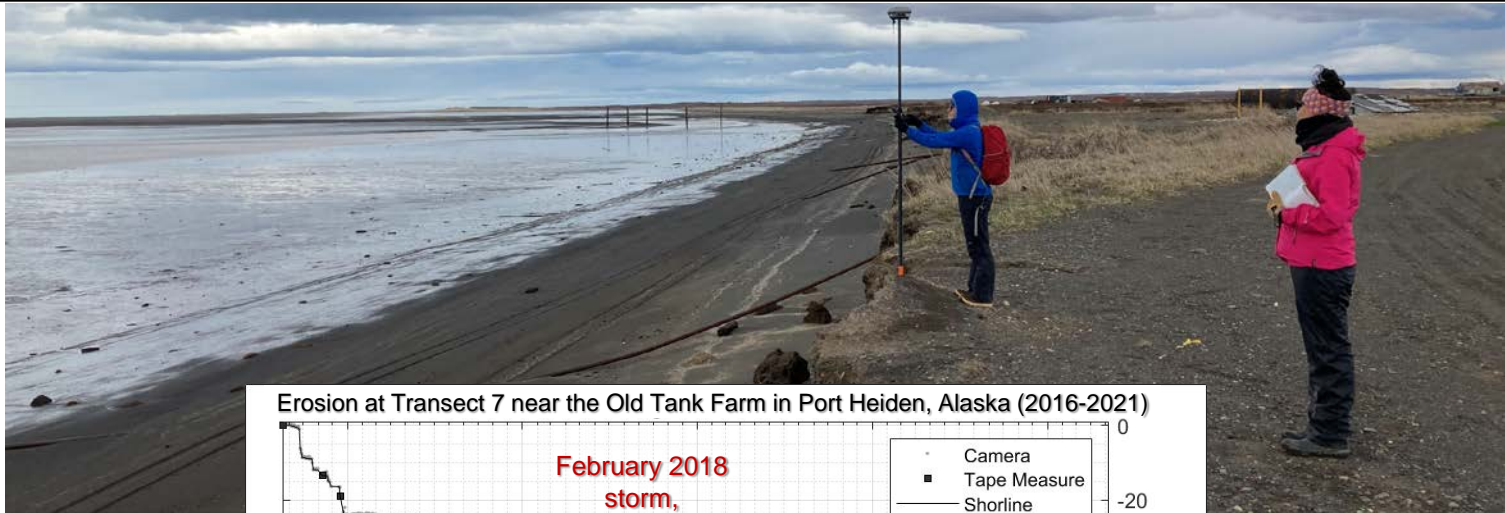
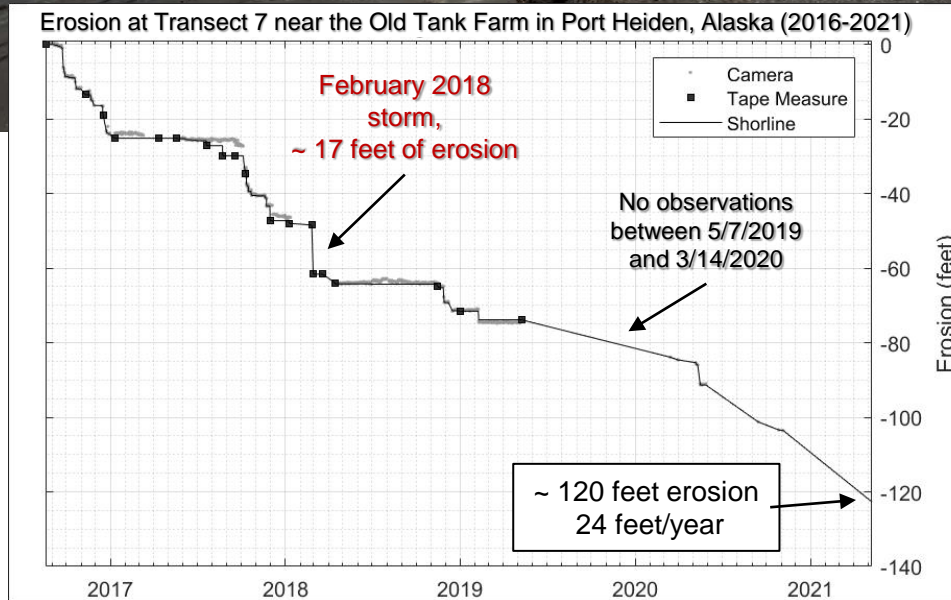
Distances are in feet  
Photograph collected 5/8/2021

Summary of erosion at community-based erosion monitoring site in Port Heiden, Alaska. Plot shows contemporary bluff erosion since the monitoring site was established in 2016. Arrows point to significant erosion events and highlight erosion rate. The monitoring site was established collaboratively between DGGS, University of Alaska Fairbanks, Bristol Bay Native Association, Alaska Sea Grant, and the Native Village of Port Heiden.
