Report of Investigation 2021-3 Quinhagak

EROSION EXPOSURE ASSESSMENT—QUINHAGAK

QUINHAGAK EROSION EXPOSURE ASSESSMENT

Report of Investigation 2021-3
Buzard and others, 2021
Quinhagak, Sheet 1 of 2

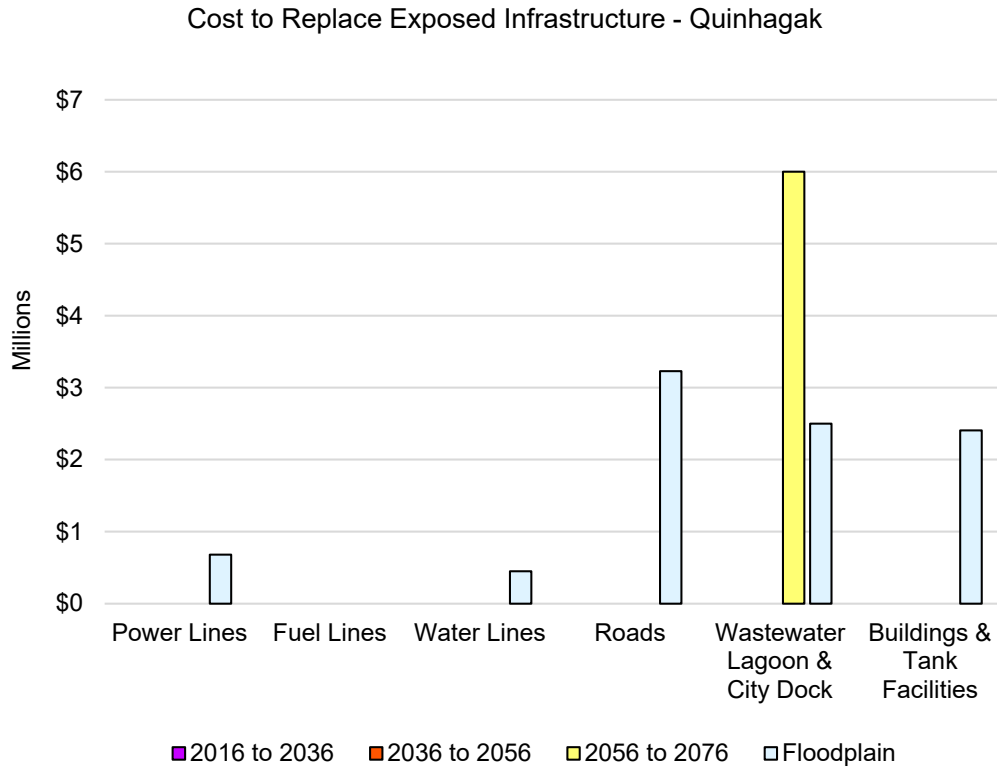
Figure 1. This figure shows the replacement cost of infrastructure in the erosion forecast area and within the topographic floodplain (blue). The only infrastructure exposed to coastal erosion is the wastewater lagoon in the 2056 to 2076 period (yellow). Infrastructure within the topographic floodplain are exposed to erosion but the timing is not known.

The wastewater lagoon is exposed to coastal erosion between 2056 and 2076 (table 1). No other types of infrastructure are within the 60-year coastal erosion forecast area. In the topographic floodplain there are power lines, water lines, roads, and buildings (including many small sheds and fish drying racks; table 1). The greatest costs of exposed infrastructure are roads (\$3.2 million) and buildings (\$2.4 million), especially around the old airport (tables 2–3; fig. 1). The total replacement cost is estimated to be \$15.3 million (\pm \$4.6 million).
