Report of Investigation 2021-3 Unalakleet

## EROSION EXPOSURE ASSESSMENT—UNALAKLEET

This is a summary of results from an erosion forecast near infrastructure at Unalakleet, Alaska. We conduct a shoreline change analysis, forecast 60 years of erosion, and estimate the replacement cost of infrastructure in the forecast area. Buzard and others (2021) describe the method and guidance for interpreting tables and maps.

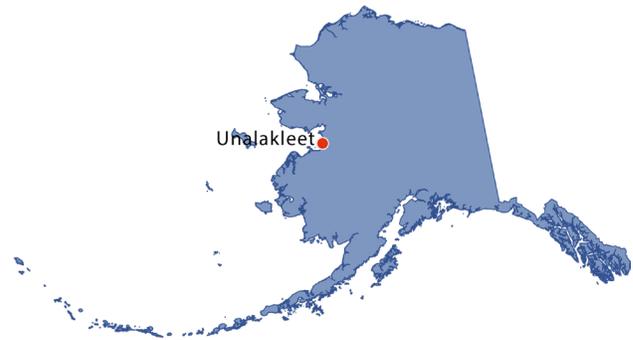
Unalakleet is built on a sand and gravel spit at the head of Norton Sound where the Unalakleet River exits into the sound. Storm surge and riverine processes cause erosion at Unalakleet (U.S. Army Corps of Engineers [USACE], 2009). The highest rates of erosion were at the tip of the spit until a wall of gabions (wire baskets filled with rocks) were built in 2000 (USACE, 2009; Overbeck and others, 2020). The gabions were damaged in a storm in 2003 (USACE, 2009). In 2010, a rock revetment was constructed to reinforce the gabions and by 2017

a sheet pile revetment was extended to protect the entire end of the spit up to the fish processing facility (USACE, 2017). Other segments of the coast have also been reinforced, including placement of rip rap along airport facilities and a rock revetment in front of the school (City of Unalakleet, 2008; Overbeck and others, 2016).
