All Hands-On Deck Data Collection Response to 2022 Bering Sea Storm from Typhoon Merbok

November 15, 2022 GIS Day Celebration

Ex-Typhoon Merbok Post- Storm Data Response

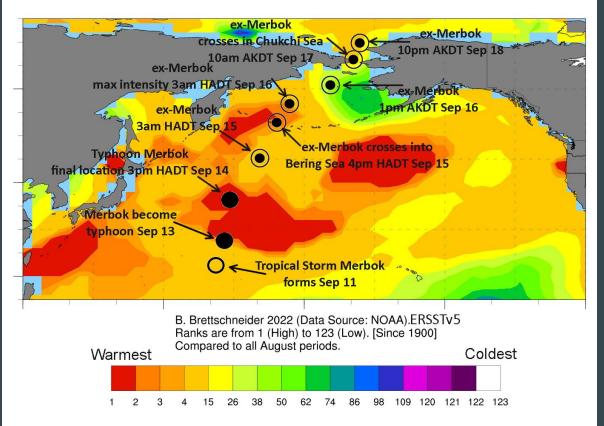
Track of Merbok, September 11-18, 2022 August 2022 Sea Surface Temperature Ranks Relative to 1900-2021

- Sept. 15 formation
- Warmest temperature on record in region of formation
- Sept 17 landfall in western Alaska

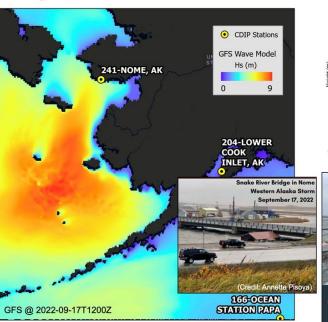
CDIP Wave Observations: **Alaska Storm / Bering Sea**September 16-19, 2022

- Remnants of Typhoon Merbok generated powerful waves and storm surge in the Bering Sea, causing historic severe widespread coastal flooding.
- Waves at CDIP 241 Nome reached a maximum Hs of 5.63 m, with a maximum individual wave of 9.69 m, while the tide exceeded 3 m MLLW, its highest level since 1974.
- Station was established in 2018 and is operated in cooperation with AOOS and the Port of Nome.

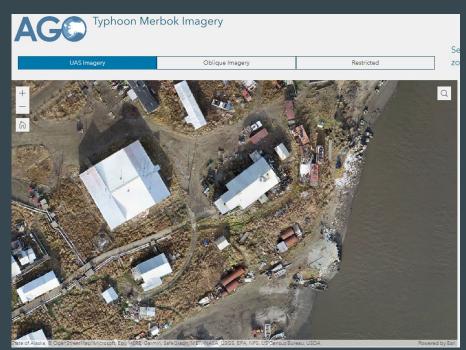
UAS survey UAF, Chevak, AK served up on SOA geoportal.

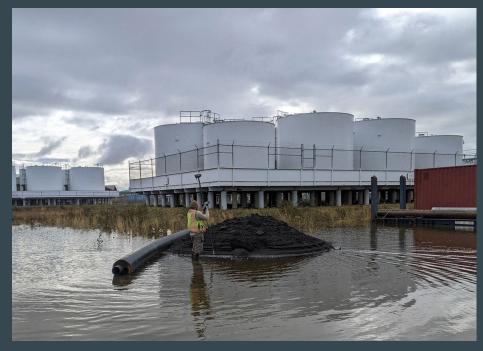
High water mark surveying, DOOS/USOS, Stebbins, AK

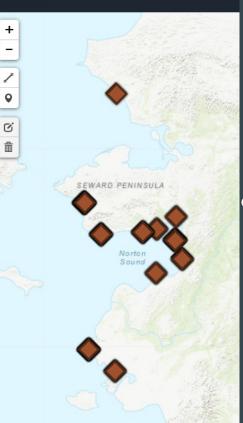
Flood Event Viewer

EVENT: 2022 September AK Extratropical Cyclone

16 Sep 2022 thru 23 Sep 2022

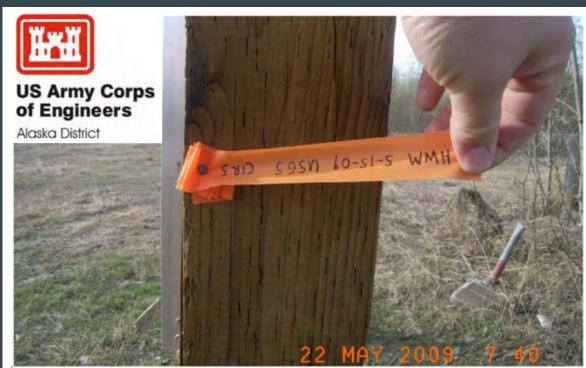
Figure 1: Durable high water mark in Circle placed by USGS on 5/15/09, surveyed by USACE on 5/22/09. Note that the silt line has disappeared at the time of the USACE survey. Without the nail and flagging, this point would not have been surveyed.
