2022 Alaska Coastal & Ocean Mapping Summit

2022 Bering Sea Storm Recap Panel

Ex-Typhoon Merbok Introduction and Collaborative Data Response

2022 Bering Sea Storm

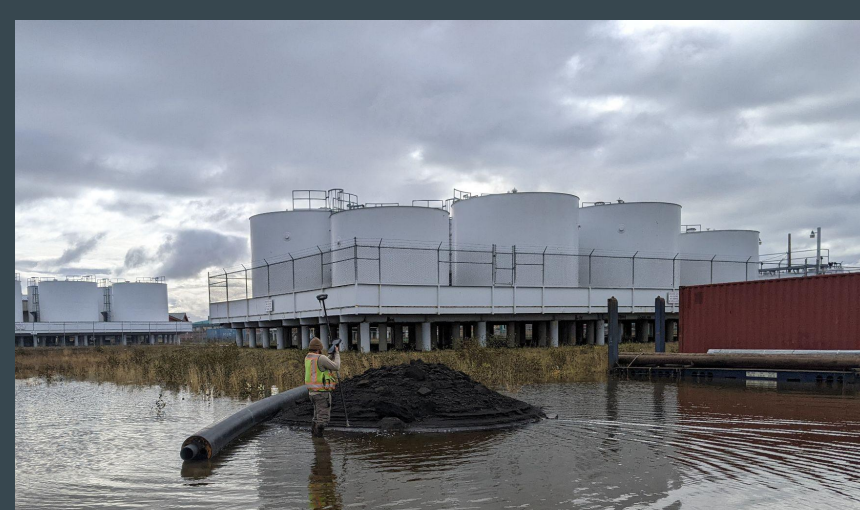
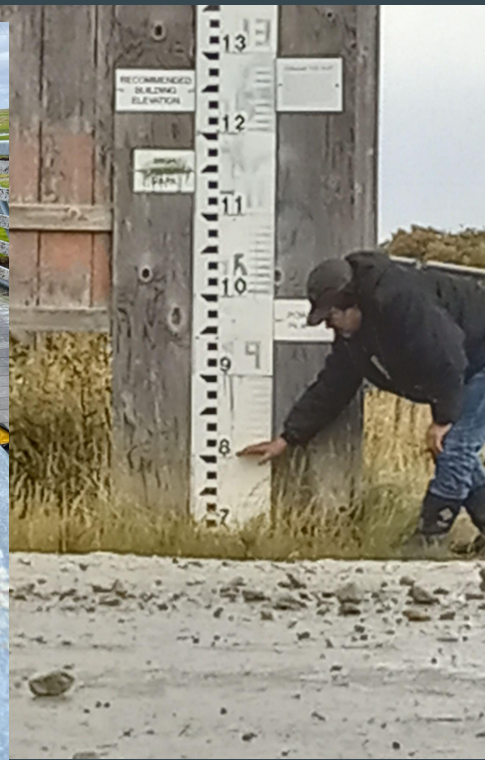
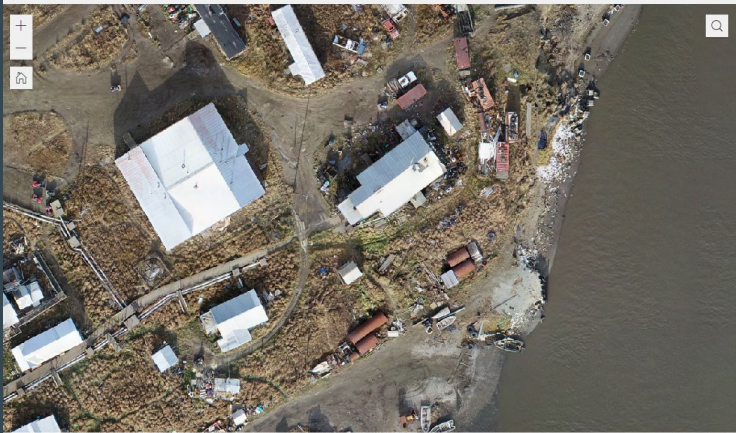
High water mark surveying, DGGs/USGS, Stebbins, AK.

Above: **Water level sensor** installation, DGGs, Kwigillingok, AK.

Flood staff photo, Alakanuk Tribe IGAP, Alakanuk, AK.

Left: **UAS survey** UAF, Chevak, AK.

High water marks are critical datasets for document the height that water reached in and around communities to understand and map flood extent. More information at: <https://pubs.er.usgs.gov/publication/tm3A24>

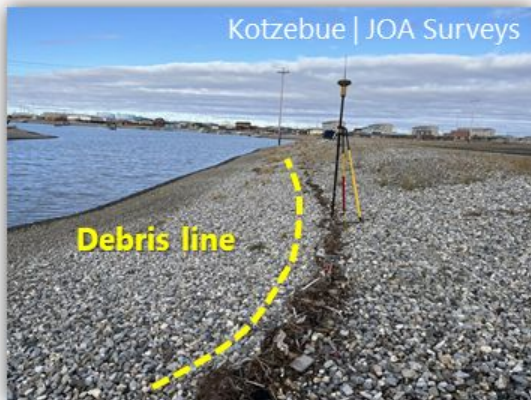
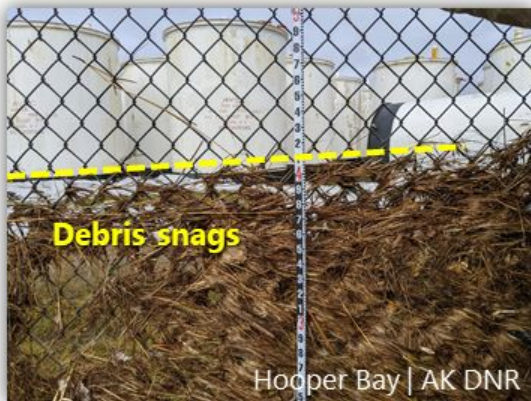
HWMs = evidence marking
highest elevation of floodwaters

Many common types of HWMs

- **debris lines** most common in Bering Sea Storm

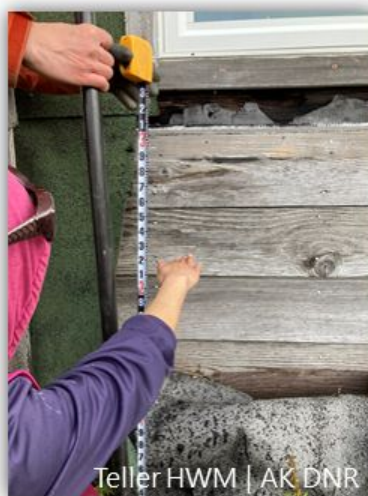
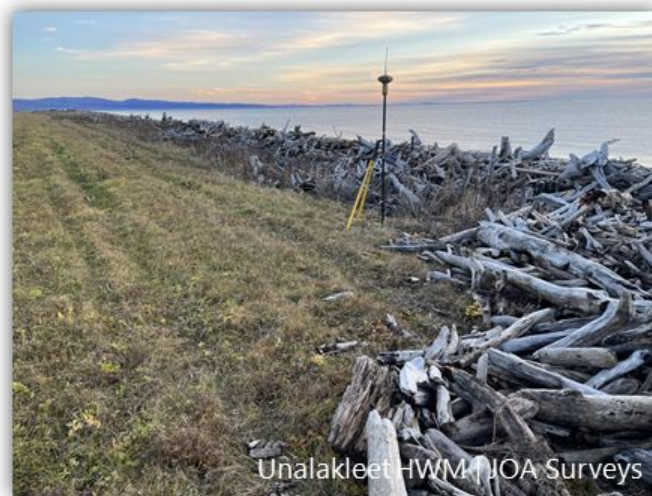
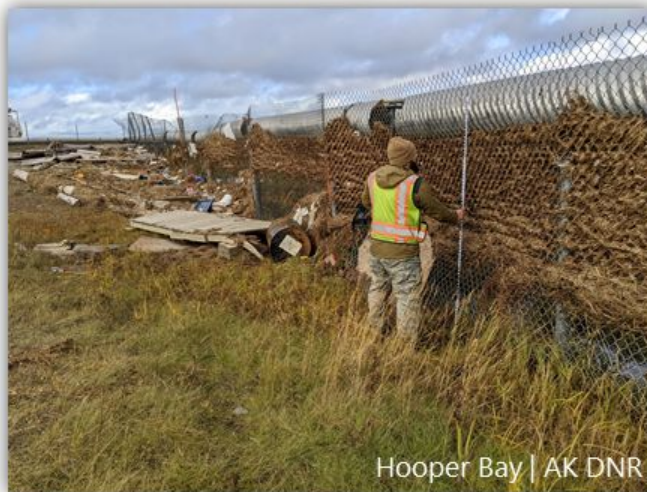
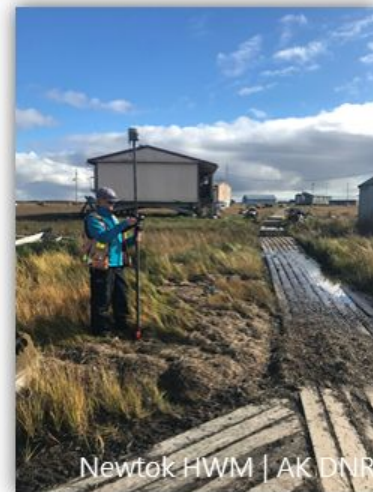
Crews occasionally met with local/state officials: mayors, public works, etc.

Crews were often welcomed and assisted by community residents who:

- Pointed out HWMs
- Shared personal or social media photos
- Relayed flood observations
 - water levels, damage, blocked drainage pathways, etc.

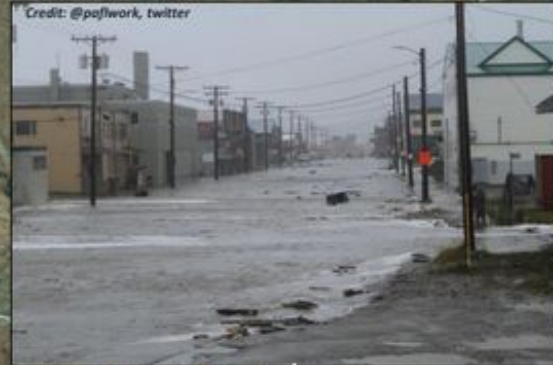
Inundation Mapping

Nome

5.0 m (16.6 ft) MHHW

16.6 ft MHHW

*estimated from photos at Front Street.
More accurate near the coast,
overestimating near airport.

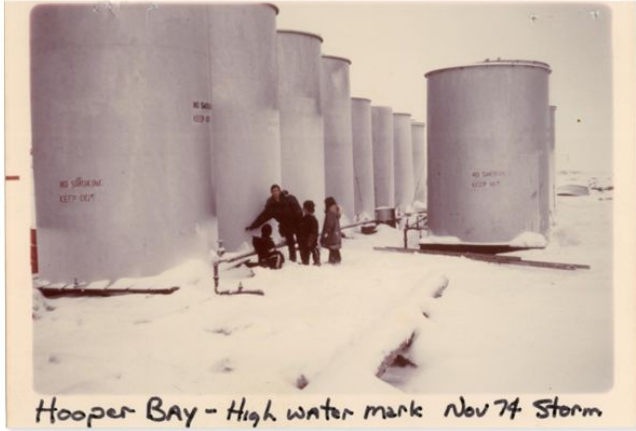
Hooper Bay residents identify the flood height of the November 1974 storm. Source: U.S. Army Corps of Engineers Flood Information Papers, photo taken by community member of Hooper Bay.

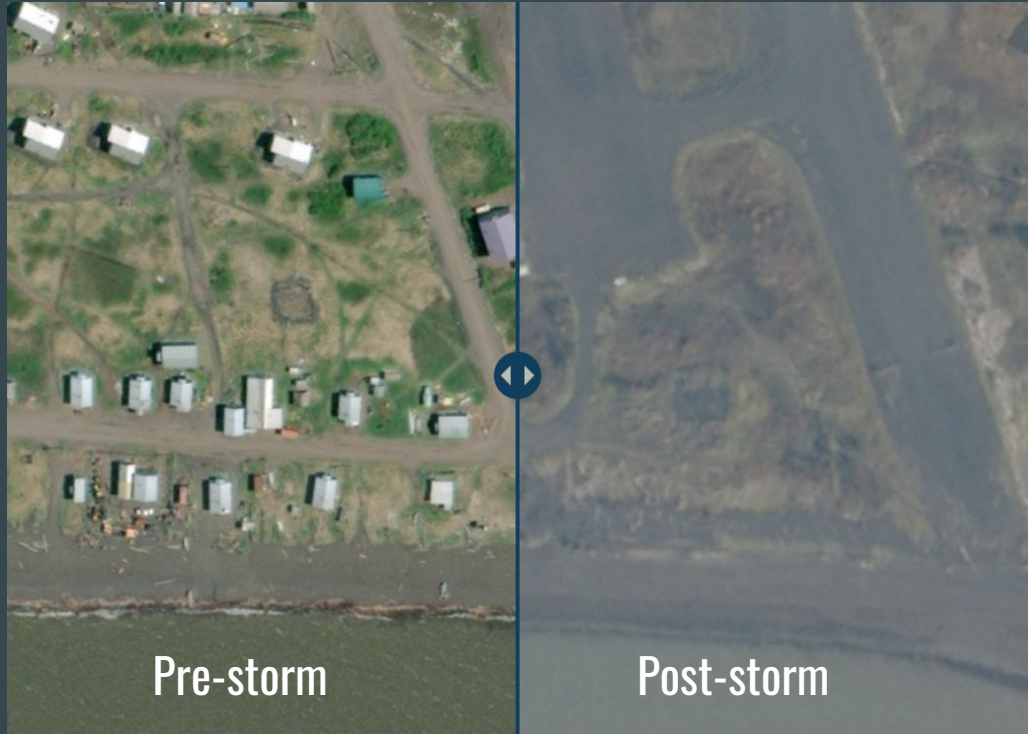
Quantifying Erosion

Stebbins

Pre-storm

Post-storm
