**GUIDEBOOK 4**

**GUIDEBOOK TO PERMAFROST AND RELATED FEATURES  
ALONG THE ELLIOTT AND DALTON HIGHWAYS,  
FOX TO PRUDHOE BAY, ALASKA**

**Fourth International Conference on Permafrost  
July 18-22, 1983  
University of Alaska  
Fairbanks, Alaska, U.S.A.**

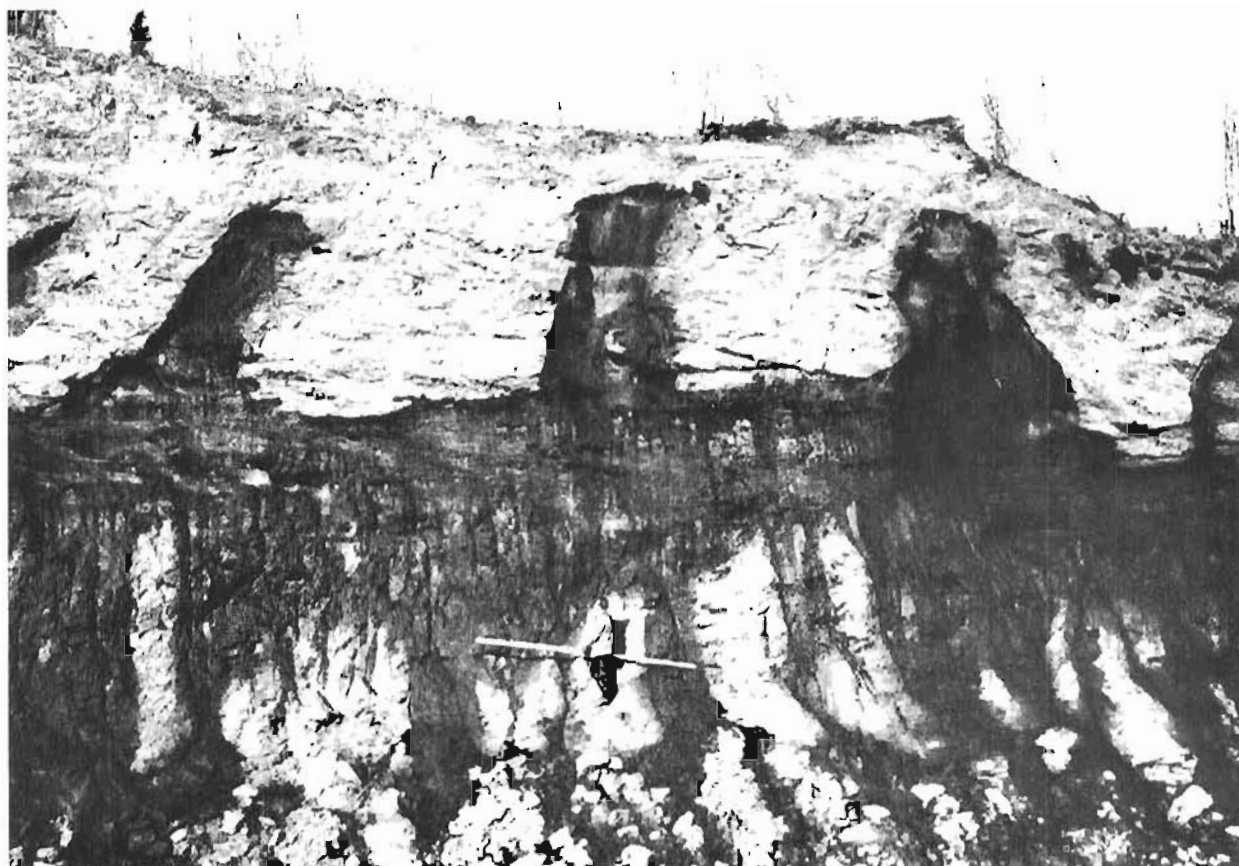
Figure 19. Highway cut made through ice wedges at Fox in October and November 1977. See Sellmann and others (1979) and Osterkamp and others (1980) for details (photograph taken by P.V. Sellmann in spring 1978).

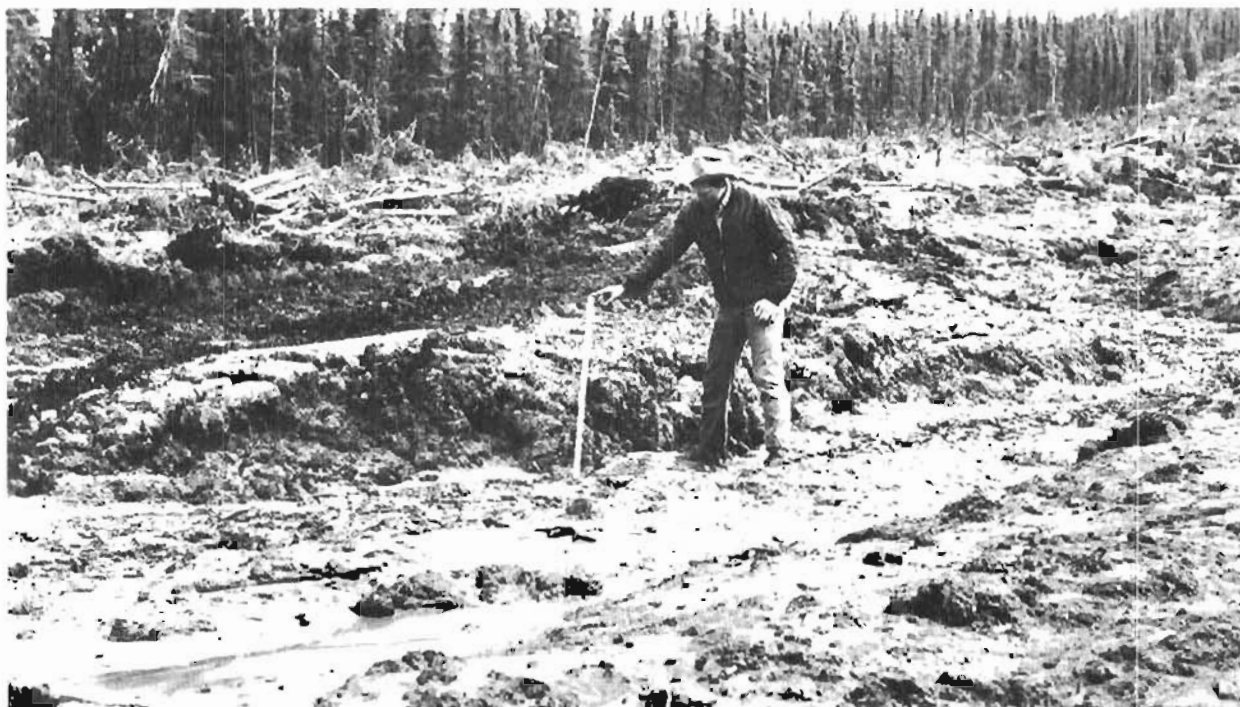
Figure 25. Fireline conditions immediately following the 1971 Wickersham fire (photograph taken by L.A. Viereck).

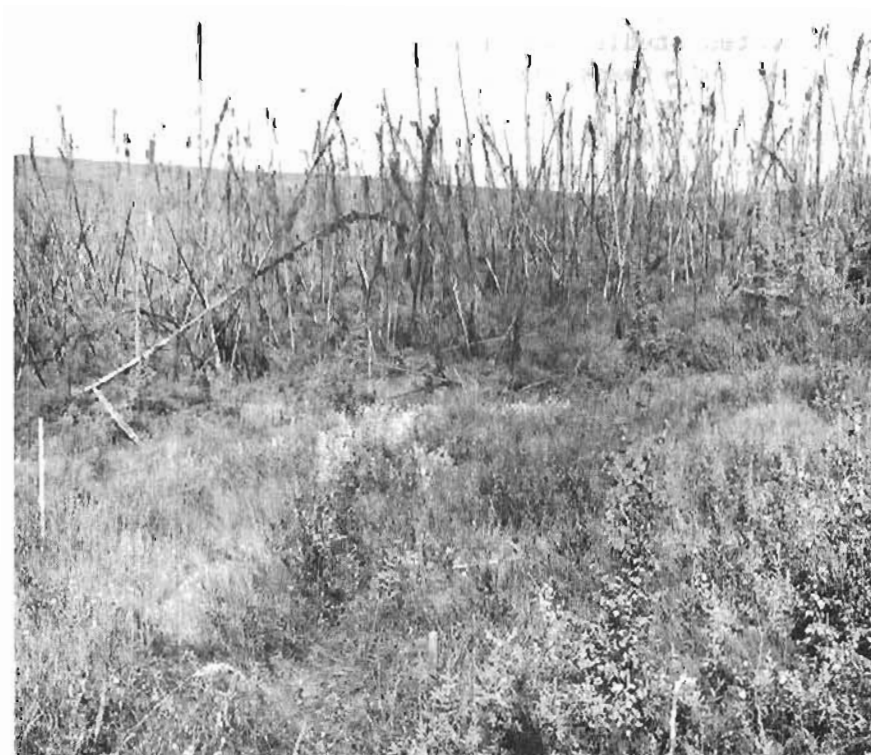
Figure 26. Condition of the fireline shown in figure 25 in 1980 (from Viereck, 1982, fig. 2).

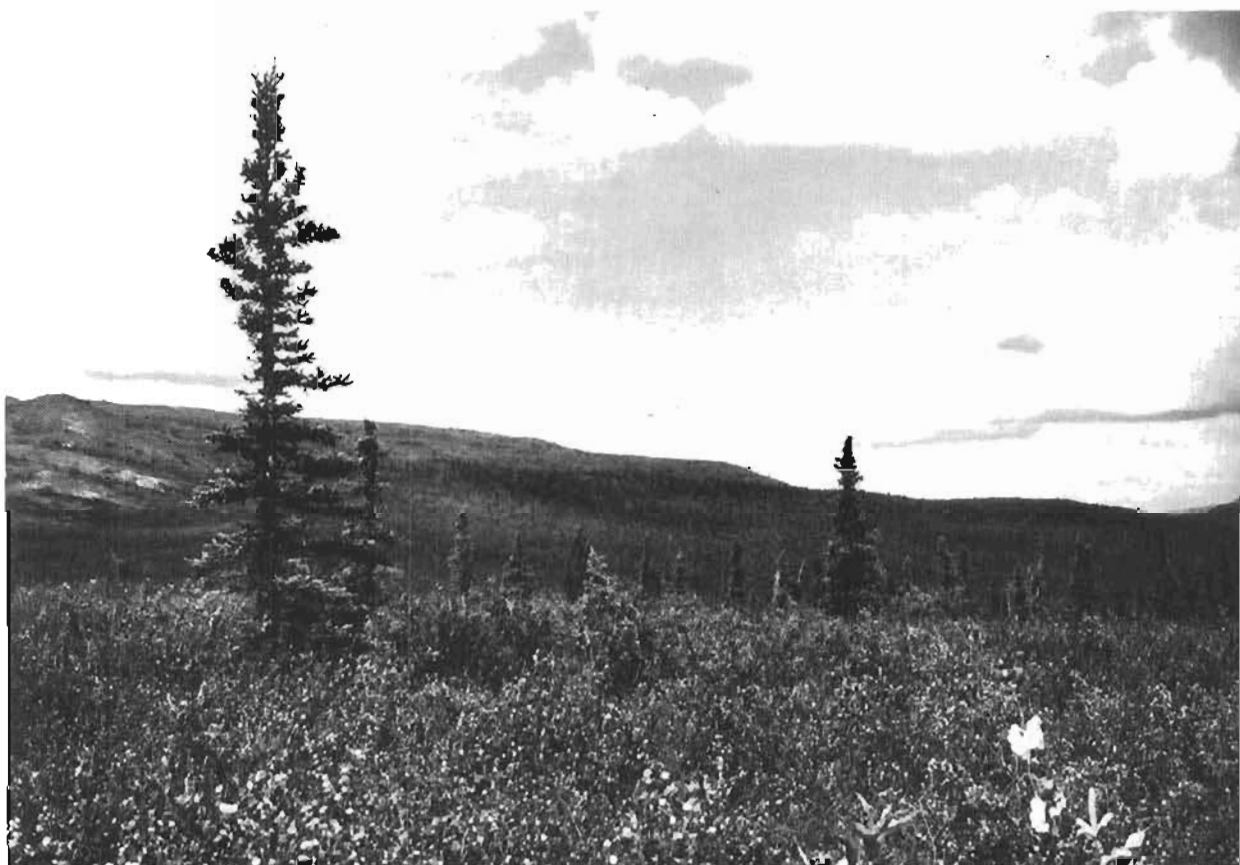
Figure 30. Upright, well-formed white spruce, all approximately 40 yr old, growing in shrub birch and willows above the older established treeline on Wickersham Dome (Viereck, 1979, fig. 4).

Open treeline stands of scattered black and white spruce can be seen to have a nearly continuous layer of shrub birch, alder, and willow. Above the highway, treeline can be observed as scattered upright trees, typical of many treeline sites in Alaska (fig. 30); wind-pruned, low, matted 'krumholz' tree forms are lacking.

Two common treeline phenomena can be observed. One is the 'candelabrum' type of spruce clump described originally from Labrador. Black spruce commonly reproduces by layering, the rooting of the lower branches in the moss mat. This results in a tree clump, all stems originating from one individual, with the oldest and tallest stem in the center surrounded by progressively smaller and younger trees. Several of these clumps can be seen in figure 30.

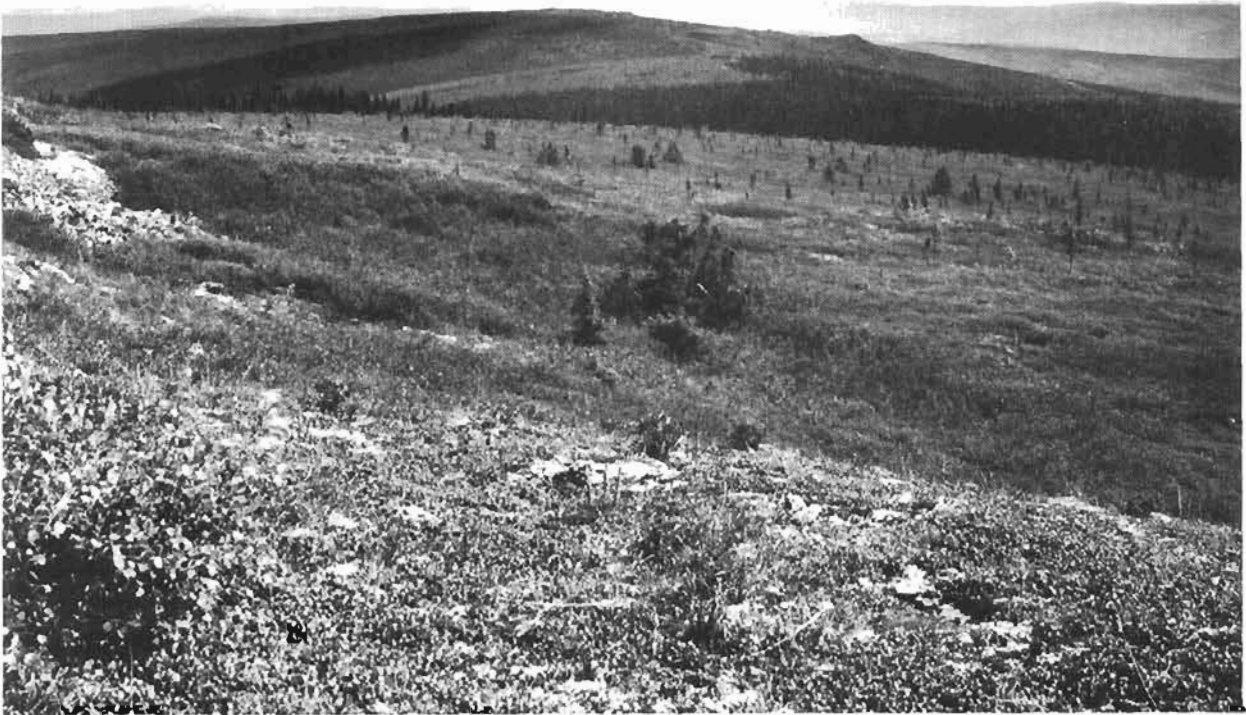
Figure 31. Scattered spruce, all approximately 40 yr old, growing in the shrub-birch zone above the old stabilized treeline on Wickersham Dome (Viereck, 1979, fig. 3).

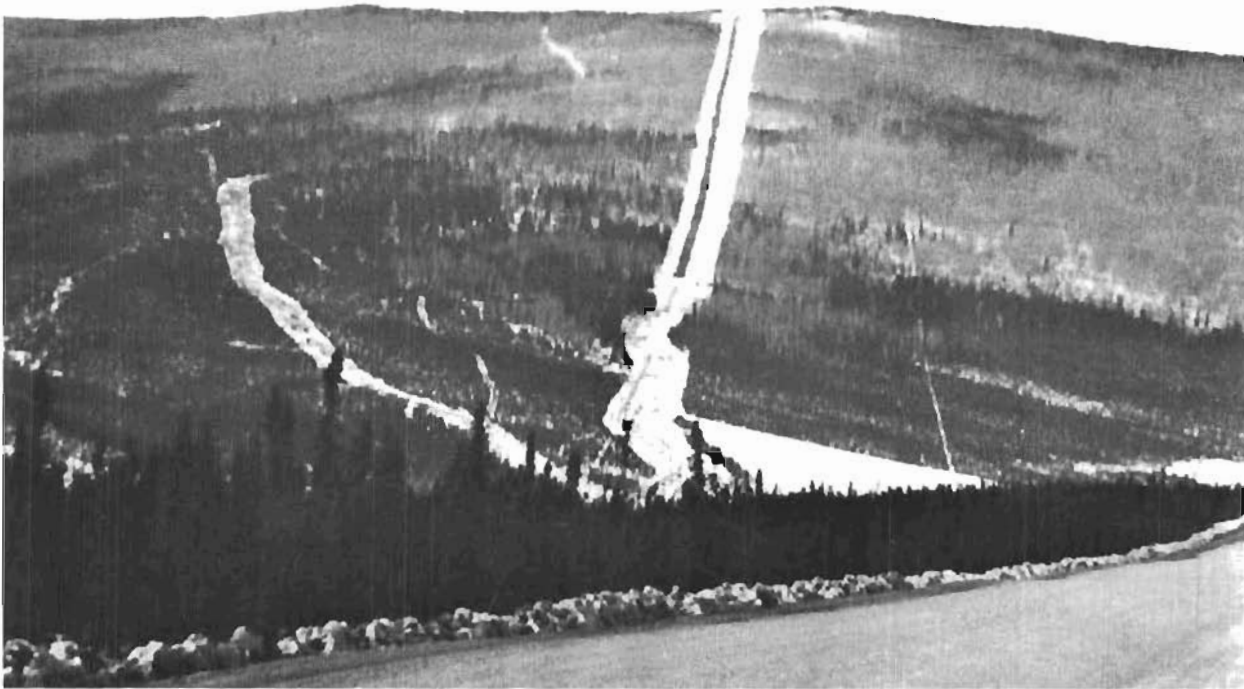
Figure 33. View of the trans-Alaska pipeline in its elevated mode in the valley bottom and buried mode on the slope and ridge top. Snow has melted over the soil warmed by the heated oil pipeline. The wide strip devoid of forest cover was cut over in the late 1960's for access trails (see Rickard and Slaughter, 1973) (photograph taken by Bruce Brockett on April 12, 1982).

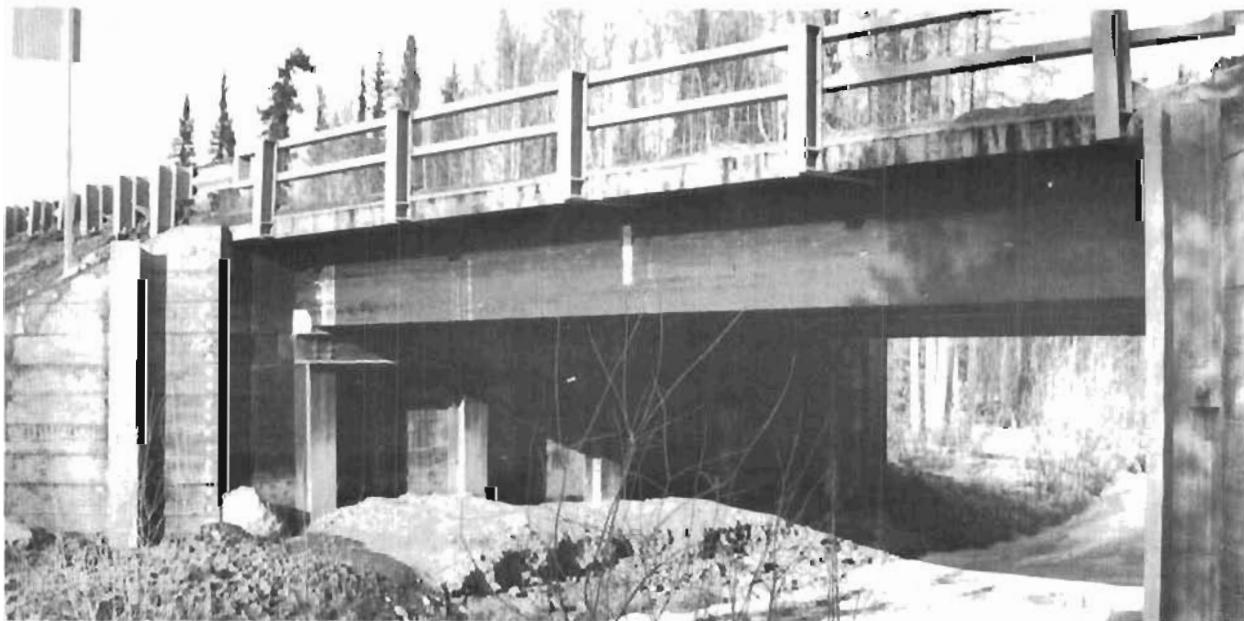
Figure 34. Single-span bridge and timbered abutment across Globe Creek designed to prevent icing over the channel (photograph taken by Bruce Brockett on April 12, 1982).

To reduce winter icing on the small streams, many crossings have timber bridges instead of metal culverts, as at Globe Creek. The vertical wood side-walls prevent ice from forming on the sides, as it does on the cold metal culverts. Water continues to flow under the ice cover. Highway construction in Alaska has proven that at stream crossings the placing of support structures in the streambed should be avoided to avert icing of streams that usually do not ice thickly over. The road is on ice-rich permafrost. To the north are two dome-shaped summits commonly referred to as the 'Grapefruit' Rocks.

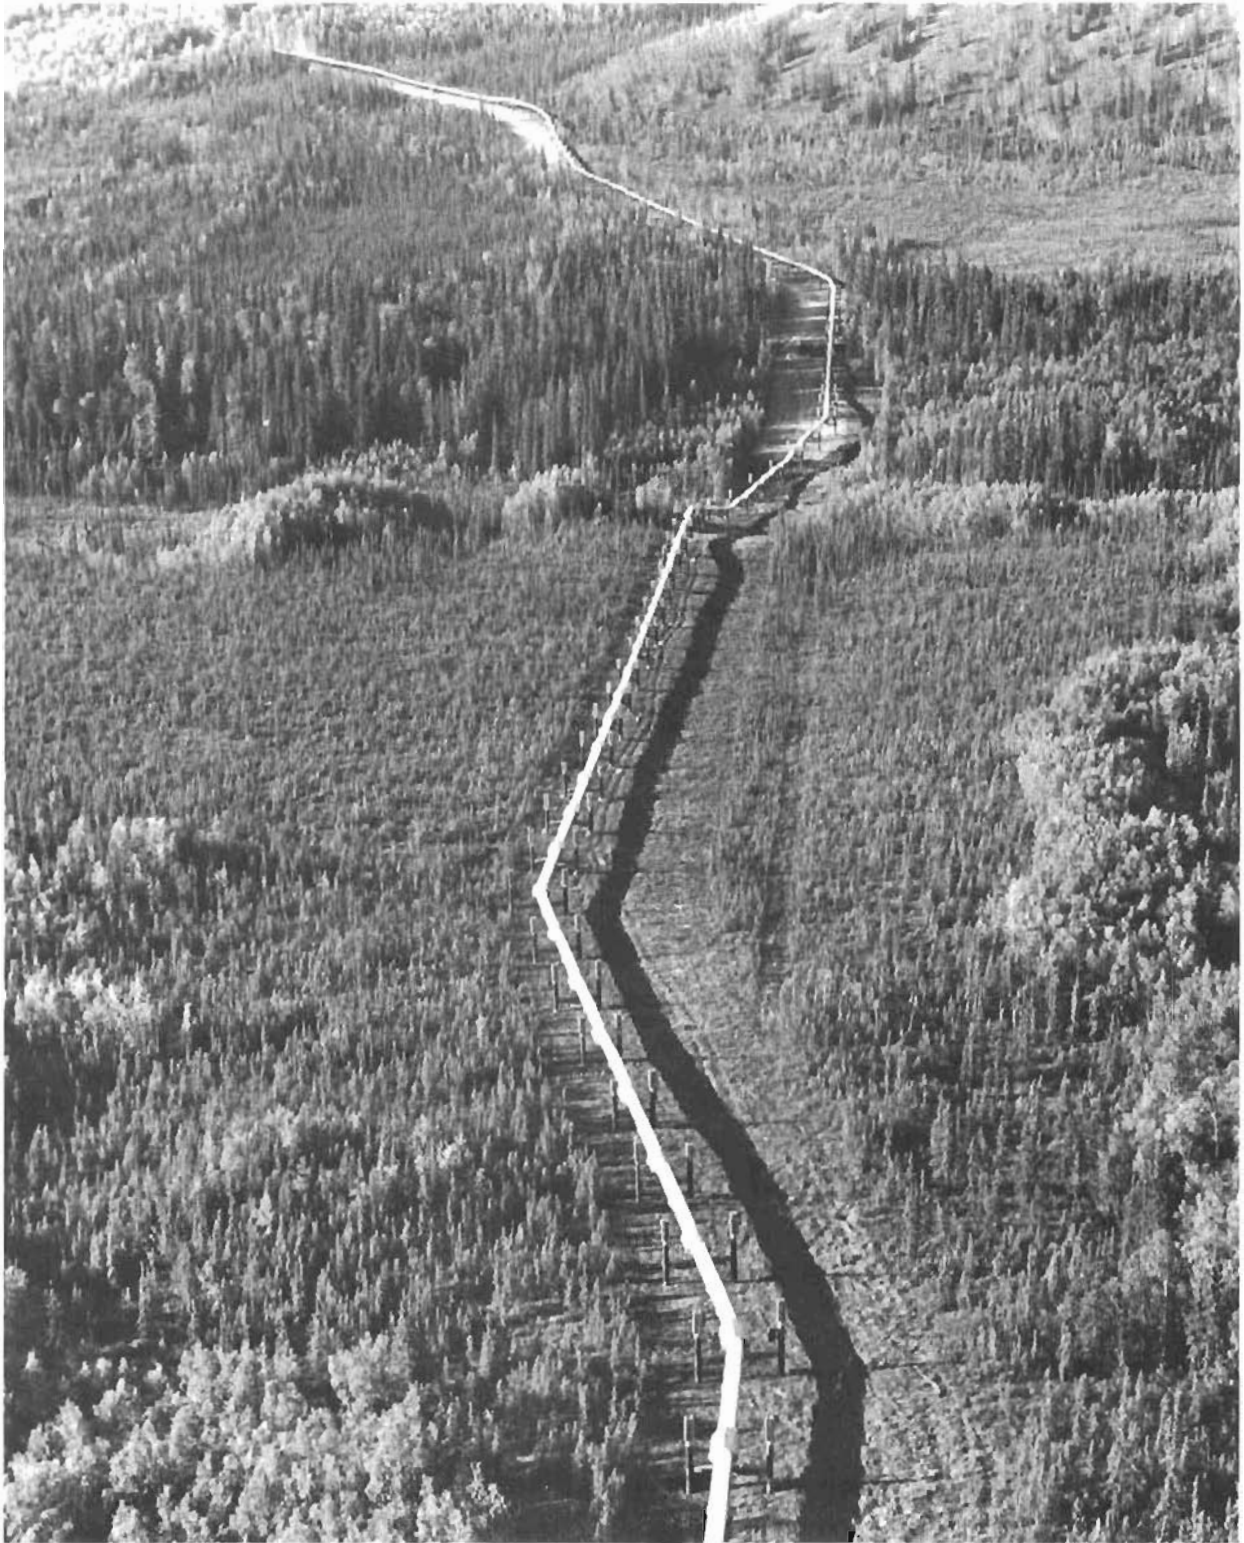
Figure 35. Looking north to Globe Creek. The elevated pipeline was constructed by use of a snow pad in order to prevent thawing of the ice-rich permafrost. The normal gravel work pad can be seen on the north side of Globe Creek. Photograph courtesy of Alyeska Pipeline Service Company.

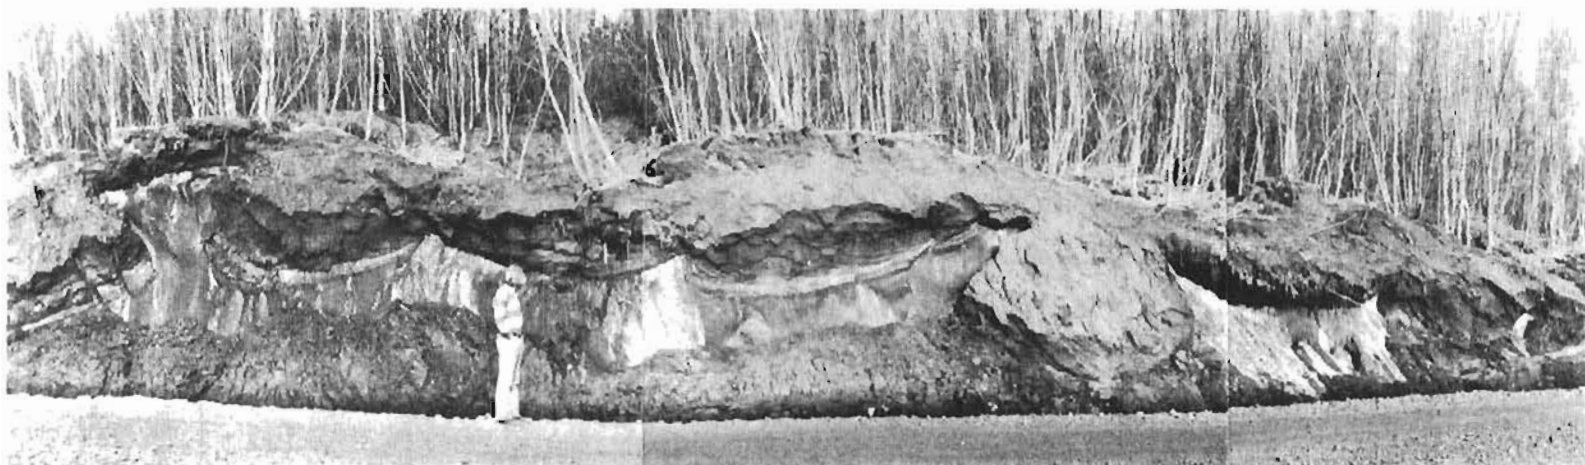
Figure 37. Roadcut exposing ice wedges in vicinity of Mile 53 of the Elliott Highway (photograph taken by R.A. Kreig).

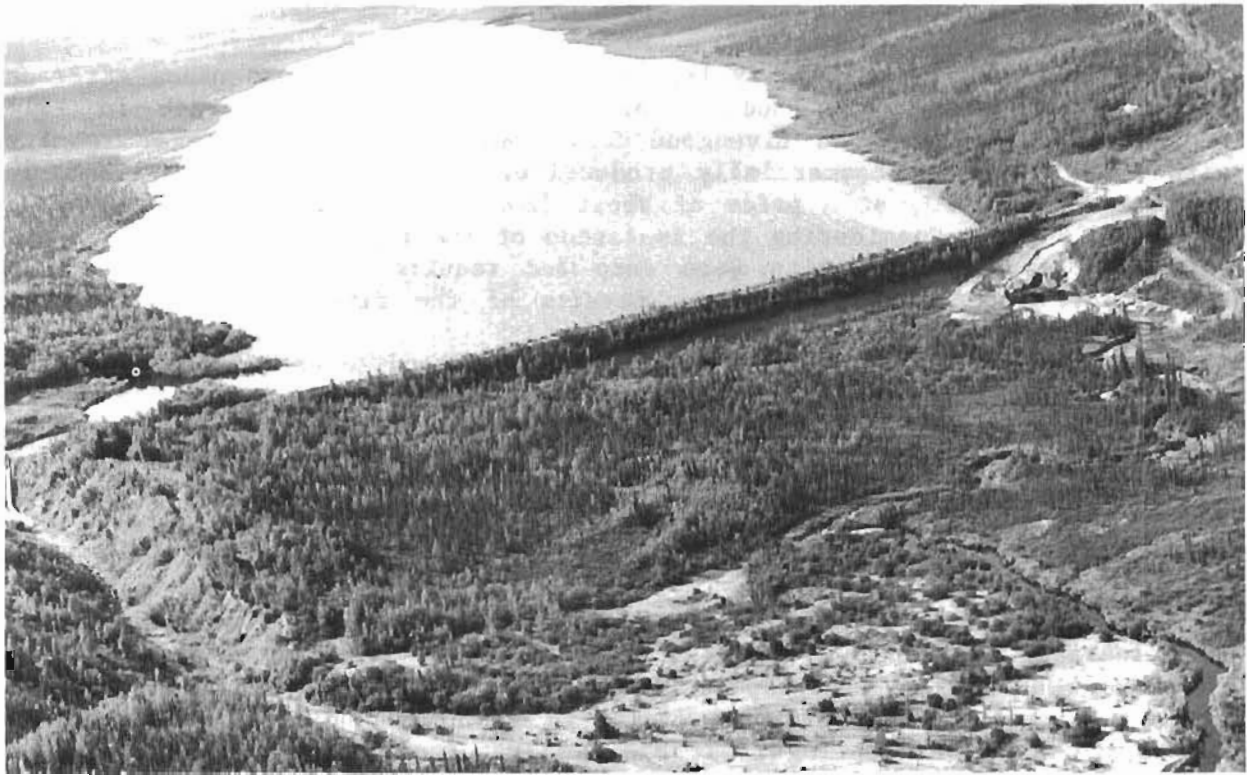
Figure 39. Aerial oblique photograph looking south to Hess Creek Dam and reservoir (photograph taken by D. Atwood on July 19, 1982).

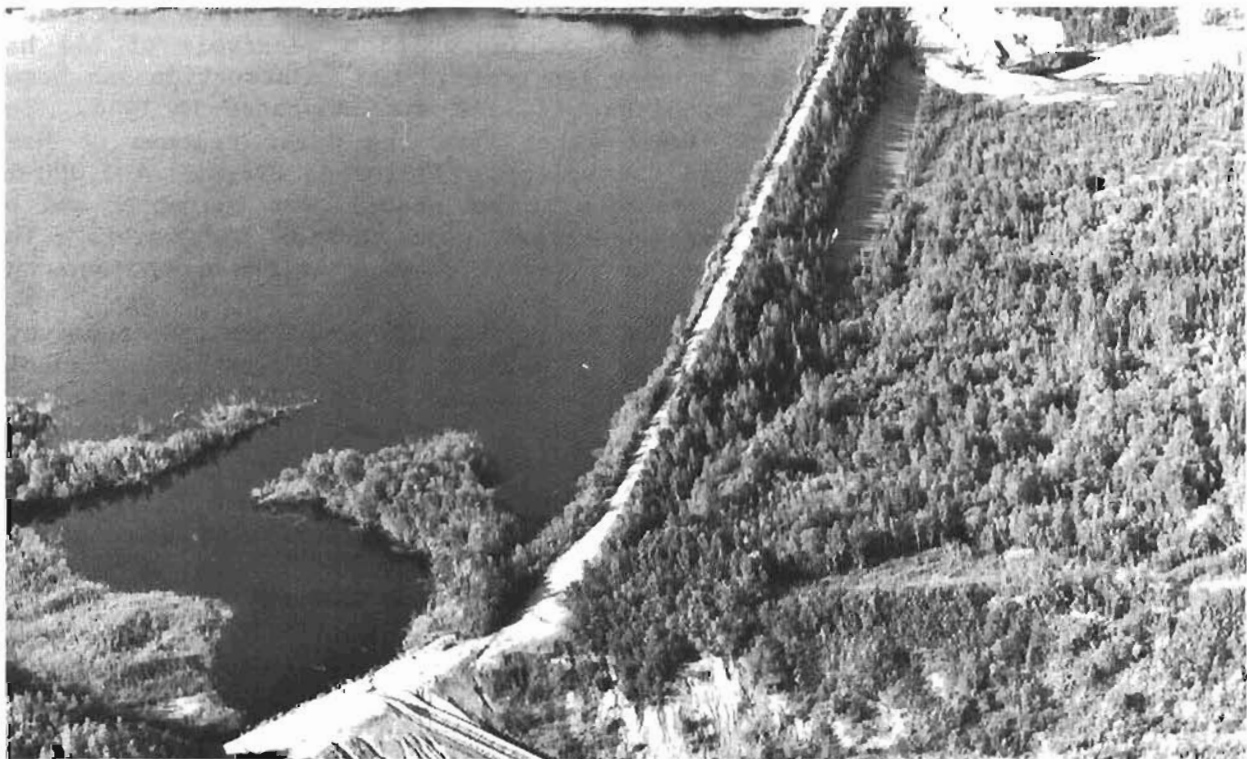
Figure 40. Closeup of the reconstructed spillway of Hess Creek Dam (photograph taken by D. Atwood on July 19, 1982).

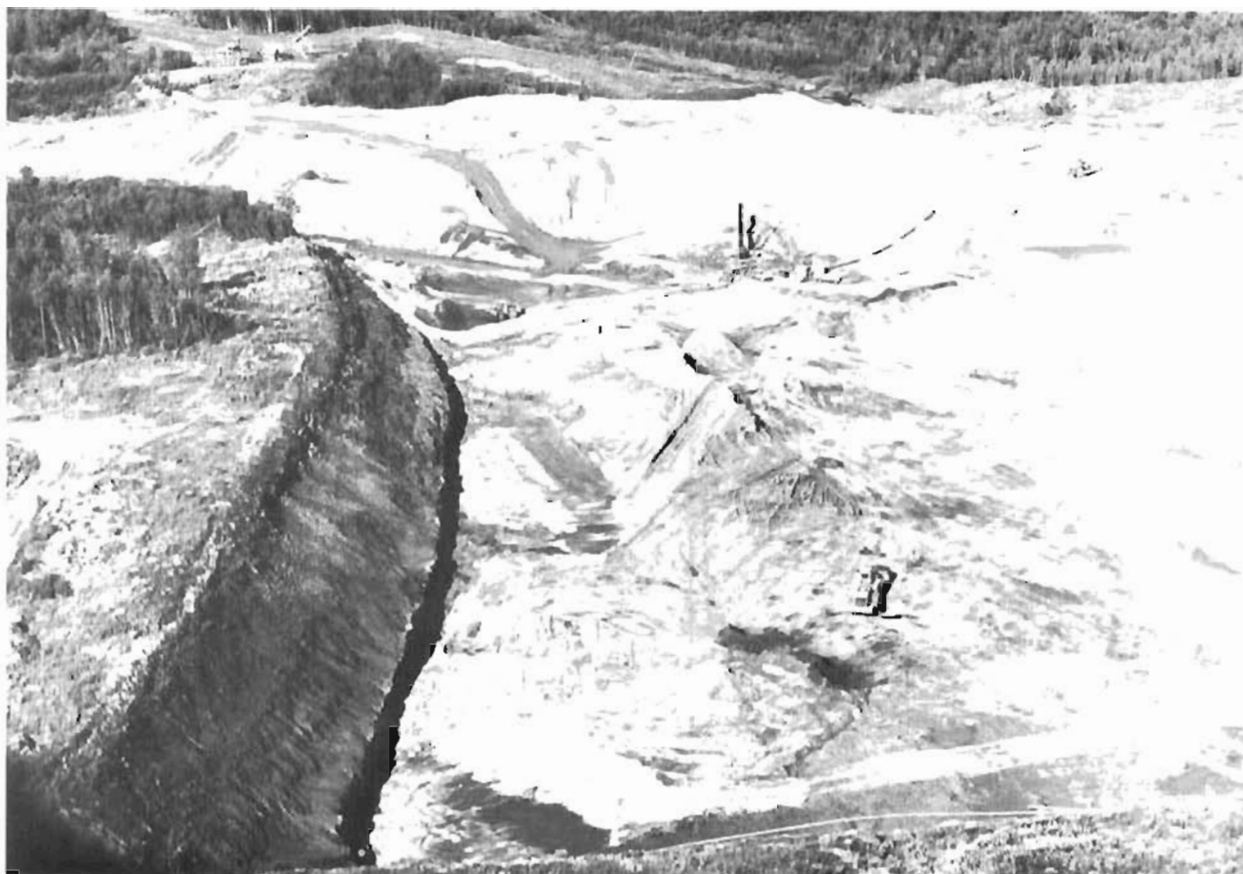
Figure 41. Aerial photograph of the recently reopened placer-mining operation at Livengood (photograph taken by D. Atwood on July 19, 1982).

some 15-20 m of frozen overburden is being removed with rippers and bulldozers. The old technique of hydraulicking the overburden is no longer used to avoid excessive siltation in streams and rivers. The underlying 8 to 10 m of gravel is stockpiled and then processed in a washing plant. The runoff from this washing operation is discharged into a large settling pond, where suspended solids are removed.

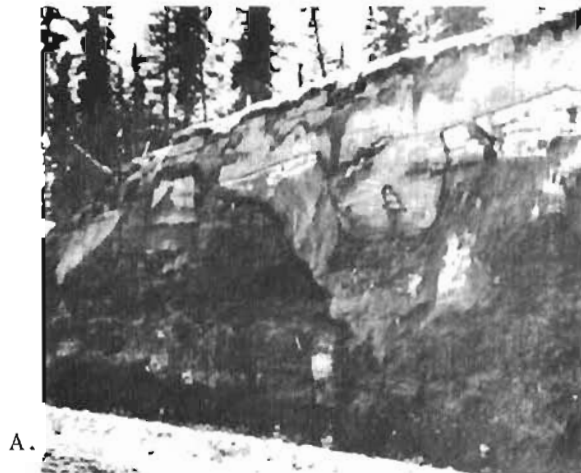
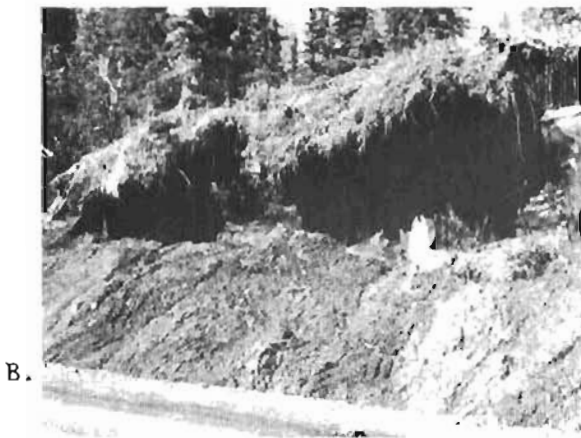
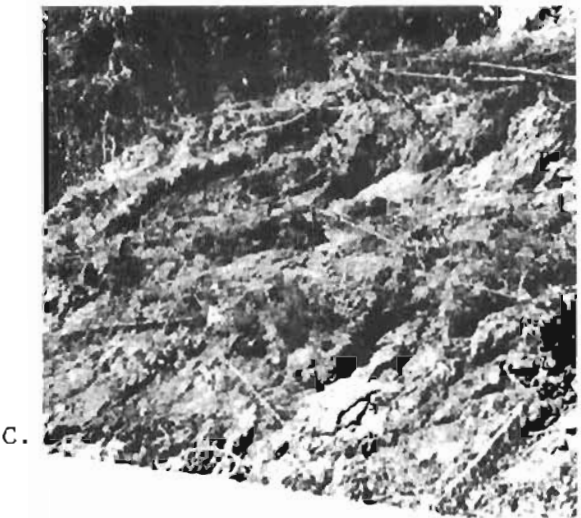
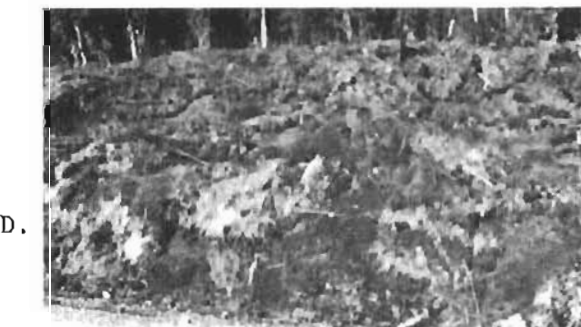
Figure 44. Example of self-stabilization of roadcut containing ice wedges. A. Vertical exposure showing ice wedge soon after excavation, March 1970. B. Overhanging organic mat and accumulation of sediment at base of slope, June 1970. C. Stabilizing slope, June 1971. D. Partially vegetated slope, June 1973 (photographs taken by R&M Consultants, Inc.). Sections E, F, and G are schematic cross sections illustrating the self-stabilization process seen in the photographs (modified from Berg and Smith, 1976, fig. 74).

The road was excavated through a series of massive ice wedges (fig. 44) (Smith and Berg, 1973; Berg and Smith, 1976; Pufahl and others, 1974; McPhail and others, 1975, 1976). Recession and recovery of this slope were typical of those of most ice-rich slopes along the road (fig. 44). Generally the cuts were nearly vertical, that is, with slopes of 1:4, to minimize the surface area exposed to the new thermal environment. Siltation along the west side of the road is evidence of continuing sediment transport from the receding cut banks. Subsidence under the road still presents maintenance problems.

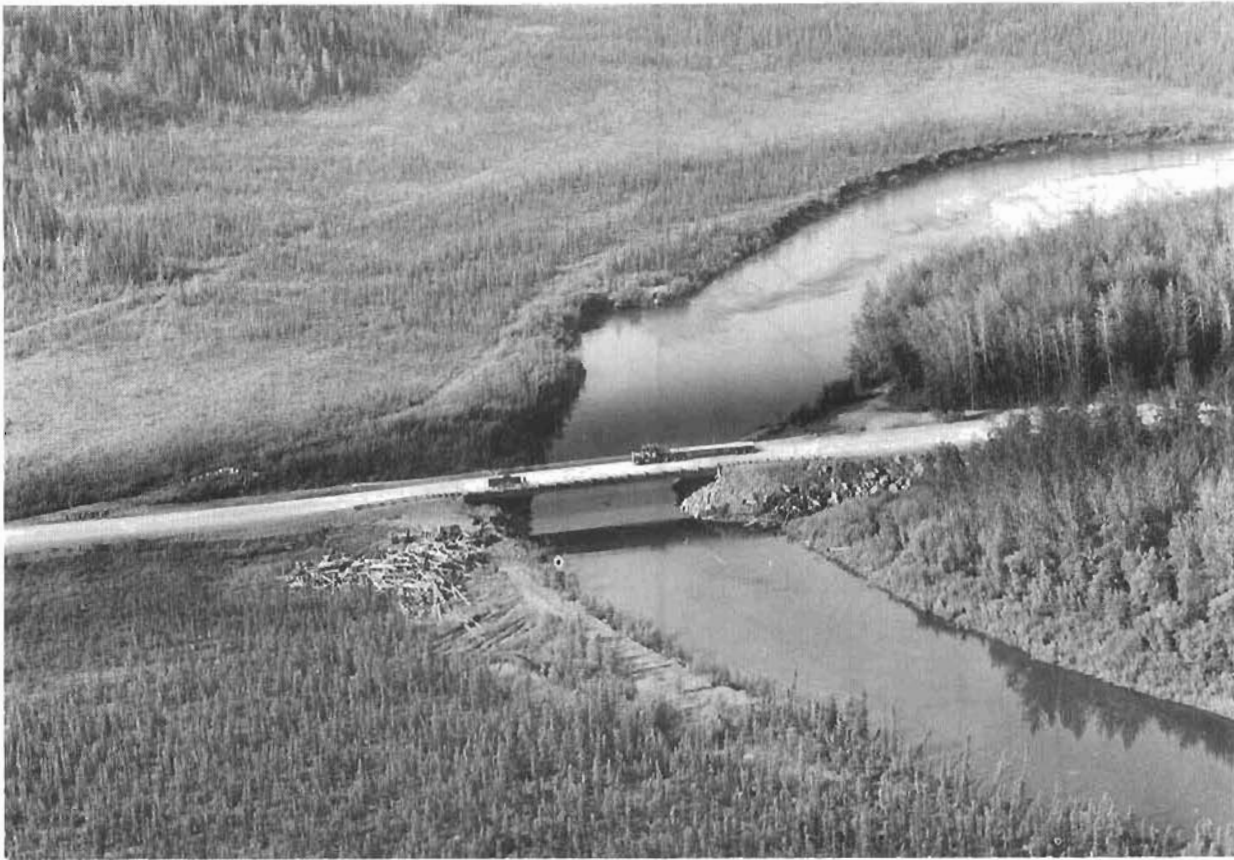
Figure 45. Aerial photograph of Hess Creek showing point bars, terraces, vegetation, and new bridge (photograph taken by D. Atwood on July 19, 1982).

Hess Creek bridge (fig. 45) was reconstructed in late 1981 to prevent floating trees and debris from hanging up on the bridge piles. The new bridge has 36-m-long bulb-T-prestressed concrete girders. Hess Creek is the largest stream between the Elliott Highway and the Yukon River. As the river actively meanders, it cuts laterally into ice-rich permafrost. A recent cutoff 5 km downstream is less than 20 yr old. Old oxbows gradually fill with overbank flood deposits and organic material and eventually blend with the surrounding abandoned flood-plain surfaces. Sediments beneath the flood plain of Hess Creek consist of 1.2 to 4.5 m of organic silt and silty sand, which represents overbank deposits. These deposits are underlain by riverbed deposits of sand, with some gravel and sandy gravel extending to bedrock as deep as 23 m (Kreig and Reger, 1982, pl. 13).

The flood plain of Hess Creek illustrates the time required for permafrost to develop in exposed stream sediments (figs. 45 and 46; Viereck, 1970; Kreig and Reger, 1982, fig. 9). Permafrost is generally absent under the stream and on newly deposited point bars down to as much as 23 m. Test holes in this area, which were generally 15 m deep, failed to reach the base of permafrost. Deeper holes in flood-plain alluvium in the Fairbanks area and elsewhere demonstrate that permafrost generally thickens with increasing age of the alluvial surface (Williams, 1970). The fresh silt and gravel surfaces on the insides of the meander curves are first colonized by willows and alders, but are overtopped by balsam poplar in about 15 to 25 yr. Permafrost is usually absent during these early successional stages. Shade-tolerant seedlings of white spruce become established under the balsam poplar, and within 75 to 100 yr overtop the balsam poplar, which by that time have become overaged and decadent. As the white spruce stand matures and the balsam poplars die out, a mat of feathermosses develops a thick insulating organic layer on the forest floor, especially when the frequency of flooding is reduced. The insulating effect of the thick forest layer reduces the mean annual ground temperature and favors development of permafrost after 200 to 300 yr. As the active layer becomes shallow, white spruce is gradually replaced by black spruce. Eventually, permafrost incorporates all mineral soil, restricting annual thaw and plant roots to surface organic layers. Bog vegetation of scattered black spruce, Sphagnum moss, and low shrubs (Labrador tea, resin birch, blueberry and diamond-leaf willow, and scattered thaw ponds with aquatic vegetation are present in the final stage of succession on the abandoned flood-plain terraces. This process of 'swamping' is common and has been reported elsewhere (Benninghoff, 1952; Williams, 1962). The south-facing dry bluff along Hess Creek is covered by grassland vegetation.

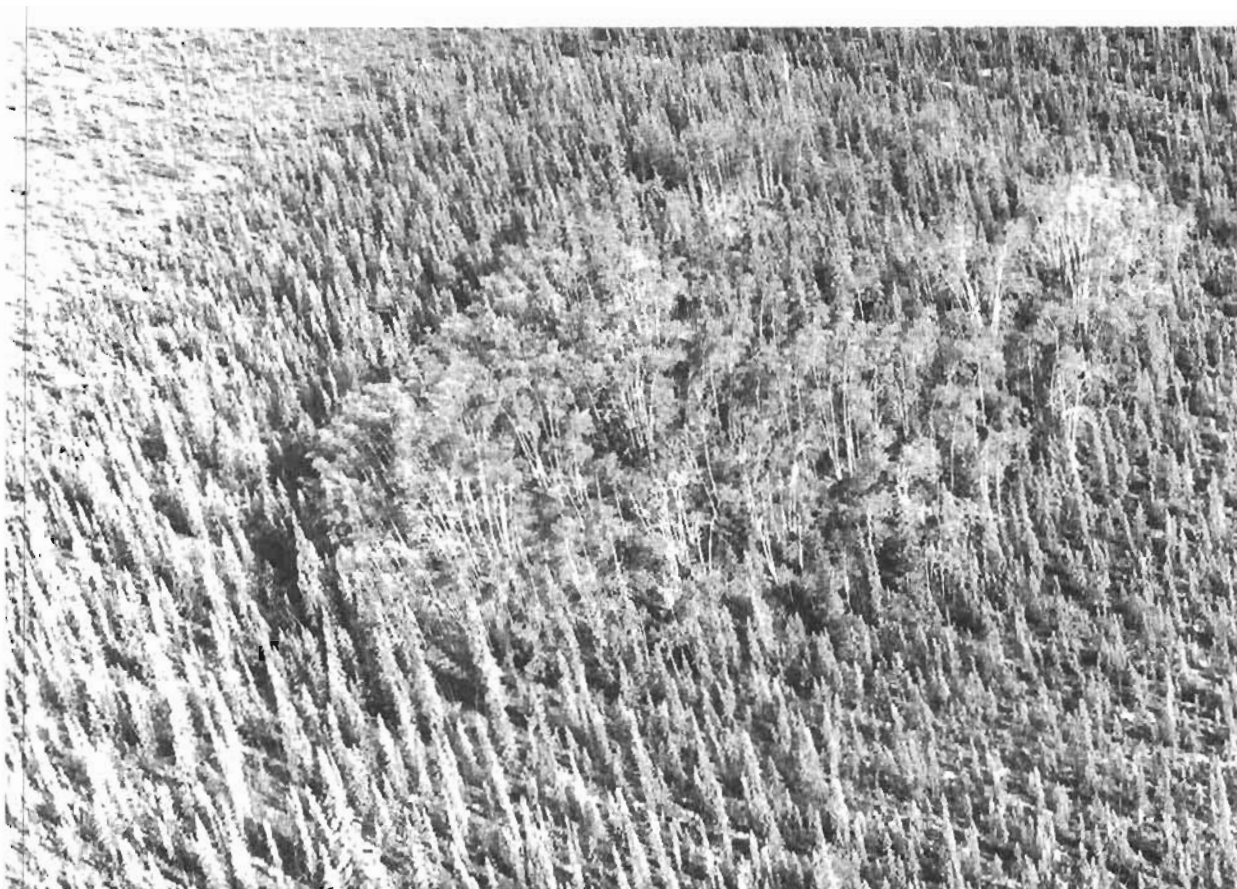
Figure 48. Aerial photograph of probable open-system pingo west of Mile 32.8 on Dalton Highway (photograph taken by D. Atwood on July 19, 1982).

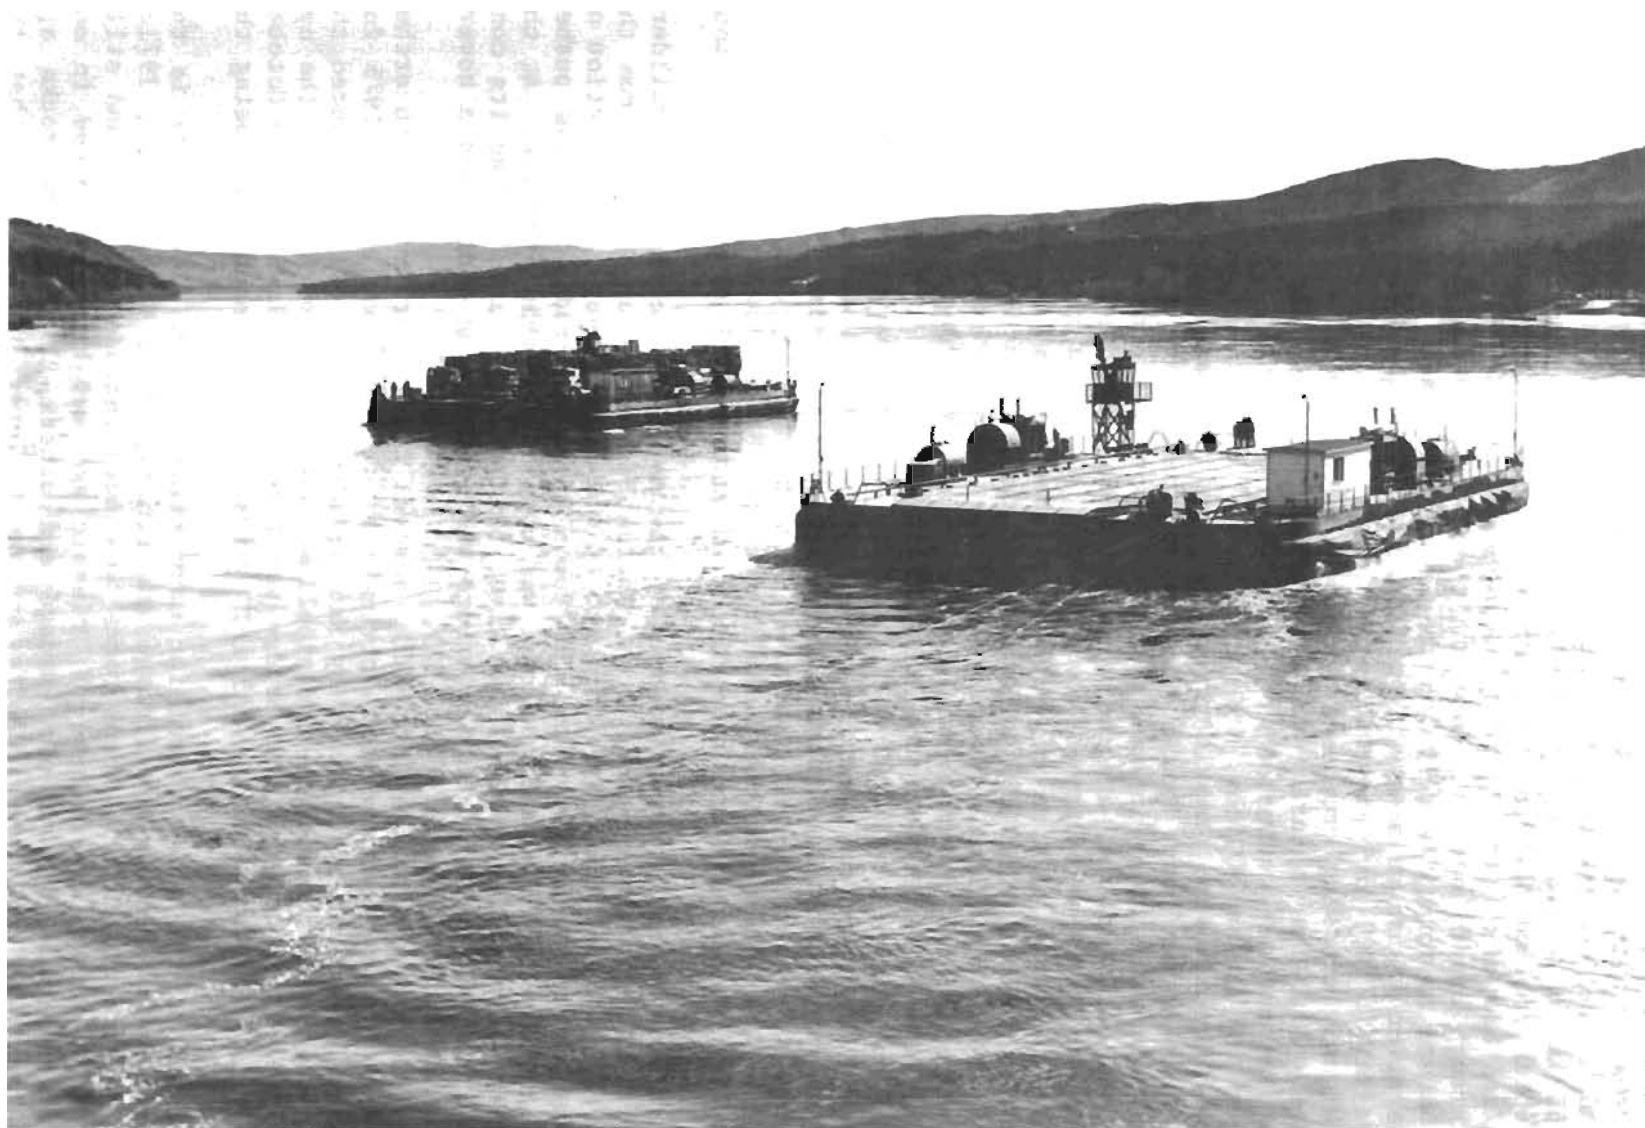
Figure 52. Before construction of the Yukon River bridge, two air-cushion transporters ferried supply trucks for the trans-Alaska pipeline across the river. The vehicles, termed 'hovercraft,' were supported on a cushion of air and were pulled across by cables (photograph courtesy of Alyeska Pipeline Service Company).

The Yukon River crossing was one of the major obstacles facing builders of the pipeline. Construction of the Dalton Highway began in 1969 from the Elliott Highway near Livengood northward to the Yukon River. Construction of the remainder of the highway from the Yukon River to Prudhoe Bay was pushed forward rapidly in 1974, and the road was completed within 5 months. At the same time, construction of the Yukon River bridge was begun. During its construction in 1974 and 1975 an ice bridge was used during winter and a hovercraft was used during summer (fig. 52).

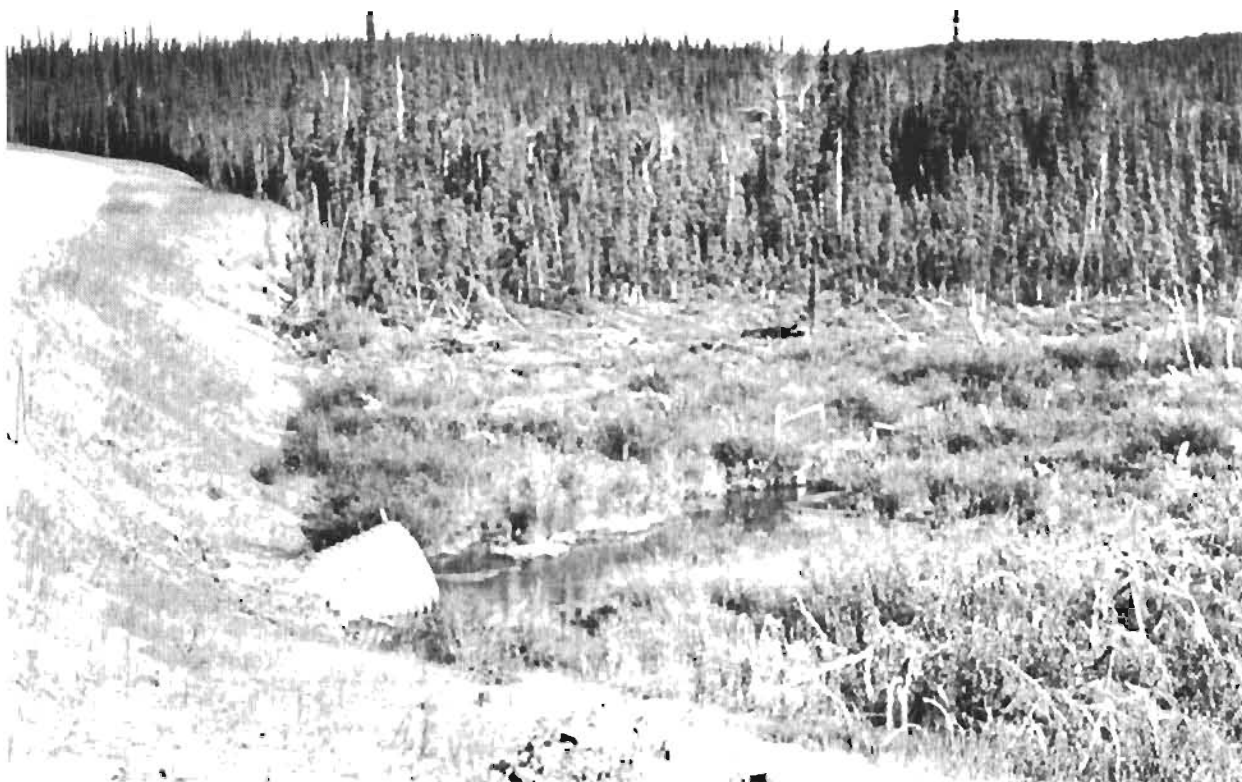
Figure 57. Dead trees resulting from winter icings (photograph taken by D. Cate on July 20, 1982).

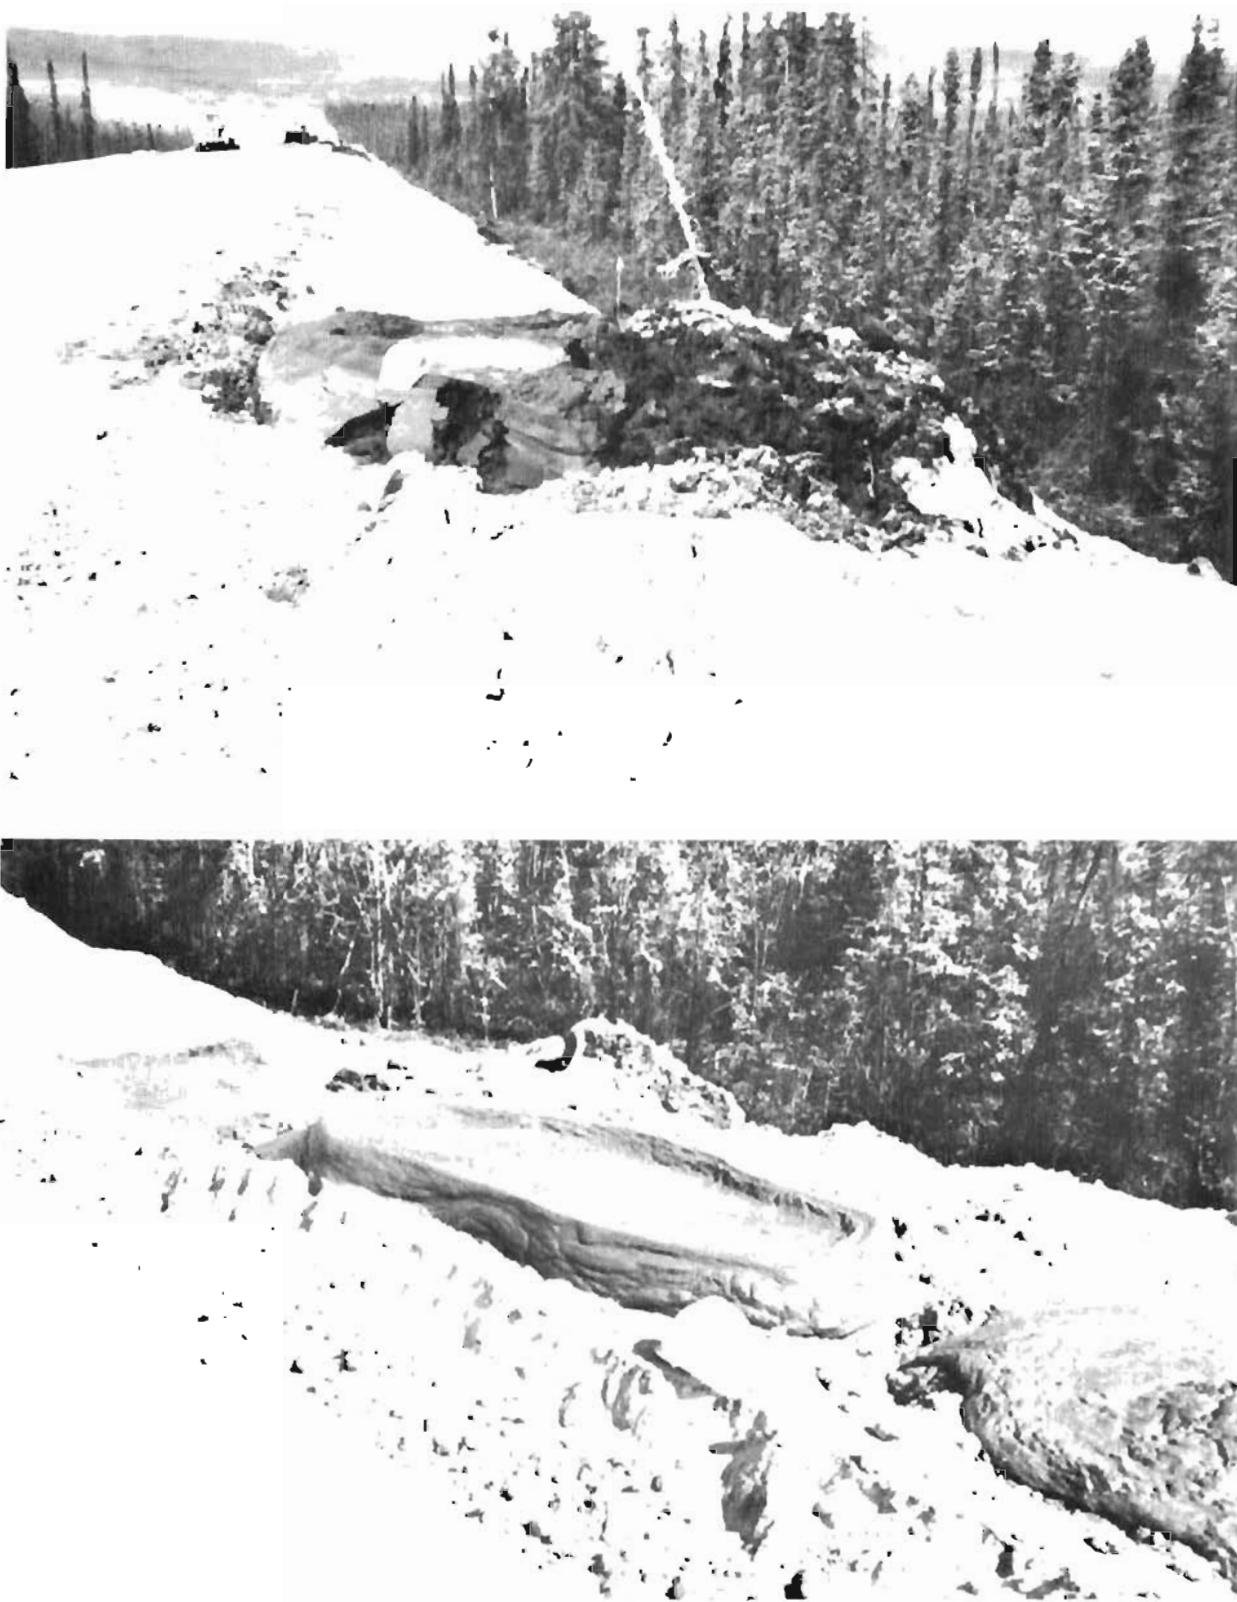
Figure 60. Displacement of underlying thawed silt through highway fill just south of No Name Creek (upper photograph APO 9126U; lower photograph APO 9126T, Alaska Pipeline Office, Anchorage, August 1974).
