**GUIDEBOOK 4**

**GUIDEBOOK TO PERMAFROST AND RELATED FEATURES  
ALONG THE ELLIOTT AND DALTON HIGHWAYS,  
FOX TO PRUDHOE BAY, ALASKA**

**Fourth International Conference on Permafrost  
July 18-22, 1983  
University of Alaska  
Fairbanks, Alaska, U.S.A.**

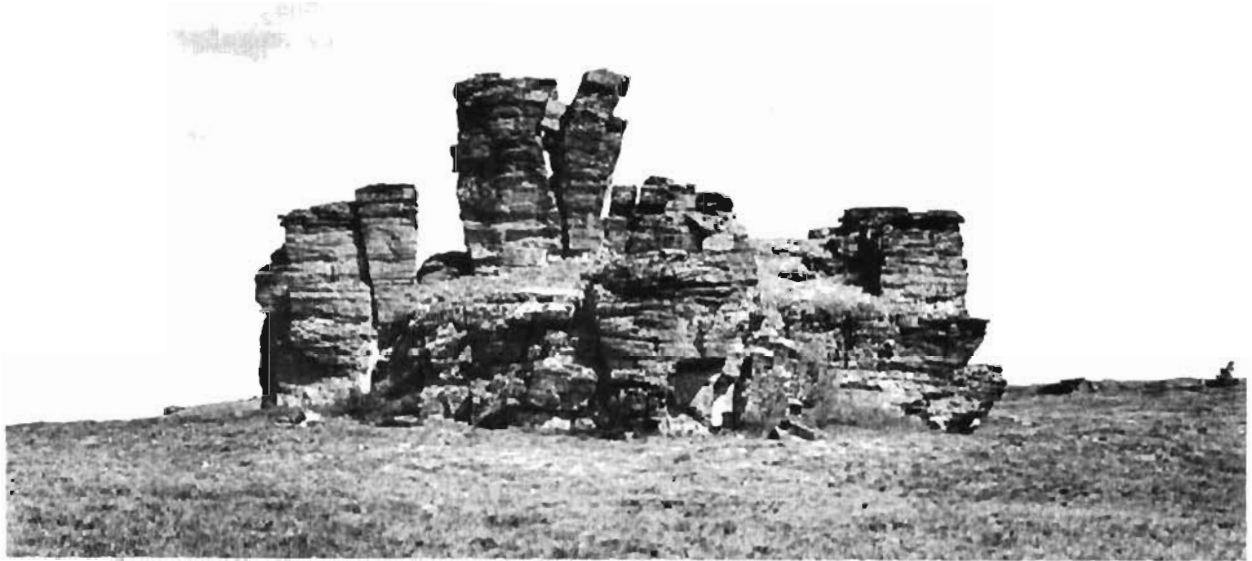
Figure 62. Large, blocky tor on 'Castle Mountain' consisting of horizontally foliated metamorphic rock (photograph taken by P.K. Bailey on June 24, 1982).

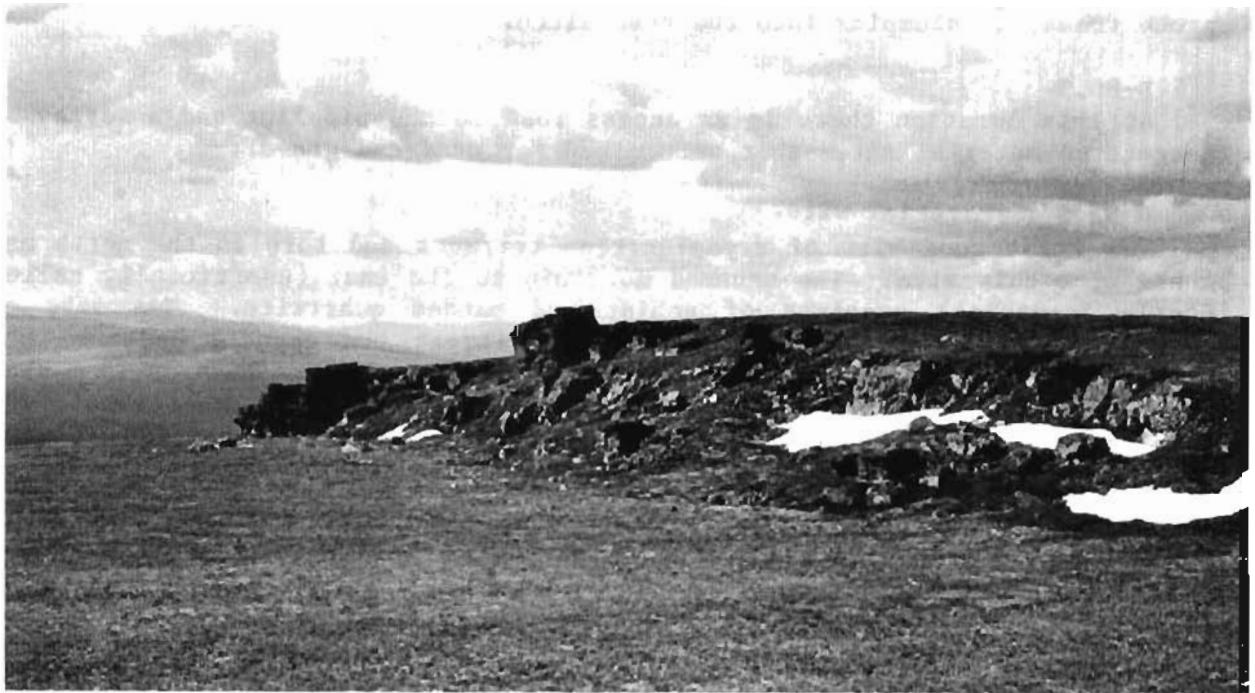
Figure 63. View from top of tor shown in figure 62 showing a cryoplanation scarp and small tors on the east end of the mountain (photograph taken by P.K. Bailey on June 24, 1982).

The first good view of cryoplanation terraces and tors to the north may be had from this site. The unnamed mountain to the east (unofficially called 'Castle Mountain') consists of schist and banded quartzite. Two sets of vertical joints perpendicular to each other break the exposed bedrock into well-defined columns and blocks, some of which form tors as high as 15 m that rise spectacularly from the cryoplanation surface. Some tors are separate and free standing, and others are part of the cryoplanation scarp (figs. 62 and 63).

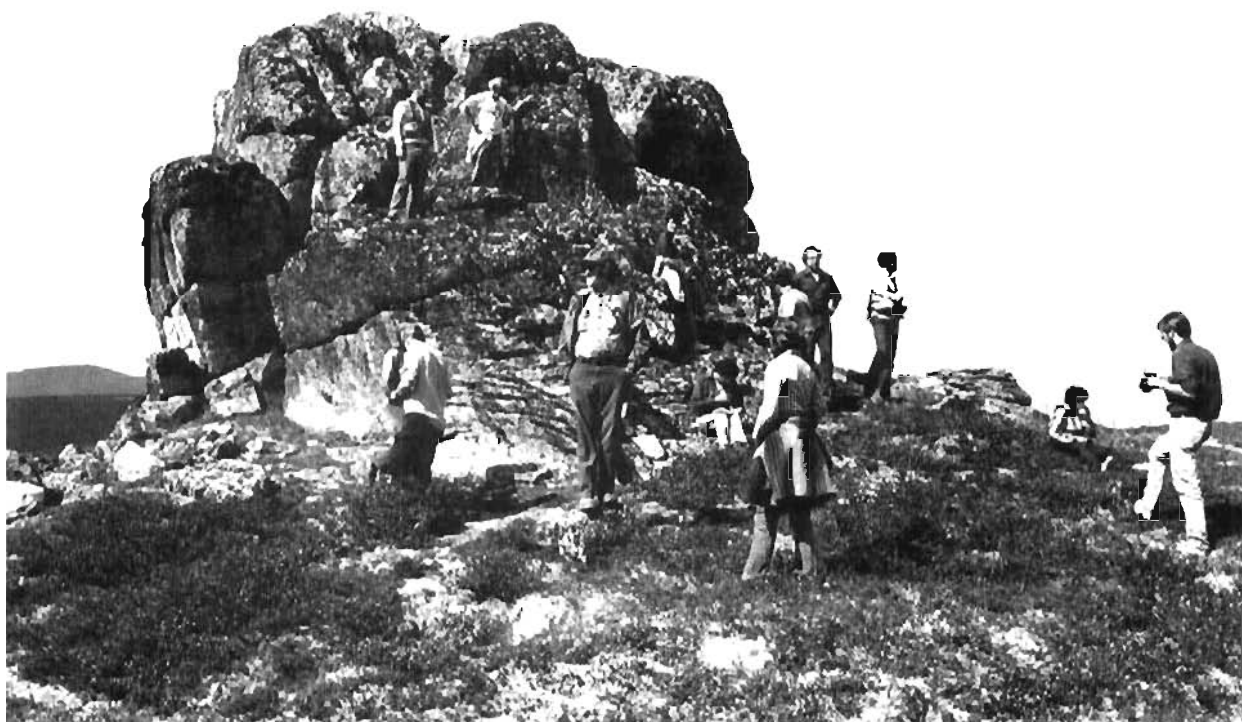
Figure 65. Granite tor on Finger Mountain uplands on south side of road. Note intersecting joints. Well-developed ground cover includes lichen and dwarf birch (photograph taken by R. Veazey on July 20, 1982).

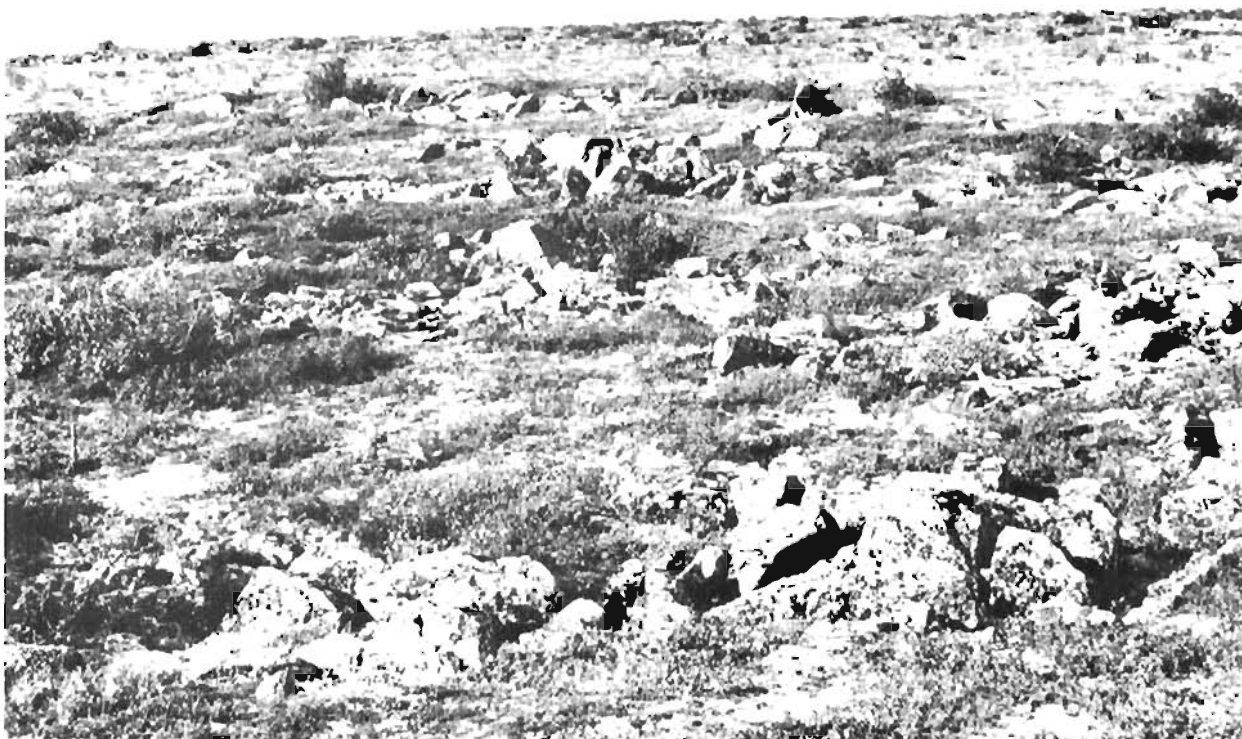
Figure 66. Large, apparently stable stone nets outlined by lichen-covered blocks of granite in the vicinity of Mile 99 (photograph taken by K.R. Everett).

The tors are products of deep weathering of long duration in the porphyritic granite. The spacing of the N-S/E-W joint sets in this bedrock may have contributed to their development (fig. 65). Joint geometry also controls the patterns in the thin mantle of coarse boulders or *felsenmeer* (fig. 66). In some areas, the patterned ground has been covered by vegetation. Large 8- to 10-m-diameter polygons, bordered by boulders and with small centers of fine mineral soil, form areas that are generally free of all vegetation except lichens. Other polygons have large mineral soil centers and considerable vegetation. As slope increases to about 9°, shallow drainage swales and poorly developed stone or vegetation stripes occur. The drainage-ways are generally wet, and in many cases contain solifluction features (hummocks and lobes). The wetter sites, together with solifluction micro-topography (commonly <0.5 m in height), become extensive lower on the slopes. Also common to the middle and lower slopes, especially near drainage ways, are lichen-covered boulders that are surrounded or overgrown by thickets of alder or willow. These boulders commonly form a polygon pattern, but the area of fine-textured mineral soil in the polygon centers is either very small (1 m or less) or completely lacking. Relief within the polygons may exceed 1 m or more, and many of the boulders or slabs are loose or 'rocking.' Water can sometimes be heard running beneath the boulder surface.

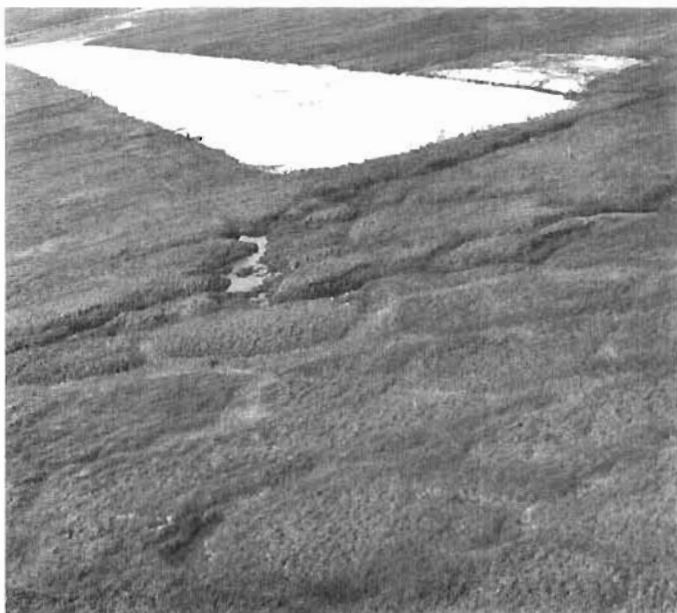
Figure 70. Low-angle aerial photograph from east end of Old Man runway. Ice-wedge polygons visible in the foreground. Ice-cored relief occurs on the upslope side of the runway (photograph taken by D. Atwood on July 19, 1982).

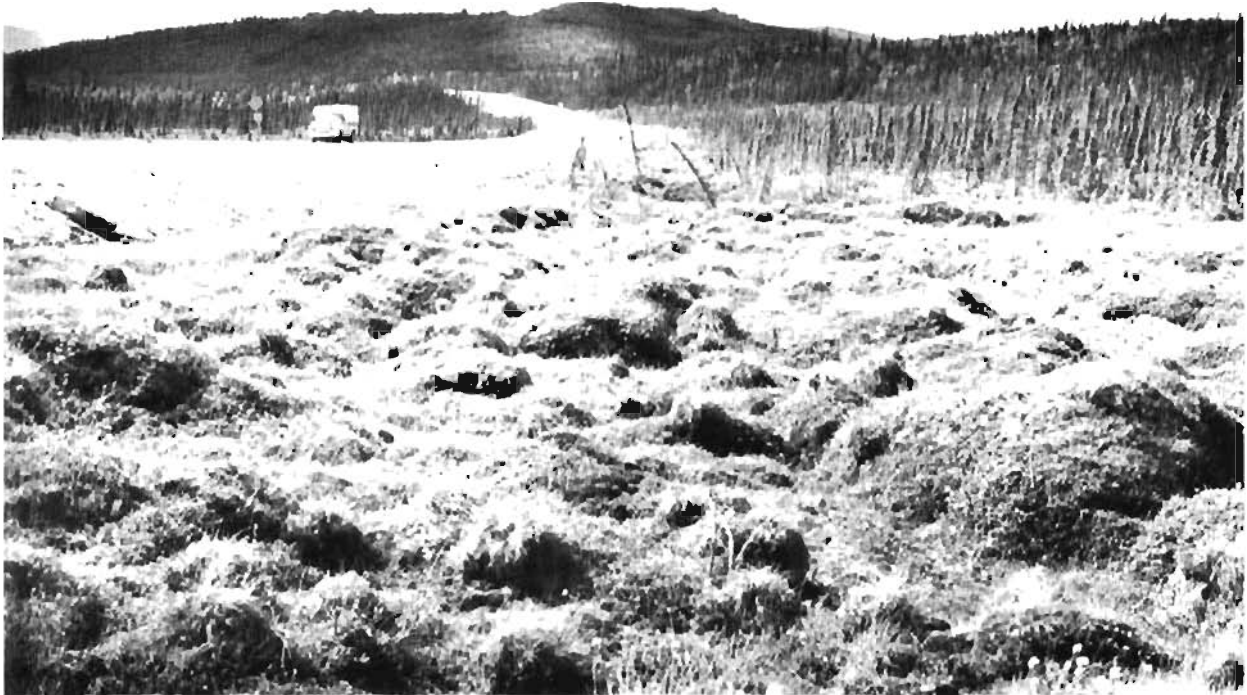
Figure 73. Ice-cored mounds in various stages of degradation (photograph taken by P.K. Bailey on June 26, 1982).

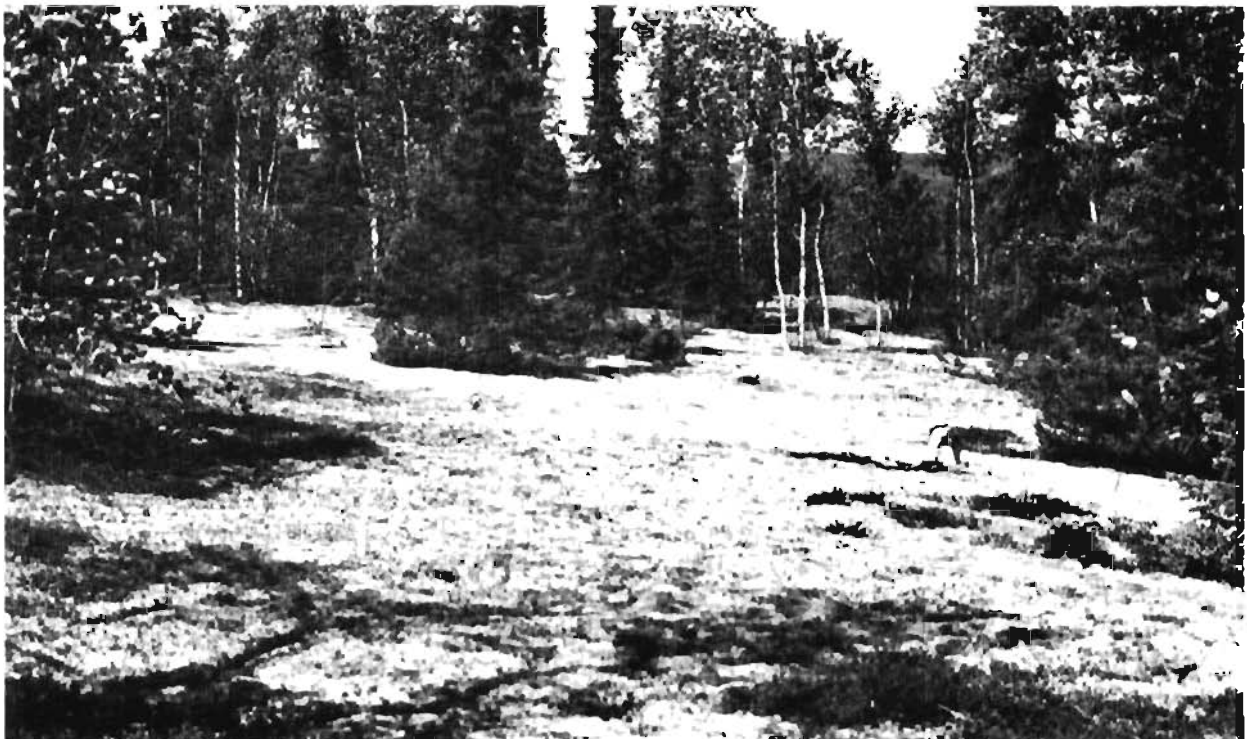
Figure 74. Open forest covered with a thick growth of reindeer lichen overlying granitic grus (photograph taken by P.K. Bailey on June 26, 1982).

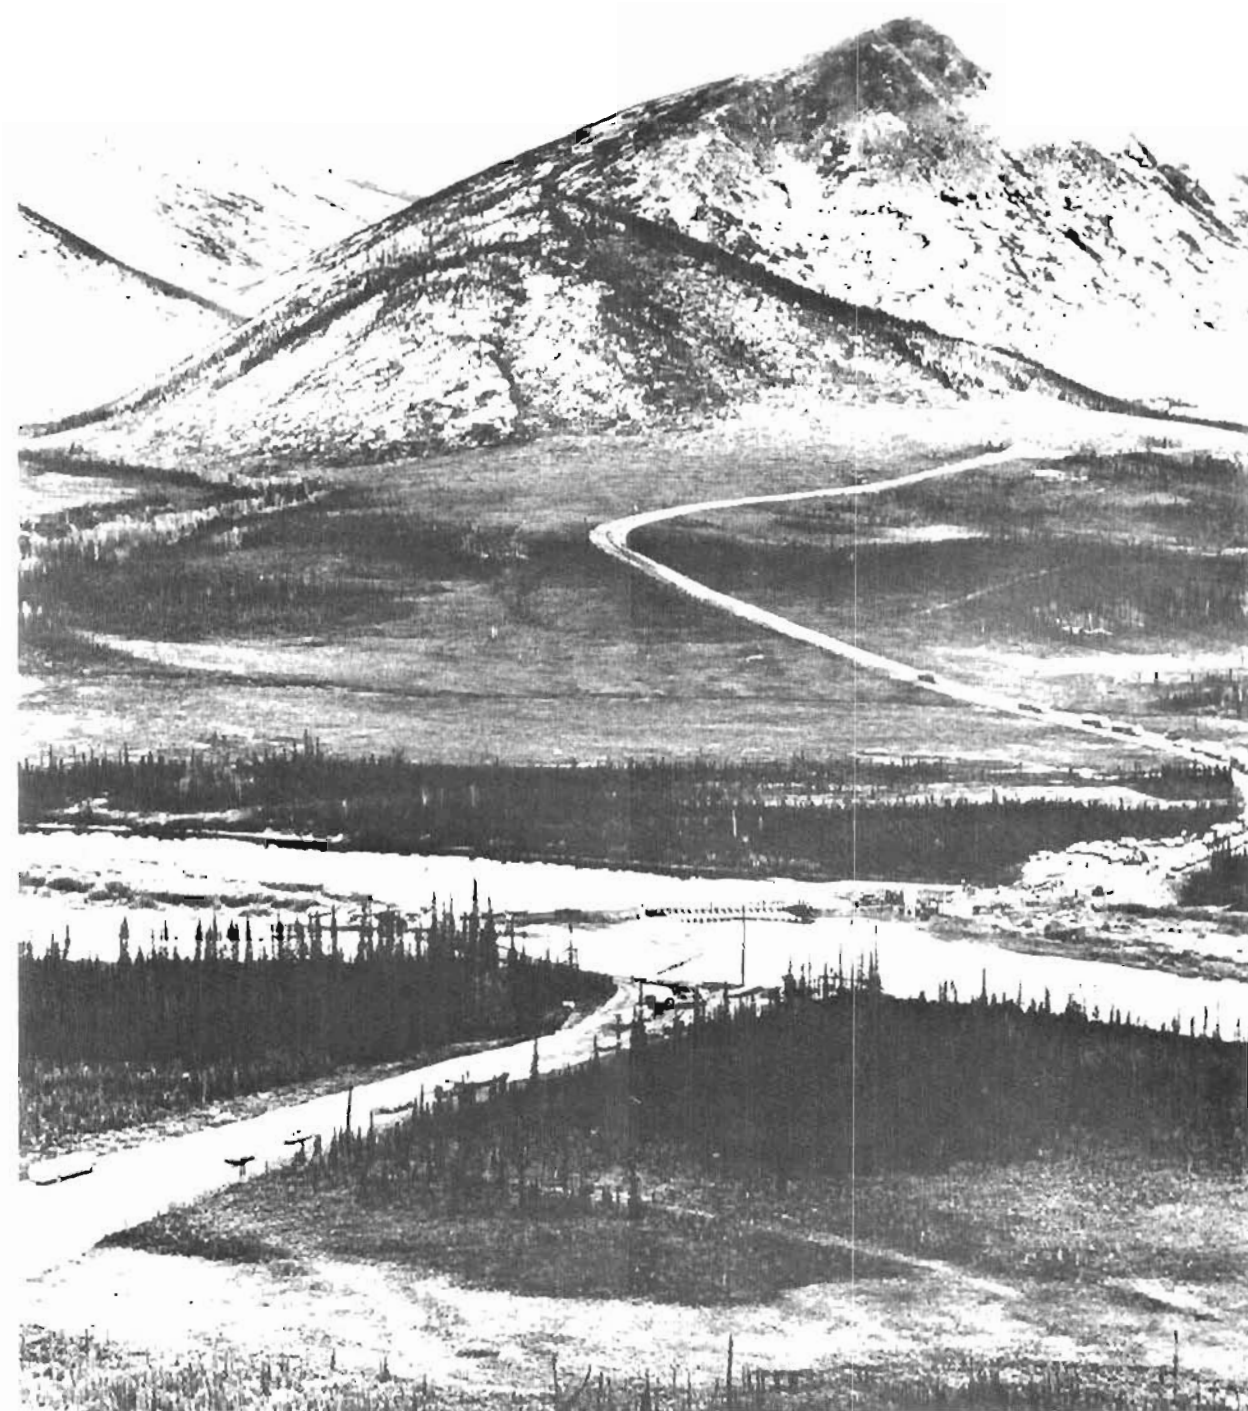
Figure 79. View looking south of final linkup of the haul road, which took place on September 27, 1974, at the South Fork Koyukuk River. Possible large contraction cracks have been observed in talus above the turn in the road (photograph courtesy of Alyeska Pipeline Service Company).

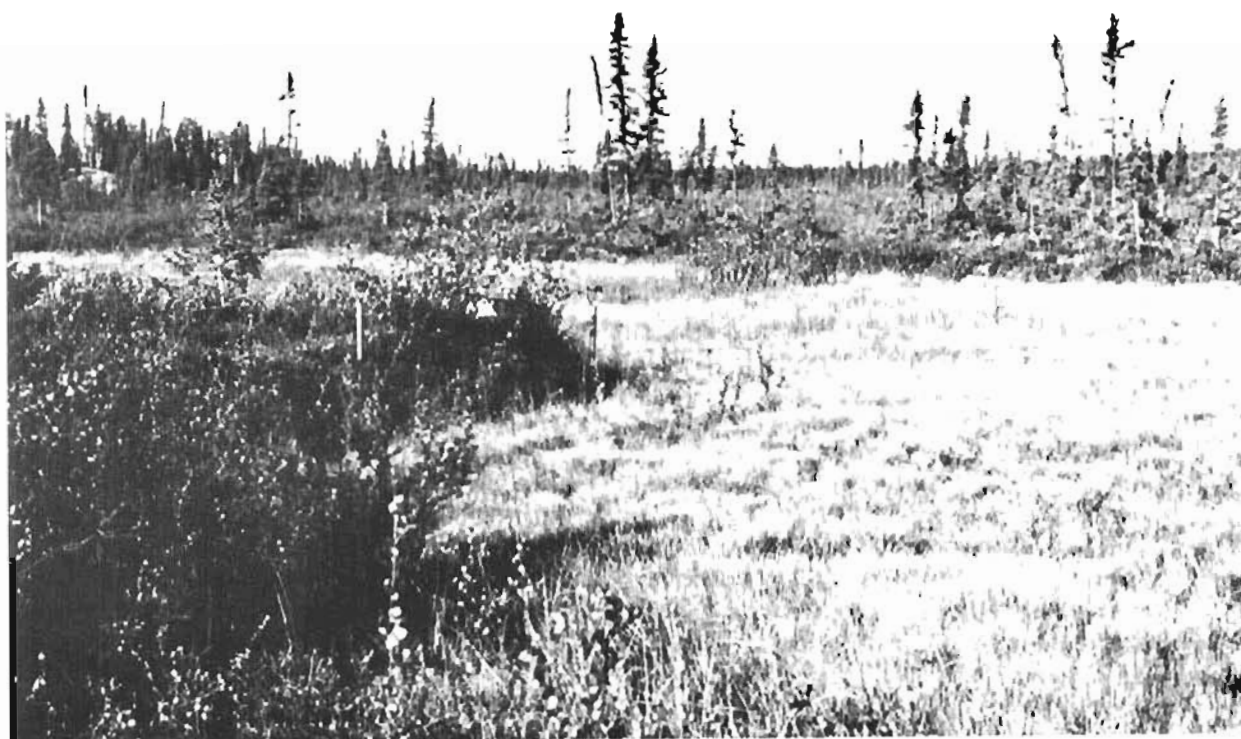
Figure 80. Acidic Sphagnum peat (left) rises 1 m above adjacent alkaline sedge fen. An area of well-drained outwash gravels can be seen in extreme upper left (photograph taken by K.R. Everett).

The site on the west side of the road illustrates the development of peat islands associated with sedge fens (fig. 80). Much of the surrounding area consists of narrow, often discontinuous gravel ridges that rise 10 m or more above the surrounding fens. Small kettle lakes and ponds occur between or are surrounded by the ridges. Most of the fens are crossed by narrow streams, some of which are 1 m or more deep. Occasionally, nearly circular thermokarst ponds interrupt a drainage and reach depths greater than 2 m. Peat islands

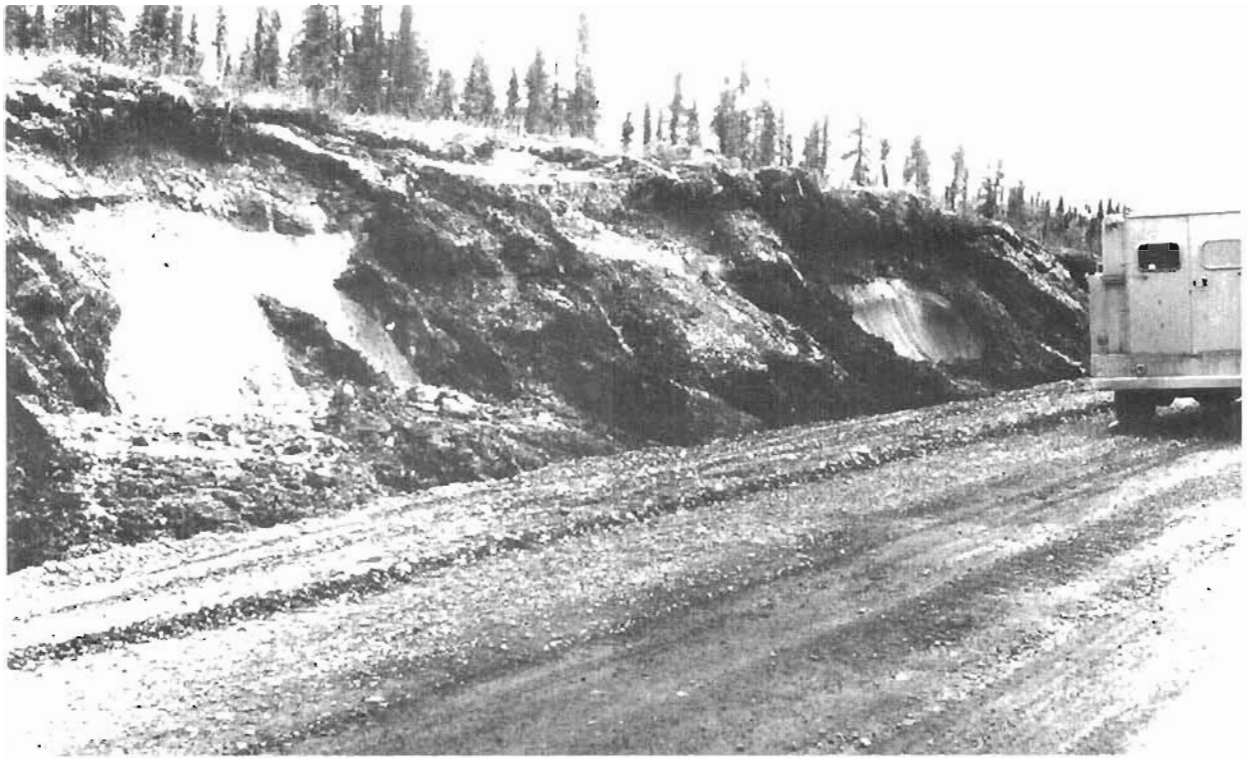
Figure 84. Exposure of ice wedges on the south side of Rosie Creek (Brown and Berg, 1980, fig. 19; photograph taken by R.L. Berg on May 30, 1975).

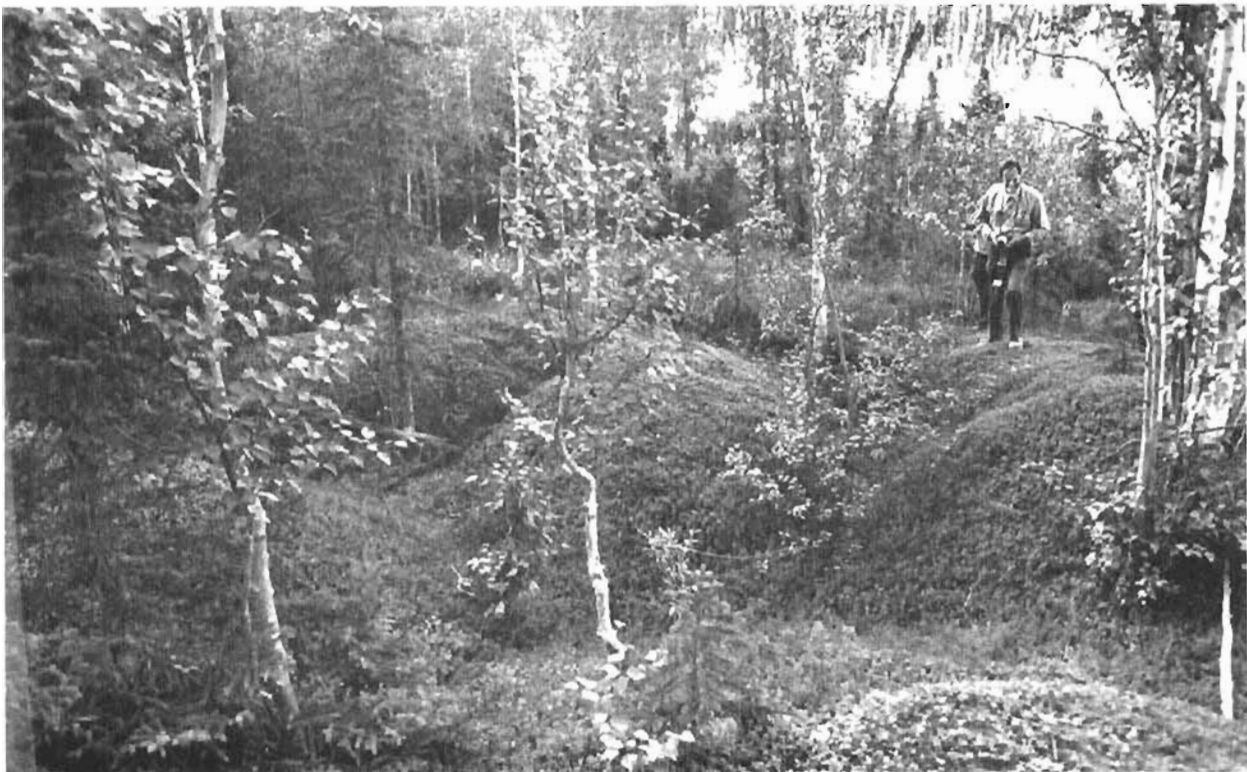
Figure 85. Siberian cemetery mounds, or baydzherakh, downslope from exposed ice-wedge cut shown in figure 84. Mounds are erosional remnants left after ice wedges have melted (photograph taken by R. Veazey on July 20, 1982).

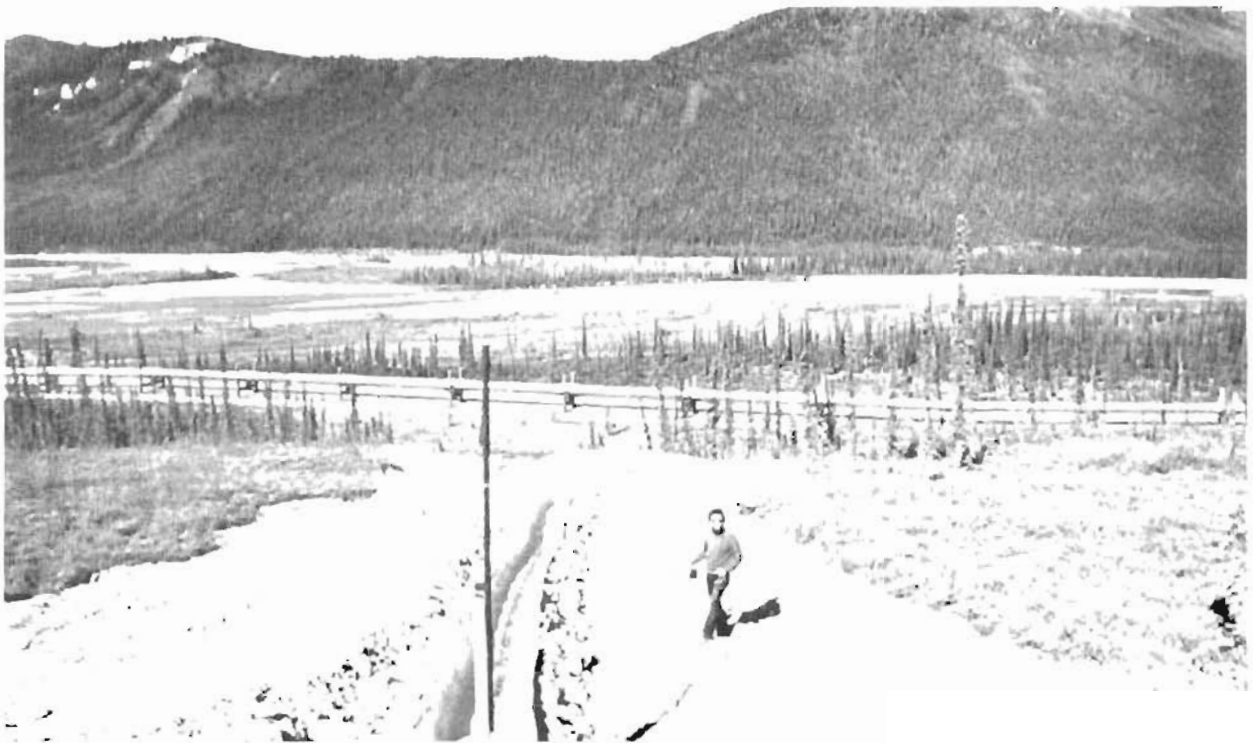
Figure 92. Half sections of corrugated metal pipe (CMP) used to channel water downslope from culvert. The CMP sections were over granular fill placed in a gully caused by thermal erosion (Brown and Berg, 1980, fig. 59; photograph taken by G.L. Guymon, May 1978).

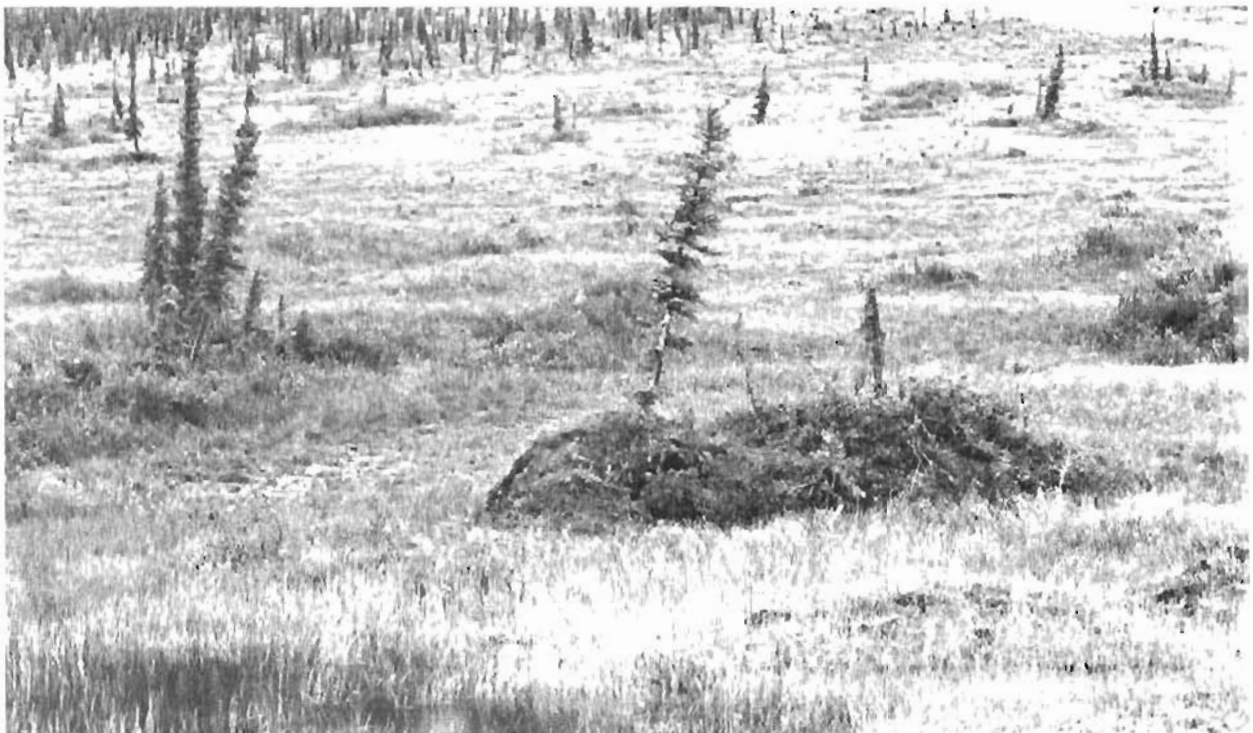
Figure 93. Ice-cored mounds on slope below Sukakpak Mountain (photograph taken by R. Veazey on July 21, 1982).

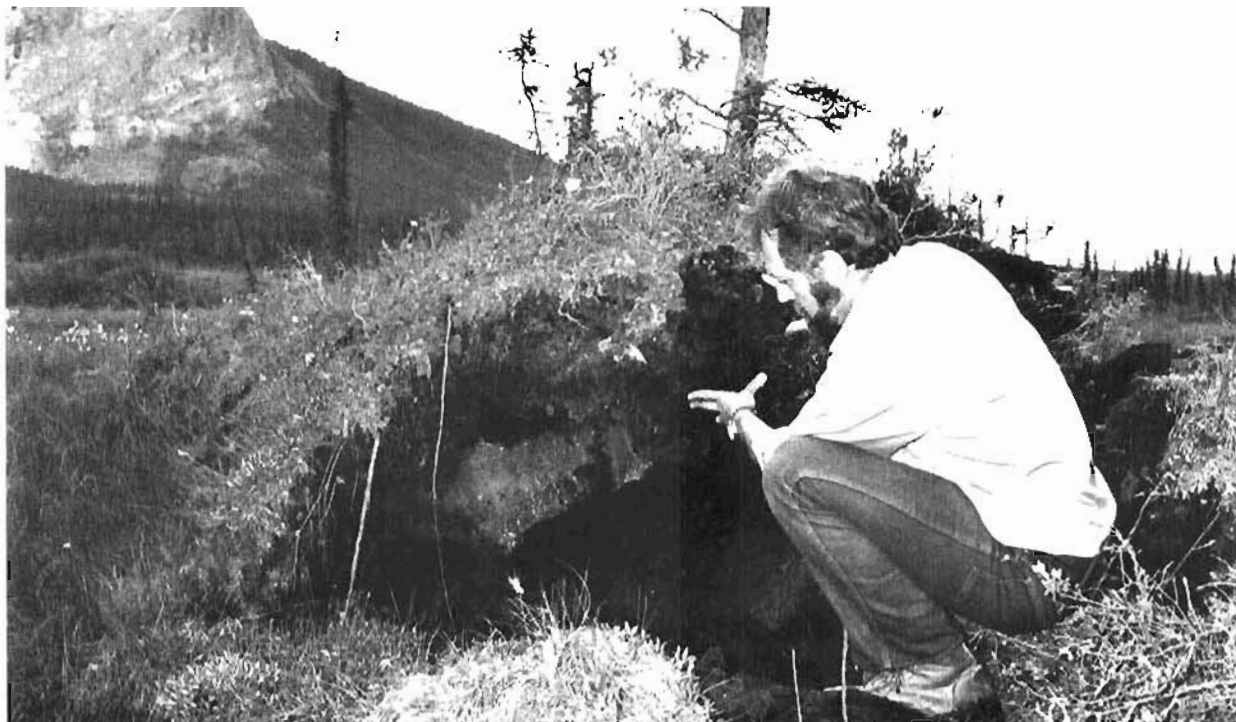
Figure 94. Ruptured mound showing arched ice layer and cavity (photograph taken by R. Veazey on July 21, 1982).

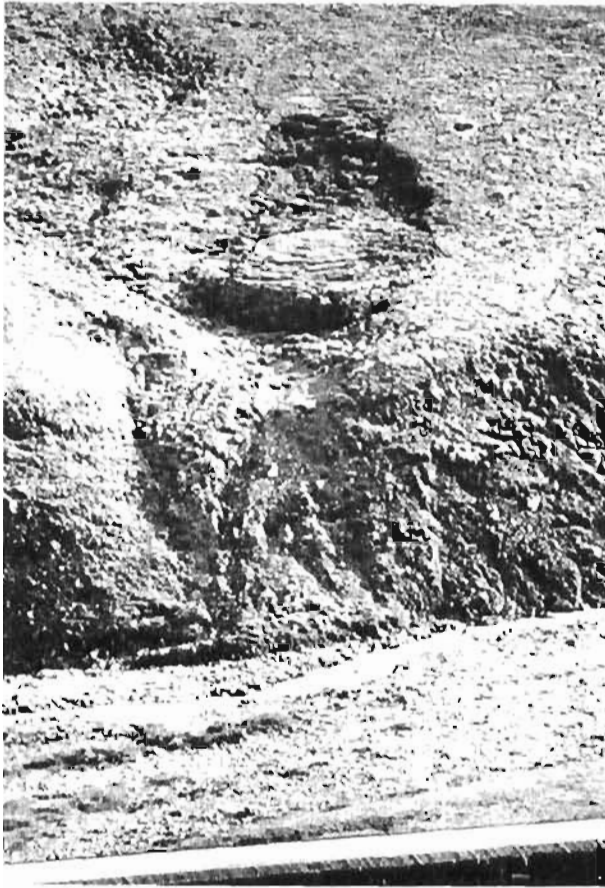
Figure 100. Slope failure adjacent to west tributary of North Fork Chandalar River. Slide occurred in August 1977. Road sign is in foreground (photograph taken by J.M. Ellis).

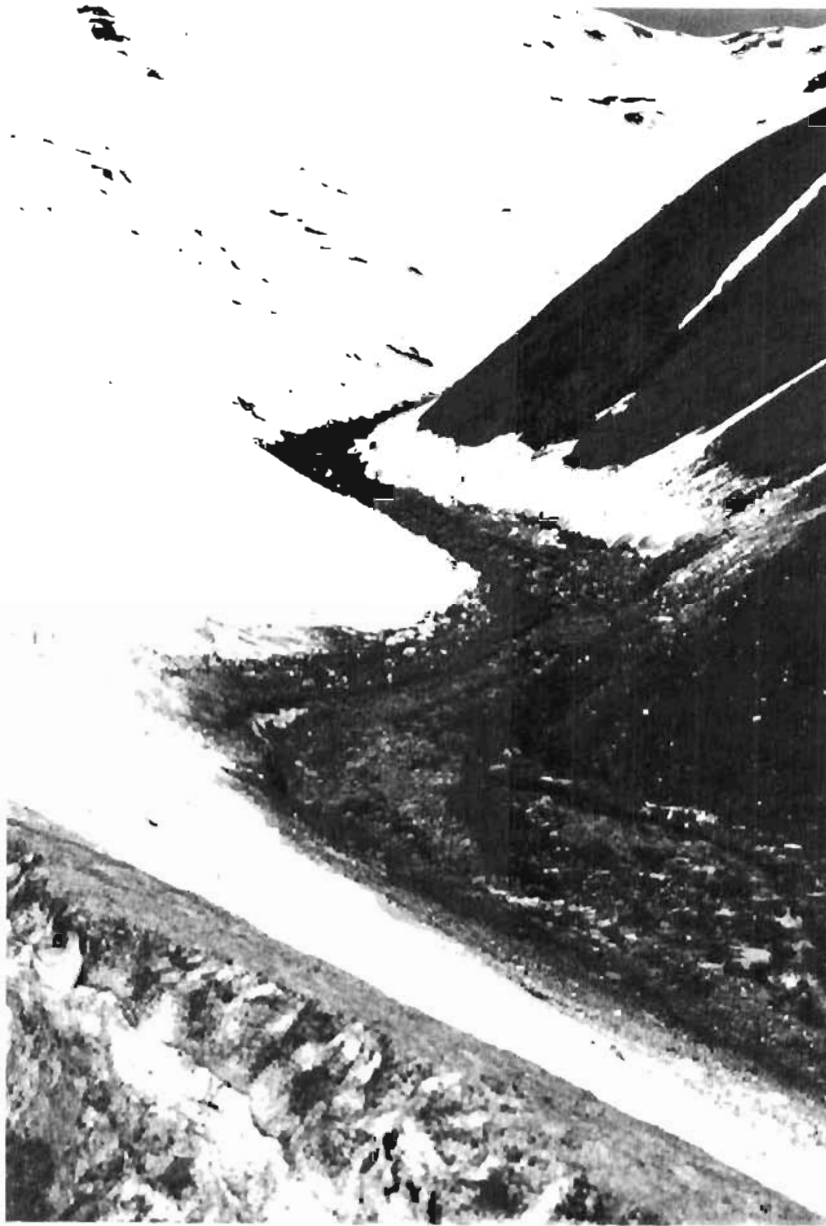
Figure 108. Superelevation of slushflow on outside of bends in chute (photograph by L.J. Onesti).

Observation of slushflow tracks in steep chutes suggests that high-velocity flows move at supercritical rates. When a slushflow encounters a change in chute alignment or a constriction, it superelevates on the outside of bends and is diverted diagonally, deflecting back and forth across the chute (fig. 108).

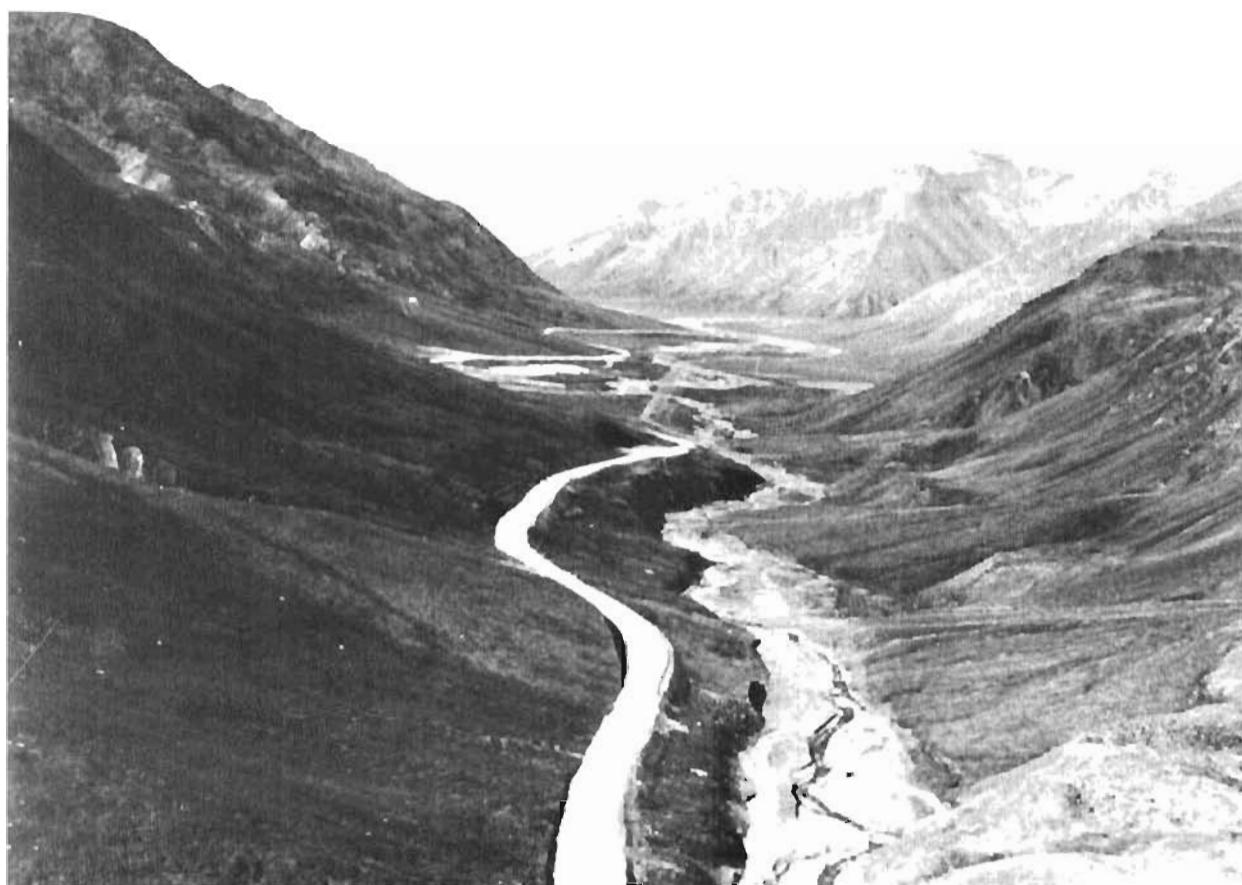
Figure 109. Glaciated, U-shaped Atigun Valley looking north (photograph taken by D. Atwood on July 19, 1982).

Atigun Valley displays the classic U-shaped form of glaciated mountain valleys (fig. 109). Mass-wasting deposits are abundant and of varied

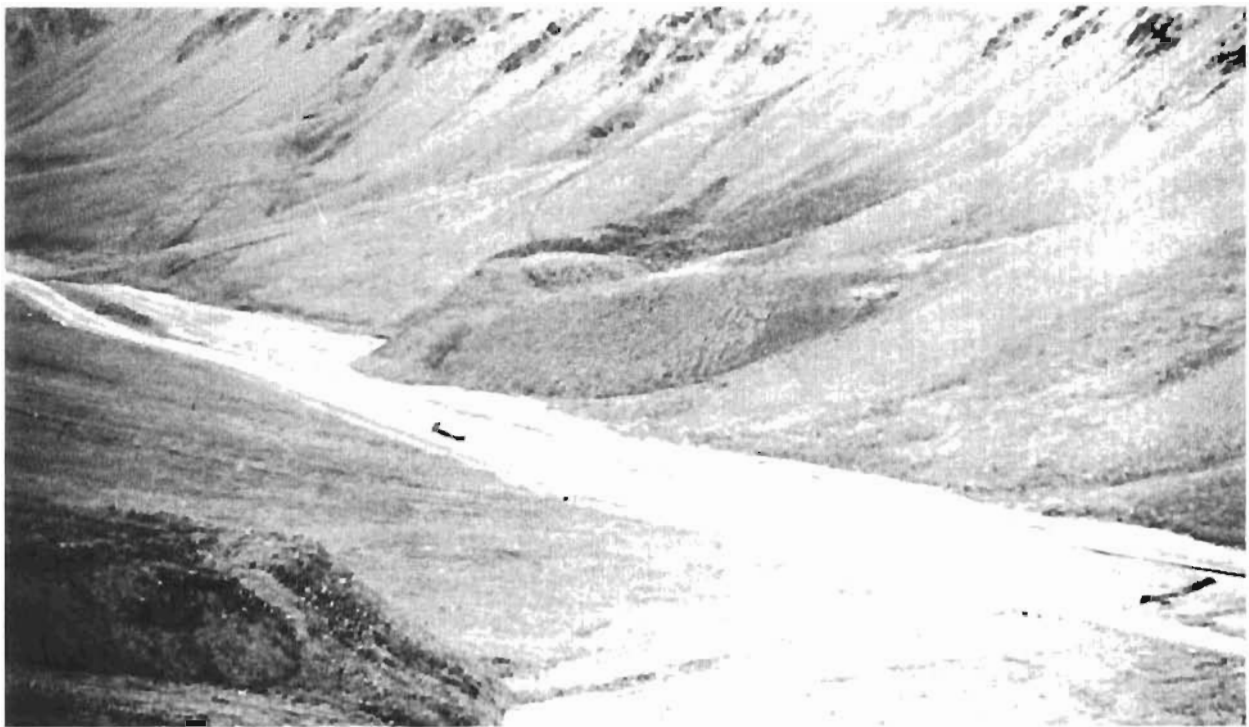
Figure 110. Lobate rock glacier with a curved bouldery rampart on east side of Atigun Valley. Pipeline is buried in the river. The slope is the foreground has slushflow channels and proximal hump deposits characteristic of slushflow features (photograph taken by R.K. Fahnestock).

character on the valley walls. In the upper third of the valley and especially near its head are steep-fronted ( $27^\circ+$ ), curved, bouldery ramparts or rock glaciers (fig. 110; Ellis and Calkin, 1979; Bruen, 1980). The downslope face of these features is composed of angular boulders and rises to a height of 10 m or more. Behind the rampart is a platform or tread that slopes as much as  $6^\circ$  downward toward the valley wall. Commonly there is a depression in this surface, which is the site of snow accumulation and a pond (or former pond). In some cases, the rampart is breached by a V-shaped trough leading to the depression. Slopes above the tread area are composed of talus cones or talus sheets that terminate on the tread. The origin and significance of the ramparts are not completely understood. Fines have been removed from the boulder face of the rampart by entrainment and snowbank sapping. At least one of the larger forms displays a group of nested, curved protalus ramparts developed on the tread. These have been formed by rock fragments loosened by freeze-thaw sliding over large snowbanks to the tread. The number of protalus ramparts suggests either a progressive thinning or recession of the seasonal snowbank (indicating a warming climate) or seasonal variability in the extent of the snowbank (no climatic significance).

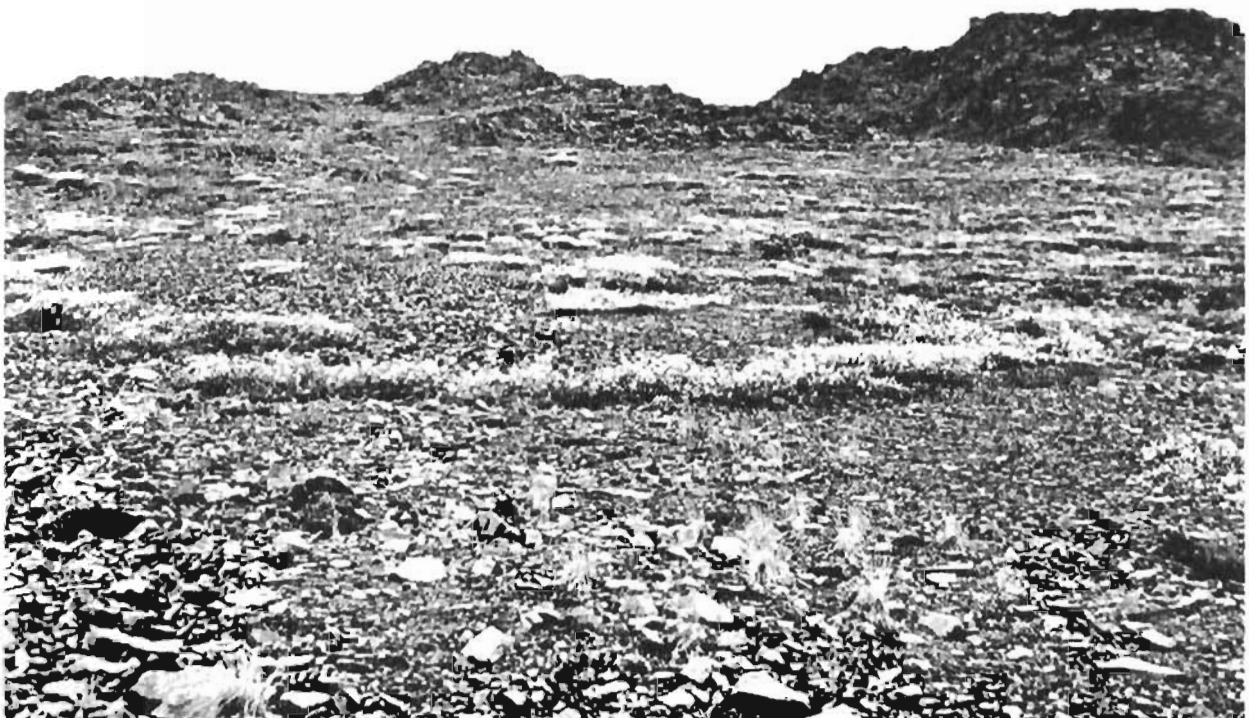
Figure 111. Steep talus slope (50°) with partially vegetated steps and stripes consisting of Dryas octopetala and willows (photograph taken by K.R. Everett).

Narrow rockfall chutes commonly terminate in talus sheets or steep talus cones. Typically, these features have temporarily stabilized areas of willows and mountain avens (*Dryas octopetala*) in the form of discontinuous stripes parallel to the slope (fig. 111). Rockfall and creep are the principal processes of accumulation and movement. Talus cones (fig. 112) have relatively small material source areas and high slope angles, and are composed mostly of large angular boulders with relatively few fines. Fine materials increase in abundance near the apex and in the shallow subsurface. Water and

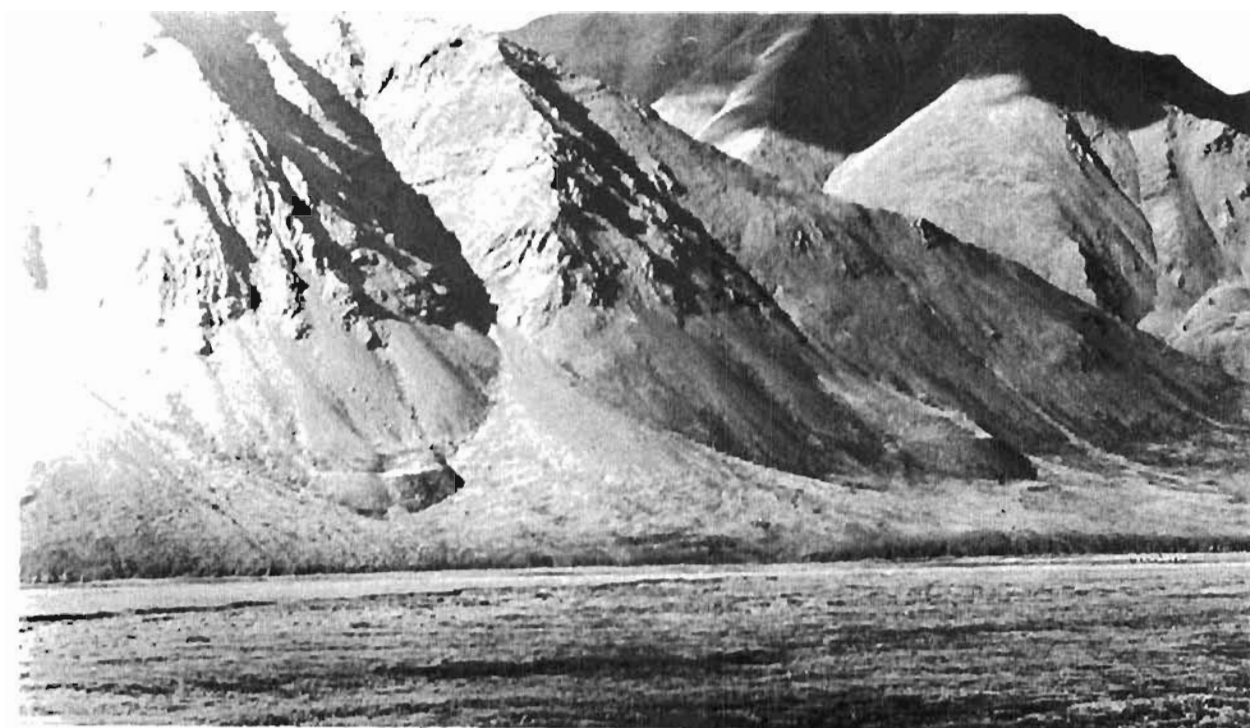
Figure 112. Several debris cones developed from shaly bedrock. These steep cones ( $22^\circ$ ) exhibit active debris flows. Note lobate rock glaciers at base of faceted spurs (photograph taken by K.R. Everett).

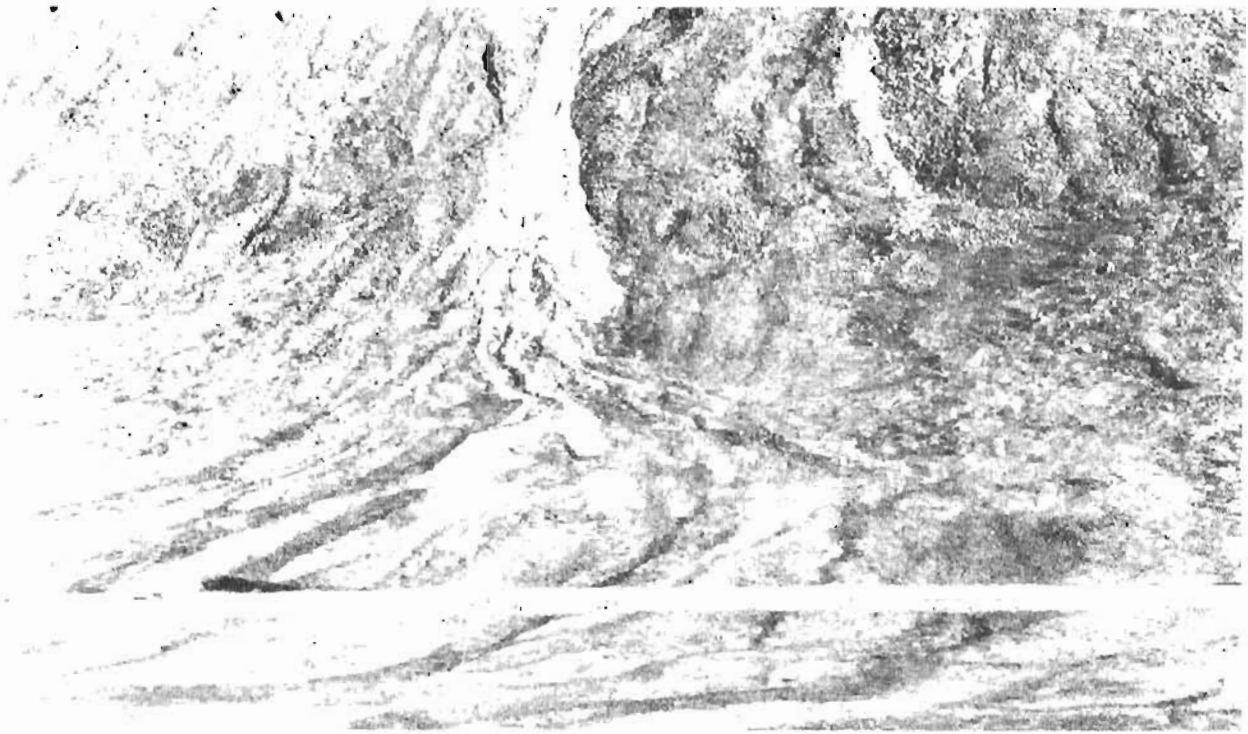
Figure 113. Mudflow or debris cone on east wall of Atigun Valley (photograph 55-18 taken by R.A. Kreig in 1974).

More deeply incised chutes with larger source areas produce steep debris cones (fig. 113). These cones are intermediate in volume and slope angle between talus cones and alluvial fans. The geometry of this form reflects the dimensions of the material source areas and the type of transport mechanism, that is, the amount of water or slush and the gravity component. Debris cones are composed of materials of all sizes, but angular and subangular boulders dominate at the surface. Surface water flow tends to be confined to early summer. Some of these forms are 0.5 km or more across at their bases. They are characterized by numerous active and formerly active slushflow or mudflow channels and levees. Many of the surfaces support vegetation.

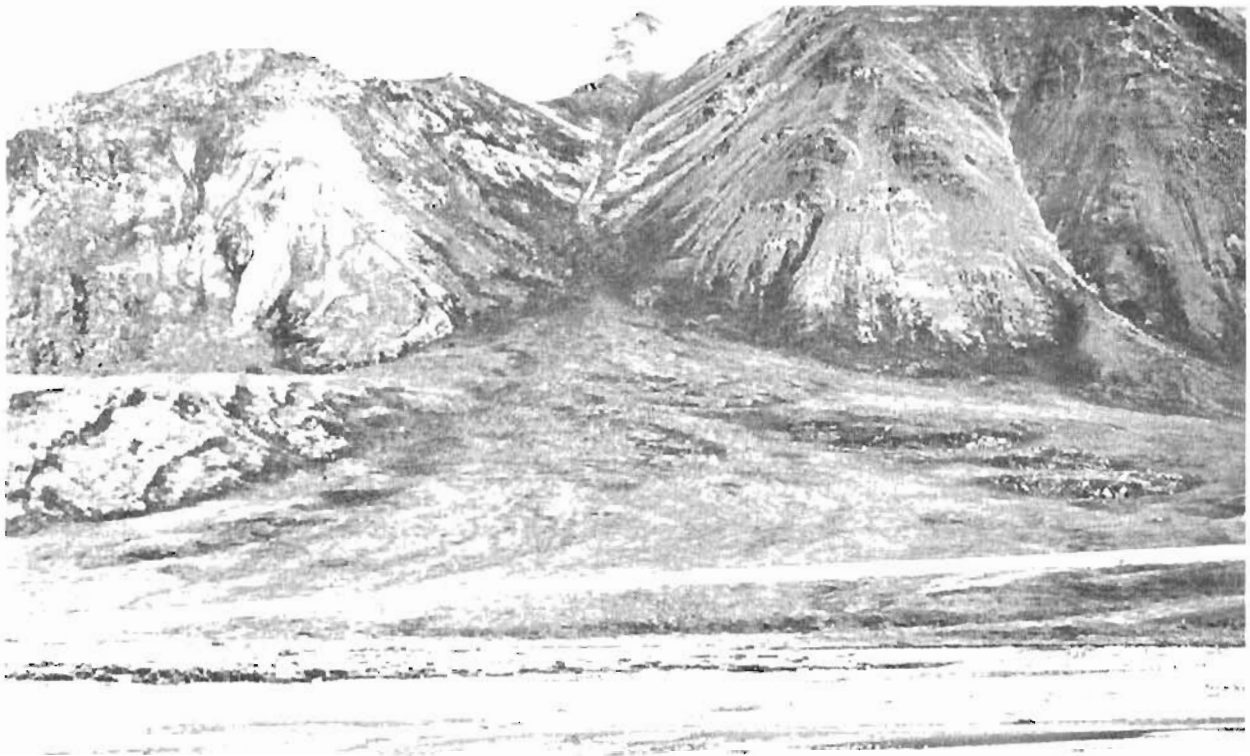
Figure 114. Alluvial fan (slope  $13^{\circ}$ ) displaying characteristics intermediate between those of the debris cone (far right) and the broad, low-angle ( $4.5^{\circ}$ ) fan that emanates from a larger source area (photograph taken by K.R. Everett).

Numerous steep ( $11^{\circ}$  or more) alluvial fans line the valley walls (fig. 114). These features, composed of a wide range of particle and fragment sizes, are the products of debris flows. Their surfaces commonly show many distributary channels. Such fans are intermediate in form between the talus cones and the broad (2-3 km), low-angle ( $4$  to  $6^{\circ}$ ) alluvial fans (fig. 109). They form by a combination of fluvial and colluvial processes. The large fans have extensive source areas and are crossed by one or more perennial distributary stream. The fans have a long history of shifting channel movement, deposition, and erosion, and are composed of materials of nearly all sizes. Large, subrounded boulders are most common at the apex area and fine sand and silt are more important near the toe.
