**GUIDEBOOK 4**

**GUIDEBOOK TO PERMAFROST AND RELATED FEATURES  
ALONG THE ELLIOTT AND DALTON HIGHWAYS,  
FOX TO PRUDHOE BAY, ALASKA**

**Fourth International Conference on Permafrost  
July 18-22, 1983  
University of Alaska  
Fairbanks, Alaska, U.S.A.**

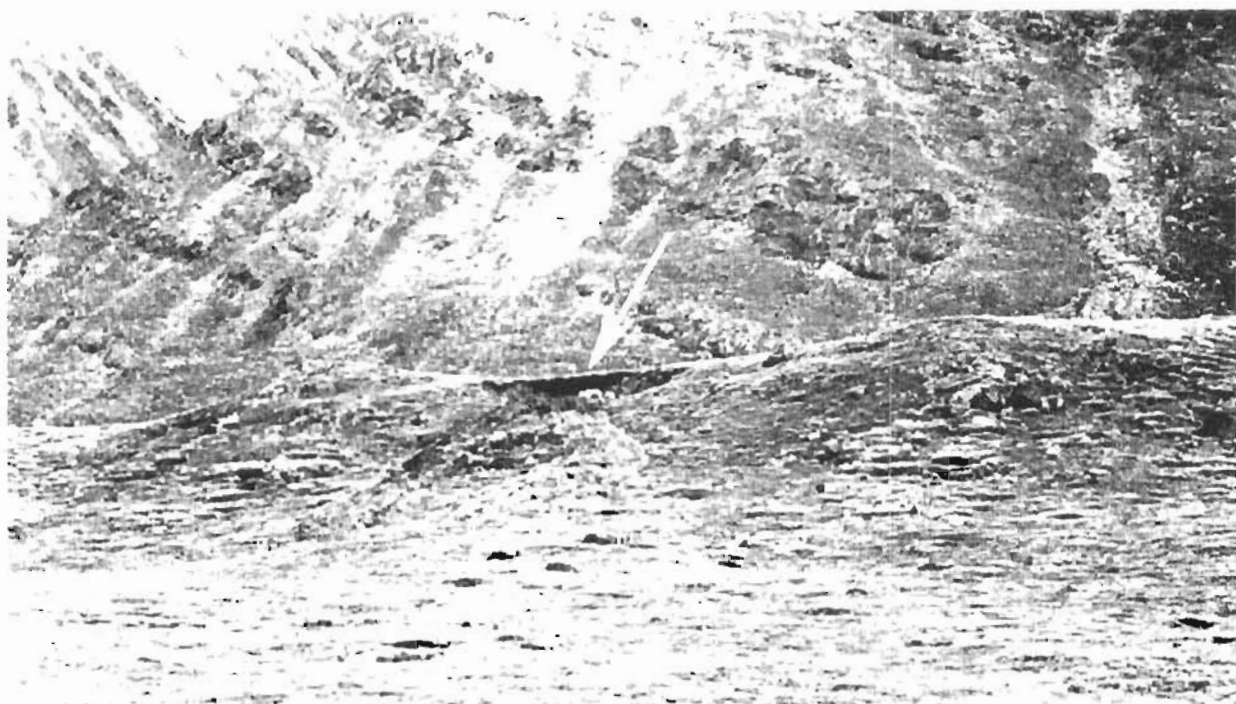
Figure 116. Slope failure (arrow) in colluvium and kame-terrace material on the east side of Atigun valley. Flow occurred September 3, 1979 (photograph taken by K.R. Everett).

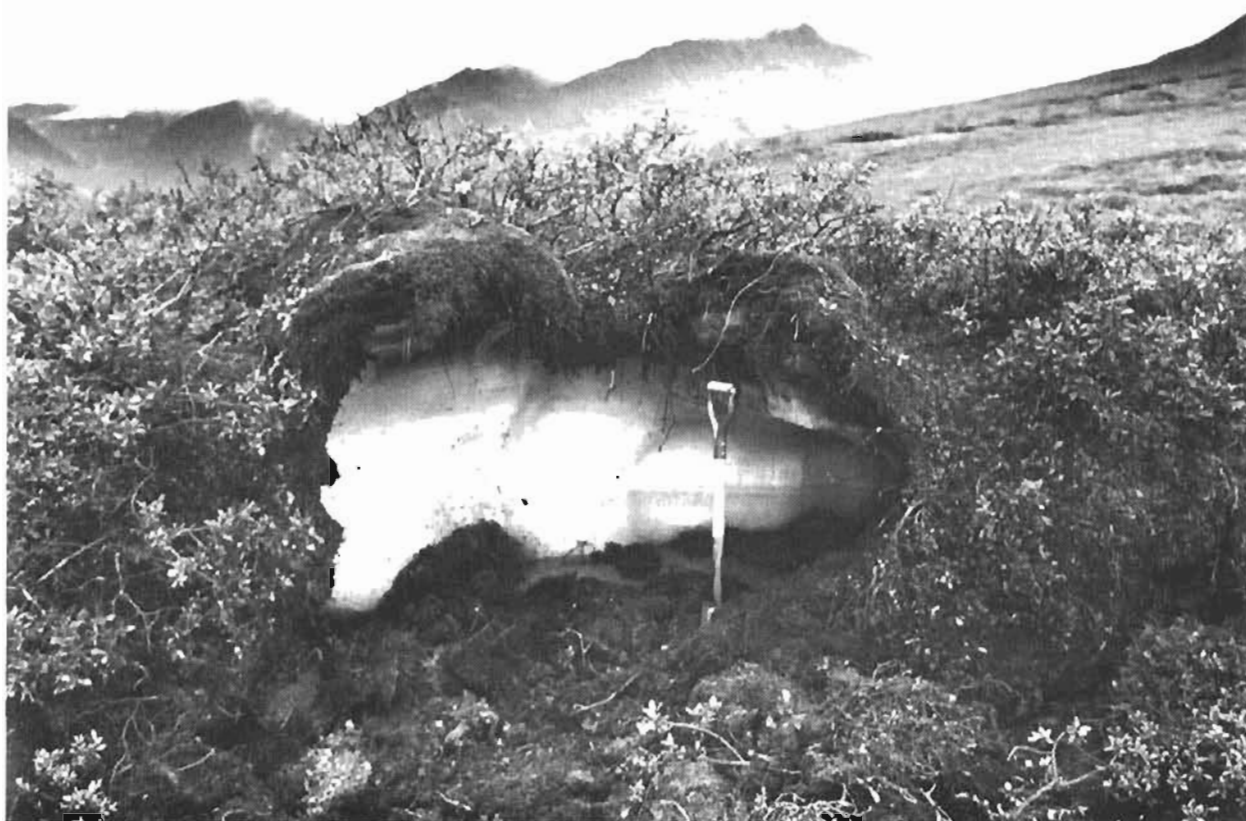
Figure 117. Exposed ice at base of fan opposite road from Atigun Camp (photograph taken by R. Veazey on July 22, 1982).

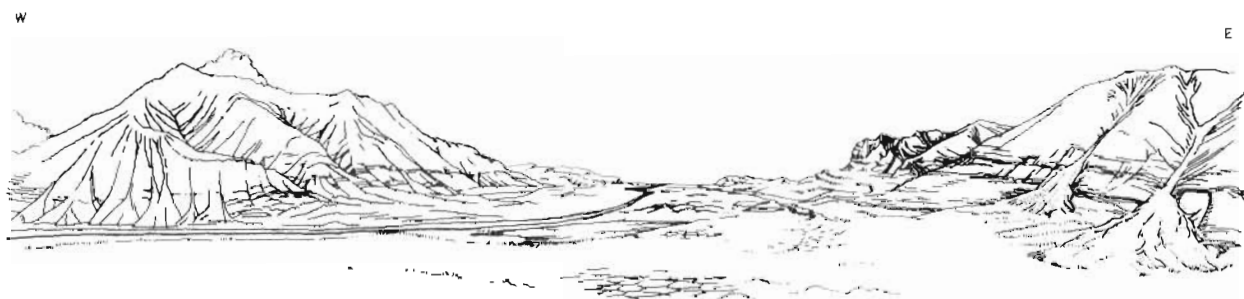
Figure 122. Panoramic sketch of Atigun Valley looking north from Pump Station 4 (sketch by Eleanor Huke).

The panorama across Atigun Valley looking to the north from Pump Station 4 illustrates landforms and vegetation of this glaciated valley (fig. 122)<sup>18</sup>. The plant cover is discontinuous and is predominantly of cushion and mat-forming types that form closed communities only at sites of surface

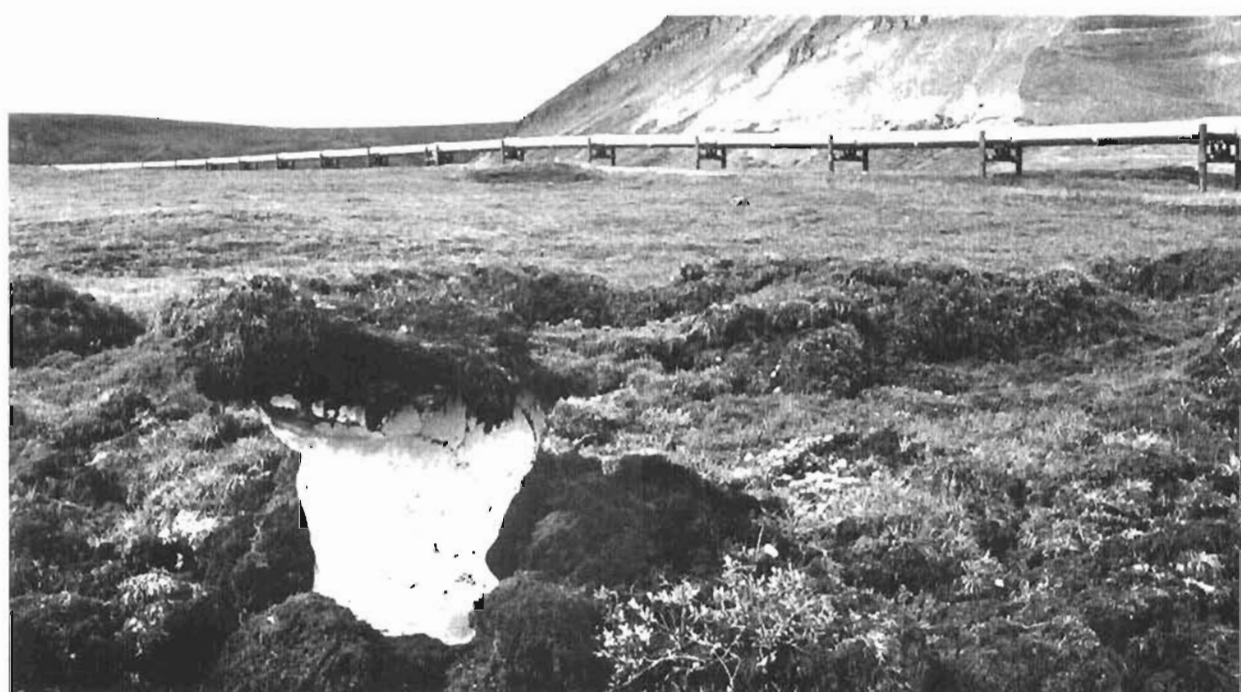
Figure 127. Remains of a mound immediately adjacent to those in figure 126. The ice was gone by the following week (photograph taken by R. Veazey on July 22, 1982).

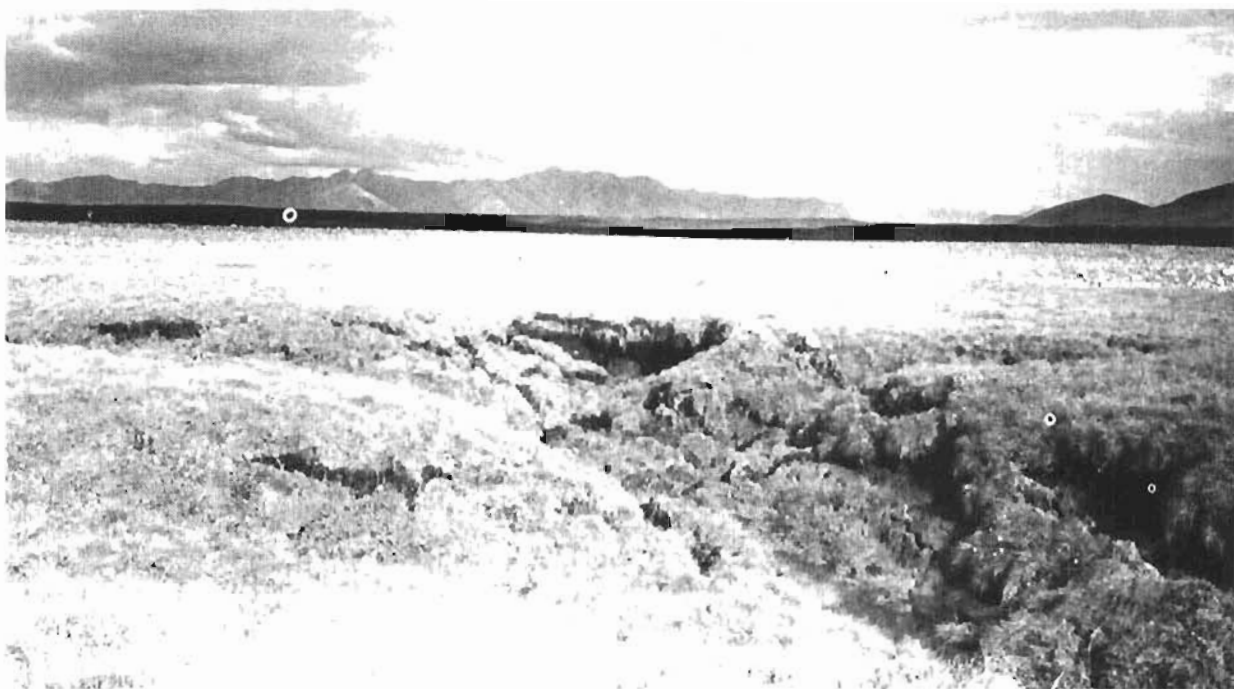
Figure 128. Ice-wedge meltout adjacent to road (photograph taken by J. Brown on July 5, 1981).

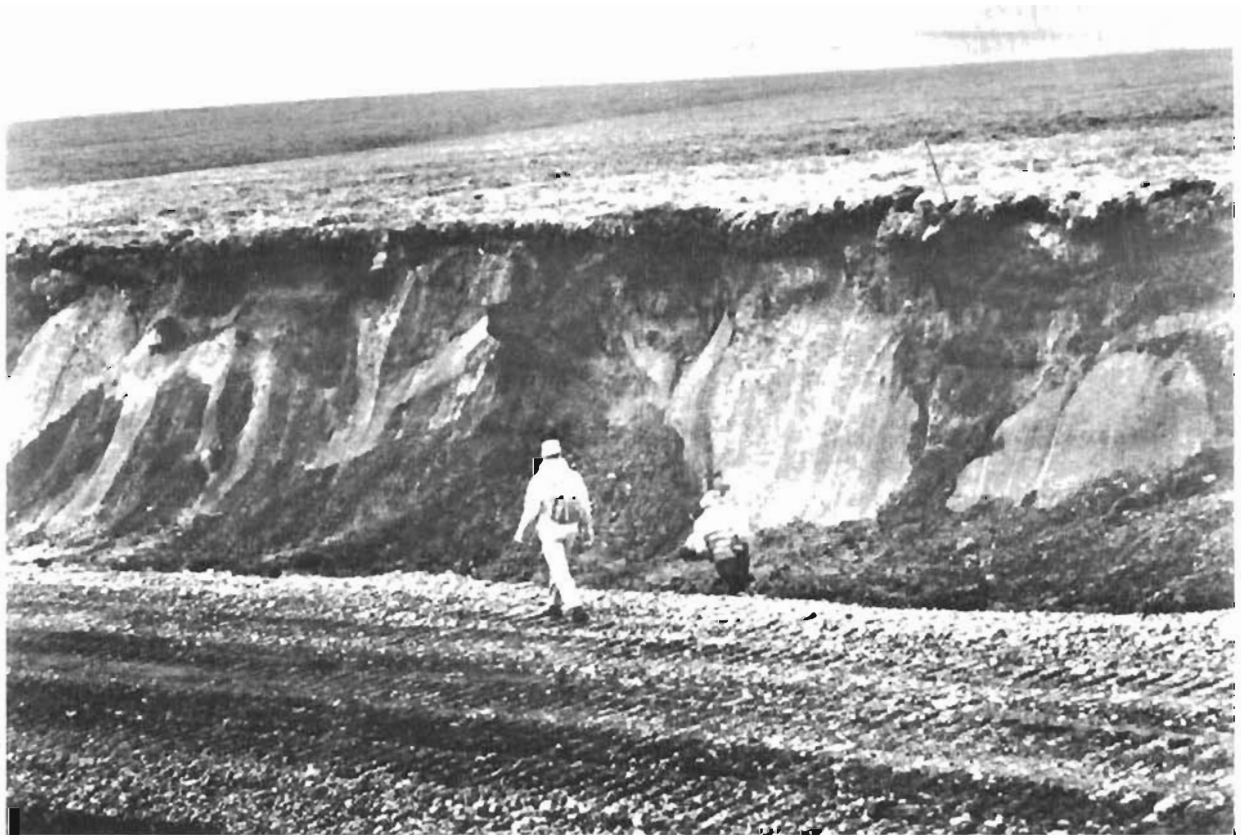
Figure 132. Ice wedges exposed in Happy Valley cut, June 1974 (photograph taken by R&M Consultants, Inc.).

about 50 m up a steep grade to an upland surface underlain by bedrock and glacial deposits (fig. 130). In 1974, roadcuts exposed muck and peat with ice wedges and other massive ground ice above a lens of till resting on bedrock (figs. 131 and 132).

By July 1975, massive ground ice was no longer visible in roadcuts, but it continued melting and caused slope retreat by slump and flowage. The slope has gradually receded as ice continues to melt. Ample evidence of ice-wedge polygons in the area is seen on close inspection of aerial photographs. About 0.5 km north of here and on the east side of the road, gully erosion has exposed large ice wedges (fig. 133). The gully is forming from the erosive forces of drainage water collected by the road and channeled through a culvert. Although headward erosion toward the road was still quite active in summer 1982, the lower portion of the gully is stabilizing naturally.

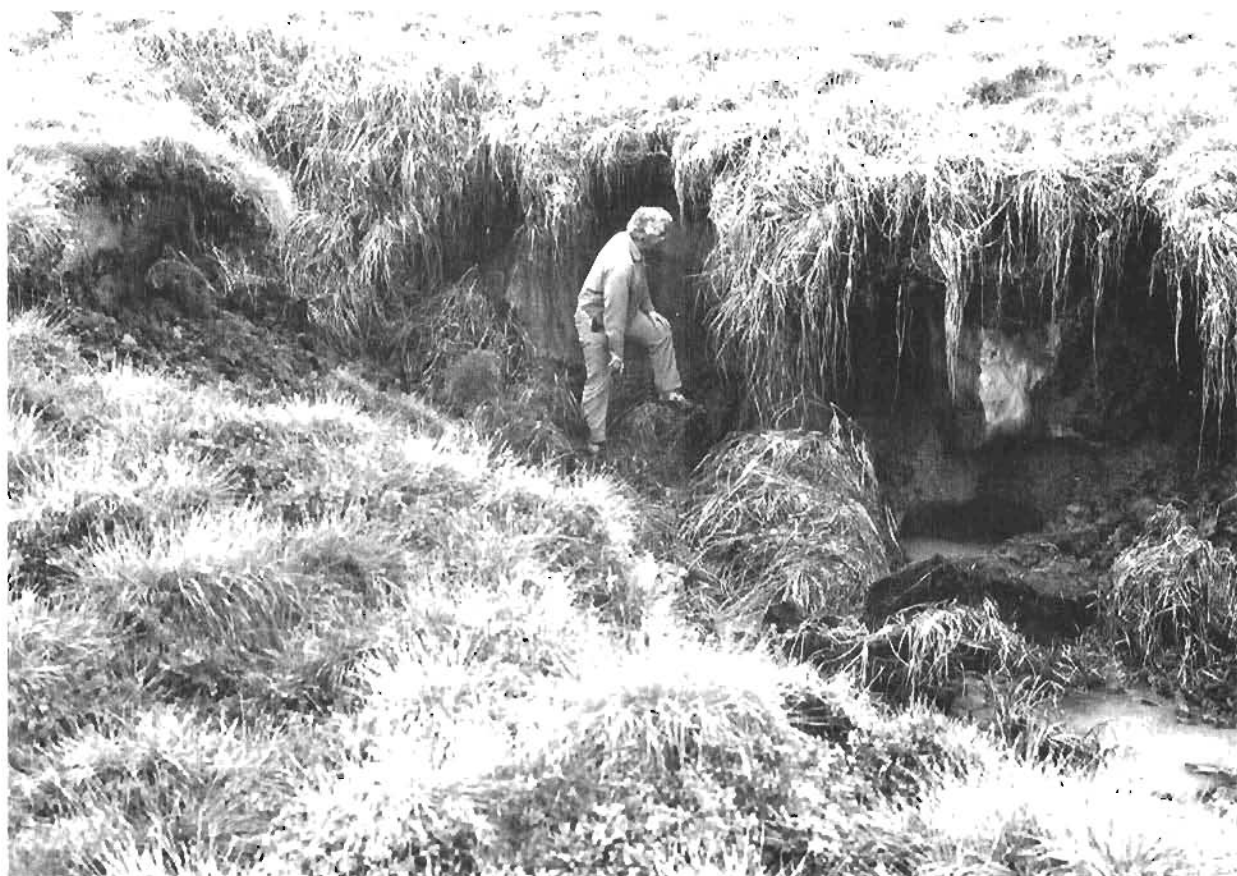
Figure 133. Gully erosion exposing large ice wedge just north of the Happy Valley cut (photograph taken by R. Veazey on July 22, 1982).

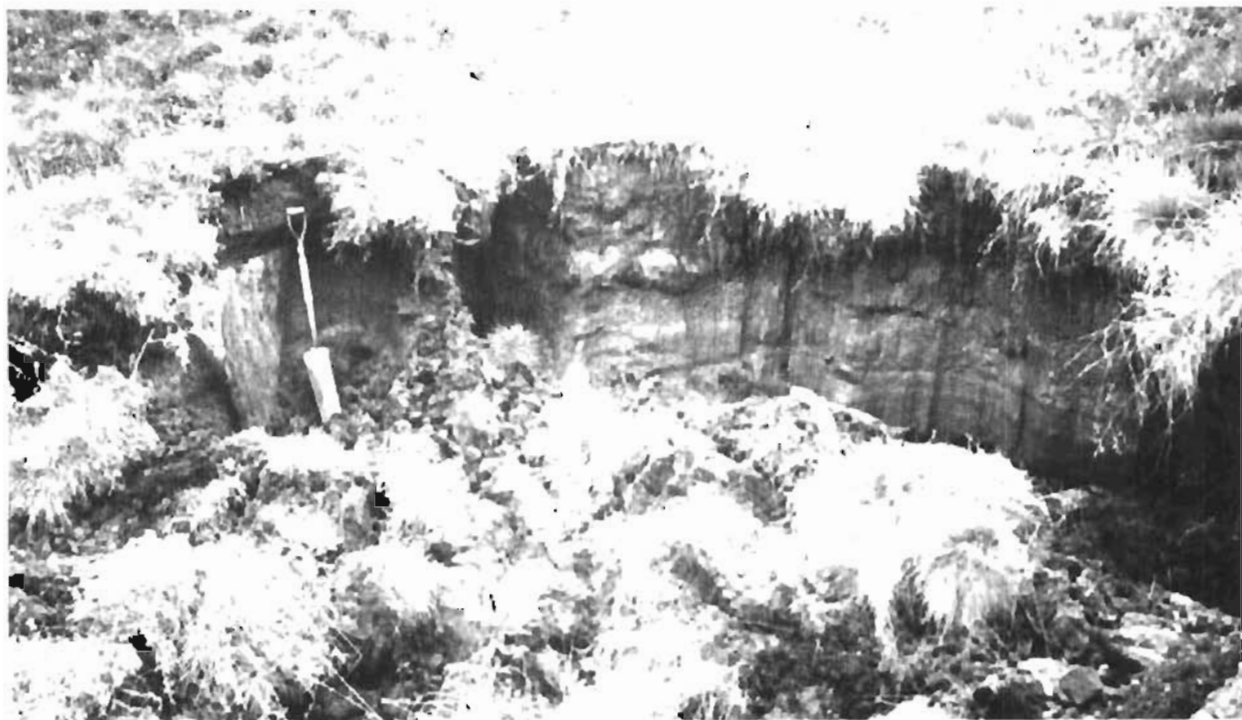
Figure 136. Gully erosion adjacent to east side of road on Sagwon upland exposed ice-rich sediment and small ice wedge (next to shovel) (photograph taken by J. Brown on July 5, 1981).

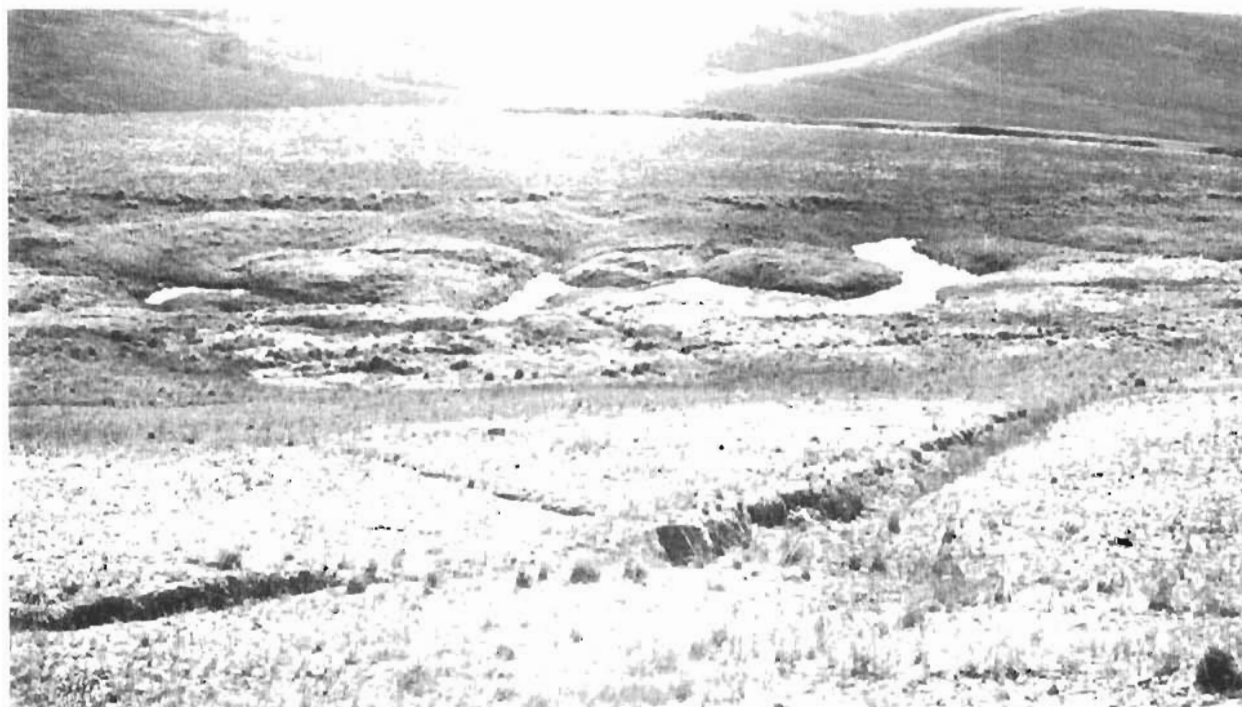
Figure 137. Large contraction cracks (foreground) were exposed during extraction of poorly cemented gravel of Tertiary age for road construction at Material Site 127-2.18. Interconnecting ice wedges have since melted to form thermokarst troughs (photograph taken by J. Brown on July 15, 1981).

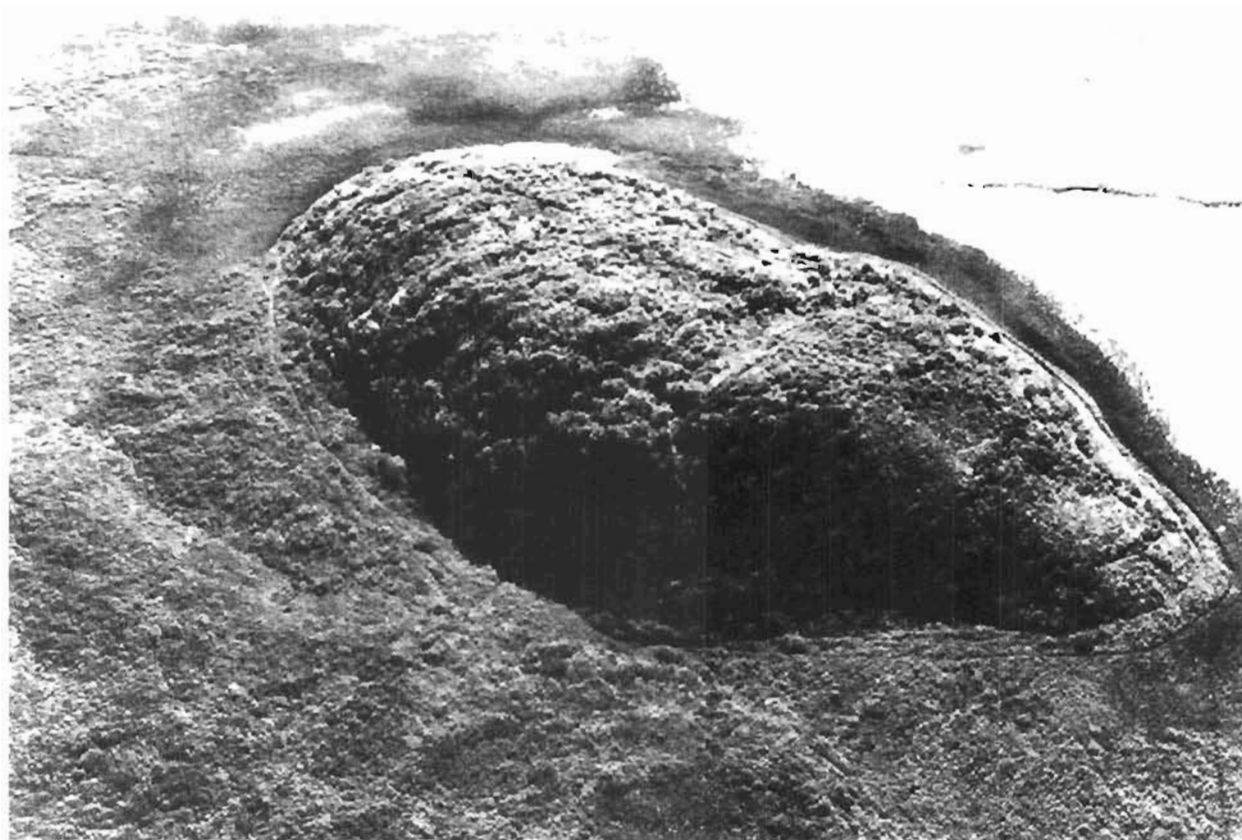
Figure 139. A relatively small pingo in the Toolik River pingo field. Such features are generally less than 5 m in height, and willows are the principal shrub on them. Note polygonal troughs on right end (photograph taken by K.R. Everett).

The small hill about 8 km west of the road is one of many pingos in the Toolik River pingo field. This field occupies an area of the lake-dotted flat terrain typical of the Teshekpuk Lake section of the Arctic Coastal Plain that projects south between segments of the White Hills. This area serves as a corridor for the present Sagavanirktok, Putuligayuk, and Toolik rivers. Regional elevation ranges between 60 and 75 m, and relative relief, excluding the pingos, ranges between 3 and 6 m. The pingos are numerous, and the concentration is probably the greatest on the North Slope. In plan, most pingos in the area are ovoid and their long axes range from 50 to over 130 m (fig. 139). There is also a considerable range in height from a few meters for

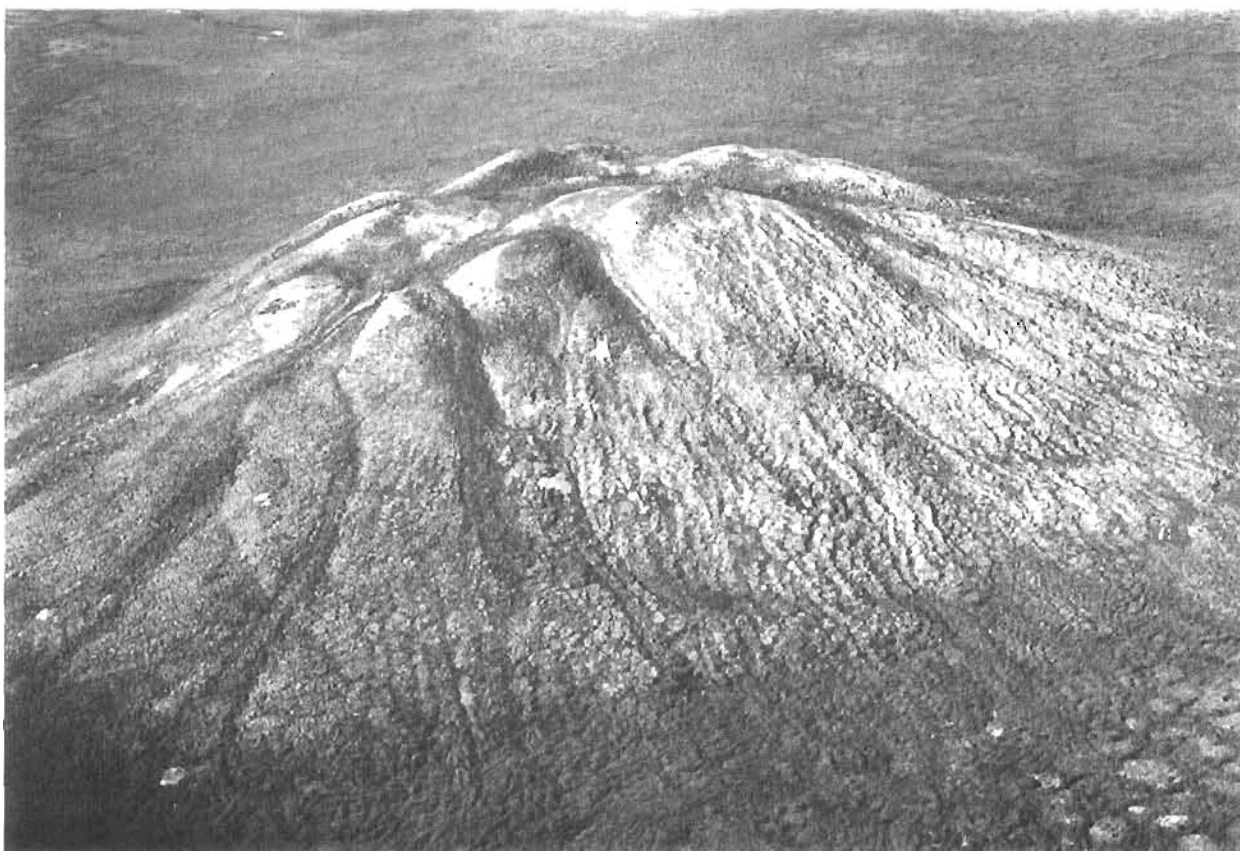
Figure 140. Percy Pingo, one of the largest pingos in the Toolik River pingo area, located approximately 5 km west of the road (photograph taken by D. Atwood on July 19, 1982).

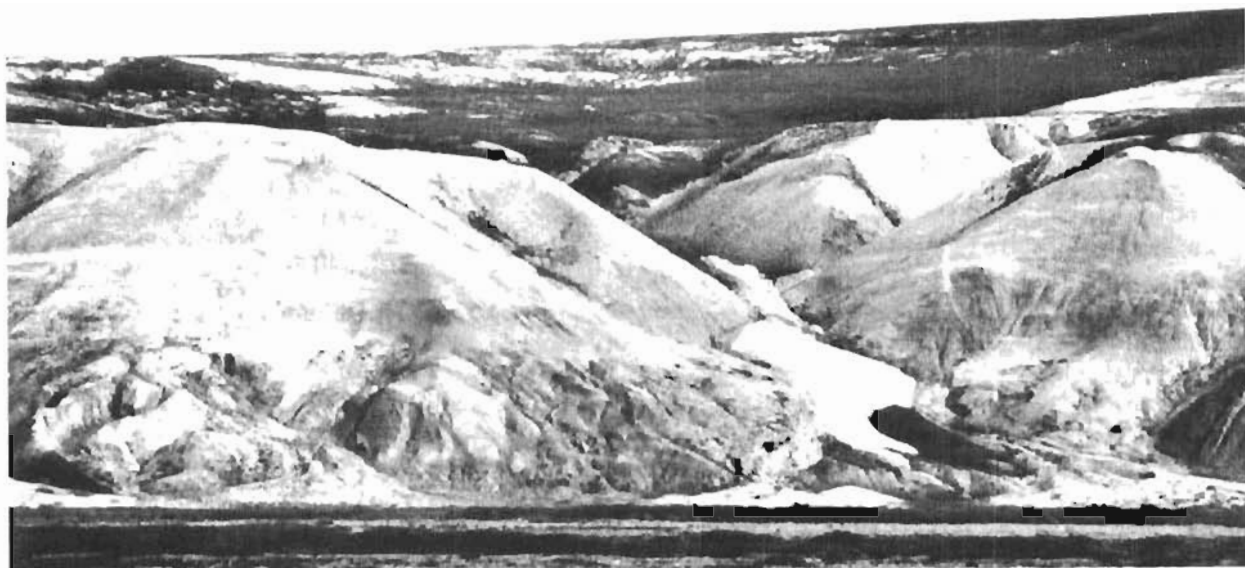
Figure 141. Franklin Bluffs with late snowbeds in July. Lower beds are siltstone, sandstone, and pebble conglomerate. Upper beds are quartz pebble conglomerate (photograph taken by G. Johns on July 15, 1981).

Franklin Bluffs may be seen to the east and a pingo to the west. Franklin Bluffs is a remnant of lower Tertiary claystone, siltstone, sandstone, and conglomerate beds (fig. 141). These units compose the lower part of the Sagavanirktok Formation. Through much of their extent, the bluffs are being actively eroded by the east branch of the Sagavanirktok River. The

orange coloration of the lower part of the bluffs reflects ferruginous, weakly indurated siltstones interbedded with relatively thin (several meters), strongly indurated gritty sandstones and pebble conglomerates. The cementing material is intensely colored by oxidized iron. These beds are undergoing badlands erosion (fig. 142). The upper part of the high bluffs is composed of a very bright, white quartz pebble conglomerate. These materials are exposed at various other locations on the bluffs and on upland positions on the foothills east of Toolik River. Their color lends the name White Hills to this physiographic section of the Arctic Coastal Plain.

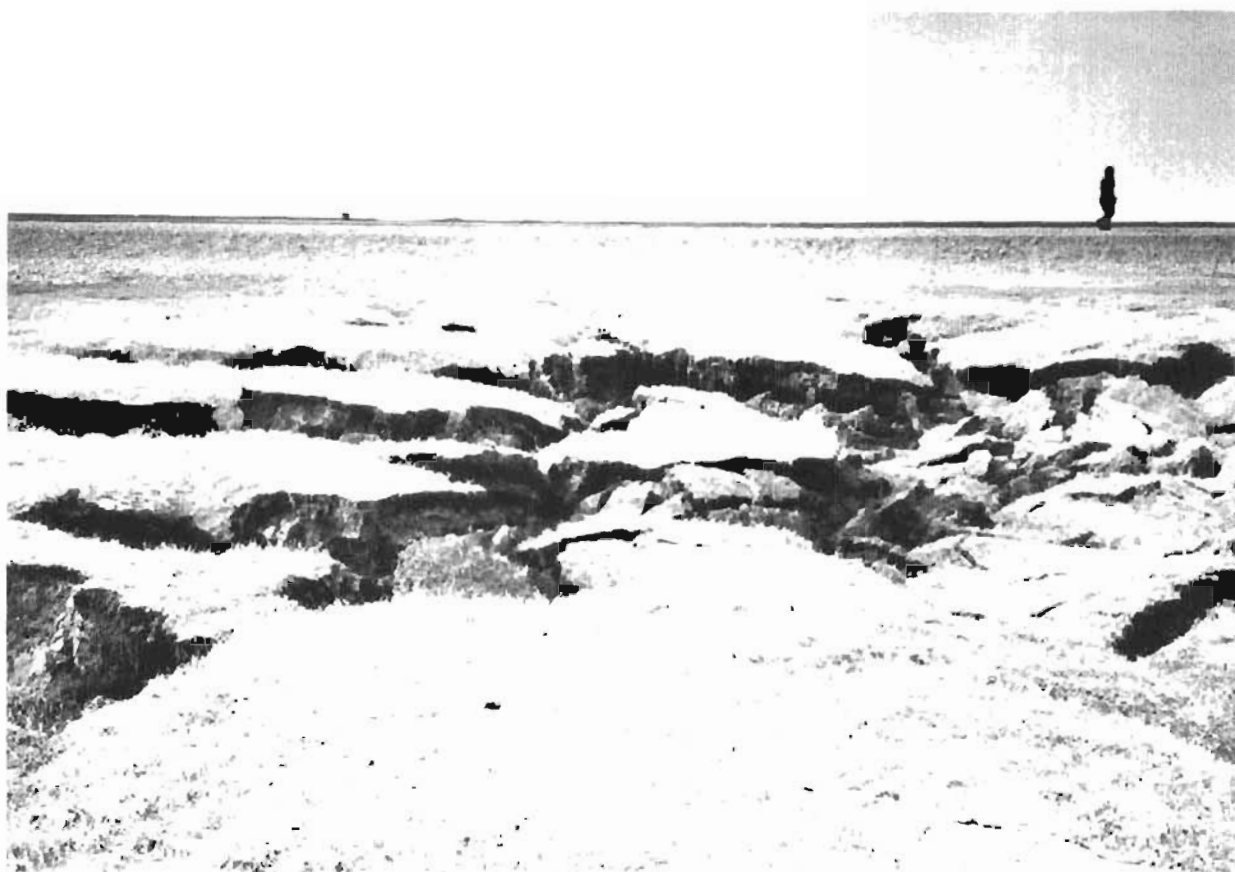
Figure 143. Erosion channels caused by melting of ice-rich permafrost adjacent to road at Material Site 135-A,B,C. Although the pattern resembles polygonal ground, some horizontally bedded massive ice was observed in the exposed cut (from Brown and Berg, 1980, fig. 31, photograph taken by J. Brown on June 24, 1976).
