Public-Data File 89-16

MATERIAL STUDIES ALONG KUSKOKWIM RIVER,
MCGRATH TO KALSKAG, SOUTHWEST ALASKA

T.K. Bundtzen, G.M. Laird, and W.G. Gilbert

Alaska Division of Geological and Geophysical Surveys

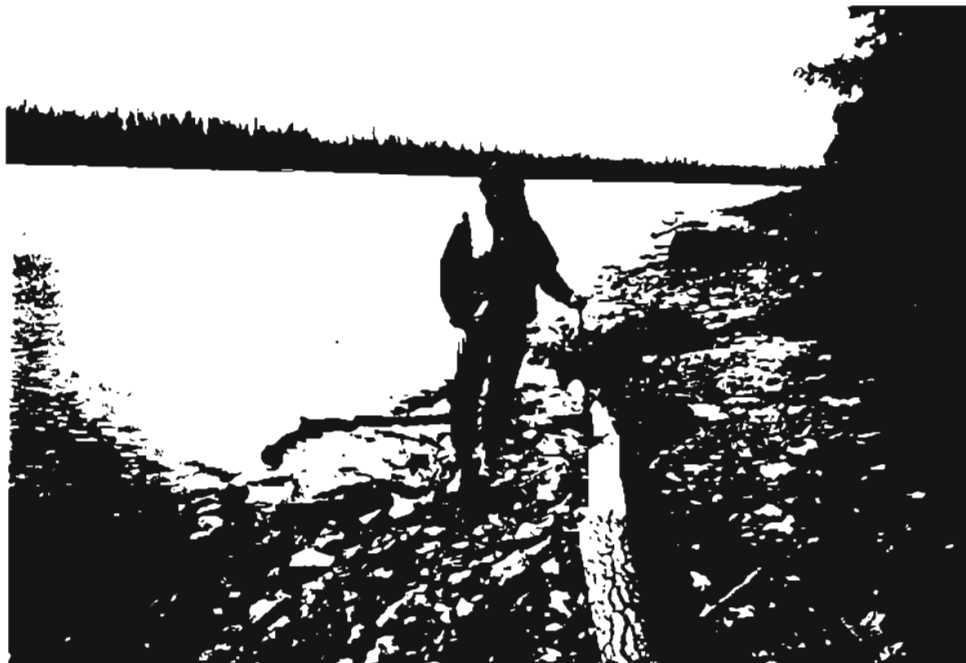
Figure 4. Photograph showing extent and physical properties of limestone rubble at sample site 87MDT1.

This locality is the first limestone outcrop on the river 8 mi upstream from McGrath at NE $\frac{1}{4}$, NE $\frac{1}{4}$, Sec. 10, T33N, R33W, McGrath D-5 Quadrangle near a homesite owned by Marcia Whitworth of McGrath (fig. 2). The limestone occurs in rubble along the beach and against a vegetated bluff about 150 ft high. No exposures of bedrock were observed or encountered in test pits (figs. 3 and 4).

Rubble consists of medium to dark gray, strongly effervescent, distinctly laminated, locally tan or bleached, rhombohedrally veined grainstone with iron-stained boundstone layers centimeters to meters thick. In thin section nearly 96 percent of the groundmass was found to be calcium carbonate with 3 to 4 percent quartz and graphite. The age is probably Devonian on the basis of correlation of similar outcrops described by Patton and others (1980) in the Medfra Quadrangle.

The laminated limestone breaks parallel to bedding into slabs 1 to 6 in. thick. Slabs vary greatly in dimension from 1 to 35 in. long, from 2 to 6 in. thick, and 2 to 80 in. wide. Over half the material is estimated to be 6 by 8 by 12 in. Beach rubble indicates the zone is about 425 ft long, 375 ft of which includes coarse material. In terms of size, some of the material could pass DOTPF Class I riprap specifications, but because no coherent bedrock was found in place, quarry potential would need to be determined by subsurface investigations. A 45 lb sample submitted to the DOTPF Anchorage materials lab yielded a T-13 Degradation value of 47, which exceeds slightly minimum DOTPF standards recommended for riprap.

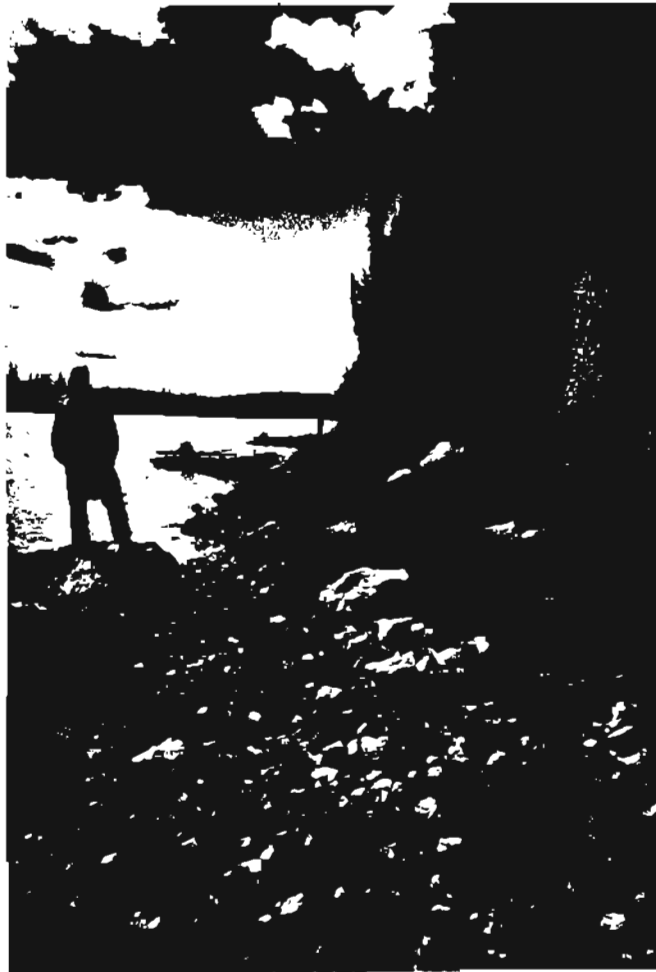
Figure 10. Photograph of limestone rubble upstream from sample site 87MDT7.

Exposures consist of heavily veined, light-to-medium gray, micritic limestone--variation boundstone. Bedding strikes N33°W and dips 30°SW. Lag and rubble upstream from the outcrop contain concretionary layers and zones up to 18 in. diam (fig. 10).

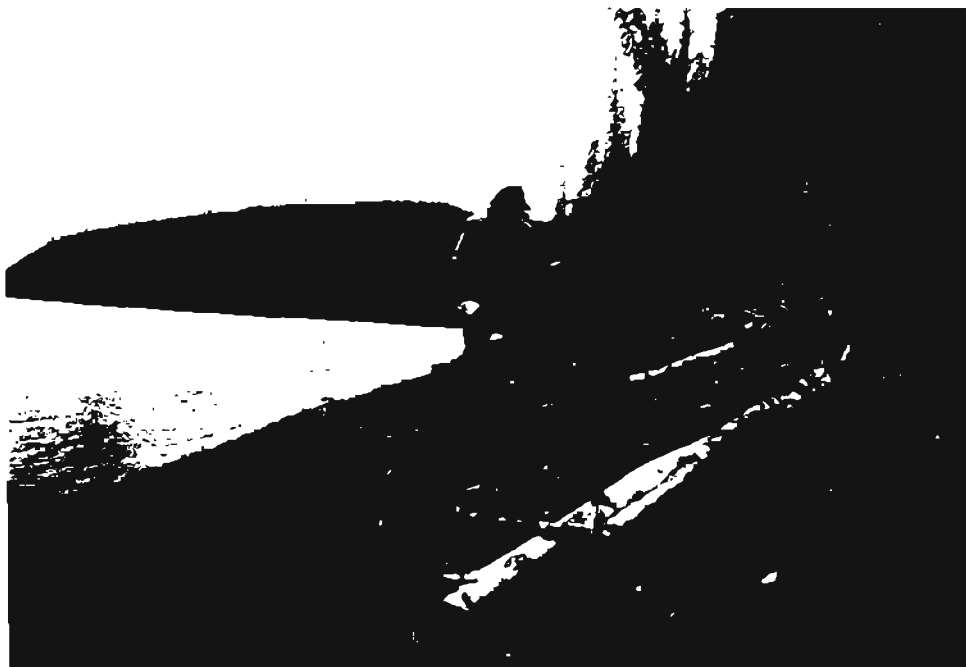
Figure 11. Photograph showing sheared, fine-grained sandstone and shale at sample site 87MDT3; similar to sample site 87MDT2.

Two sites along a near-continuous exposure of Kuskokwim Group sedimentary rocks were examined along the north side of the river 6 to 10 mi upstream from McGrath (fig. 2). The semi-continuous exposures occur on a steep inclined bedrock ramp 30 to 100 ft above mean high water mark of Kuskokwim River (fig. 11).

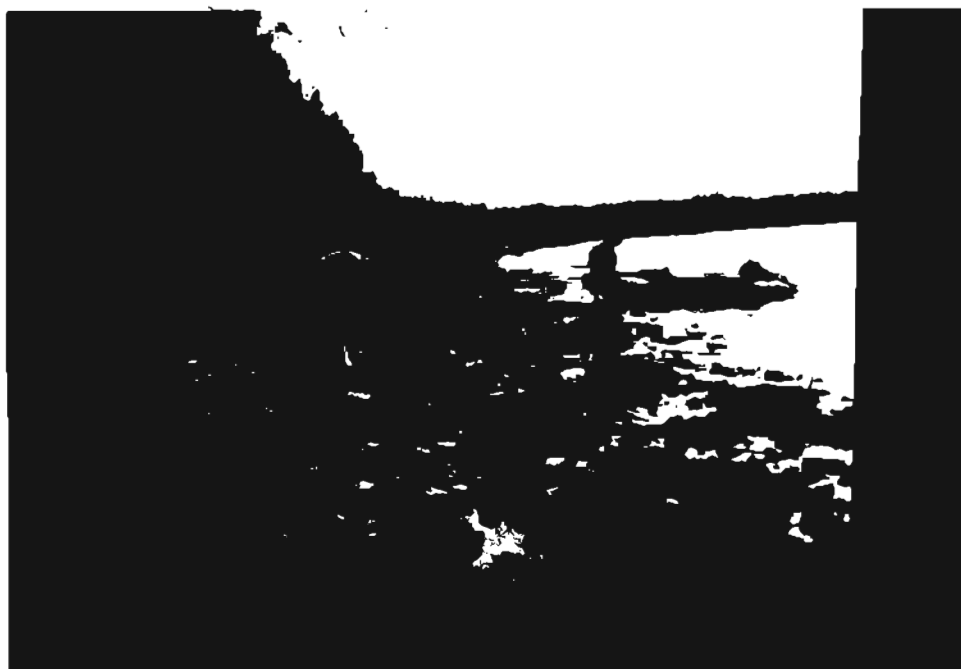
Figure 17. Photograph showing residual sandstone blocks on beach at sample site 87MDT14.

A conjugate joint set--striking N7°E, dipping 80°SE and striking N68°E, dipping 55°SE--breaks sandstone lenses into relatively large blocks ranging from 4 by 4 by 2 in. to 4 by 6 by 6 in. Bank armor rock is platy with flattened surfaces parallel to bedding planes. The sandstone section contains material passing Class I riprap specifications but the sandstone does not contain desirable length-width ratios. The bluff is an intact block measuring 250 by 90 by 450 ft and contains a conservative estimate of 375,000 yd³ of sandstone and siltstone about 75 percent of which is the former lithology (fig. 17). No degradation tests are available from the site.

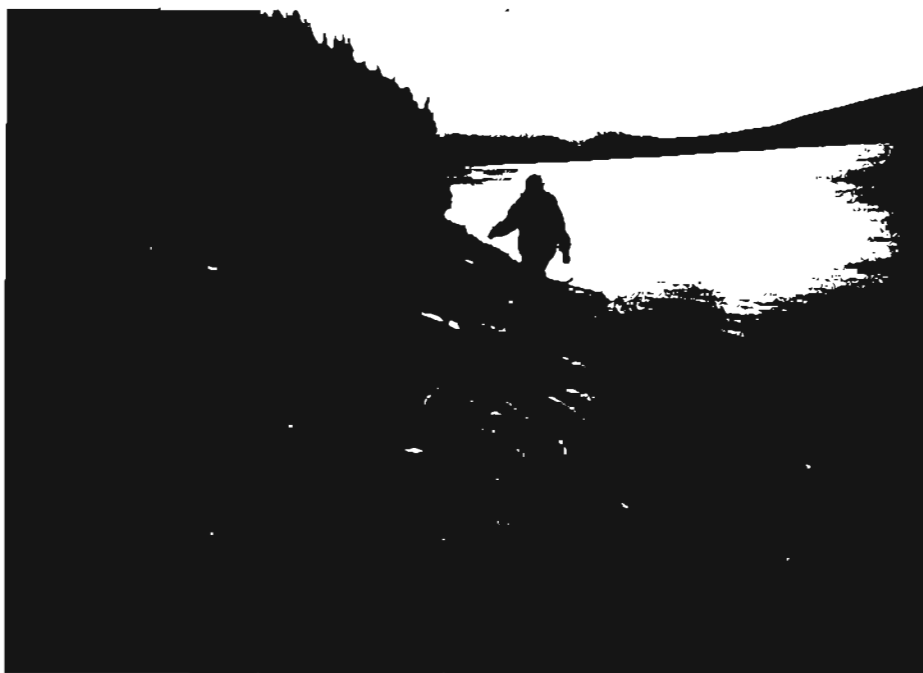
Figure 24. Rubble from rhyolite dikes at sample site 87MDT21.

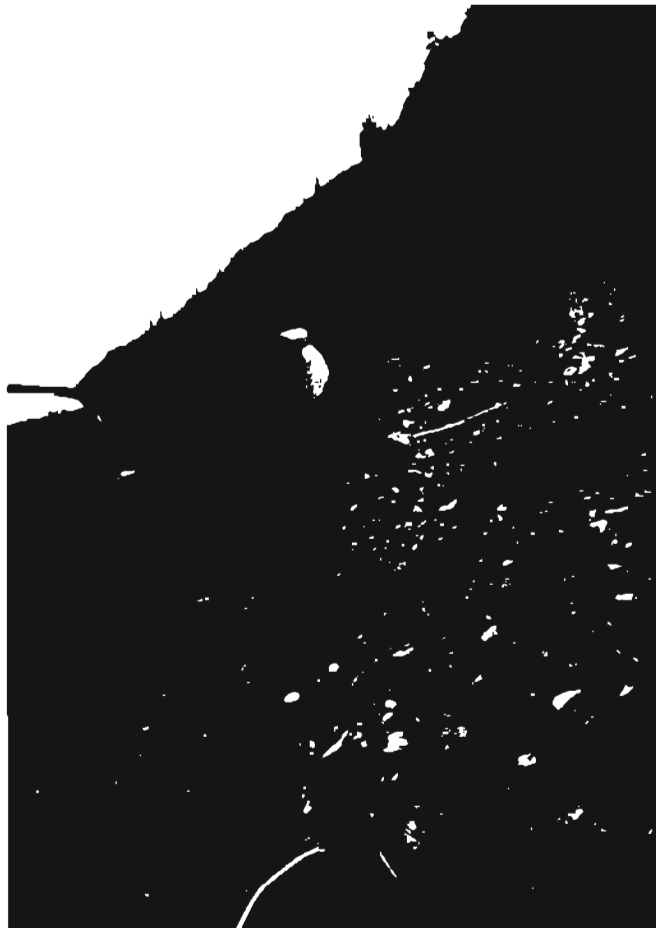
Figure 30. Rubble clasts of turbidite section at sample site 87MDT30 near Kolmakof River.

Well-exposed outcrops consist of coarse lithic sandstone and highly micaceous siltstone striking N50°E and dipping 40°-45°NW (fig. 30). On the basis of graded bedding and flutes, the section appears to be right-side-up. Several Inoceramus shells were identified in beach rubble, confirming the section is Late Cretaceous in age. In thin section, sandstones are mainly composed of clasts of sedegenic origin. Subangular clasts are chert (35 percent), polycrystalline quartz (30 percent), white mica (2 percent), volcanics (5 percent), slate clasts (15 percent), graphite (6 percent), prehnite (4 percent), and calcite (3 percent).

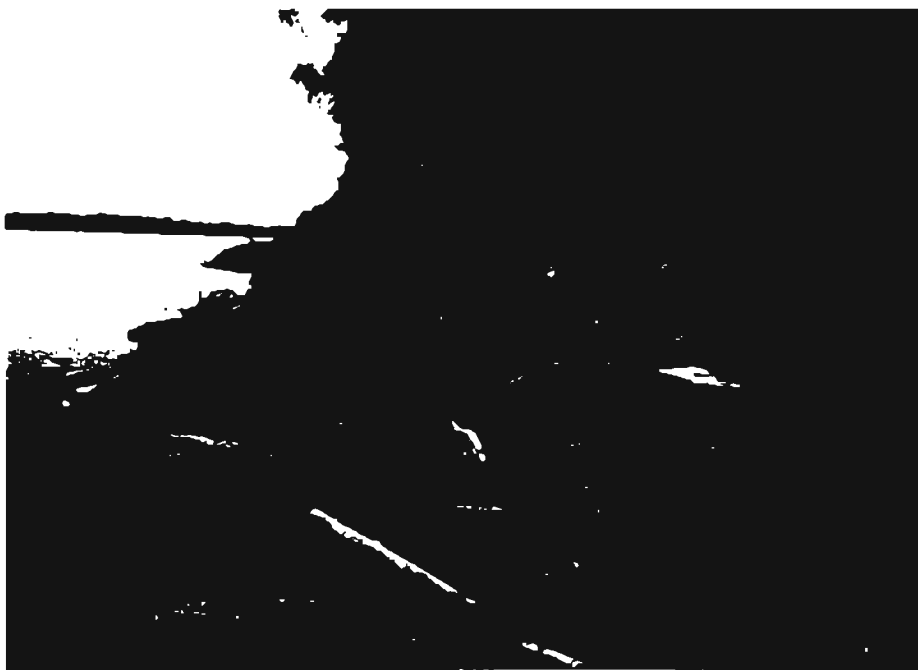
Figure 36. Blocky basalt sill at sample site 87MDT33.

Dikes have a well-developed 'columnar-like' joint set with N12°W striking 60°NE dipping, N30°E striking 30°SE dipping, and N5°E striking 30°NW dipping orientations (figs. 35 and 36). Evenly spaced joints have created large blocky material averaging 6 by 10 by 12 in. The largest dike has a surface dimension of 55 by 70 by 70 ft and the eastern subsidiary dike has a measured dimension of 25 by 75 by 45 ft. Total inferred volume at the beach is about 13,125 yd³; incremental additions to this resource are probable but not assured when one considers the irregularities of dike swarms in the area. At least 85 percent of the dike material qualifies in terms of size as Class I riprap and nearly 40 percent achieve Class II size specifications. However, a 65 lb sample of basalt from this site yielded a T-13 degradation value of only 10--far below the minimum (45) recommended by DOTPF for riprap applications (table 1). We have no explanation why the material performed so poorly in lab testing and additional lab work is suggested.
