PUBLIC-DATA FILE 94-37

**THE BIRCH CREEK, MILE 101 STEESE HIGHWAY PLACER MINE
RECLAMATION PROJECT: YEAR ONE RESULTS, 1993
Interim report to USEPA Region X**

Edmond C. Packee Jr.
Graduate Student
School of Mineral Engineering
University of Alaska Fairbanks

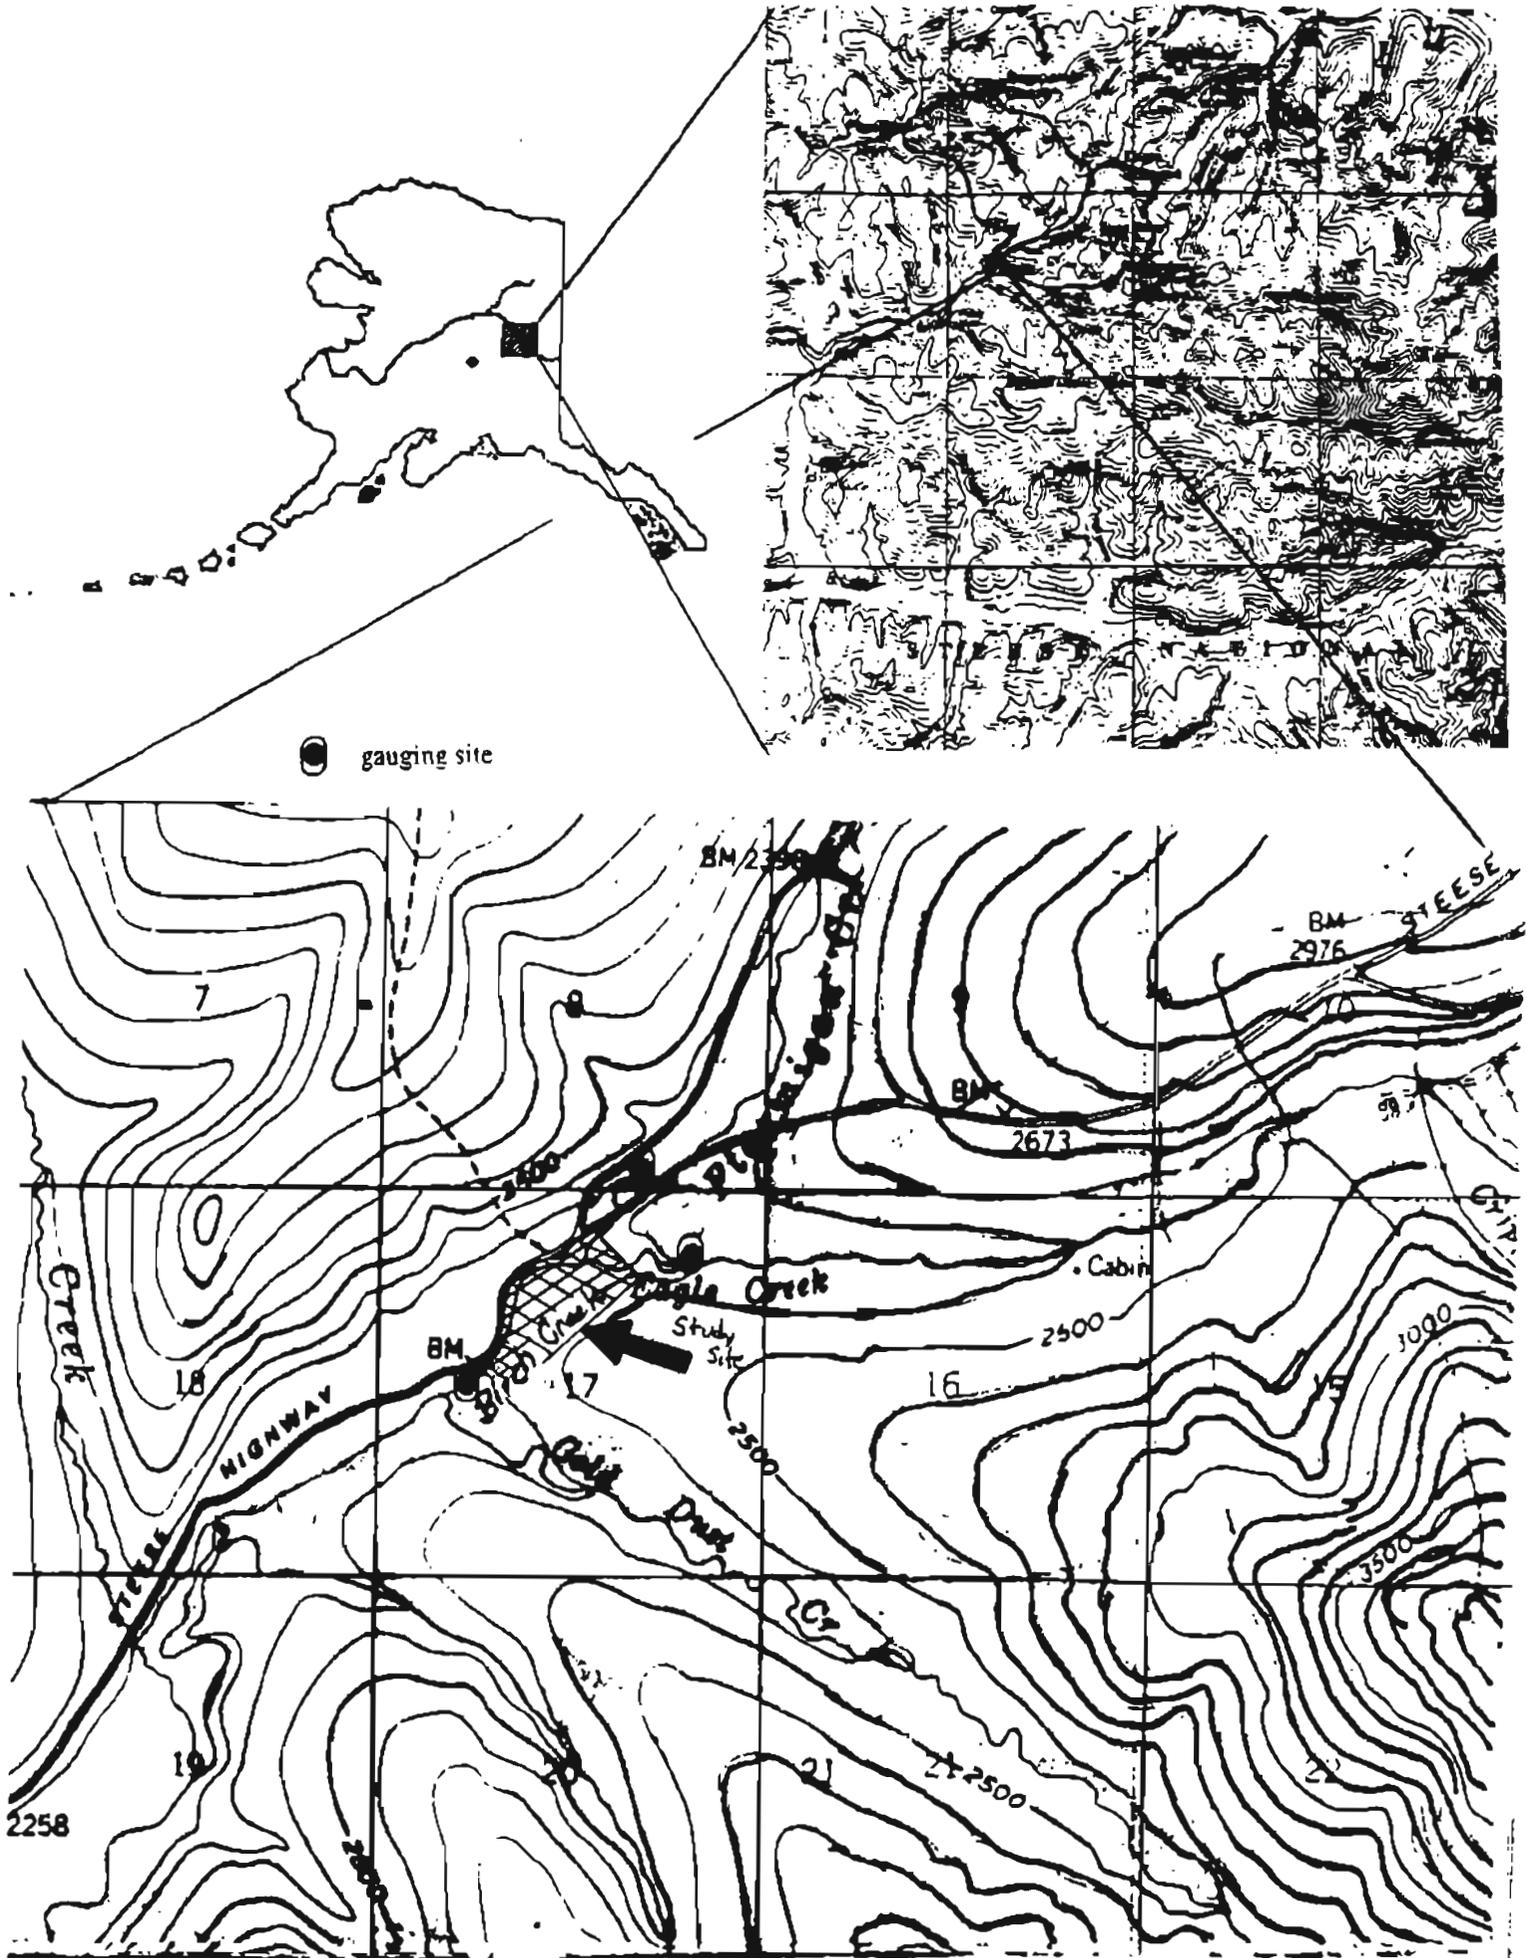
Figure 1. Location of Birch Creek, 101 Mile Steese Highway project and gauging sites.

The EPA 319 study site shown in Figure 1, an abandoned placer mine on Birch Creek, is located approximately 100 miles northeast of Fairbanks, between mileposts 101 and 102 of the Steese Highway. The legal location of the study site is the flood plain of Birch Creek and Eagle Creek south of the Steese Highway, from milepost 101 of the Steese Highway to a claim boundary located 500 feet southwest of the Ptarmigan Creek Bridge, Section 17, Township 7 North, Range 11 East, Fairbanks Meridian. Placer mining permits, obtained from the Alaska Department of Natural Resources, Division of Mining, indicate that three sets of State mining claims were staked in this area. The State mining claims were abandoned by 1986. Land patented under the General Mining Law of 1872 (P.L. Stat. 91), is adjacent to the study site between Ptarmigan Creek and the Steese Highway, downstream of the Steese Highway bridge (U.S. Location Monument No. 5002). The historic operational status of this patent is unknown. The Birch Creek site is assumed to be representative of abandoned placer mines in Interior Alaska.

Prior to field investigations, aerial photographs of the Birch Creek site were obtained by ADEC. Aerial photographs taken in 1989 for the Alaska Division of Mining, and aerial photographs taken during mapping programs in 1951 and 1972 were obtained from the Geophysical Institute at the University of Alaska Fairbanks. In conjunction with the Alaska Division of Mining's normal aerial photographing schedule, aerial photographs of the site in August 1993 were obtained. The project work group conducted a visual inspection of the Birch Creek site during breakup in May 1993. During this inspection it was determined that the gauging sites located on Ptarmigan Creek and Eagle Creek, selected by the Alaska Division of Water during the 1992 field season, would also be utilized for the Birch Creek project. A new gauging site (Birch Creek below Reclamation) was added downstream of the Birch Creek Site, near the mouth of the Gold Dust Creek valley. (see Figure 1.)

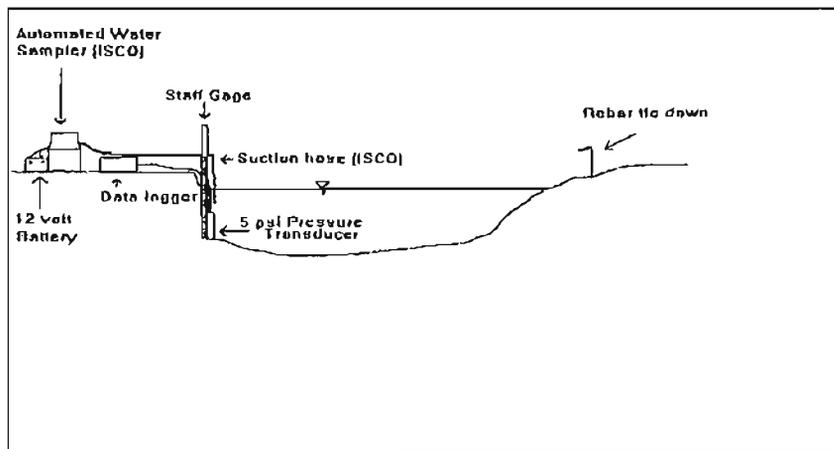
Figure 2. Typical gauging site and equipment used at the Birch Creek Reclamation site.

suspended solids and turbidity. Water was collected four times daily at 6 hour intervals to obtain a daily average sample. Samples were collected using an automated water sampler (ISCO Inc. Lincoln Nebraska). A 5 psi pressure transducer, connected to a data logger (Data pod) was installed to record changes in water surface elevation across the control section. A flow measurement transect, consisting of a staff gage and attachment points for a fiberglass tape, were set-up at each site. Bedload sampling was performed with a Helley Smith bedload sampler along the flow measurement transect. Shortly after installation, the Eagle Creek flow measurement station was moved approximately 1500 feet downstream due to turbulent flow near the gage site. A typical gauging site is shown in Figure 2.

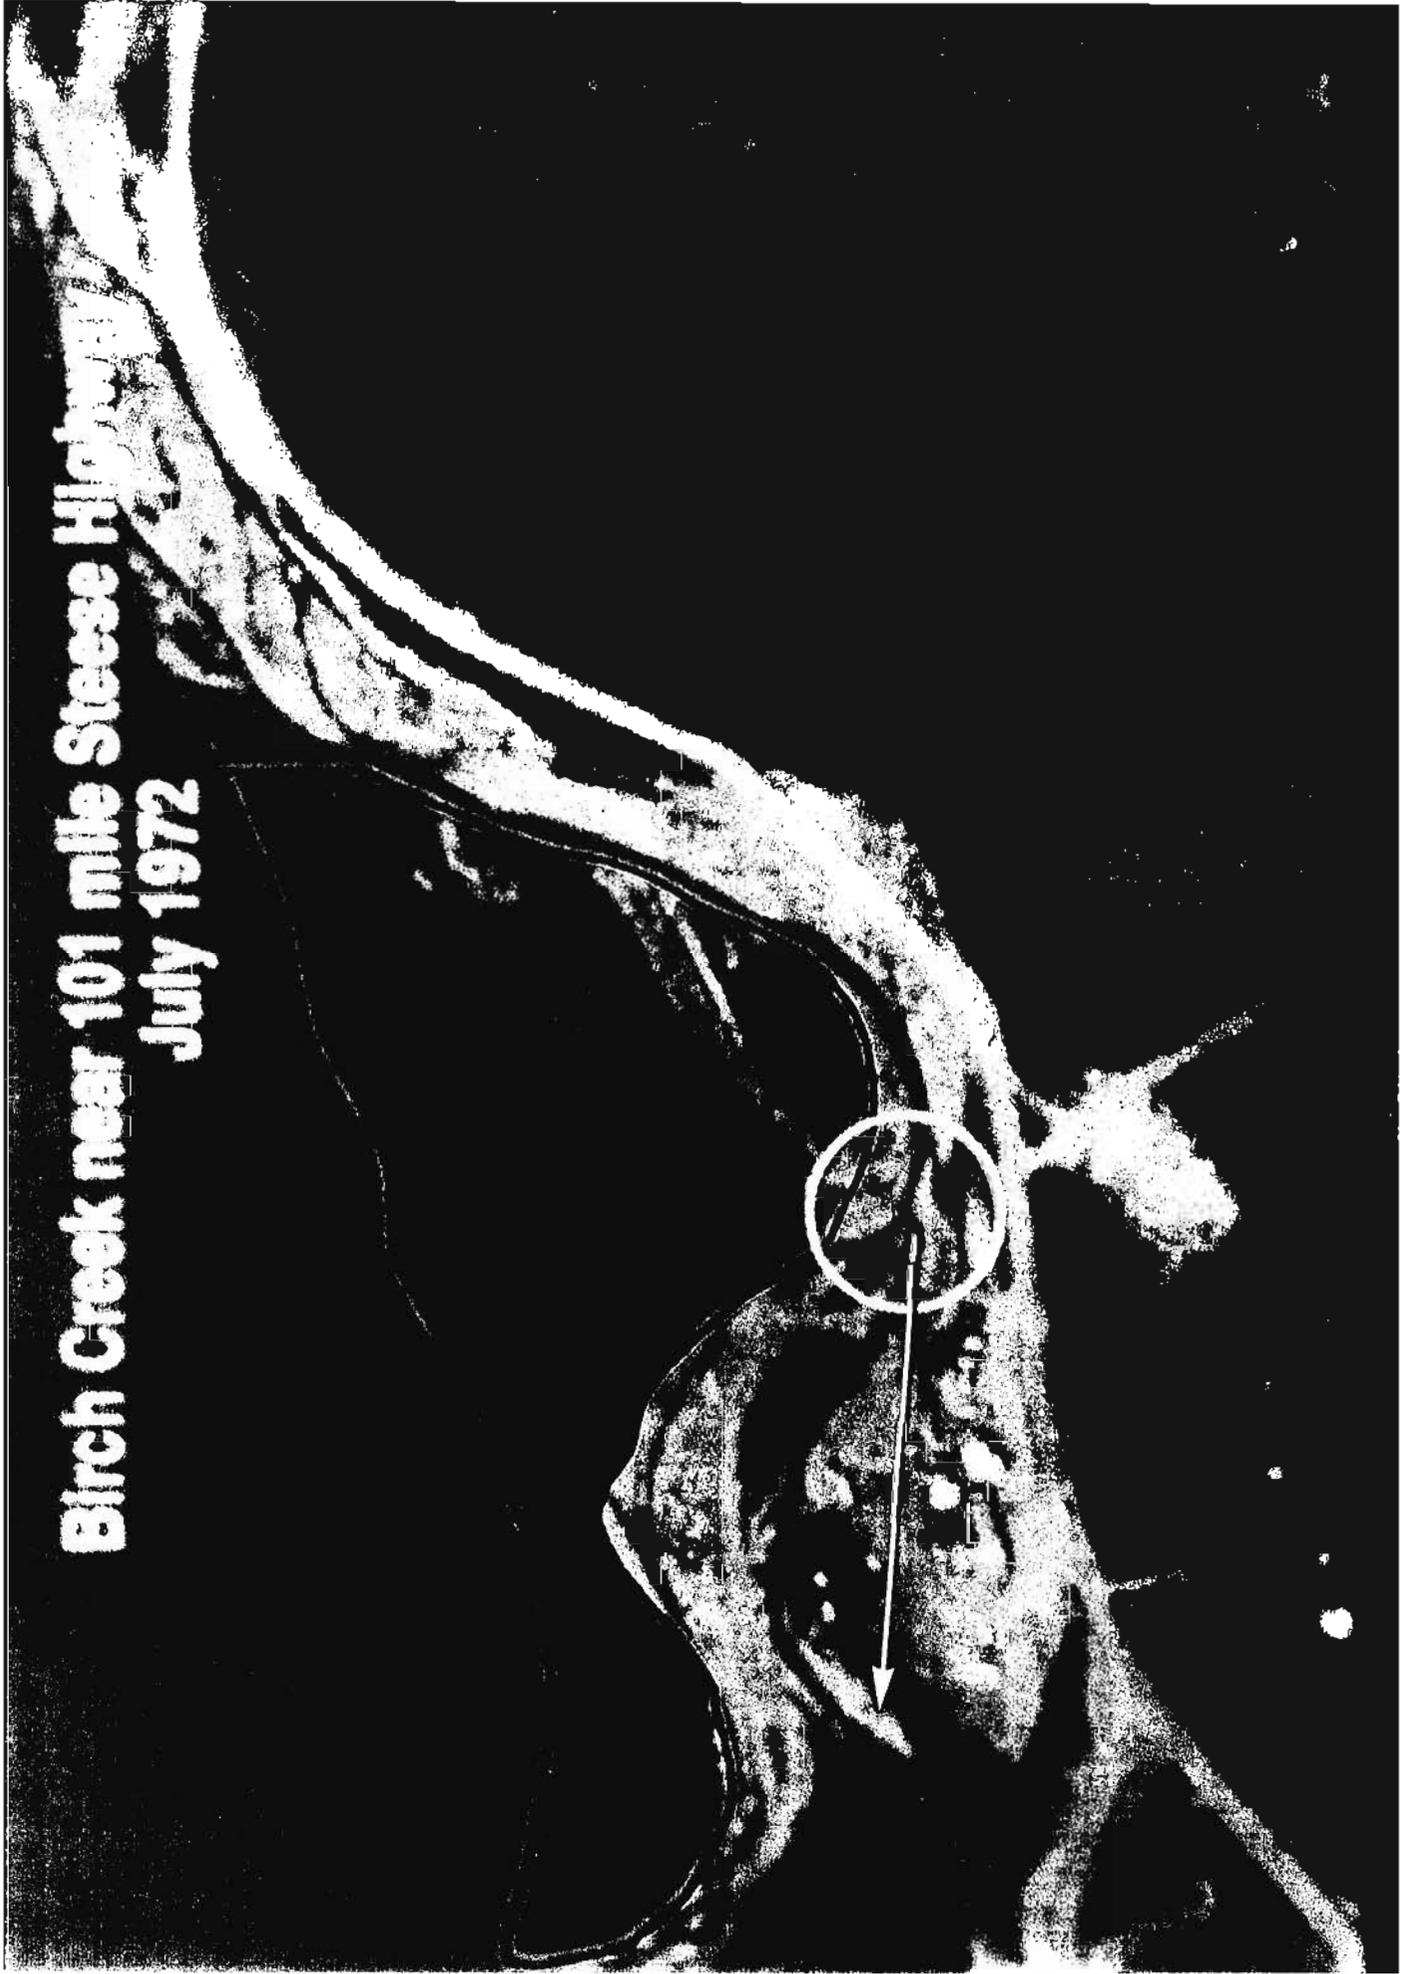
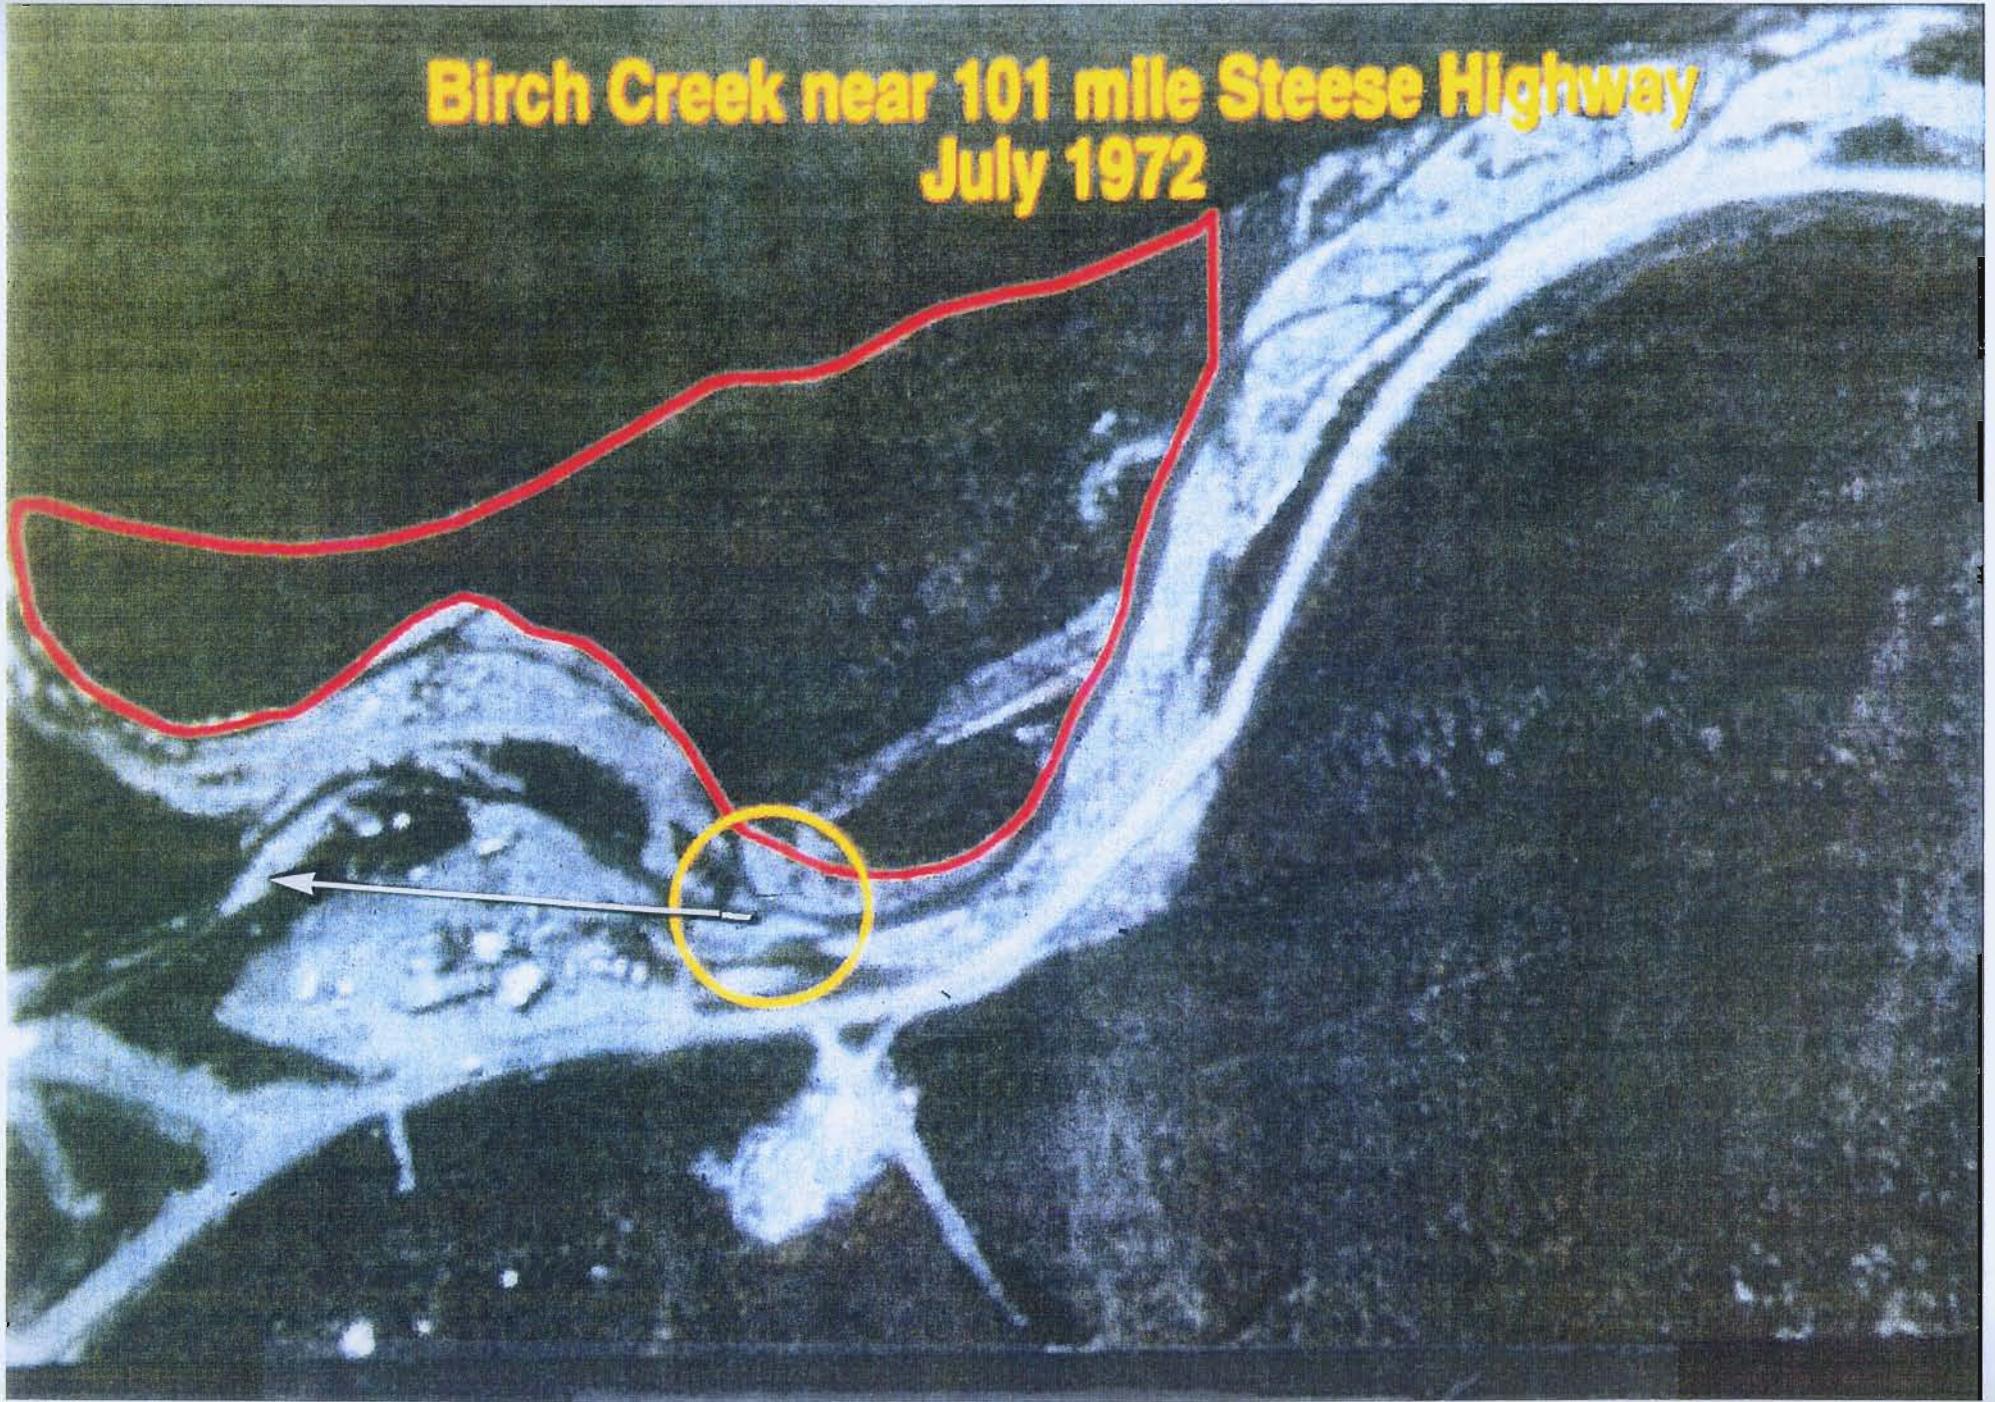
Figure 4. Upper Birch Creek Near 101 Mile Steese Highway (July 1972)

Figures 3 - 6 show available aerial photographs of the Birch Creek site. The aerial photograph taken in 1951 (Figure 3) shows the upper Birch Creek watershed in a relatively undisturbed condition. The 101 Mile Lodge and the Steese Highway are visible, and the approximate boundaries of the current Birch Creek Site are also shown. The 1972 aerial photograph (Figure 4) was taken during the reconstruction of the Steese Highway, during which, a bridge was constructed over Ptarmigan Creek and a section of road was built across the flood plain of Birch Creek downstream of the 101 Mile Lodge. Between 1951 and 1972, Ptarmigan Creek appears to have migrated laterally towards the lodge. The outlined area shows the vegetation that was stripped during subsequent placer mining operations. The large arrow shows subsequent movement of the confluence of Eagle Creek and Ptarmigan Creek. The confining influences of spoil piles in the Eagle Creek and Birch Creek flood plains are shown in the 1989 aerial photograph (Figure 5). Placer mining operations appear to have been confined to Eagle Creek and the southern limits of the Birch Creek flood plain. The new location of the Eagle Creek channel has caused sediment deposition at the confluence with Ptarmigan Creek (outlined), and lateral migration of Ptarmigan Creek towards the Steese Highway (small arrows). The presence of spoil piles prevents Eagle Creek from migrating laterally away from Ptarmigan Creek. The aerial photographs taken by the Alaska Division of Mining in 1993 (Figure 6) show continued growth of the alluvial fan (outlined), at the confluence of Eagle Creek and Ptarmigan Creek. The lateral migration of Ptarmigan Creek appears to have slowed. However, lateral migration of Eagle Creek (small arrows) has forced the channel into the spoil piles, causing downstream bank erosion. The location of the six cross sections are shown in Figure 6.

Aerial photographs of the upper Birch Creek basin show the impacts man's activity can have on riparian systems through time. The Ptarmigan Creek bridge, built in 1972 during reconstruction of the Steese Highway, has apparently stopped lateral channel migration of Ptarmigan Creek. The elevated Steese Highway subgrade reduces the areal extent of the Birch Creek flood plain near milepost 101. Hence flood flows are concentrated in the existing channel-flood plain system.

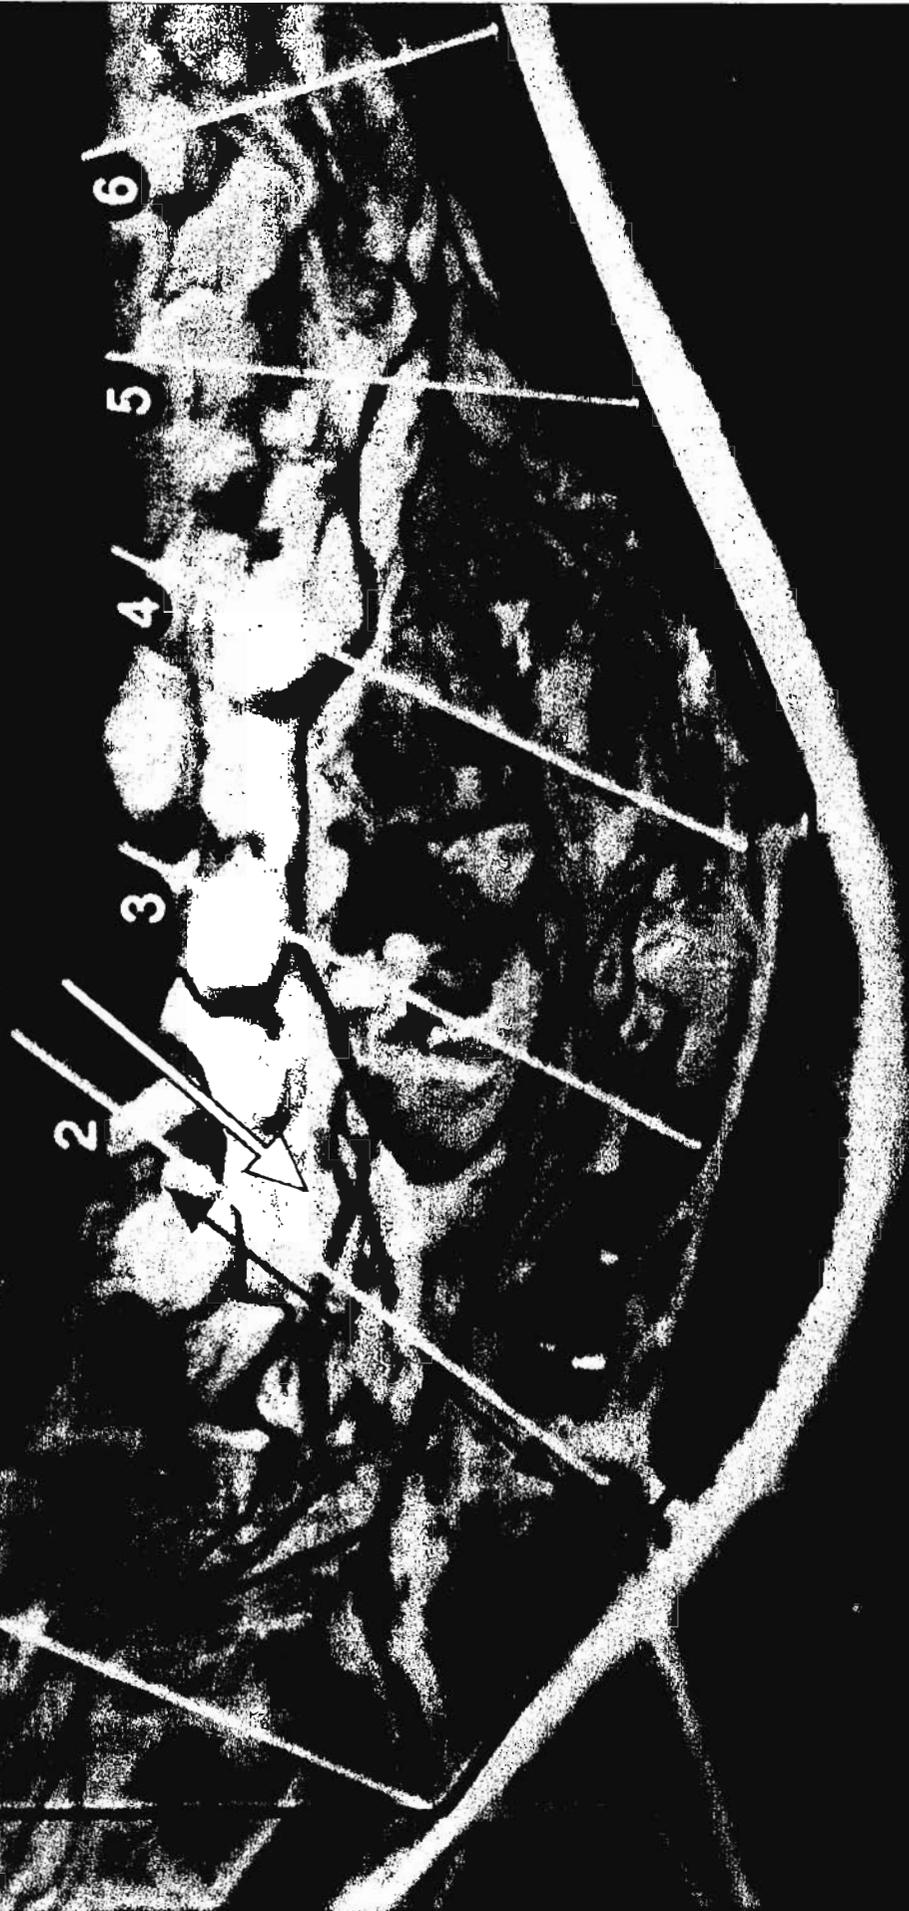
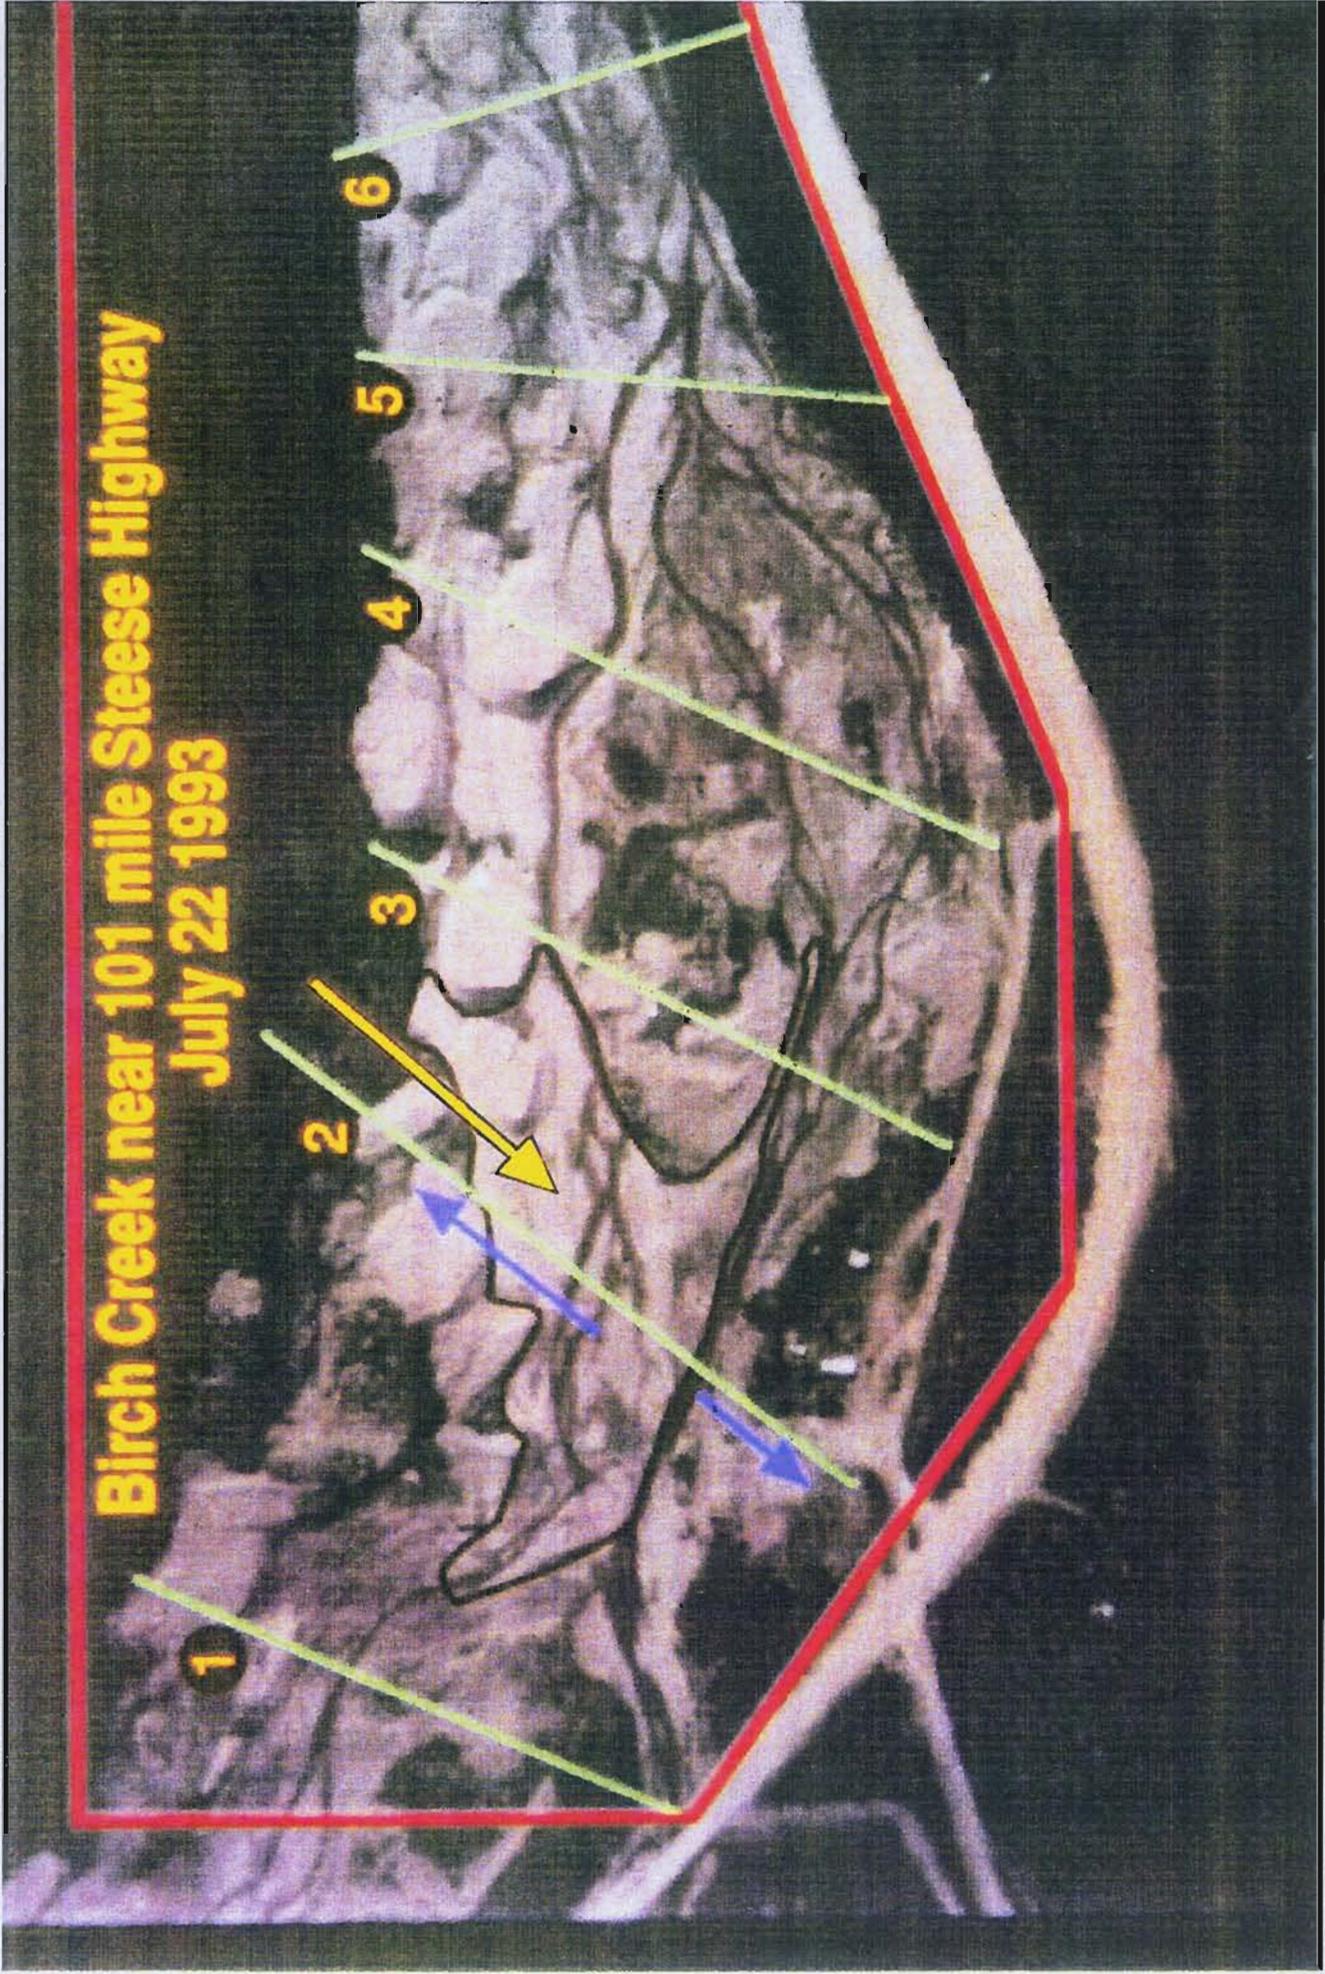
Figure 6. Upper Birch Creek Near 101 Mile Steese Highway (July 1993)

The water surface profiles prior to reclamation work are plotted in Figure 7. Eagle Creek has a gradient of 0.018 ft/ft and Ptarmigan Creek has a gradient of 0.012 ft/ft. Birch Creek and Ptarmigan Creek have similar gradients through the Birch Creek site (0.012 ft/ft and 0.014 ft/ft, respectively). Birch Creek changes gradient downstream of the project site from 0.0114 ft/ft to .0167 ft/ft, a gradient closer to that of Eagle Creek. The loss of 0.06 ft/ft gradient between Eagle Creek and Ptarmigan Creek reduces of stream energy at the confluence, causing the deposition of sediment and formation of the alluvial fan seen in Figure 5 and Figure 6.

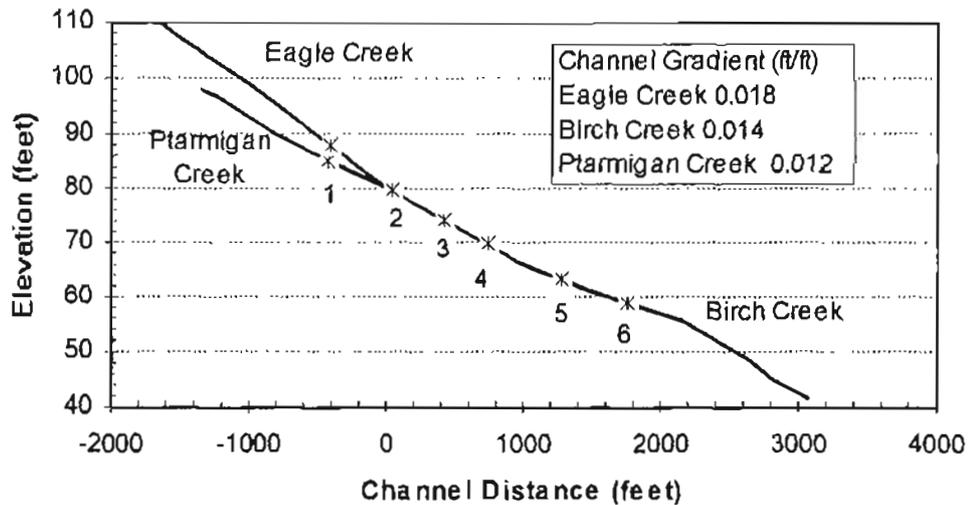
Figure 7. Water Surface Profile Prior to Reclamation of the Birch Creek site.
 * Numbers correspond to surveyed cross sections.

Surveyed channel gradients at the Birch Creek site indicate the presence of 0.06 ft/ft loss in gradient between Eagle Creek and Ptarmigan Creek. Sediment deposition and alluvial fan formation (Figure 5 and Figure 6) indicate a reduction of stream energy at the confluence of Eagle Creek and Ptarmigan Creek.

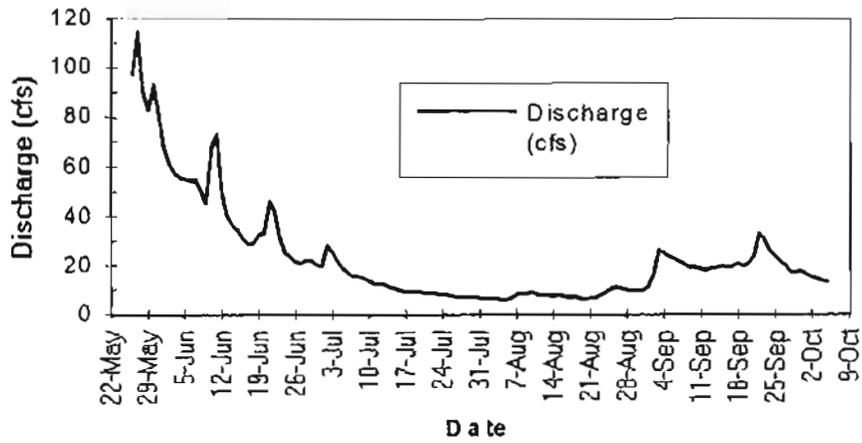
Figure 8. Ptarmigan Creek daily average discharge (1993)

hydrograph from 1 July until late August indicates little precipitation occurred over the upper Birch Creek drainage. The flood event of 2 September was a rain on snow event. Figures 8-10 are the seasonal hydrographs for Ptarmigan Creek, Eagle Creek, and Birch Creek. Daily average discharge values for the three gauging sites are found in Appendix D.

Daily average discharge for Ptarmigan Creek varied between 115 cfs (27 May) and 6.0 cfs (5 August). The Ptarmigan Creek hydrograph (Figure 8) indicates the absence of runoff generating storms in the Ptarmigan Creek basin from 3 July until 2 September.

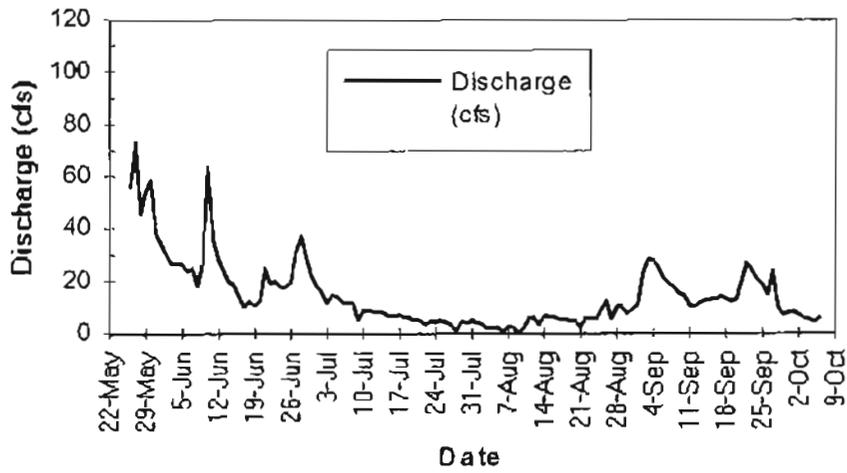
Figure 9. Eagle Creek daily average discharge (1993).

Daily average discharge for Eagle Creek varied between 73 cfs (27 May) and 0.44 cfs (9 August). As with Ptarmigan Creek, the Eagle Creek stream flow hydrograph indicates the absence of runoff generating storms between 3 July and 2 September. Impacts of active placer mining operations on Eagle Creek can be seen in the stream flow hydrograph for Eagle Creek (Figure 9). Contrasted to the smooth recession curve evident in the stream flow hydrograph for Ptarmigan Creek, the recession curve for Eagle Creek is irregular. Water demand for active placer operations coupled with low precipitation, necessitated surface water withdrawal into recycle ponds. The withdrawals, commonly lasting less than two hours, account for the irregularities in the Eagle Creek hydrograph.

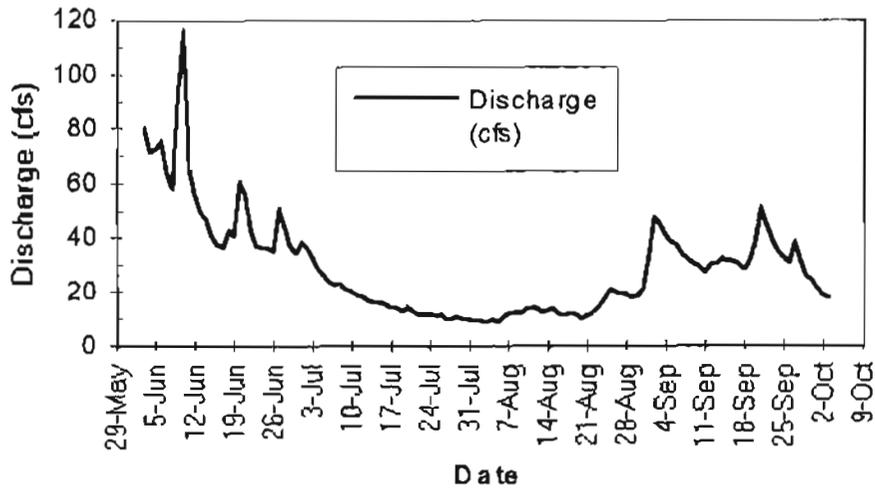
Figure 10. Birch Creek daily average discharge (1993).

Daily average discharge for Birch Creek below the reclamation site varied from 116 cfs (10 June) and 8.6 cfs (3 August). Assuming no losses between gauging sites, discharge at the Birch Creek gauge should be equal to the combined discharge at the Eagle Creek and Ptarmigan Creek gages. Figure 14 shows the discharge at the Birch Creek gage plotted as a function of the combined discharge of Eagle Creek and Ptarmigan Creek gages.

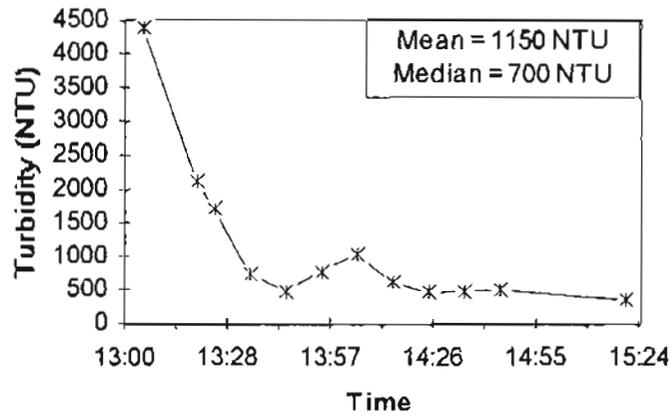
Figure 11. Turbidity at New Eagle Creek Channel Site during Eagle Creek channel realignment. (9 October 1993)

Results of sediment sampling (10 minute intervals) at a site in the constructed Eagle Creek channel and at Birch Creek are shown in Figures 11 and Figure 12, respectively. Raw turbidity values for both sites can be found in Appendix C.

The peak turbidity in the new Eagle Creek channel was 4500 NTU. Turbidity decreased linearly to 500 NTU 45 minutes after the initiation of flow at the gauge in the new Eagle Creek channel. The rise to 1000 NTU after 65 minutes probably indicates the arrival of the full Eagle Creek discharge at the sampling station. Turbidity appears to gradually decrease, presumably to near baseline levels (see Figure 11).

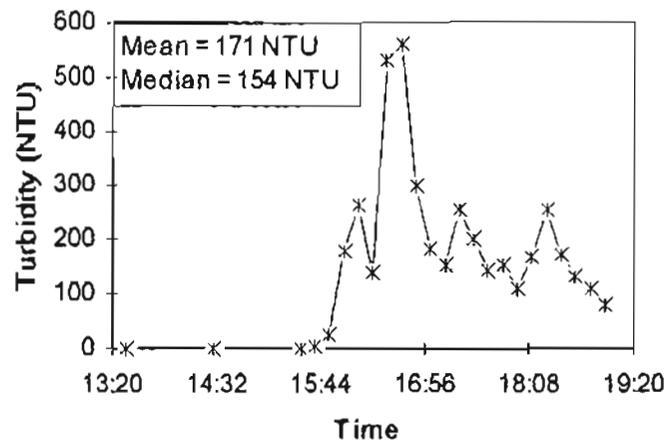
Figure 12. Turbidity at Birch Creek Gauging Site during Eagle Creek channel realignment. (9 October 1993)

The initial turbidity peak (275 NTU) at the Birch Creek gauge is due to construction of the new Eagle Creek channel. Although gravel was not moved near Eagle Creek and heavy equipment did not travel through Eagle Creek, sediment was introduced into Eagle Creek by reclamation activity. It was observed that as the heavy equipment traveled near Eagle Creek, sediment laden water would seep from the banks into Eagle Creek. The second peak of 550 NTU is the arrival of the 4500 NTU Eagle Creek peak. The two subsequent peaks at 250 NTU are poorly understood. (see Figure 12)

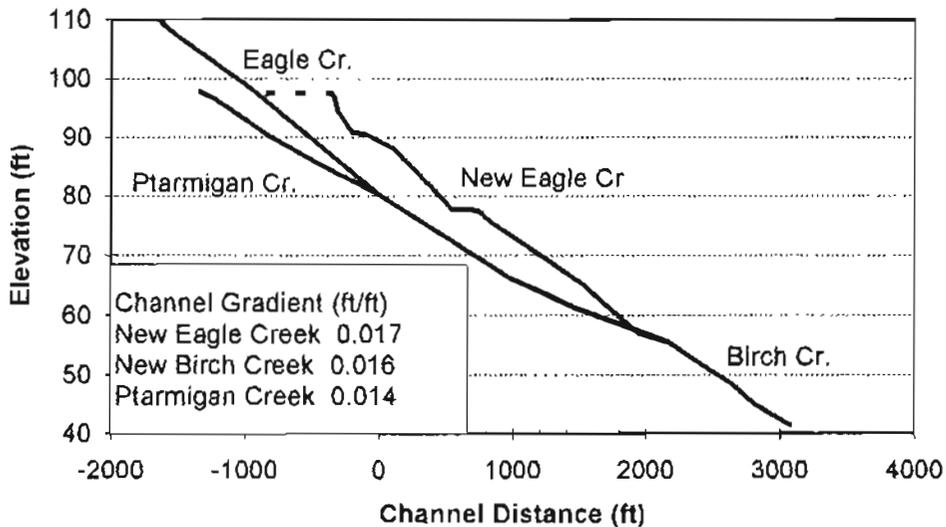
Figure 13. Water surface profile after reclamation of the Birch Creek site.

The six cross sections were resurveyed and are presented in Appendix A (Figures A.7-A.11). Water surface profiles for the site after reclamation were surveyed. The channel length of Eagle Creek was increased by approximately 1000 feet. The gradient of Eagle Creek was reduced from 0.018 ft/ft to 0.017 ft/ft. The gradient change at the confluence of Eagle Creek and Ptarmigan Creek was reduced to 0.001 ft/ft by moving the confluence downstream 2000 feet. The water surface profiles after reclamation are shown in Figure 13. No further monitoring was performed as unexpected delays resulted in the completion of reclamation in early October rather than late August.

The overall length of Eagle Creek was reduced by 500 feet above the existing Ptarmigan Creek and Eagle Creek confluence during channel realignment. Channel gradient differences were minimized by locating the confluence of Eagle Creek 2000 ft downstream of its original location. The flattened area of the water surface profile shown (Figure 13) is a pond that formed over a depression. Eliminating the rapid gradient change at the confluence of Ptarmigan Creek and Eagle Creek should allow both discharge and sediment to be transported through the Birch Creek site without deposition or scour. Gradient adjustment will allow bedload to be transported through the site. Although increased bedload transport downstream of the Birch Creek site will not impair water quality, the effects of changing bedload dynamics on the benthic community are not known. The channel will be continuously monitored for changes in gradient, bank erosion and bar formation.

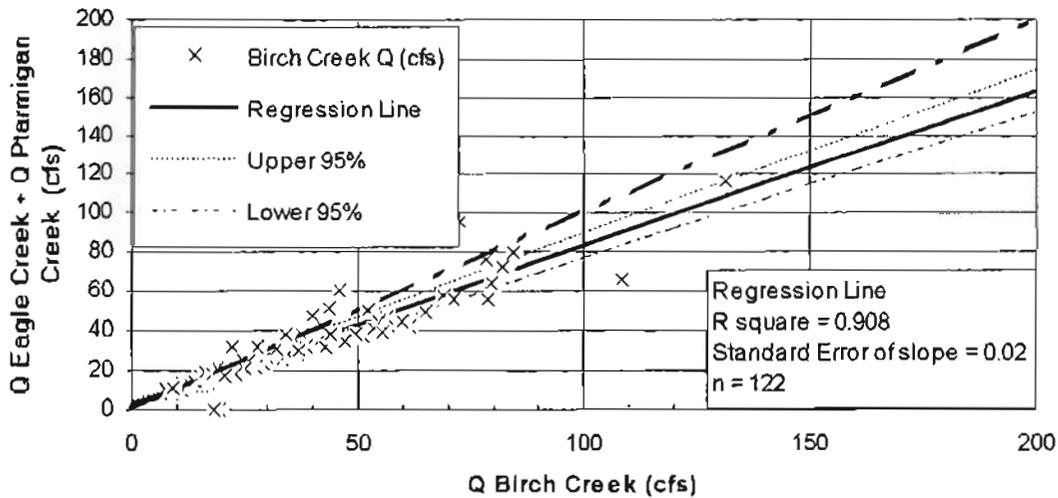
Figure 14. Discharge of Birch Creek as a function of the combined discharge of Ptarmigan Creek and Eagle Creek.

*Bold dashed line represents theoretical ($Q_{in} = Q_{out}$)

The discharge relationship between the discharge entering the site (Ptarmigan Creek and Eagle Creek) and the discharge leaving the site (Birch Creek) should theoretically be 1 to 1, assuming no losses. A regression line between the combined discharge of Ptarmigan Creek and Eagle Creek and the discharge at the Birch Creek gauge was calculated. For the above assumption to be true, namely no losses, the confidence interval of the regression line must include the theoretical line. The regression results and data are plotted in Figure 14. Since the confidence intervals do not include the theoretical line, the slope of the regression line shown in Figure 14 is statistically different than 1 (95% confidence). The magnitude of the losses indicated in Figure 14 indicates a surface water- ground water connection.

Calculated discharge values are based upon discharge measurements, which may be in error as much as 15%. To determine whether the relationship shown is real or an artifact of measurement error, the precision and accuracy of flow measurements will be tested during the 1994 field season.

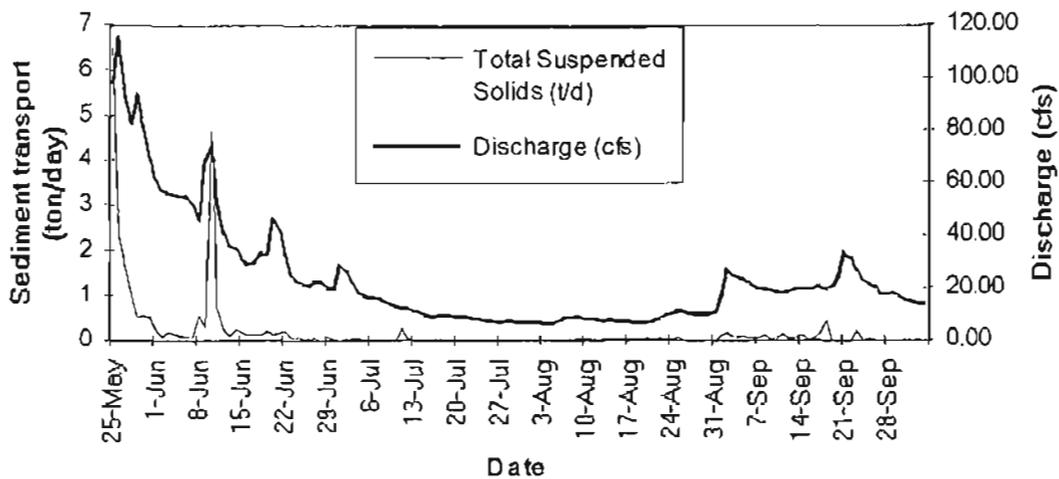
Figure 15. Ptarmigan Creek Discharge and Sediment Transport.

Seasonal turbidity for Ptarmigan Creek ranged from a peak of 2.2 NTU (26 May) to a low of 0.25 NTU (8 September). Mean turbidity of Ptarmigan Creek was 0.62 NTU and median turbidity was 0.49 NTU. The suspended load of Ptarmigan Creek does not appear to vary significantly with discharge (Figure 15).

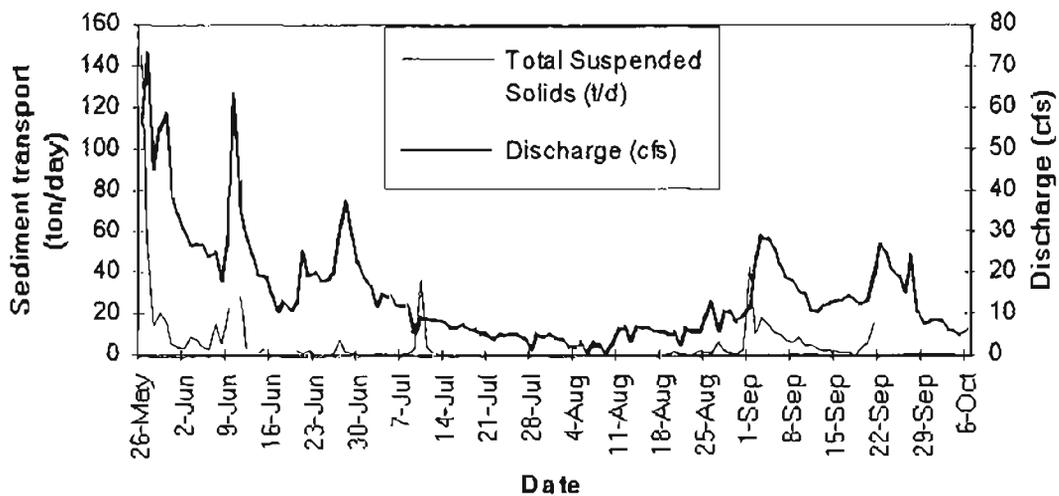
Figure 16. Eagle Creek Discharge and Sediment Transport.

Suspended sediment transport in Eagle Creek is far more sensitive to changes in discharge. Figure 16 shows both Eagle Creek discharge and suspended sediment transport during the 1993 field season. The relationship between discharge and sediment loading is almost directly proportional. This is consistent with results reported by others (Peterson et al., 1985). Eagle Creek has been mined from its confluence with Ptarmigan Creek to its ephemeral reaches on Mastodon Fork. The increased sensitivity observed is likely due to the presence of unbedded material in the flood plain of Eagle Creek.

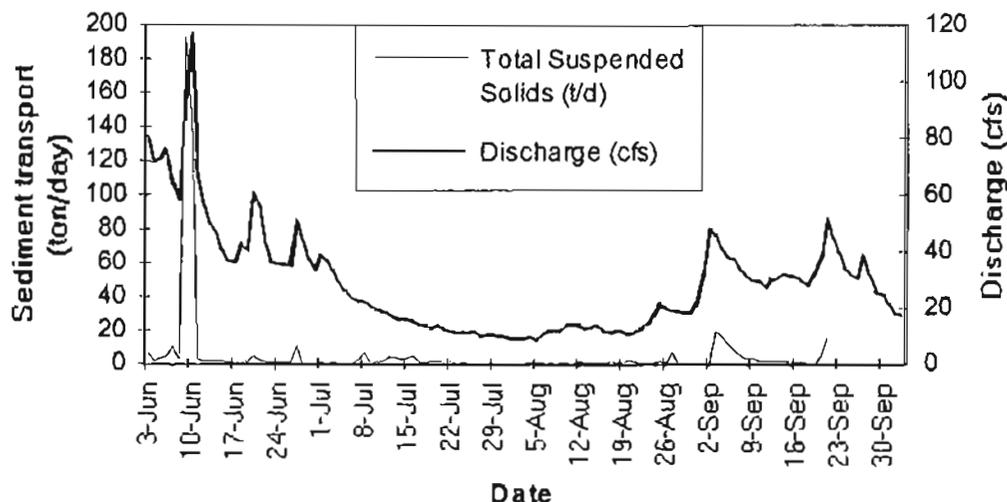
Figure 17. Birch Creek Discharge and Sediment Transport.

Suspended sediment transport at the Birch Creek below Reclamation gage displayed sensitivity to discharge comparable to that of Eagle Creek. Suspended sediment transport by Birch Creek showed that for average flow conditions the sediment loads of Eagle Creek and Ptarmigan Creek were transported through the Birch Creek Site. At high flows, suspended sediment loads at the Birch Creek gage were

higher than those of Eagle Creek and Ptarmigan Creek combined. Figure 17 shows the relationship between sediment transport and discharge for the Birch Creek gage.

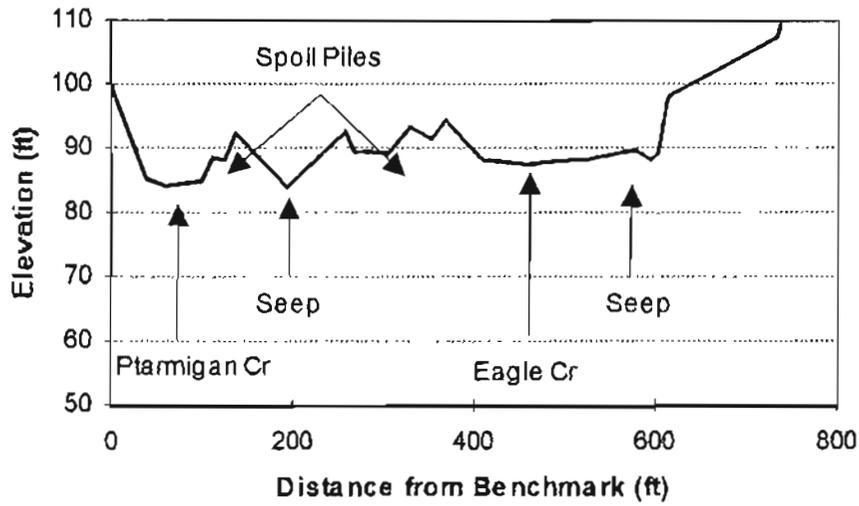
Figure A.1 Cross section #1 (22 June 1993)

Plots of site cross sections prior to reclamation work are shown in Appendix A. Surveyed elevations show that both Eagle Creek and Ptarmigan Creek are actively eroding their banks and that the bed of Eagle Creek is consistently higher than that of Ptarmigan Creek. Cross section #2 (Appendix A,
